STANDING BUILDING SURVEY, MILL OF BONNYTON, OLD RAYNE, INSCH, ABERDEENSHIRE, AB52 6TD

CAMERON
ARCHAEOLOGY
15 February 2011

SUMMARY

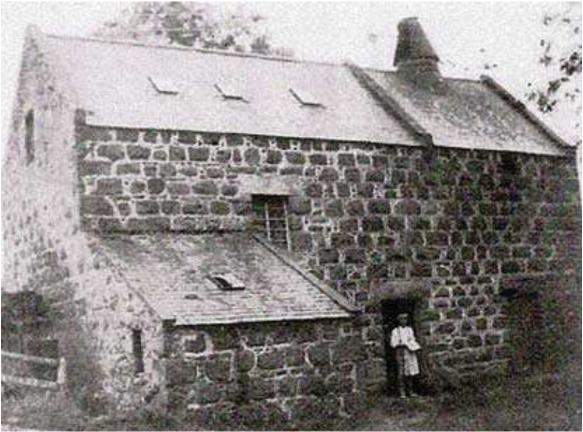
Ill 2 Building 1 and 1A, the south (front) façade of the mill showing the kiln and chimney (right)

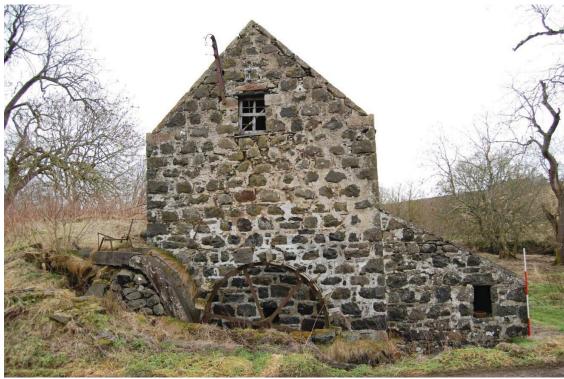
Ill 4 Building 1 west gable showing wheel (centre) and Building B1A (right) and mound of soil and stones F1 (left)

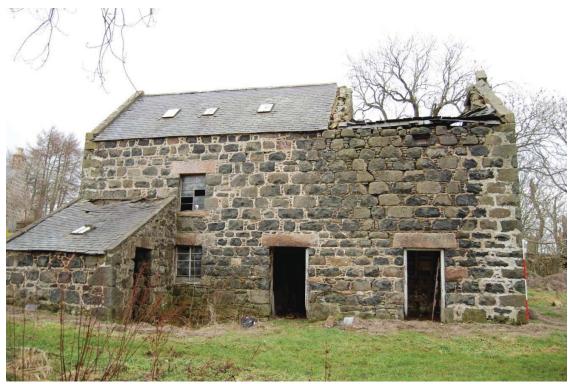
III 6 Building 1 south front façade of mill showing B1A (left) and damage and repair to kiln area (right)

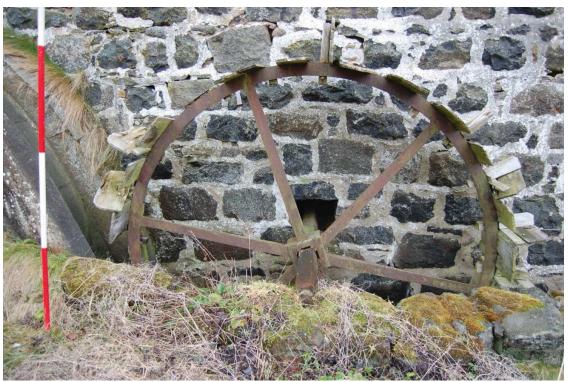
III 9 Building 1 millwheel 1 on west wall

The mill wheel (III 9) is 2.6m diameter and the paddles are constructed of one or two joined wooden planks 0.59 x 0.29m in size and 0.015m thick. The wheel is of cast iron and the paddles joined to the wheel with iron plates and bolts. The race and channel (III 7) leading to the wheel pit is 1.05m wide and the water channel 0.6m wide. The wheel is stamped 'Grandholm Foundry 1835' (III 11).

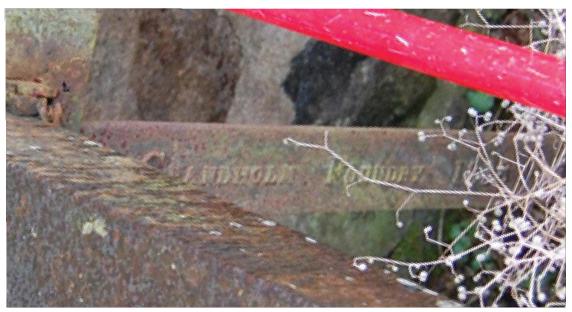
III 11 Building 1 'Grandholm Foundry 1835' on wheel spoke

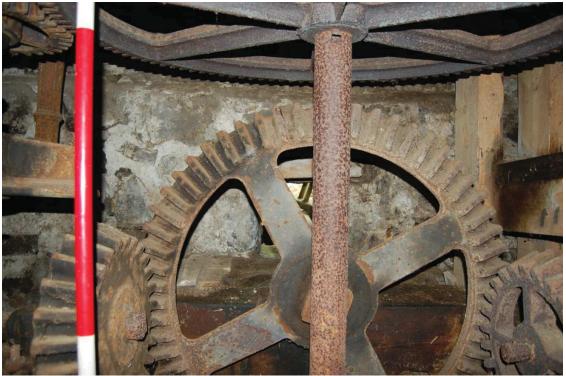
III 13 Building 1 detail of interior flywheels

A series of flywheels survive in a wood panelled room at the west of Building 1 (Ills 13, 14). On this partition is a wooden chute (Ill 14) which carried grain from the 2nd and 1st floors to the milling floor and kiln on the ground floor. There are two other chutes between the first and ground floors (Ill 15).

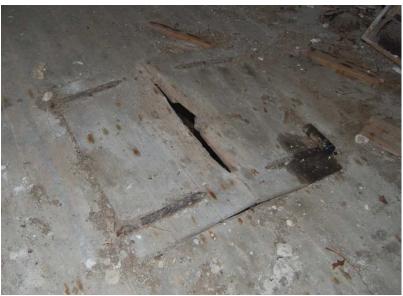
III 16 Building 1 First floor details of trapdoor

Trapdoors (III 16) in the centre of the floor on the first and second storeys allowed grain to be easily hoisted between floors on rope and pulleys.

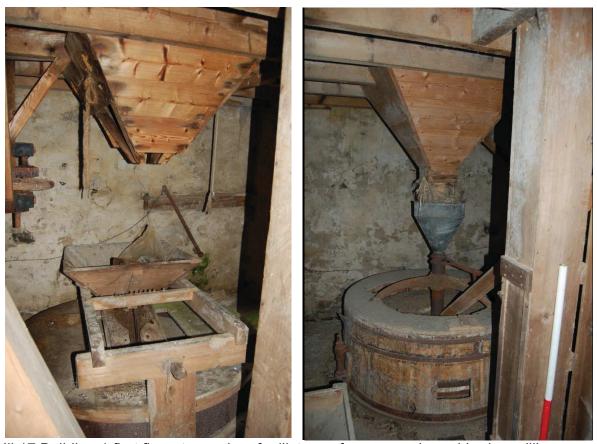
Ill 17 Building 1 first floor, two pairs of millstones for corn and pearl barley milling, west end of room

Building 1 still retains 2 pairs of meal stones on the first floor for milling corn and pearl barley (III 17), an oat bruiser (III 18) and the drying kiln (IIIs 15, 19).

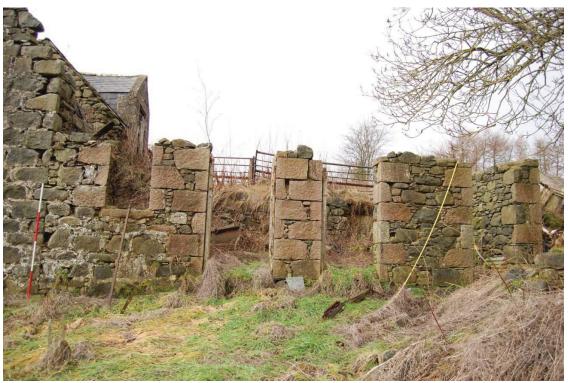
Building 2 is $9.5 \times 4.5 \text{m}$ in size and is attached at the SW gable onto the east end of the north wall of Building 1. There is no access between Building 1 and 2 but the wall between them is charred and damaged due to the proximity of the kiln on the opposite side of the partition wall. This would limit the uses of this building but it would have been a warm space.

III 23 Building 2 SE façade showing junction with Building 1 (left)

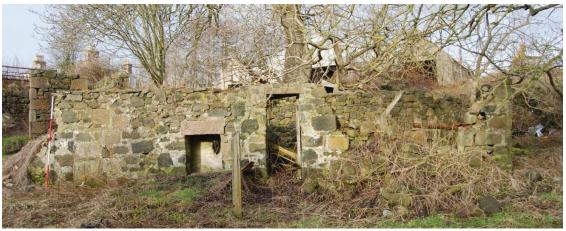
Building 3 is 10.7 x 3.7m in size and is on a NE-SW orientation. It is constructed of granite rubble and the front façade is to the SE. This façade now has four apertures including one (D8) with a large pink granite lintel. This was built as an agricultural building and the ground level was probably lower to the SE of this buildings. Central door D9 (III 26) is very narrow and is probably a later addition after the ground level was raised by up to one metre. D8 is probably the original door and a possible original plan and elevation is suggested in III 27.

III 24 Building 3 SE façade showing later door (D9 centre).

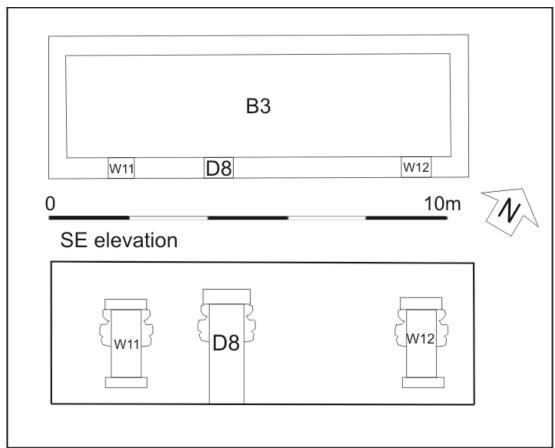
Ill 27 Building 3 proposed original plan and elevation; it is suggested that the ground level has been raised in this area and that D8 as the original door and W11 and W12 windows. Door D9 and the internal partitions associated with this door were probably later additions.

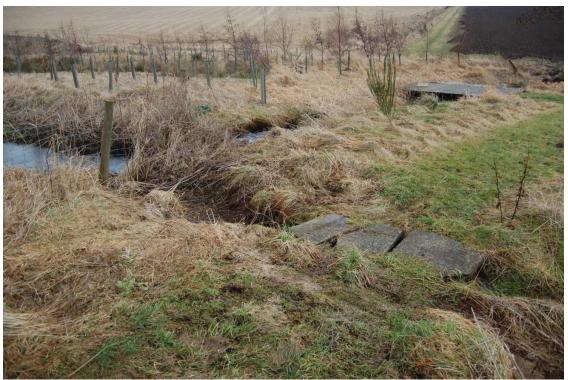
A mill pond and a series of overgrown mill lades survive (III 32-36) which are to be reopened during the current redevelopment. A mill lade has been constructed from the Bonnyton Burn at the extreme north of the site (III 32, 33). The lade took water to the site, splitting immediately north of Building 4 into a lade running west to the Mill wheel 1 and the main mill and the other running west to Building 4. Both then return into Bonnyton Burn. The lade to the main mill wheel is now partially underground whereas the line of the other is still visible (III 34).

Ill 32 Bonnyton Burn (left) and mill lade covered with stone (right foreground)

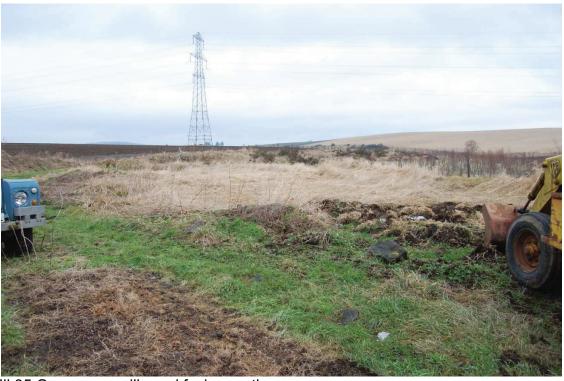
III 35 Overgrown mill pond facing north
