SHORE PORTERS SOCIETY,
33 COTTON STREET,
ABERDEEN, AB11 5EE

SHORE PORTERS SOCIETY, BANNERMILL PREMISES, 33 COTTON STREET, ABERDEEN, AB11 5EE

SUMMARY

A standing building survey was carried out on 8 February 2011. Access to the interior was limited slightly by the contents of the warehouse but sufficient areas were accessed to carry out the survey to the relevant detail.

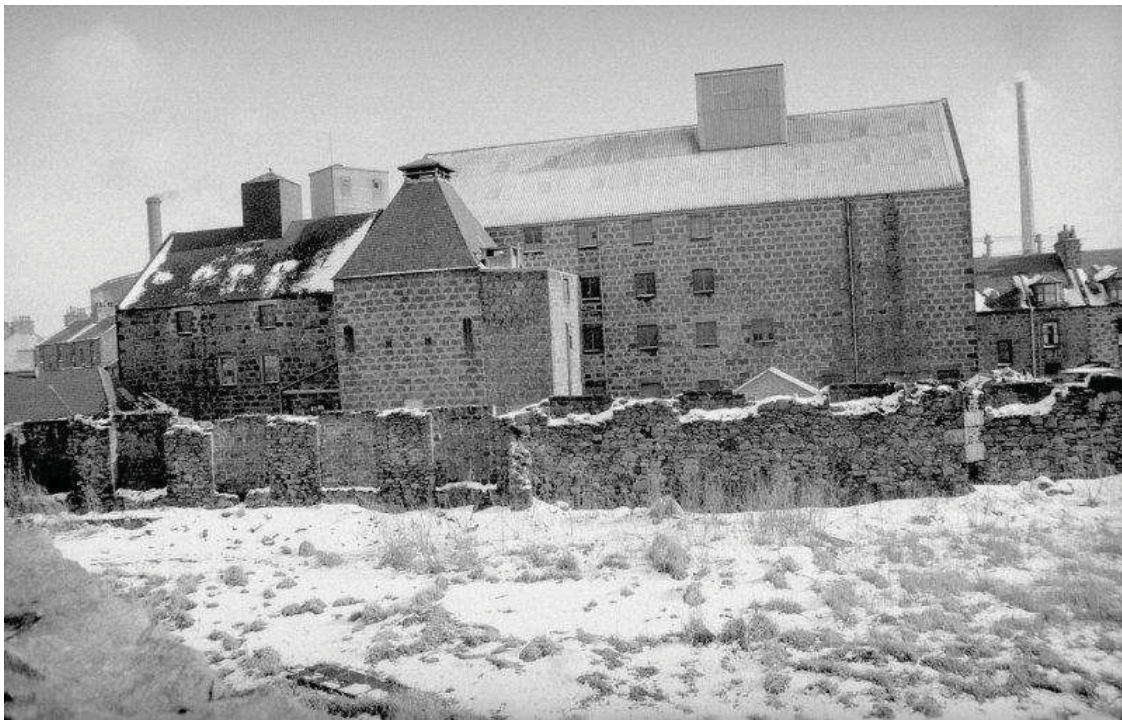
III 3 NW façade showing kiln now demolished (copyright CANMORE)

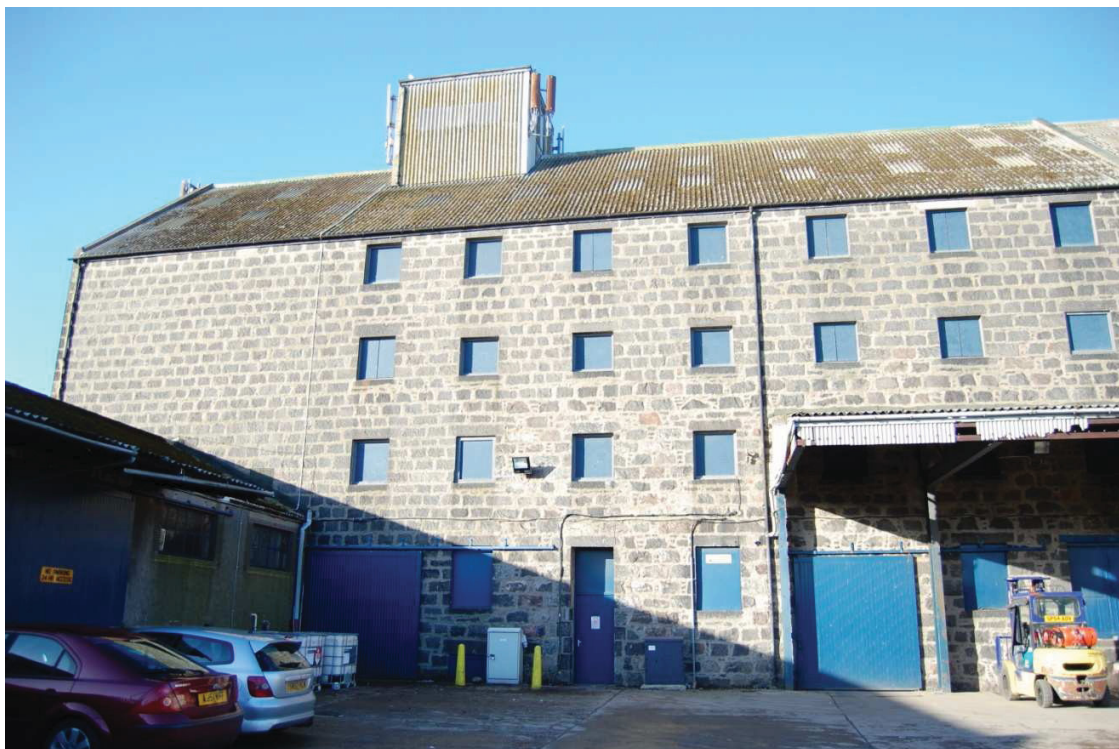
III 5 Building 1 SE façade

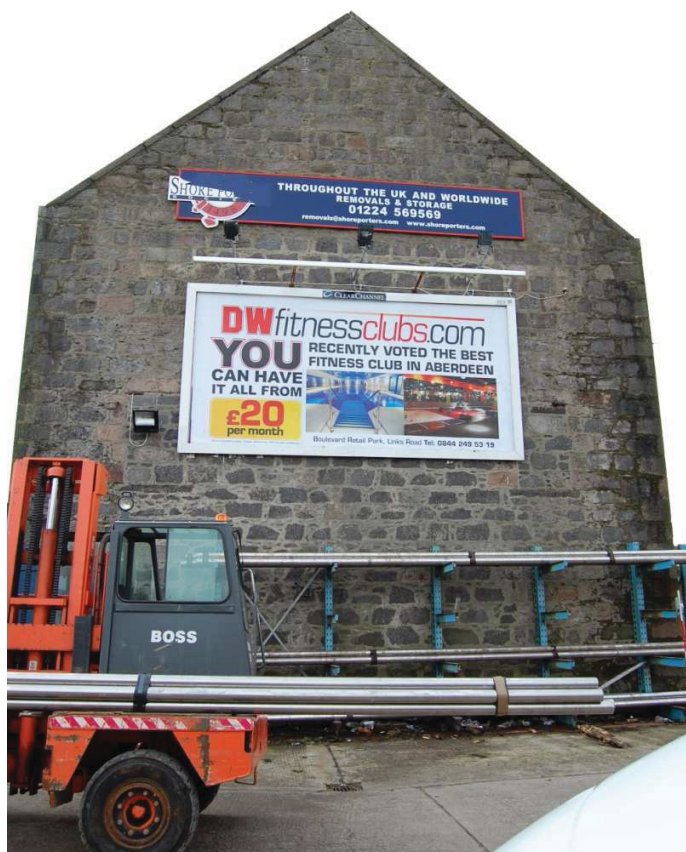
III 10 Building 1A NE gable

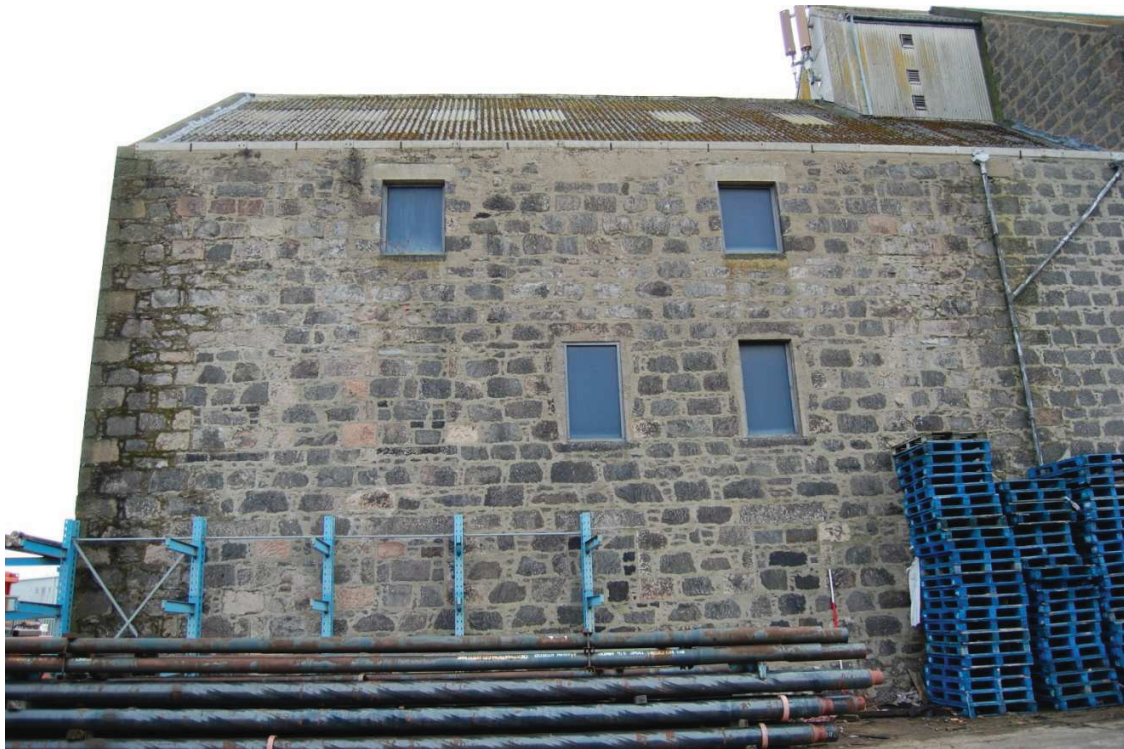
III 11 Building 1A NW elevation

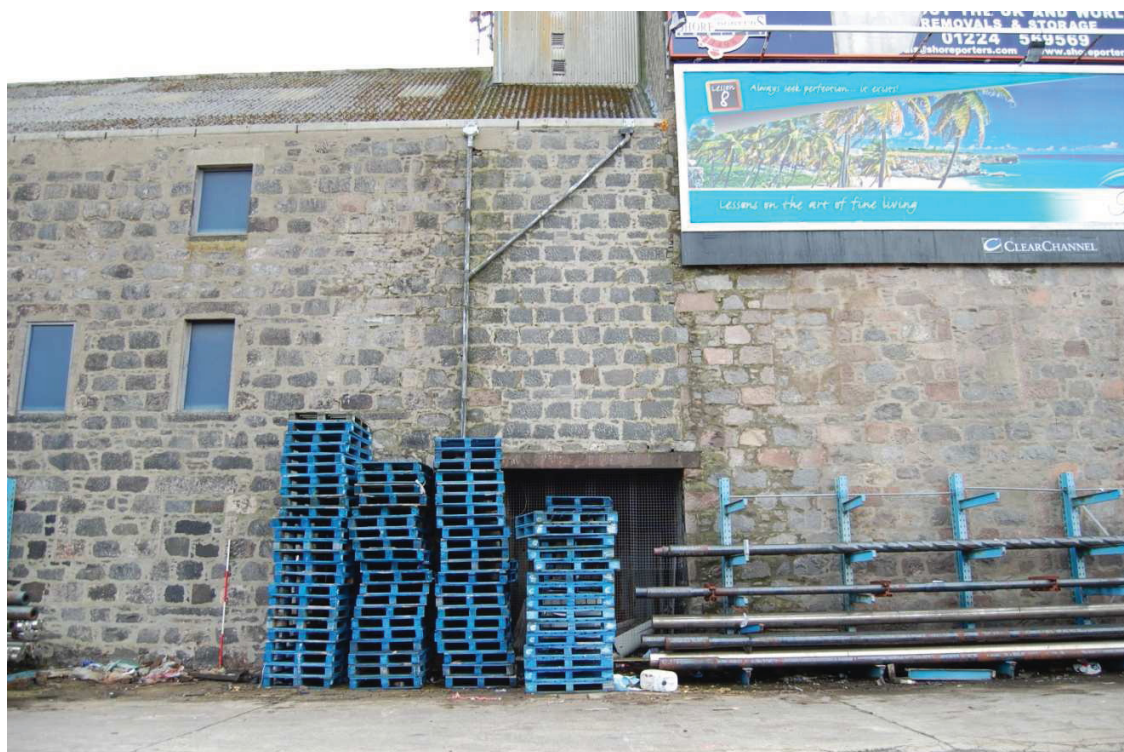
III 14 SW elevation showing scar where kiln removed prior to 1970

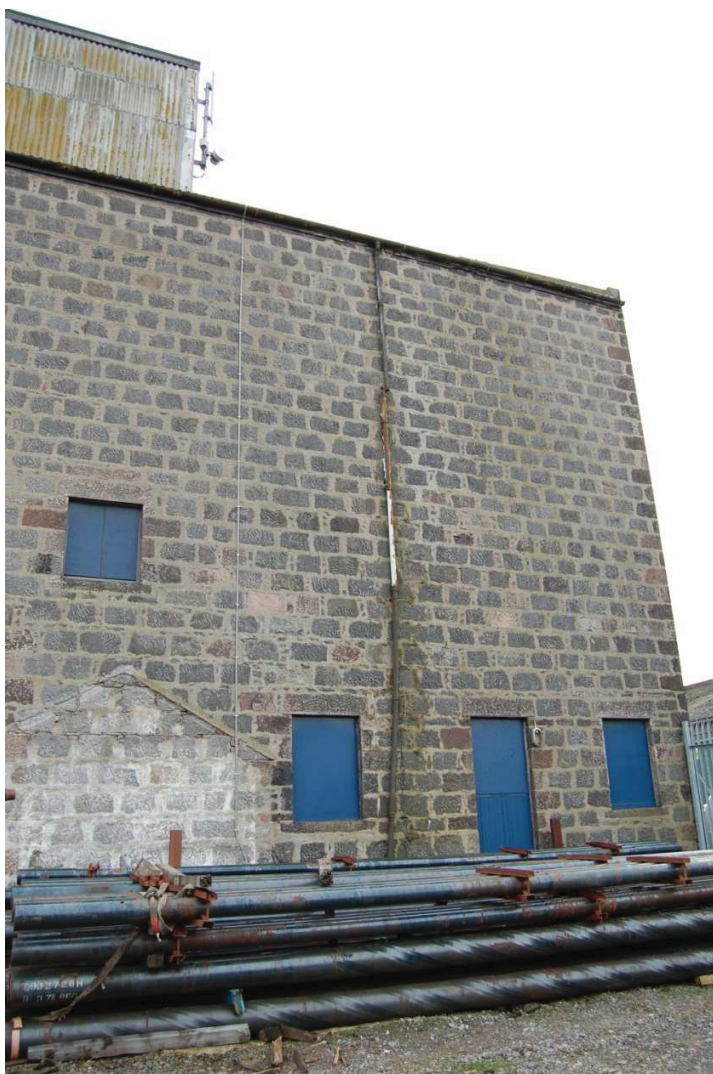
III 15 SW elevation including scar where toilet block removed (left)

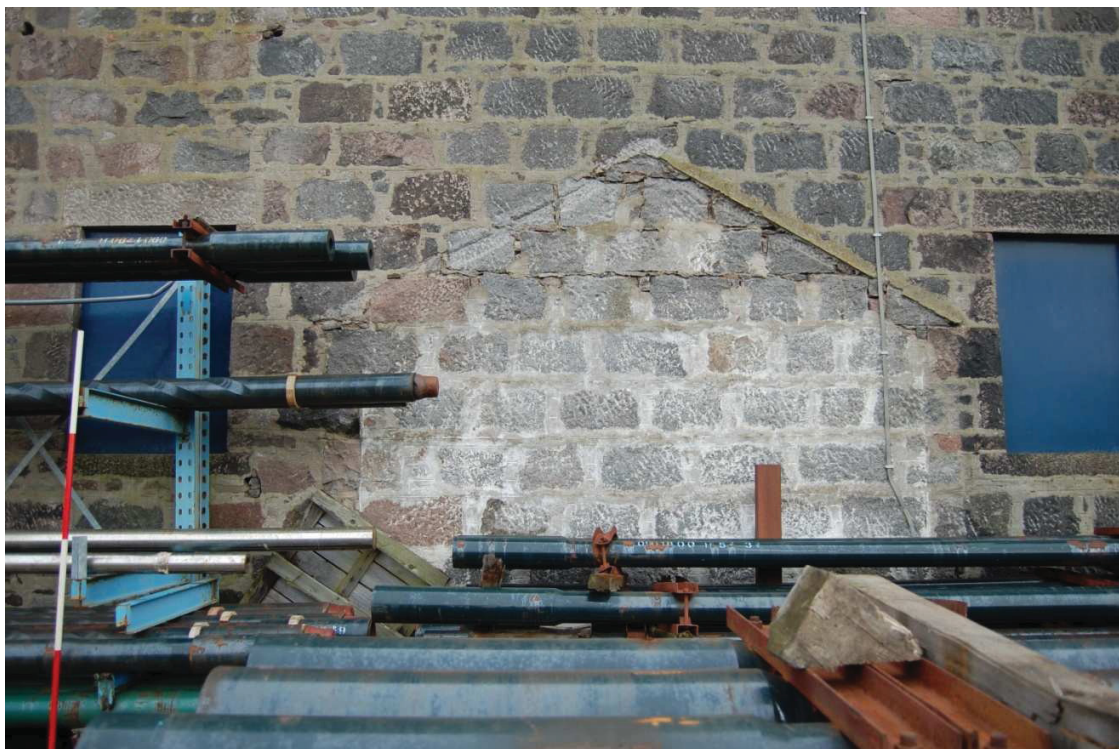
III 16 SW elevation including scar where toilet block removed

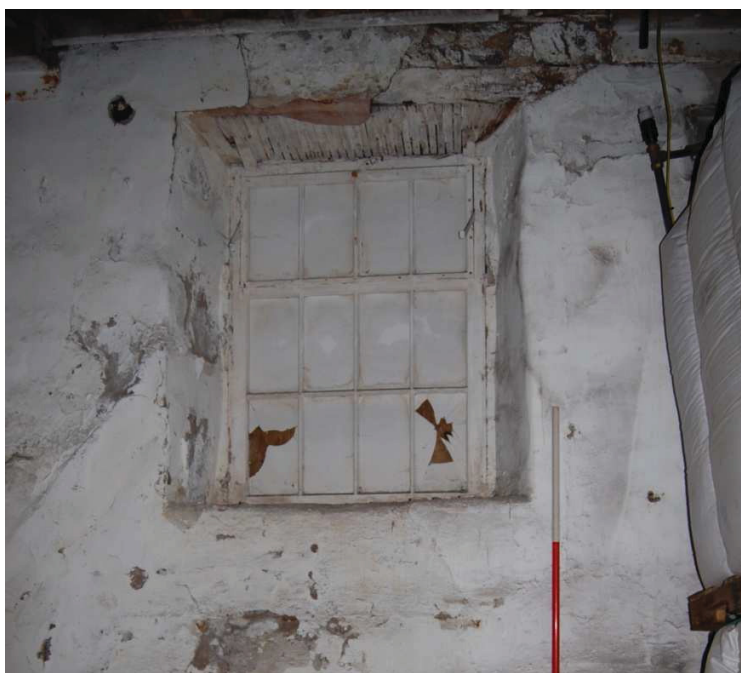
III 17 First floor window SE façade

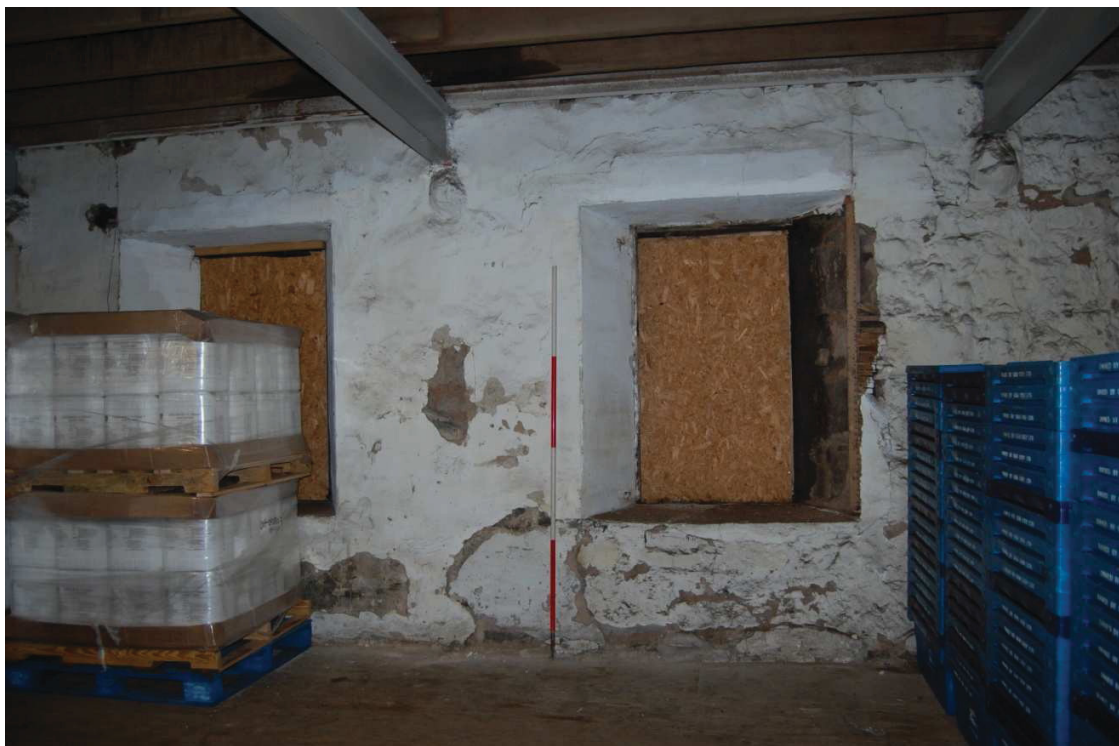
III 18 First floor Building 1

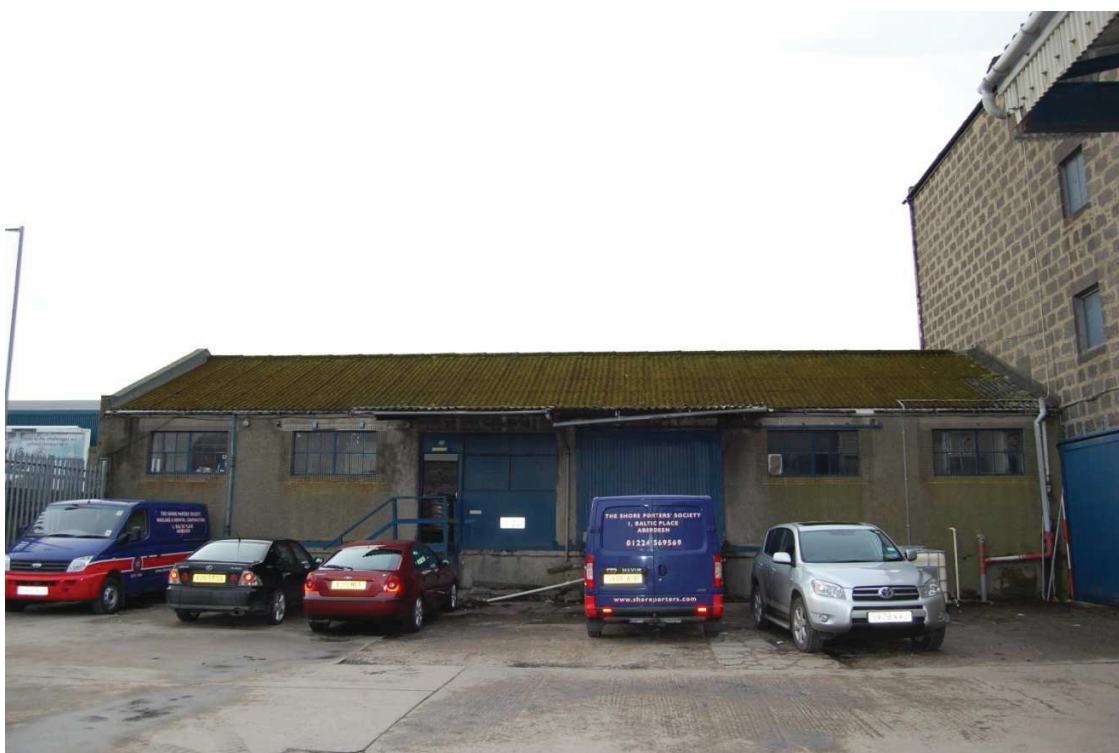
III 19 Building 2

Building 2 is 21m x 8.5m in size and was added on to the main complex in the 1970s when Shore Porters obtained the buildings. It is concrete with a concrete asbestos roof. Part of the stone boundary wall has been built into the south end of this building.

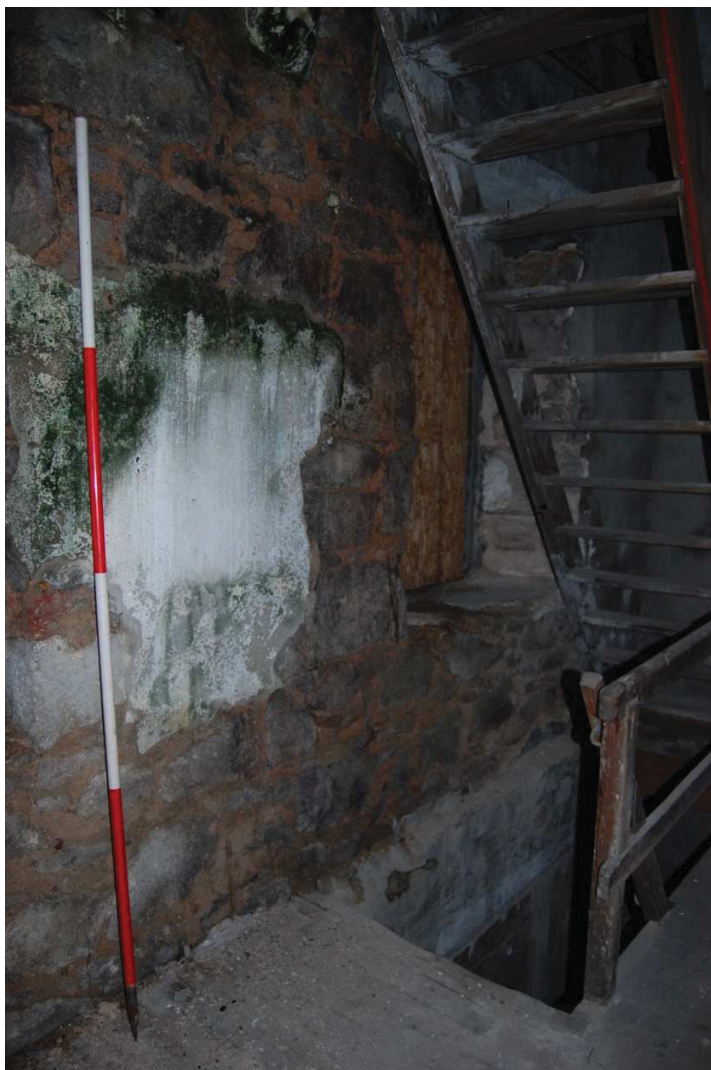
III 20 Building 1A stairwell
