Kennall Vale, Ponsanooth, Cornwall

Archaeological management and interpretation

Client	Conserving Cornwall's Past
Report Number	2011R021
Date	May 2011
Status	Final
Report author(s)	Ann Preston-Jones
Checked by	Peter Rose
Approved by	Peter Rose

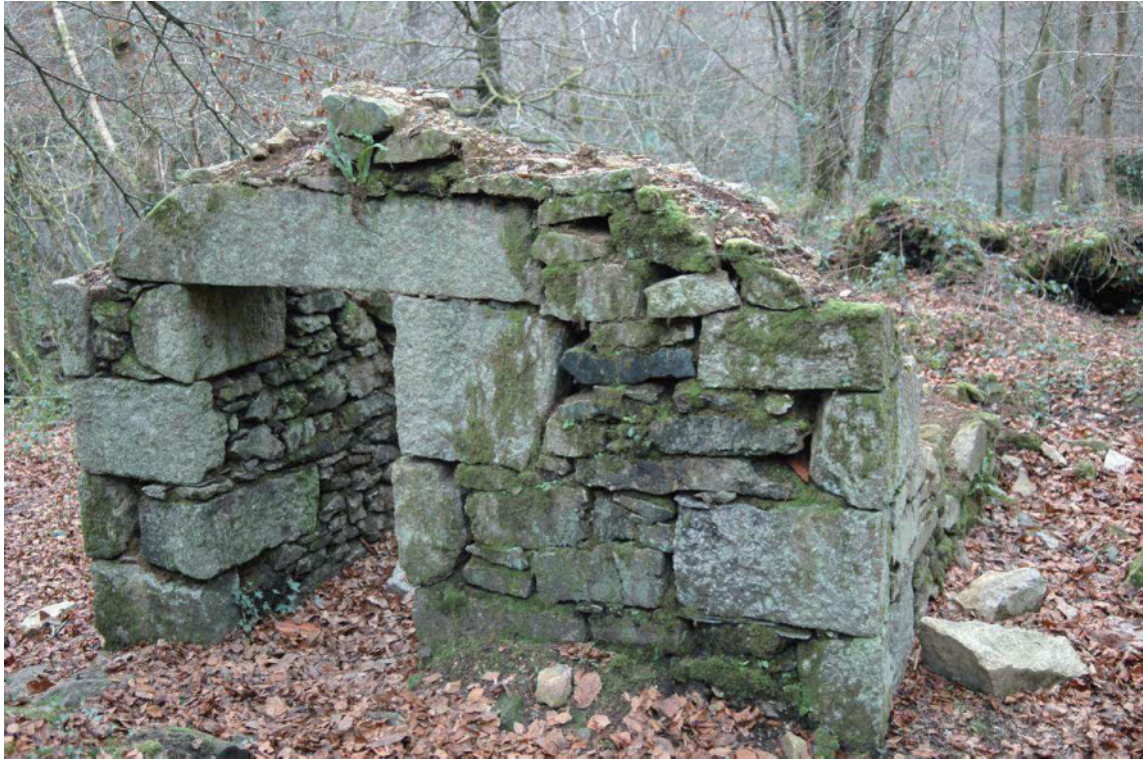
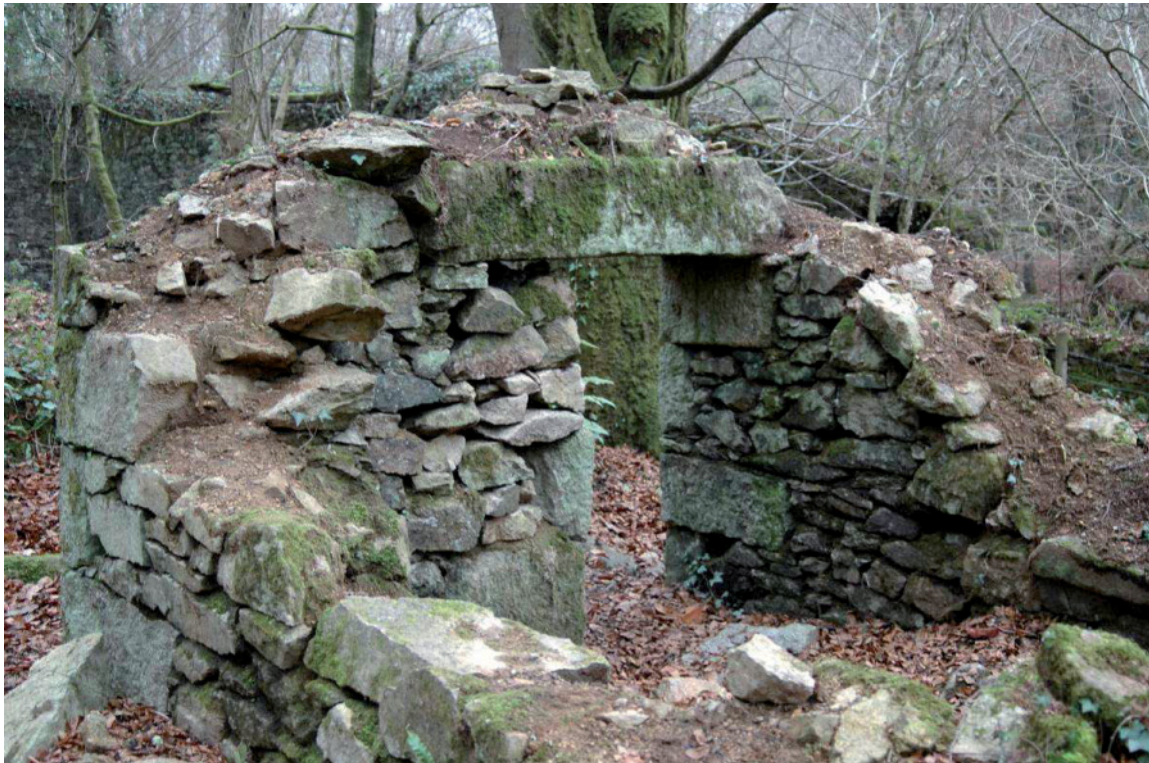
SW wall: although masonry had been replaced beneath the internal lintel, this was cosmetic only and not supporting the lintel at all. The masonry of the wall as a whole had very little surviving mortar and light could be seen right through in places. Vegetation (ivy and bramble) had been removed from the wall-top, possibly in a misguided attempt at conservation, but this had only had the result of leaving the wall exposed and vulnerable to further erosion.

Fig 9 Cask house, SW wall, from west (above) and east (below)

1. The area of vandalised stonework in the doorway was rebuilt, in order to support the internal lintel, using stone retrieved from the foot of the wall, and in a style which matched the adjacent walling. This involved the replacement of one substantial squared granite quoin (shown in red on Fig 8 and labelled on Fig 15)
2. The entire wall was deep pointed, recessing the pointing, and finishing by covering all joints in earth to hide the mortar and encourage recolonisation of moss and lichen.
3. On the top of the wall: the top two courses of stone were removed, reserving stones and any surviving earth/rab mortar. The stones were cleaned and re-bedded in mortar, in exactly the positions from which they had been removed.
4. Reserved rab/earth was replaced on top of the wall, to encourage vegetation to regenerate.

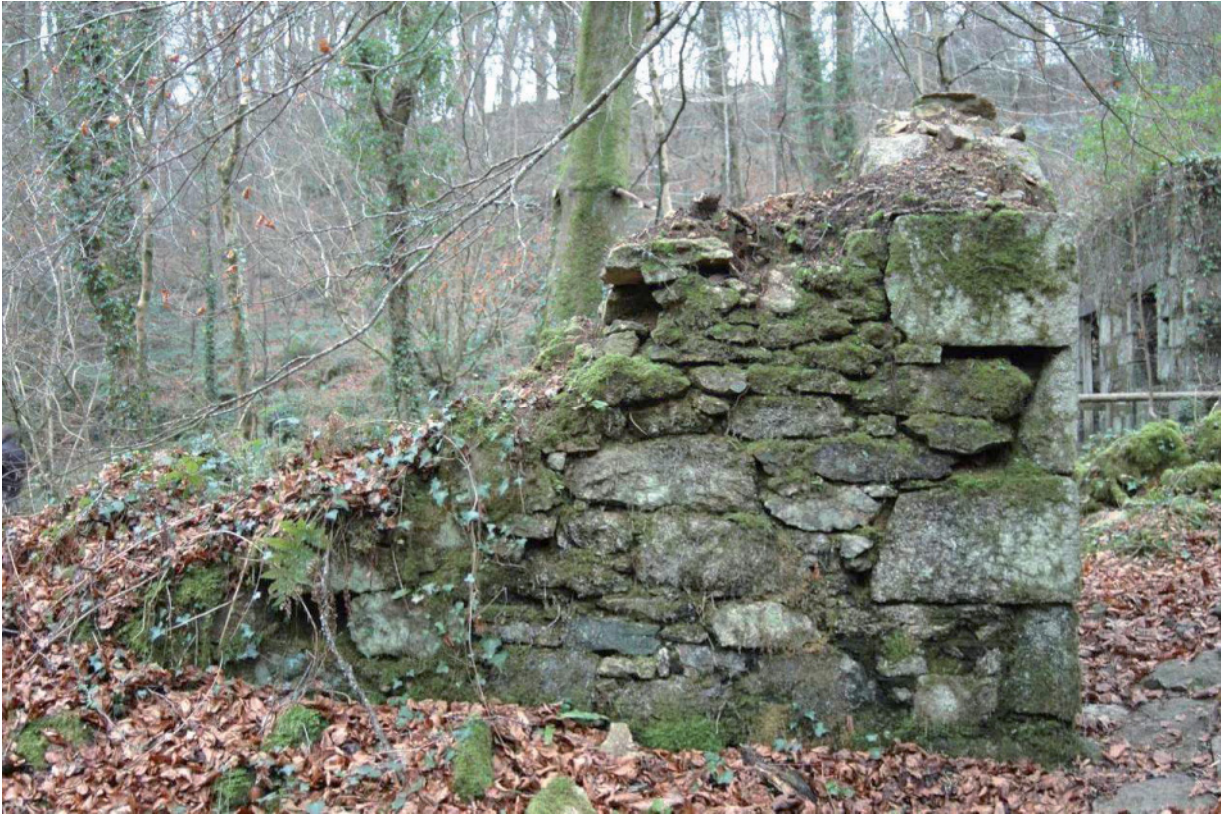
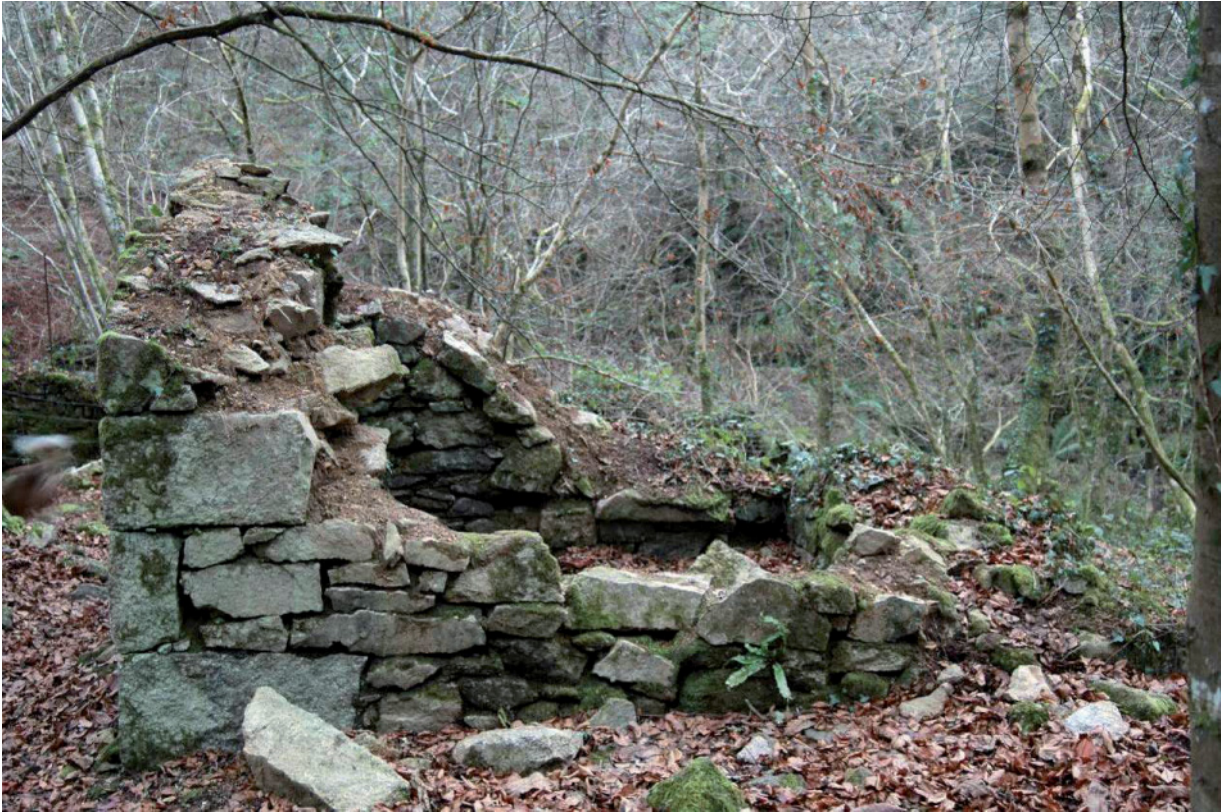
NW and SE walls: where masonry adjoins the SW wall and still stands to any height, the stonework was in similar condition to the SW wall. Where it had already been eroded and reduced in height, it was more stable, although the recent removal of vegetation from the tops had exposed the tumbled remains to further erosion.

Fig 10 North-west (above) and south-east (below) walls of cask house

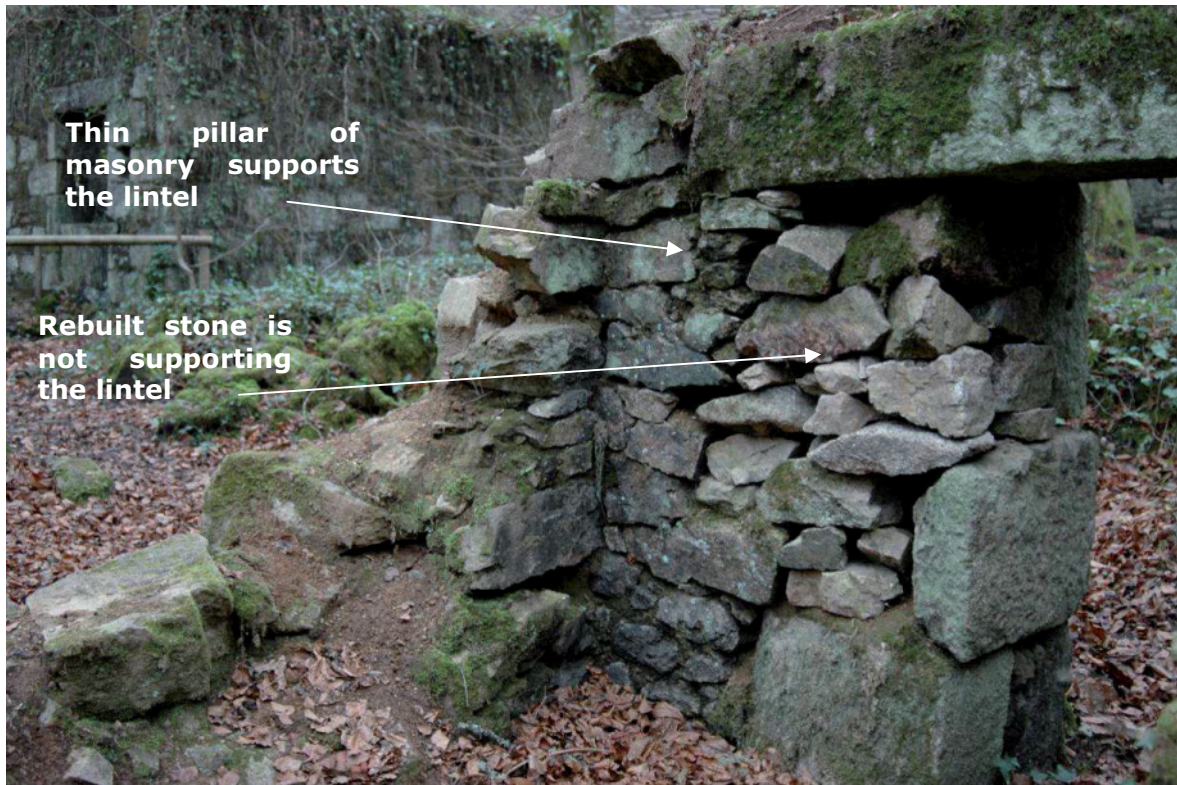
In 1985, upstanding walls stood to approximately half their original height, except at door end which was virtually intact (Smith 1986b). By 1999, however, Herring noted that consolidation of walling was urgently needed on the SE and NW corners, as well as removal of saplings from the walls and the interior (Herring 2000, 11). In September 2006, a FMW's damage report recorded recent vandalism, stones having been pulled from the walls in various places. At that date, the building's walls were bare of vegetation but the tops, where not vandalised, had a thin protective covering of ivy and some bramble (Preston-Jones 2006). On subsequent FMW visits, further robbing of stone from the structure was noted and in October 2008 the internal face of the wall containing the door was found to have been robbed of stone to the extent that the lintel was now supported on a very slender pillar of masonry only.

Fig 11 Barely supported lintel of cask house

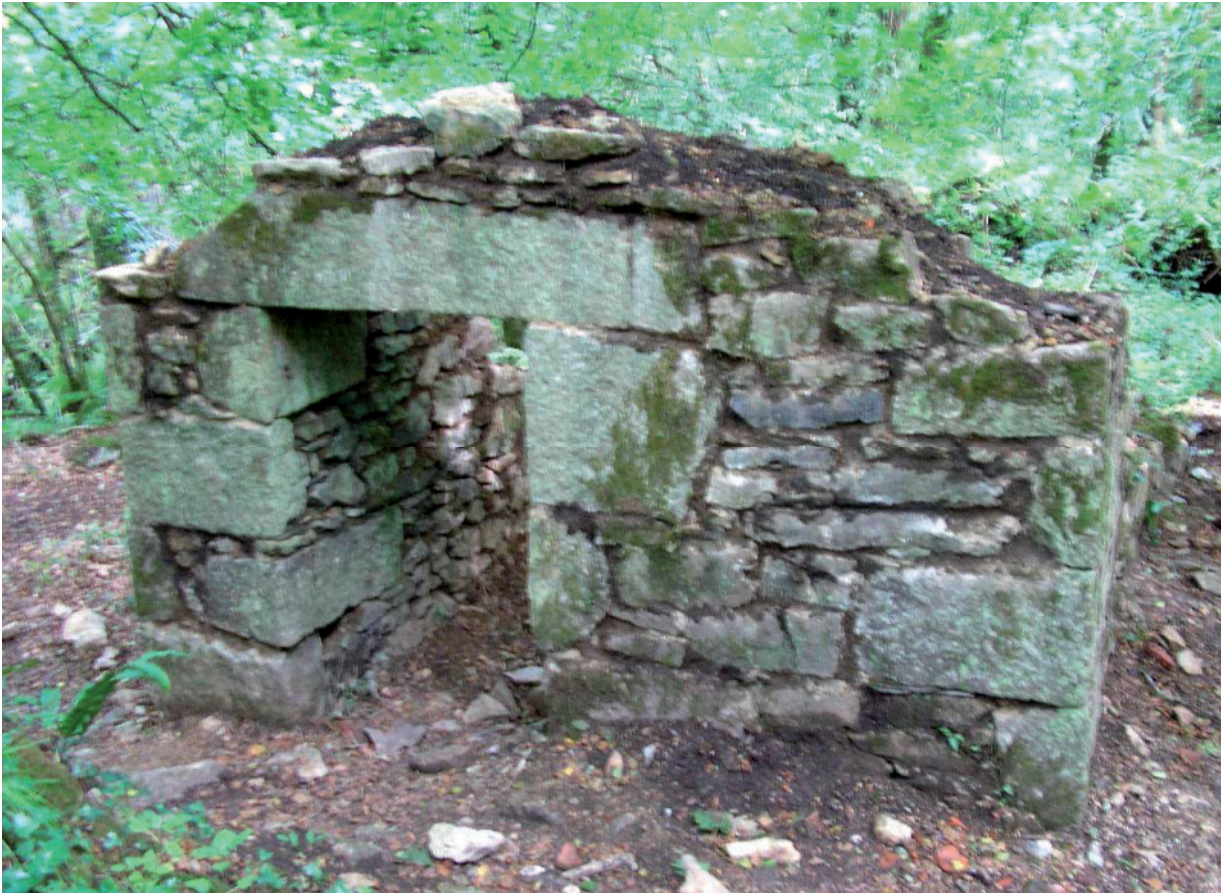
Fig 14 Cask house SW wall after consolidation

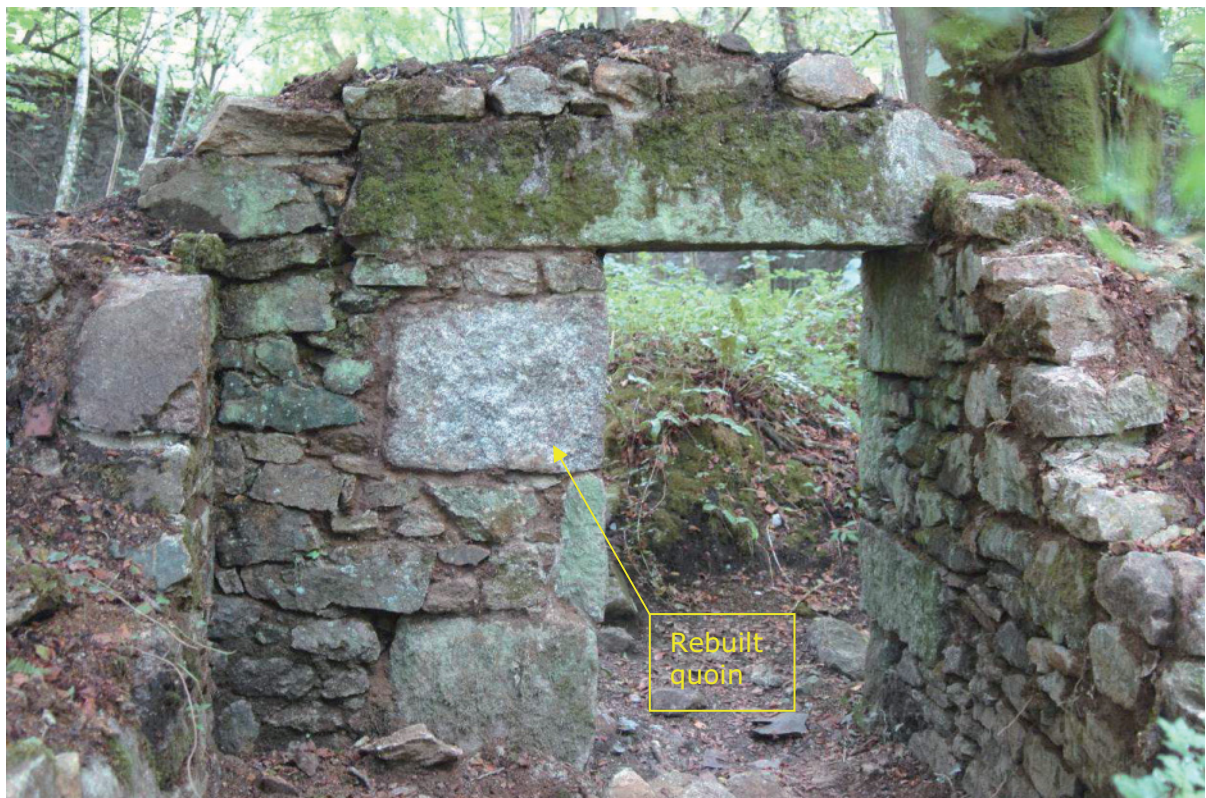
Fig 15 Cask house SW wall after rebuilding of door jamb

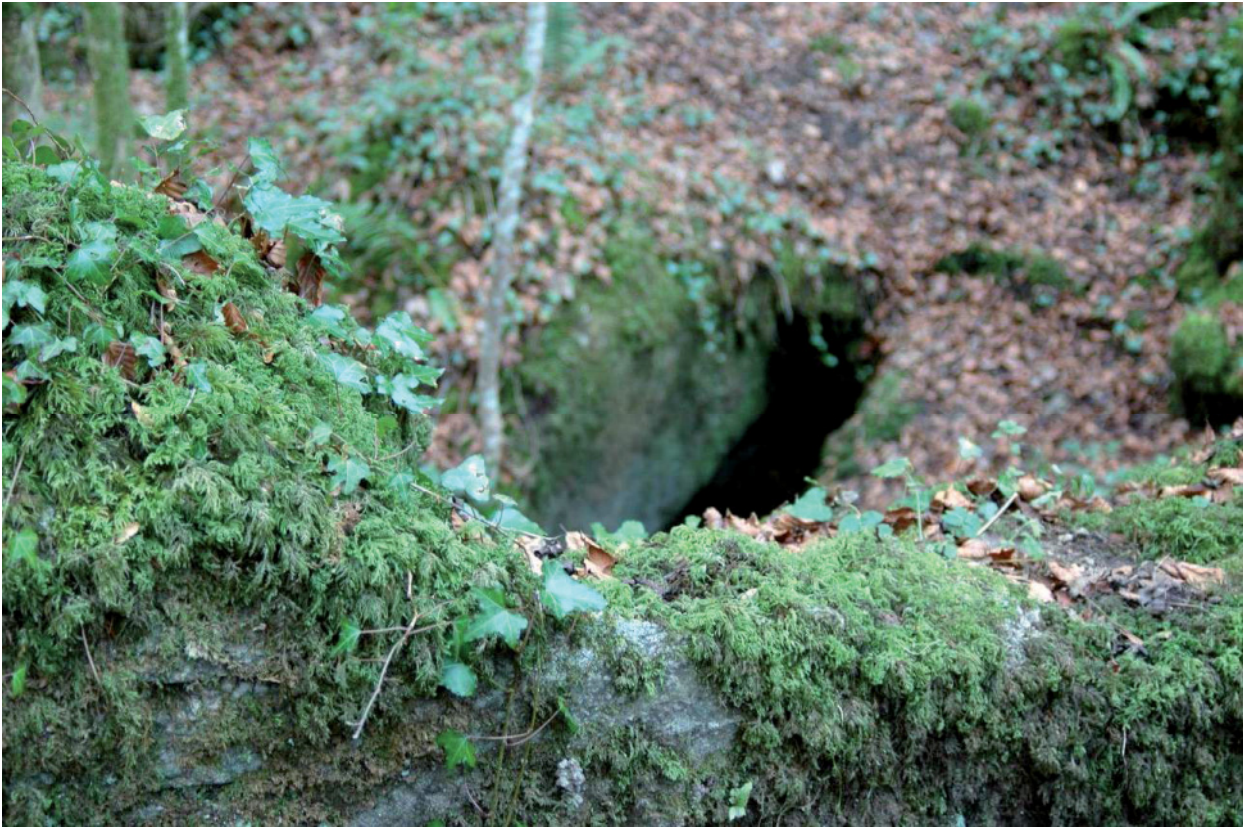
Damage to the parapet of the bridge appears to have taken place before 1999 (Herring 2000, 37), but has never been deemed a priority for repair. However, in December 2008, CWT suggested that it should be repaired, since the damage at this point facilitates access to a 1-metre diameter hole in the ground immediately to the west, where the roof of a culverted section of leat has collapsed, leaving exposed a drop of nearly two metres into the leat below (Fig 18).

Fig 18 Hole above culvert adjacent to bridge

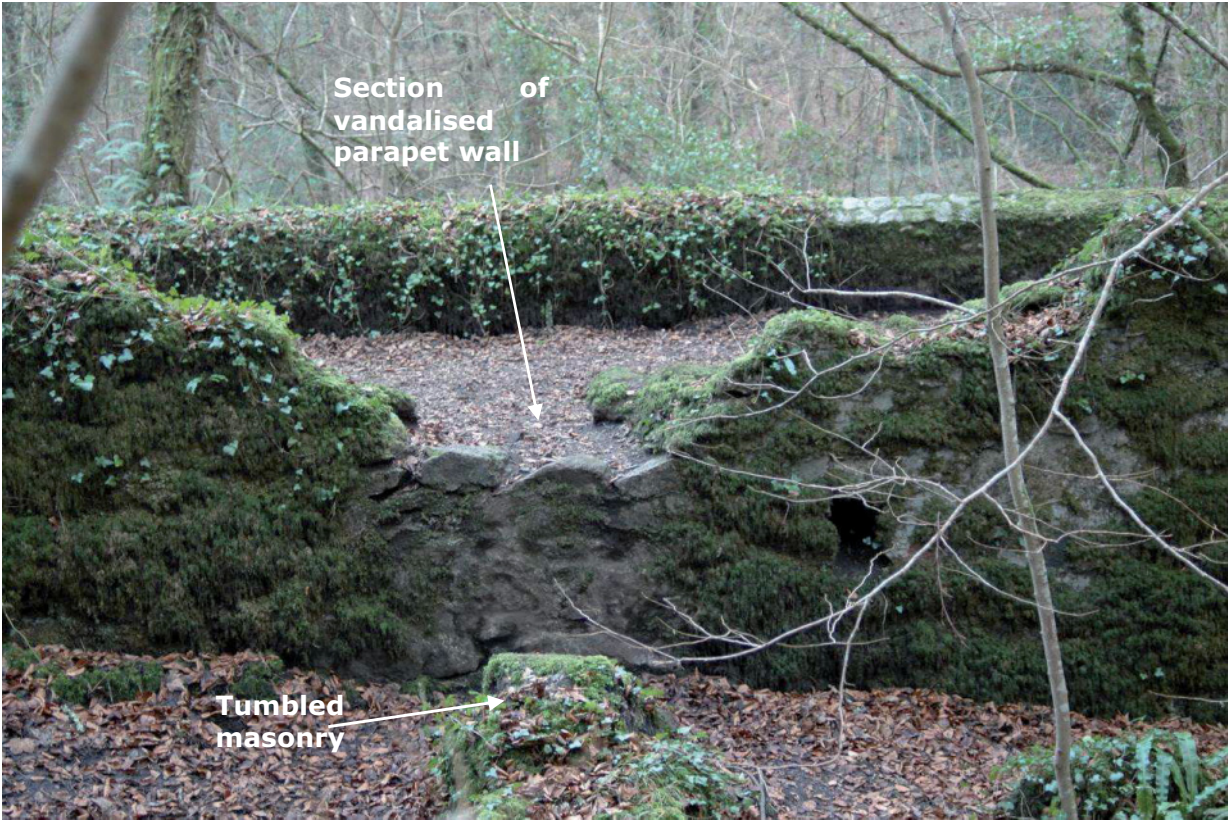
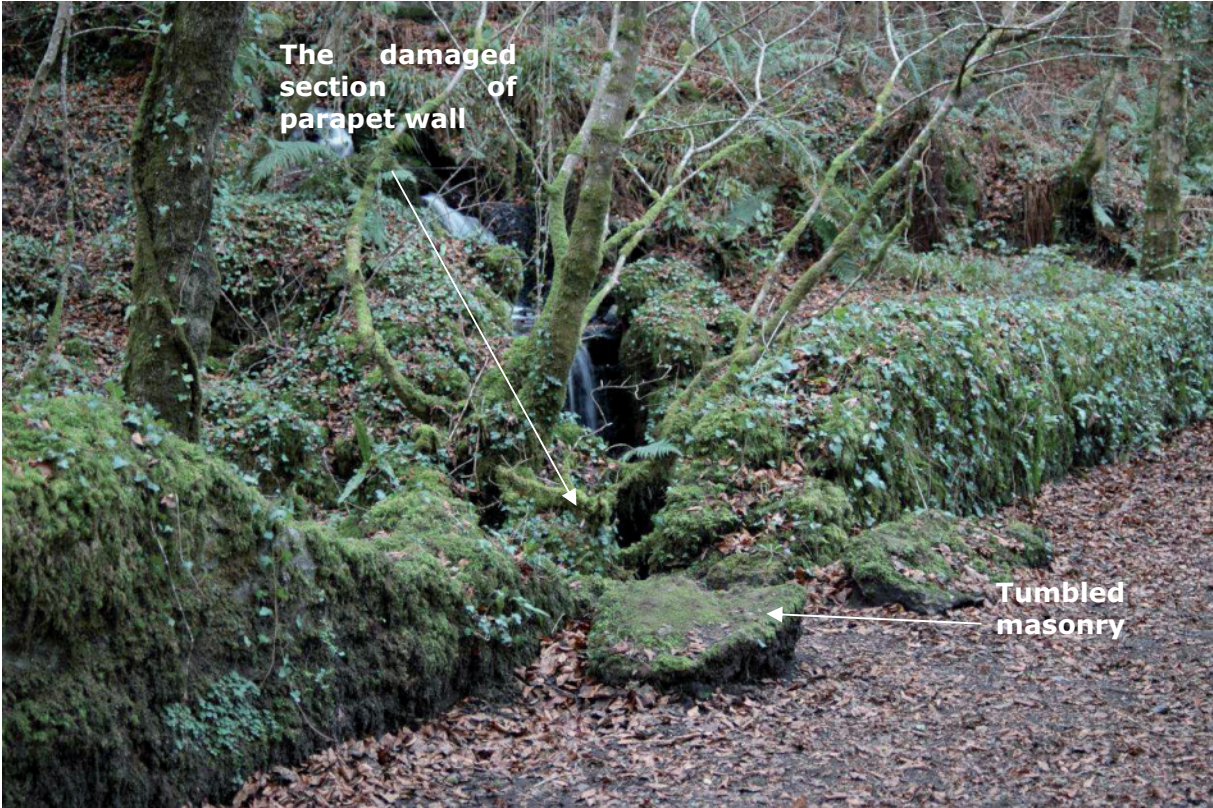
The damage affects a four-metre length of the parapet on the causeway leading to the bridge, not the bridge itself (see Figs 19, 20). Lumps of moss-covered masonry lie on the ground to either side of the bridge.

Fig 20 Damaged parapet of causeway leading to bridge, from the east (above) and from the south (below)

This section of parapet wall was repaired in July 2009, using stone found at the base of the wall and nearby. Although the wall has been repointed in cement, this section was rebuilt using lime mortar, as indicated in section 8.1. The repair was made in a style which matches that of the masonry in adjoining sections of the wall. See Fig 21.

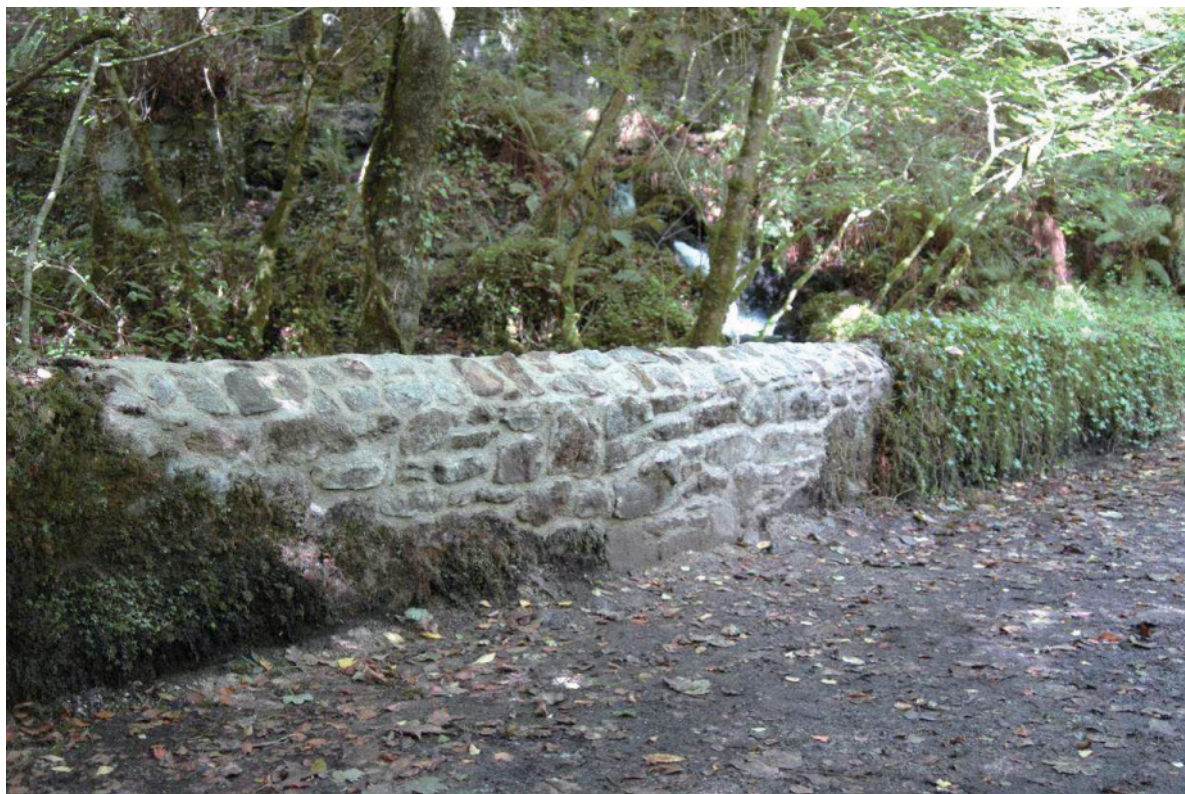
Fig 21 The rebuilt parapet

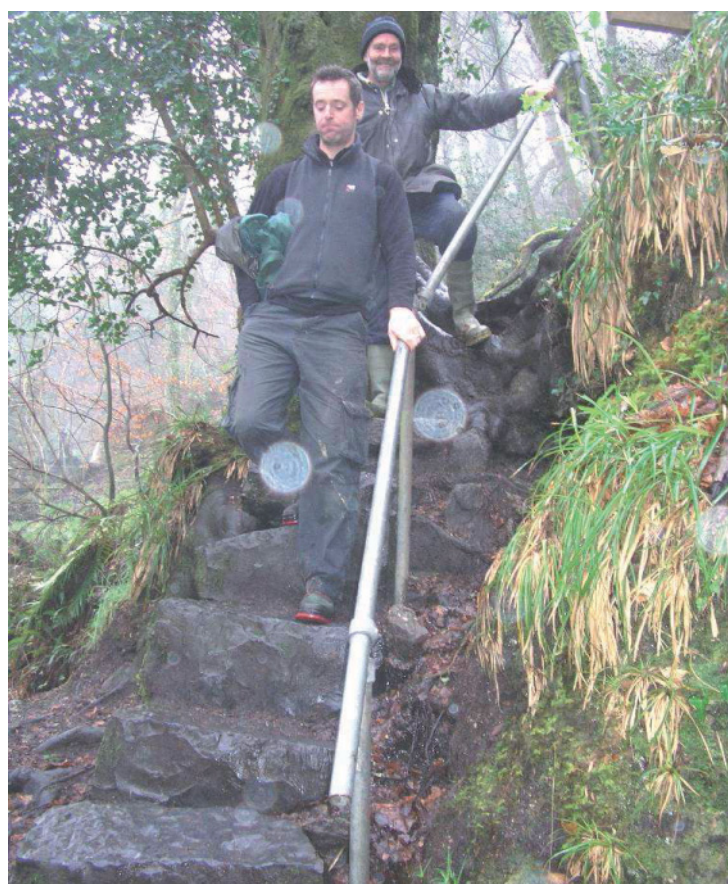
The steps leading to incorporating mill pair 22/23 from the west are built of blocks of grey limestone, recycled from the millstones used in the incorporating mills. As a result of frequent wear, they are very smooth and slippery, as well as uneven and hazardous, particularly in wet weather. See Fig 22.

Fig 22 Limestone steps adjacent to mills 22/23

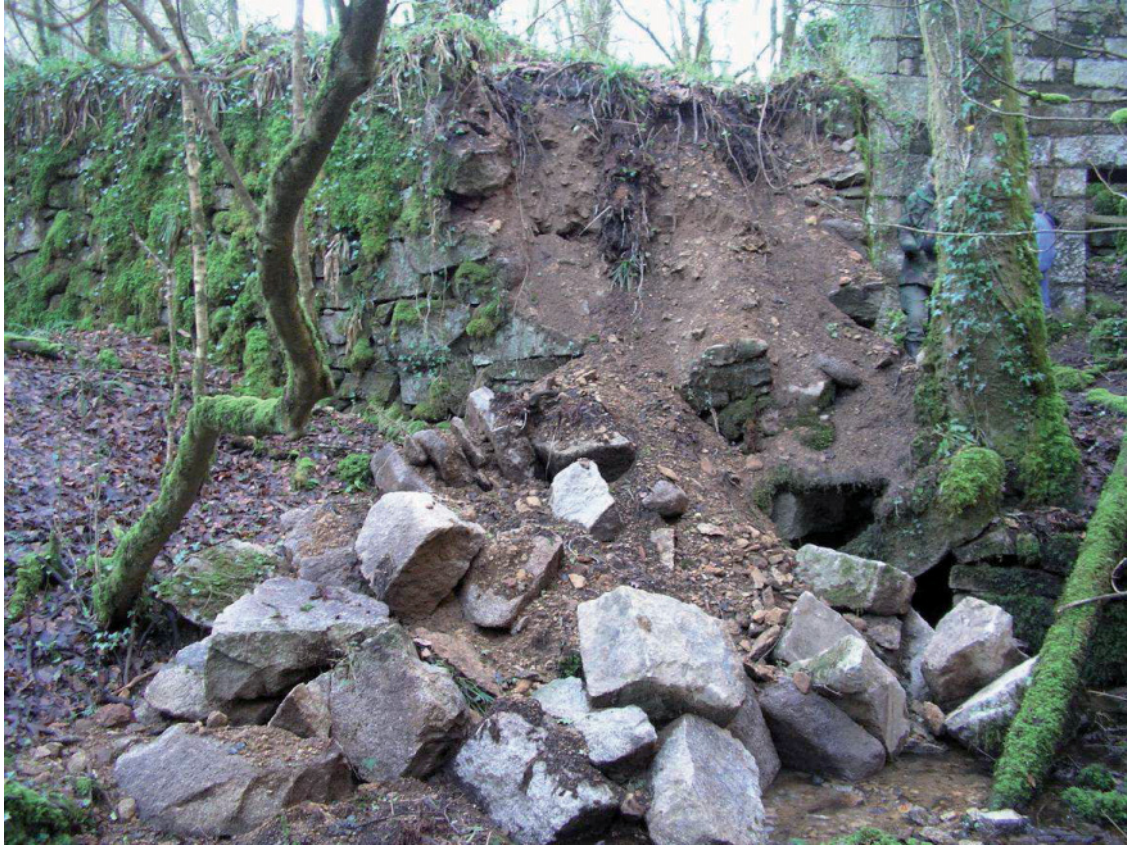
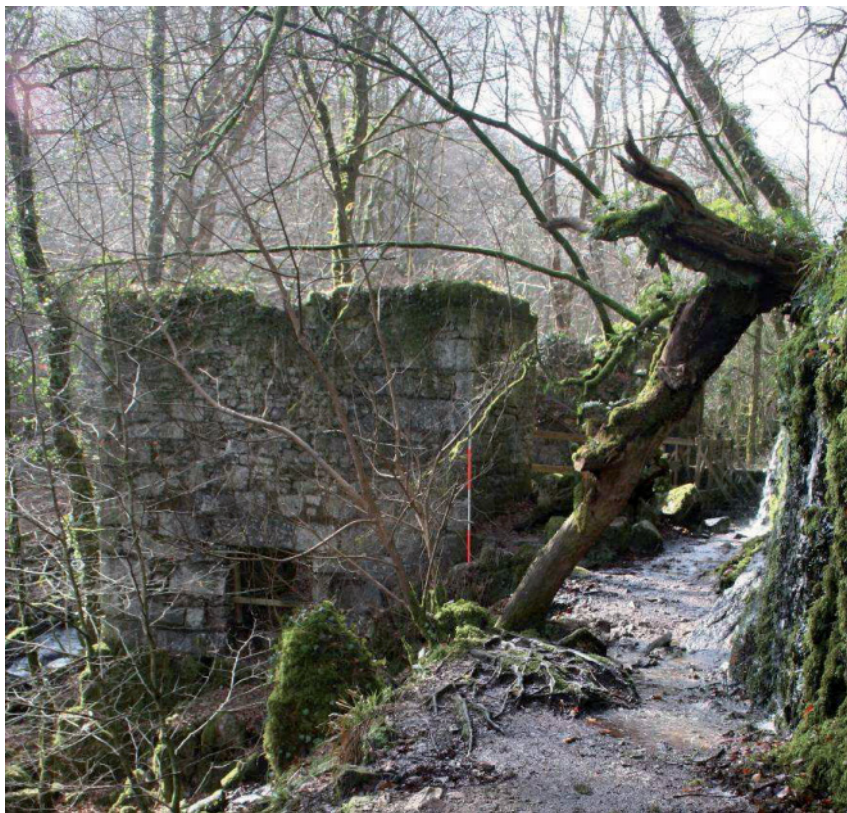
The FMW had also wished to explore the possibility of reconstructing a large section of walling retaining a bridge abutment, damaged after the fall of a tree in 2003 (Fig 23), but this had to be ruled out, once discussion with a builder indicated that the expense would be beyond the reach of the present project.

As mentioned above (section 3.1) trees are one of the major threats within Kennall Vale – to public safety as well as to the buildings. Fig 23 (above) illustrates the potential results of tree-fall on a bridge abutment; 23 (below) shows where a tree fallen across a path with, behind it, a dangerously leaning tree. The continuous nature of the threat is demonstrated by the description below, recorded by Adam Sharpe of HE, who was monitoring the repair work to the cask house in July 2009 when a tree fell nearby. Note that this was apparently spontaneous and happened in the summer, not at a time of heavy rain or high winds.

Fig 23 Examples of tree damage at Kennall Vale: the top picture shows where a tree rooted into a bridge abutment has fallen and taken a large quantity of stone with it; the lower shows where a tree has fallen onto the path which runs beside the leats, linking the incorporating mills. This path is used by most visitors

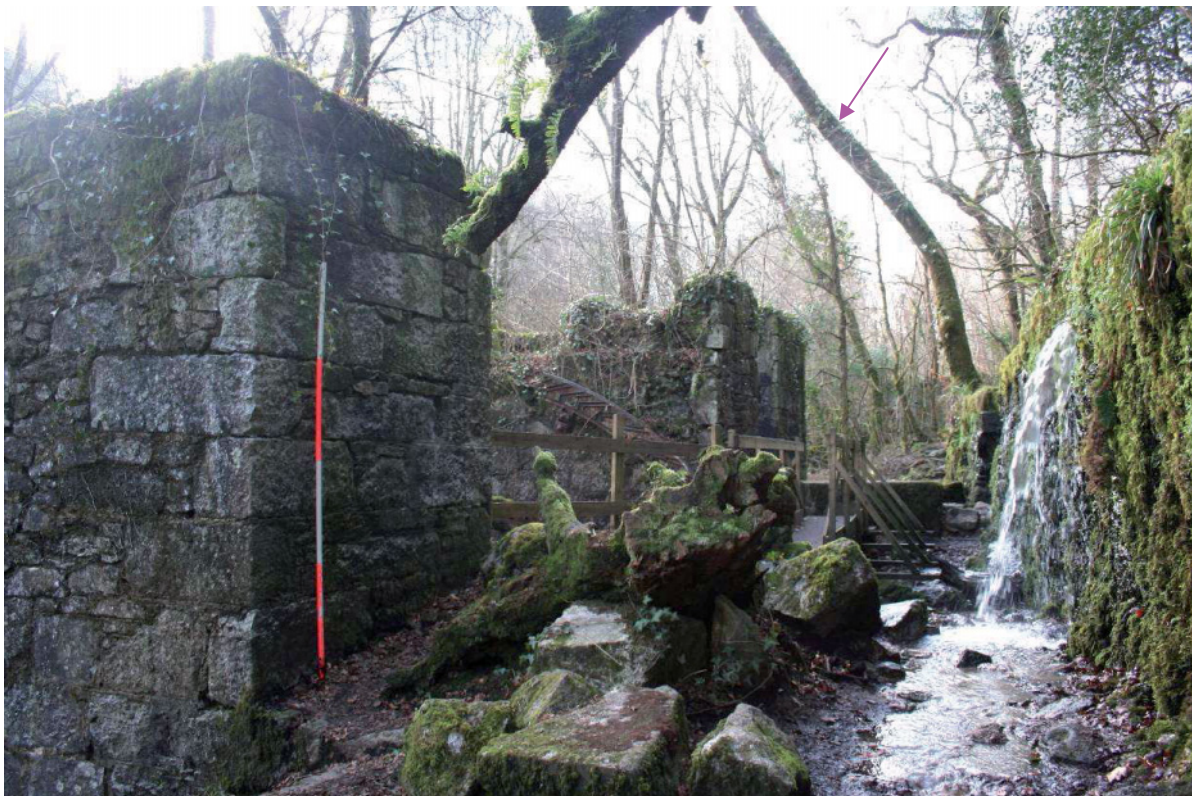
Fig 25 One of the trees which has now been felled, seen leaning out over leat, mill and a bridge used by visitors
