# **Barn at Lower Cory, Morwenstow, Cornwall**

## **Historic Building Record**

2011R067

Barn at Lower Cory, Morwenstow, Cornwall,  
Historic Building Record

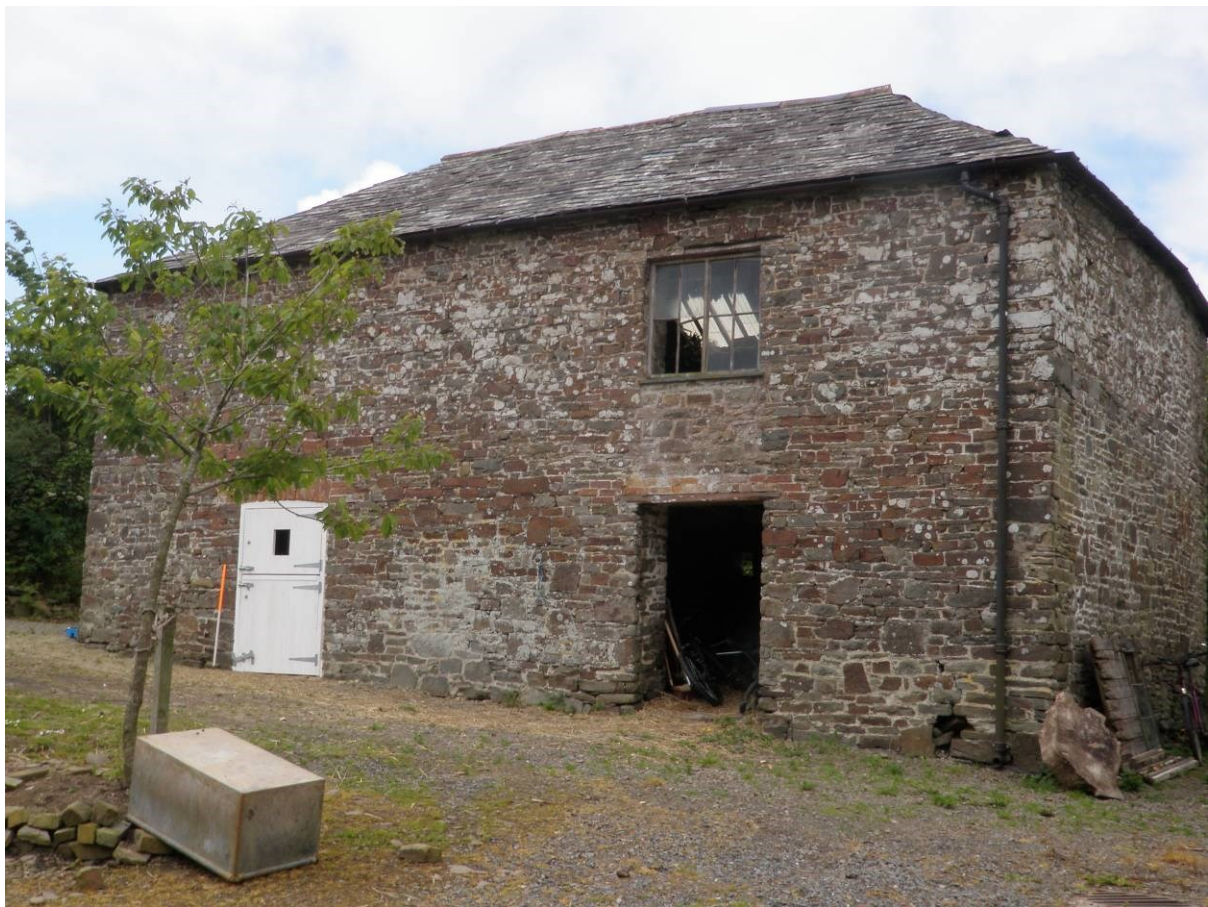
*Fig 8: East (front) elevation*

This wall is constructed from sandstone rubble bonded with lime mortar. There are three original door openings. The two ground floor openings (one leading to the stable and the other to the cow-house) have inserted brick lintels replacing earlier timber lintels. The first floor threshing door opening has a timber lintel but has been blocked with a workshop window inserted. The stable door itself is modern and there is no door surviving to the cow-house.

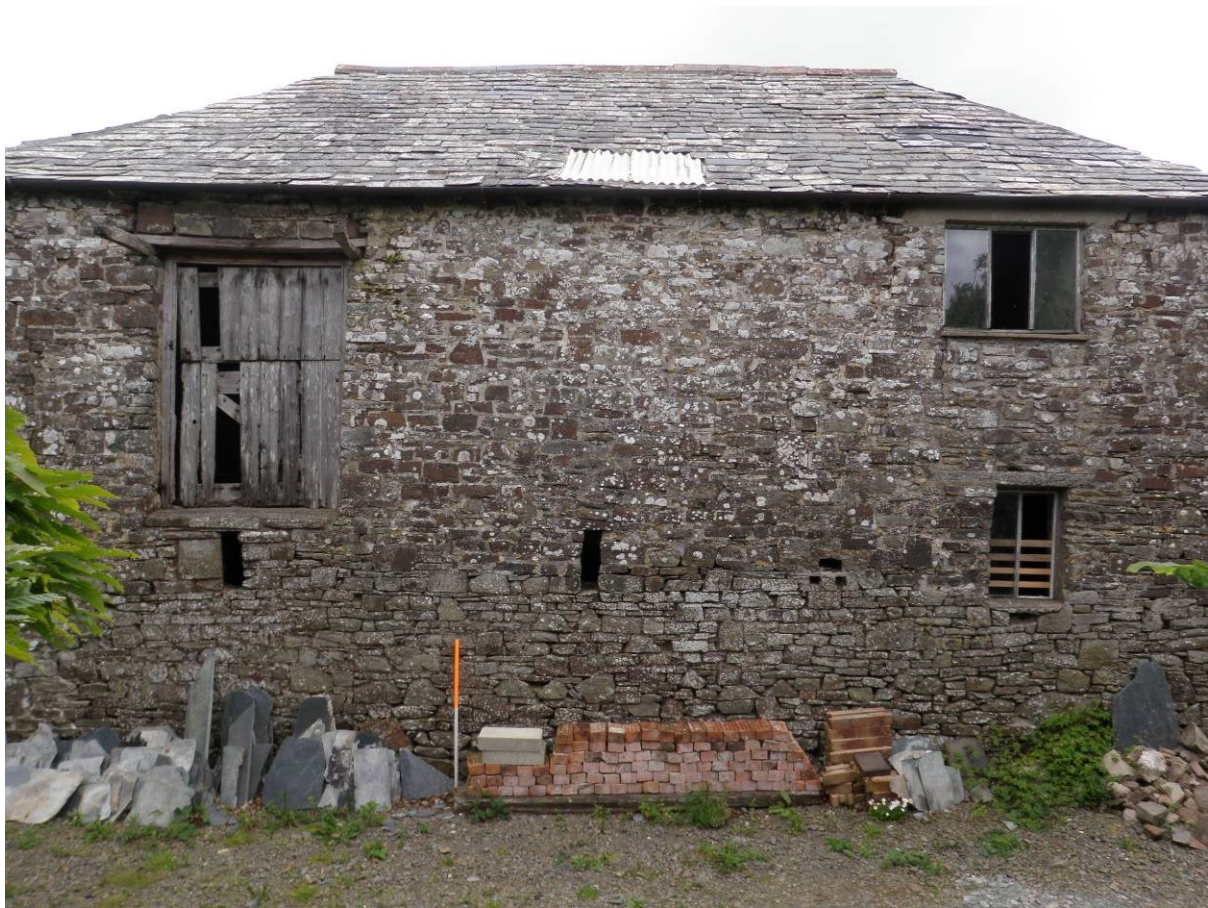
*Fig 9: West (rear) elevation*

The west wall is constructed from sandstone rubble bonded with lime mortar. The northern half of the wall relates to the cow-house on the ground floor and the threshing barn on the first floor. At ground floor level here there are two slit ventilators and the level of the former ground surface can be seen immediately below these openings. At first floor level here is the threshing door opening containing its original door with timber

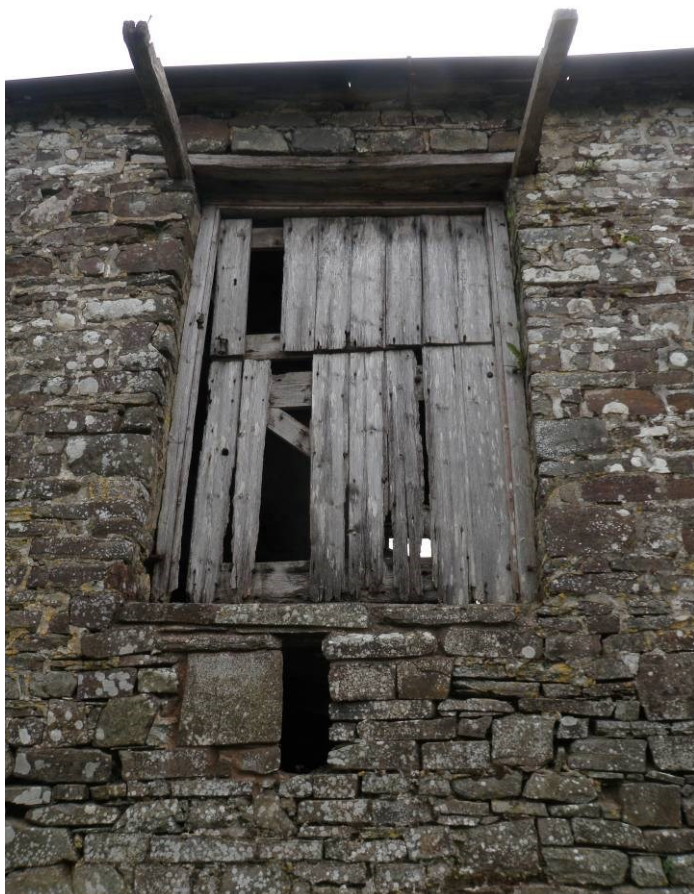
*Fig 10: Threshing door in west (rear) elevation*

lintel over and timber supports for a former hood (Fig 10). The southern half of the wall relates to the stable on the ground floor and the hay loft on the first floor. At ground floor level here is an original window opening which has been partially blocked on its northern side and a workshop window inserted and cement replacement lintel. To the north of this window is a small inserted opening for a drive shaft indicating that a small grinding or chopping machine was installed at some point inside the stable (possibly to crush oats for horses). The line of the earlier external ground level can be seen in the west elevation at the base of the window and drive shaft opening. At first floor level here there is a blocked loading door opening (serving the former hay loft) containing an inserted window. This also has a replacement cement lintel. All the openings are original in this wall except the small opening for the drive shaft which has been inserted.

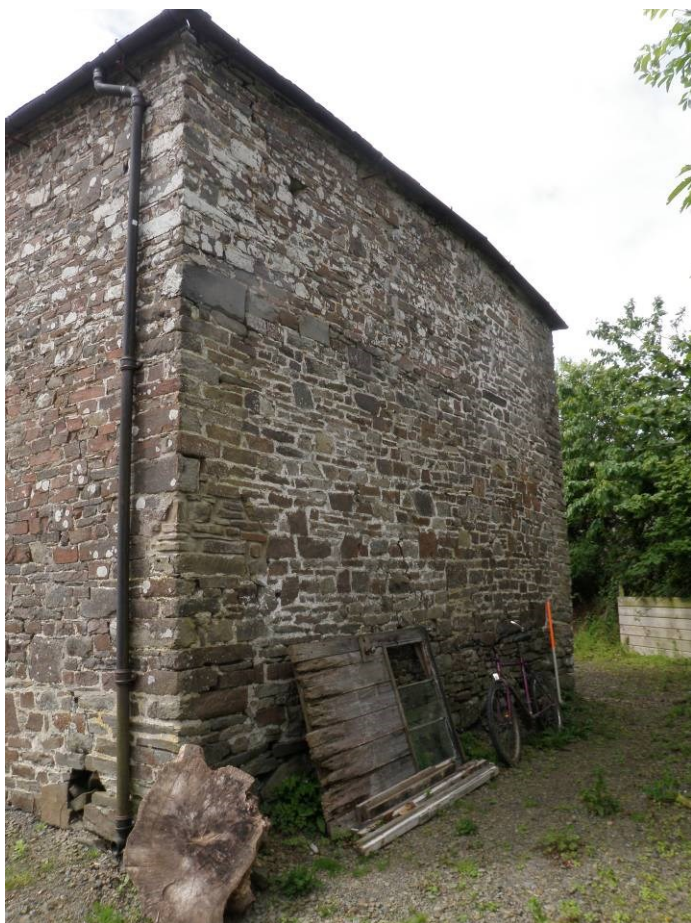
*Fig 11: North elevation*

The north wall is constructed from sandstone rubble bonded with lime mortar. Towards the base of the north elevation are two reused worn slate blocks (possibly former steps). In this elevation the position of the roof line of the now demolished lean-to (former piggery) is visible. Above this at first floor level in the eastern half of the wall is a small opening (possibly a pigeon hole).

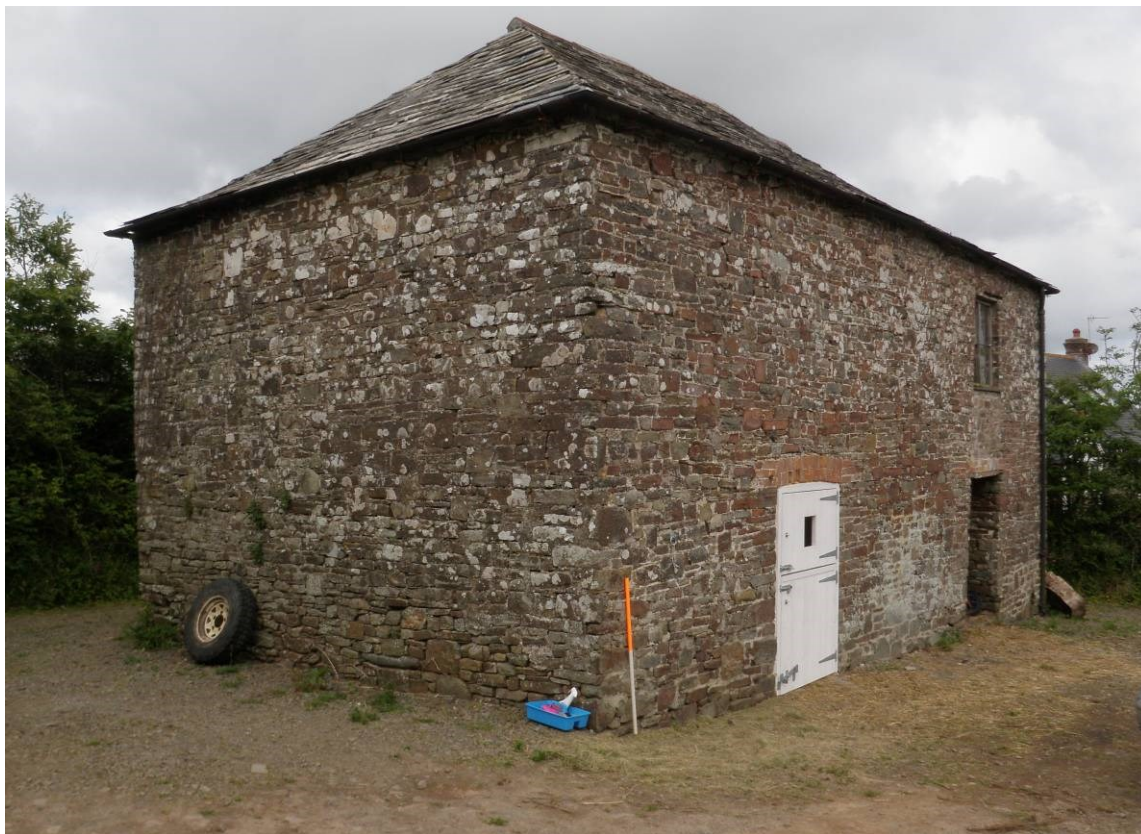
*Fig 12: South and east elevations*

The south wall is constructed from sandstone rubble bonded with lime mortar. Towards the base of the north elevation are two reused worn slate blocks (possibly former steps). There are no openings or other features of note in this wall.

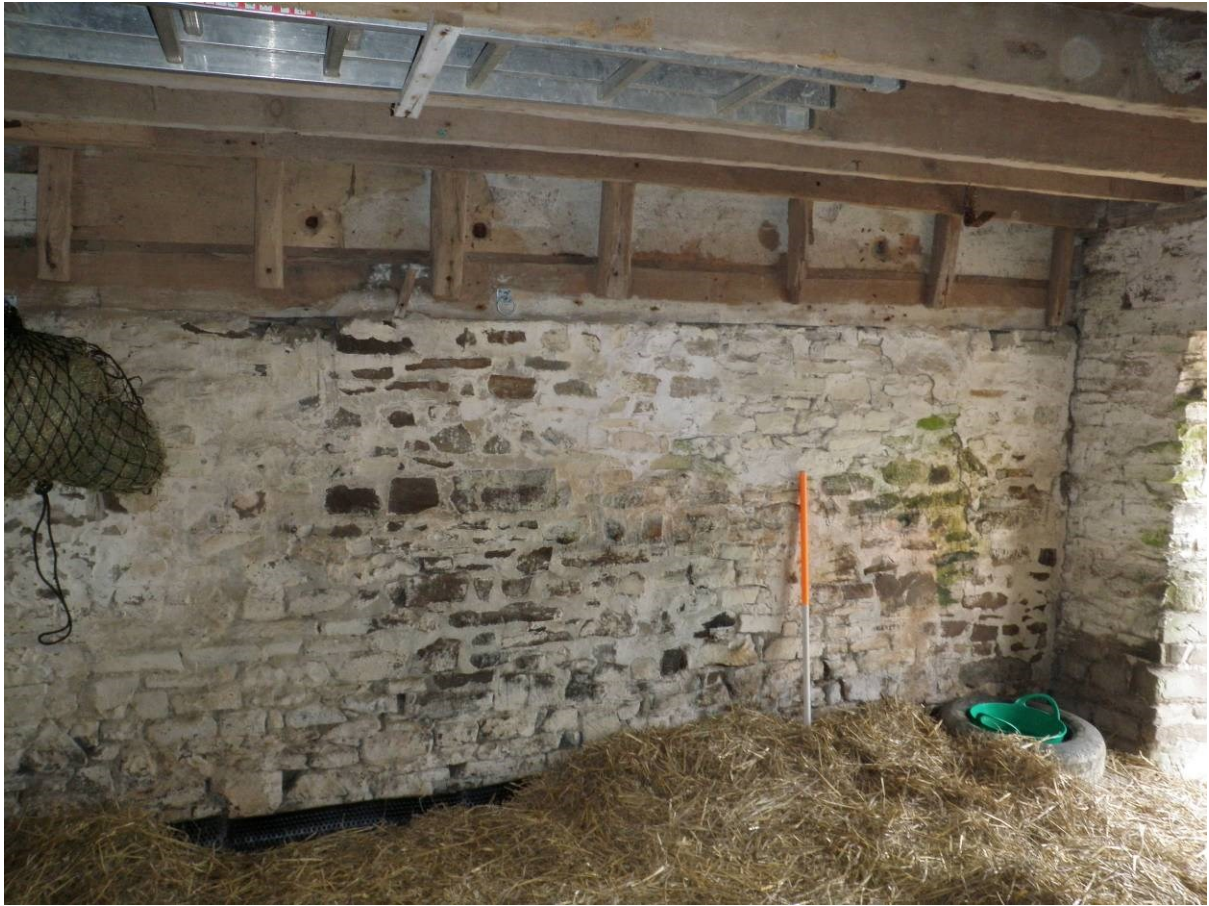
*Fig 13: Partition wall inside the stable showing ground floor stone rubble wall with remains of timber stud wall extending up to the first floor*

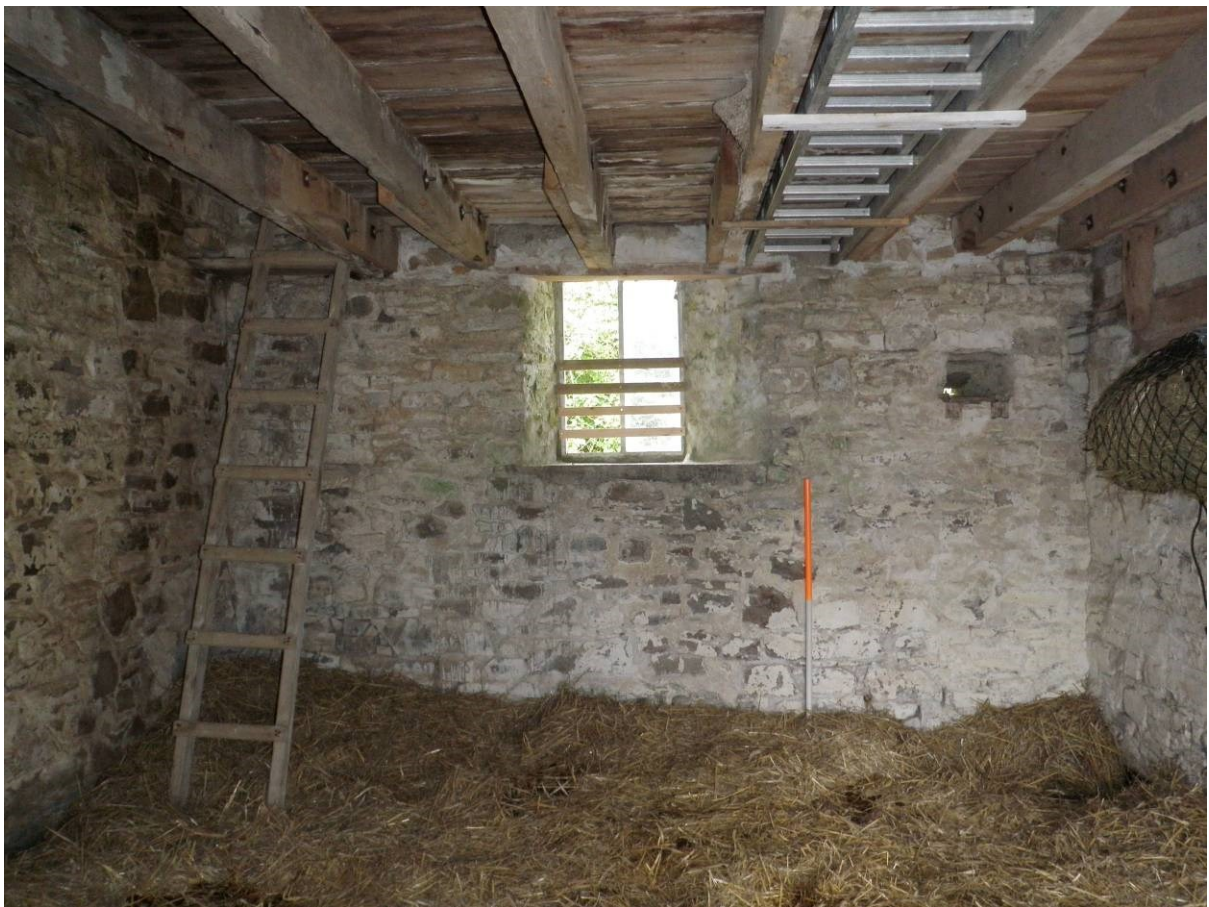
The floor is slate or sandstone cobbles partially overlain with modern cement. The ceiling is exposed timber joists and the floor boards above. This floor structure is a late 19<sup>th</sup> or 20<sup>th</sup> century replacement of the original. All of the joists have been strengthened in recent years by the addition short lengths of timber bolted to them at the western end. In the south-west corner there is access via a ladder to the hay loft above. The walls are lime-washed and in the west wall there is a partially blocked original window opening and an inserted opening for a drive shaft. The north (partition) wall in this room is stone built up to the first floor level in the northern half of the building. However, the first floor level in the southern half of the building is 0.45m higher than that in the northern half, to allow the extra height a horse would need. This lower part of the first floor stud partition is therefore visible on top of the stone partition in this room. This room appears to have been originally constructed to function as a stable. At some point in its

*Fig 14: Rear wall inside stable showing a partially blocked original window opening and an opening for a drive shaft to the north of it*

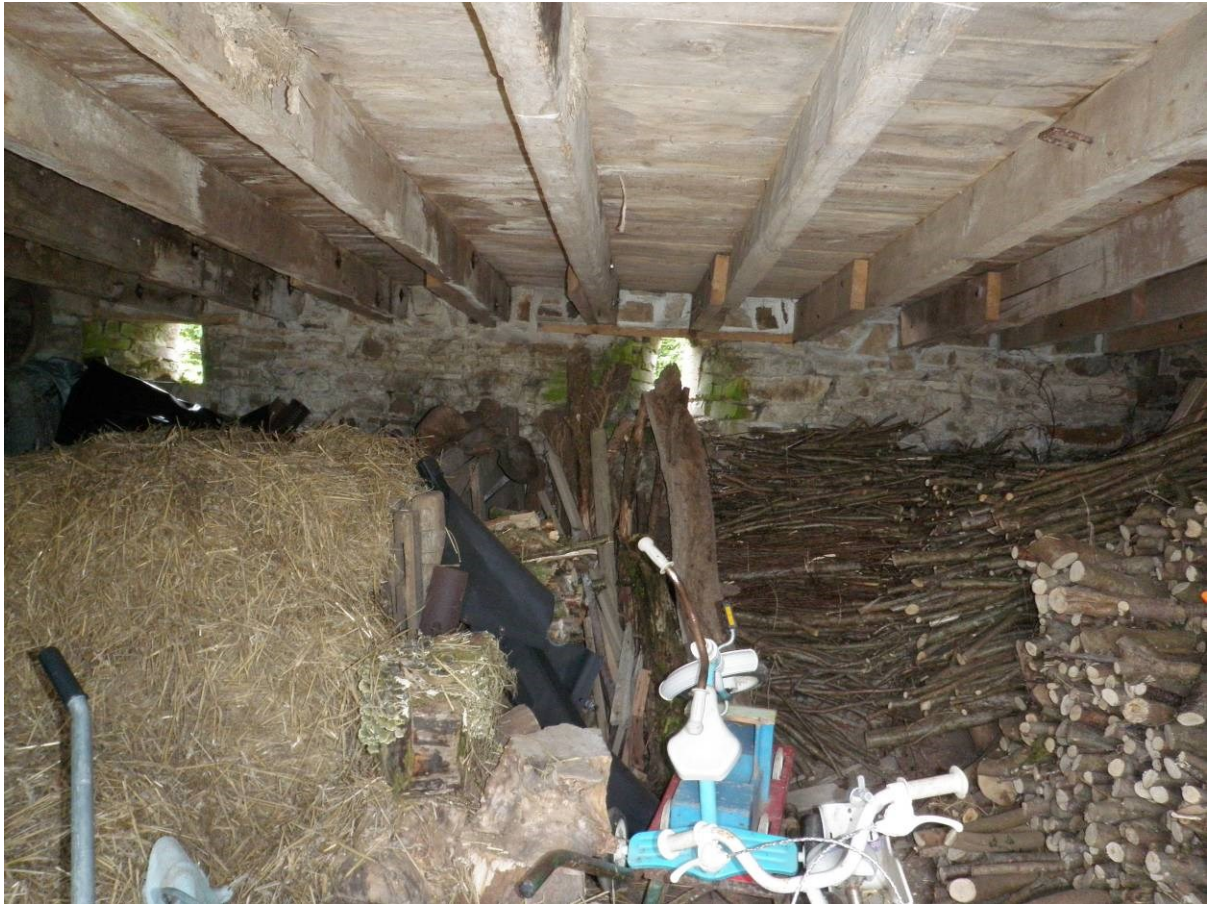
The floor itself is slate or sandstone cobbles (although only a small area was visible at the time of the survey) and there is a surface drain which runs north-south across the room within the eastern half. The ceiling is exposed timber joists and the floor boards above. Many of the joists are original and have clearly been cut with an adze and display carpenters marks whilst others are later sawn replacements. Two of the joists have plain chamfers and are likely to have been repositioned. All of the joists have been strengthened in recent years by the addition short lengths of timber bolted to them at the western end. Supported by the joists in the northern half of the room wide threshing boards are visible whilst narrow boards are visible in the southern half. Two internally splayed slit ventilators are visible immediately below first floor level in the west wall of this room and the door opening to the yard lies opposite them in the east wall. This room was originally constructed to function as a cow-house. At the time of survey it was in use as a storage room.

*Fig 15: Rear wall inside cow-house showing two internally splayed ventilators and threshing floor above*

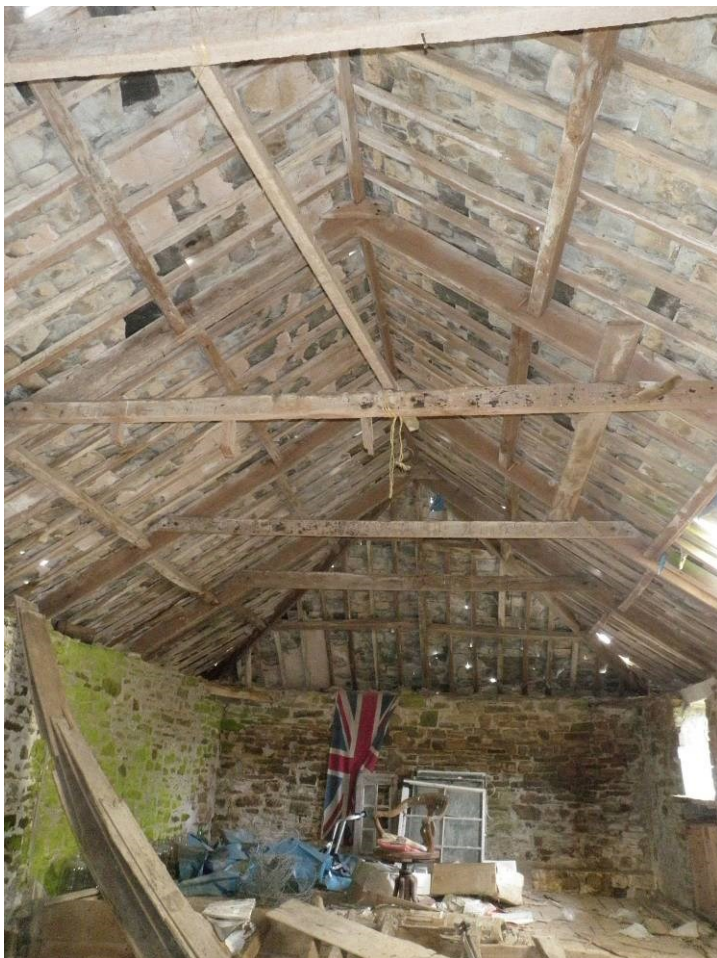
*Fig 16: First floor interior looking south into former hay loft*

The hay loft area was once partitioned off from the room(s) to the north with a timber stud wall and there are indications that there was a door at the west end of this partition wall. The floor of the hay loft lies 0.45m above that of the threshing barn. This appears to be an original part of the building design to allow extra head room in the stable below. The joists and boards here are late 19<sup>th</sup> or 20<sup>th</sup> century replacements and the original floor may have been approximately 0.1m higher since a floor ledge survives in the south wall 0.1m higher than the present floor level. In the west wall is the original (blocked) loading door and in the south-west corner an opening in the floor giving access to the stable below.

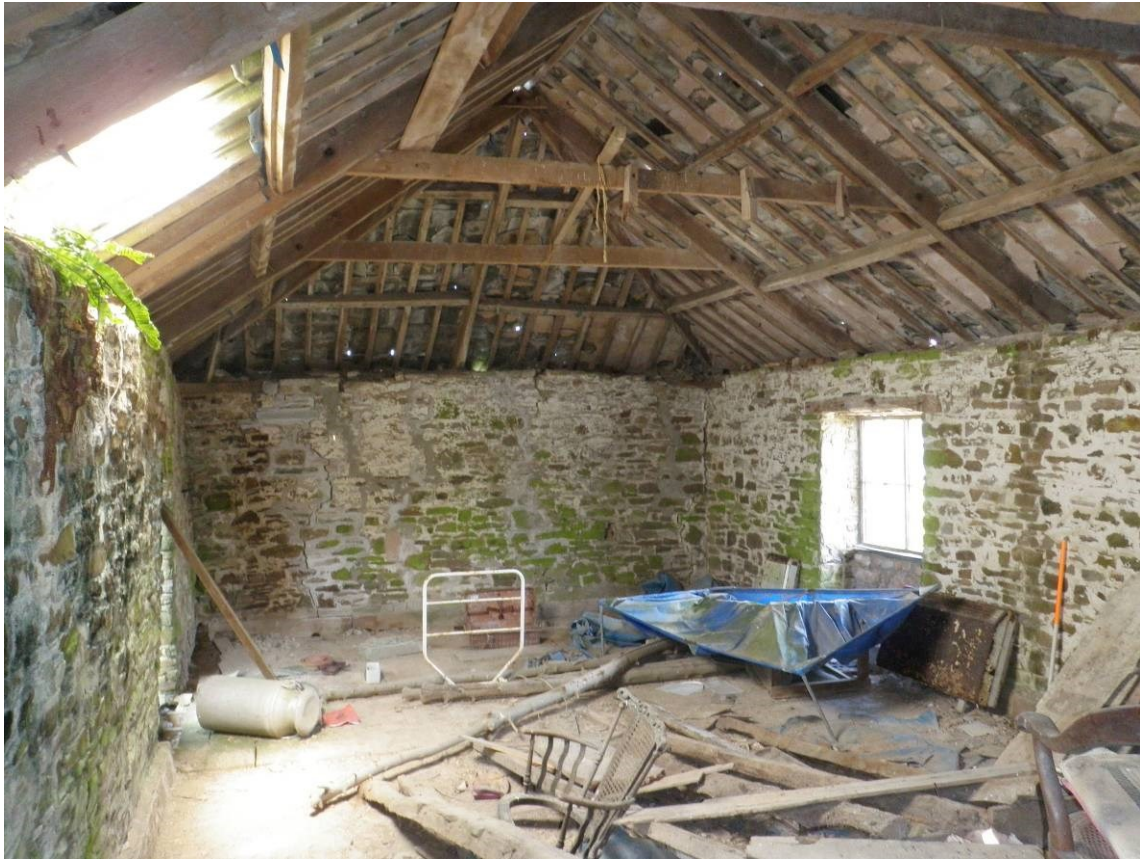
Although now a single open room space the first floor was originally partitioned with stud walls to form two, if not three, rooms all open to the roof space. The northern room is the former threshing barn with its threshing floor still intact. The boards measure 0.35m wide and extend from the north wall as far as a line between the southern jambs of the two opposing threshing doors where the threshing took place. The opposing doors were designed to create and control a draught for winnowing (removing the chaff). To the south of this, but still within the threshing barn, the boards are narrow, probably late 19<sup>th</sup> century replacements in an area which is likely to have been used for storage. It is possible that this narrow area was partitioned off to form a separate room since there are signs of removed stud walls either side of the central bay (see Fig 20). Around the walls within the whole of this area there is a timber skirting approximately 0.2m high; a typical feature of a threshing barn. In the north-east corner of the floor a slot has been cut in recent years (Mr Axworthy pers comm.). The area of the threshing barn and storage area measures 5.8m north-south where as the area of the hay loft at the southern end of the first floor measures 4.1m north-south.

*Fig 17: First floor interior looking north into former threshing barn showing the location of a former stud wall as a shadow on the east wall and the remains of studs attached to the truss*

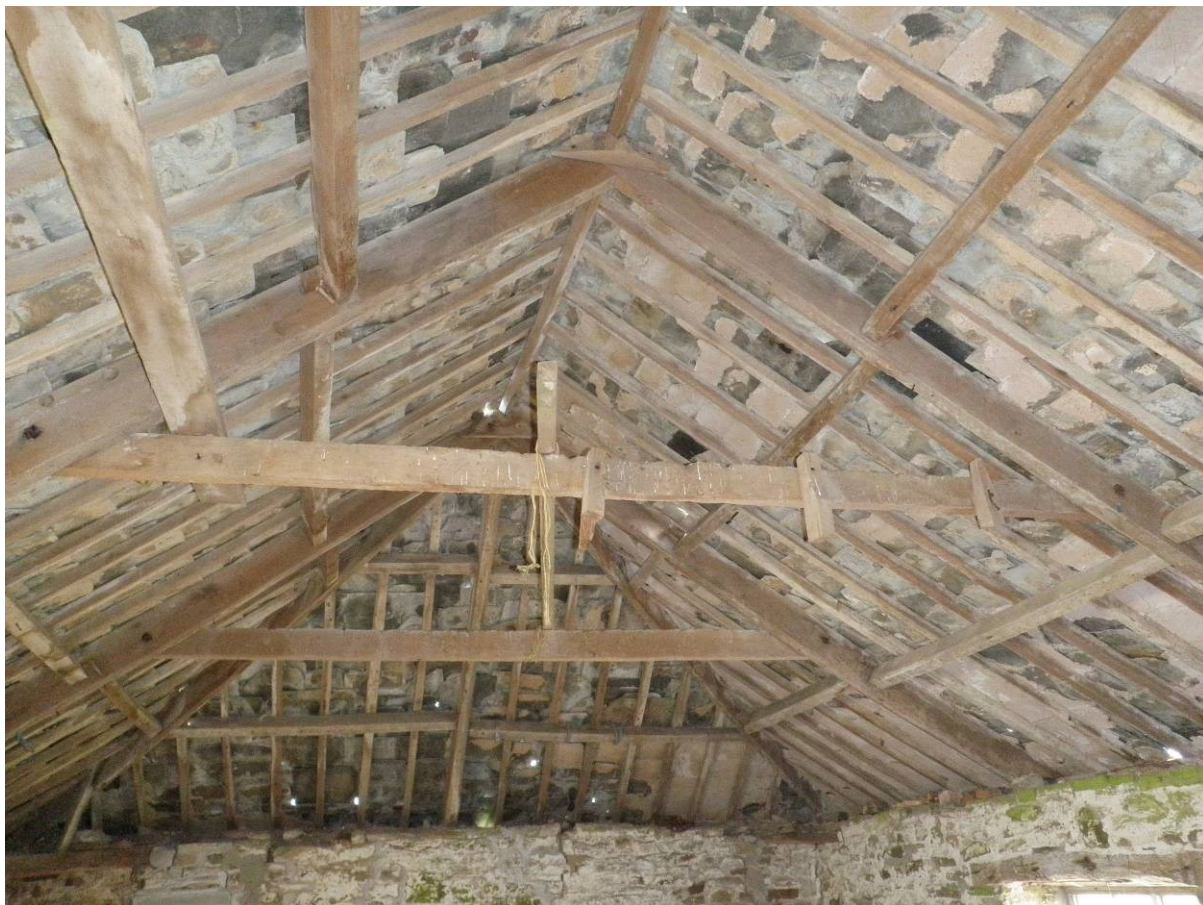
*Fig 19: Roof structure looking north*

The roof structure is a late 19<sup>th</sup> or early 20<sup>th</sup> century replacement of the original. It is a hipped roof comprising five bays with simple iron-bolted timber A-frame trusses and a slate covering with ceramic ridge tiles. There is no indication that the roof has been either raised or lowered from its original position and it is likely that it replaced a roof of similar construction.
