Condolden Barrow, Tintagel, Cornwall

Erosion repair to Scheduled Monument

Cornwall Council

Report Number	2010R099	
Date	July 2010	
Status	Final	
Report author(s)	Dick Cole and Ann Preston-Jones	
Checked by	Ann Preston-Jones	
Approved by	Peter Rose

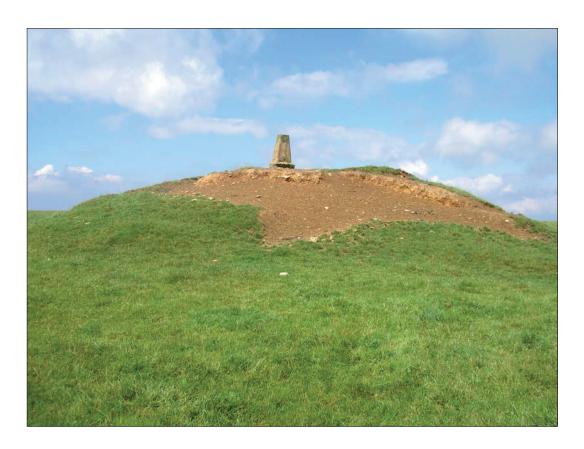
"...trig pillar now 18" [0.45 metres] above level of barrow with concrete foundation fully exposed ...fresh erosion on face on west ...yellow clay capping exposed over a large percentage of the mound ..."

Fig. 7 Condolden Barrow photographed from the south in 2007

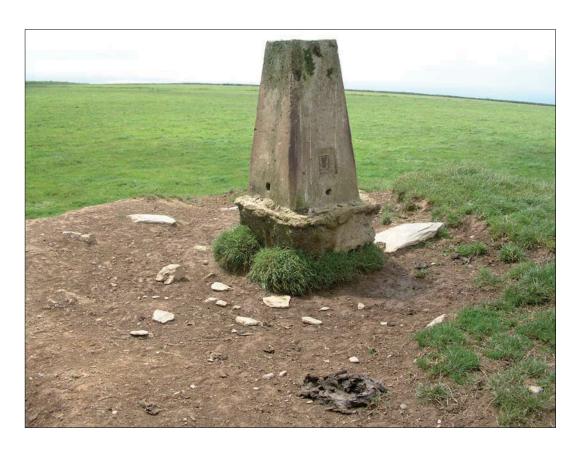
Fig. 8 Erosion around the trig pillar on the top of Condolden Barrow in 2007.

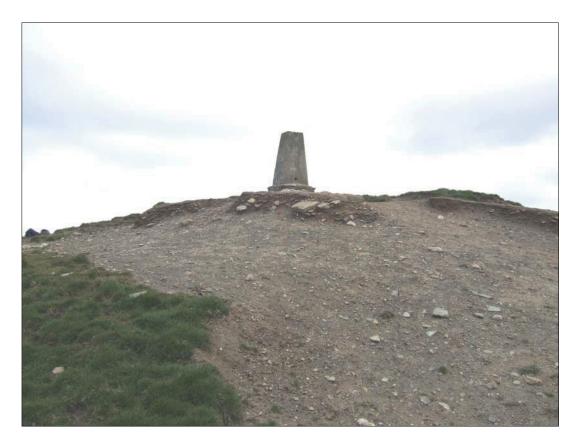
Fig. 9 Condolden Barrow photographed from the south east in April 2008

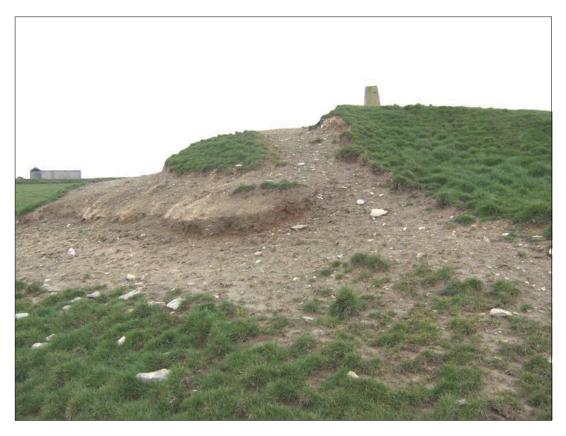
Fig. 10 Condolden Barrow photographed from the east in April 2008

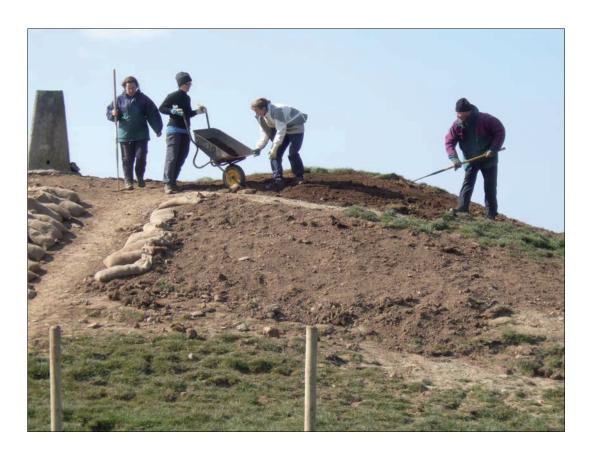
Fig. 11 Volunteers at work on Condolden Barrow in April 2008

The eroded parts of the beacon were reconstructed with sandbags, which were filled with soil and packed closely together to provide a firm surface. Soil was then spread over the top of the bags in order to match the contours of the surrounding, un-eroded parts of the barrow. Grass seed was then scattered over this surface. See Figs 11 and 12.

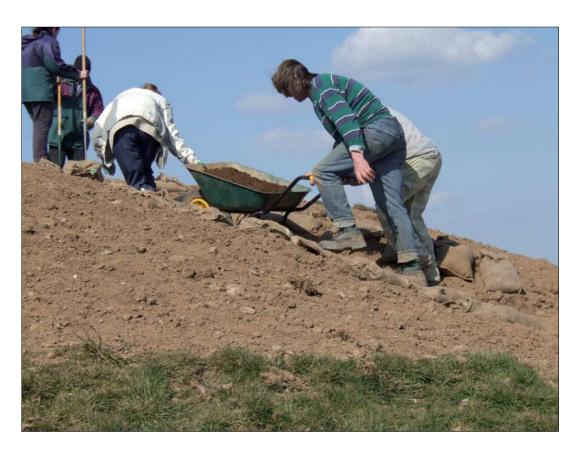
Fig. 12 Volunteers at work on Condolden Barrow in April 2008

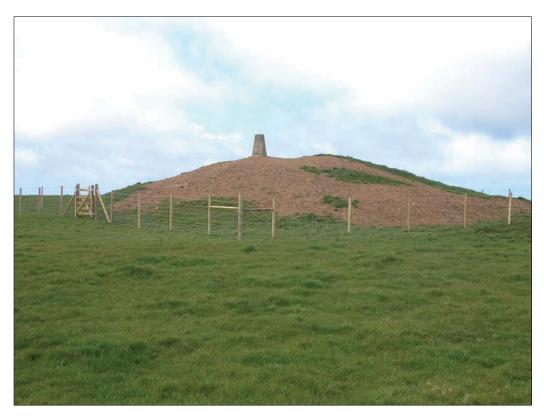
Fig. 13 Condolden Barrow immediately following conservation works in April 2008.

A fence was erected at the foot of the barrow's mound, in order to prevent future erosion. It comprised sheep netting and two strands of barbed wire. The fence, which measured approximately 20 metres on each side, was positioned to have least visual impact and included a 5ft wide gate on the south side, to allow for continued visitor access to the barrow and occasional grazing. The six strainer post-holes were all hand-dug under archaeological supervision, the rest hammered in. See Fig. 13.

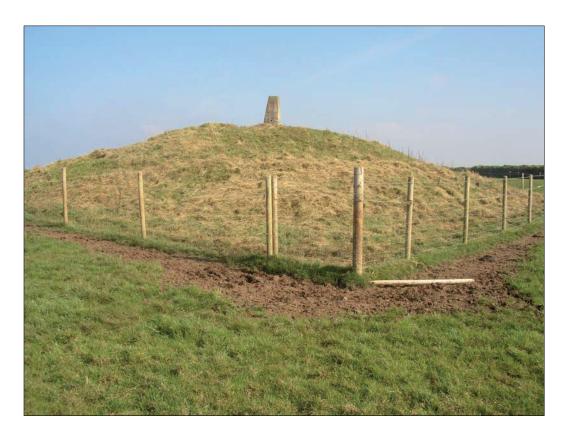
Fig. 14 Condolden Barrow photographed from the south west in October 2008.

Following completion of the work, it was suggested to the farmer that stock should be kept off the mound for at least a year, in order to allow sufficient opportunity for the repair work to consolidate and the grass to become adequately established. See Fig. 14.

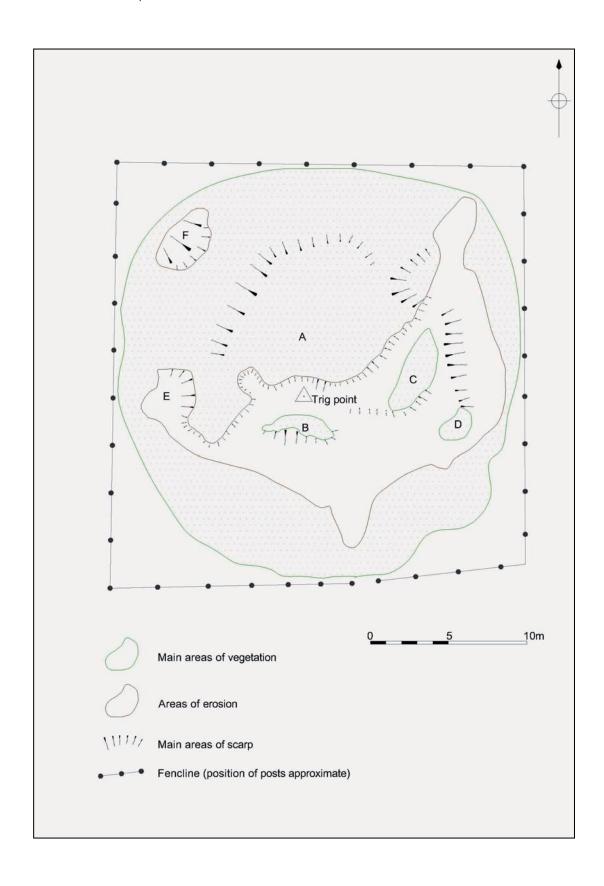
Fig 15CC HE survey of Condolden Barrow

The survey of the barrow demonstrated that the barrow is a circular feature roughly 27m in diameter (Fig 15). The main area of maximum erosion was on the southern side of the monument and stretched from one side of the barrow, almost to the opposing side - a distance of over 22m.

The main eroded area sloped down gently from the top of the mound, but included a number of surviving scarps of soil, the eroded downslopes of which were more severe. There were also three islands of material, within the eroded area, which were still vegetated.

It is clear that the erosion caused by the cattle has caused substantial damage to the core of the monument and the loss of the soily killas spreads of prehistoric date that were thrown up to create the monument.
