Sara's Foundry, Tolgus, Redruth, Cornwall

Archaeological watching brief during tree removal

Report No	Report Name	Report Author		
2009R046	Sara's Foundry, Tolgus, Redruth: Watching brief during tree management	James Gossip		
Event Type				
Watching brief/advice				
Client Organisation		Client Contact		
English Heritage				
Monuments (MonUID)				
Fieldwork dates (From)		(To)	(Created By)	(Create Date)
30/03/09	09/04/09	James Gossip	20/05/09	
District		Location		
Kerrier, Redruth	Town Mills, Tolgus Road, Redruth			
Town				
Redruth				
Easting X co-ord		Northing Y co-ord		
SW 69124	42590

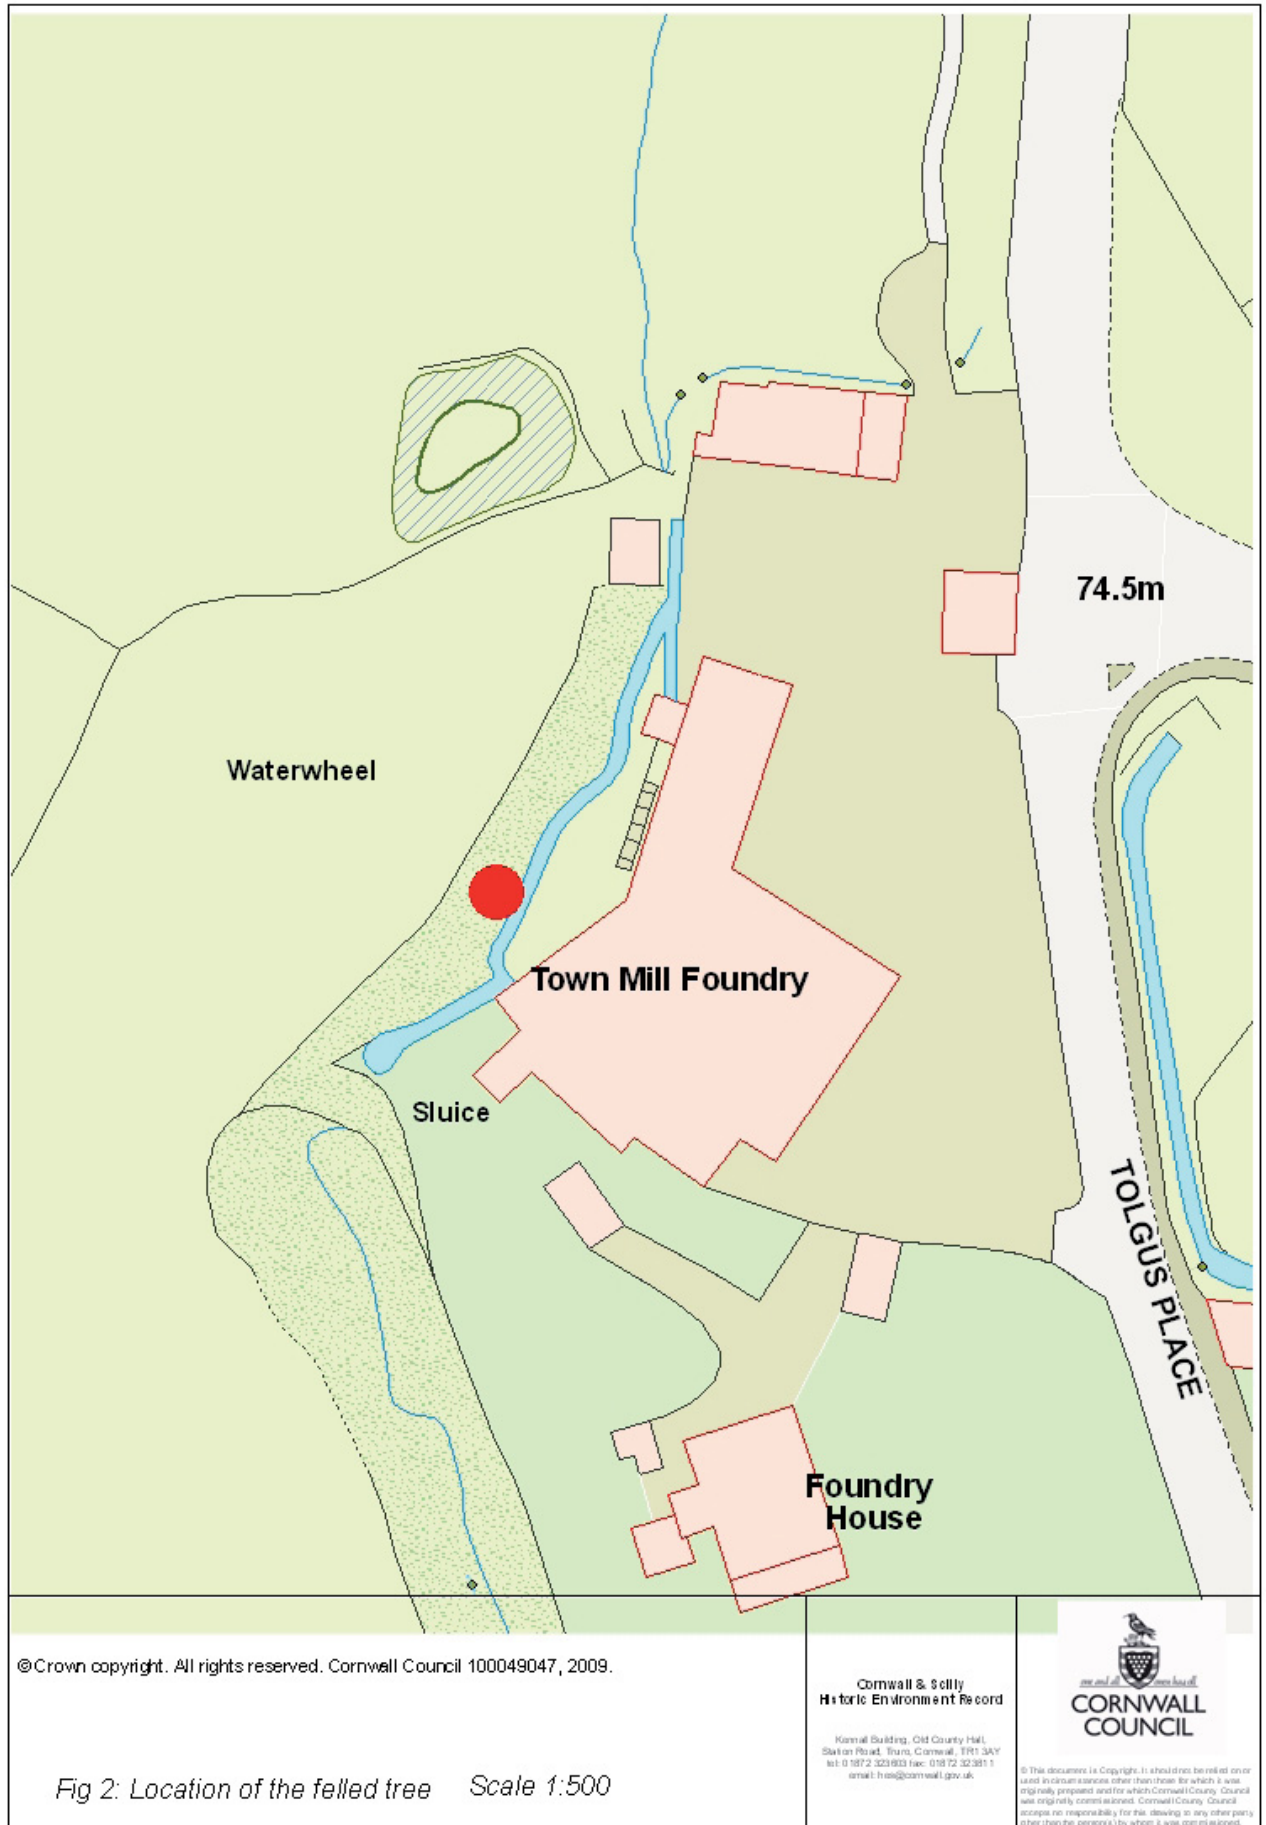
Fig 2 Location of the felled tree.

The tree removed was a mature beech tree growing from a steep bank on the western side of a leat supplying water to the foundry waterwheels. A large branch growing from the side of the tree had broken and collapsed onto the roof of the foundry building some time ago, damaging the roof. Bracket fungus growing from below the branch-collar of the broken branch indicated serious disease. This was probably of the type *Ganoderma*, a widespread wood-decaying fungus. This was confirmed when sections of the trunk were removed and diseased areas were found to be in an advanced state.

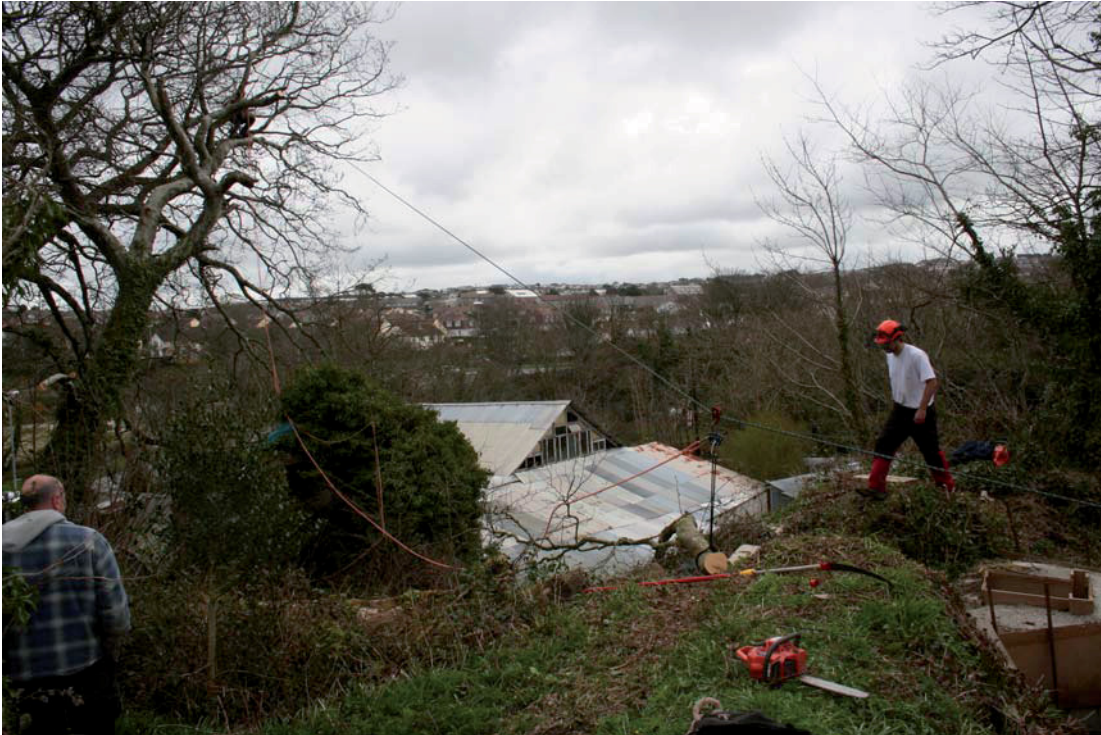
Fig 3: Initially branches were lowered carefully towards the mill pond

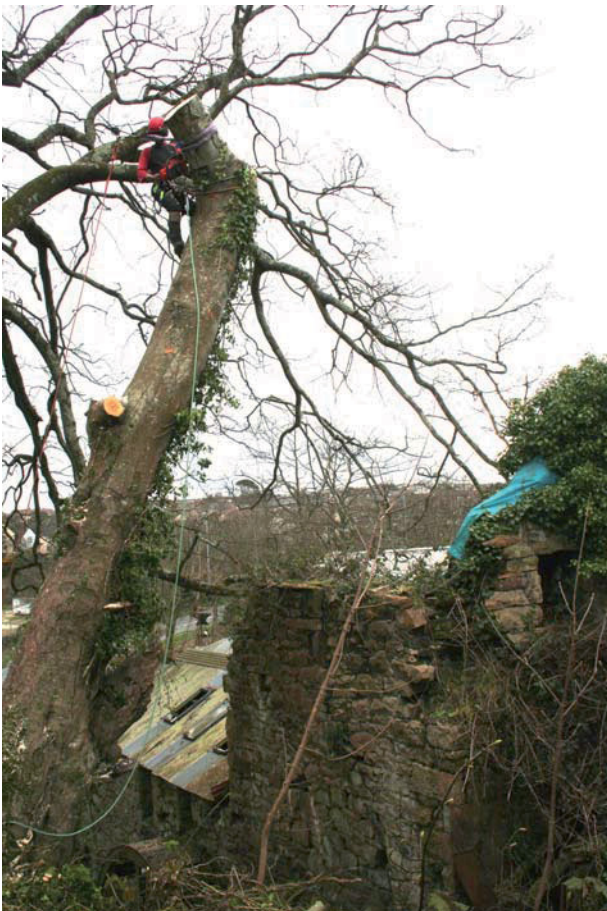
Extreme care was needed since the tree partly overhung the foundry building. There was a significant risk that the work could threaten the building either through accident or by careless handling of its removal.

Fig 4: Extreme care was taken due to the proximity of the tree to the foundry building

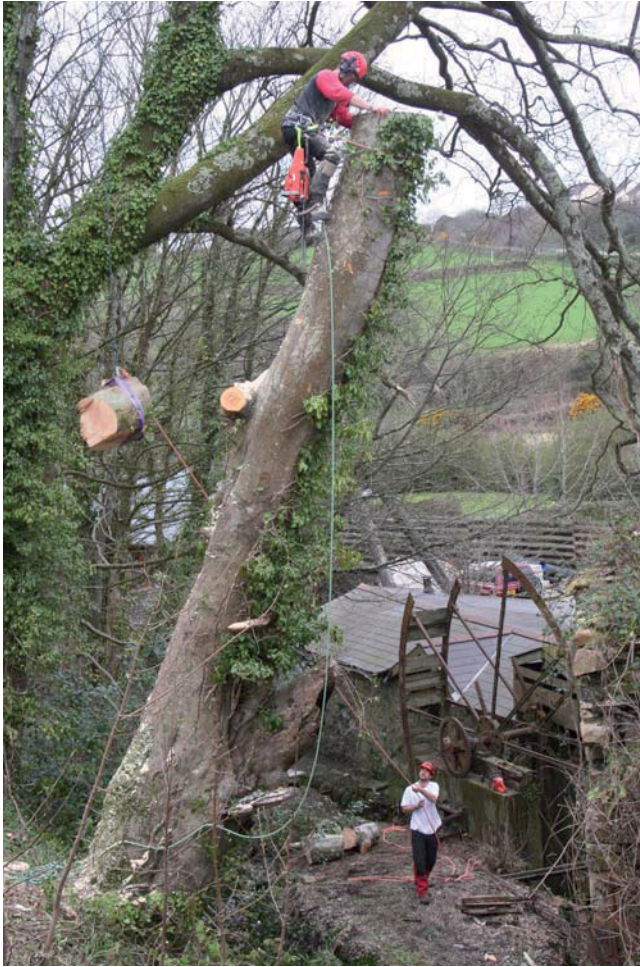
Fig 5: As felling progressed sections were lowered onto the flat area adjacent to the mill leat.

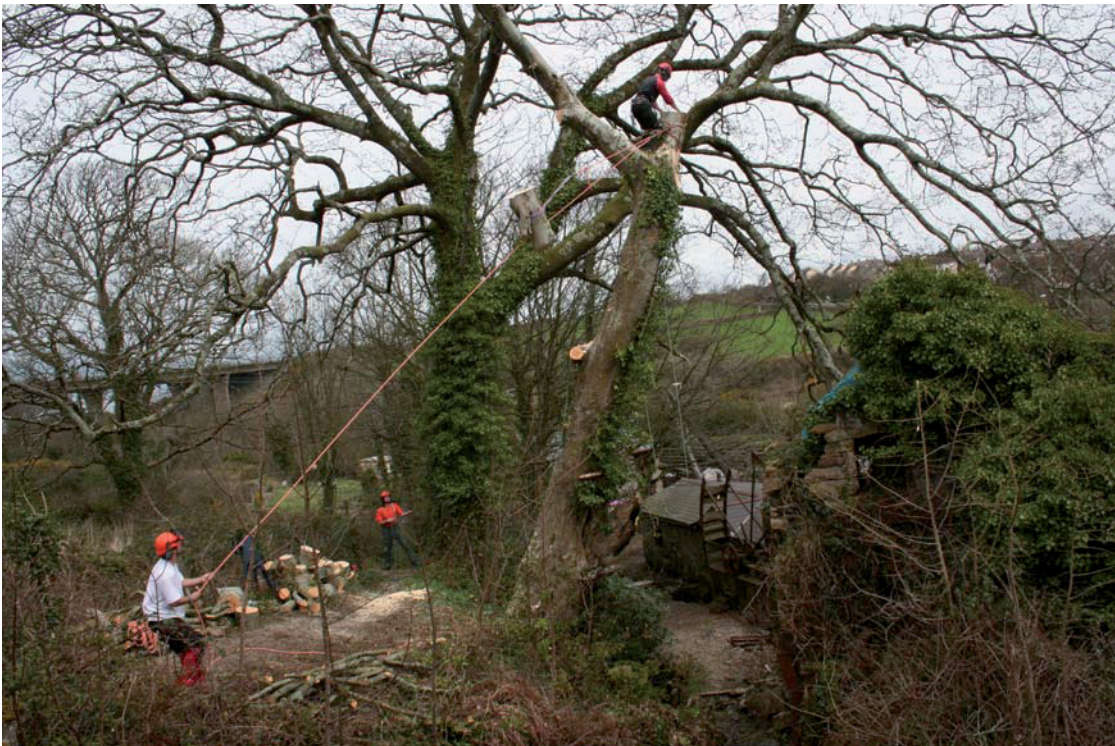
Fig 6: Tree sections were stabilised by securing with ropes held from the ground
