St. Helen's Oratory, Cape Cornwall

Archaeological recording during repair works

Client	LUDU, Cornwall Council and The National Trust
Report Number	2010R153
Date	26 January 2011
Status	Final
Report author(s)	Adam Sharpe BA MifA
Checked by	Peter Rose, Projects Manager, Ann Preston Jones
Approved by	Peter Rose, Projects Manager

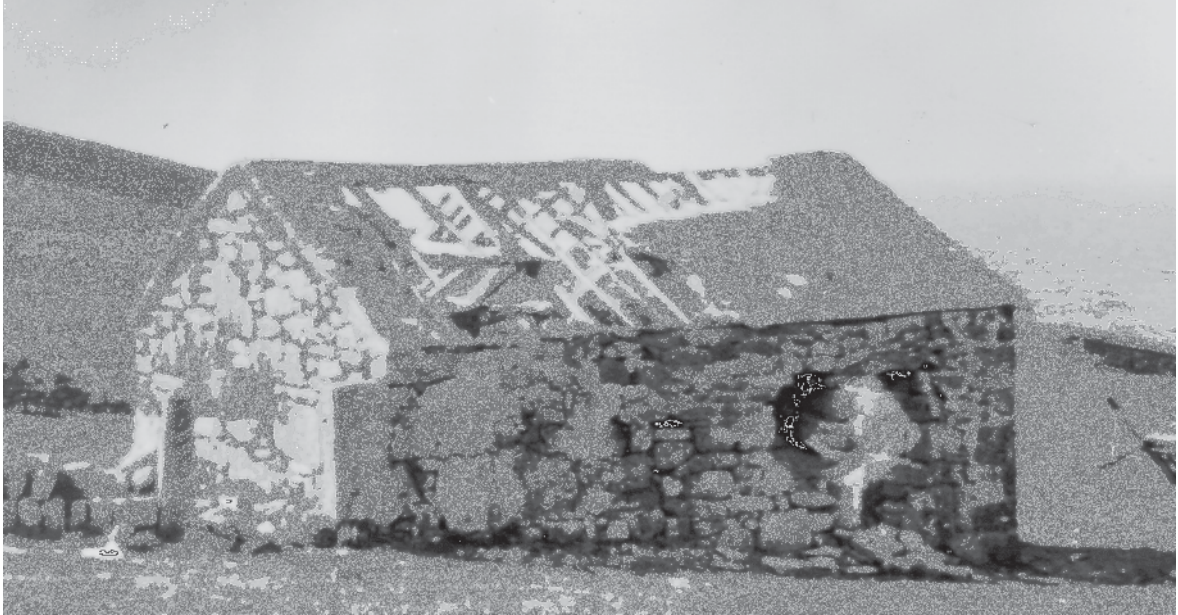
Little maintenance work seems to have been carried out the building from the 1960s by when this field had become agriculturally marginal. Its slated roof gradually disintegrated (see Figs 8 and 9), and eventually sections of its southern wall collapsed. These were rebuilt in 1985 by the then owner, Donald Payne of Nanpean Farm. However the rebuilt walling again collapsed in 1999, necessitating its reconstruction in 2001.

Fig 8. A view of the Chapel from the south-east, of unknown date but probably the early 1960s, when the structure still retained some of its roof, and when the area of the wall adjacent to the door had begun to collapse. NT Collection.

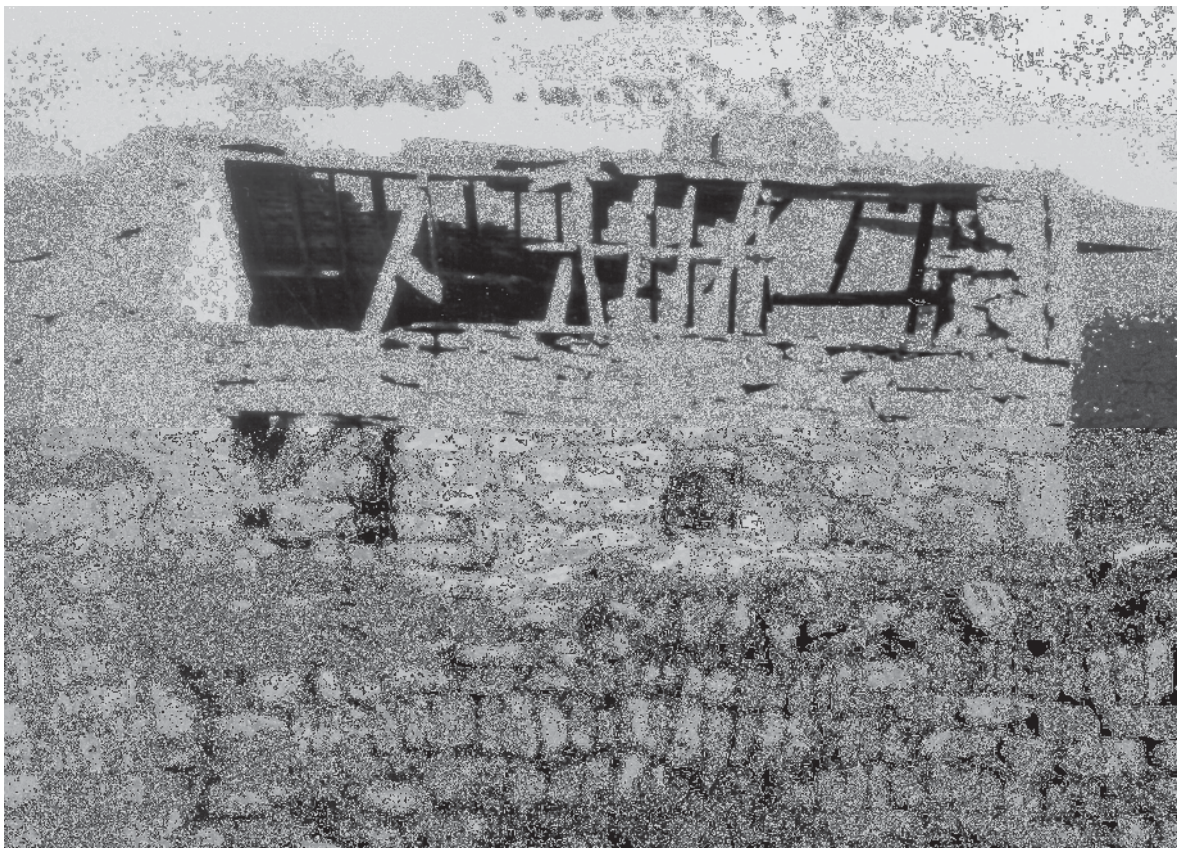
Fig 9. A view of the Chapel from the west, again probably taken during the early 1960s showing the severe deterioration of the roof structure at that date. NT Collection.

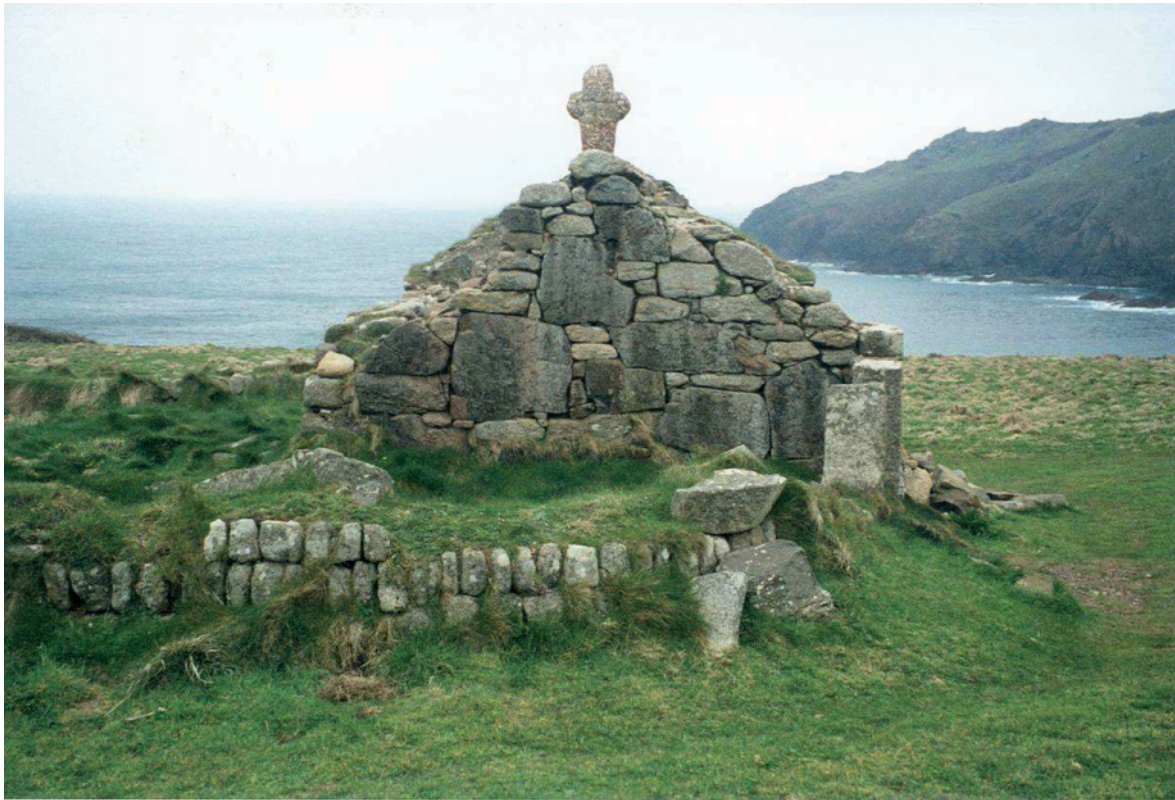
Fig 10. St. Helen's Chapel from the south prior to works showing the massive stones used in the construction of this wall and the cross re-erected on its gable. HE Digital Image Archive.

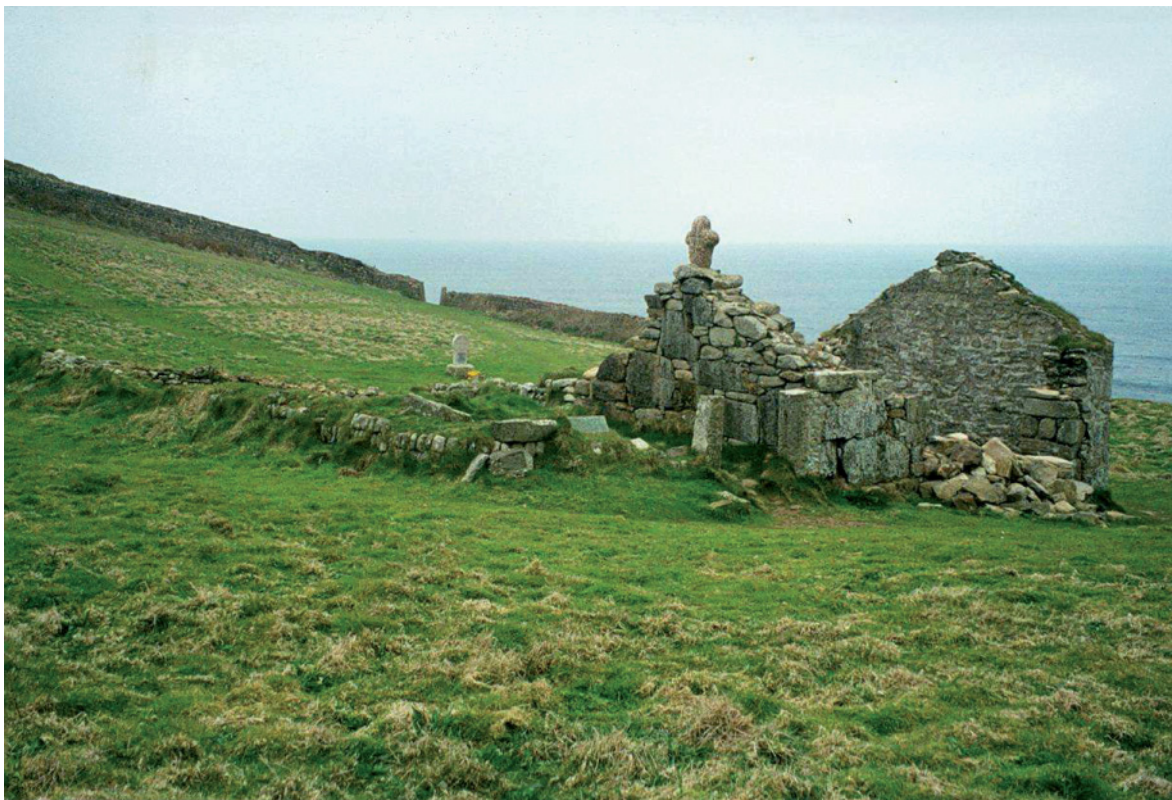
Fig 11. St. Helen's Chapel from the south-east prior to works, showing the collapsed masonry adjacent to the doorway, and the low walls forming the enclosures to the west. HE Digital Image Archive.

1. Reconstruct the east wall of the building to its pre-collapse outline, using only masonry recovered from the rubble pile at the foot of the wall. Reference will be made, if possible, to any photos made of the building before the wall collapsed.

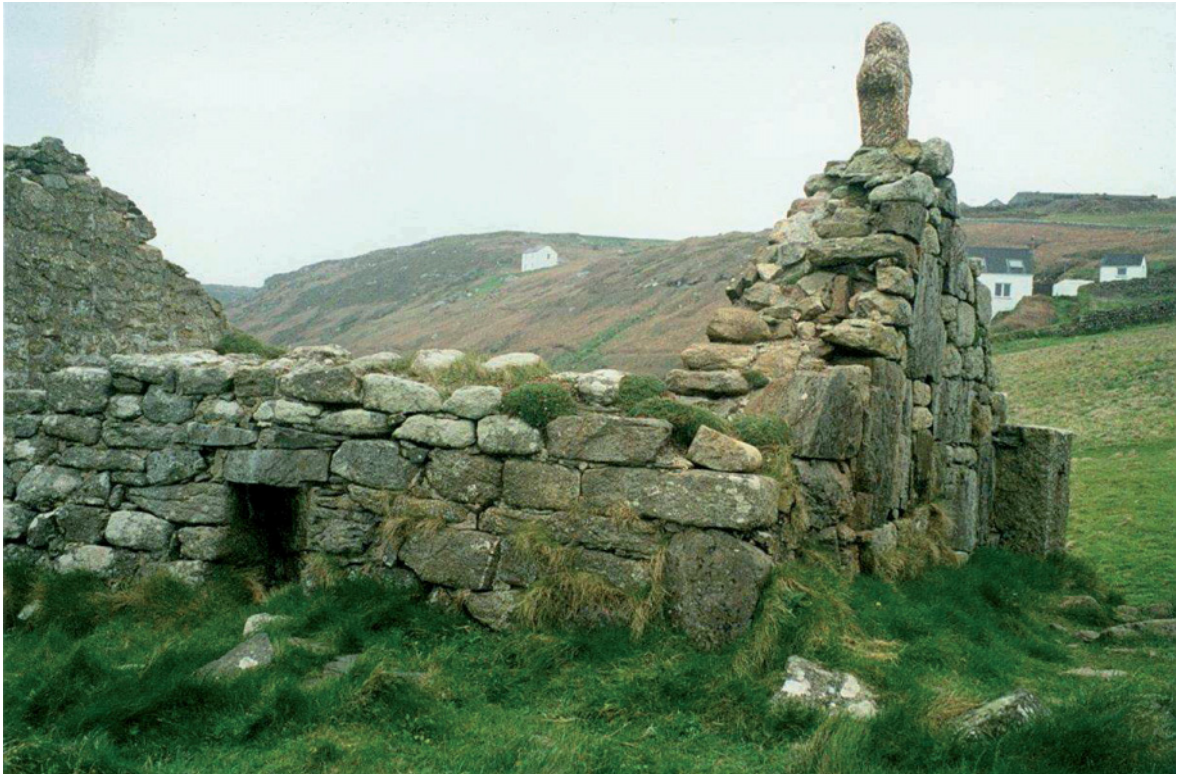
Fig 12. St. Helen's Chapel from the west-south-west before works, showing the window, the smaller size of masonry used in this wall and the deterioration of the southern wall head. HE Digital Image Archive.

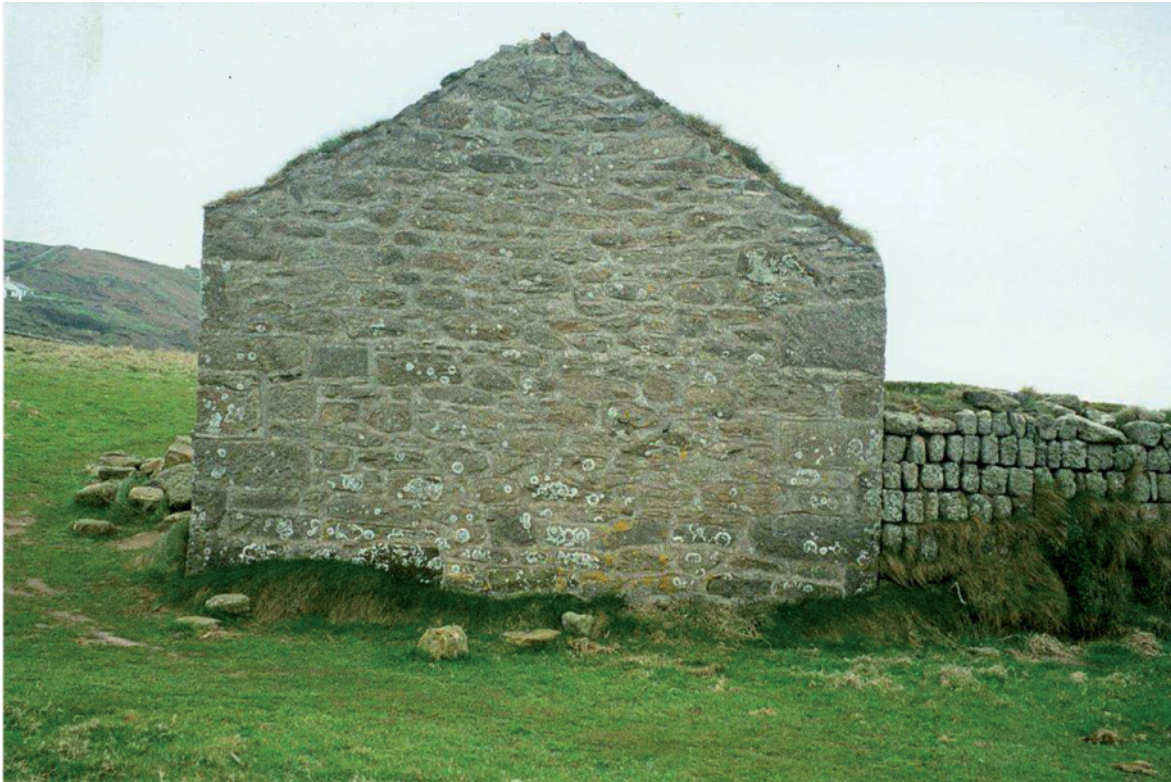
Fig 14. St. Helen's Chapel from the north before works, showing the markedly different style of stonework used in the construction of this wall. HE Digital Image Archive.

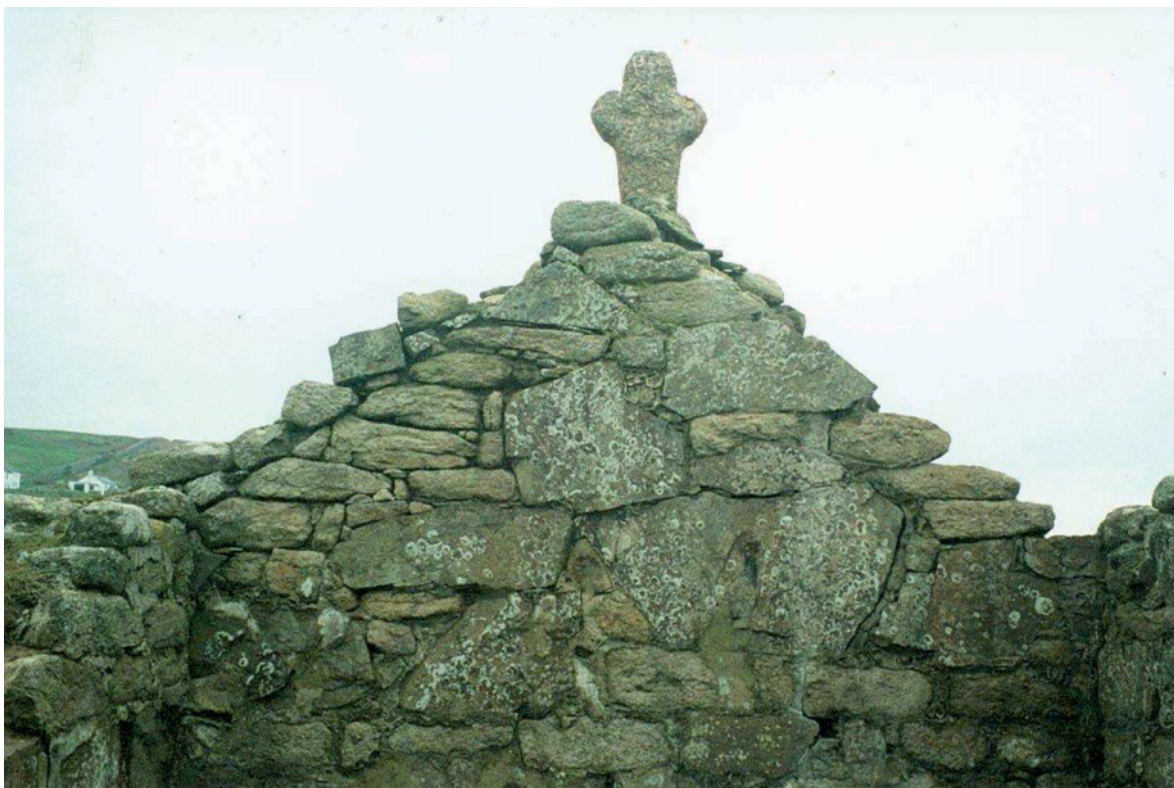
Fig 15. The internal elevation of the southern wall of St. Helen's Chapel before works, showing some evidence for the original gable line having been raised in smaller stone (left). HE Digital Image Archive.

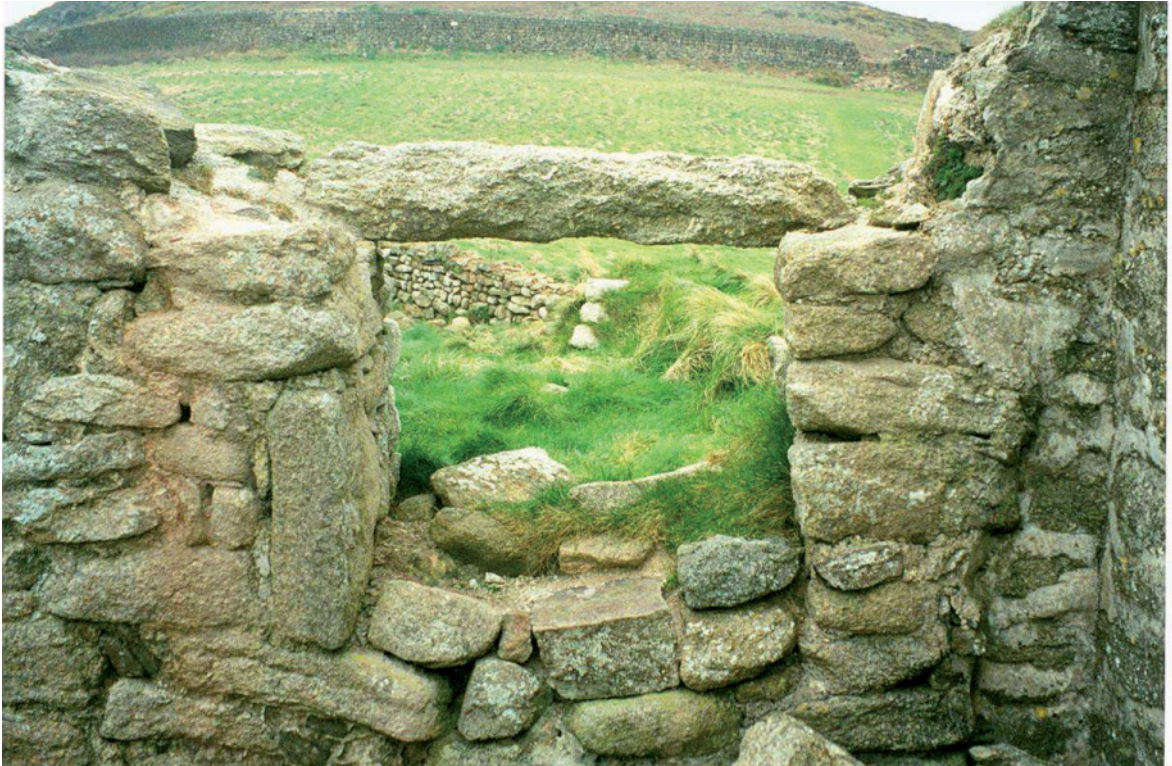
Fig 16. The small window in the eastern wall of St. Helen's Chapel before works, showing the lost inner lintel. HE Digital Image Archive.

2. Re-set loose stonework in the south wall of the building.
3. Replace a missing granite lintel over the window opening in the west wall and rebuild a small amount of masonry above.

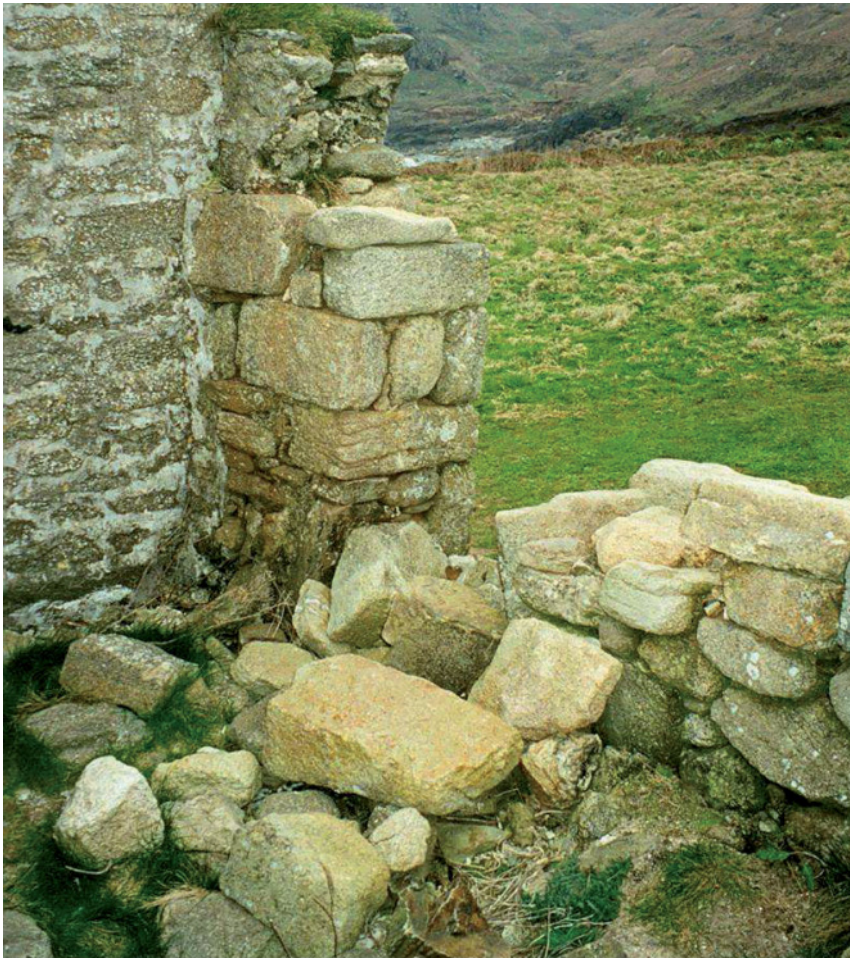
Fig 17. The collapsed masonry adjacent to the doorway in the north-eastern corner of St. Helen's Chapel prior to works. HE Digital Image Archive.

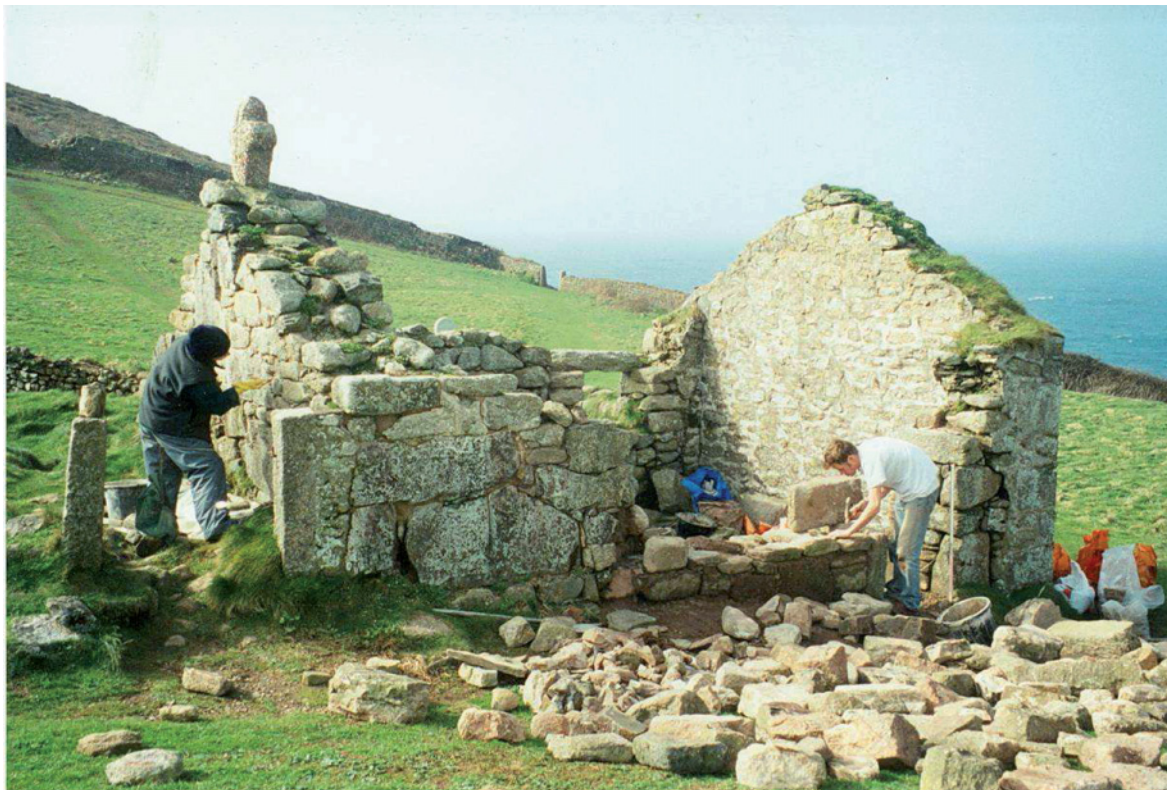
Fig 18. An early stage during the conservation works. The foundation courses of the collapsed walling have been reconstructed, whilst repointing is under way on the southern wall. HE Digital Image Archive.

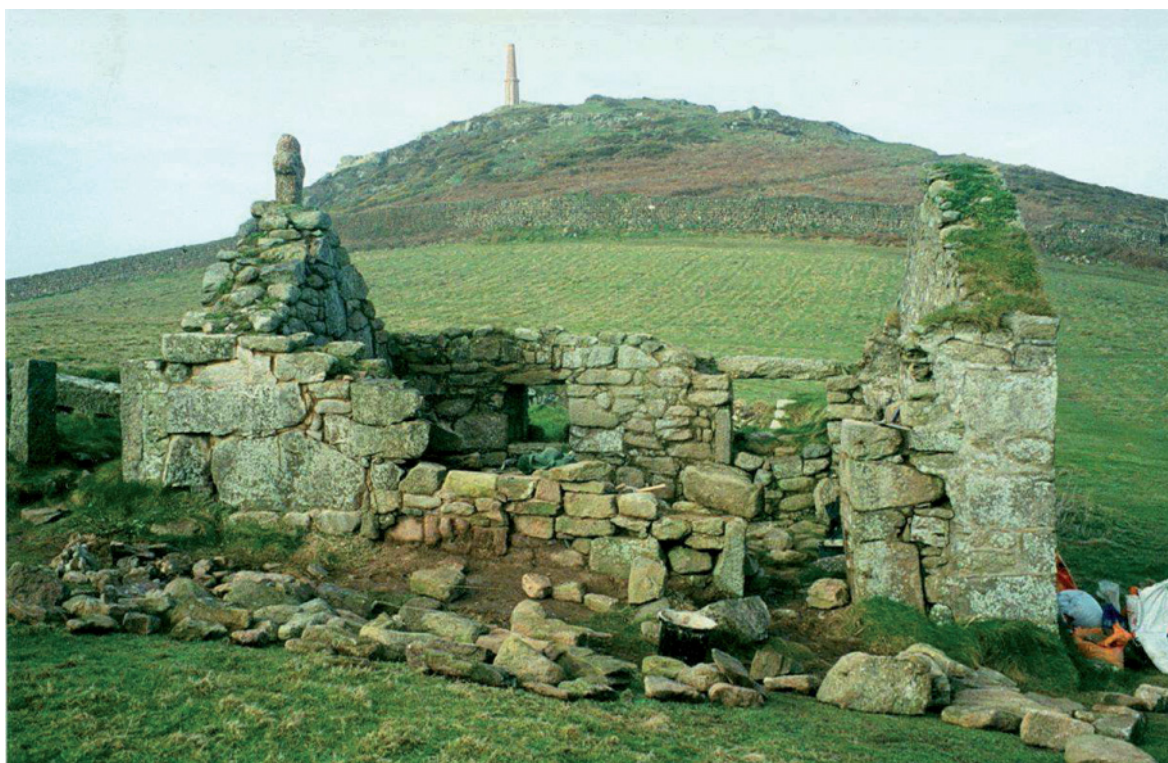
Fig 19. A later stage during the reconstruction of the eastern wall and doorway reveal. HE Digital Image Archive.

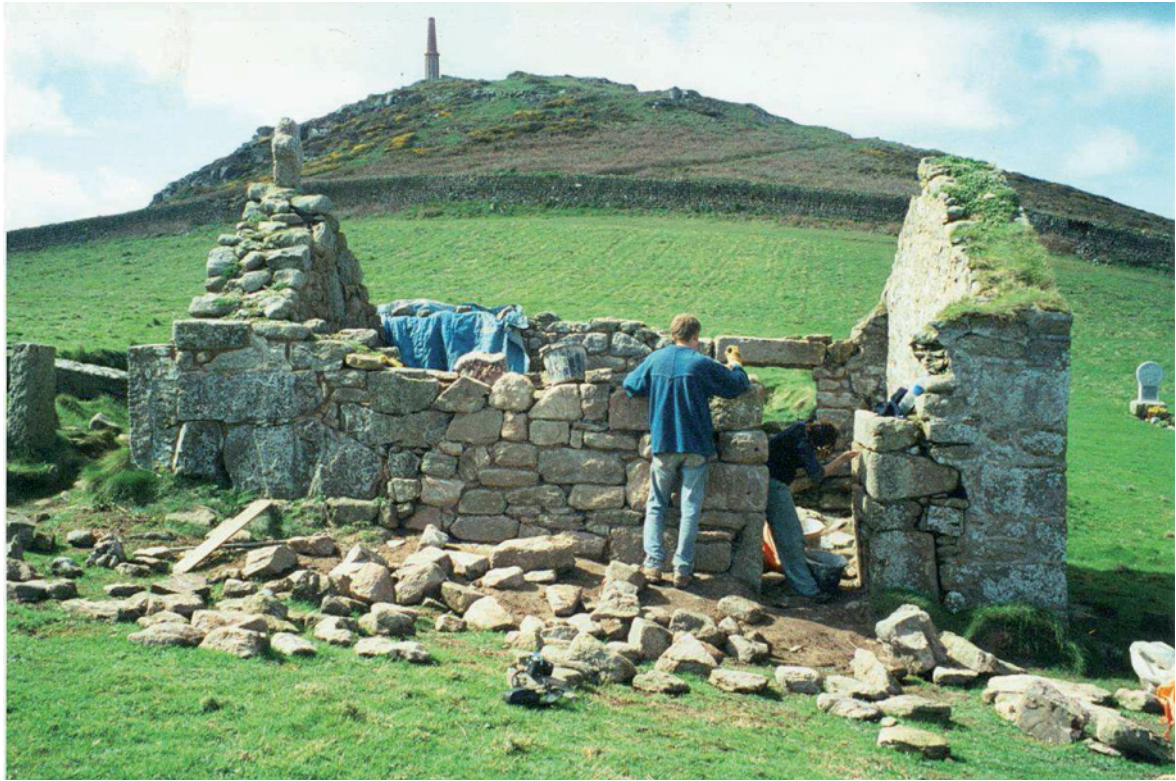
Fig 20. The reconstruction of the collapsed section of the eastern wall approaching completion. HE Digital Image Archive.

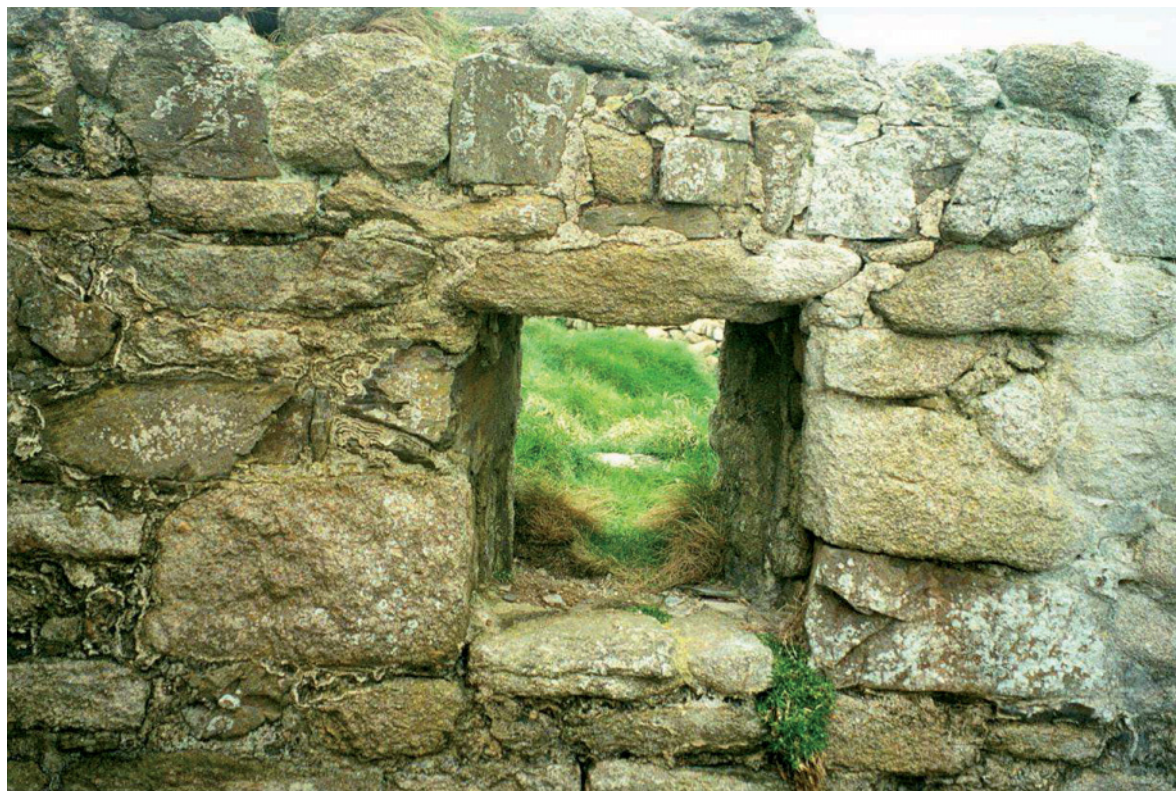
Fig 21. The masonry over the external face of the window in the western wall. HE Digital Image Archive.
