Lambessow barn, St Clement, Cornwall

Historic Building Record

2011R079

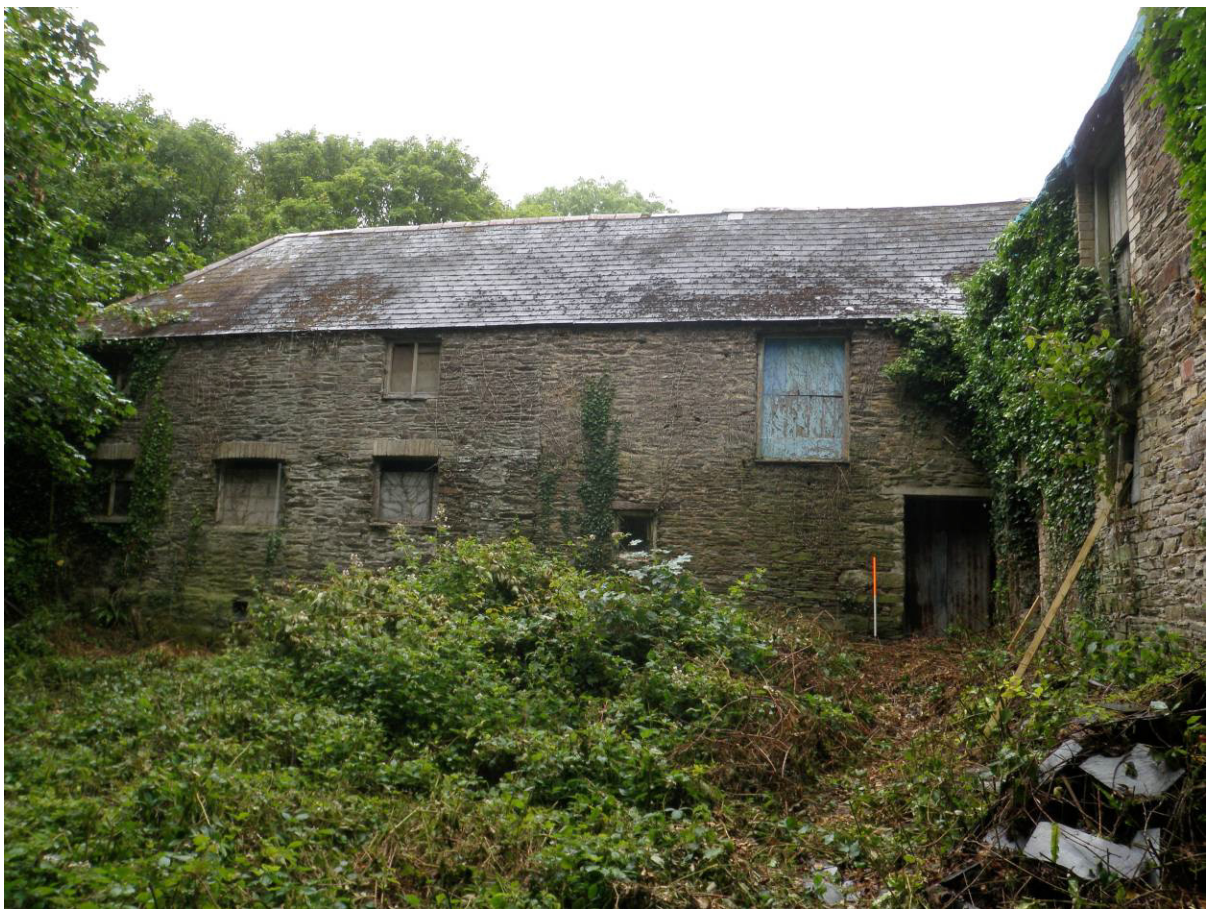
The north-eastern half of this wall is part of the earlier phase 2 barn which is separated by a straight joint from the south-western half, a phase 3 extension and part of the mid/late 19th century remodelling. Also along the base of the wall earlier phase 1 masonry survives indicated by the base of the straight joint not reaching the base of the wall but stopping approximately 0.7m from the base of the exposed footings. The north-eastern (phase 2) half of the wall has a threshing door at ground floor level, a rebuilt or possibly inserted door at ground floor level and a small original window at first floor level. The south-western phase 3 extension is the stables on the ground floor with hayloft over. There is a central blocked door opening to the yard on the ground floor with a window opening either side (all of which have brick arches), and another two window openings on the first floor. Three of the original, phase 3 window frames survive along with their internal timber shutters. The roof covering is a modern slate replacement.

Fig 6: South-east elevation of the west range

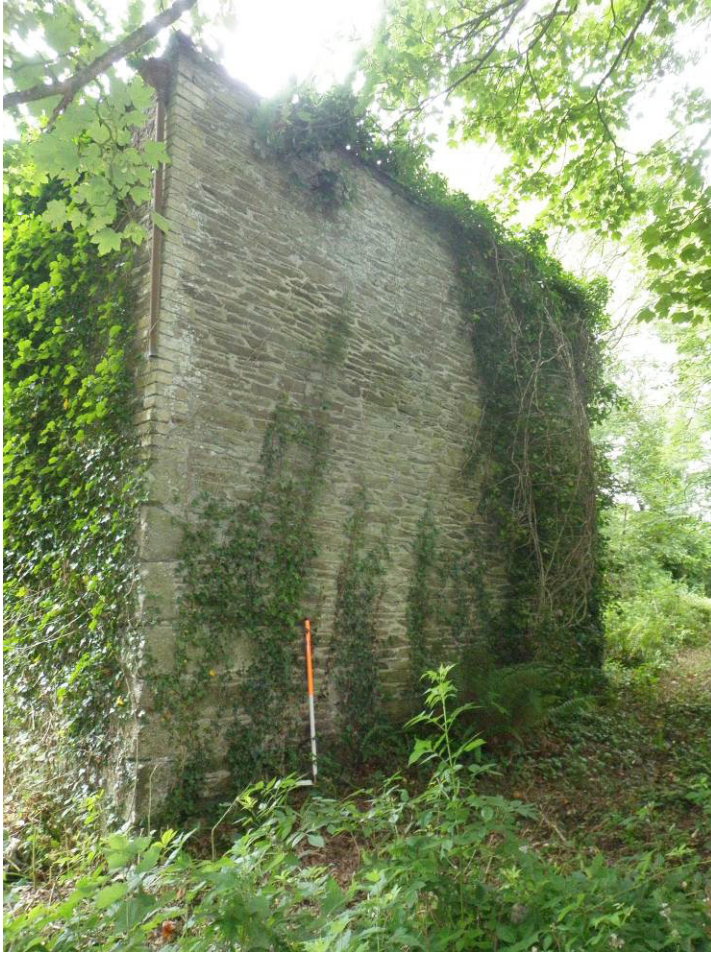
This is the hipped end wall of the phase 3 mid/late 19th century extension of the east range. It is constructed from slate rubble bonded with lime mortar and has granite quoins up to approximately 2m high and then brick jambs to the eaves. There are no openings or alterations in this elevation

Fig 7: South-east elevation of the east range

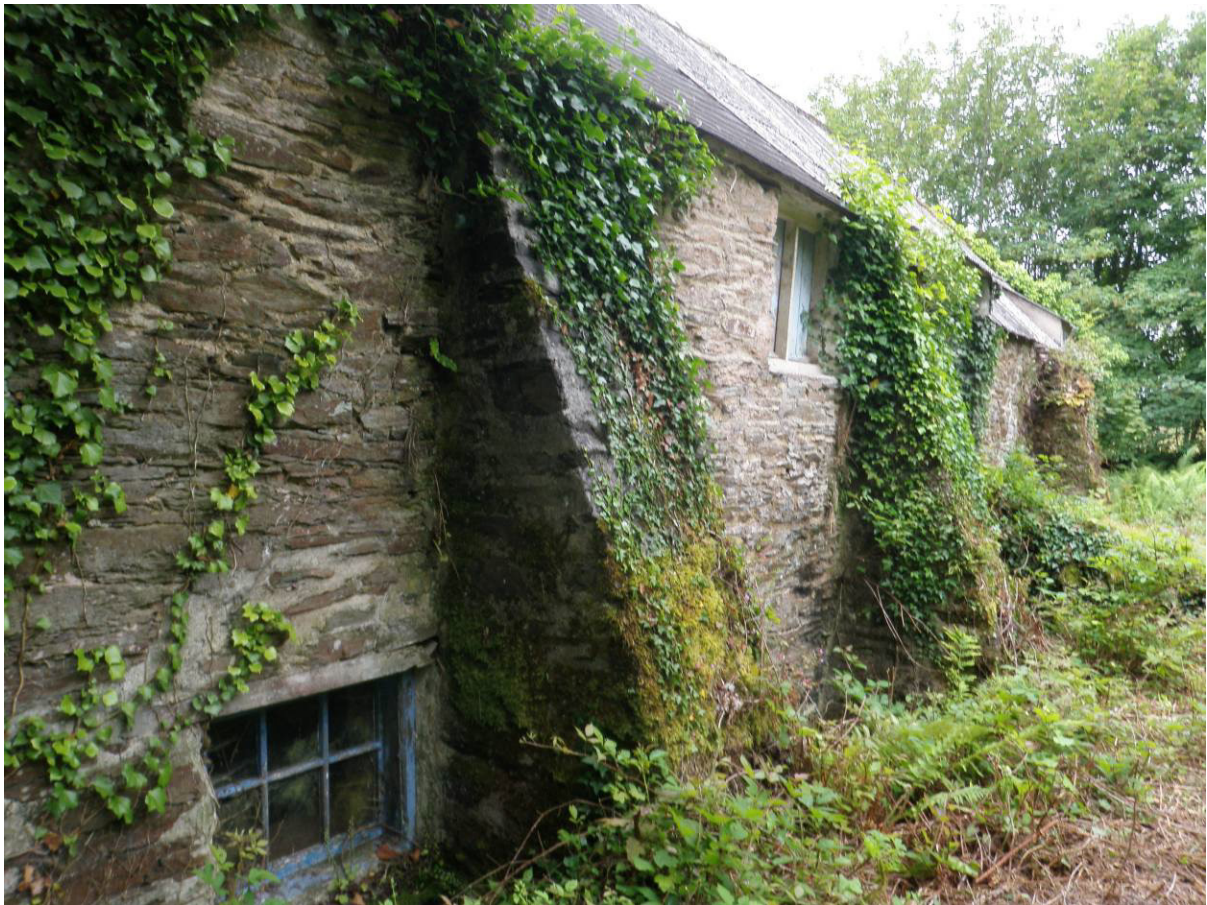
The north-west wall is constructed from slate rubble bonded with lime mortar. The south-west half of the wall relates to the phase 3 stable on the ground floor and the hay loft on the first floor. In this part of the wall there is a single first floor loading door opening containing an inserted sash window. There also appear to be two phases of walling at this end, the lower half appearing to relate to phase 1 and the upper part containing the loading door relating to phase 3.

Fig 8: North-west elevation looking south

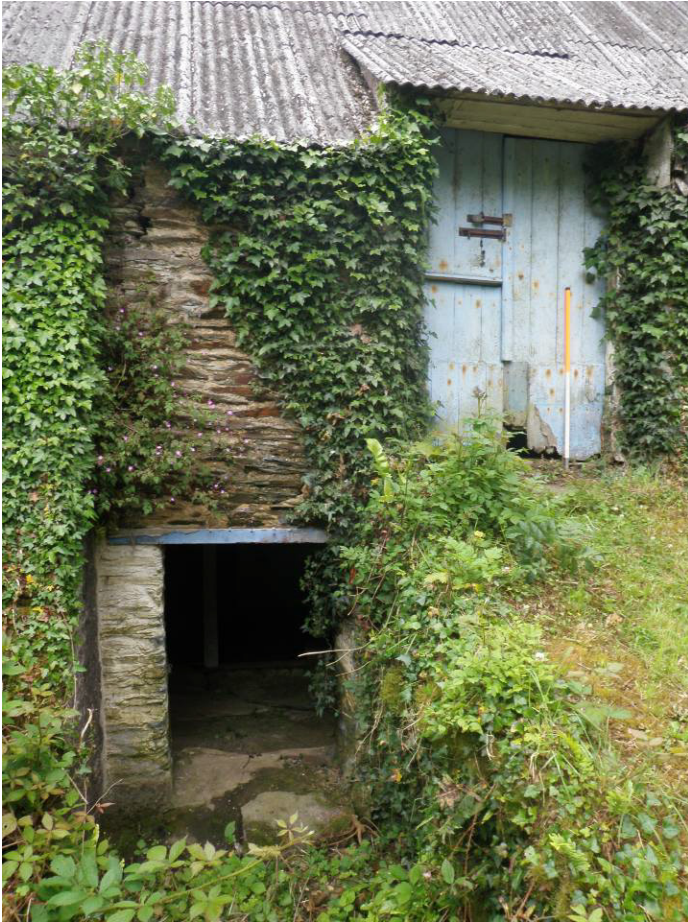
at first floor level a phase 2 and 3 threshing barn. At ground floor level in the wall there is a wide partially blocked phase 1 door opening with a partially blocked phase 1 window to the south-west of it and a further blocked opening to the north-east of it. The window opening at the far north-east end of the ground floor has been inserted at a later date. At first floor level in the north-eastern half of the wall is a phase 2 threshing door opening containing a mid/late 19th century door and an inserted phase 3 window to the north-east of it. The three buttresses and ramp up to the first floor threshing door are later additions and likely to have been added for stability as part of the phase 3 remodelling. The buttresses and ramp are constructed from slate rubble bonded with lime mortar.

Fig 9: Door openings in north-west elevation

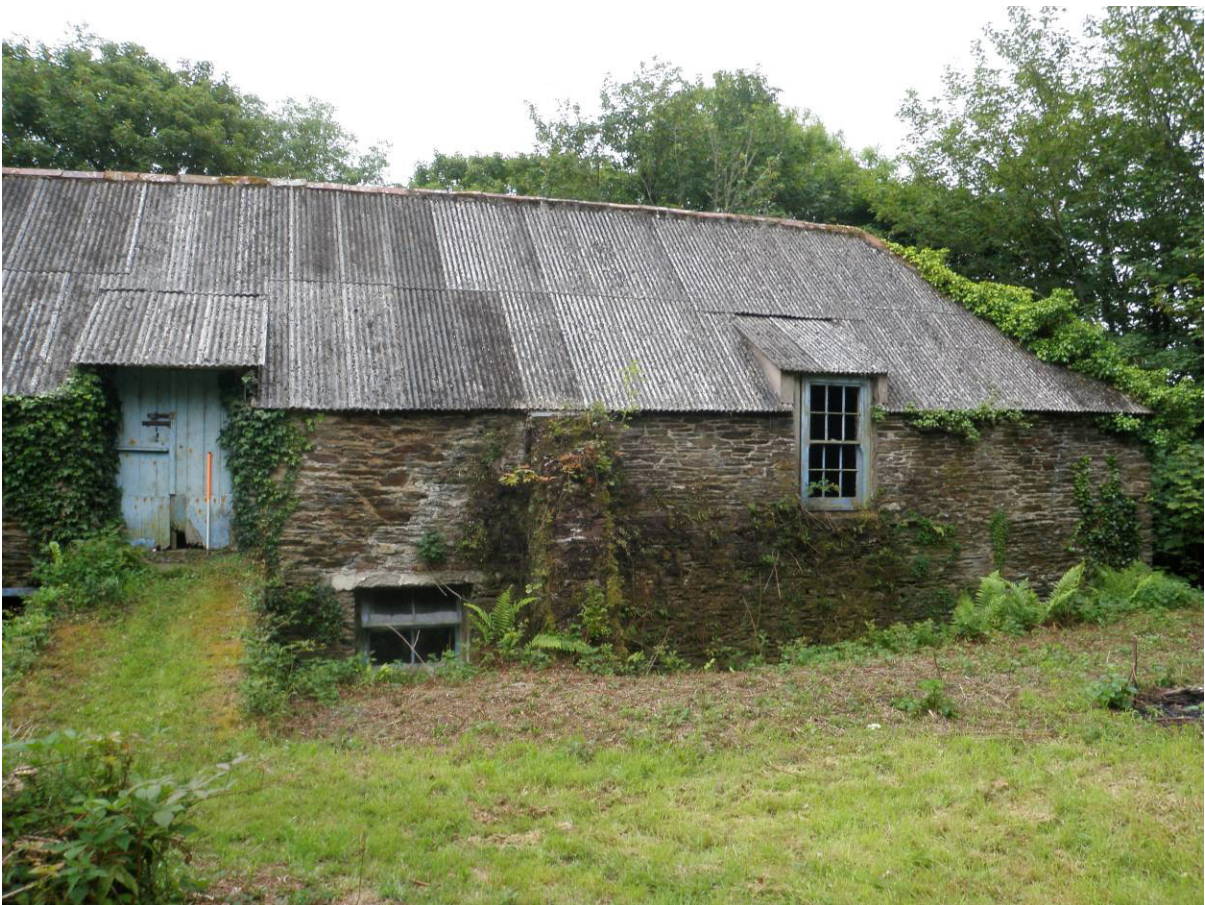
Fig 10: South-west half of north-west elevation

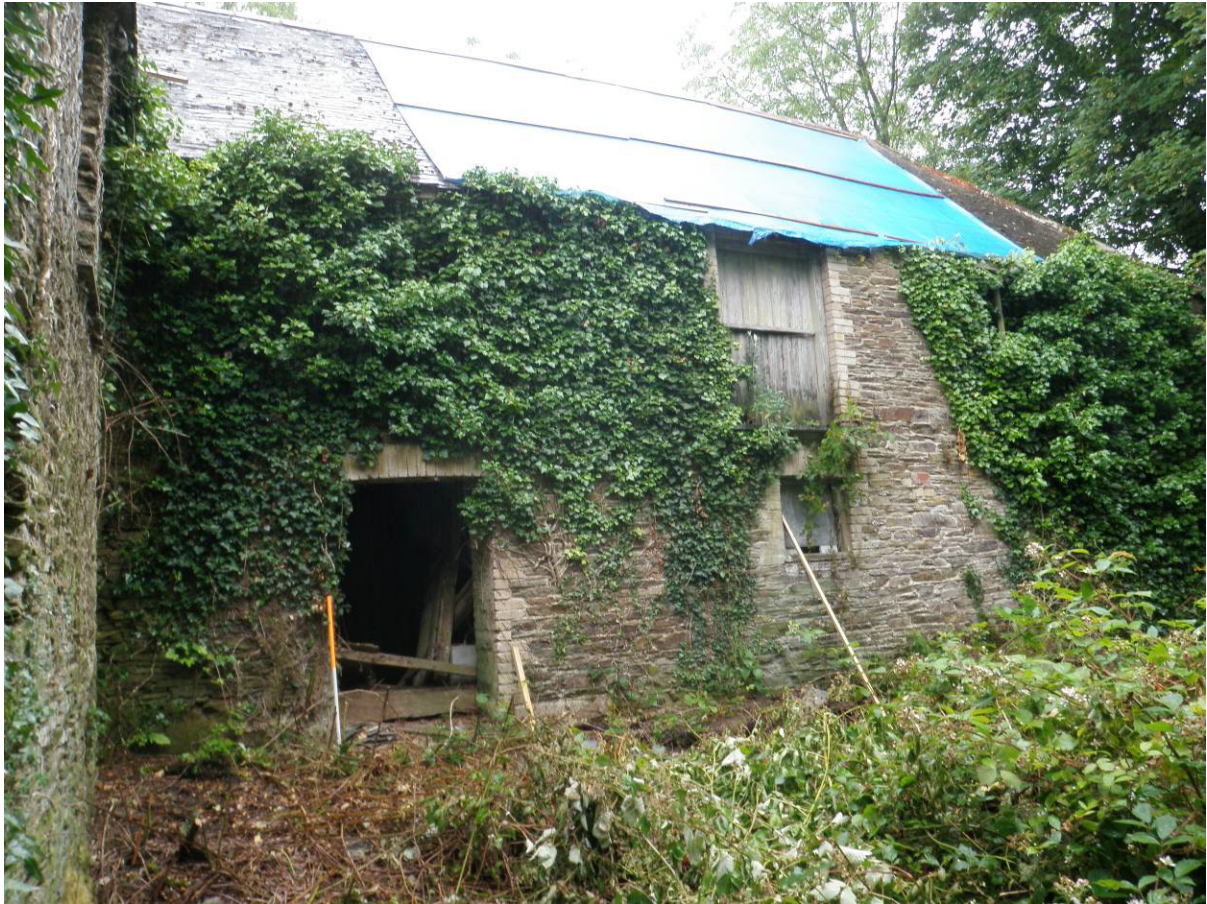
The north-western end of this wall is part of the earlier phase 2 barn demonstrated by the north-west jamb of the ground floor door opening which is constructed from slate rubble whilst the south-east jamb of this door opening is brick-built and part of the phase 3 mid/late 19th century extension. The whole structure to the south-east of the north-west jamb of the door opening was built anew as part of the phase 3 remodelling. All the openings in this part of the elevation have brick jambs. Those on the ground floor have brick arches and those on the first floor, timber lintels. At first floor level there is a threshing door opening (with original timber planked door) with a window either side of it. Both windows retain their original frames and shutters. At ground floor level serving the cow-house and possible cart house (at the south-east end) is the door opening to the north-west with two windows to the south-east of it. Much of the elevation is obscured by thick ivy. The roof covering is 19th century slate which is badly damaged.

Fig 11: South-west elevation of east range

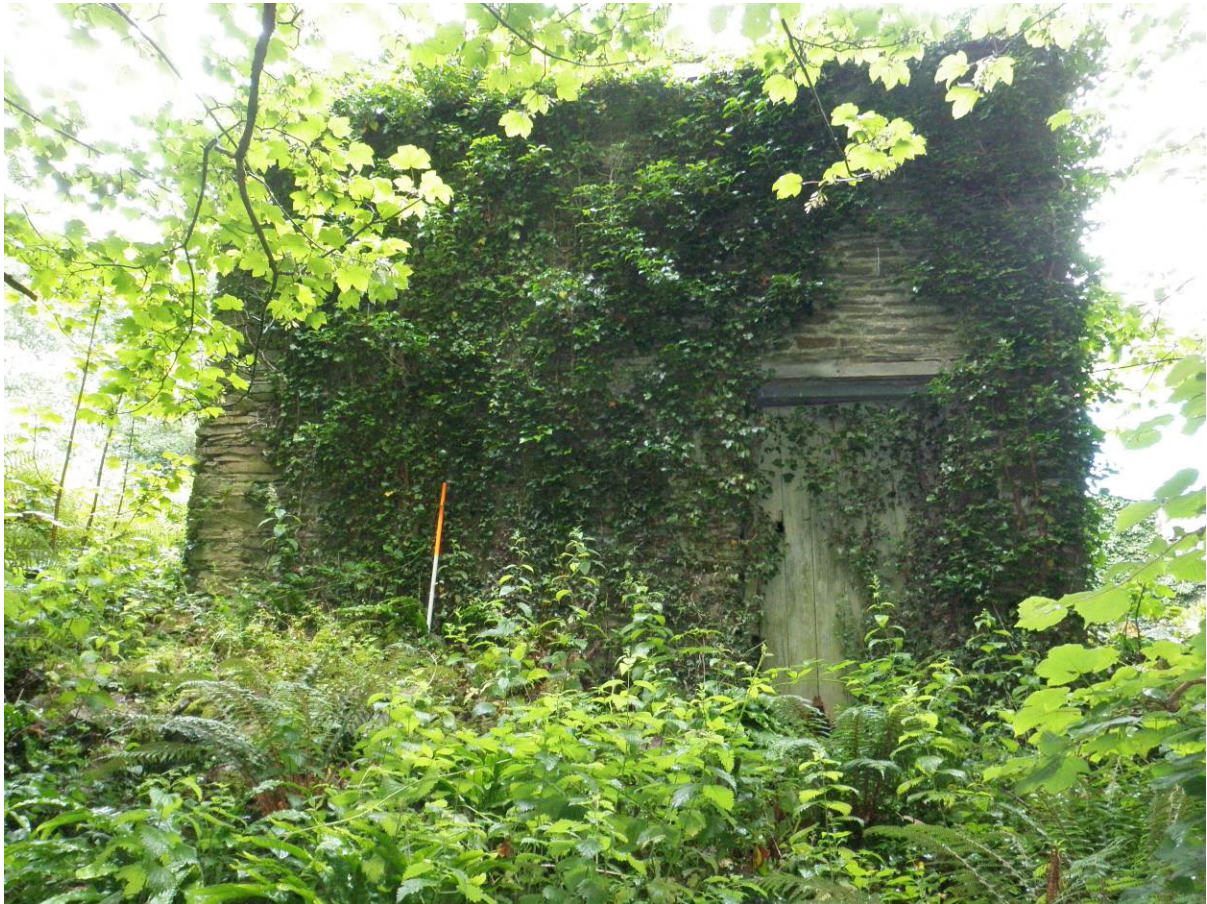
This is the hipped end wall of the phase 3 mid/late 19th century remodelling of the west range. It is constructed from slate rubble bonded with lime mortar. It contains a single door opening at ground floor level giving access to the stables and on the lower half of the north-west quoin there is a scar showing the former location of a now demolished yard wall which would have created an enclosed yard for horses separate to the main farmyard. The fact that the quoins and jambs of the door opening are constructed from slate rubble suggests that at least some of this wall may survive from phase 1 although any rebuilt sections were not visible due to extensive ivy coverage.

Fig 12: South-west end elevation of west range

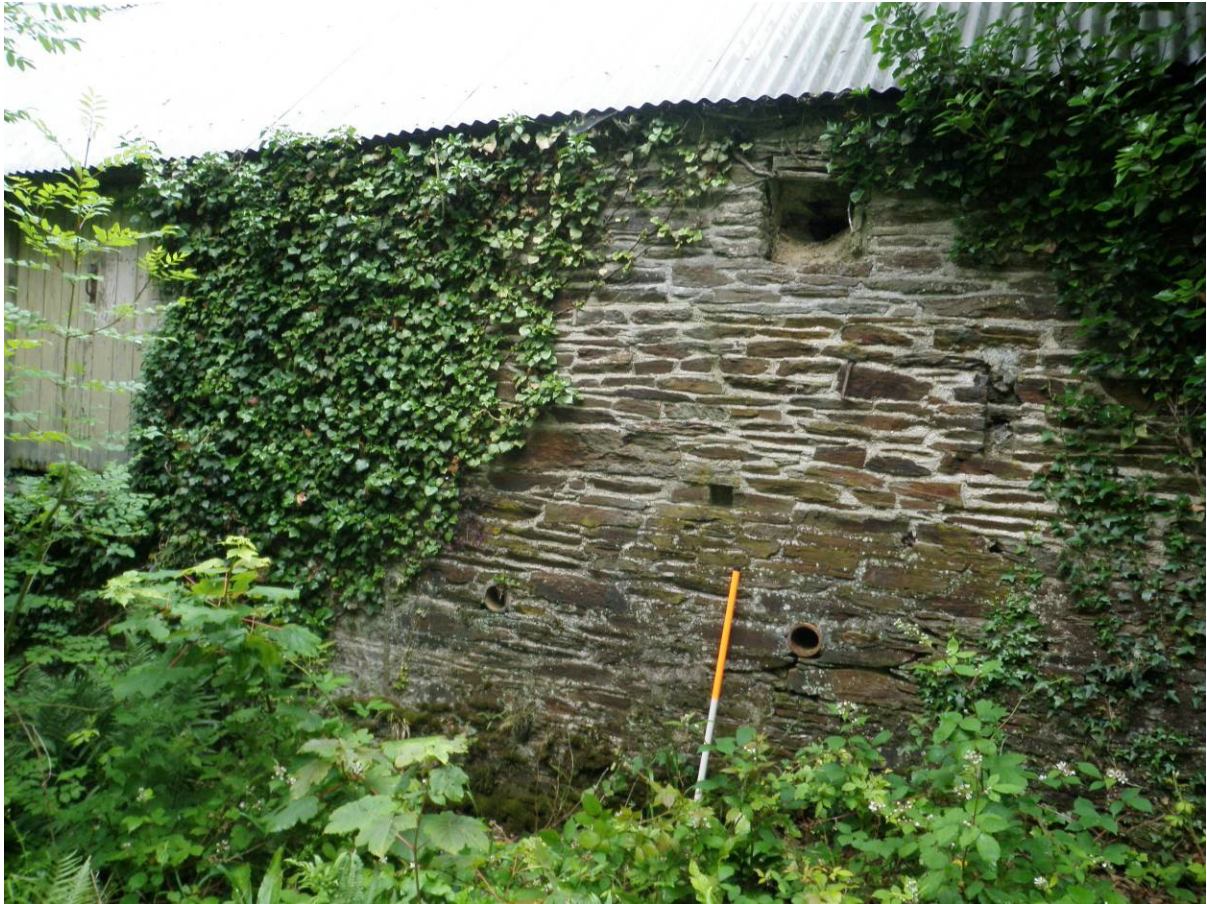
The north-east wall is constructed from slate rubble bonded with lime mortar. The south-east half of the wall relates to the phase 3 extension of the east range and the north-west section to the northern end of the west range (phases 1, 2 and 3). At the time of the survey the wall was covered in thick ivy and only small sections were visible. The exterior ground level in front of the north-western half of this elevation where there was once an adjoining 19th century horse-engine house had been built up to approximately first floor level. In this part of the wall there are several blocked square openings and recesses associated with the horse-engine mechanisms and structure including a drive shaft opening towards the top of the wall. A larger rectangular blocked opening is probably a belt drive opening associated with a steam or diesel powered engine post-dating the horse-engine. A cement rendered tank with associated external vertical pipe has been inserted here at ground floor level and appears to be associated with the internal machine bearing recess/fireplace on the interior face of the wall. In the south-east (phase 3) half of the wall there is a wide double door opening on the ground floor at

the south-east end. This is likely to have been an opening to a former cart shed at this end of the building. It has a timber lintel and the jambs are slate and granite rubble and there is the base of a staddle stone reused in the north-west jamb. At first floor level there is a threshing door with timber lintel, brick jambs and an original timber planked door.

Fig 13: Section of north-east elevation of east range showing opening for horse-engine drive shaft

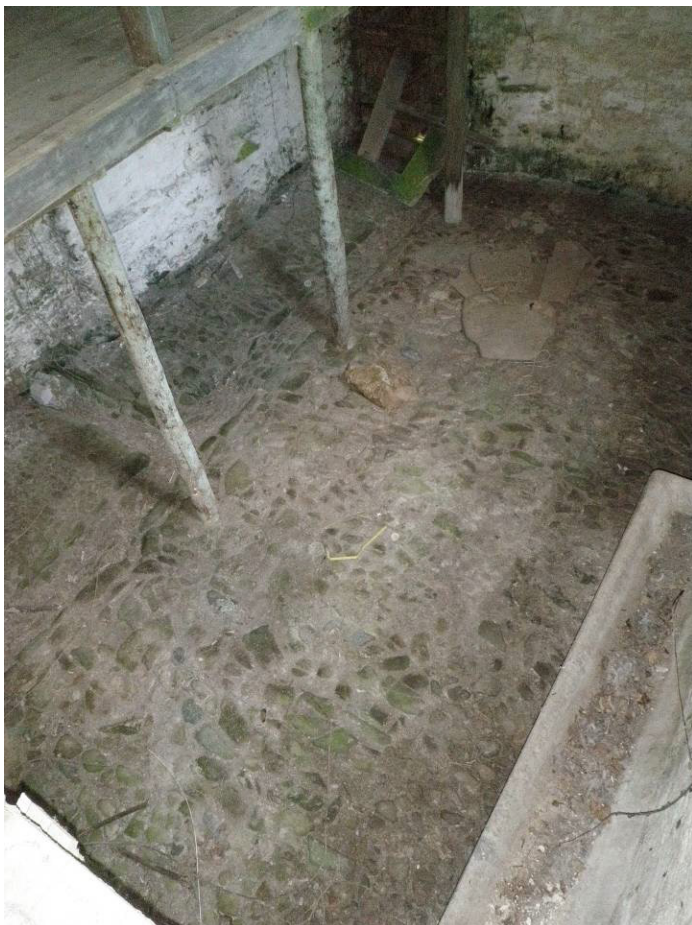
The floor in the stables is part of the phase 3 remodelling and comprises slate and granite cobbles with integral drainage gullies. The sockets to support the original stalls (now removed) can be seen in the floor and would have formed three stalls with a loose box at the north-east end of the room. The floor above the area of the stalls has since been removed and 20th century timber supports inserted. A cement rendered trough has also been inserted in the 20th century along the north-west wall after the removal of the stalls. The walls in the stable are white-washed. The two window openings and door opening in the south-east wall have reused moulded timber lintels.

Fig 14: Cobbled floor inside former stables in the west range

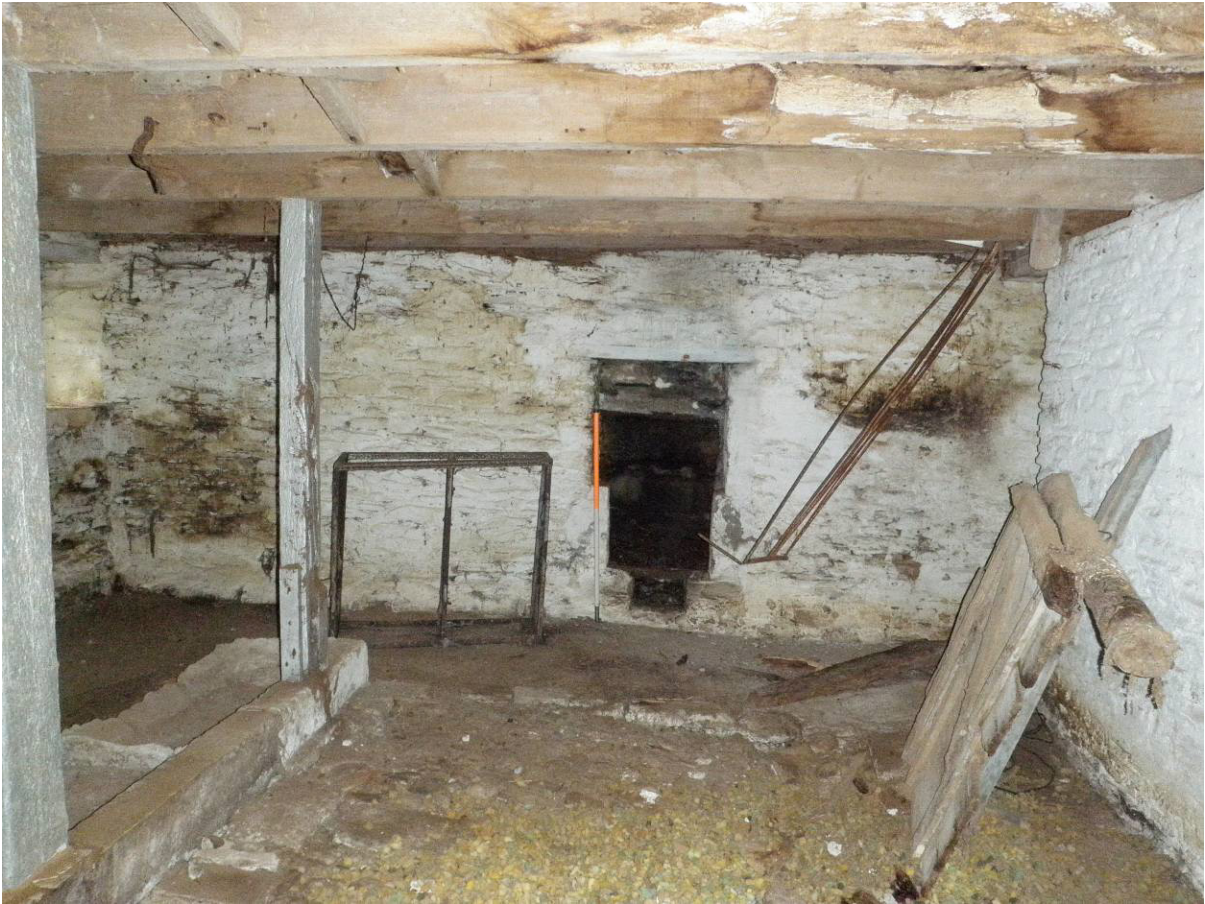
This room contains some of the oldest fabric of the building. Much of the walling is phase 1 with some rebuilding of the yard-side wall and other alterations during phase 2. Its latest (phase 3) use was as a cow-house, with a feeding passage along the north-west wall adjacent to the troughs with granite lintel fronts and slate divisions but later covered with a cement render. The stalls themselves have been removed and it is now difficult to say how many there were. The floor within most of the room is slate and granite cobbles with a drainage gully running along the back of the stalls, but there is also a patch of granite setts and another of granite lintels in the south-eastern part of the room. It is unclear whether these sections of floor post-date or pre-date the cobbles. The partition wall at the south-west end is a phase 3 insertion, but just to the north-east of it is a stone capped culvert running the width of the room and presumably draining the north-west side of the building. The door opening in the north-west wall was reduced in width during phase two to accommodate a threshing door on the first floor. During phase 1 this door opening was twice the width suggesting that it was used for cart access and that the bank immediately outside was not present during phase 1. In the north-east wall there is a large, inserted recess with iron fittings either for machine bearings or possibly used as a fireplace. The feeding passage also continues along this wall and through a door opening in the phase 3 partition wall into the east range. The walls are white-washed.

Fig 15: North-east end of ground floor in west range (former cow-house) showing machine bearing/fireplace recess

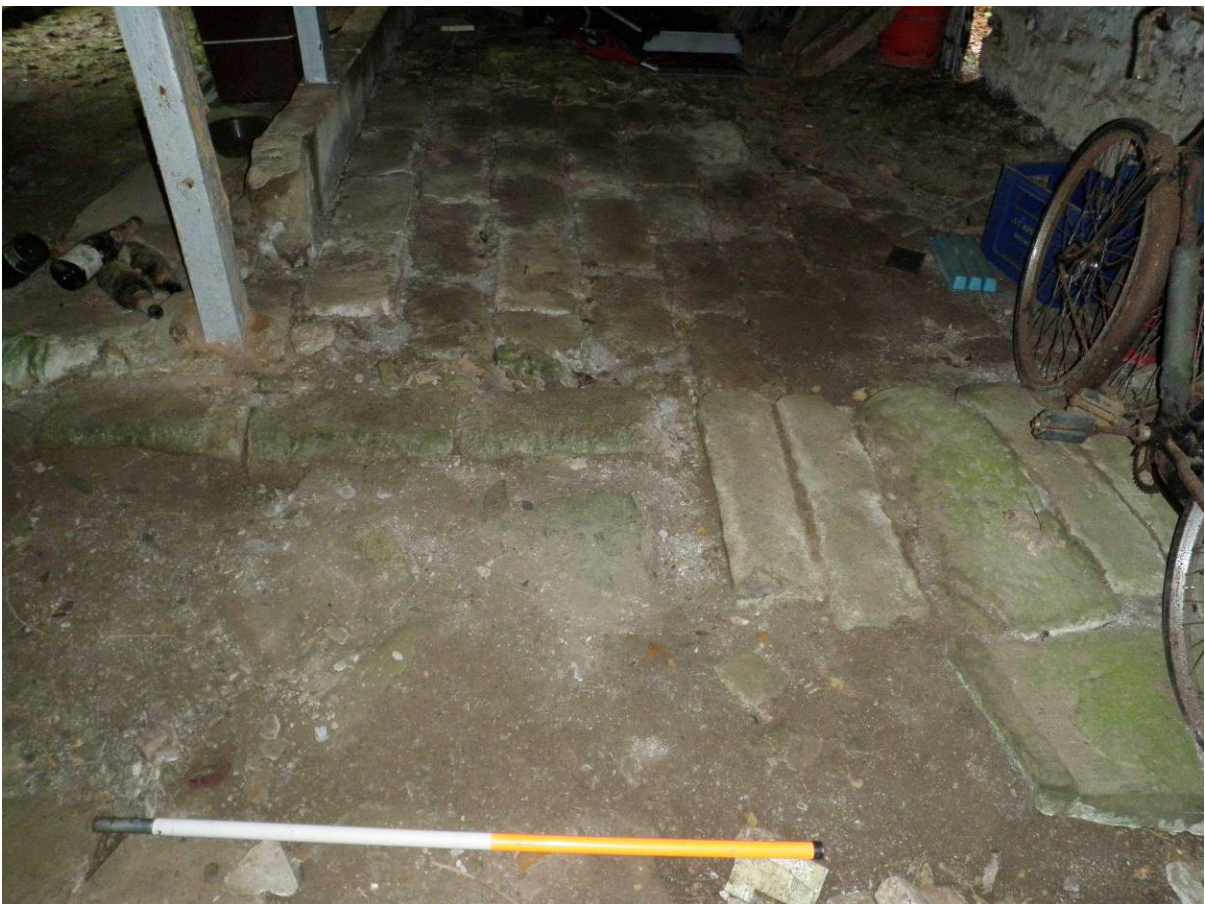
Fig 16: Ground floor in west range (former cow-house) showing granite flooring

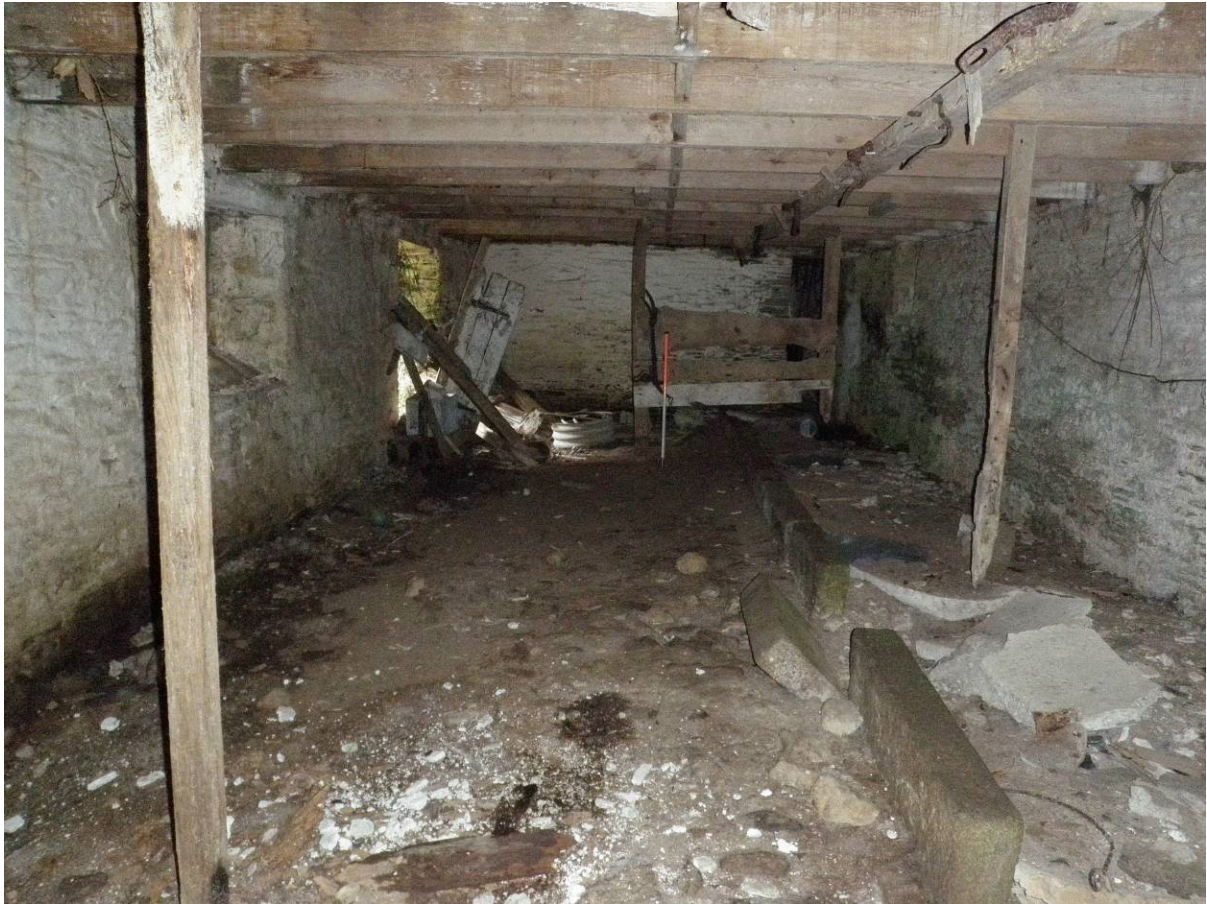
The floor is slate and granite cobbles. Its use was as a cow-house, probably with a cart shed at the south-east end. A feeding passage runs along the north-east wall adjacent to the troughs with granite lintel fronts and slate divisions but later covered with a cement render. Part of one of the stalls at the north-west end survives and the original positions of the stalls can be seen (five in total). The walling to the north-west of the farmyard door opening is part of the phase 2 building, and directly opposite it the north-east wall becomes narrower at this point to the south-east, suggesting that this was the extent of the phase 2 building.

Fig 17: Ground floor in east range (former milking parlour/cow-house) showing stalls and feeding troughs

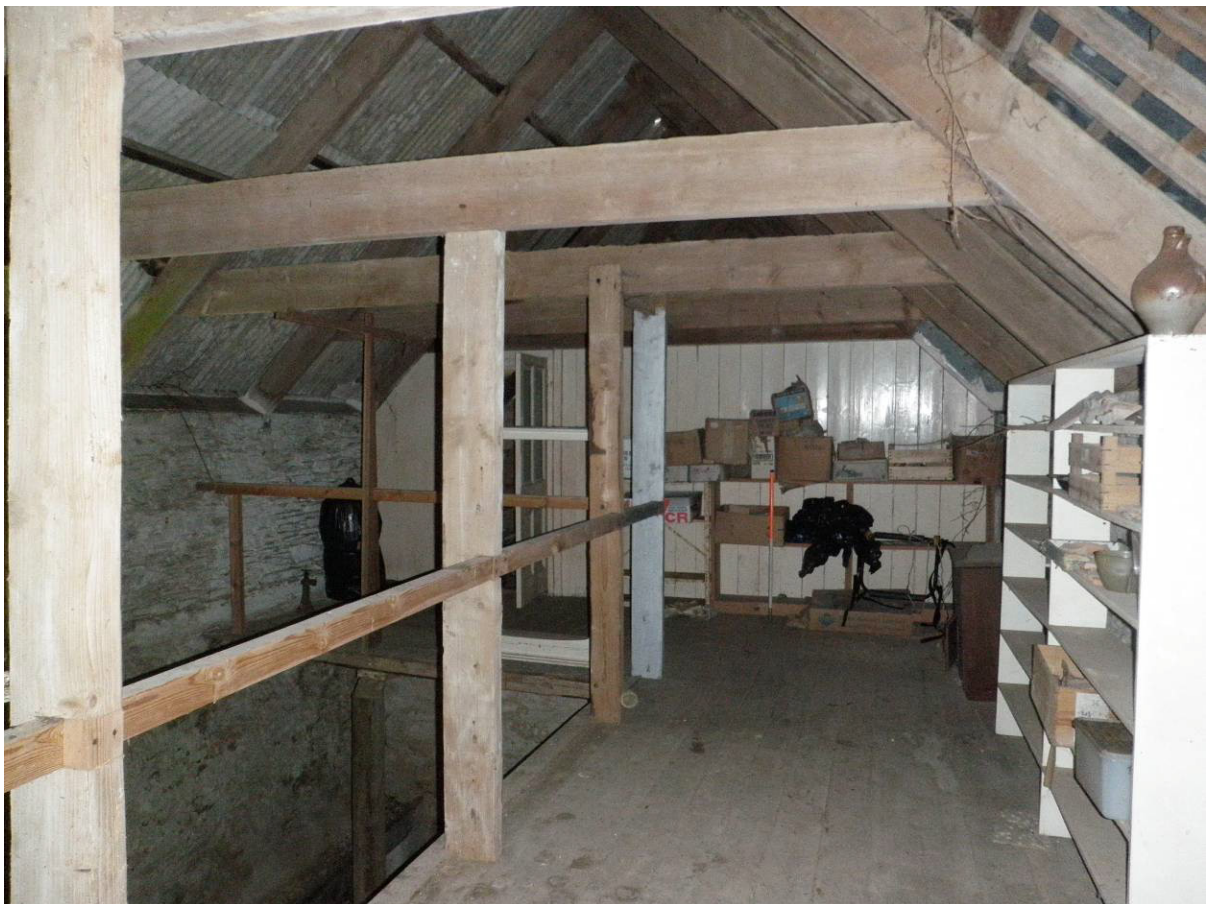
This room is located over the stable at the south-west end of the range. It is set at a slightly higher level than the rest of the first floor to allow more head room for the horses below. The floor joists and the room itself is part of the mid/late 19th century phase 3 remodelling although the boards are probably 20th century replacements. There

is a blocked hatch in the north-east corner of the room and a large part of the western half of the floor has been removed with a safety rail inserted at some point during the 20th century, and is now open to the ground floor. There is an original loading door in the north-west wall and the windows in the south-east wall retain their original frames and internal shutters. The timber planked partition wall dividing this room from the threshing floor to the north-east is a 20th century replacement of the original stud wall.

Fig 18: First floor in west range (former hayloft) looking north-east

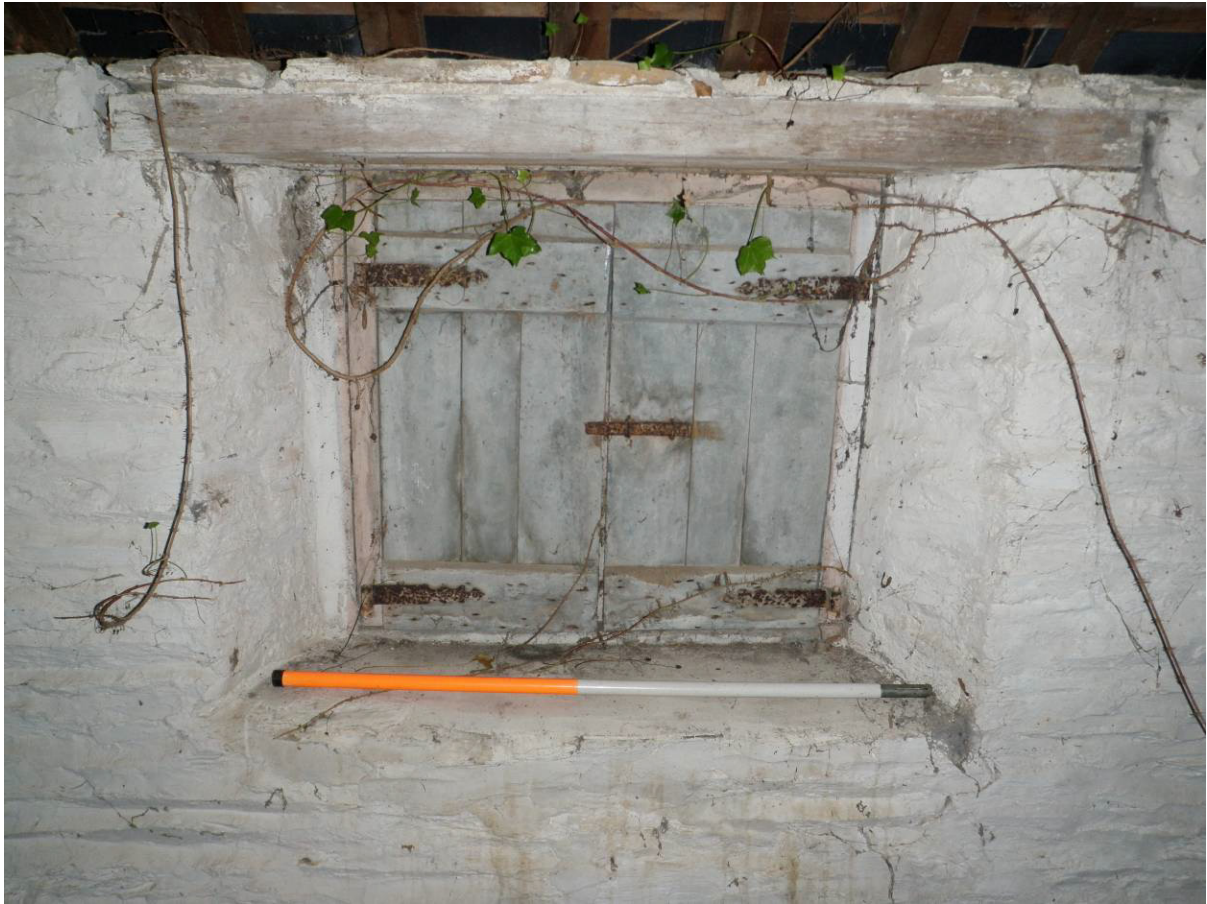
Fig 19: First floor in west range (former hayloft) phase 3 shutters in window

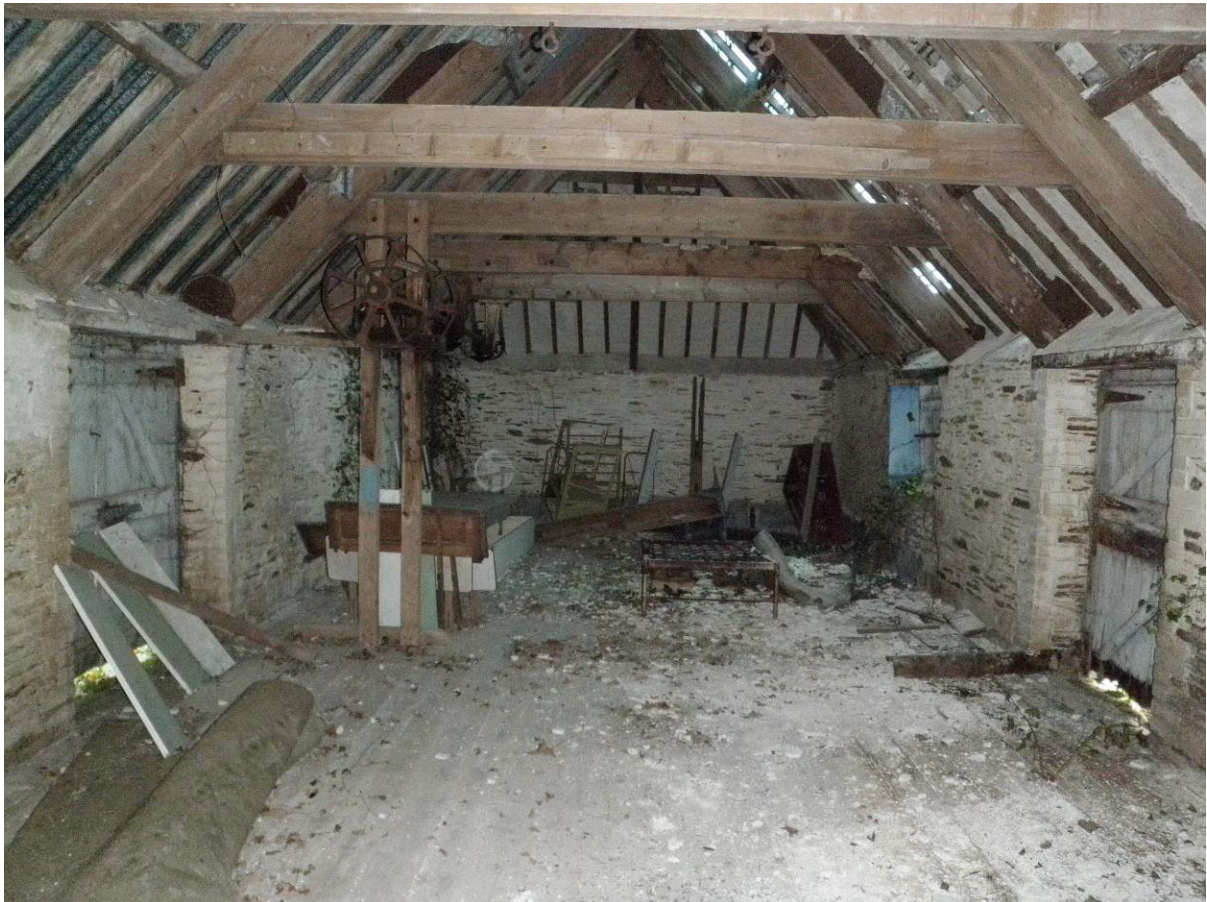
This room-space (phase 3) is open to the north-eastern half of the west range at first floor level. There are two opposing threshing doors with original timber planked doors towards the south-east end but the original threshing boards have been replaced with 20th century floor boards. At the south-east end of the room the drive shaft with belt drive wheels to power the threshing machine/chaff cutter remains *in situ* attached to the joists. The windows in the yard-side wall have original phase 3 frames and shutters.

Fig 20: First floor in east range (former threshing barn) phase 3 extension

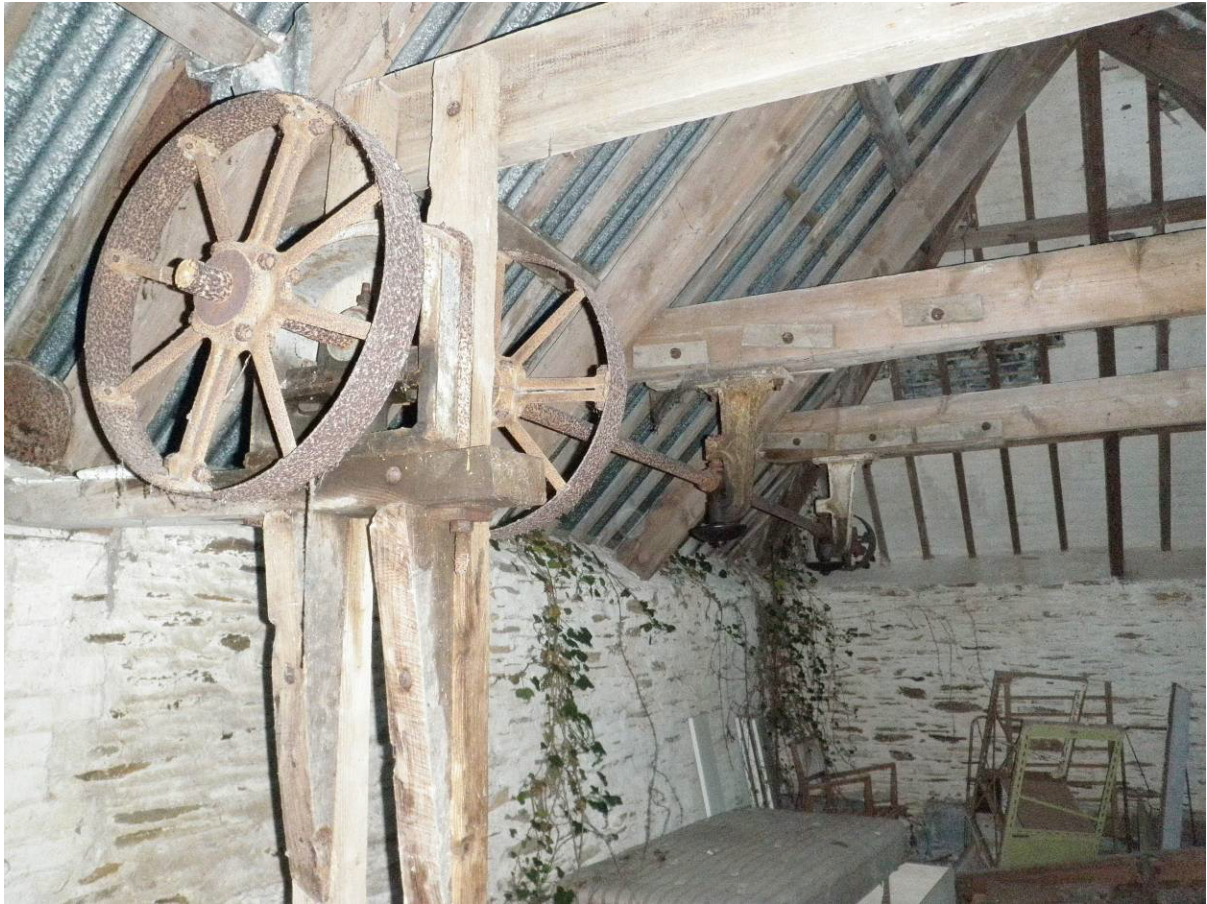
Fig 21: First floor in east range (former threshing barn) showing belt drive wheel for threshing machine/ chaff cutter

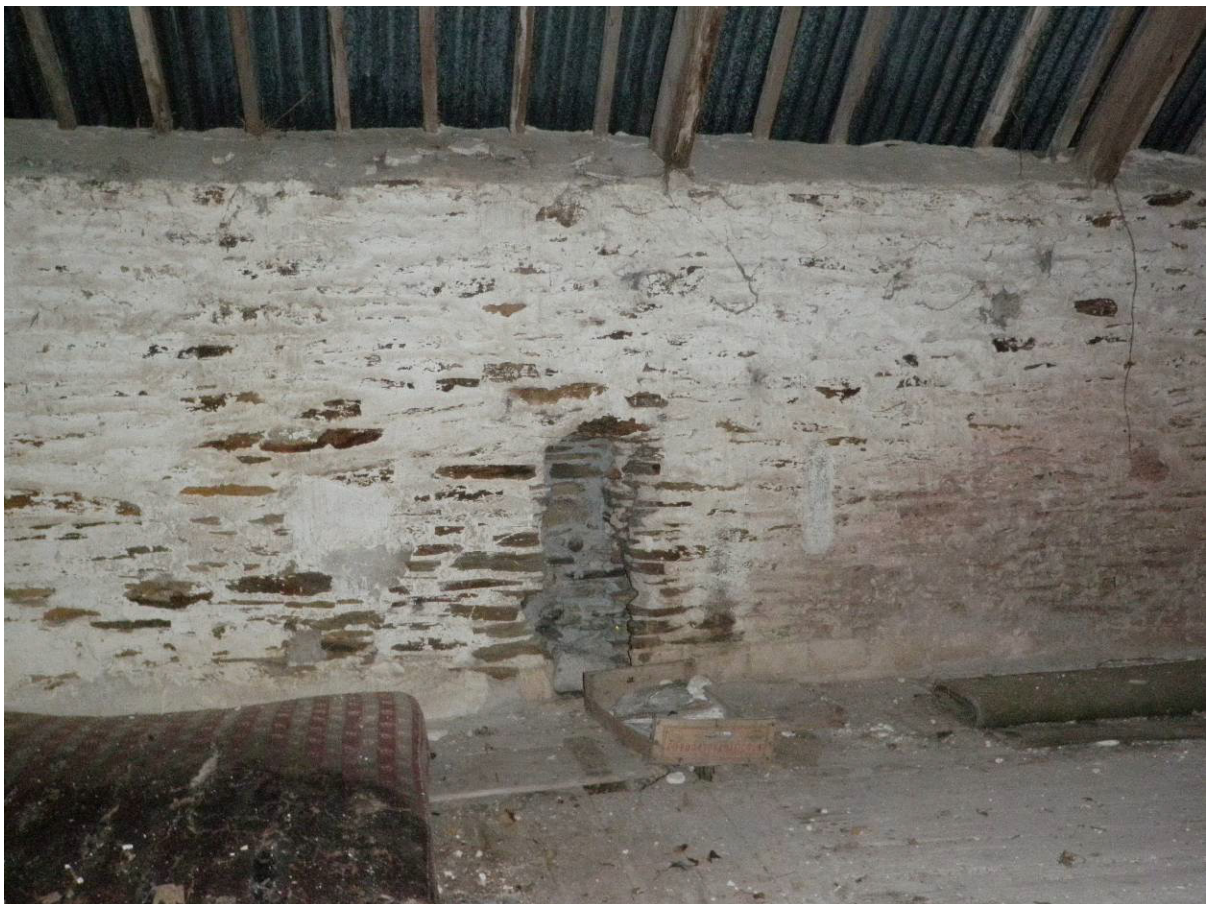
Fig 22: First floor in east range (former threshing barn) showing belt drive opening in north-east wall

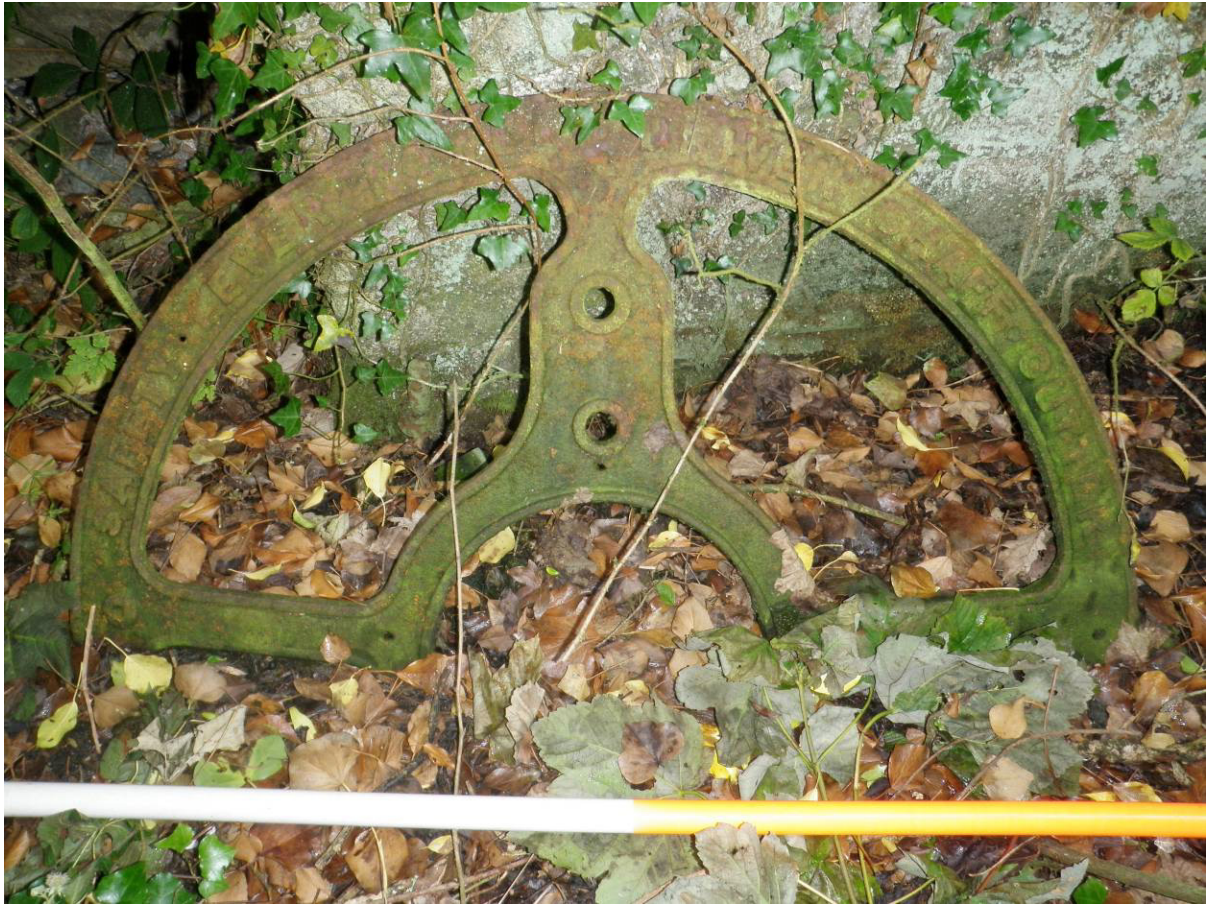
Fig 23: 'Safety lever power driven chaff cutter' found outside the east range
