## **Holmbush Mine, Kelly Bray, Cornwall**

### **Report on building conservation works (2001, 2007)**

<b>Client</b>	<b>East Cornwall Regeneration Project</b>
<b>Report Number</b>	<b>2011R092</b>
<b>Date</b>	<b>September 2011</b>
<b>Status</b>	<b>Final</b>
<b>Report author</b>	<b>Colin Buck</b>
<b>Checked by</b>	<b>AY</b>
<b>Approved by</b>	<b>AY</b>

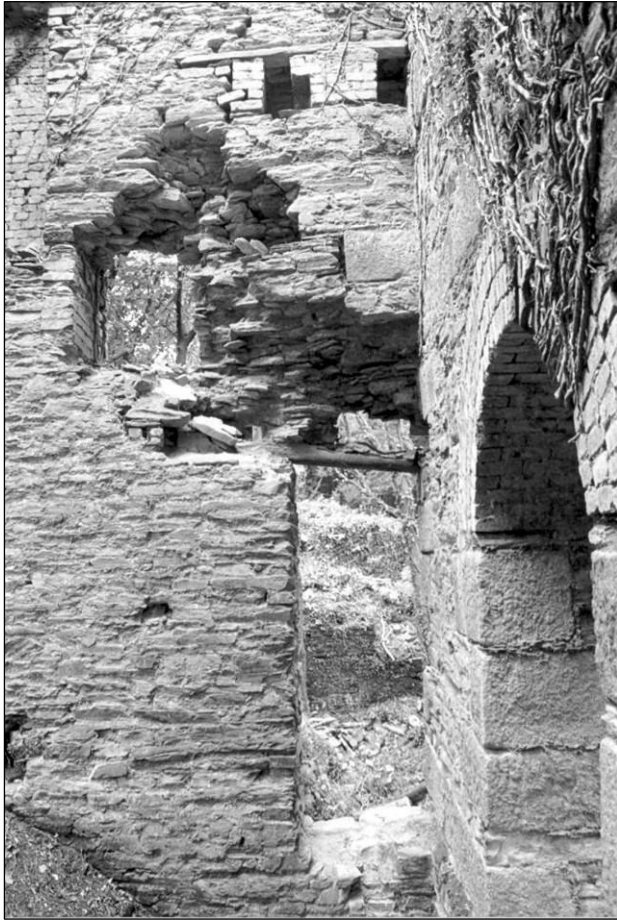
*Fig 3 Internal view of Hitchen's engine house (before works)  
C Buck 2001 © CC CAU*

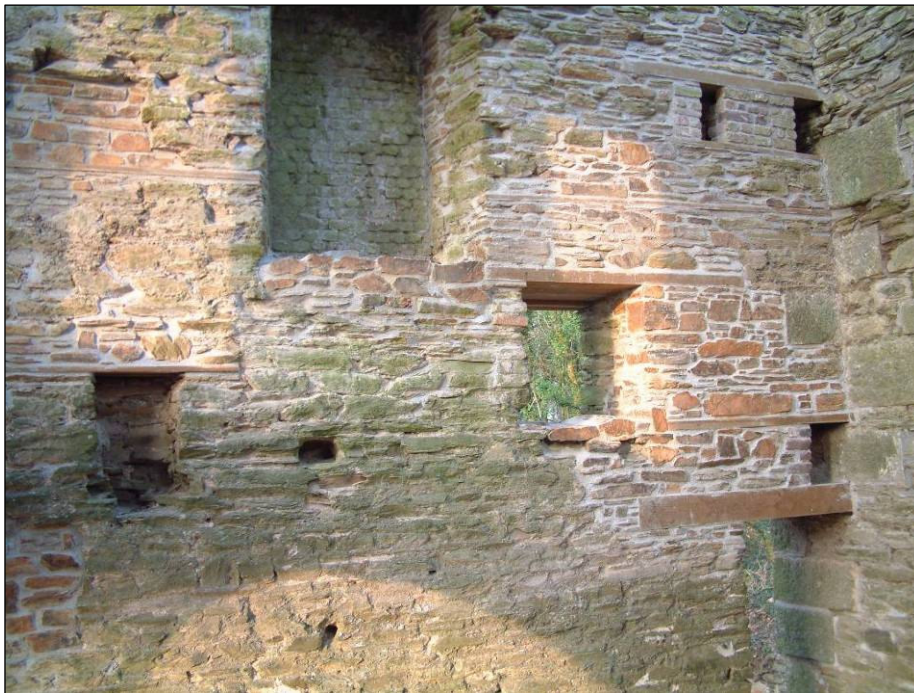
*Fig 4 Internal view of Hitchen's engine house (after works) C Buck 2001 © CC CAU*

By mid October 2001 the engine house had been fully consolidated. The tops of the walls had been 'capped' (two layers of stones rebbed in NHL 5.0 and the surface repointed to allow run-off between the masonry). The walls were repointed where necessary and the south wall upper pier had been rebuilt (as it was rotating away from its constructed position). The floor area was cleared of debris and the granite cylinder bedstones revealed with their hold down bolt holes visible (see Fig 5).

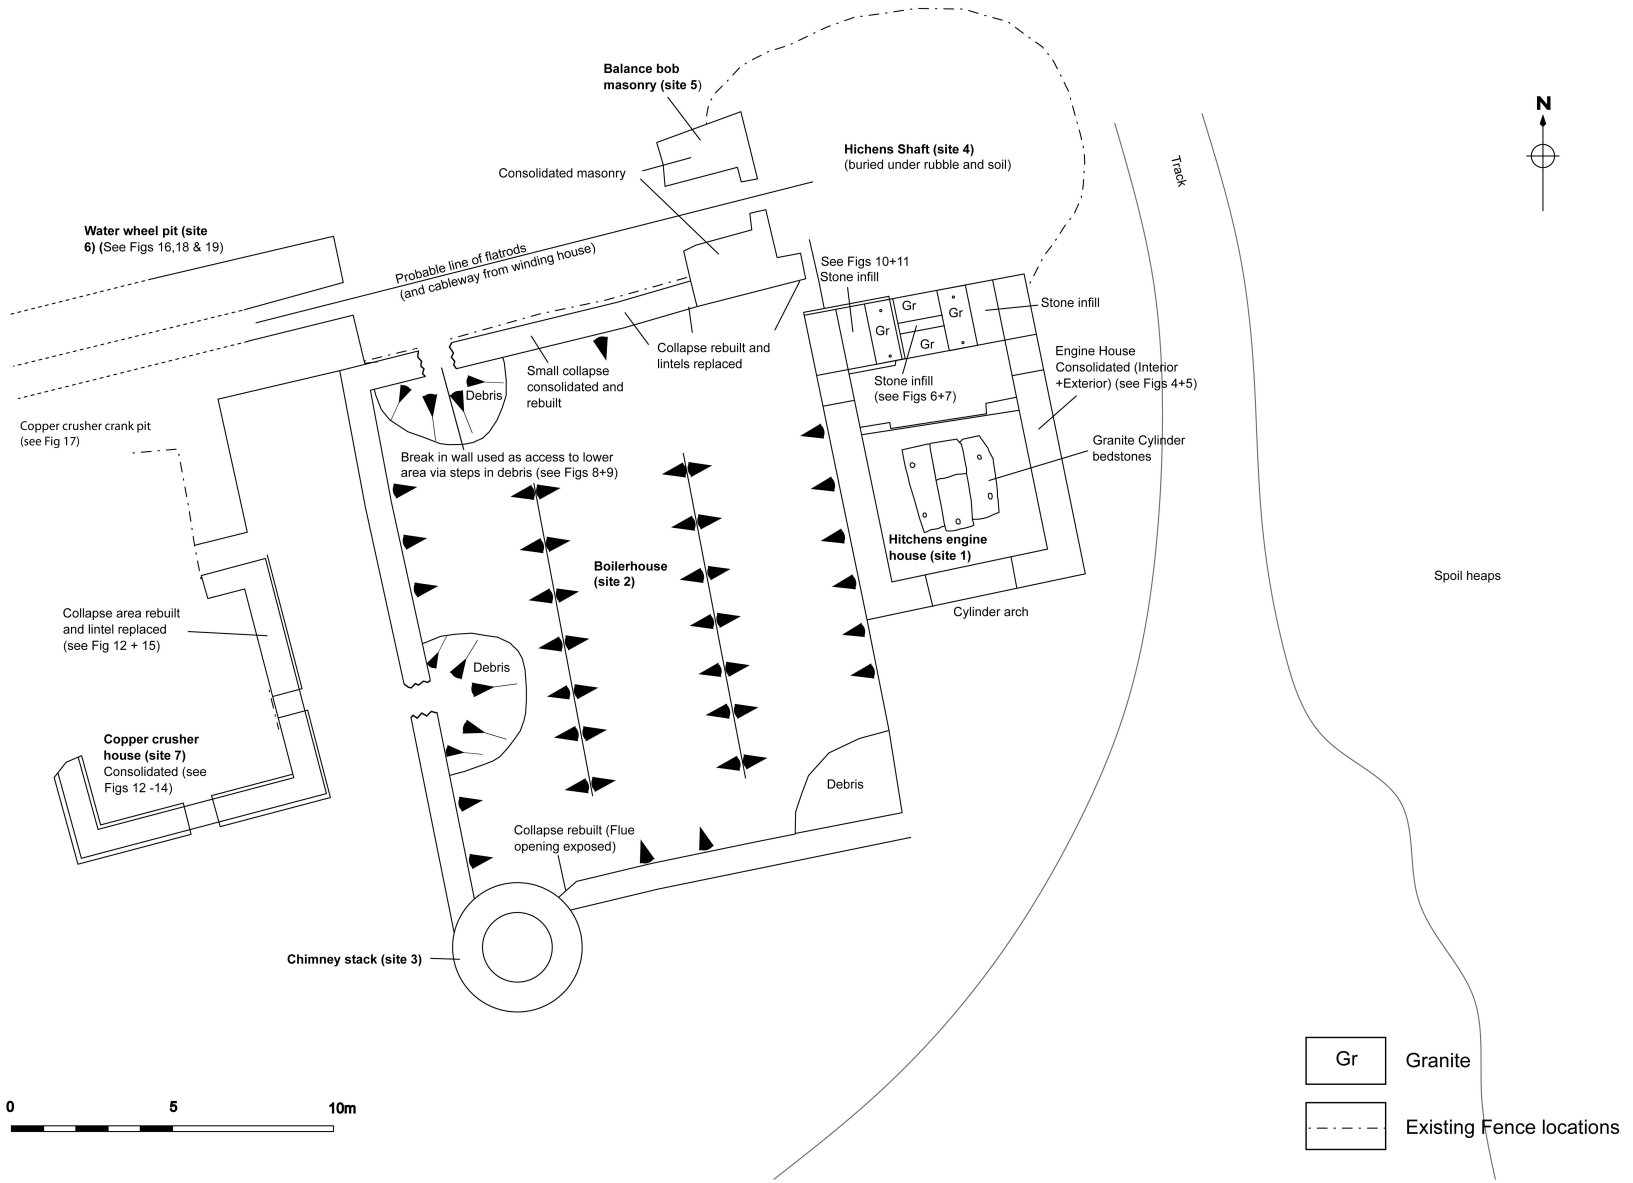
Figure 5 Survey plan of the engine house, boiler house and copper crusher after works

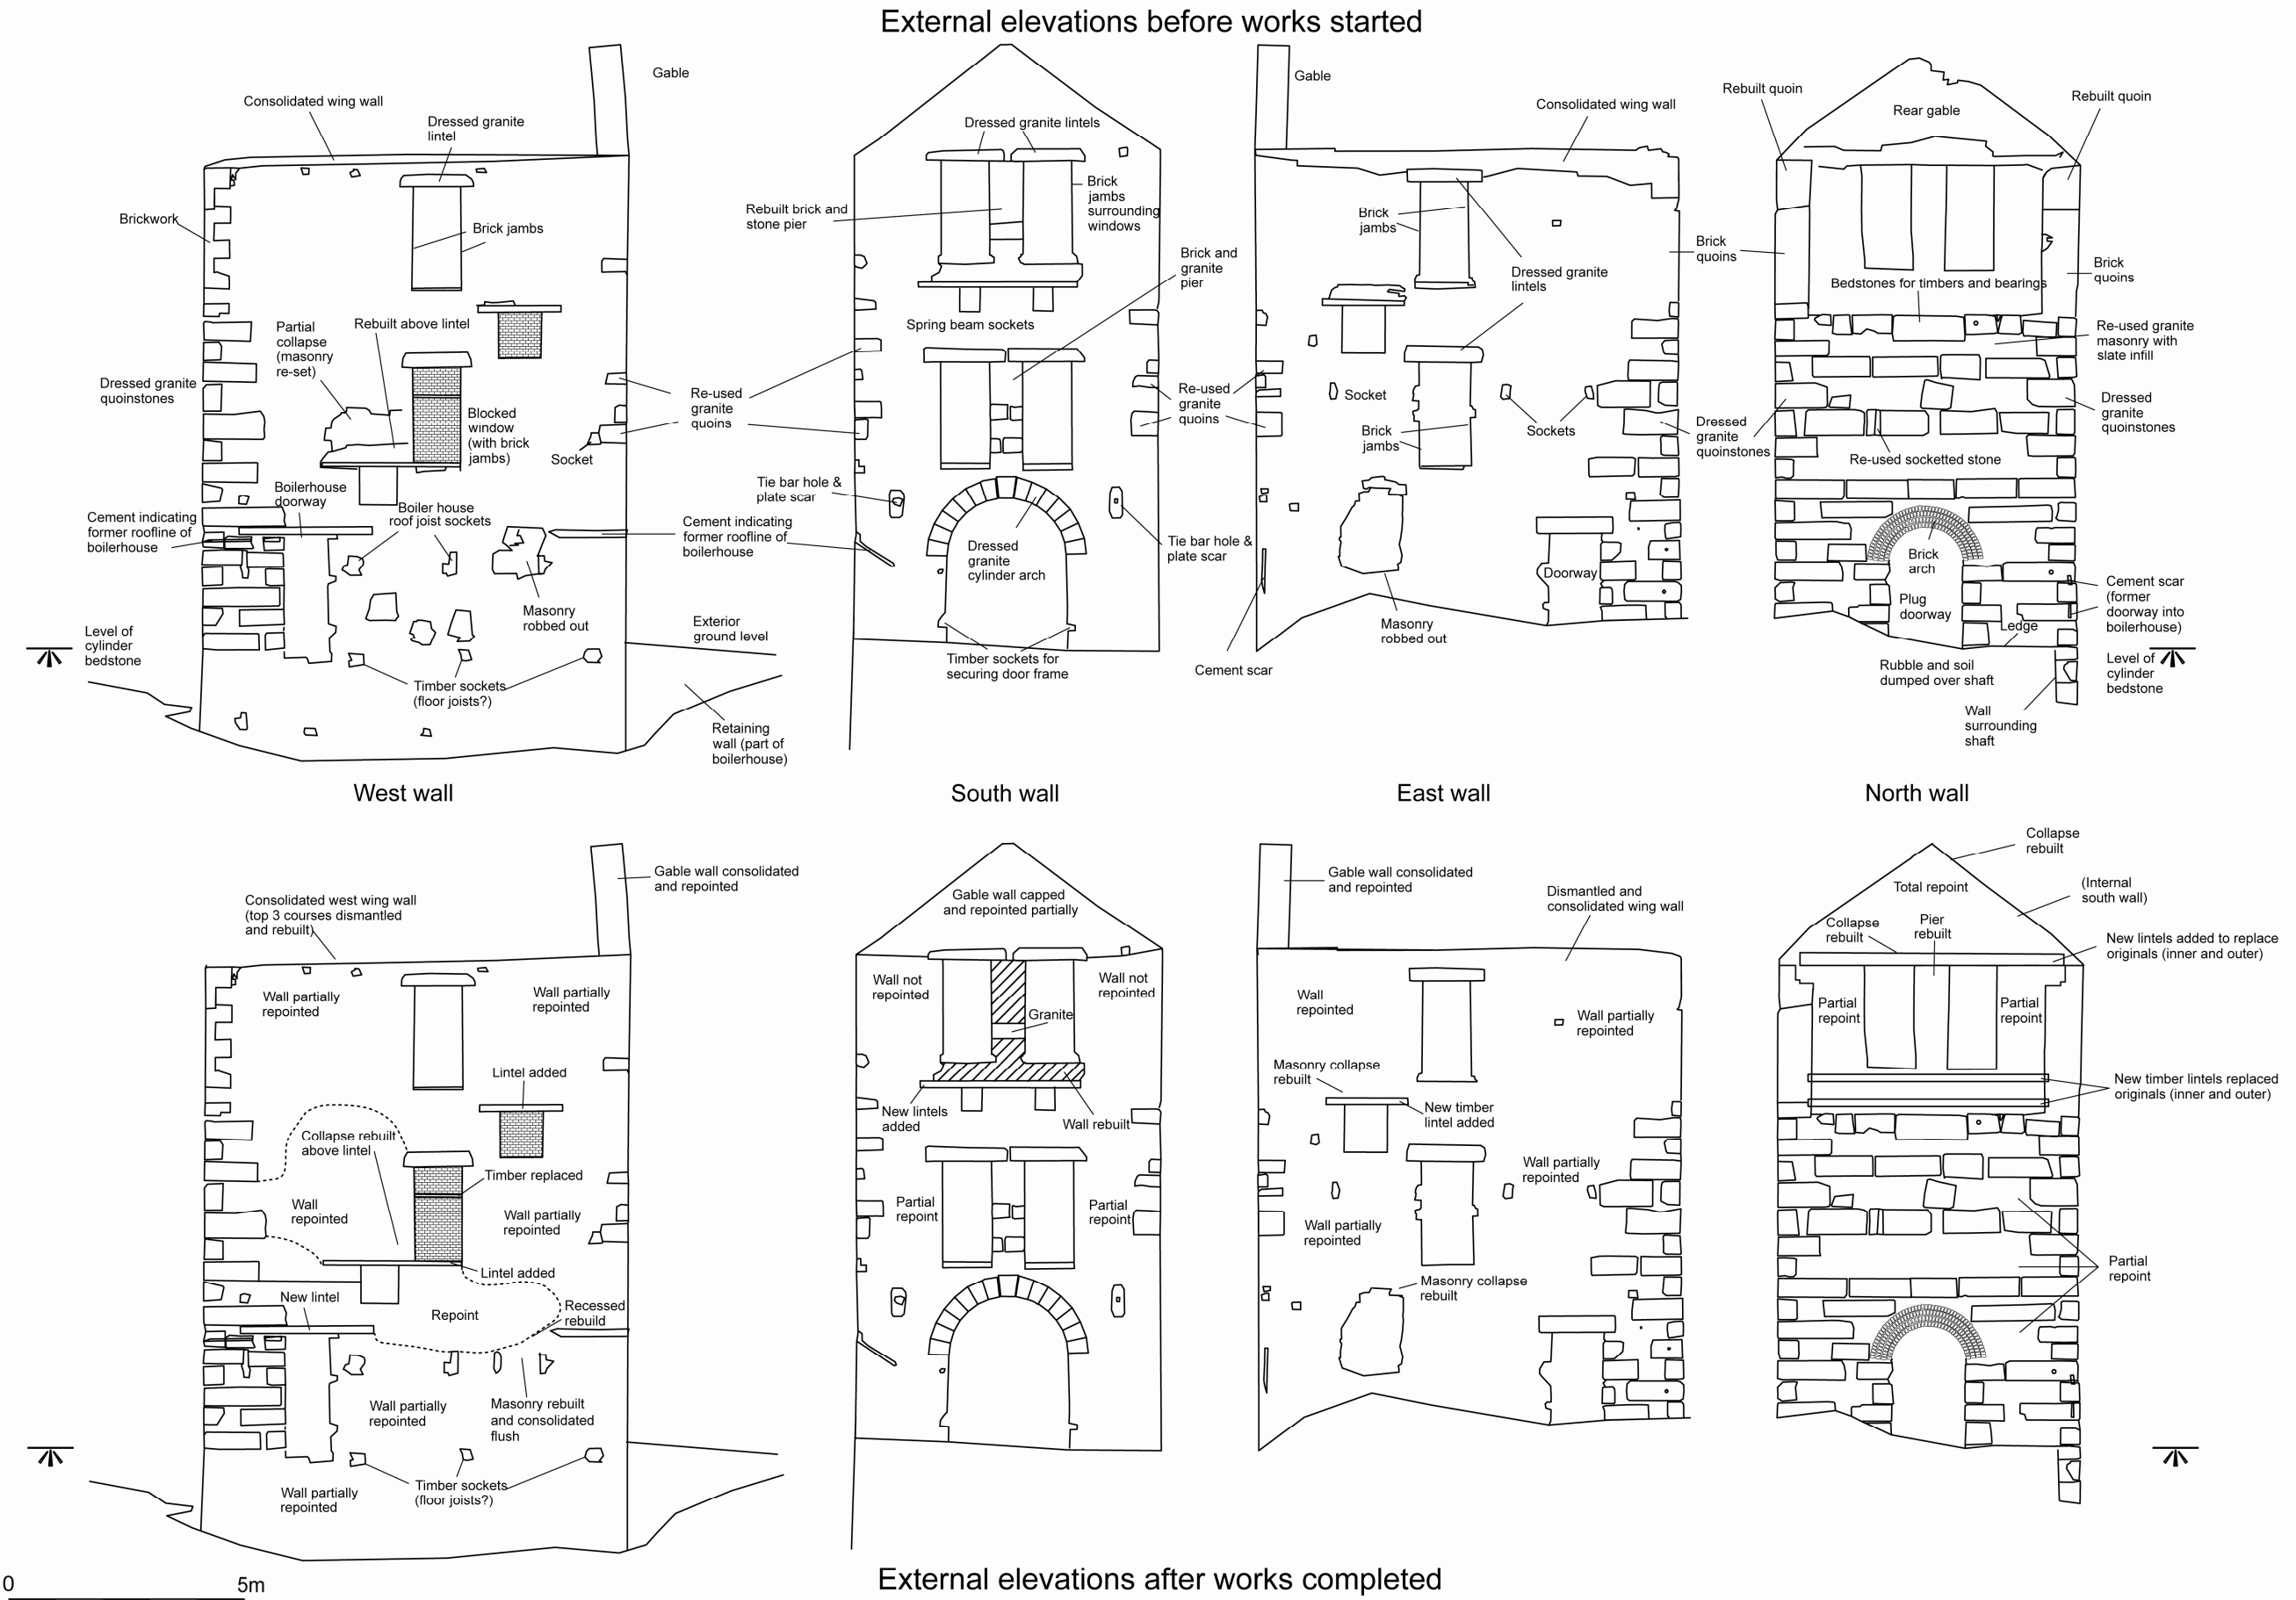
Figure 6 EDM external survey of Hitchen's Pumping Engine House before/after conservation works

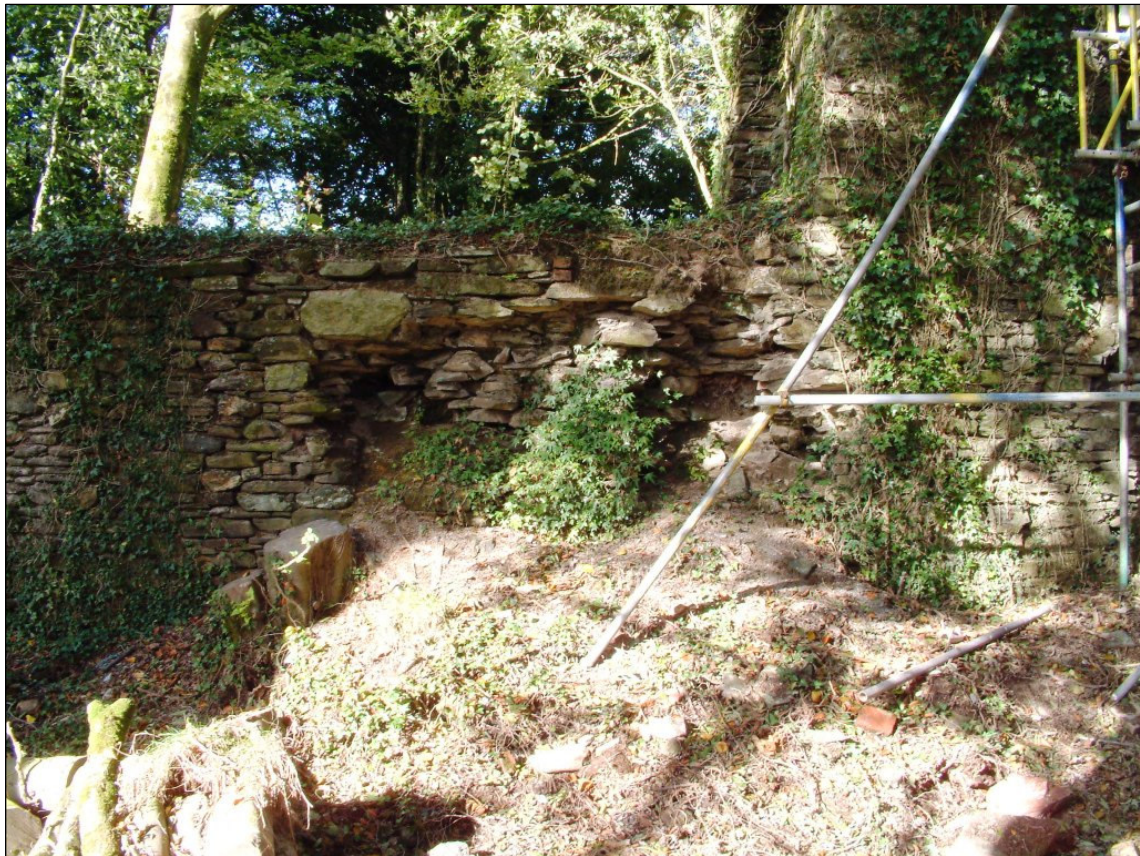
The north wall of the boiler house sited three places where structural remediation works were undertaken in October 2001. Fig 8 shows the north wall before three tanalised Douglas Fir timber lintels were added (to replace missing/rotted equivalents), masonry rebuilt above, and to the sides. The collapse of the original outer lintels had caused localised masonry collapse. Fig 9 shows the same wall after conservation works had been undertaken (and the extent of repointing and masonry replacement). Additional stone was brought in from Lean Quarry, near Liskeard. An important structural remediation was the replacement of a missing section of timber which formerly supported a corner of the south wall of the balance bob masonry to span into the engine house north west corner (see Fig 9). Due to funding constraints all of this work focussed on high priority structural works, so general repointing and wall capping was not undertaken.

Fig 8 View of the boiler house north wall (before works) C Buck 2001 © CC CAU

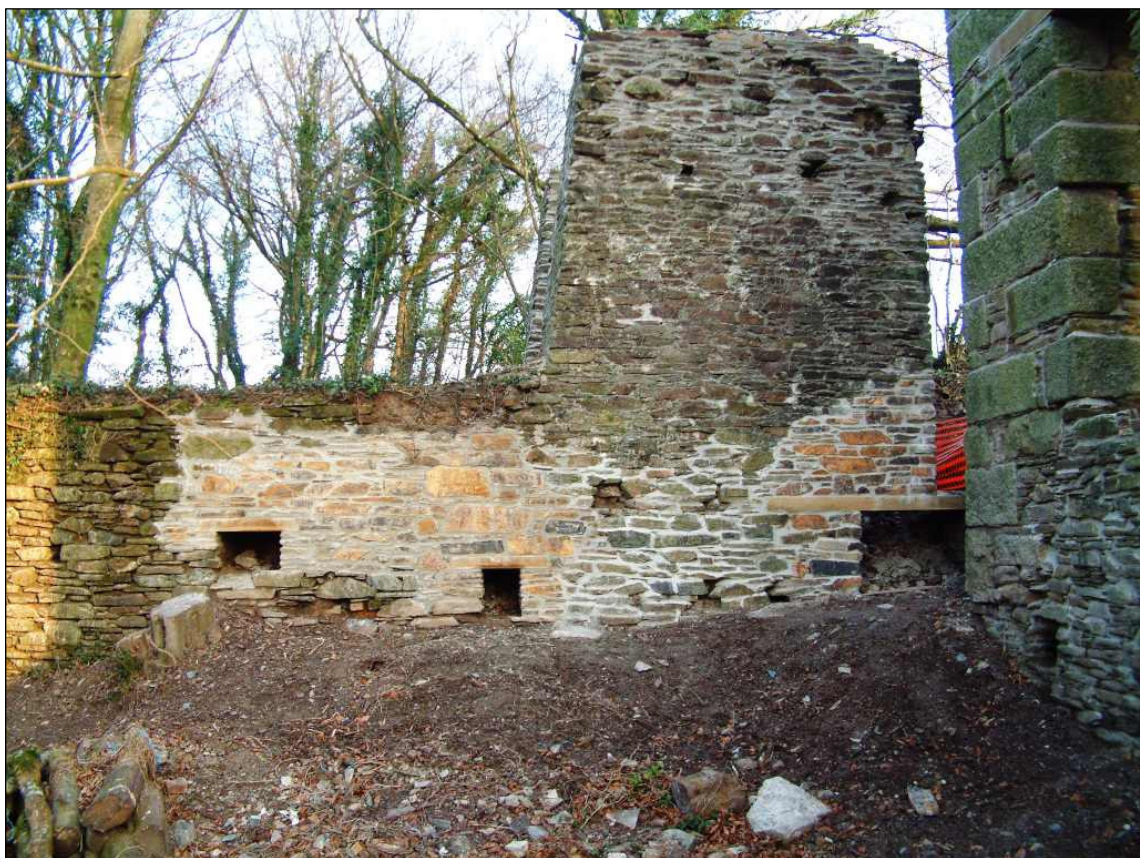
Fig 9 View of the boiler house north wall (after works) C Buck 2001 © CC CAU

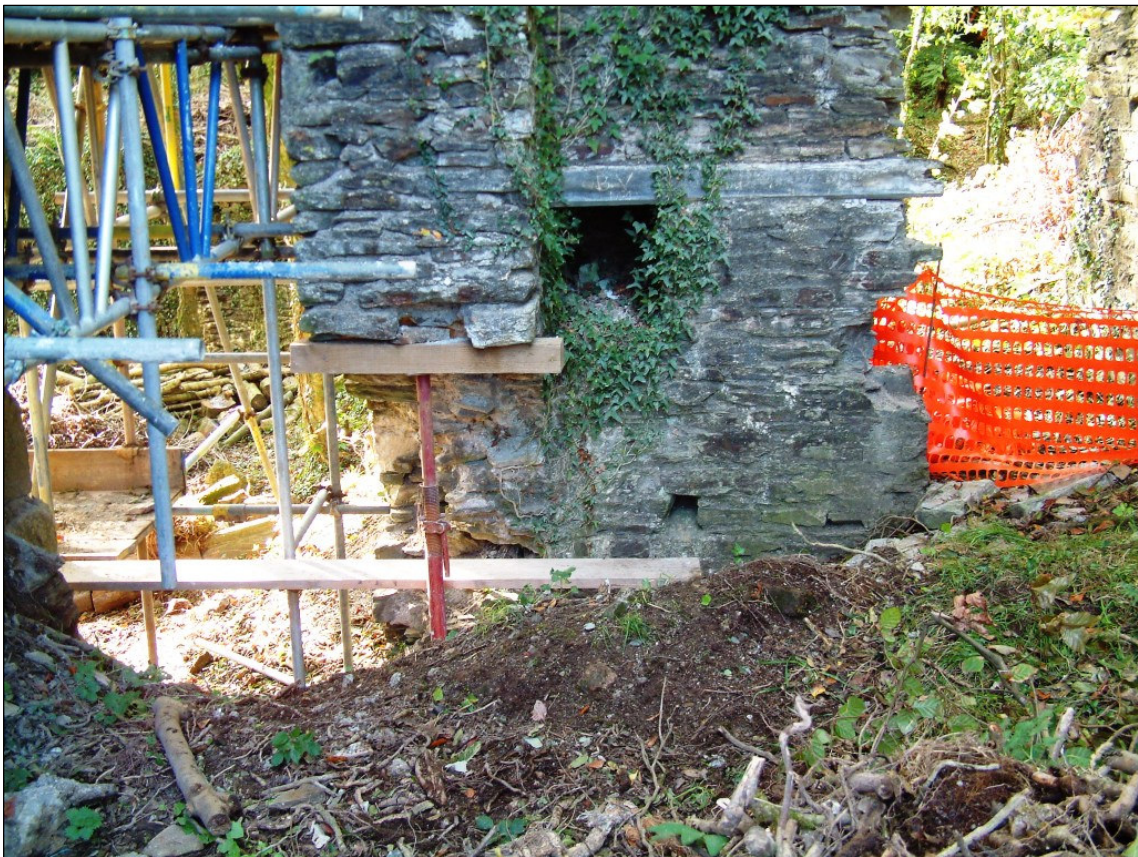
Fig 10 View of the balance bob east wall (before works) C Buck 2001 © CC CAU

Ivy and vegetation covered and obscured this mass of masonry. Once scaffolding was erected this was removed (and the thick ivy stems at ground level treated with a root killer). The tops of the walls were rebbed with mortar, and the sides of the feature repointed and rebuilt where necessary. An elevation survey of this masonry structure was not undertaken, however site photographs before works were taken (see Fig 10) show that the south east corner was very unstable as a supporting timber had rotted, and the masonry collapsed above in a localised manner. Figures 9 and 11 show the extent of repointing as well as the number and extent of new reinstated timber lintels.

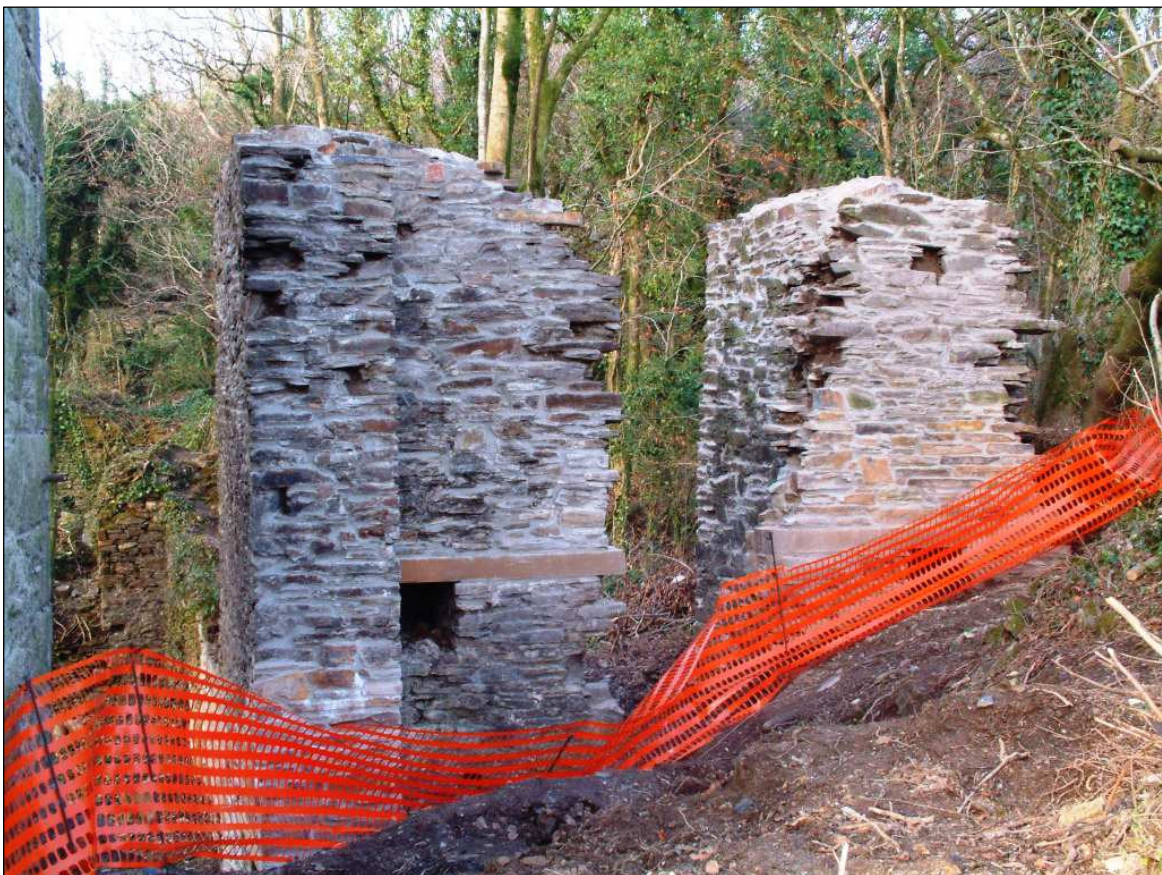
Fig 11 View of the balance bob east wall (after works) C Buck 2001 © CC CAU

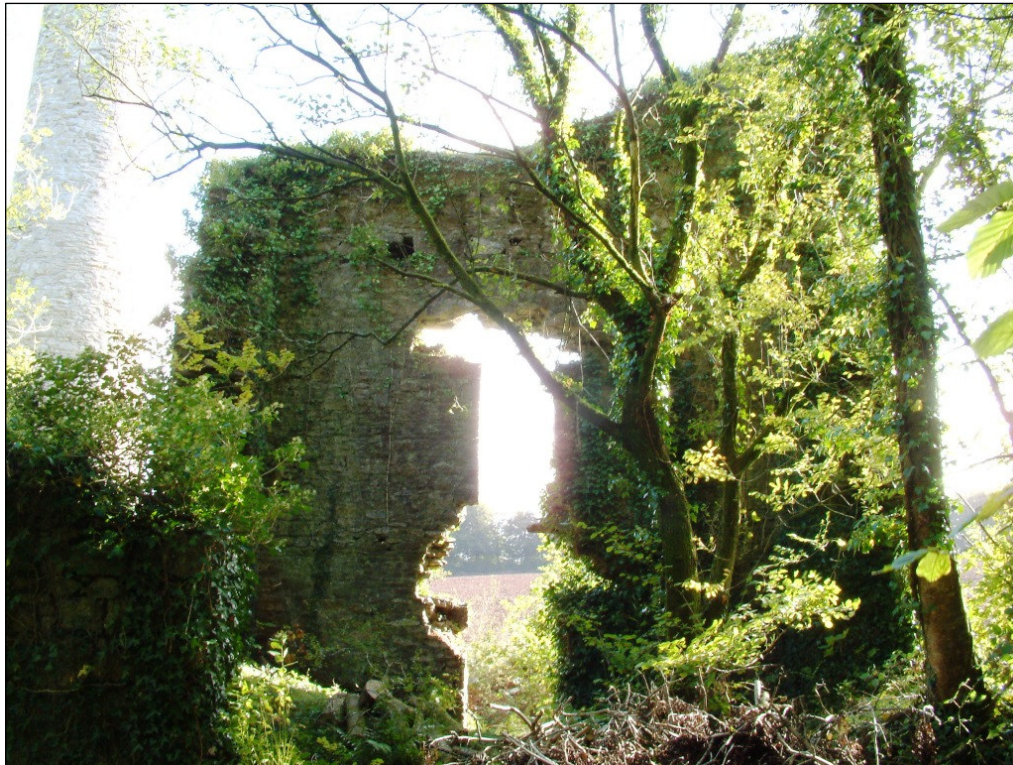
*Fig 12 View of the copper crusher (before works) C Buck 2001 © CC CAU*

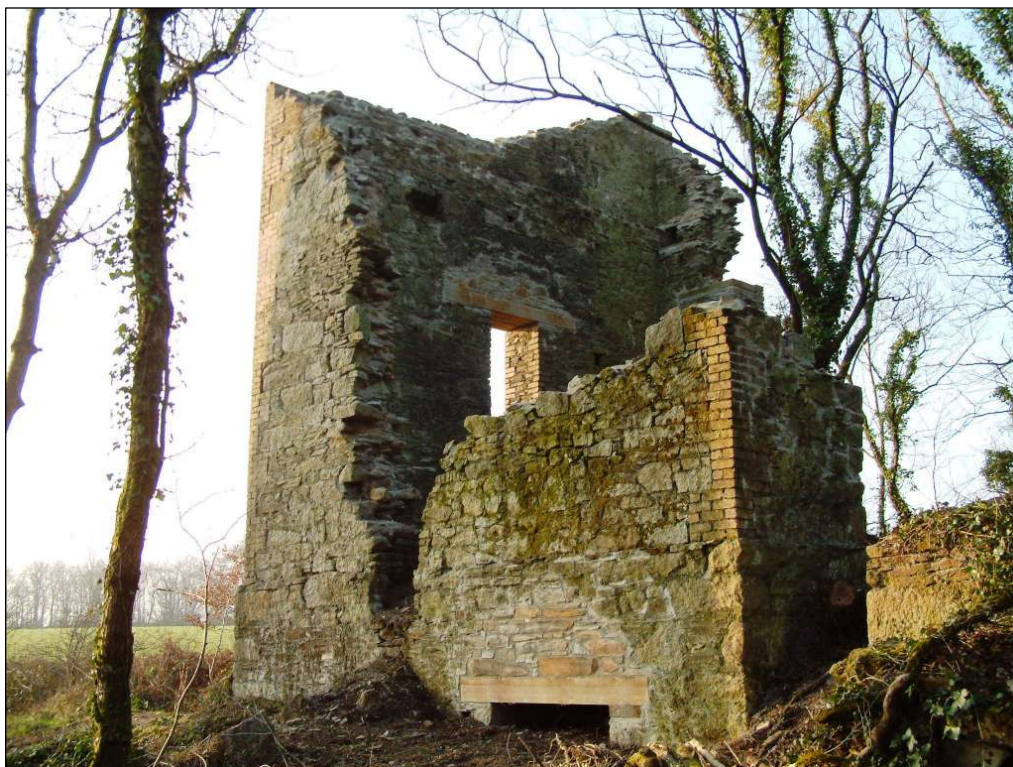
*Fig 13 View of the copper crusher (after works) C Buck 2001 © CC CAU*

By mid November 2001 the crusher house had been fully consolidated. The tops of the walls had been 'capped' (two layers of stones rebedded in NHL 5.0 and the surface repointed to allow run-off between the masonry). The walls were repointed where necessary and the east wall lintel replaced and masonry re-built above (see Fig 13).

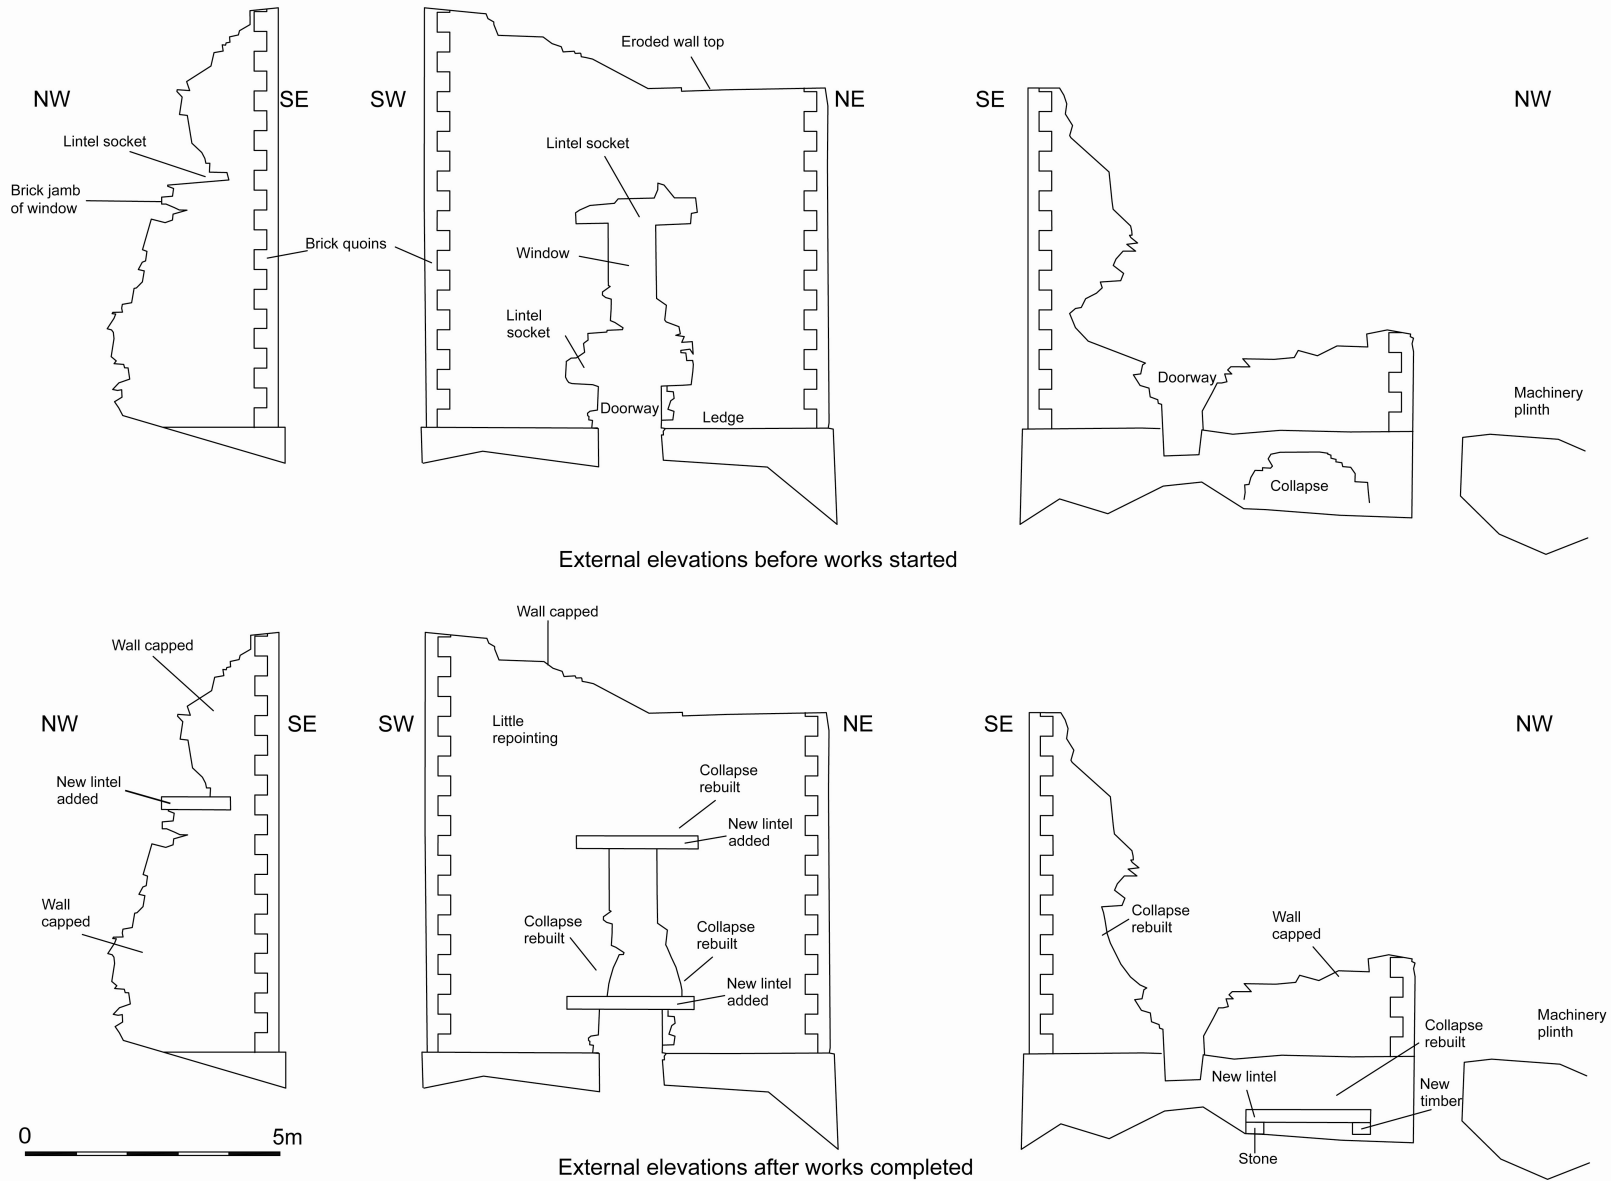
Figure 14 EDM external survey of the Copper crusher before/after conservation works

Figure 14 is an annotated reproduction (CCC HES external survey) of the external faces of the Copper crusher building showing each external building elevation both 'before' and 'after' consolidation works were undertaken. Figure 15 is an annotated reproduction of the internal faces of the detailed building survey of the same building, showing the building elevations both 'before' and 'after' consolidation work. Both figures are annotated to illustrate in more detail than described within this text, the nature and extent of the consolidation works that were carried out to each building. A photograph of the building before works were carried out is reproduced in Figure 12, which can be compared to that of Figure 13 (after works had finished).

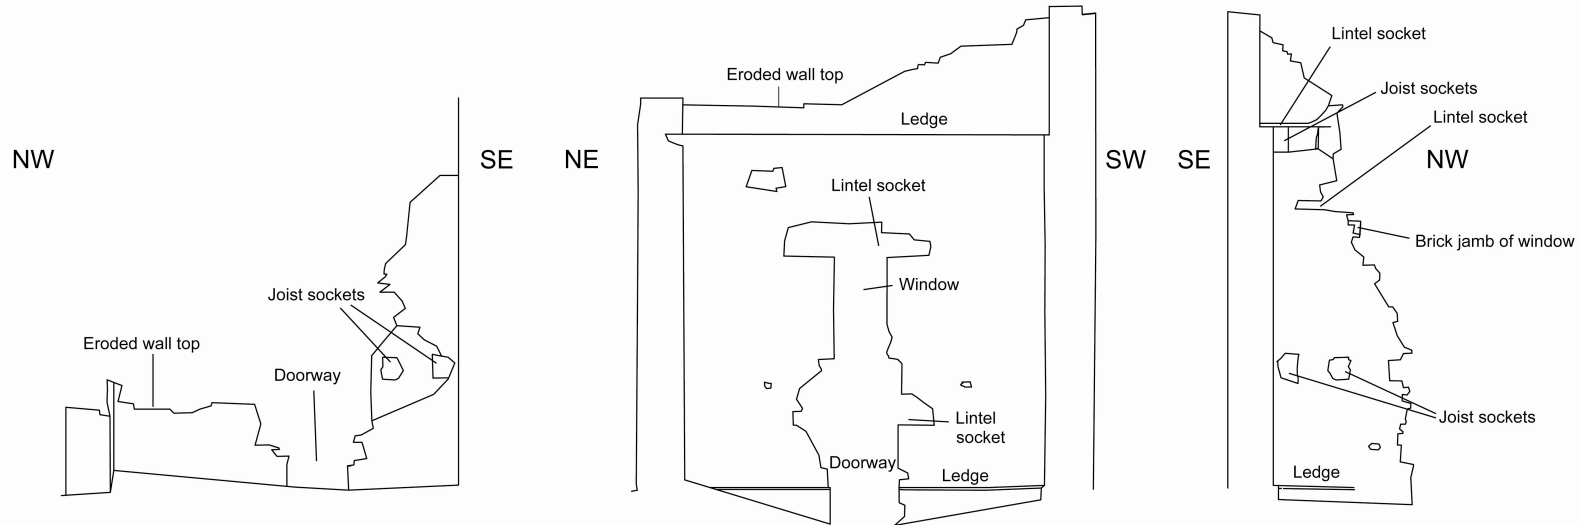
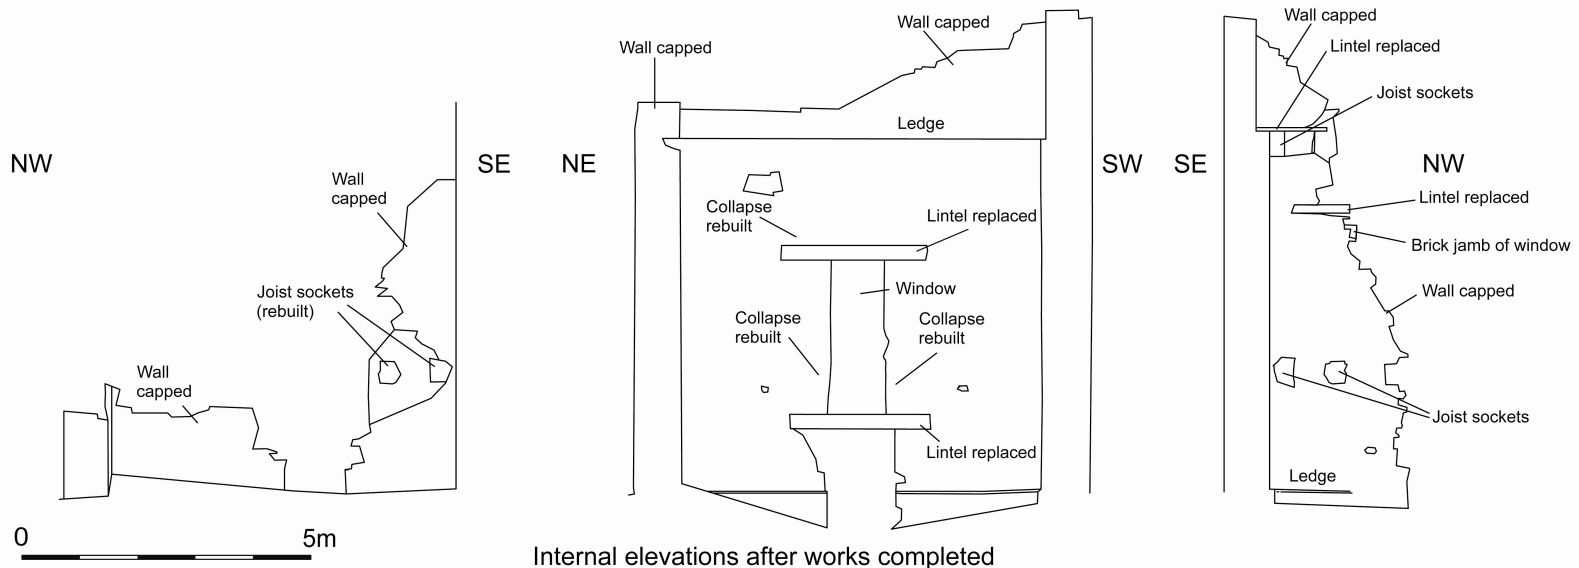
Figure 15 EDM internal survey of the Copper crusher before/after conservation works

Internal elevations before works started

Internal elevations after works completed

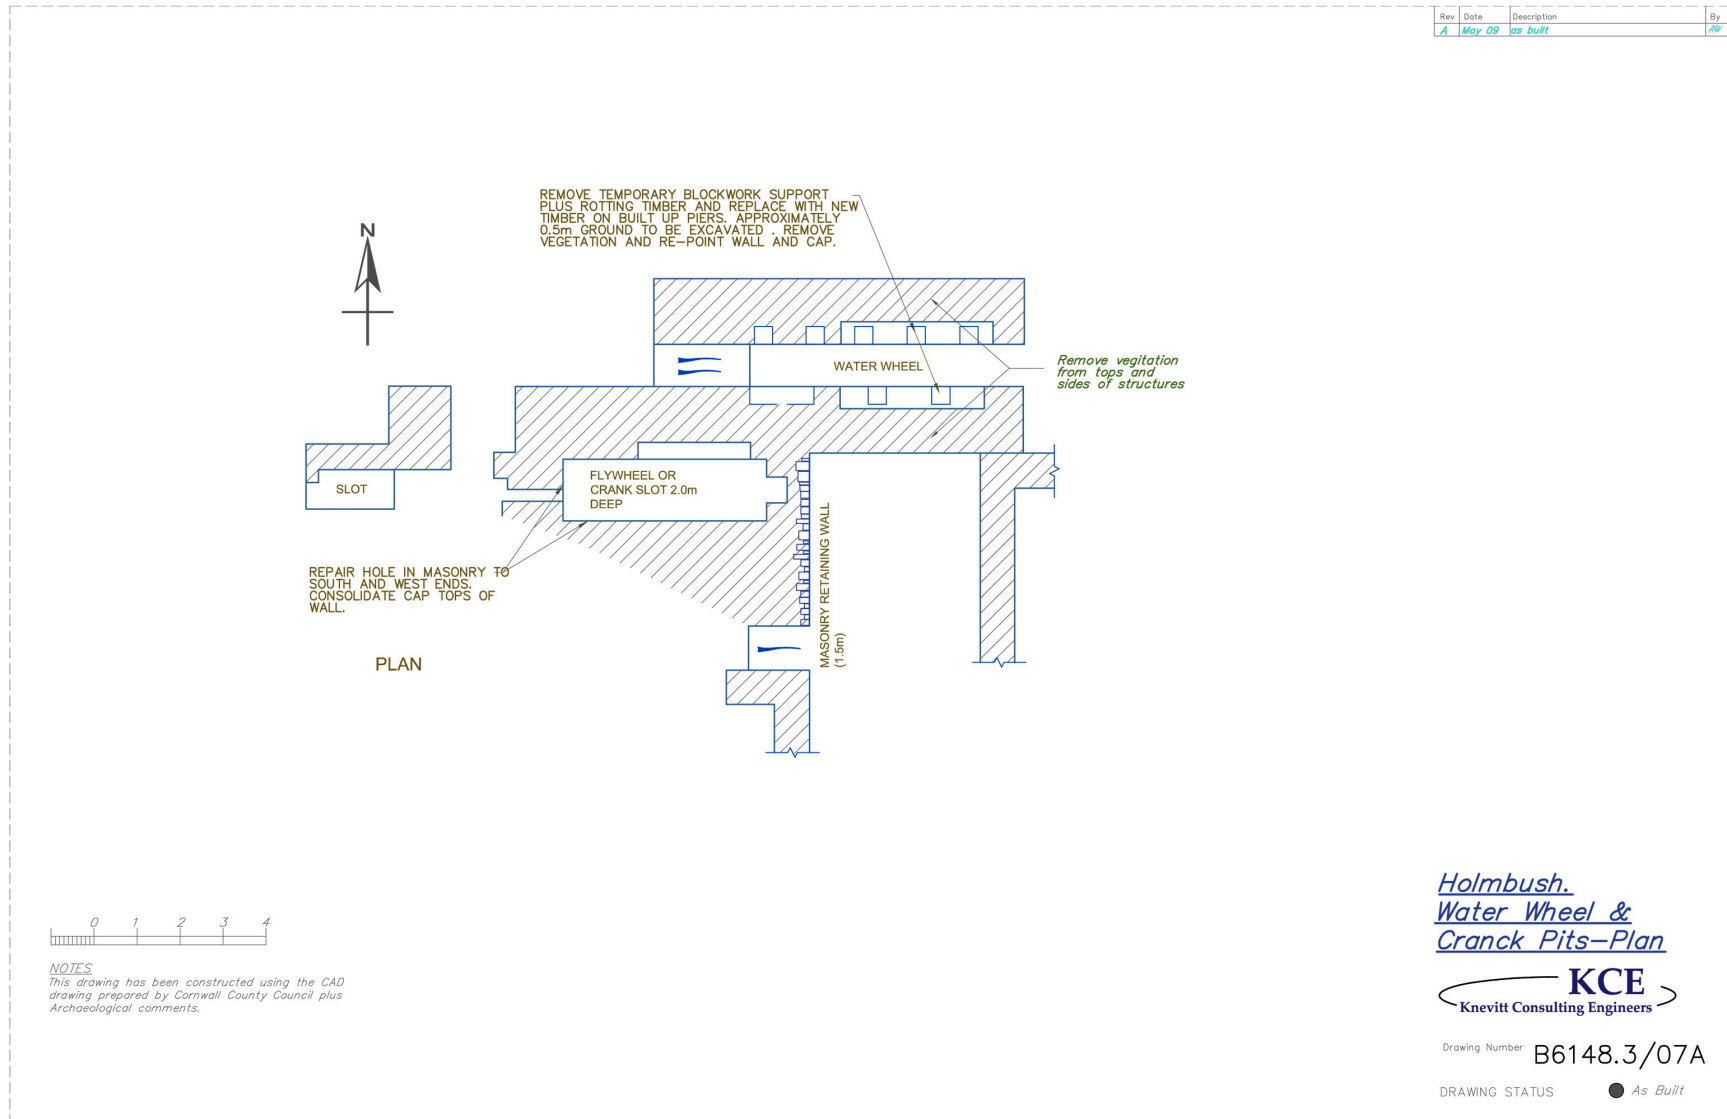
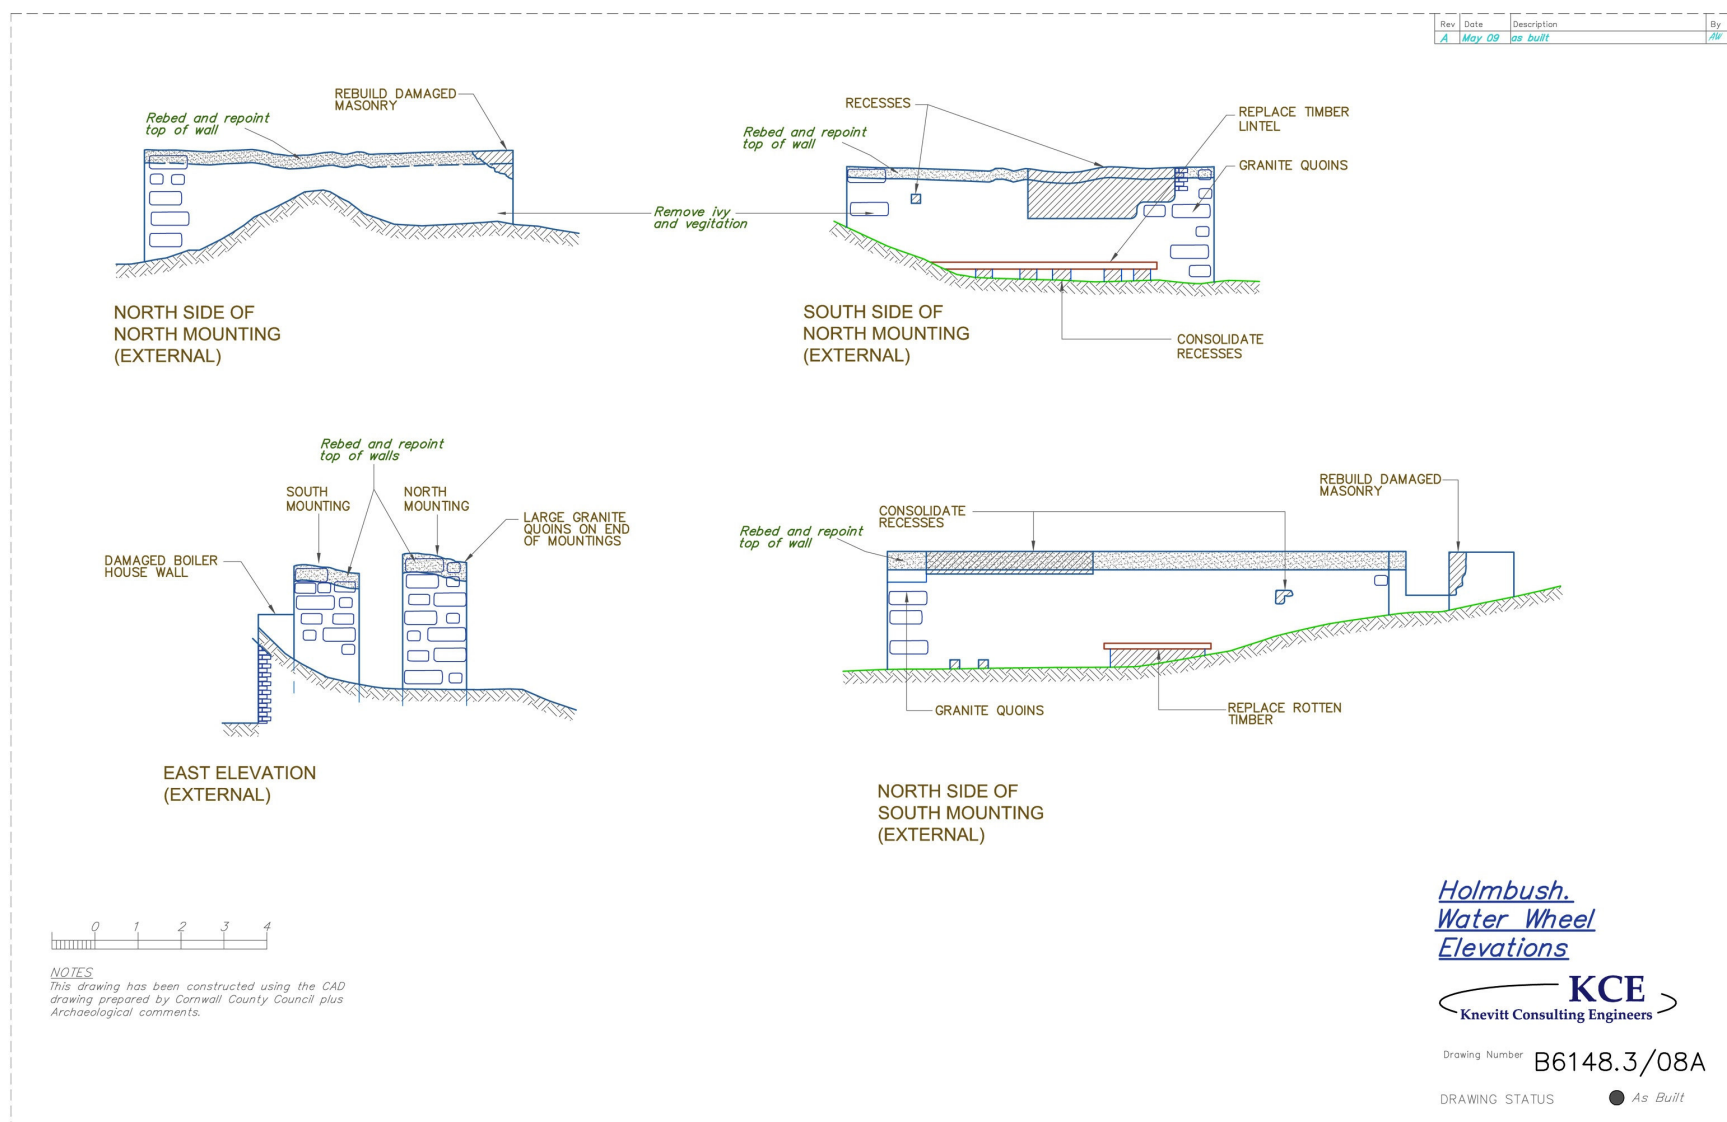
Figure 16 'As built' annotated plan/survey of the wheelpit/copper crusher crank pit after works (Kneivt Cons. Eng)

Clearance of vegetation from the walls and base of the copper crusher crank pit masonry started on 23/7/07, followed in due course by repointing the sides and wall tops (see Figs 16 and 17 – photo of the site after works). The 2001 temporary brick/blockwork put under the long (rotting) timber lintels running at the base and along the lower sides of the wheelpit was removed in September. New timber lintels were inserted to replace the rotten equivalents. Shorter sections were used inside the centre of the wall whilst the longest available lengths were used on the inner (visible) face of the wall (see Figs 16 and 18 – photo of the site after works). Figure 16 is a survey plan and elevations of these features, with annotated comments describing in detail the nature and extent of the conservation works. The short section of fence at the western end of the wheelpit was left *in situ* due to the drop in height from ground level to the base of the wheelpit. Additional funds that were left over in the project following conservation works to the winding engine house (Site 8), were used to deep point with lime mortar the remainder of the wheelpit masonry mass on its north side, as funds had not originally been allocated for this. These works were finished by the end of September 2007.

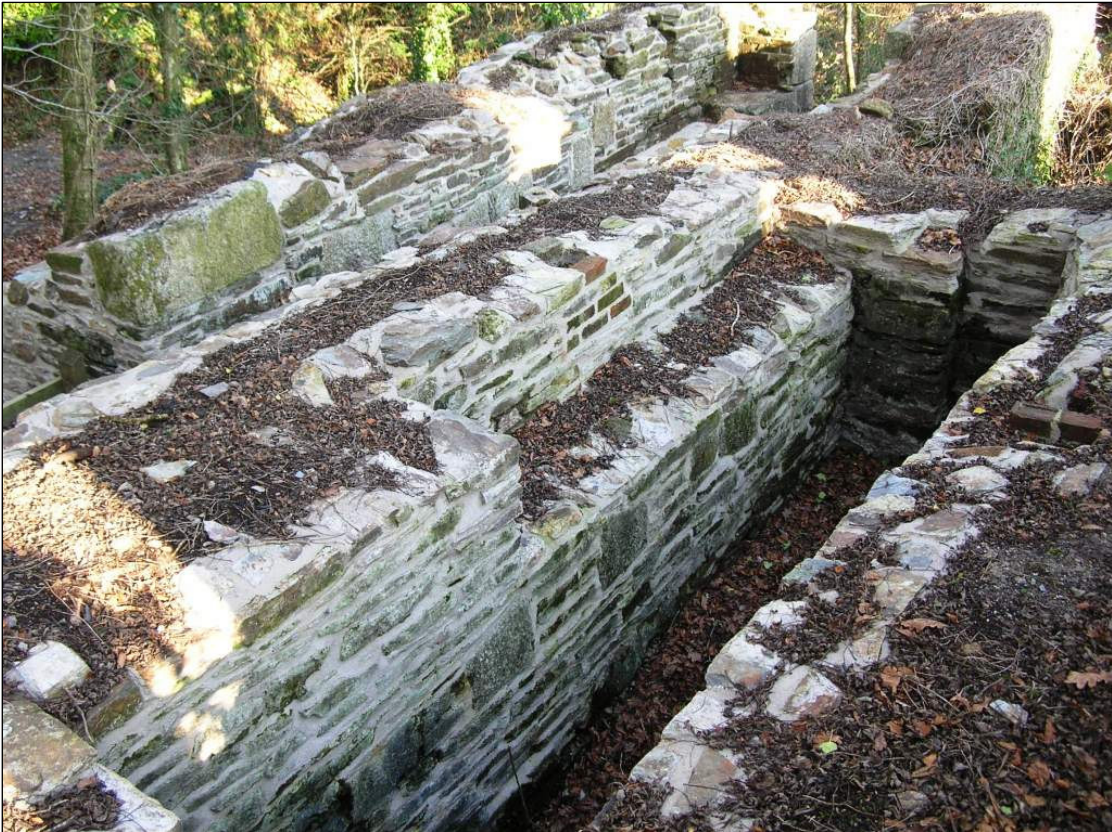
Fig 17 View of the copper crusher flywheel loadings (after works)

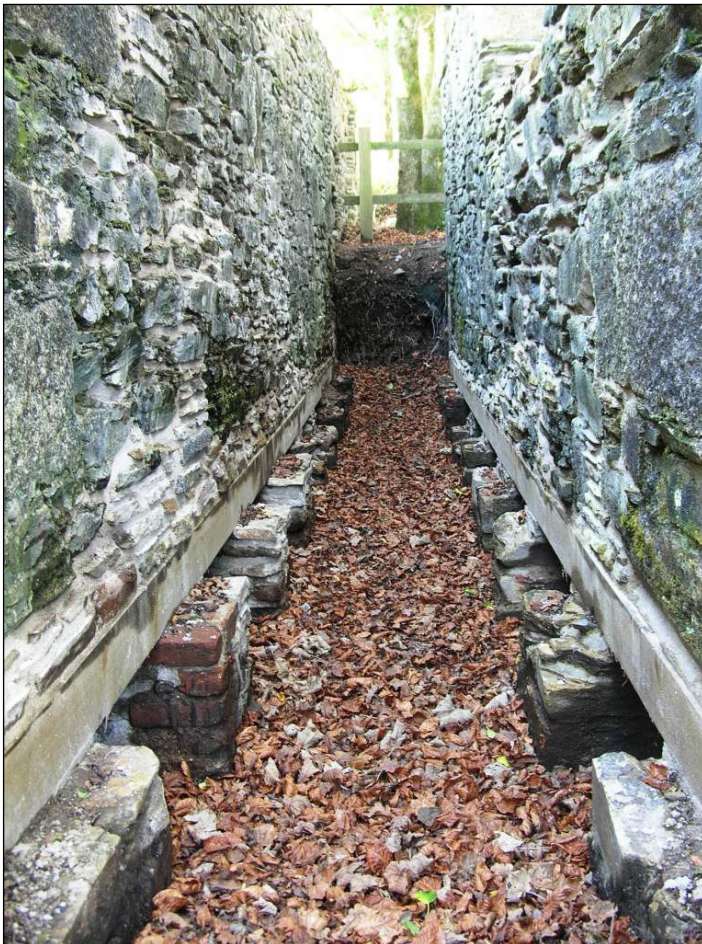
Fig 18 Photograph of the wheelpit (after works)
