## **Holmbush Mine, Kelly Bray, Cornwall**

### **Report on building conservation works (2001, 2007)**

<b>Client</b>	<b>East Cornwall Regeneration Project</b>
<b>Report Number</b>	<b>2011R092</b>
<b>Date</b>	<b>September 2011</b>
<b>Status</b>	<b>Final</b>
<b>Report author</b>	<b>Colin Buck</b>
<b>Checked by</b>	<b>AY</b>
<b>Approved by</b>	<b>AY</b>

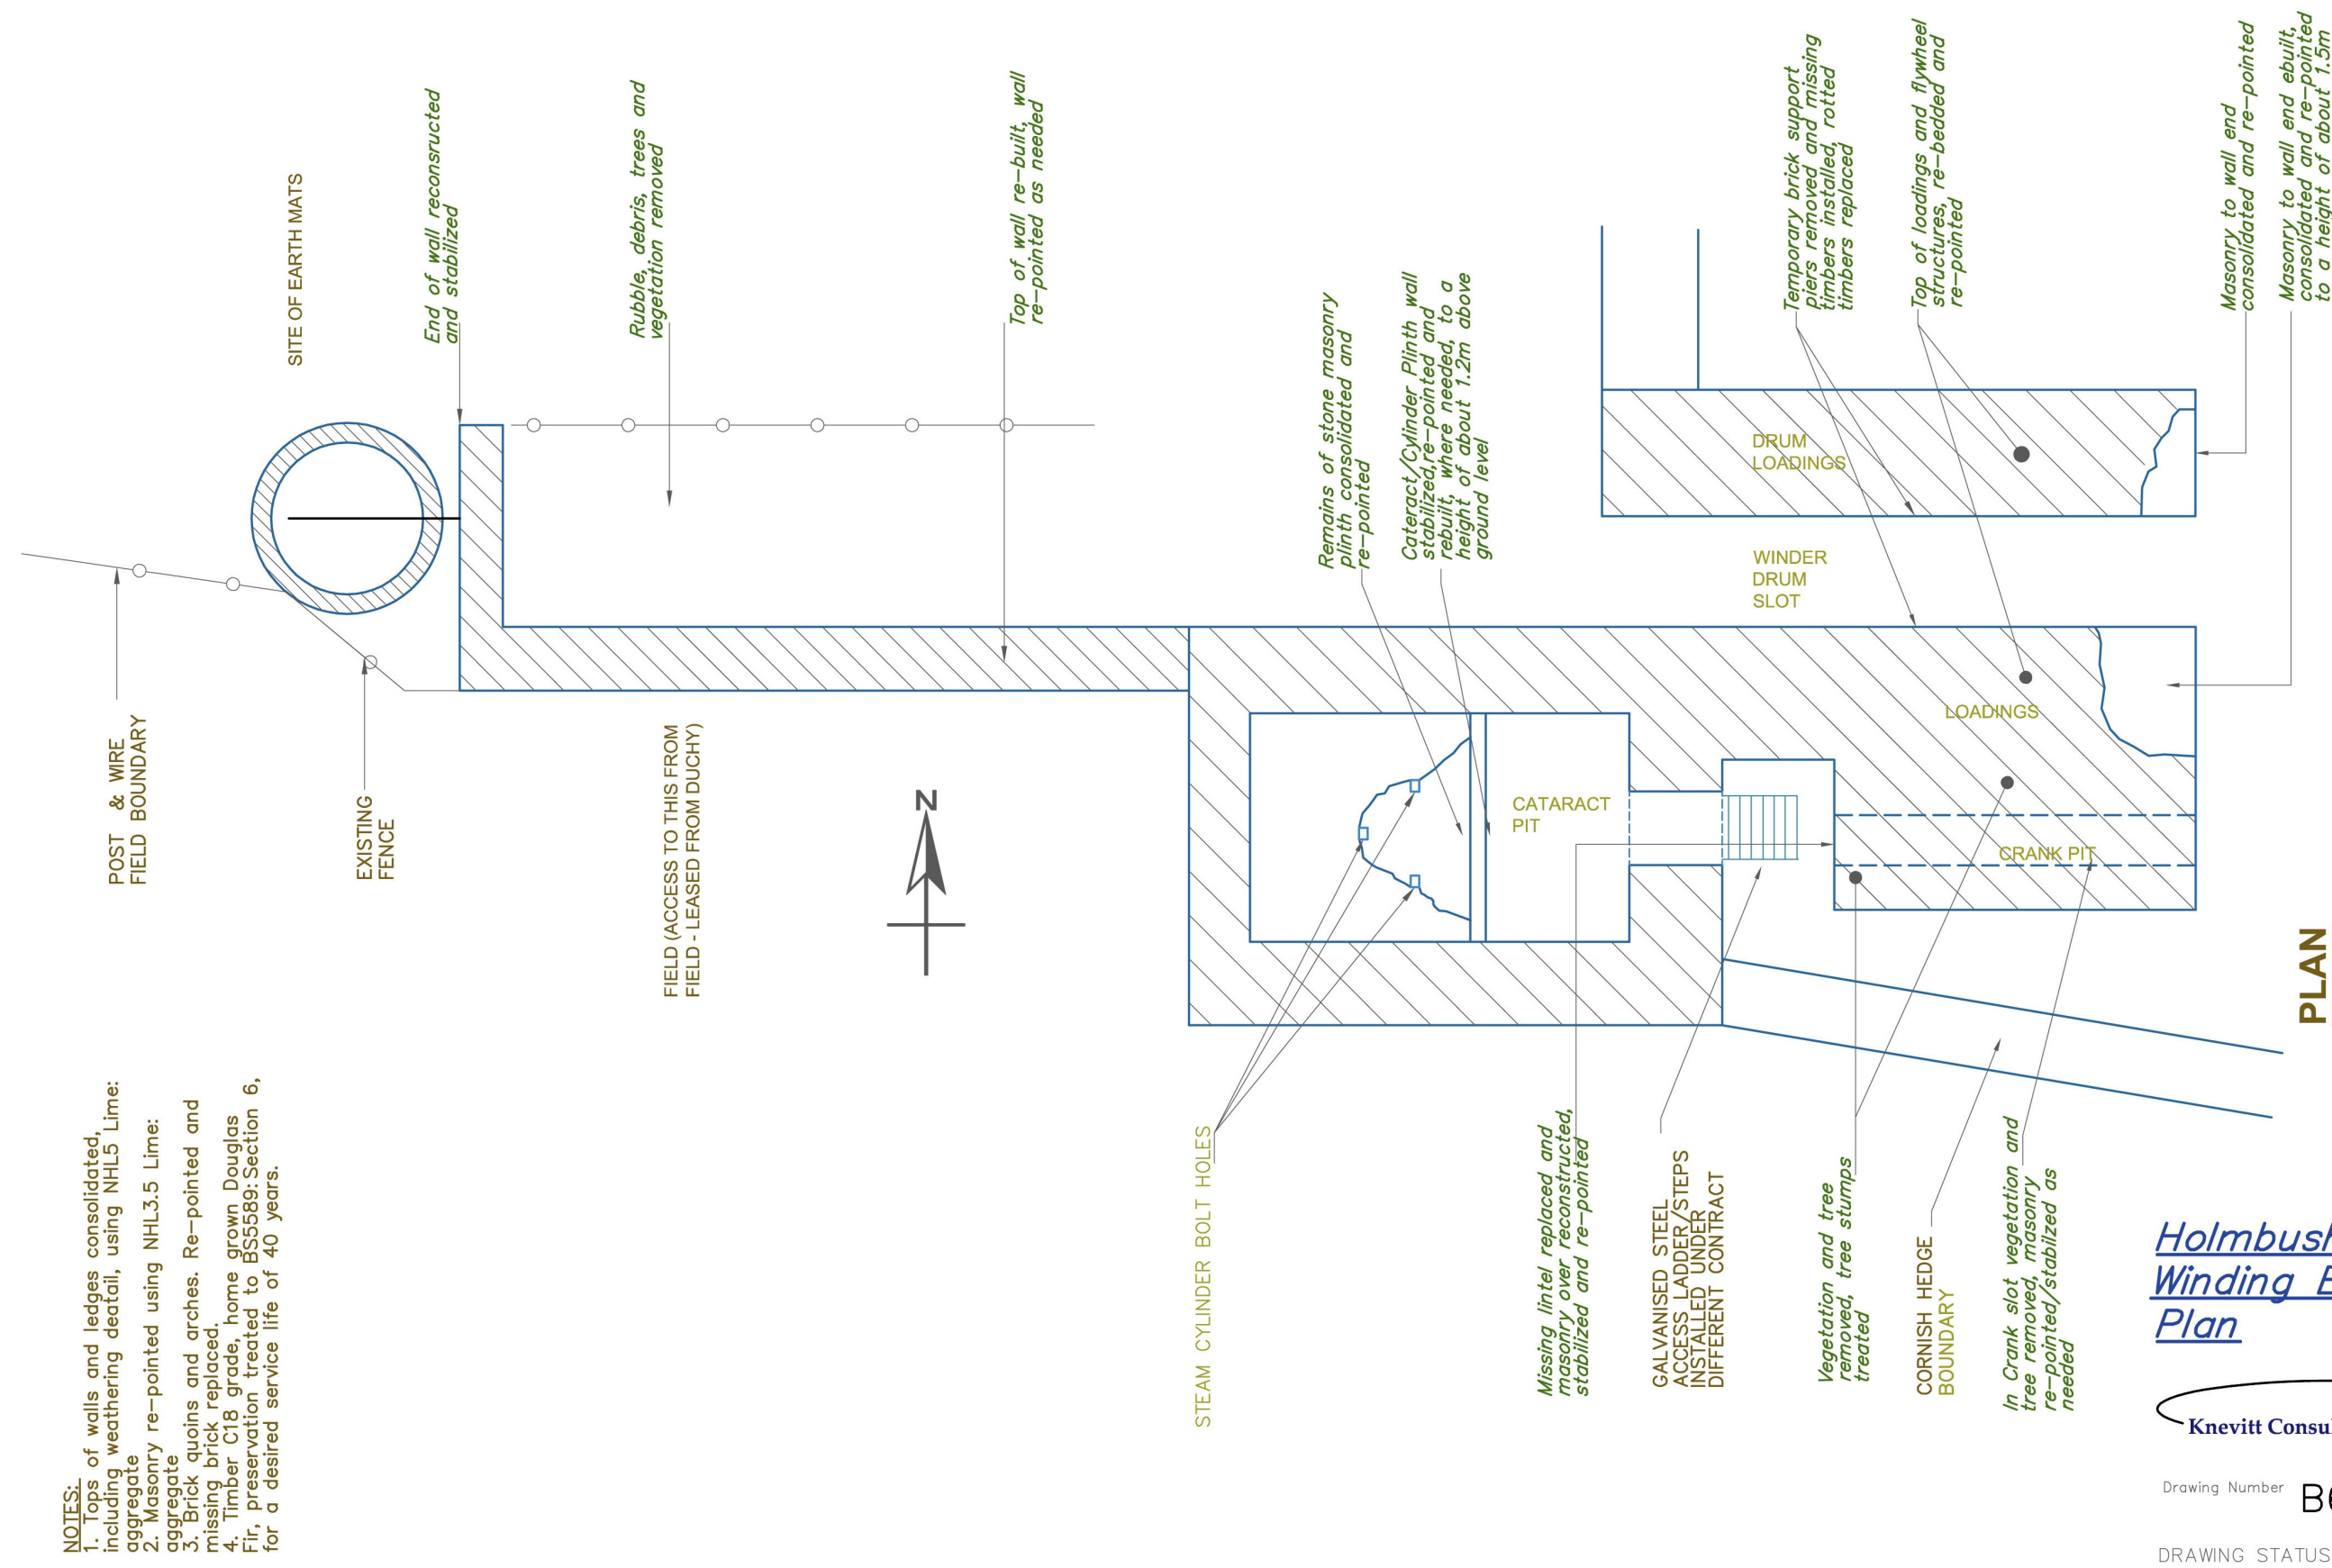
Figure 19 'As built' annotated survey plan of the winding engine house/drum loadings and crank pit after works (Knevvit Cons. Eng. 2008)

- NOTES:
1. Tops of walls and ledges consolidated, including weathering detail, using NHL5 Lime: aggregate
  2. Masonry re-pointed using NHL3.5 Lime: aggregate
  3. Brick quoins and arches. Re-pointed and missing brick replaced.
  4. Timber C18 grade, home grown Douglas Fir, preservation treated to BS5589:Section 6, for a desired service life of 40 years.

The crank pit loadings (see Fig 19 for survey plan with annotations) were repointed on all sides, and the structural collapse to the west end wall of the condensate tunnel was partially reconstructed in stone to restrict further collapse. Trees sited on top of the loadings had already been cut down and the stumps treated. However, earth and soil was left on top of the feature. In addition, the east side of the walls had been slightly

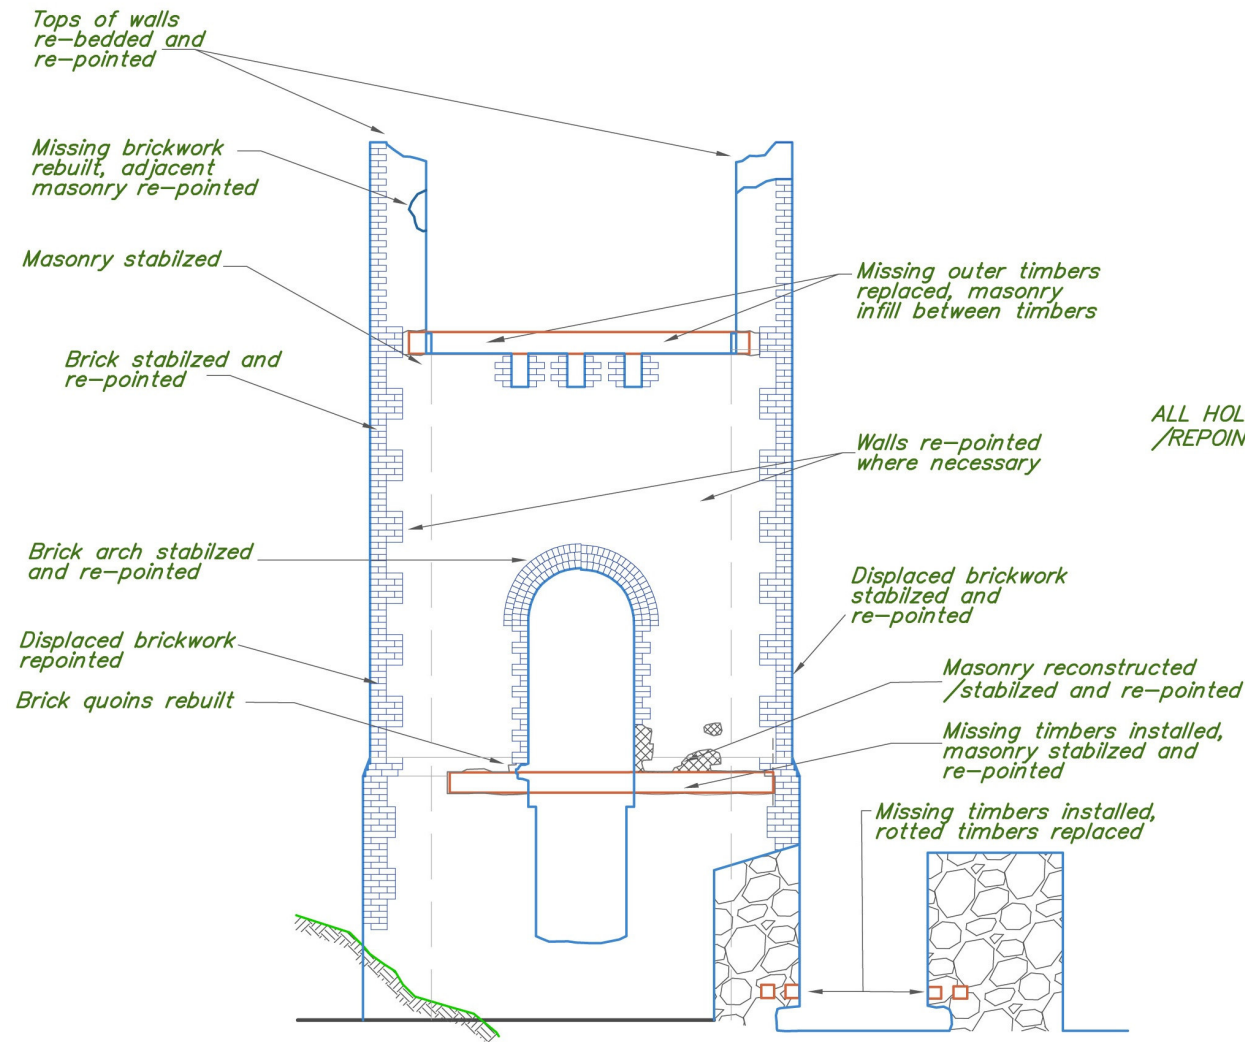
**EAST ELEVATION - BOB WALL (EXTERNAL)**  
APPROXIMATELY 35% OF ELEVATION REPOINTED

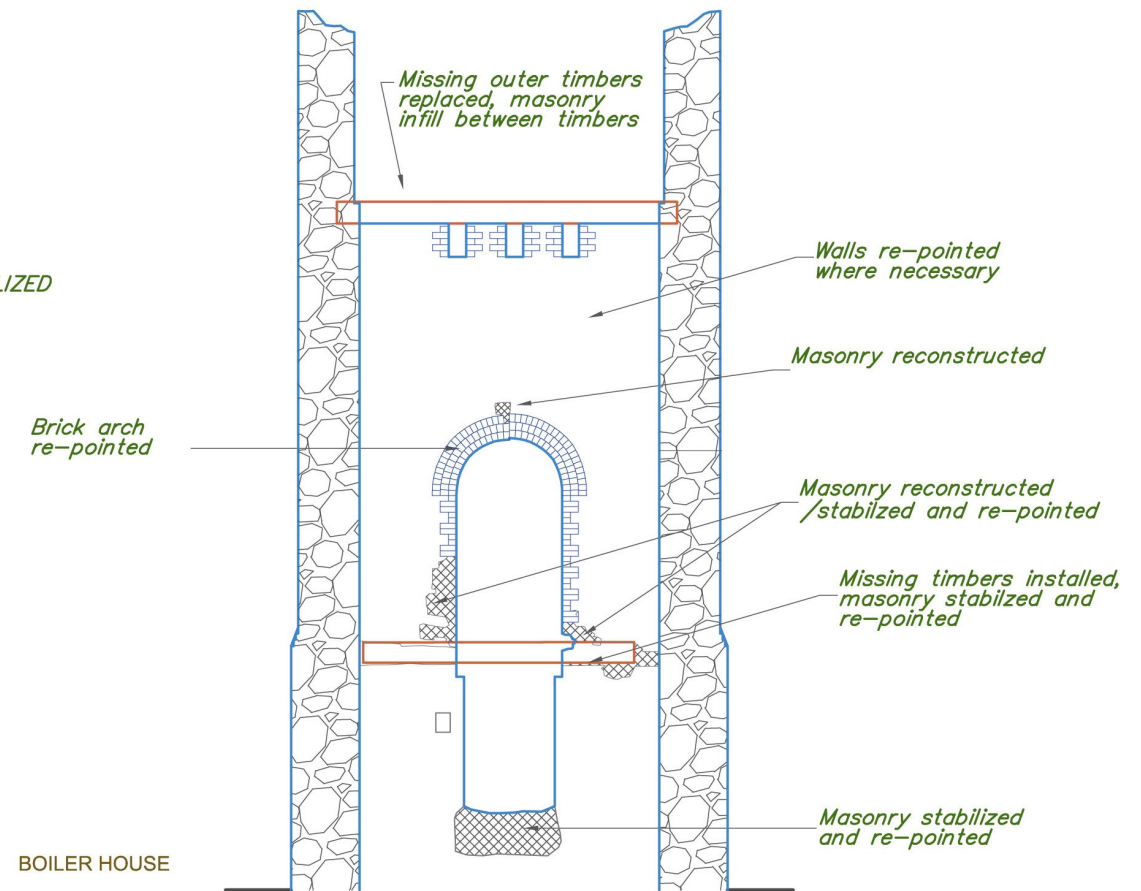
**EAST ELEVATION - BOB WALL (INTERNAL)**  
APPROXIMATELY 40% OF ELEVATION REPOINTED

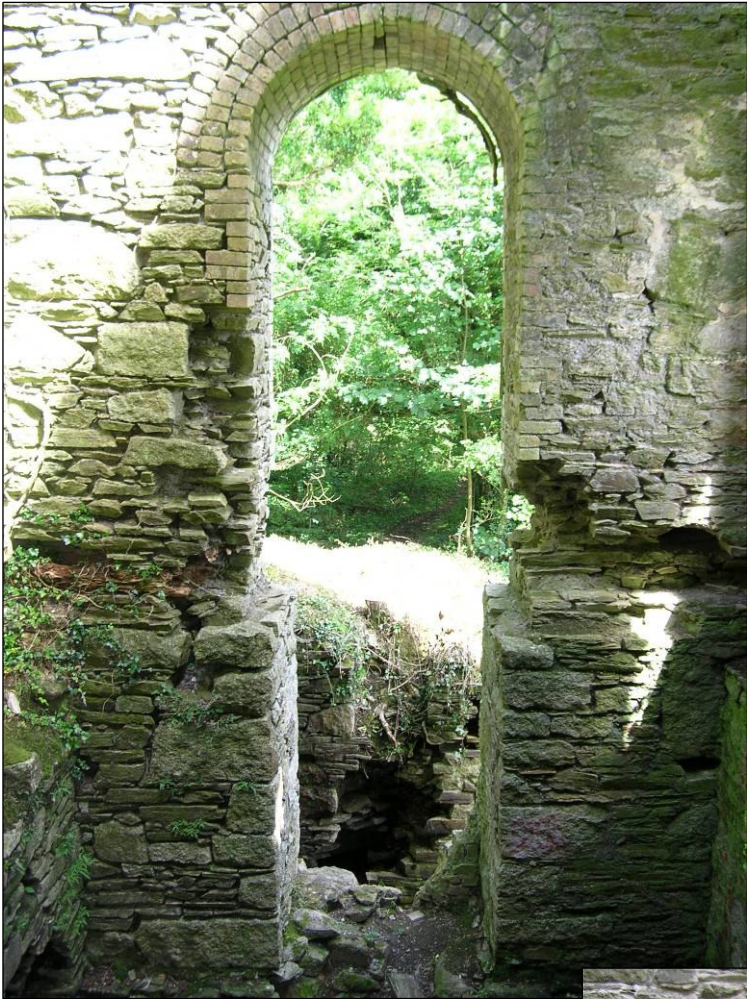
Fig 21 Internal view of the winding engine house east (bob) wall before works C Buck 2007 © CC HE Projects

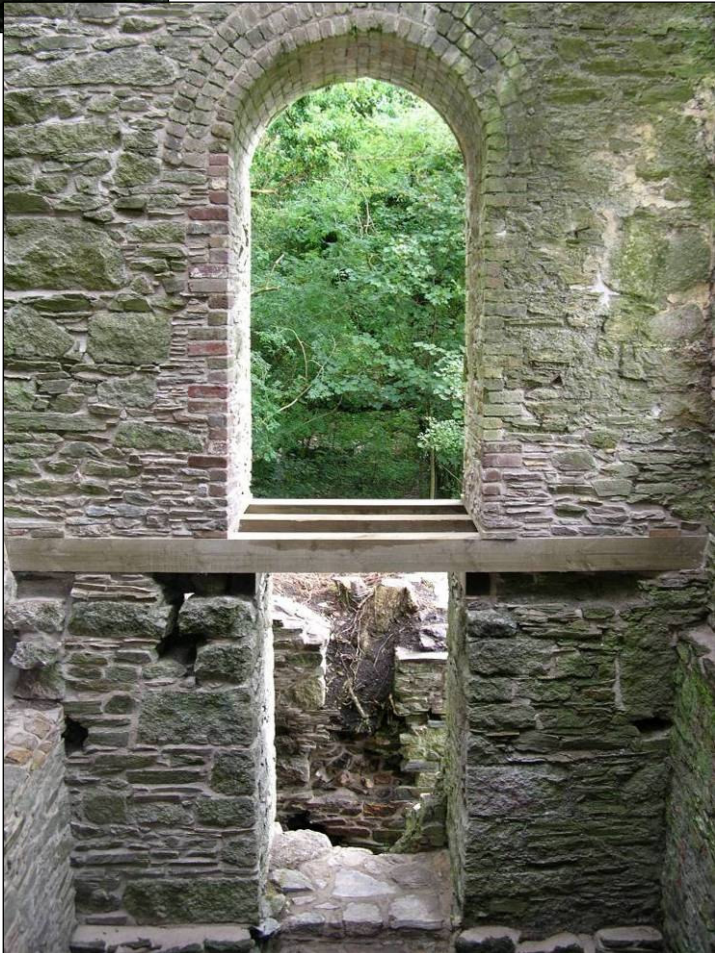
Fig 22 Internal view of the winding engine house east (bob) wall after works C Buck 2007 © CC HE Projects

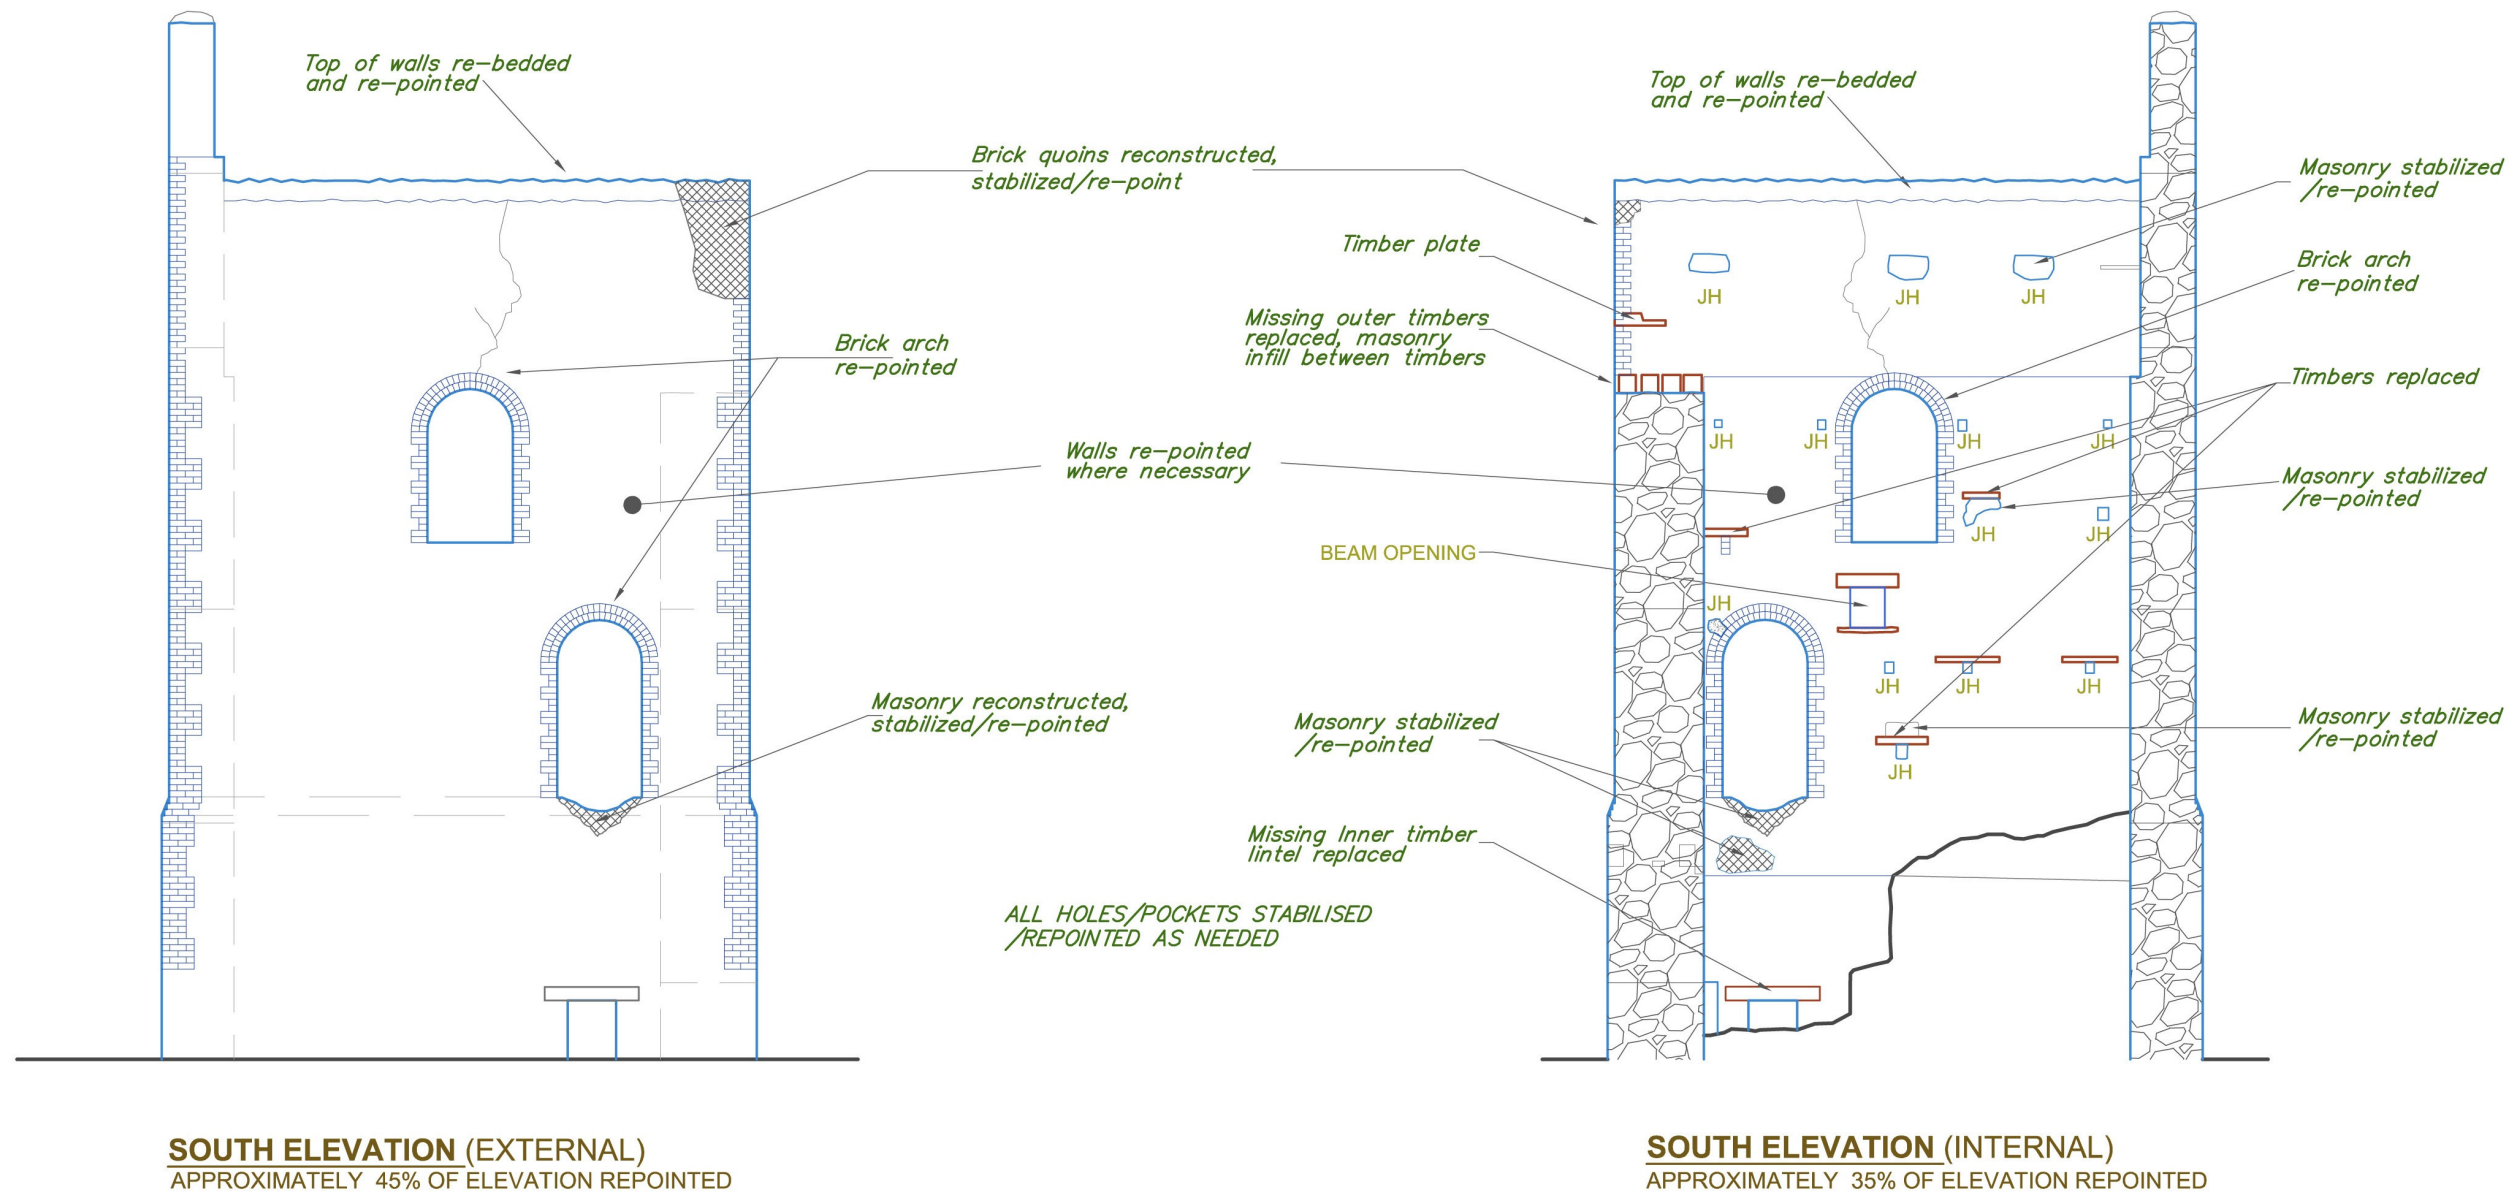
*Holmbush.  
Winding Engine House  
South Elevation*

Figure 23 'As built' annotated South elevation surveys of the winding engine house after works (Knevitt Cons. Eng. 2008 )

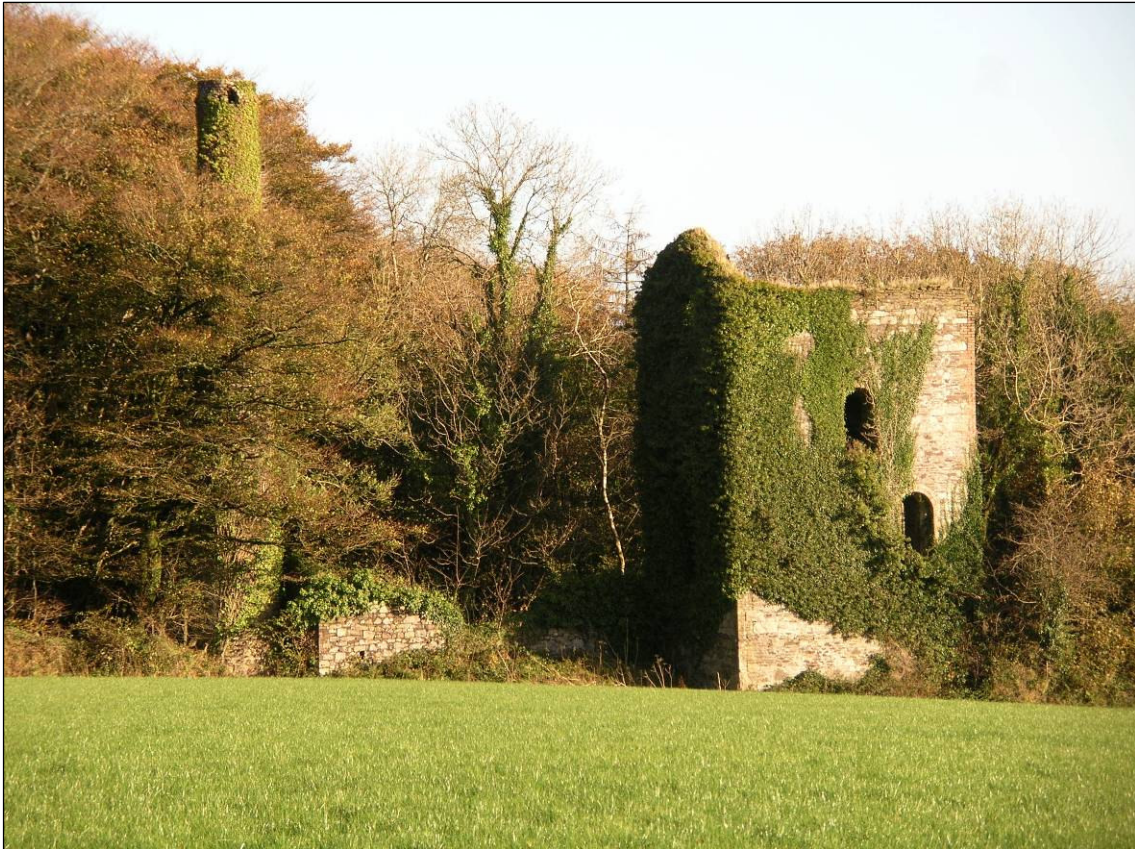
Fig 24 View of the south side of the winding engine house (before works)  
C Buck 2007 © CC HE Projects

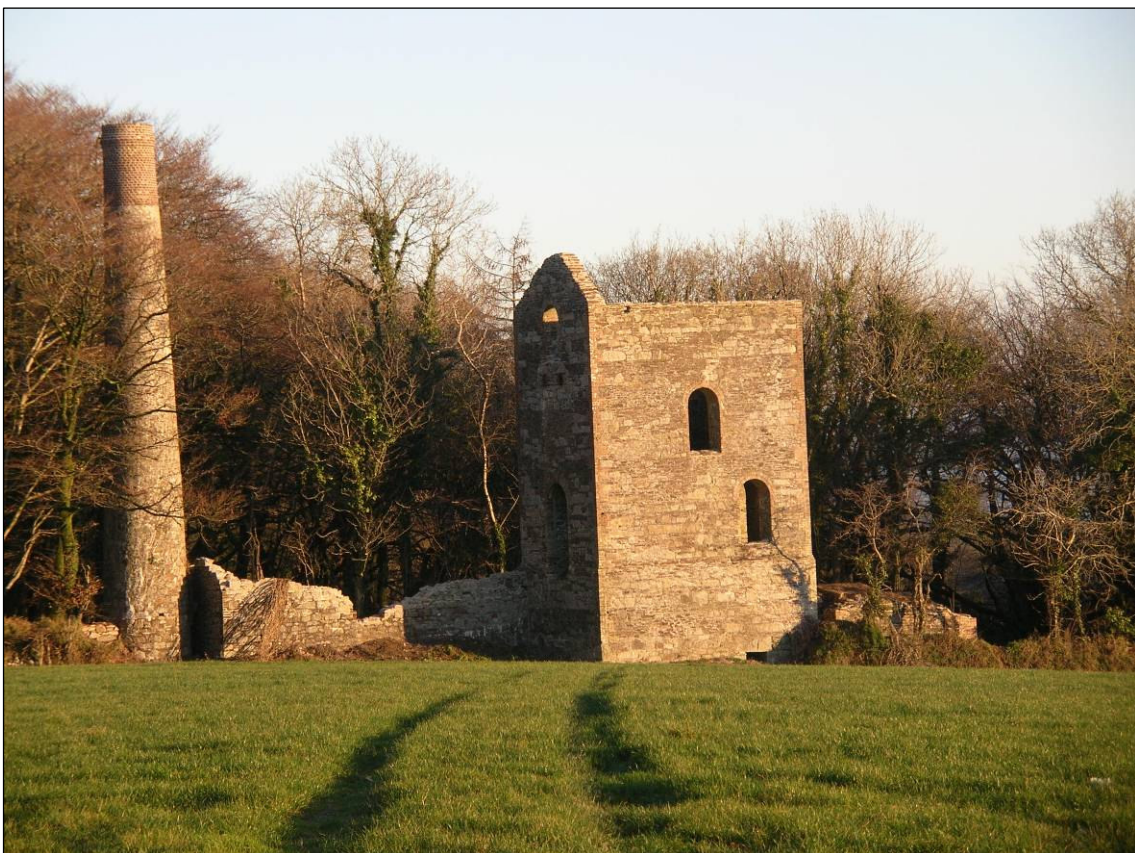
Fig 25 View of the south side of the winding engine house (after works)  
C Buck 2008 © CC HE Projects

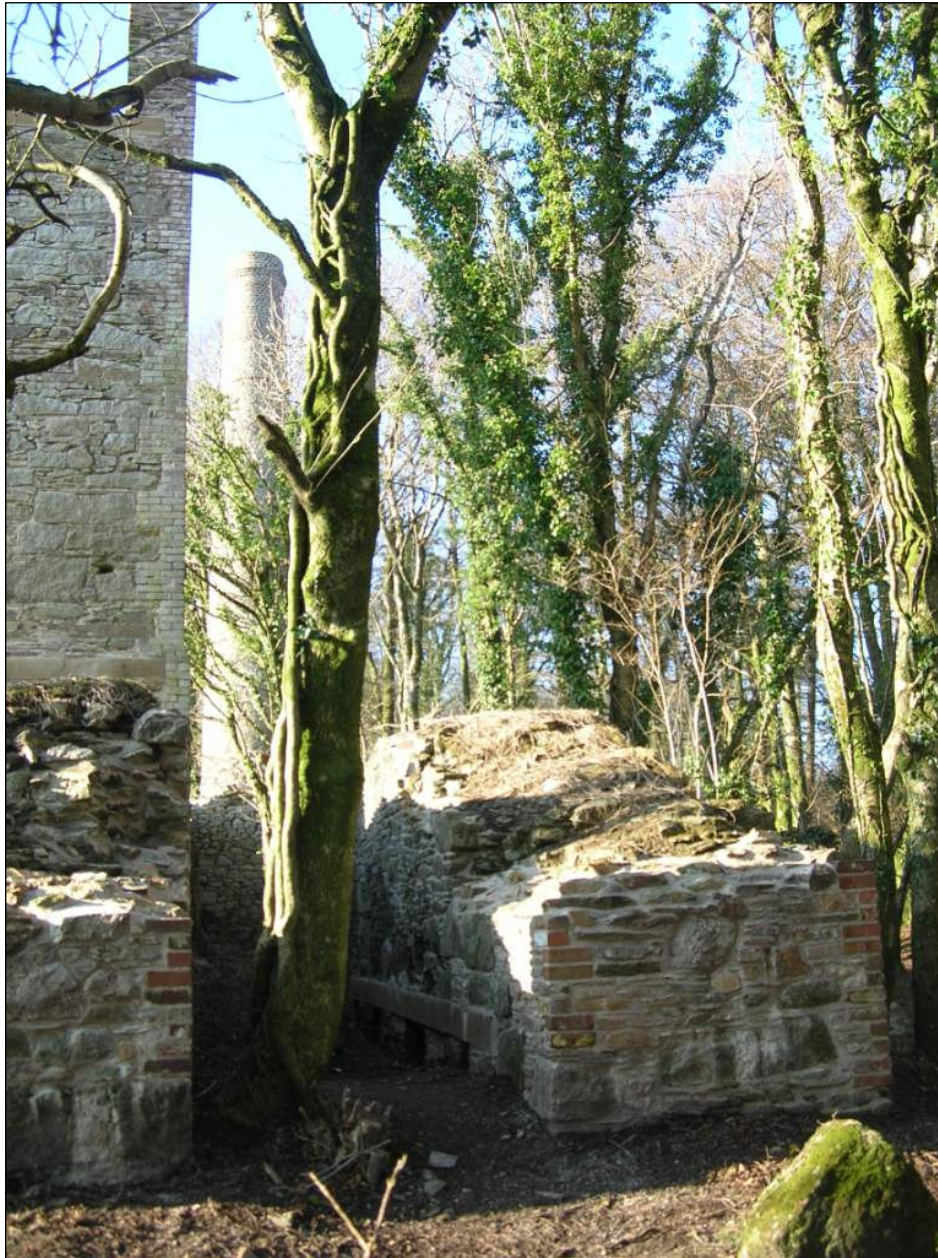
*Fig 26 View of the winding engine house winder drum loadings (after works)  
C Buck 2008 © CC HE Projects*

The 2001 temporary brick/blockwork put under the long (rotting) timber lintels running at the base and along the lower sides of the winder drum loadings were removed in September. New timber lintels were inserted to replace the rotten equivalents. Shorter sections were used inside the centre of the wall whilst the longest available lengths were used on the inner (visible) face of the wall (see Fig 26 – photo of the site after works). Figure 19 is a survey plan and elevations of these features, with annotated comments describing in detail the nature and extent of the conservation works.

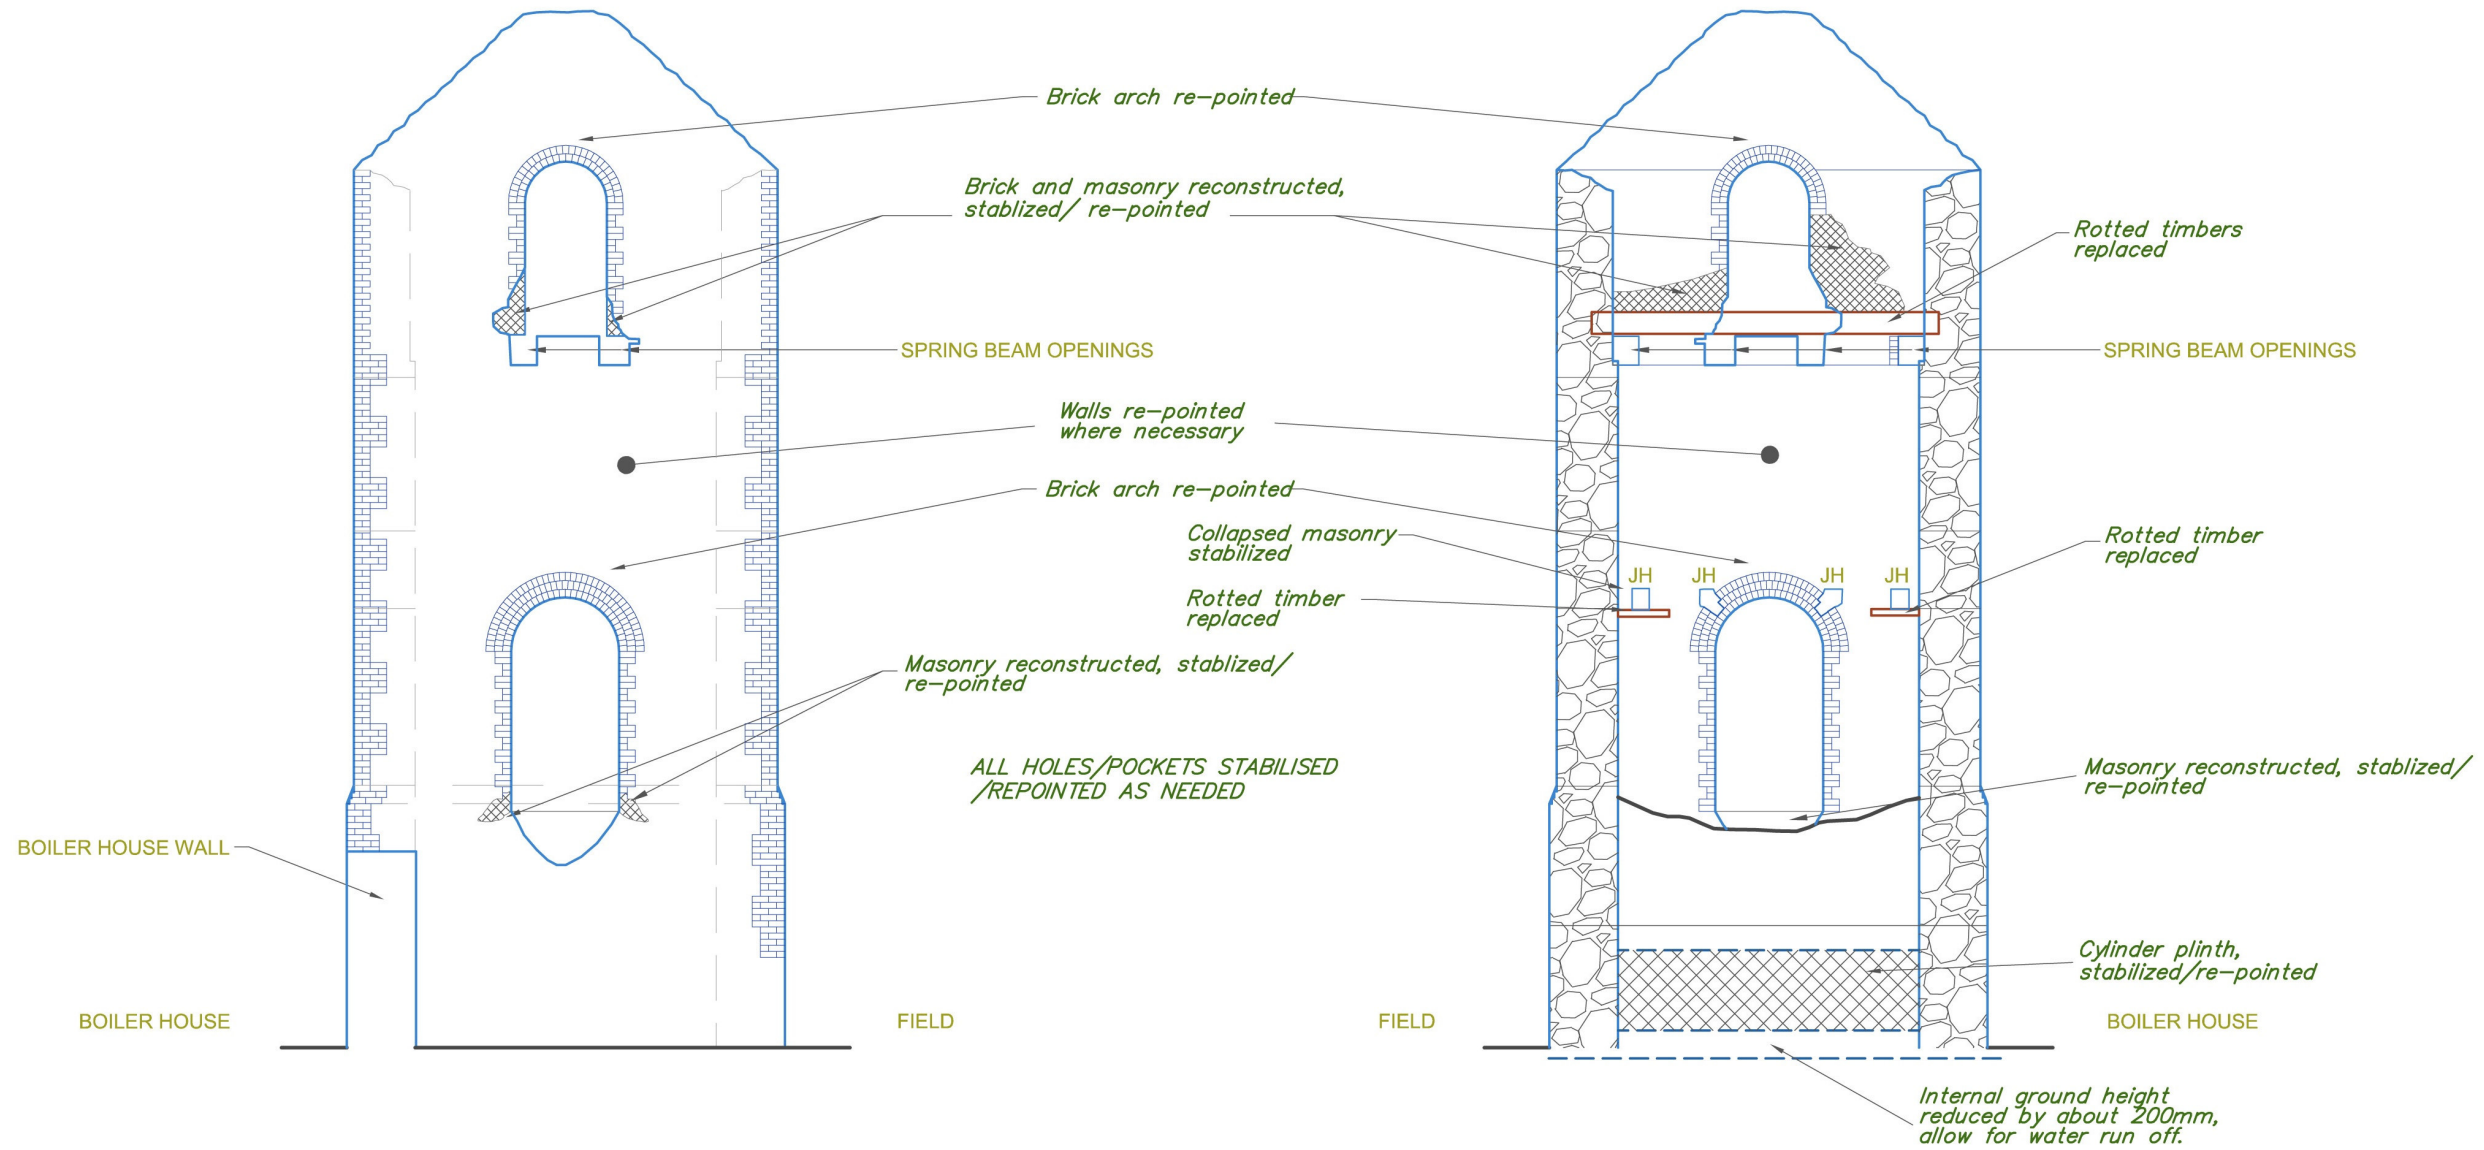
*Holmbush.  
 Winding Engine House  
 West Elevation*

Figure 27 'As built' annotated West elevation surveys of the winding engine house after works (Knevvitt Cons. Engs. 2008 )

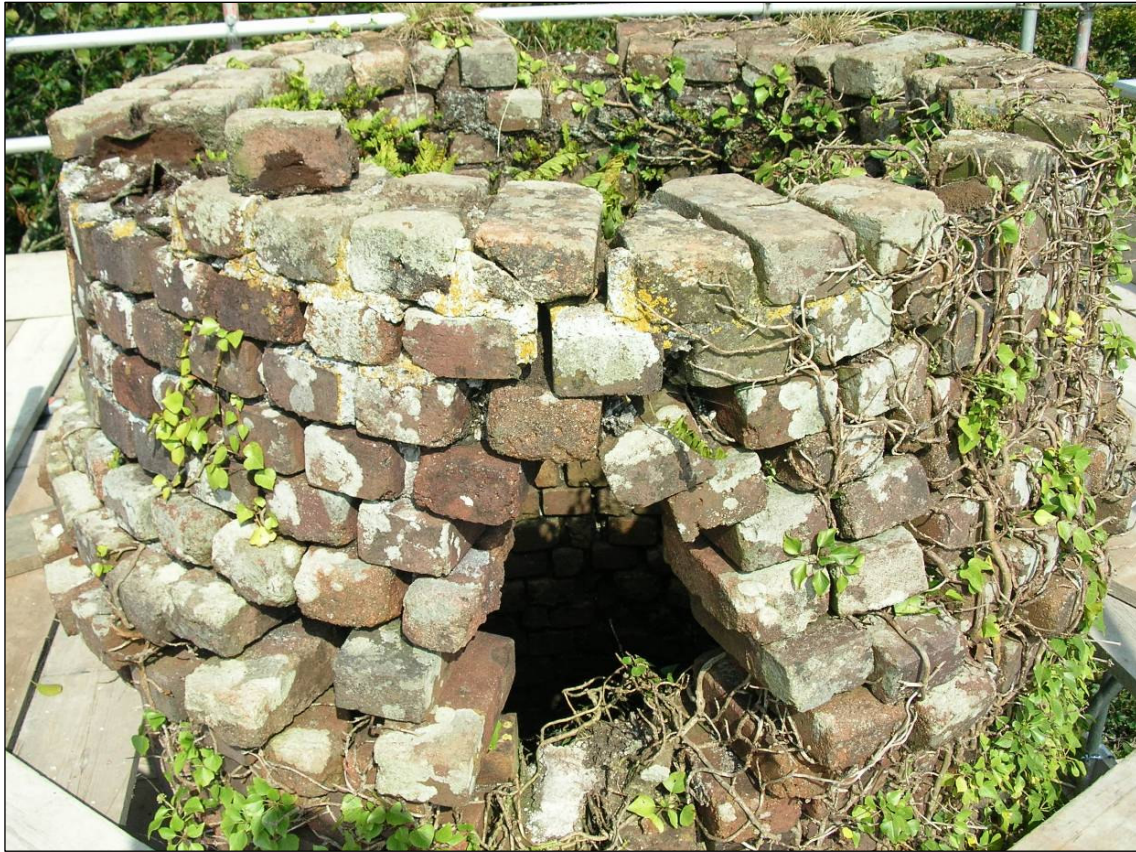
Fig 29 View of the top of the chimney (before works) C Buck 2008 © CC HE Projects

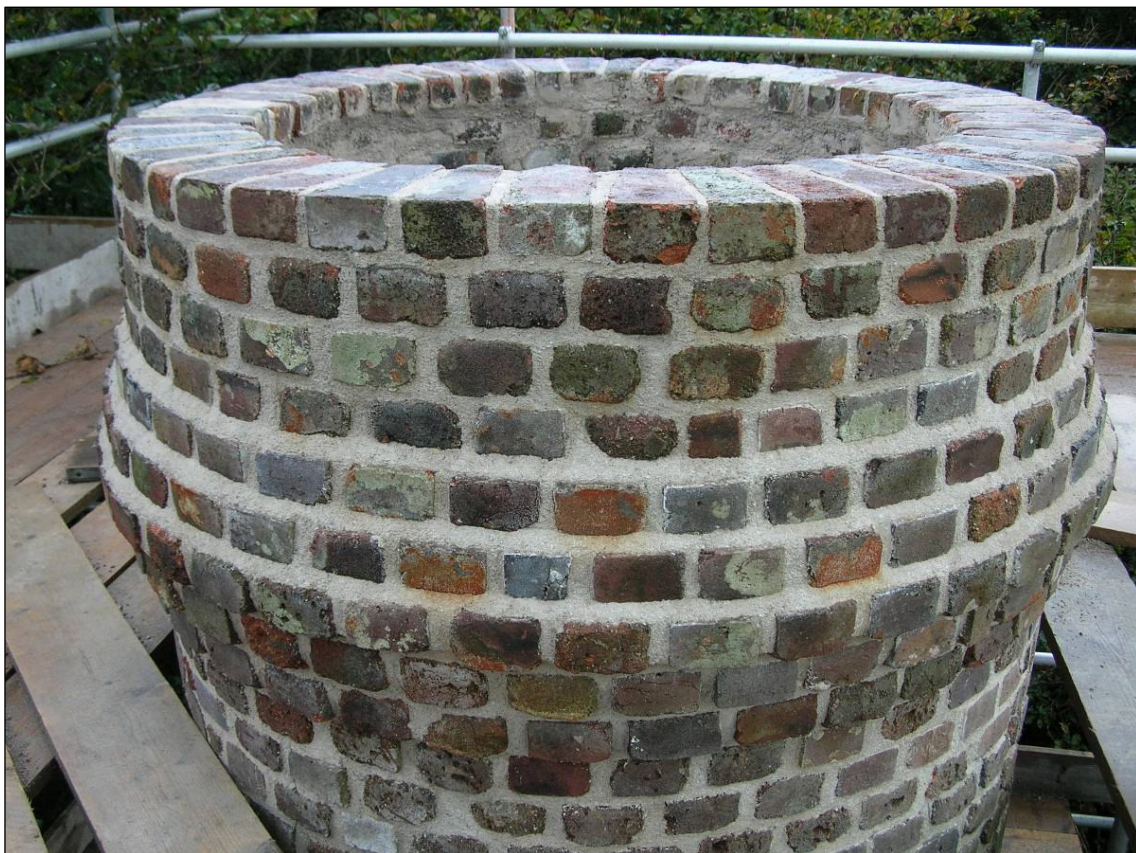
Fig 30 View of the top of the chimney (after works) C Buck 2008 © CC HE Projects

Ivy and vegetation covered and obscured most of this chimney (see Fig 24). Once scaffolding was erected only the top part of this was removed. The sides of the chimney were repointed with mortar, and rebuilt where necessary, although some small openings left for bat roosting and bird nests. Figs 29 and 30 show the top of the brick cornice before and after works. Given the state of the brickwork, and the hole in its south side, the top ten brick courses needed to be entirely rebuilt, with three layers of stainless steel reinforcement added for additional strength (each 2.5m x 6mm). In addition a wrought iron band around the chimney was replaced in its original position after repointing. This chimney did not have an elevation survey, although it can be seen on plan in Fig 19. The conservation work was finished by the end of September 2007.

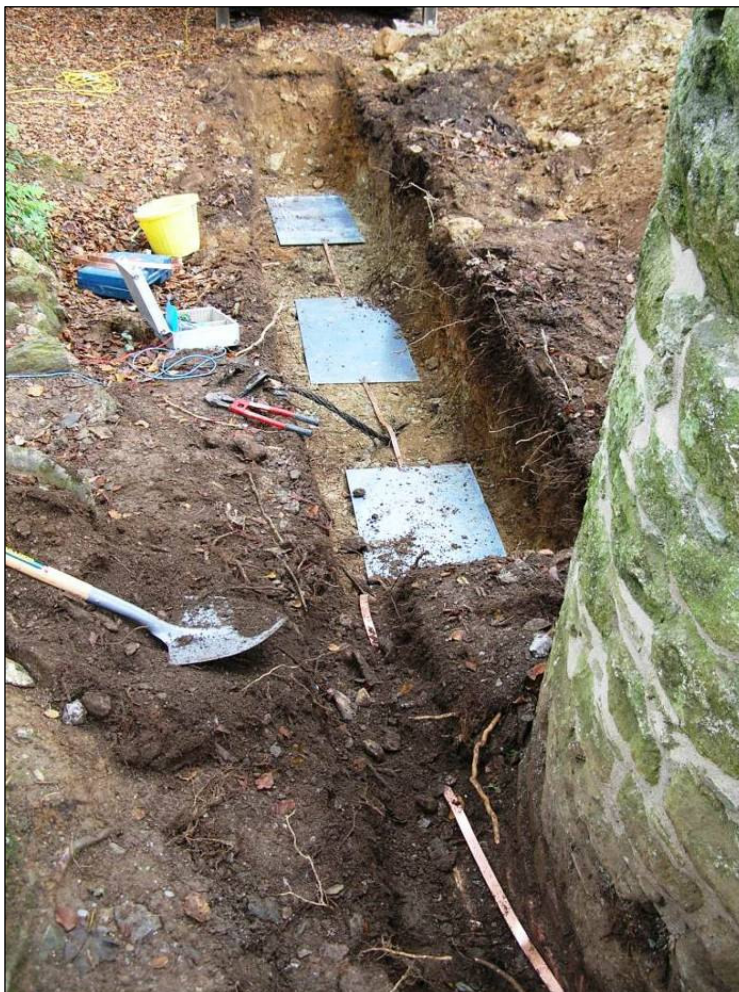
*Fig 31 View of the lightning conductor earth plates (during works) C Buck 2008 © CC HE Projects*

Before the scaffolding was removed (by 12/10/07), a copper lightning conductor was fixed around the top brick course, and connected to a copper tape that was fixed vertically into the internal side of the chimney, exiting through a small hole that had to be cut/drilled through the west side of the chimney. Excavation for the lightning conductor earth plates took place on 1/11/07, after the scaffolding had been removed. A small digger excavated a trench 0.9m deep, 0.8m wide and 6.0m long, around the west side of the chimney (see Fig 31). Three galvanised steel plates, each 0.6m wide and 1.2m long, each interconnected with copper tape (1.0m long), were placed in the bottom of the trench. The excavated soil profile was approximately 0.2m of topsoil/grass/earth, 0.3m of roots and buried stone/brick/mortar, and 0.4m of light tan coloured clay/shillet with earth/stone inclusions. There were no substantive archaeological finds apart from a section of old winding wire (which was placed back in the backfilled trench).
