Trewothack farm buildings, Gillan, Cornwall

Historic building record

Client	Mr and Mrs E Hosken
Report Number	2011R099
Date	September 2011
Status	Final
Report author(s)	Jo Sturgess
Checked by	Nigel Thomas
Approved by	Andy Jones

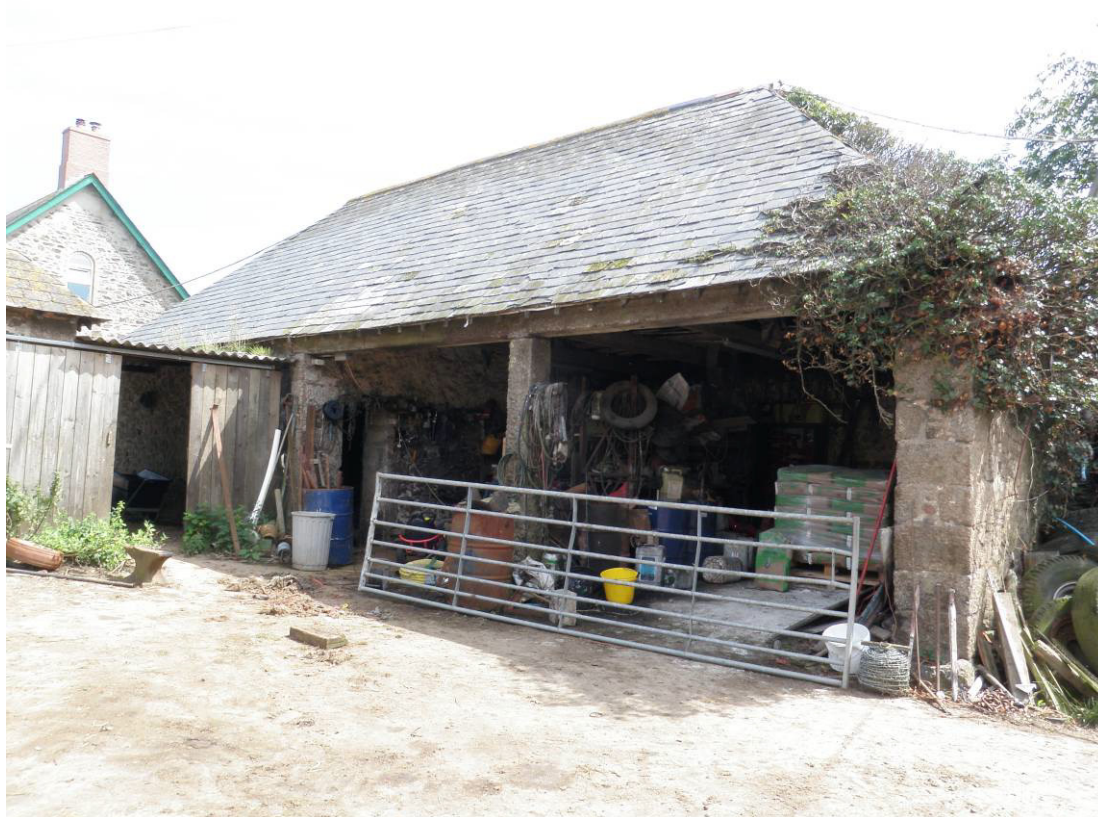
Fig 7: Building 1, north elevation

The western half of this elevation is open fronted. Here a timber lintel supports the roof, itself supported by granite quoins at either end and a centrally set granite pillar. The pillar has drill marks typical of late 19th century quarrying. The eastern half of the elevation is a slate rubble wall which has been repointed with a cement mortar. This is the rear wall of the two trap/cart houses. There is a single, small, breached window opening in the western part of this wall.

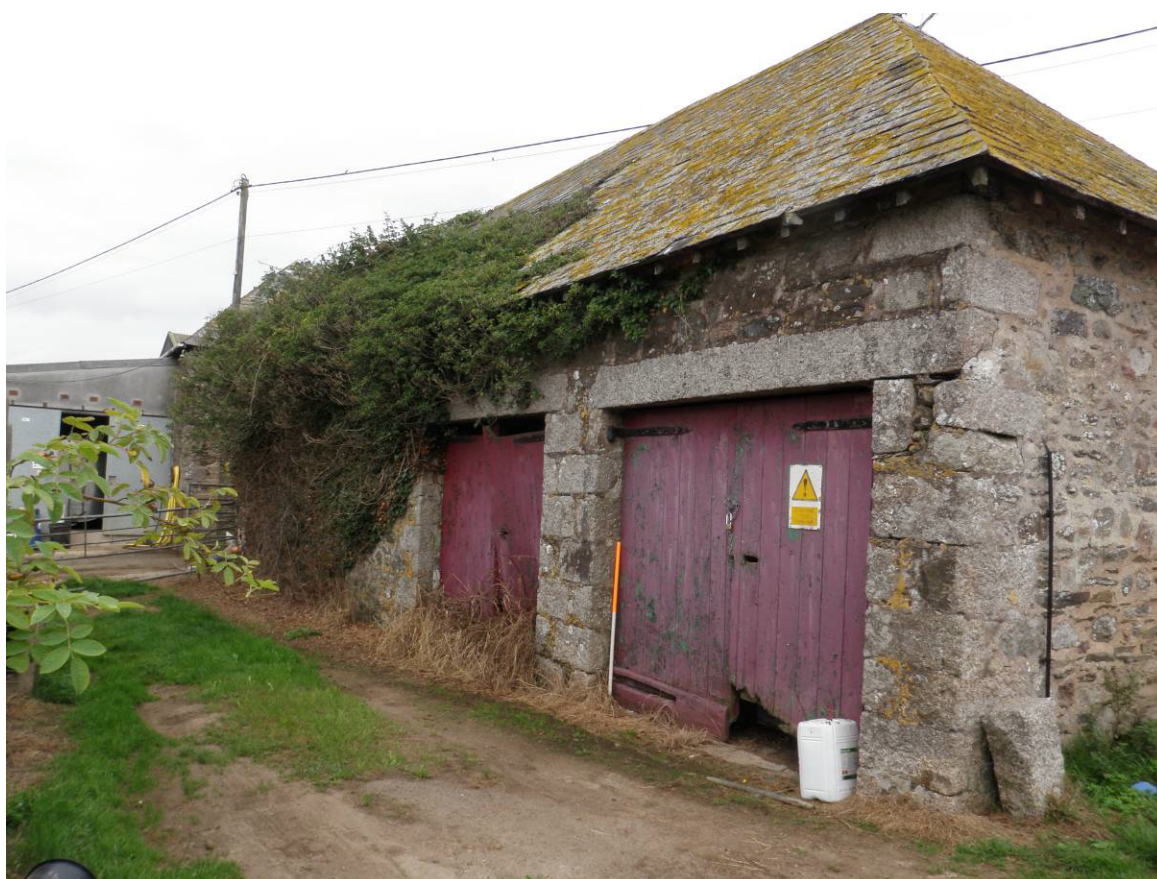
Fig 8: Building 1, south elevation

This is a slate rubble wall with granite quoins. There are two double door openings in the eastern half of the wall giving access to two probable trap houses. Both openings have granite jambs and lintels. Much of the western half of the elevation is covered in ivy.

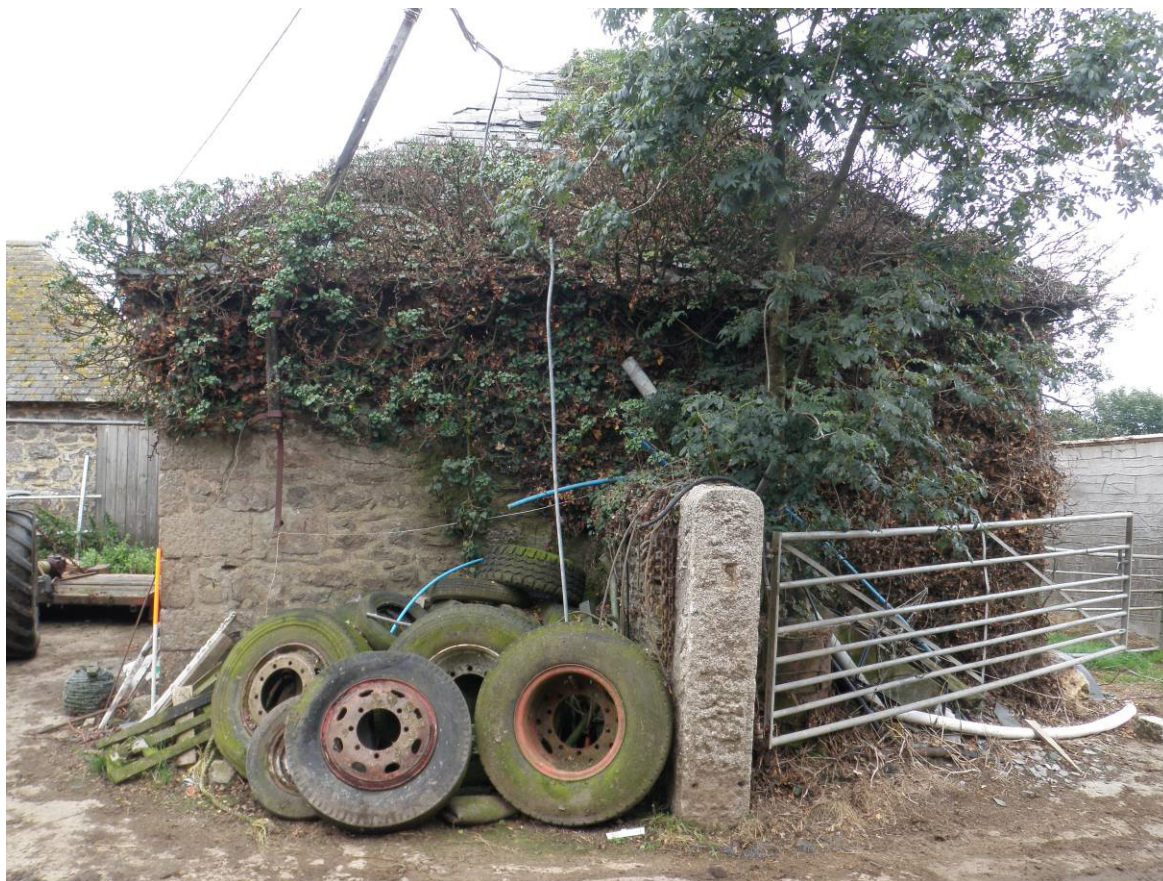
Fig 9: Building 1, west elevation

This is a hipped end elevation. It comprises a slate rubble wall with granite quoins which has been repointed with cement mortar. There are no openings but a later yard wall with granite gate post adjoins the centre of the elevation.

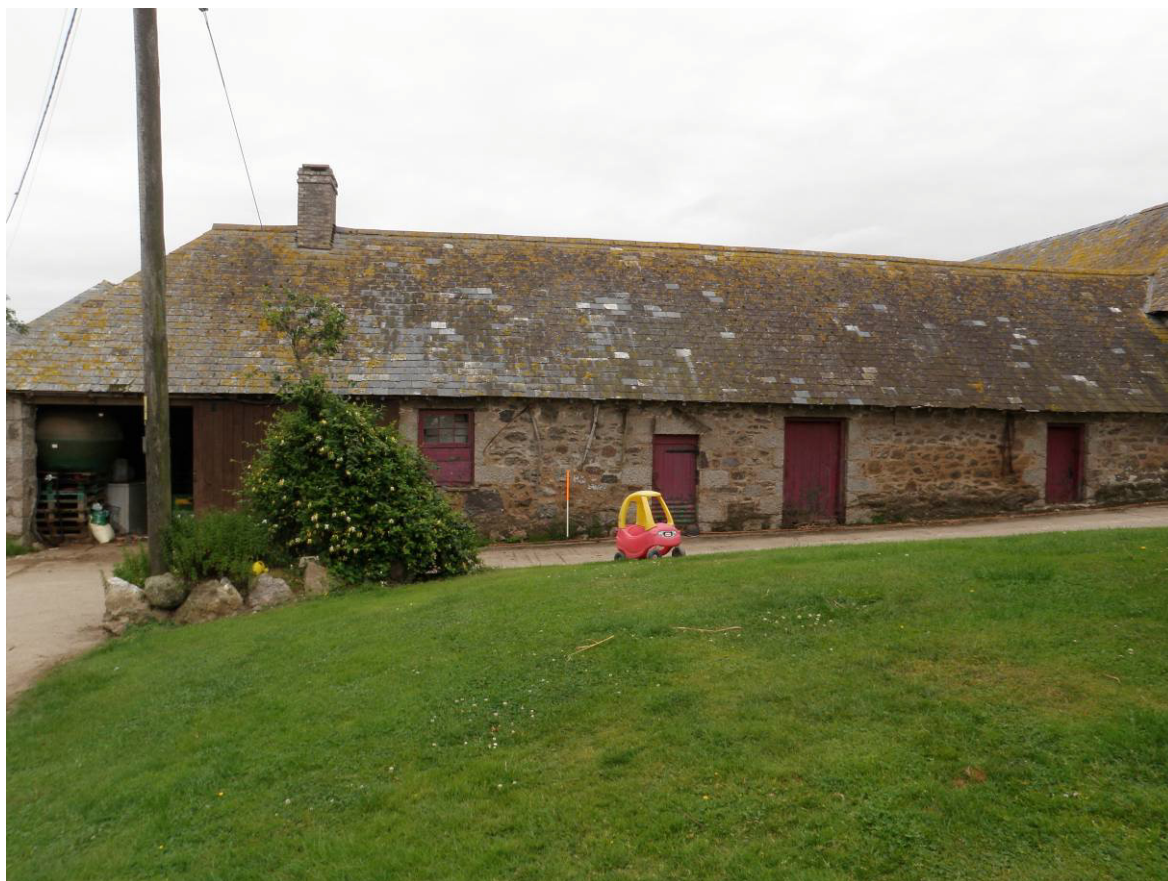
Fig 11: Building 2, east elevation

This elevation now fronts the current access road to the farmhouse which is not an original feature. It comprises a slate rubble wall bonded with lime mortar which has been repointed with a cement mortar. All the openings are original and have granite jambs and the majority have granite lintels. At the southern end there is a wide double door opening giving access to room 1 (the drying room/wash house). The door itself has been replaced by a modern sliding door. To the north of this there is a window opening with slate sill and a door opening servicing room 2. Both are now blocked internally but the original window and door remain *in situ* and both have granite lintels. To the north of this is another door opening with a granite lintel and original planked door giving access to room 3. At the northern end of the building is a door and window opening servicing room 4. The door opening has a granite lintel with the original planked door and the window opening has a timber lintel, slate sill and is boarded up.

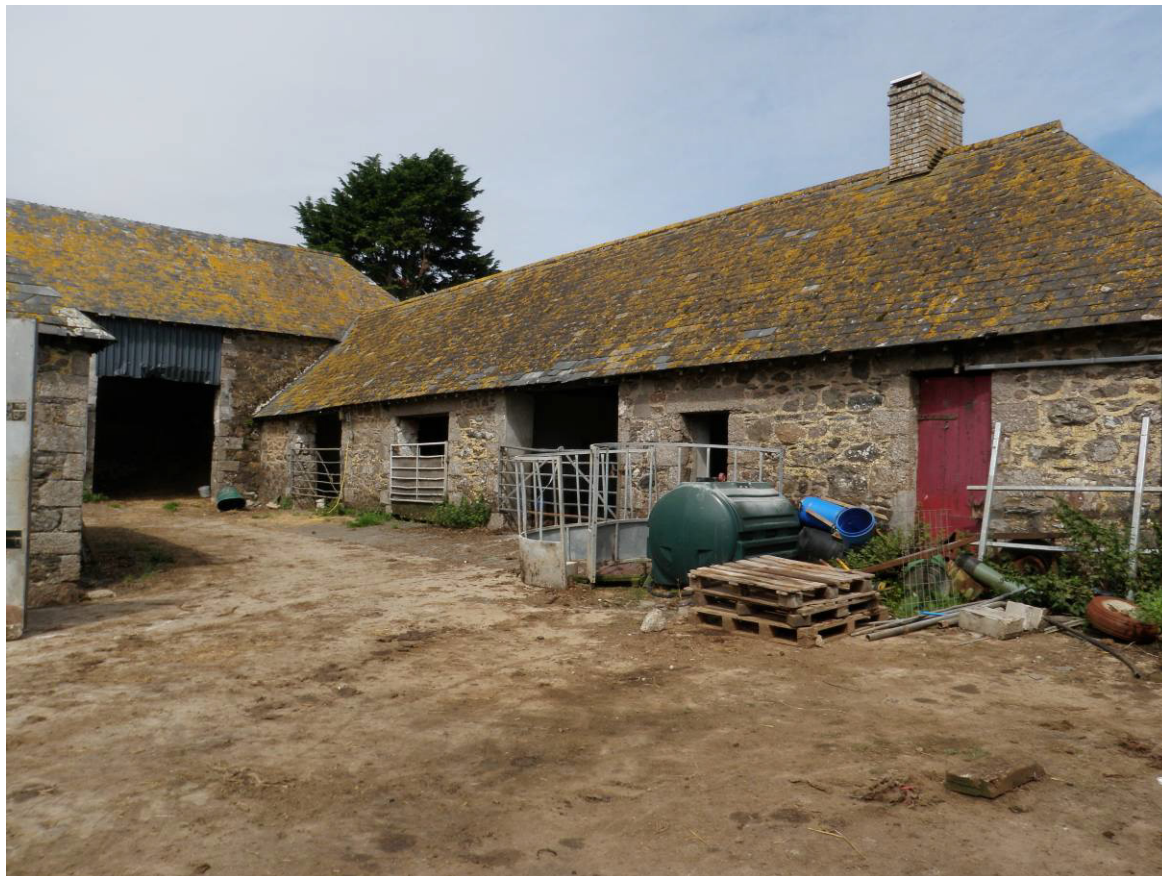
Fig 12: Building 2, west elevation

This elevation fronts the enclosed farmyard. It comprises a slate rubble wall bonded with lime mortar which has been repointed. All the openings are original (except the door opening at the northern end which has been widened) and have granite jambs and the majority have granite lintels. At the southern end there is a door opening giving access from the yard to room 1 (the drying room/ wash house). The door itself is an original planked door. To the north of this there is a small door opening and a double door opening giving access to room 2. The small door opening has a granite lintel but the door is missing and the double door opening also has no doors and has had its lintel removed and replaced by a piece of reused timber (possibly a section of ship's planking). To the north of this is another double door opening with a granite

lintel and doors removed giving access to room 3. At the northern end of the building is a door opening (with no door) which has been widened at a later date to create a double door giving access to room 4. The lintel has been replaced with a timber lintel.

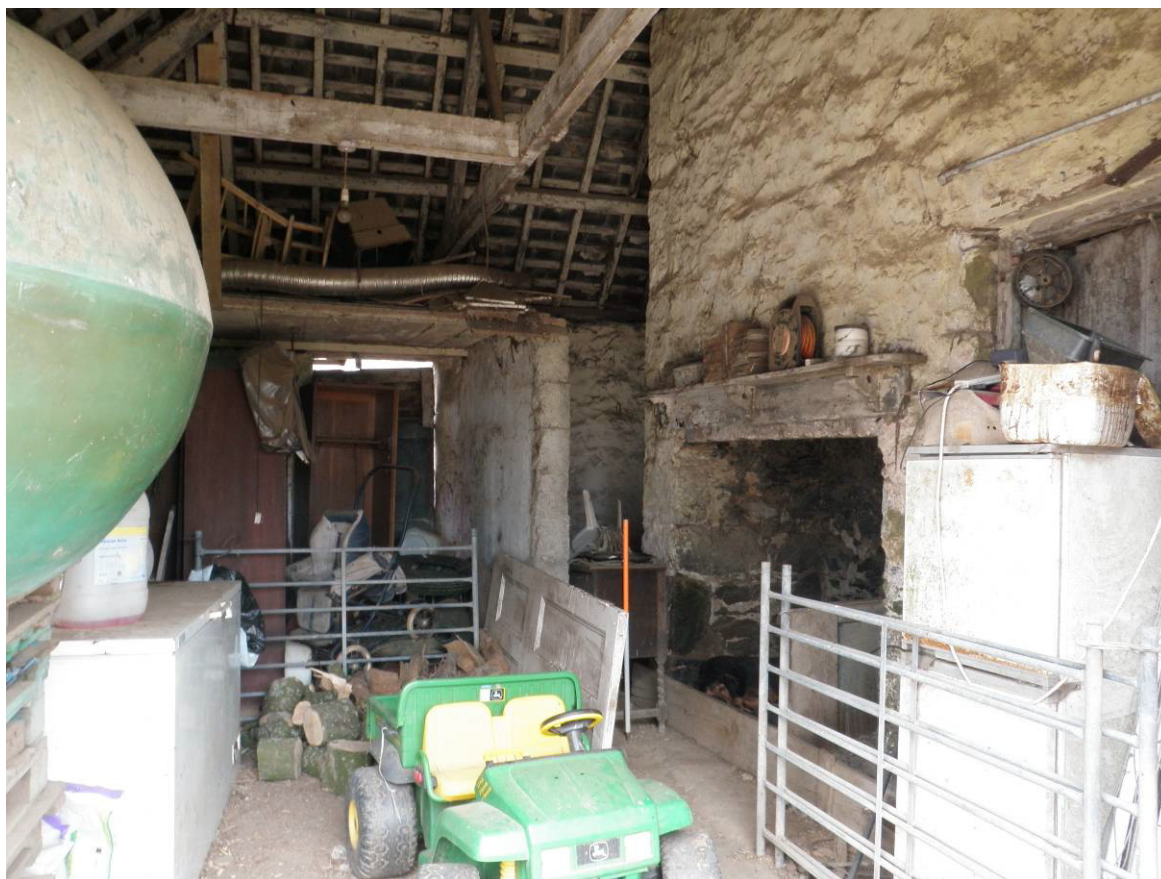
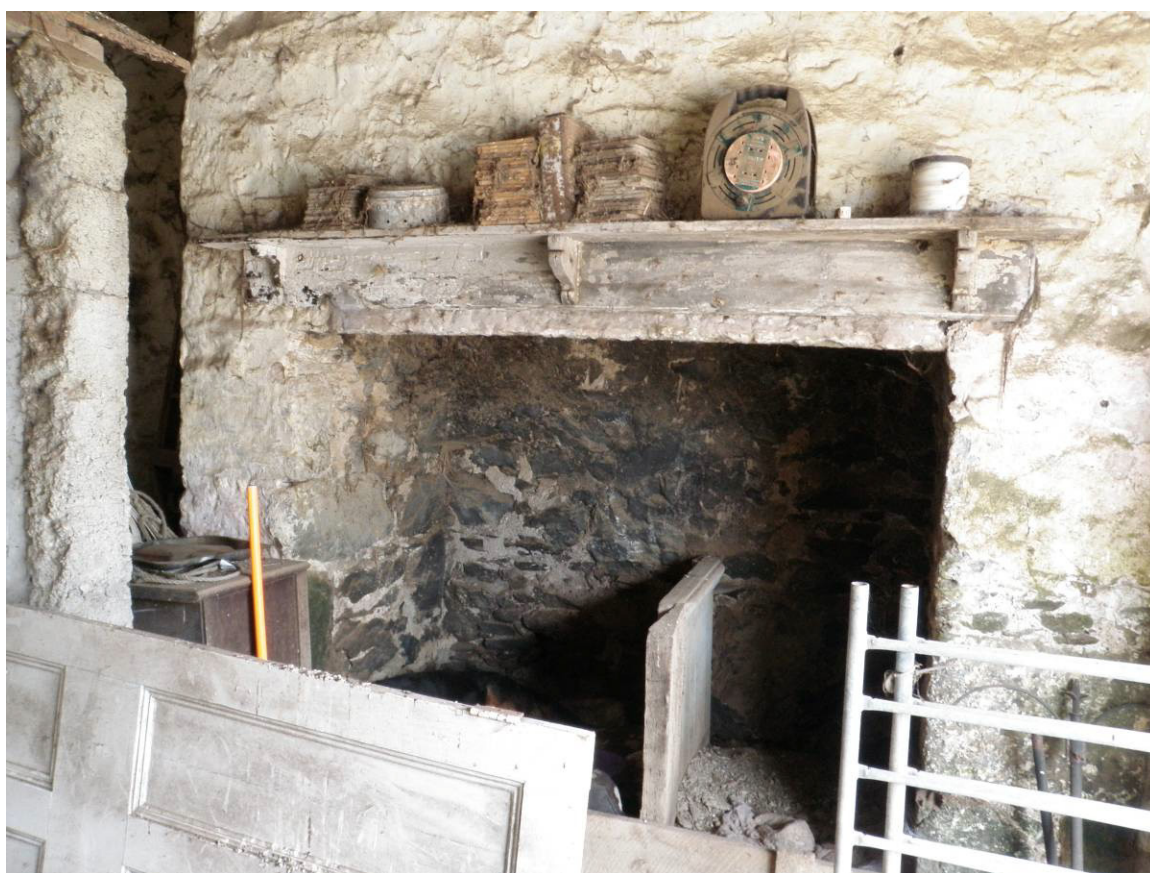
This room is located at the southern end of the range and can be accessed from both outside and inside the enclosed farmyard. It is likely to have been used as a drying room since it contains a large fireplace with original timber overmantel in its north wall, but has also been used as a wash room (E Hoskin pers comm.). To the east of the fireplace in the north partition wall is an original door opening with an original planked door giving access to a cupboard or possibly originally through to room 2. To the north of the door opening in the west wall a concrete block-built wall has been inserted. The walls are painted white.

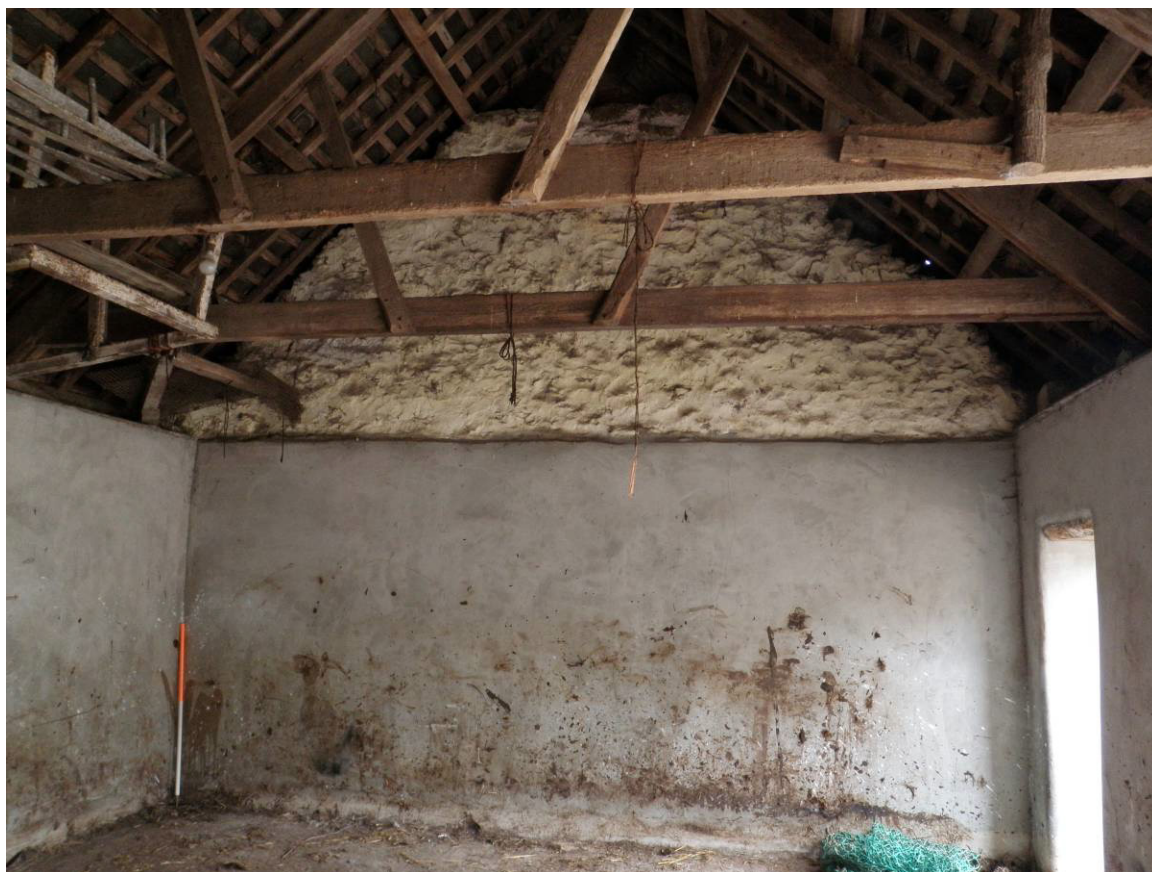
Fig 15: Building 2, room 2 looking south

This room is located to the north of room 1 and could be accessed originally from both outside and inside the enclosed farmyard. However, all the openings except the two doors in the west wall have been blocked and the walls covered with a cement render up to the level of the eaves. The original function is unclear but likely that it was used as a calf/animal house.

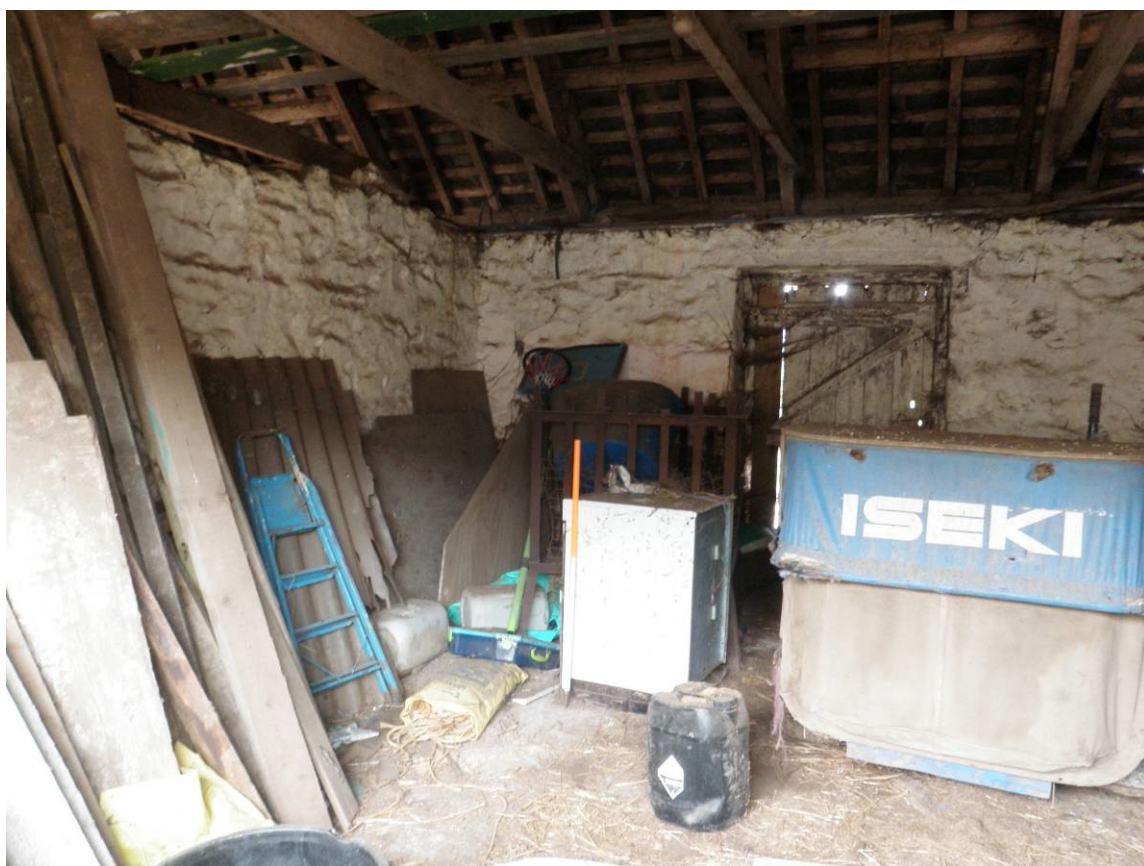
Fig 16: Building 2, room 3 looking north-east

This room is located to the north of room 2 and could be accessed originally from both outside and inside the enclosed farmyard. The original function is unclear but likely that it was used as a calf/animal house or loose box. The walls are painted white.

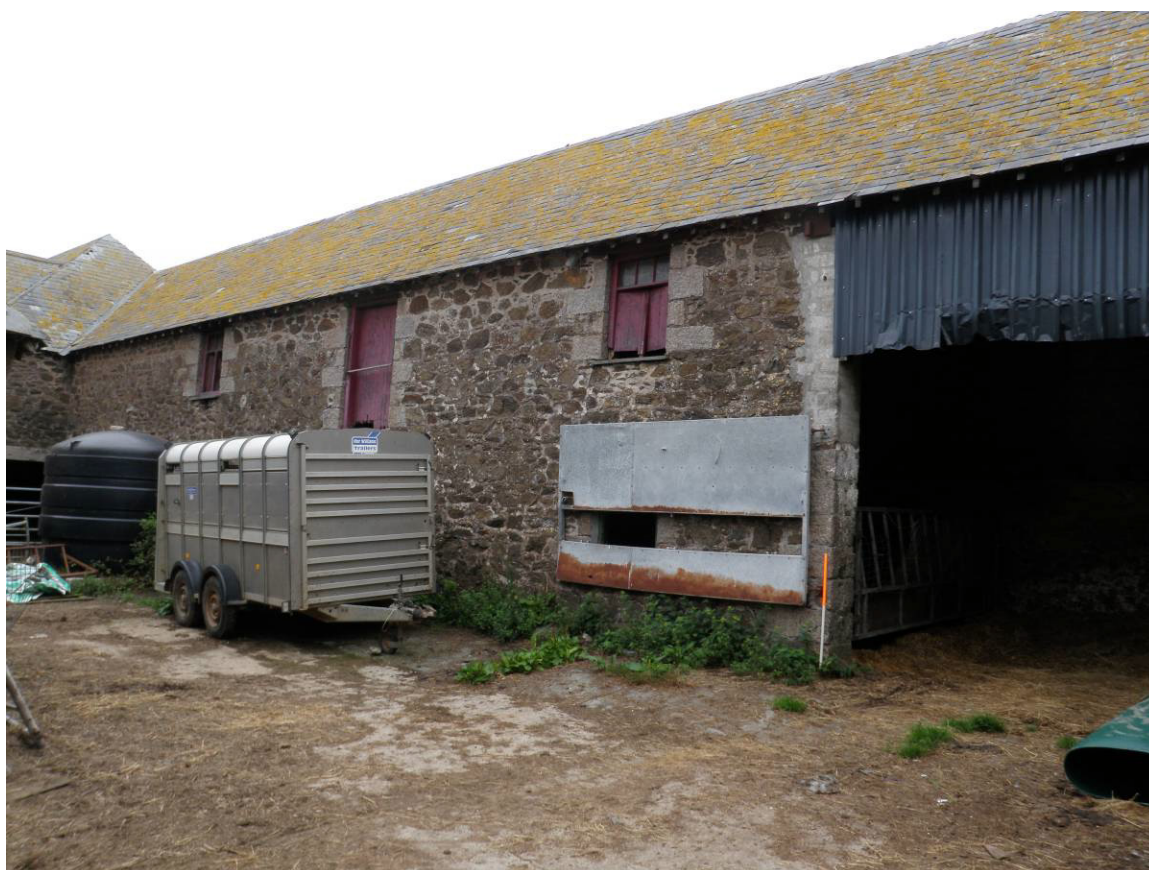
Fig 19: Building 3, south elevation

This is a slate rubble wall bonded with lime mortar. It fronts the enclosed farmyard from where the building was accessed. At the east end of the elevation there is a large two-storey door opening. This was originally a wide single storey opening but has been heightened incorporating the east granite jamb of a former first floor loading door. To the west of this at ground floor level are two window openings and two door openings set alternately. The window openings have granite lintels, jambs and slate sills and the door openings have granite lintels and jambs and original 'hit and miss' ventilators in the wooden doors. At first floor level to the west of the wide eastern door opening there are two window openings with a loading door set centrally in-between. The window openings have timber lintels, granite jambs and slate sills and retain their original shuttered windows whilst the loading door has granite jambs and threshold, a timber lintel and original planked door.

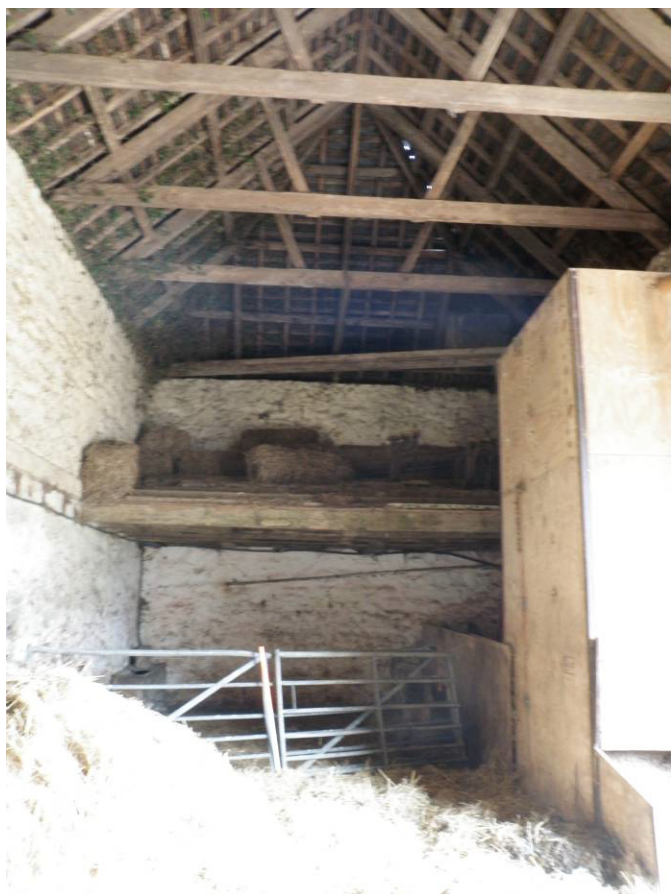
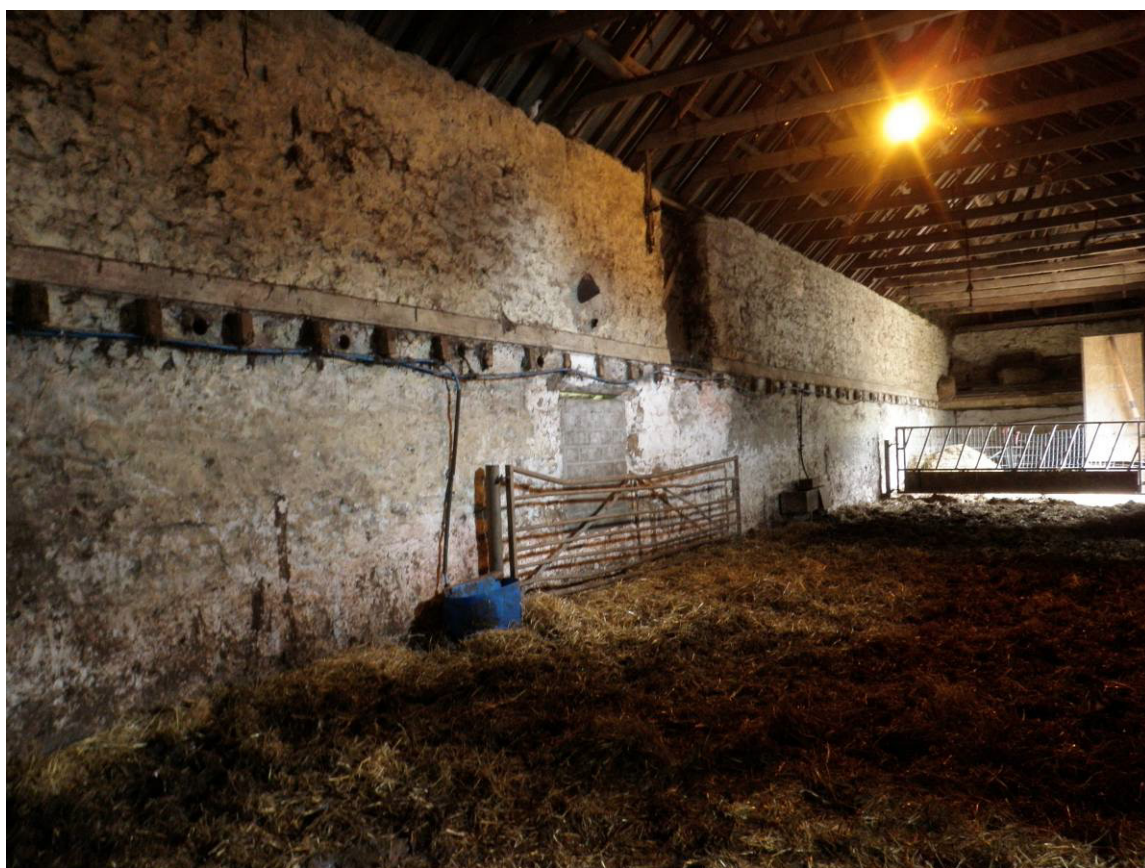
The interior of the building is now a single open room space. The joists and boards of the first floor structure have been removed except for a short section at the east end of the building. The original partition wall at the west end of the building dividing building 3 from building 4 has also been removed. There is no evidence on the ground floor for a former feeding passage or stalls. The ground floor surface has been covered with a concrete screed and the room space is open to the roof with painted white walls. At the south-east corner of the building there is a door opening giving access through to room 4 of building 2. At first floor level there are no threshing doors or any evidence for the existence of a former threshing machine.
