Prince of Wales Mine, Harrowbarrow, Cornwall Report on building conservation works

Report on building conservation works (2007/8)

| Report Number | 2011R103 |
| Date | September 2011 |

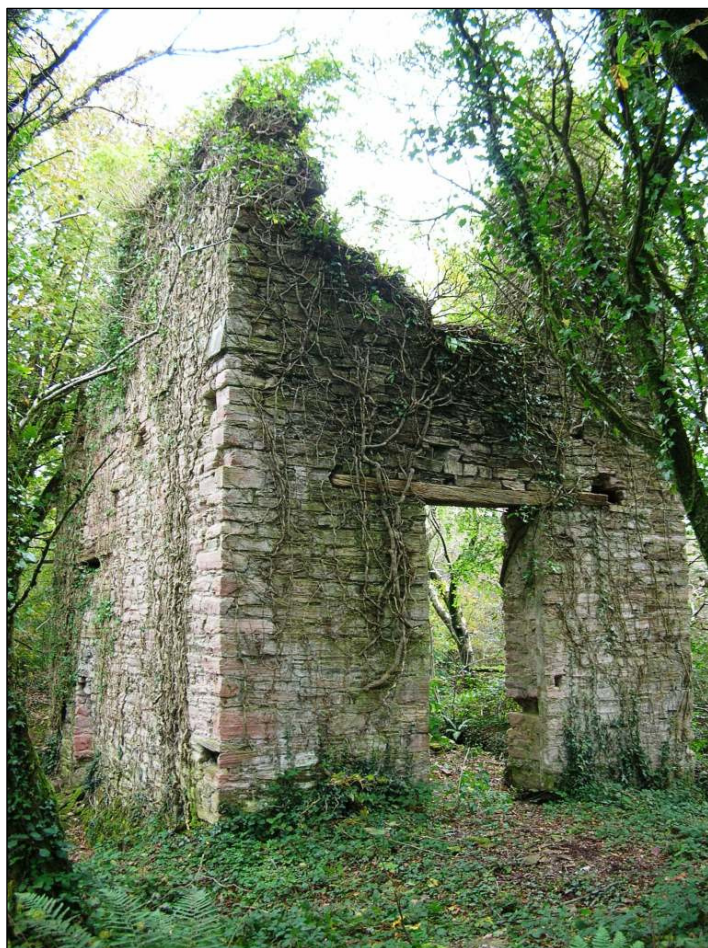
Fig 8 External view of the winding engine house before works © CC HE Projects 2007

Fig 9 External view of the winding engine house after works © CC HE Projects 2008

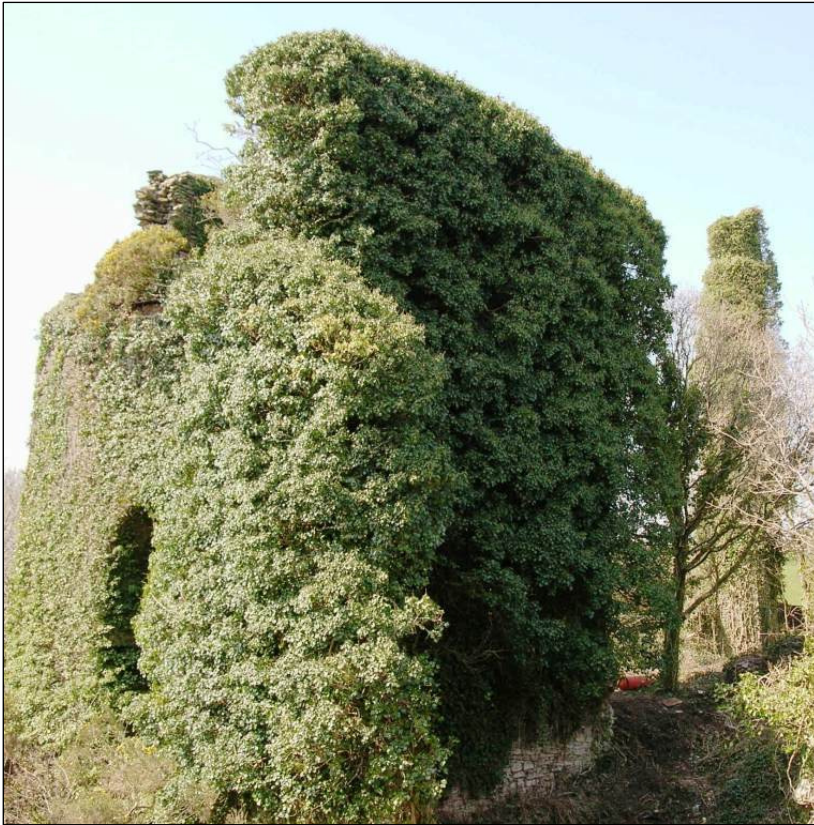
Clearance of vegetation from the sides and tops of the wing walls (see Fig 12) followed after scaffold erection (inside and out) by 29/11/07. This permitted a close detailed structural and ecological survey. In addition, the building surveyors returned to accurately survey the top edges of the building (prior to rebuilding and rebedding the tops of the walls). To summarise the conservation works; the masonry over the top of the rotted timber lintels was carefully replaced with fallen stone from the building after some new sections of tanalised Douglas Fir or oak (depending on supporting evidence of the original timber), had been inserted to mimic the original timber specification. Some original timbers were left *in-situ*. The top of the wing walls and bob wall were 'capped' and repointed. Figure 17 shows the sheets of iron and timber that were used to level and form the bob wall correct height upon which the large original timber lintels (and iron bob), was set. The walls were only repointed where there was a structural need to do so (mainly in the upper parts of all walls), in fact, the dense ivy had mainly grown against the walls, protecting the masonry and lime mortar pointing.

Fig 12 External view of the pumping engine house before works © CC HE Projects 2007

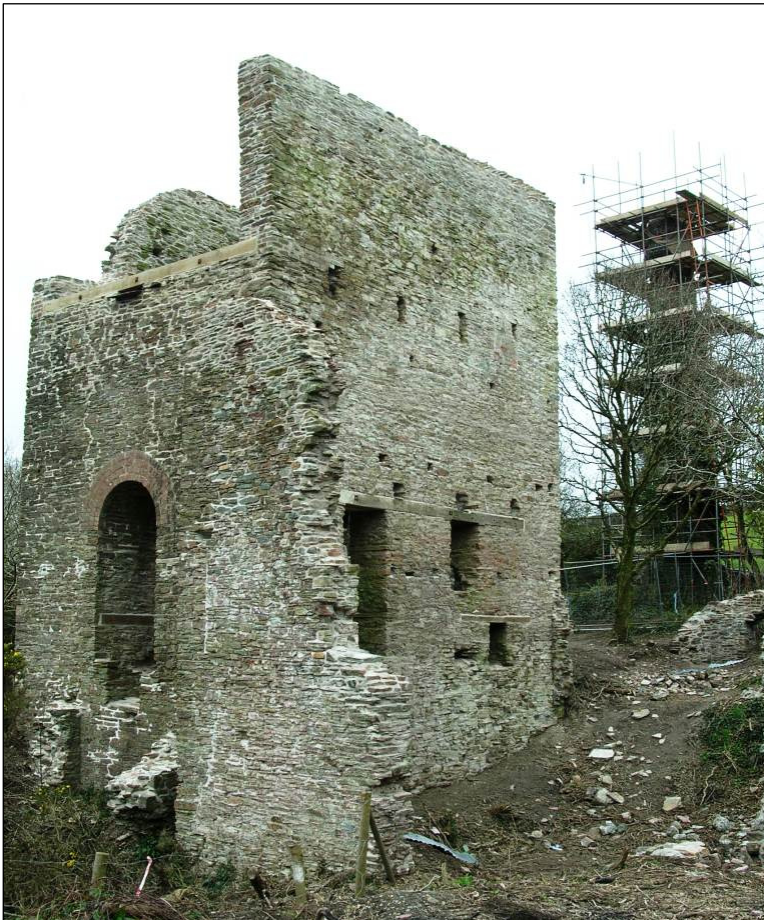
Fig 13 External view of the pumping engine house after works © CC HE Projects 2008

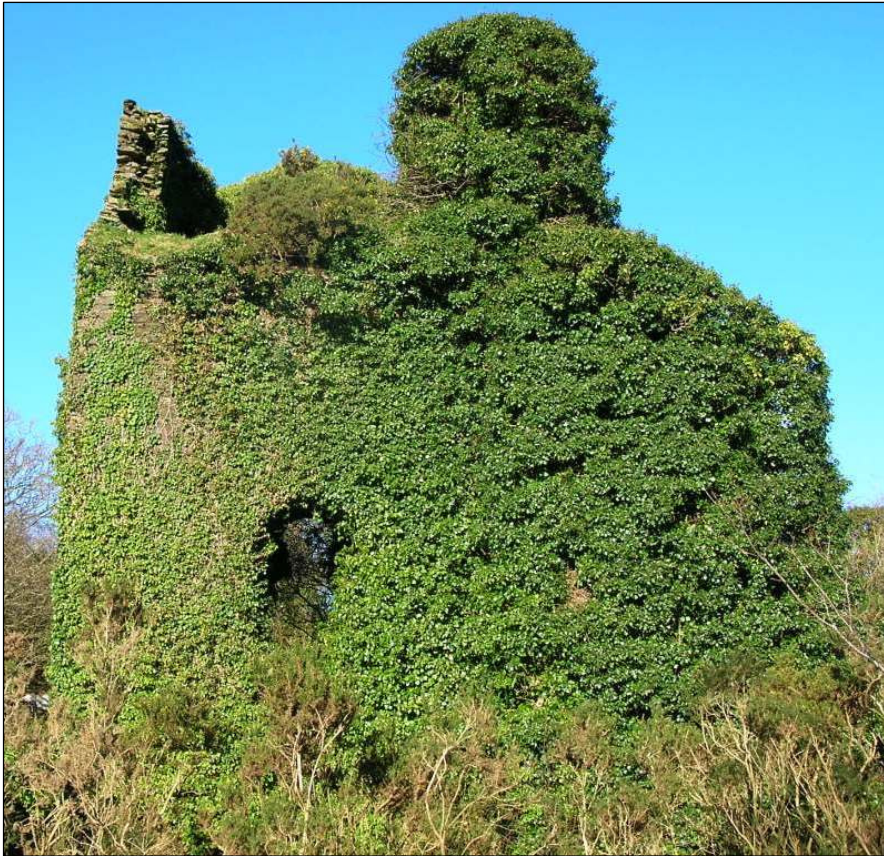
Fig 15 External view of the pumping engine house before works © CC HE Projects 2007

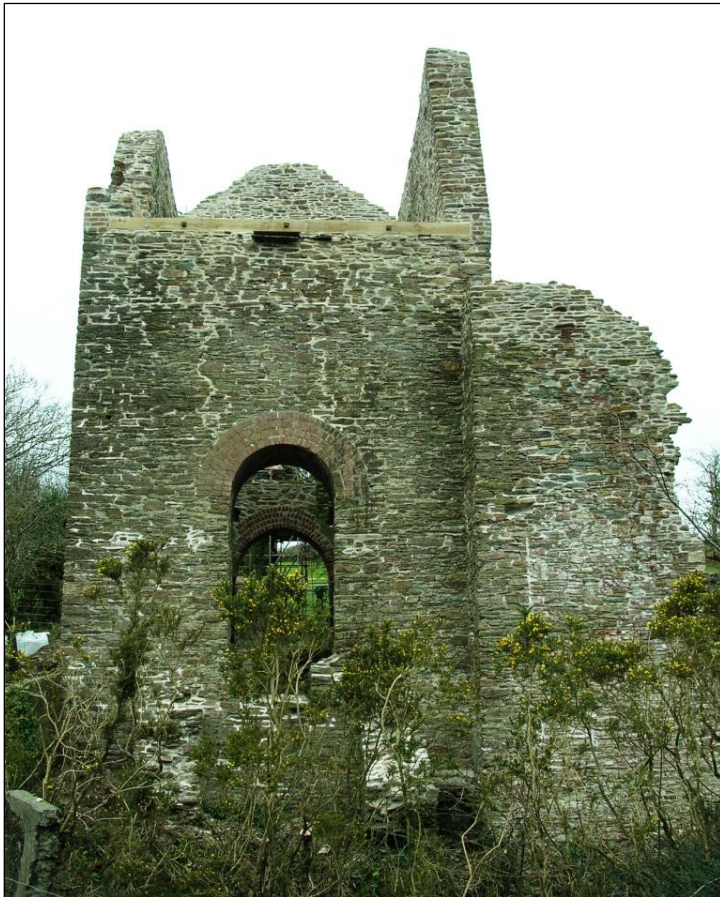
Fig 16 External view of the pumping engine house after works © CC HE Projects 2008

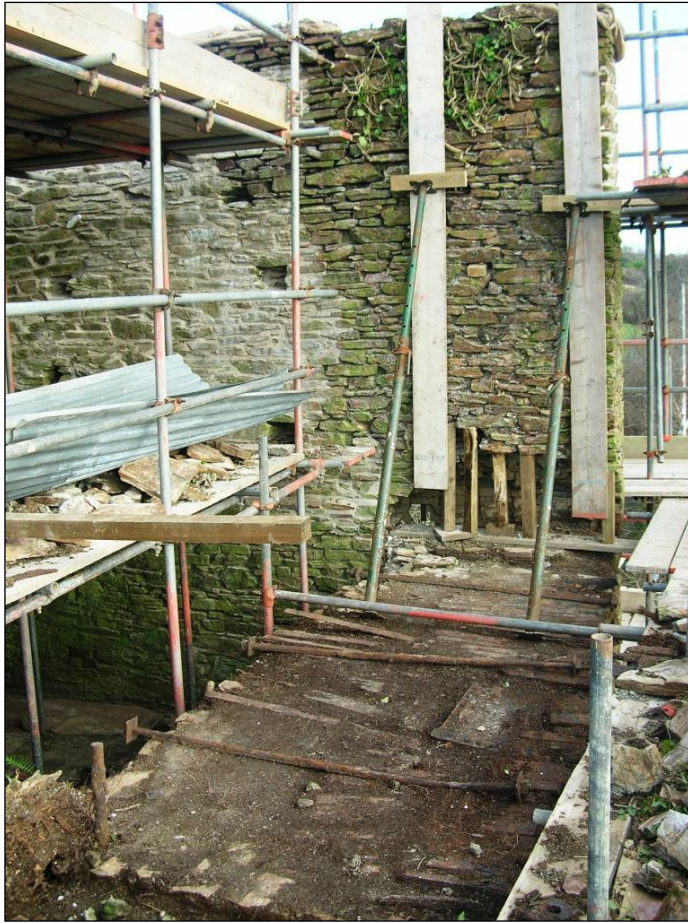
Fig 17 External view of the top of the bob wall during works © CC HE Projects 2007

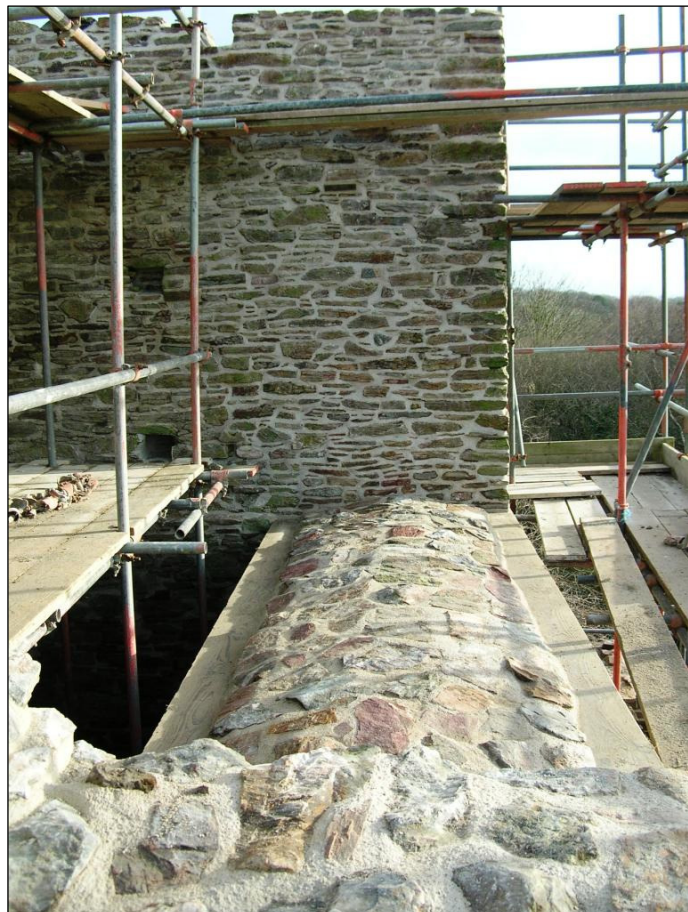
Fig 18 External view of the top of the bob wall after works © CC HE Projects 2008

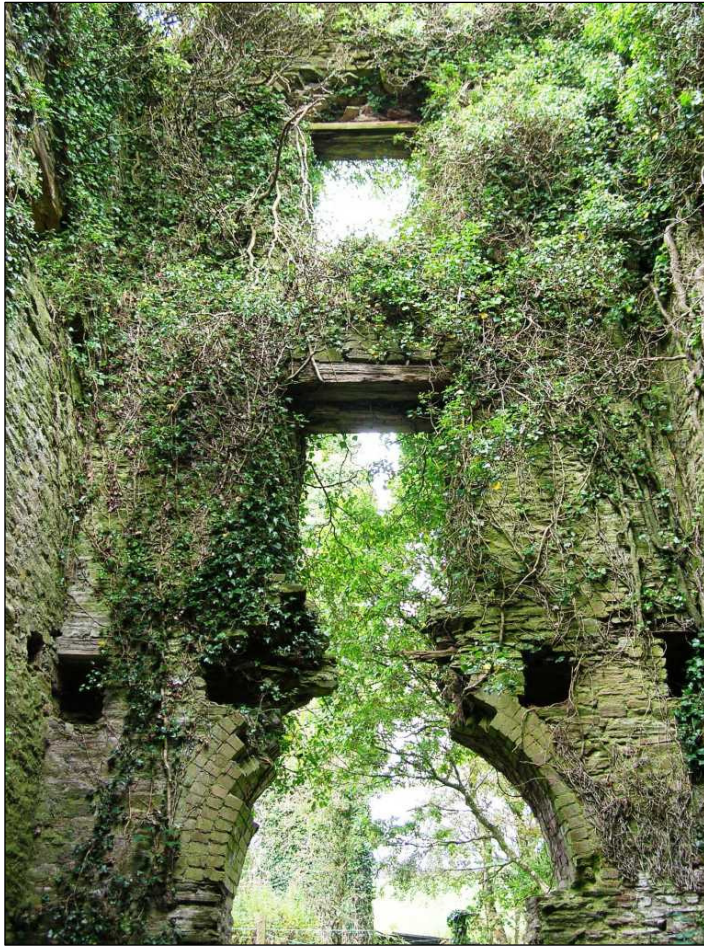
Fig 21 Internal view of the gable wall before works

Fig 22 Internal view of the gable wall after works
© CC HE Projects 2008

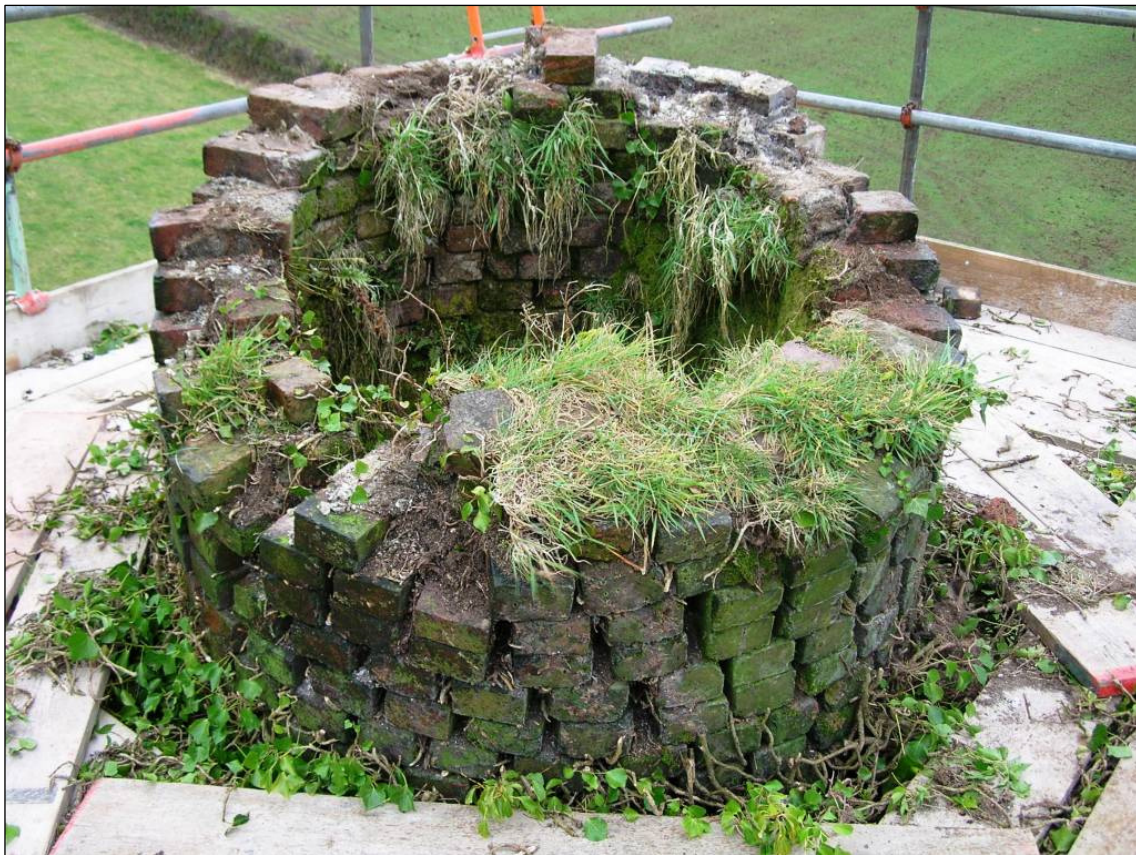
Fig 23 View of the top of the chimney (Site 3 - before works) © CC HE Projects 2008

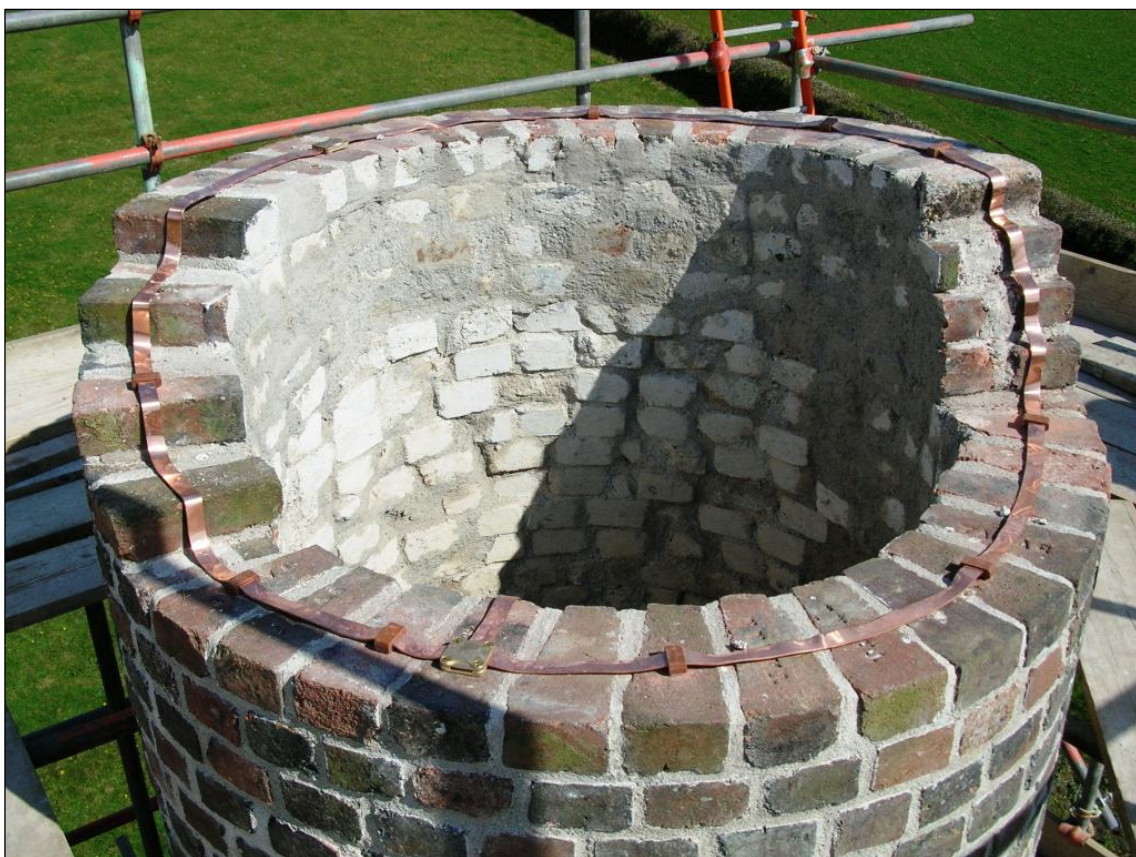
Fig 24 View of the top of the chimney (after works) © CC HE Projects 2008

Before the scaffolding was removed, a copper lightning conductor was fixed around the top brick course, and connected to a copper tape that was fixed vertically into the internal side of the chimney, exiting through a small hole that had to be cut/drilled through the south-west side of the chimney. Excavation for the lightning conductor earth plates took place on 9/05/08, after the scaffolding had been removed. A small digger excavated a trench 0.9m deep, 0.8m wide and 5m long, extending from the south west side of the chimney. Three galvanised steel plates, each 0.75m wide and 1.25m long, and each interconnected with copper tape, were placed in the bottom of the trench. The excavated soil profile was approximately 0.2m of topsoil/grass/earth, 0.3m of roots and buried stone/brick/mortar, and 0.4m of light brown coloured clay/shillet with earth/stone inclusions. There were no substantive archaeological finds.

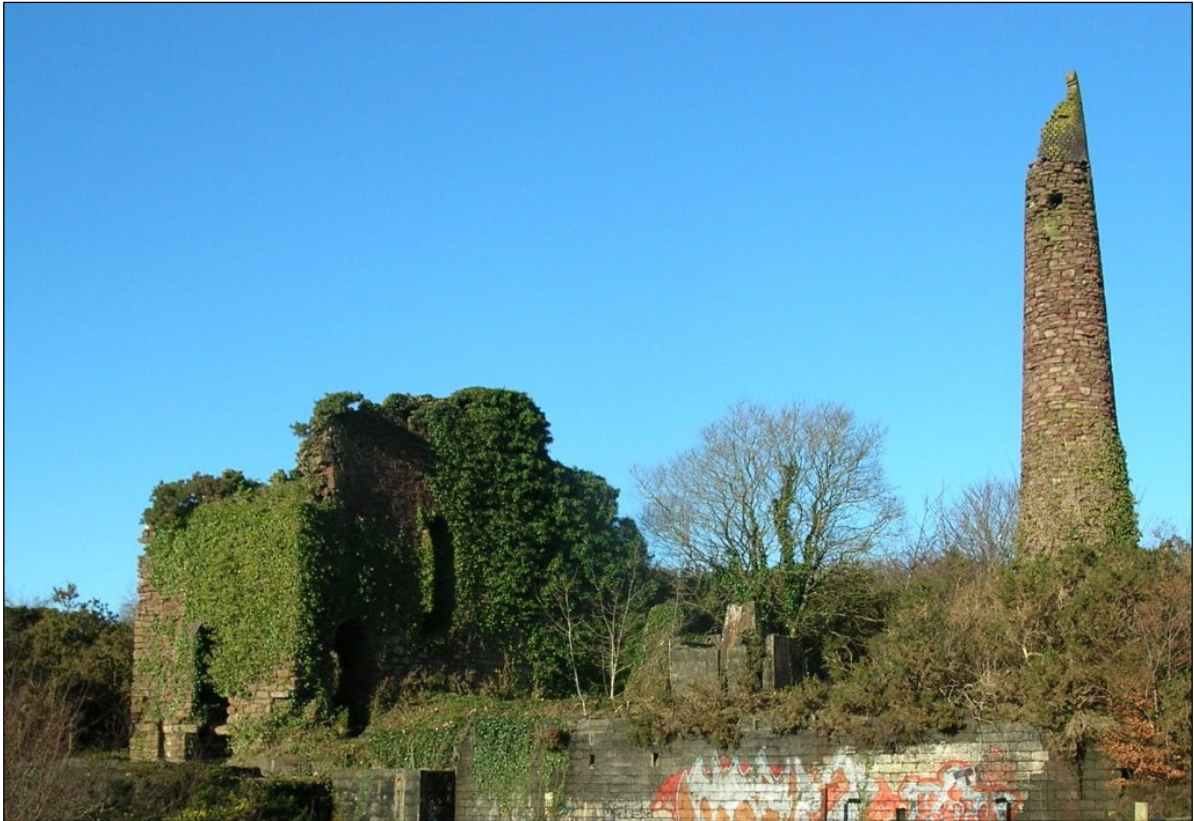
Fig 27 External view of the stamps engine house before works © CC HE Projects 2007

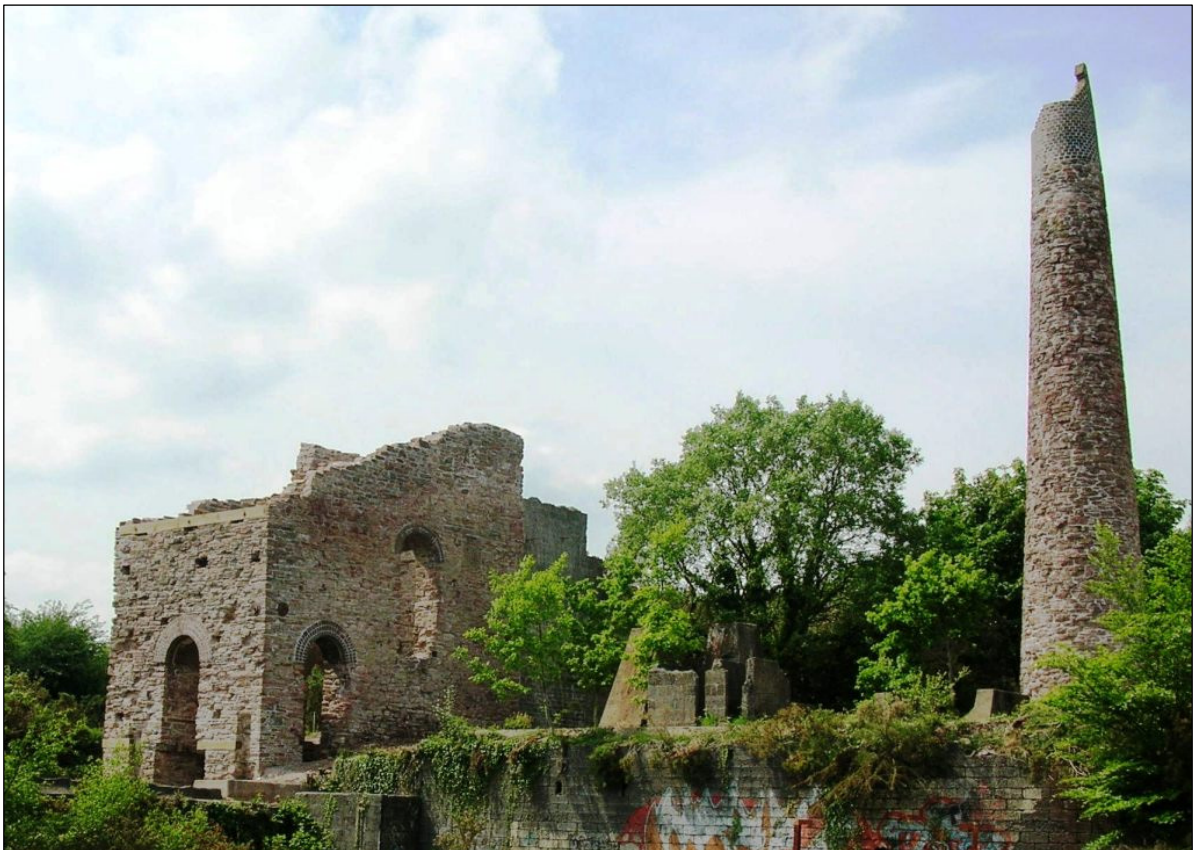
Fig 28 External view of the stamps engine house after works © CC HE Projects 2008

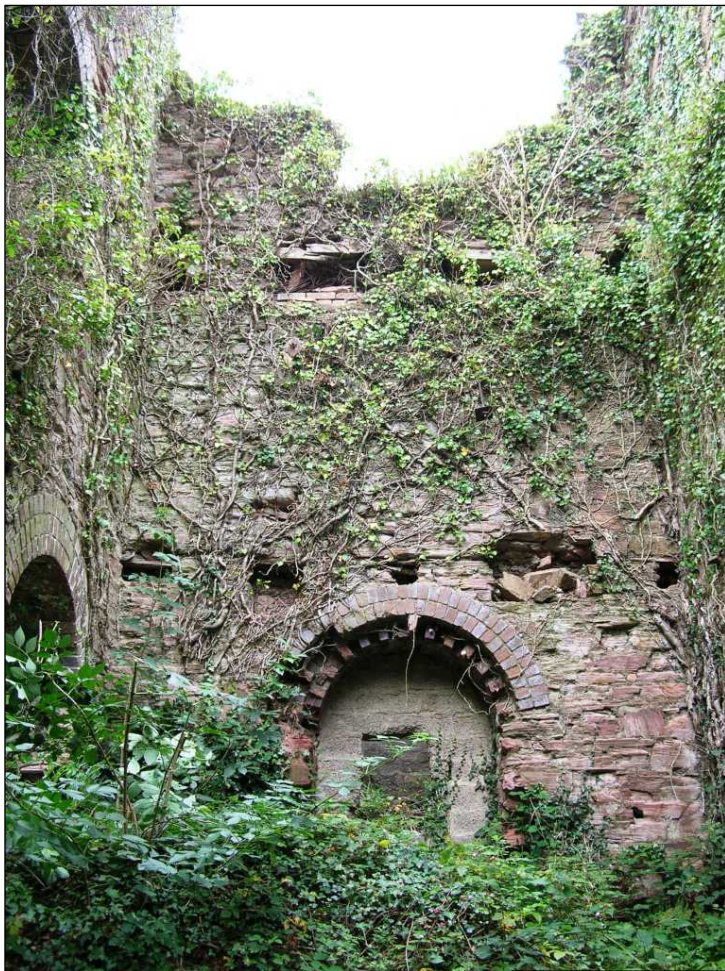
Fig 29 Internal view of the stamps engine house north (gable) wall before works © CC HE Projects 2007

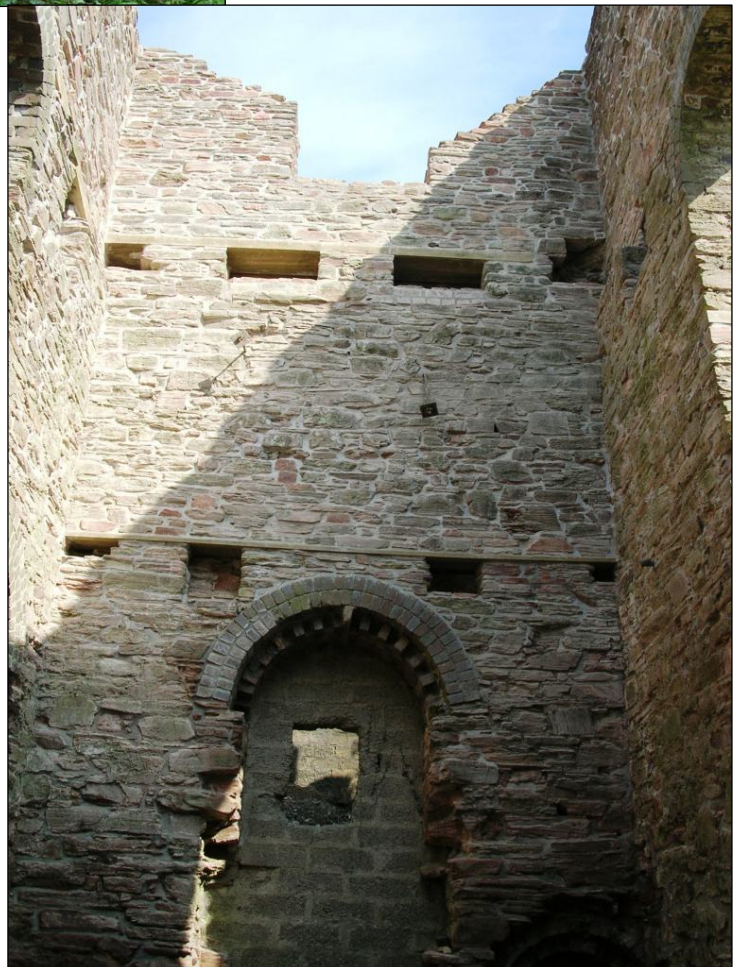
Fig 30 Internal view of the stamps engine house north (gable) wall after works © CC HE Projects 2008
