Kerris Cross, Paul, Cornwall

Conservation and repair

Client	English Heritage
Report Number	2011R105
Date	November 2011
Status	Final
Report author(s)	Ann Preston-Jones
Checked by	Andrew Young
Approved by	Andrew Young

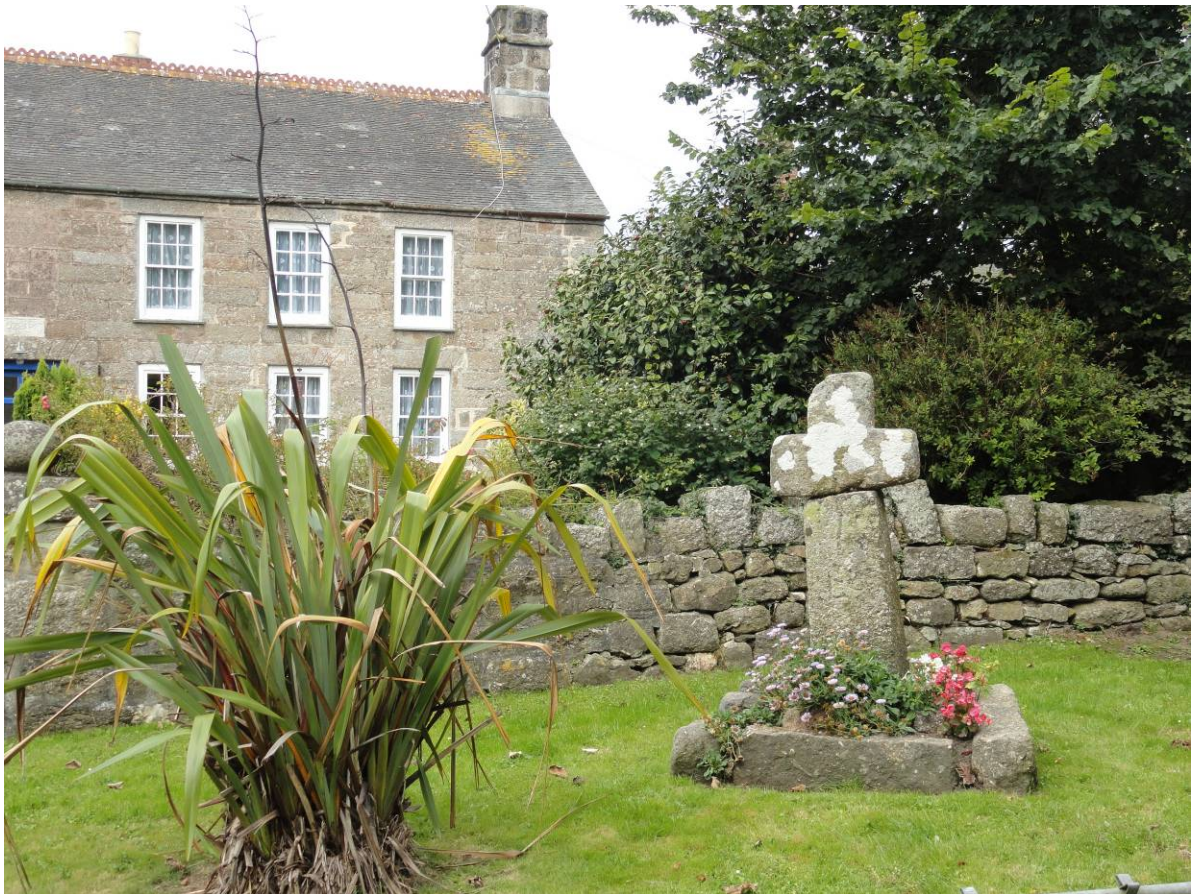
In early 2011, it was observed that in addition to this, the cross appeared to have been affected by recent freezing weather with associated frost heaving and was leaning to one side. (Figs 8 and 9)

Before this project began, the cross was leaning quite noticeably (see Figs 8 and 9). The tenant in the manor house, Alan Sunderland, said that this had happened over the last couple of years and he considered it to be the result of two very cold winters. The cross was straightened by simply digging down on the side away from which it was leaning, and gently pushing it upright from the opposite side (Fig 15). The resultant hole on the opposite side of the cross was then backfilled and finally the ground all around the cross was firmed, as far as possible, given that the 'base' is used as a flower bed.

Fig 8 The Kerris Cross before conservation

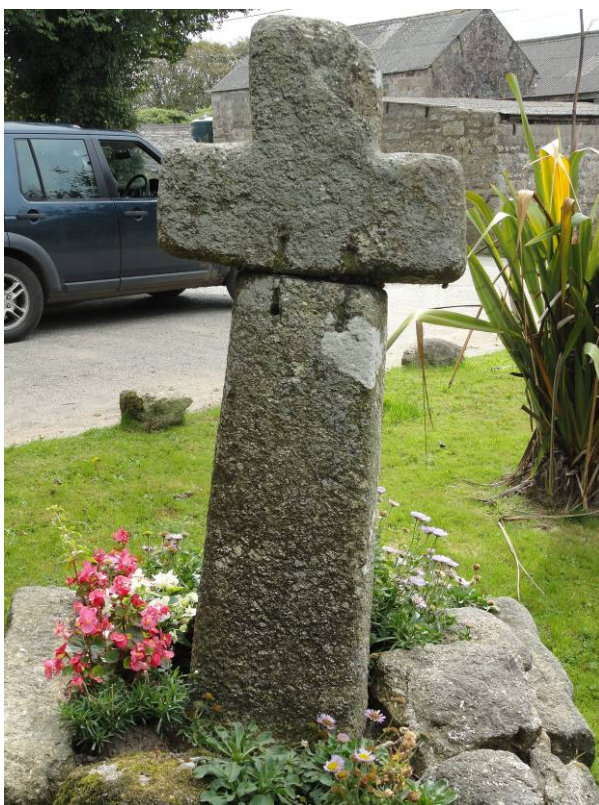
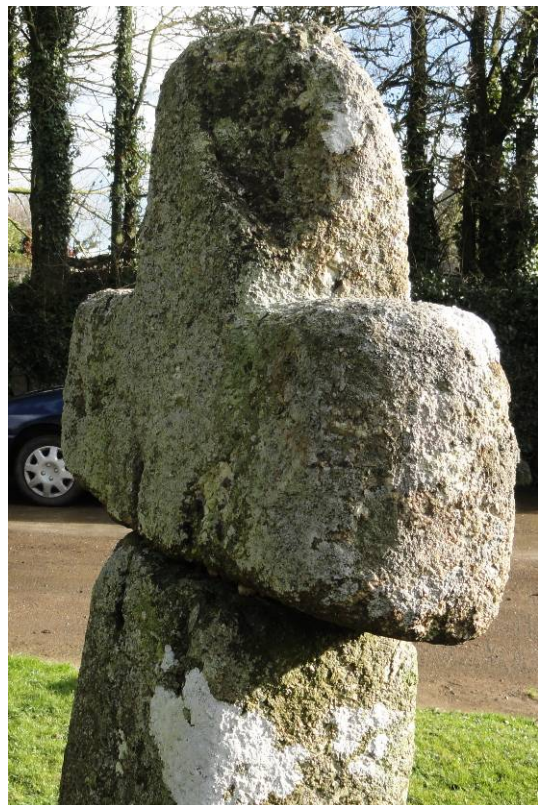
Fig 9 The Kerris Cross before conservation

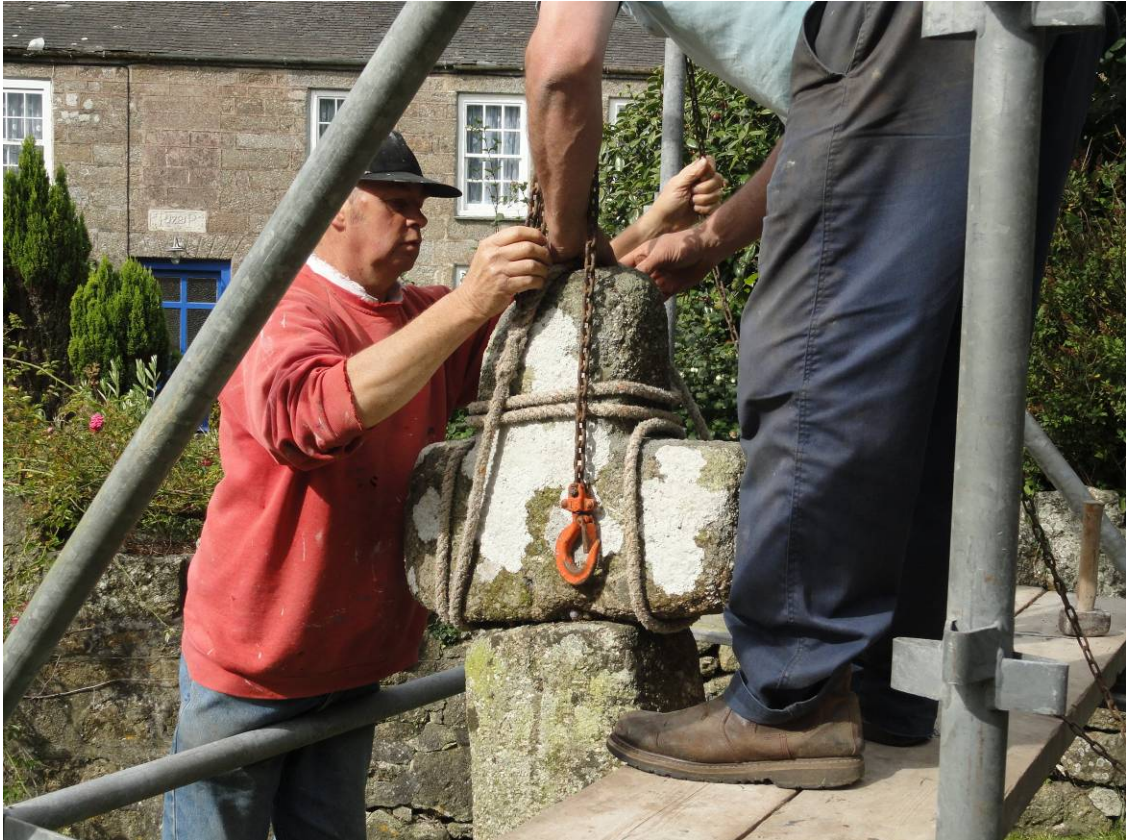
Fig 10 Removing the cross-head

1. Scaffolding was constructed around the cross
2. The cross-head was lifted off using a block and tackle (Fig 10)

Prior to work commencing, the head could be moved from right to left but it proved difficult to lift off vertically. This was eventually achieved by inserting wooden wedges all around the joint and gradually lifting with the block and tackle. This left the one-inch diameter pin protruding three inches from the shaft of the cross; it was found to have been leaded into the cross-head, but grouted into the shaft with a solid lime mortar. At the centre, where the pin had been exposed to water penetration through the joint, the pin had corroded to half its original diameter and was extremely weak (Fig 11). Hence, once efforts were made to remove it, it broke and had then to be painstakingly removed by chipping away at the mortar with a small chisel and fine dental tools, until eventually it could be pulled out with a mole wrench (Fig 12).

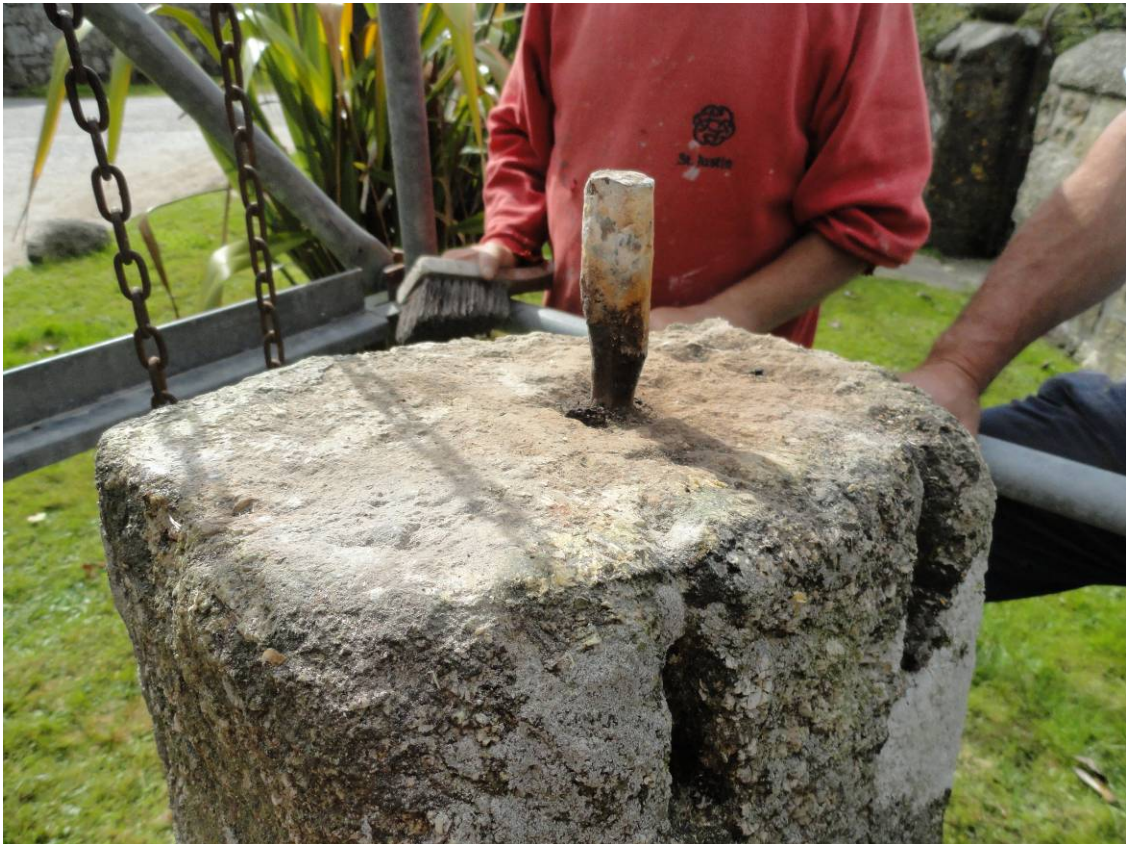
The work proved timely since it was found that the old iron pin, which was originally one inch (25mm) in diameter, had rusted to less than half an inch (12mm) at the centre where it was open to rainwater penetration through the joint. Moreover it was found that the original pin had been slightly too long for the holes that had been drilled for it, meaning that the head rocked slightly on the pin. This may explain why the staples had been added when the cross was restored in the 19th century.

In the course of undertaking this work it was discovered that the old iron pin was very weak and severely corroded at the centre, so that it broke once attempts were made to remove it. It is possible that if left it would eventually have rusted through and the cross-head might potentially have fallen. An additional problem discovered in the course of doing the work was that the original pin was a poor fit. The work could therefore be described as a stitch in time.

Fig 11 The iron pin, showing corrosion at the centre

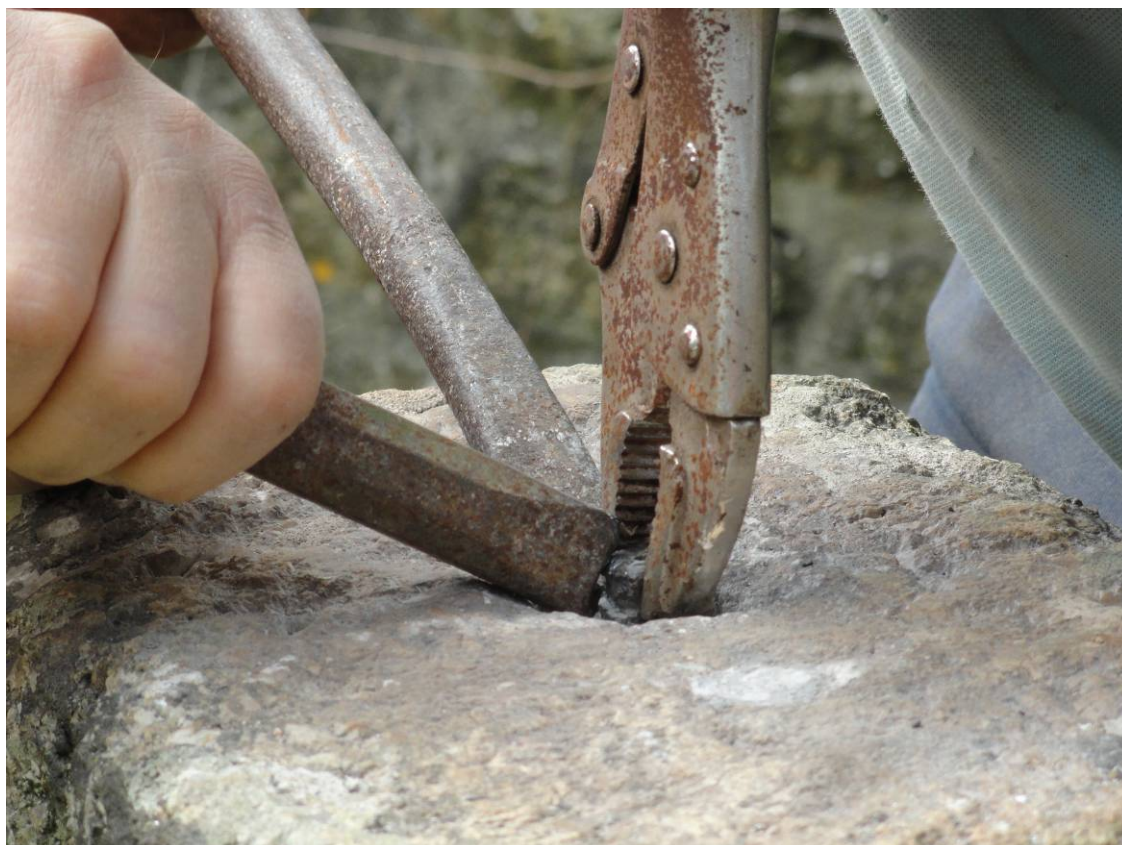
Fig 12 Removing the iron pin from the cross-shaft

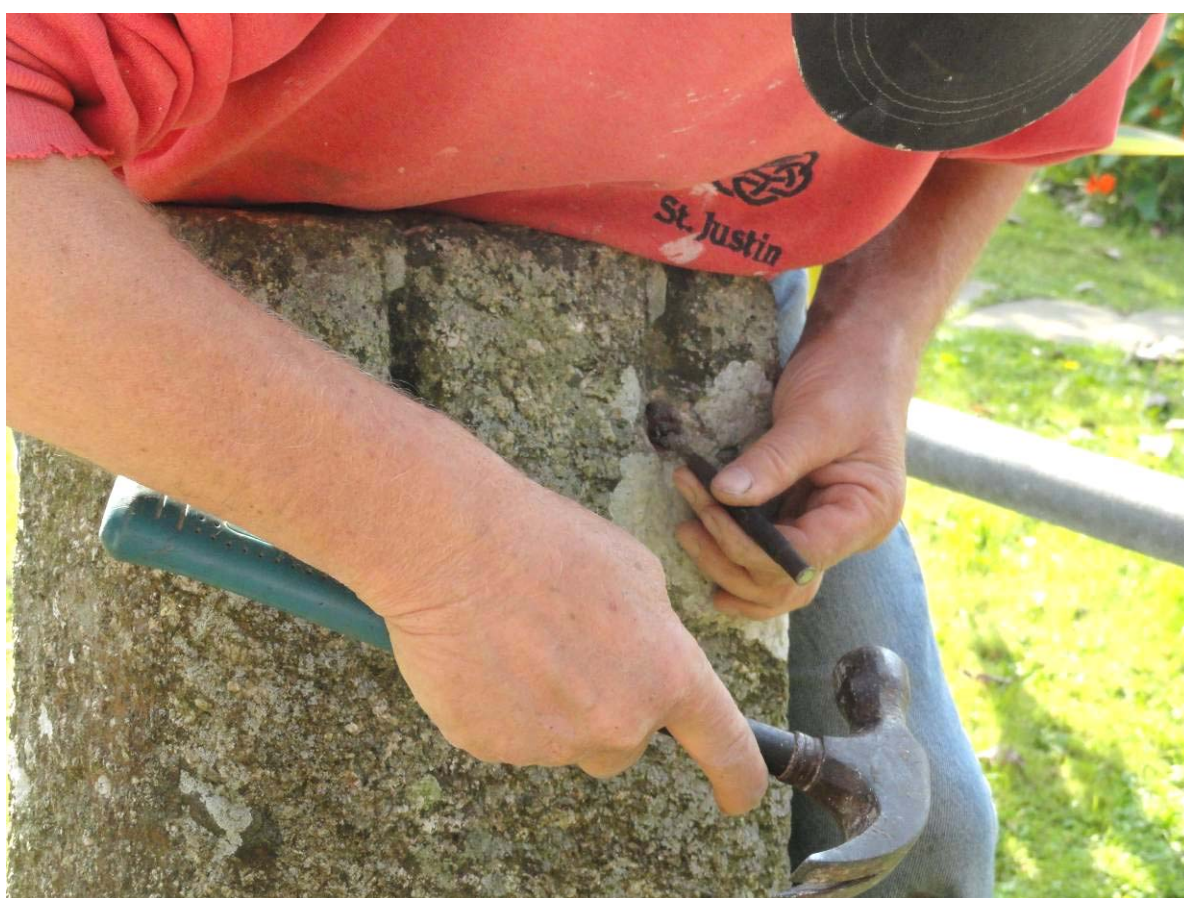
Although they had broken off or been removed decades earlier, the stub ends of the iron staples, which had been used to help hold the cross-head to the shaft, remained buried in the stone, embedded in lead. The staples were made of rectangular iron bar fixed in place with lead and iron feathers.

Fig 13 Removing the stub-ends of the staples

All ironwork was removed by carefully chipping out the lead with a small chisel and fine dental tools (Fig 13).

After the staples had been removed, the holes were filled with the same hydraulic lime mortar as the joint.

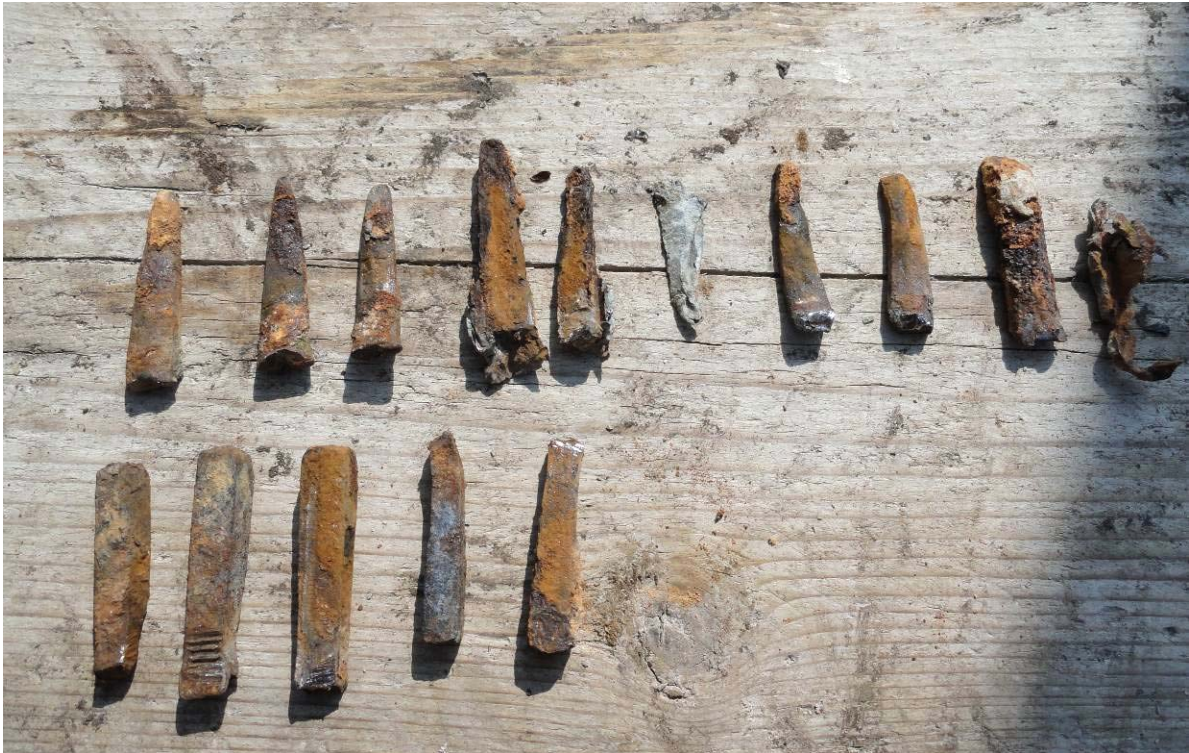
Fig 14 The ironwork removed from the cross: the broken pin, the remains of the staples, and the feathers used to hold the staples in place

All the ironwork that was removed from the cross is shown in Fig 14.

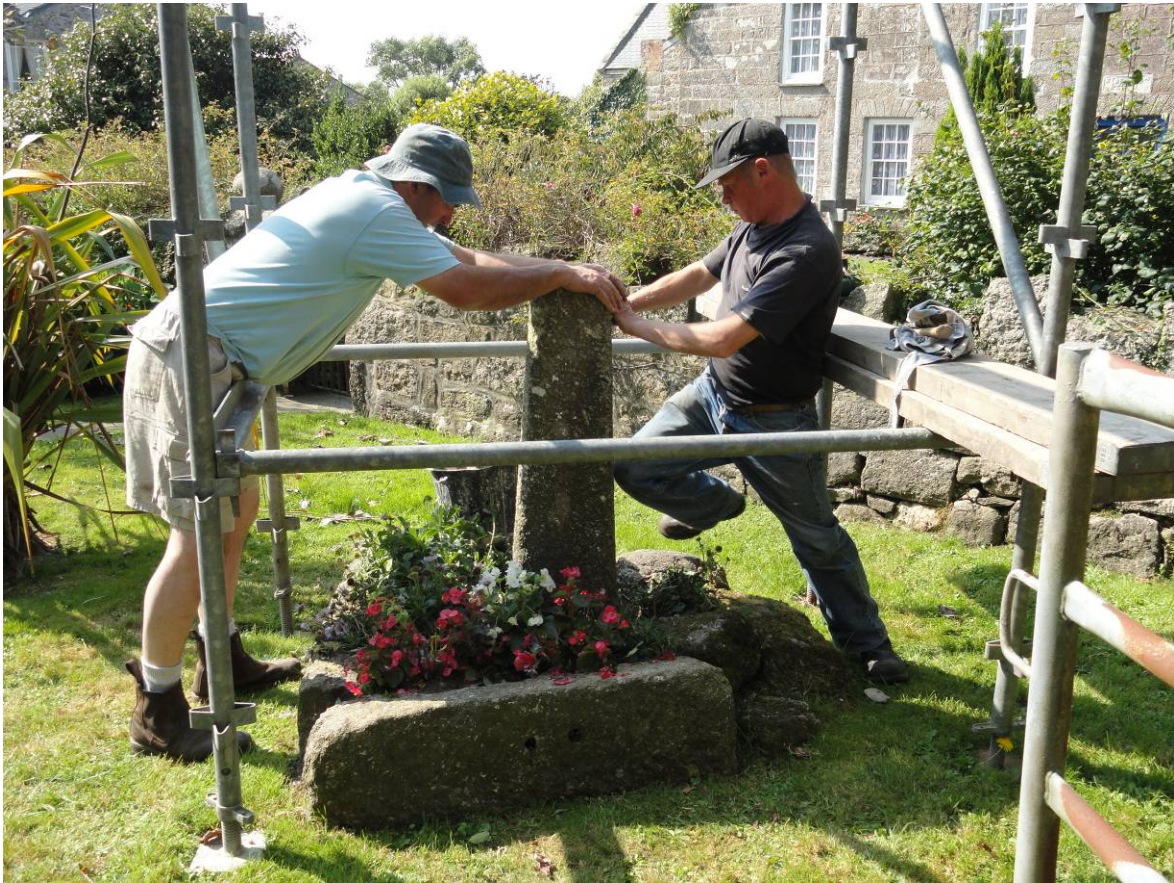
Fig 15 Straightening the cross-shaft

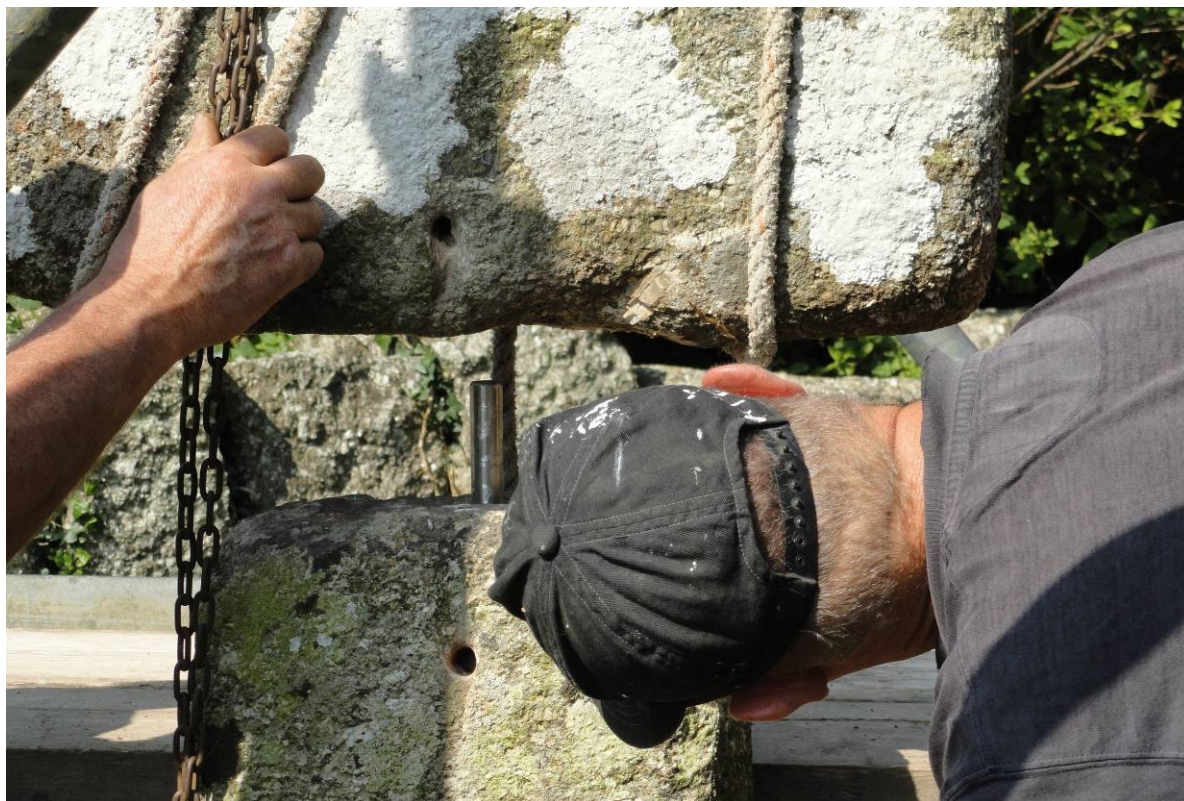
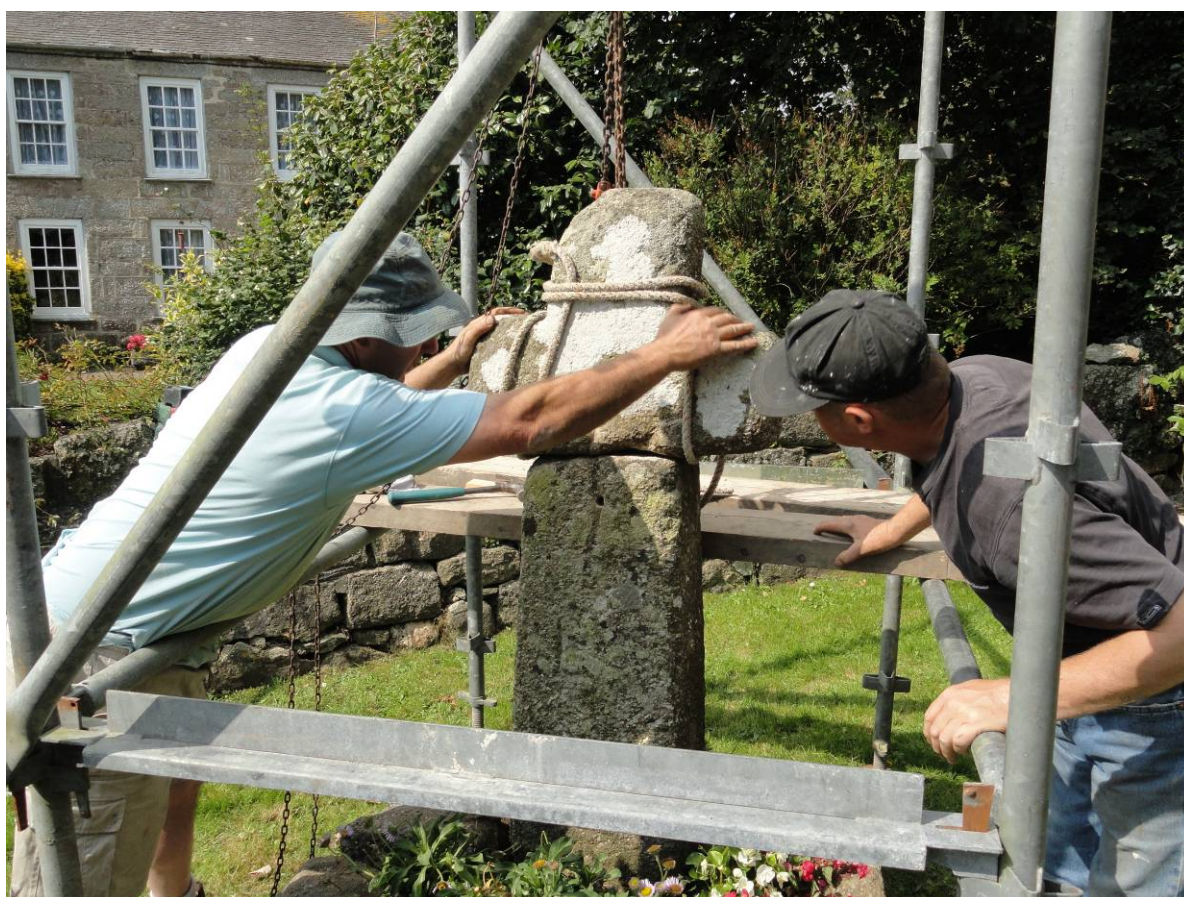
Fig 16 Lowering the cross-head onto the new pin

8. The dowel hole in the shaft was filled with polyester resin
9. Using the block and tackle, the cross head was carefully lowered onto the shaft and the resin left to fully set (Fig 16)

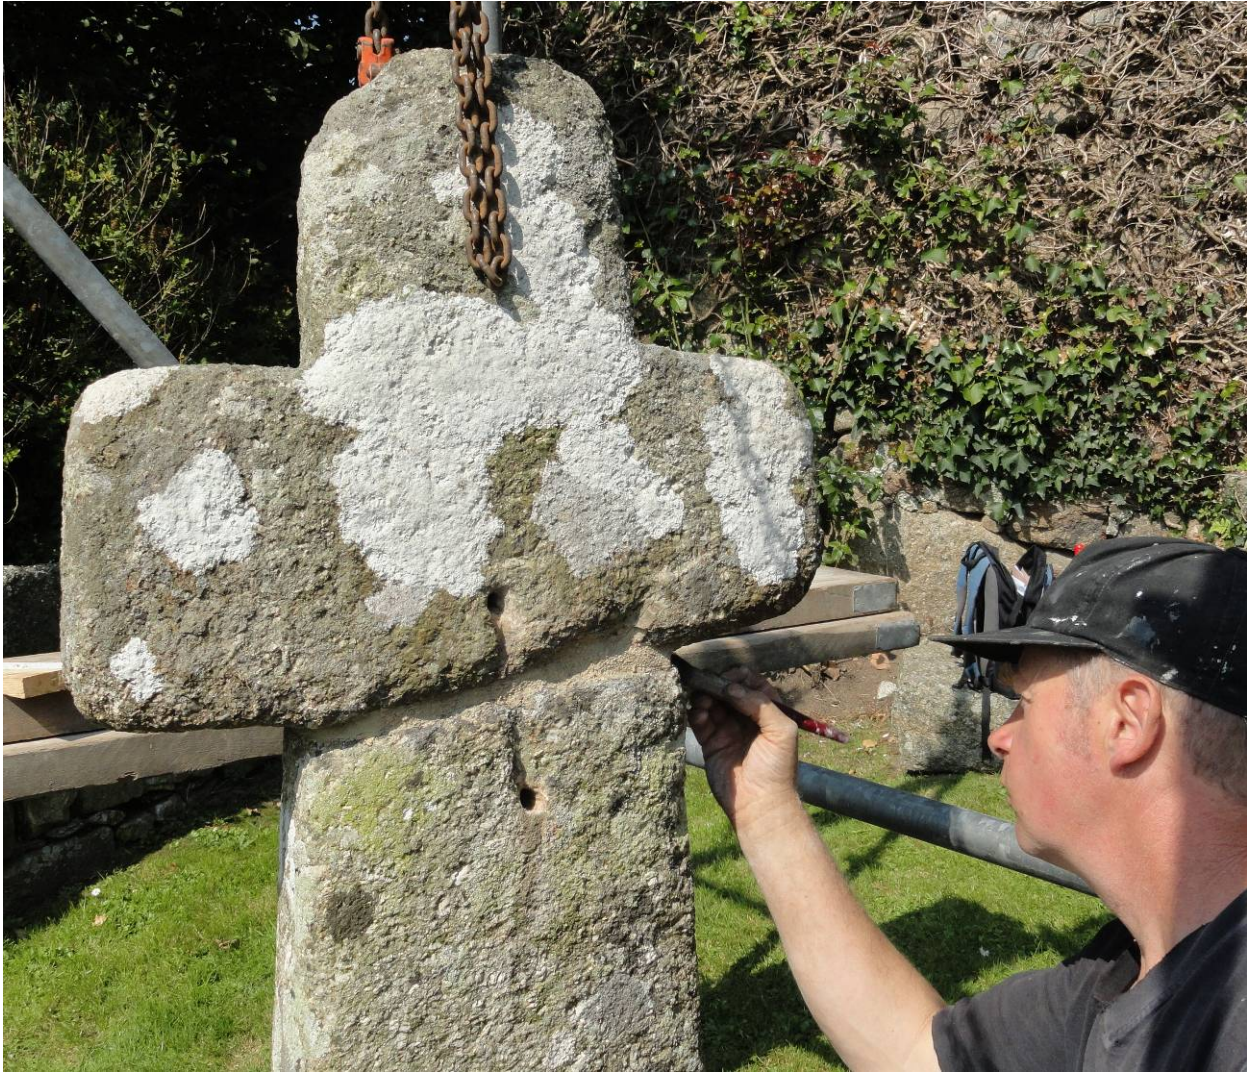
The original intention had been to leave the joint unmortared, so as to keep the appearance of the cross as unchanged as possible (even though it would originally have been mortared). However it was discovered that the break between the head and shaft is not even, and that they therefore do not fit neatly together; the bottom of the head being particularly uneven.

The reason for this is uncertain but may be explained by the fact that the head and shaft had been separated for some time prior to restoration, allowing time for the broken faces of both to be eroded and damaged. It was therefore necessary to mortar the joint to provide support for the head and reduce pressure on the pin and resin.

Fig 17 Mortaring the joint between the cross-head and -shaft

10. Finally, the joint was mortared, using a hydraulic lime mortar kept well back from the face of the stone (Fig 17) The mortar used was hydraulic lime (NHL 2.5) in a 2:5 mix with sand (CLS 25)

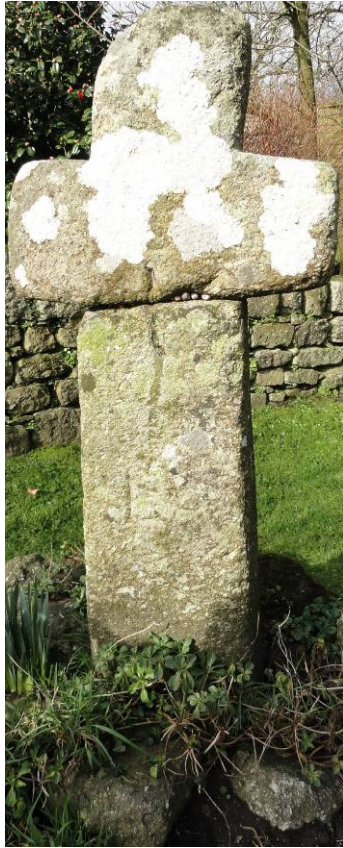
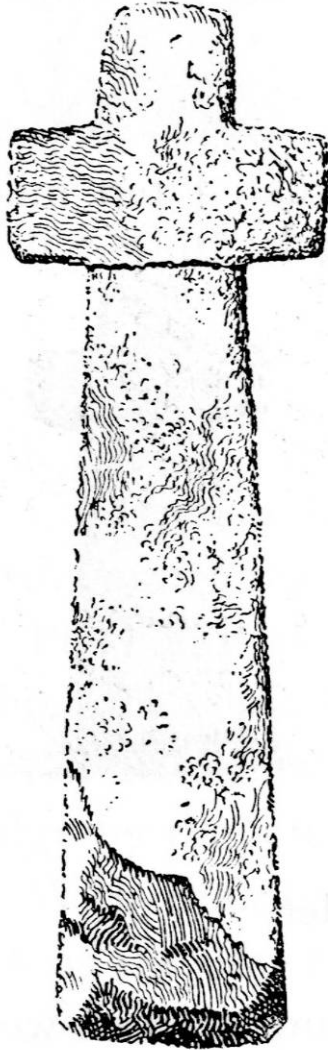
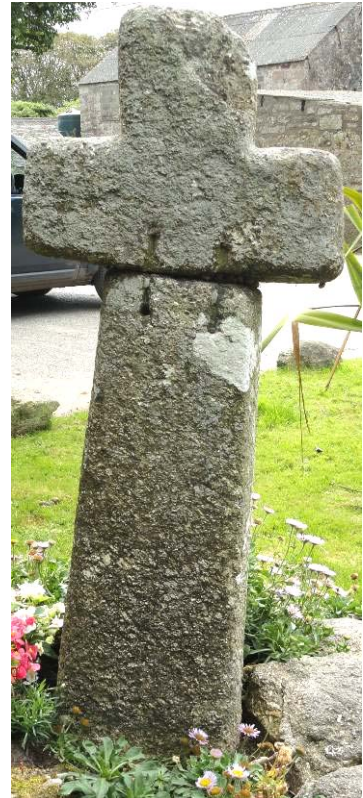
Fig 18 Full and present heights of the Kerris Cross

As a result of research undertaken for this project it was revealed that a quite large proportion of the cross is buried in the ground (Fig 18). Therefore, although it is an undoubtedly attractive and interesting feature as it stands, it is far less impressive than it would have been originally.

An aspiration for the future would be to remove the cross from the flower bed in which it currently stands and set it in a morticed granite base. This would enable a far

greater proportion of its height to be displayed, would give it much greater stature and presence than it now has and would return it to something more like its original appearance.

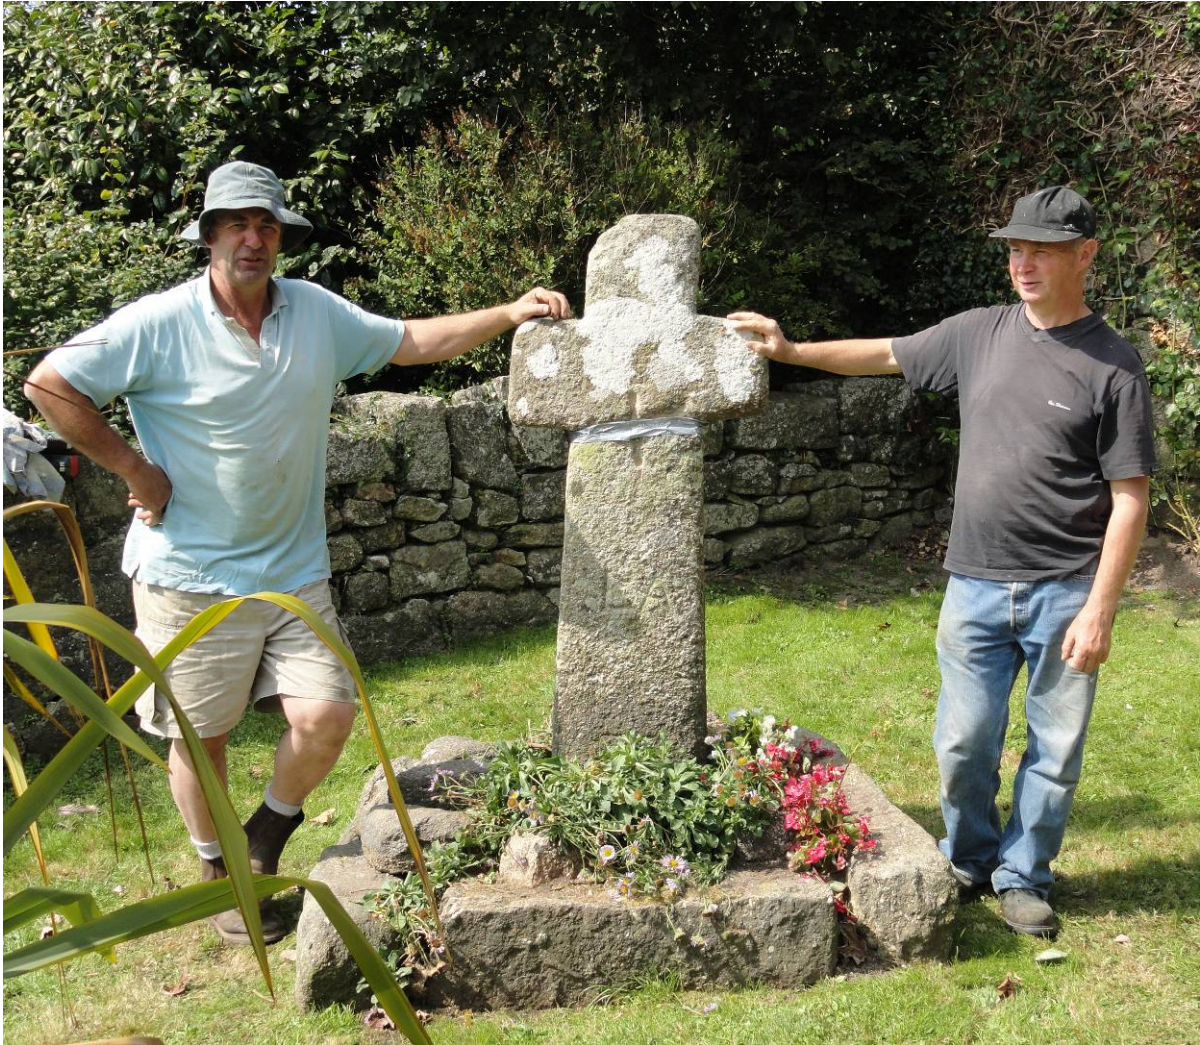
As a result of the work described in this report, the risk to the cross has been reduced from high to low risk and, barring unanticipated incidents, should be safe for many years to come (Fig 19).

Fig 19 The conserved cross
