# Cross Gates Cross, St Clether, Cornwall

## Repair and restoration

December 2007

Report No: 2007R091

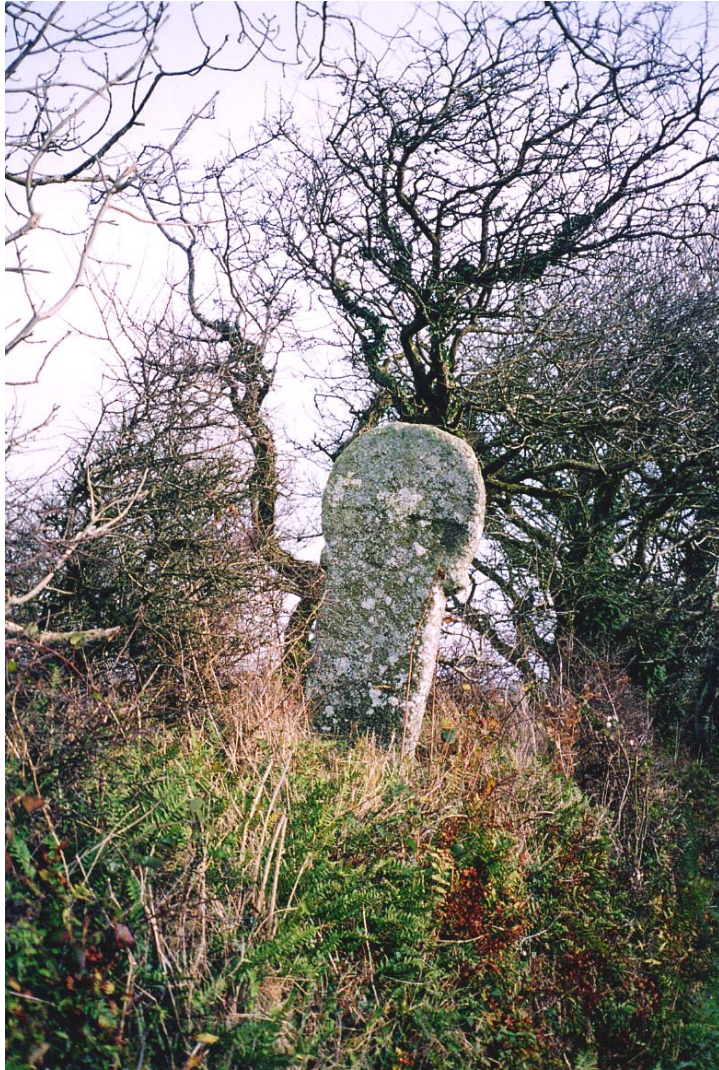
Ever since it has been recorded the cross has, as noted above, been set into the top of a hedge at SX 18869 84077. More recently, it had been partly hidden by a healthy growth of shrubs and weeds. And ever since it was first Scheduled (possibly in the 1930s), the fact that it leans slightly outwards from the hedge has been noted. See Figure 7.

*Fig 7 The Cross Gates Cross before the accident which damaged it*

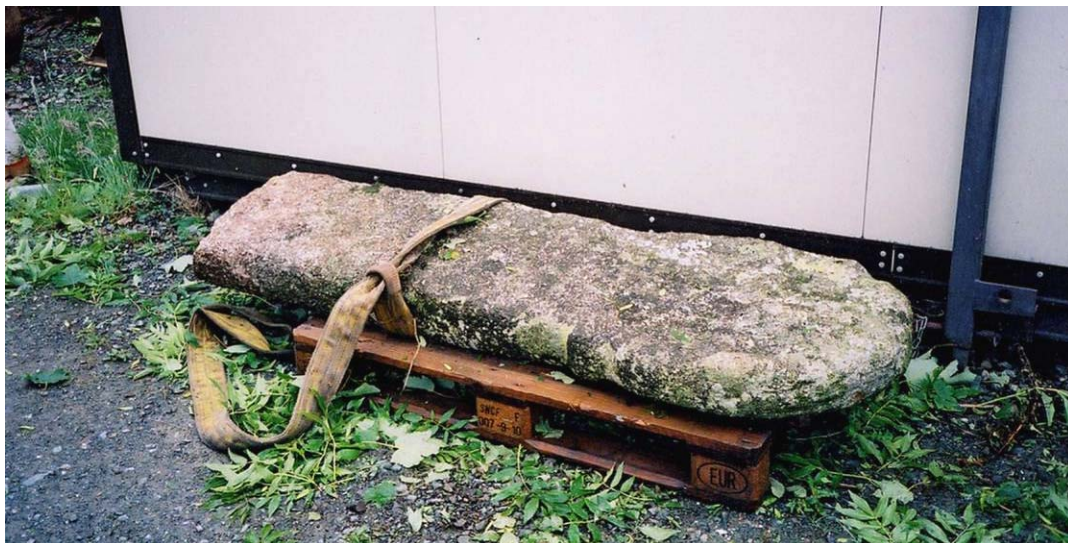
On June 17<sup>th</sup> 2004, it was discovered that the cross had been broken in two. The upper part of the cross was found lying in the road by Mr Parnell of Tregulland, St Clether, the owner of the land adjoining and therefore owner of the cross. It was rescued soon after by Mr Ham of nearby Treboy Farm, and taken back to his yard where it was stored safely on a wooden pallet (Fig 8). For the time being, the lower part of the shaft remained buried in the hedge, with a sliver of fresh granite visible to mark its position. Other than the break across the cross-shaft, there appeared to have been no other significant damage, either to the cross or to the hedge in which it was located. Fortunately, the break was a clean one, and at the time it was predicted that it should be relatively easy to repair. *How little did we know!*

*Fig 8 The cross head and shaft at Treboy Farm*

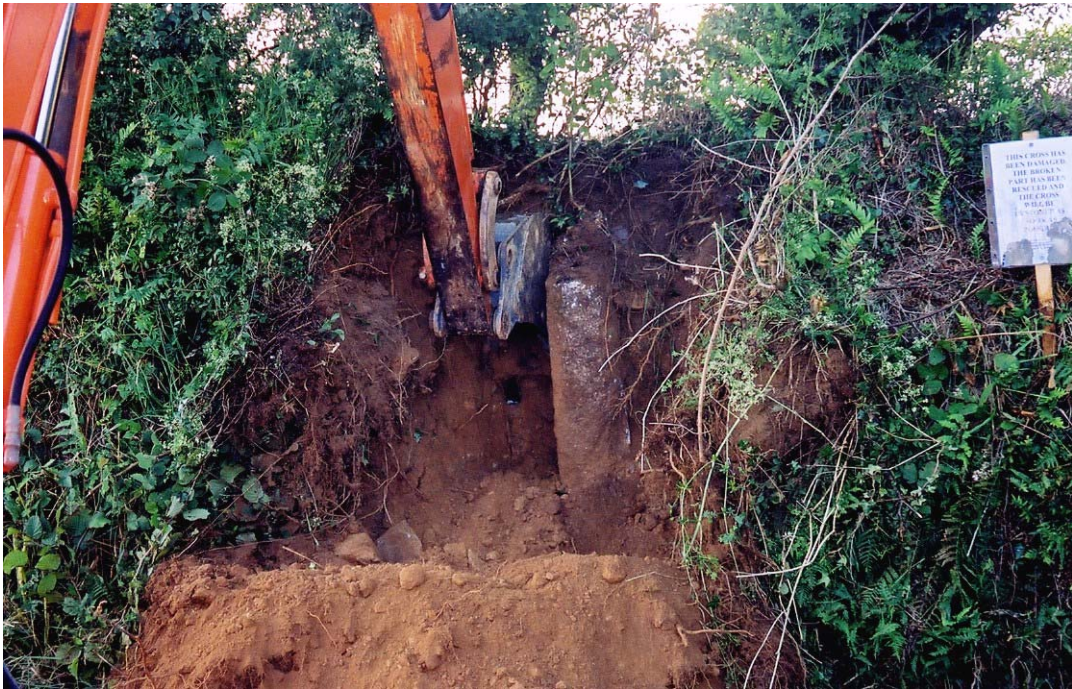
We had envisaged that the excavation of the shaft would involve simply plucking a length of perhaps 0.6 metres from the hedge, with the need for little if any excavation. It was not expected that the cross was *in situ*: rather we thought that the cross had been placed in the hedge when the latter was built, at some time between 1840 and 1880. In the event, we discovered that the cross had actually been *in situ*, with the shaft still set into its large slate base, the base set within the hedge some 0.4 metres above the present level of the road.

*Fig 9 Rescuing the shaft from the hedge: the shaft can be seen in the hedge at the centre of the picture*

Removal of both shaft and base therefore involved a fairly substantial excavation of the hedge bank. The shaft was removed first by Mr Ham's mini excavator, and the base then lifted out by Mr Parnell's tractor, with a fork-lift mounted on the front.

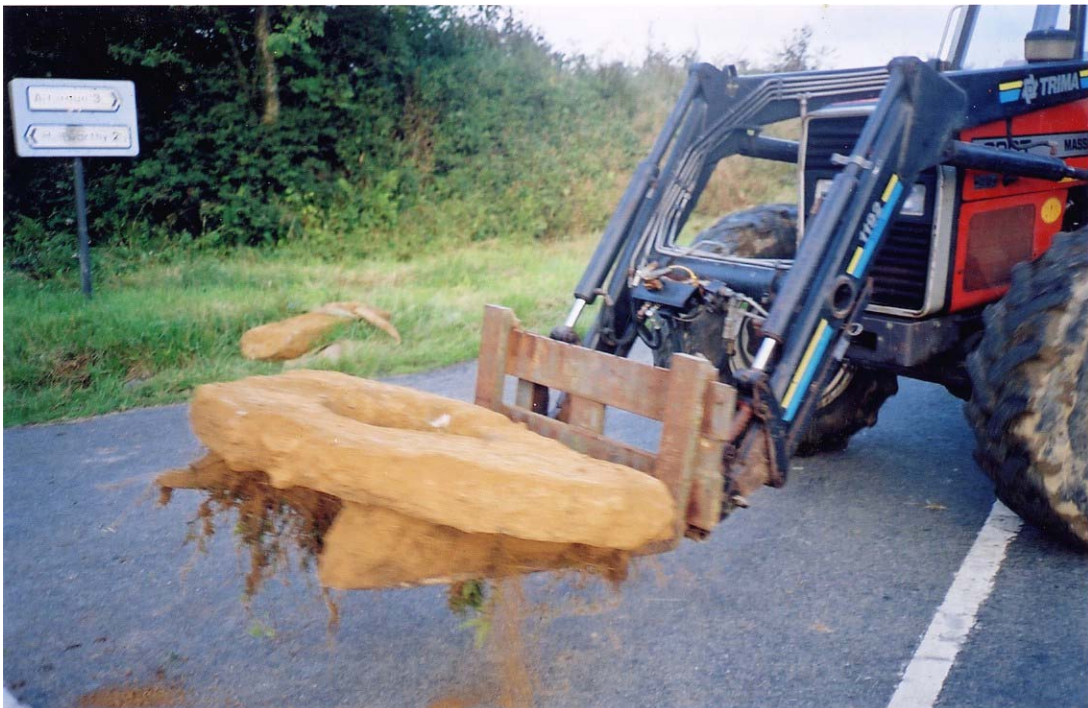
The slate cross-base found within the hedge was not level, but angled out slightly towards the road, exactly as the cross had been. It is assumed that this lean reflects the angle of the cross before the hedge was built up to it, for after this time the hedge would have acted as a buttress, supporting the cross. The base was found to be neatly bedded on a thin layer of light coloured, mottled clay (white/pink/yellow), and showing as a shiny and smooth surface when the base was removed. This was in turn laid on a layer of small stones with larger stones beneath, altogether about 15 cm thick. This bed was not disturbed, but was re-buried within the hedge, with a few coins thrown in to date the removal of the monument. No evidence was found to date the base: it is assumed that the cross was in its original medieval location, but this cannot be proved in any way, and it is quite possible that this represents a secondary location.

*Fig 10 Removing the base from the hedge*

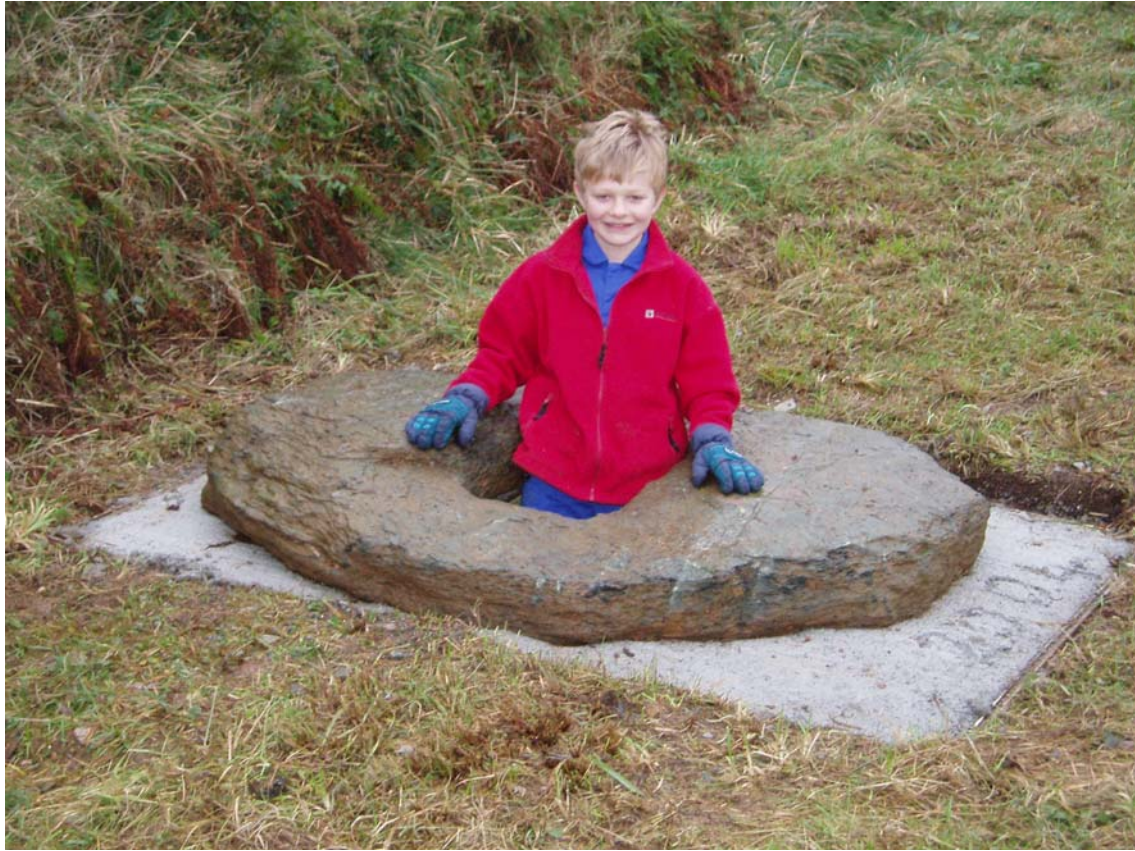
*Fig 11 The original base, restored on a new concrete foundation*

Although there was no question of doing anything other than using the original base in the restoration of the cross, there was a real problem regarding its size. Although the six inch thick slab of slate had been deemed adequate for the task of supporting the ten foot high cross by the medieval masons who first set it up, we did not have quite such confidence, given modern Health and Safety considerations. It was therefore decided that the old base should be supplemented with a substantial concrete footing, to give the cross a greater depth of support.

Initially, turf was lifted from the area to be occupied by the new base; this was reserved for re-turfing and making good around the edge of the base later on. A vertical-sided hole, 4ft x 6ft and 9in (1.2 x 1.85 x 0.23 metre) deep was cut into the verge and a wooden shuttering built all around the edge. After carefully measuring the old base and working out how this would sit on the concrete foundation, the position of the mortise was also shuttered, and a 1:4 concrete mix poured in to create the foundation, leaving a 14 x 21in (0.36 x 0.53 metre) hole near the centre, for the mortise. Using a telescopic handler operated by Mr Ham, the cross-base was then slid onto the concrete base before the concrete had set, taking care to ensure that the mortise in the cross base fitted exactly over the mortise in the foundation. The whole thing was then left to set.

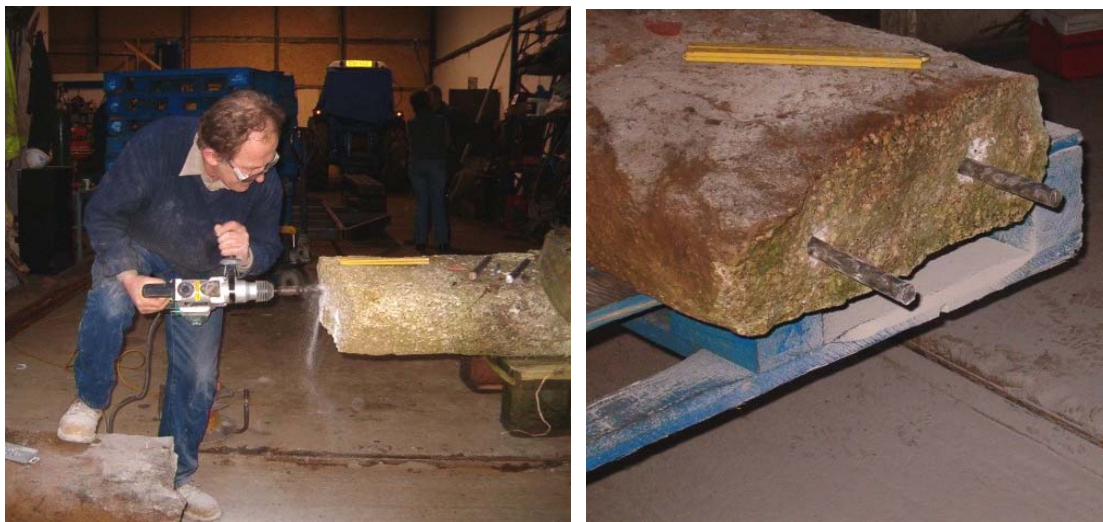
*Fig 12 Ernie Hillson drilling and pinning the cross, and to the right, the stainless steel pins in position*

1. Monday December 13<sup>th</sup>, 2004. At Trebov Farm, Ernie Hillson drilled and pinned the two portions of the cross, with the cross in a horizontal position. Two 10 inch (0.25 metre) long, three quarter inch diameter (2 cm) stainless steel pins were used, the pins being set into 1 inch diameter, 5 inch deep holes (25 x 12 cm) and the two halves of the cross joined with a polyester stone glue. Mr Ham assisted by manoeuvring the cross into position with a forklift truck (Fig 11). Because the break had been a clean one, the joint achieved was nearly perfect.

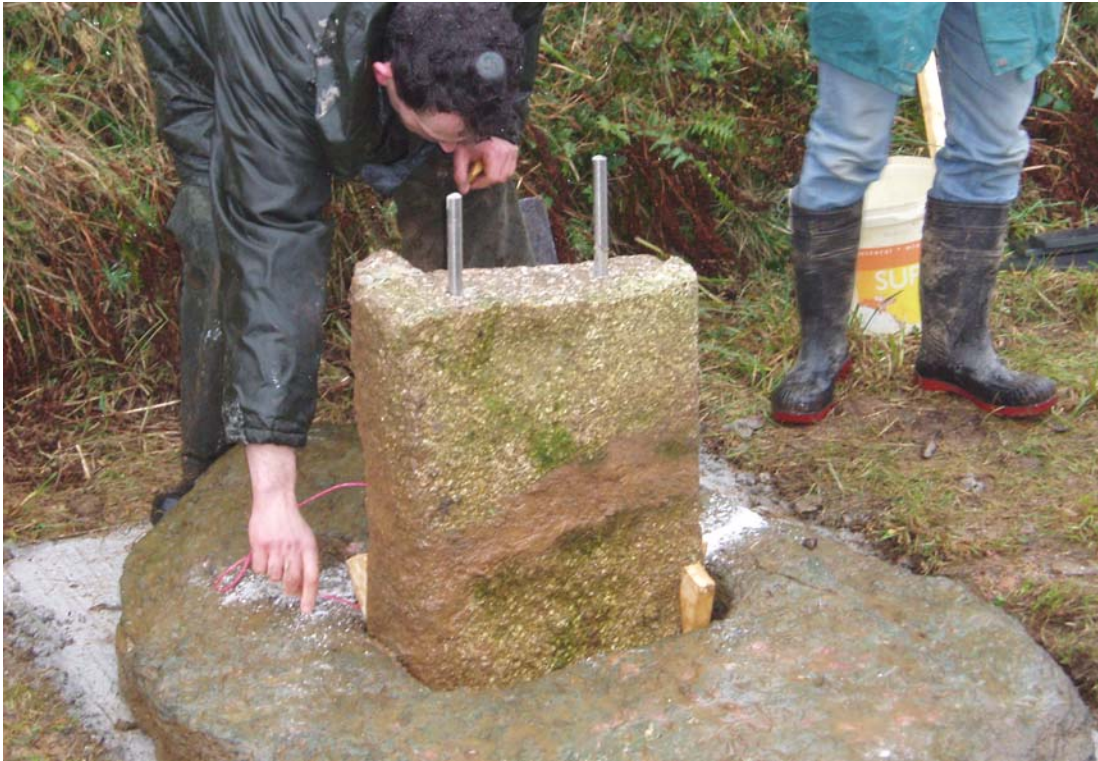
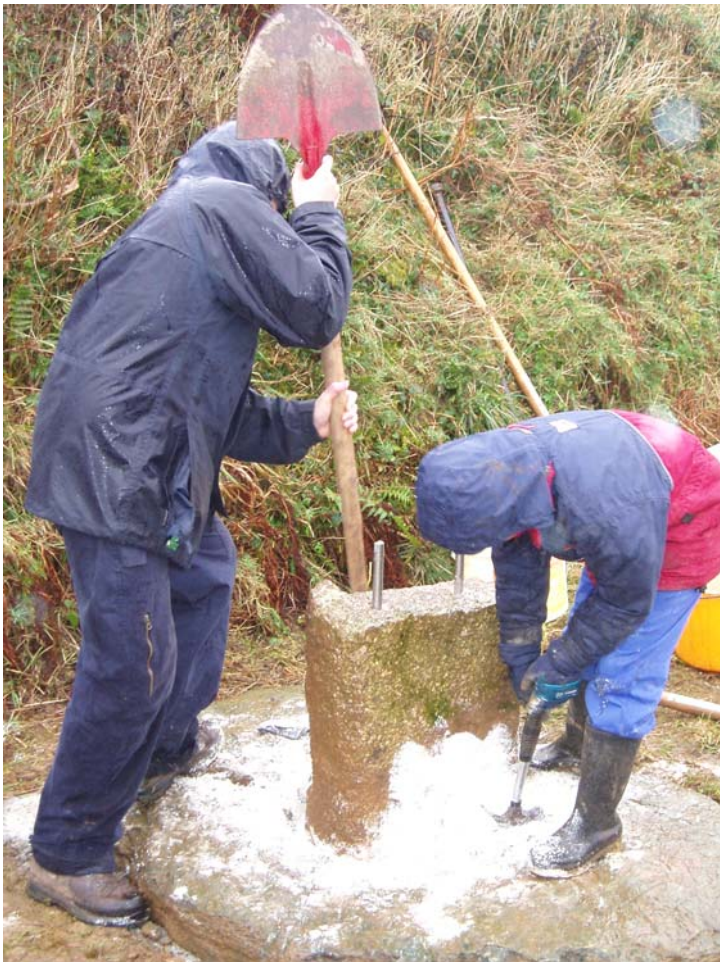
*Fig 13 The restoration of the lower part of the shaft: : above, the shaft (note the stainless steel pins) is put into place and below, the shaft is mortared into the base by Reuben Butts and Tommy Rose-Jones*

2. Saturday 18<sup>th</sup> December. An attempt was made to re-erect the cross, but as soon as lifting started the new joint began to separate and it was obvious that the entire cross could not be lifted in one go. So an alternative strategy, rapidly devised, was then attempted. The plan this time was to secure the bottom part of the shaft in place in the base and then to lift the upper part onto this, securing the joint with fresh glue. However, because the weather became increasingly wet as the morning progressed, only the bottom part of the shaft was put into place and the top part left for a better day. The lower part of the shaft was secured into the base with a

mortar consisting of hydrated lime and Cornish sand. It was orientated so that the cross head once restored would face in the same direction as the original. (Fig 12).

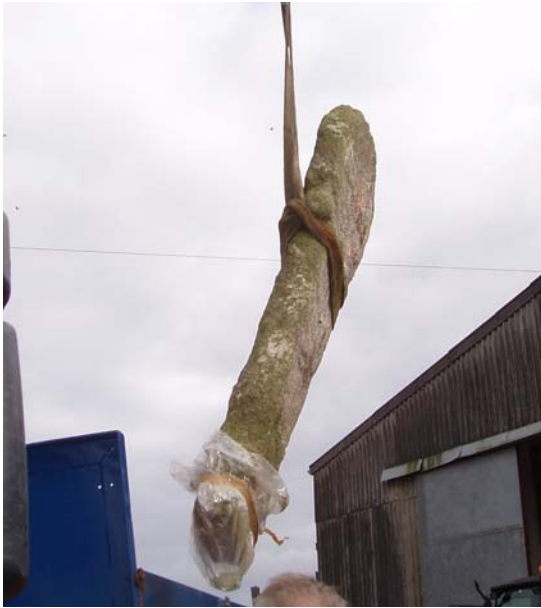
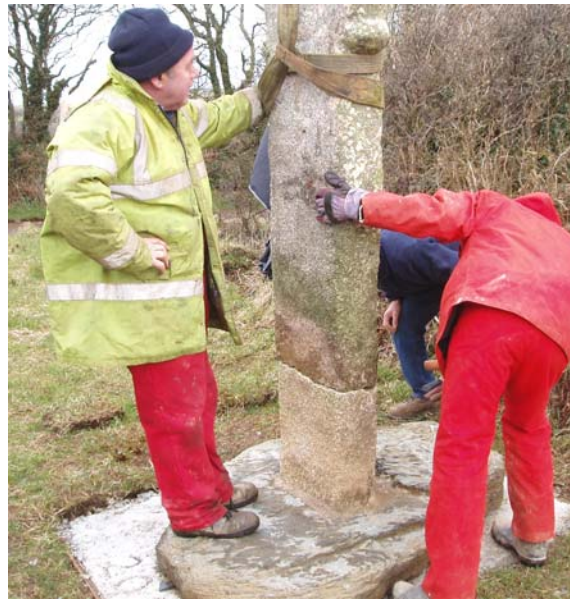
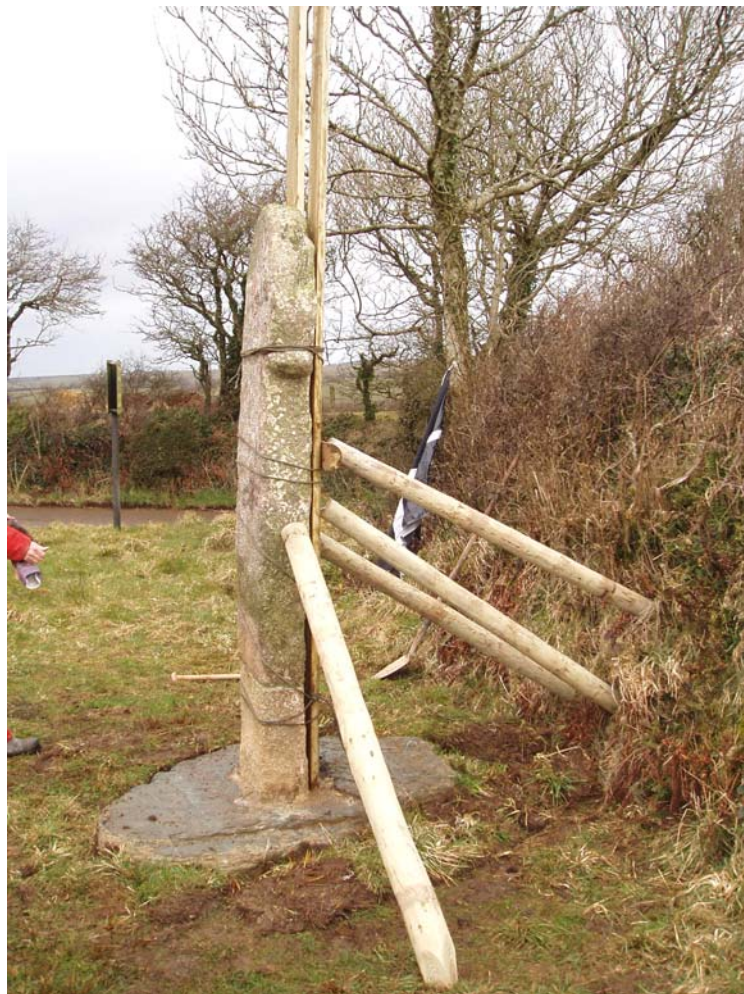
5. Several days later, Mr and Mrs Ham confirmed that glue had gone off and that the cross seemed solid. But for security, it was decided to leave the bracing in position for the time being as there remained considerable concern over what we knew to be a poor joint, low down, at the narrowest part of the top-heavy shaft. We felt that some form of additional support was needed to secure this joint.

*Fig 14 The restoration of the upper part of the cross.: above left, lifting the cross onto the lorry to take it to the site; above right, the two halves of the cross united and below, the restored cross, braced to prevent the new joint from moving in the wind.*

3. Saturday 8<sup>th</sup> January 2005. Proposed date for restoration of top half of cross is postponed due to very windy weather.
4. Saturday March 6<sup>th</sup> 2005. A second attempt was made to restore the top part of the cross. The weather was a problem, a fresh and blustery wind sweeping down from Davidstow Moor; but far worse was the fact that once the cross was lifted into position by Mr Ham's Hiab, and an attempt made to unite the two halves, they did not fit perfectly, necessitating more and more glue to try to achieve union. Moreover, in the cool conditions, the stone glue was extremely slow to go off, so it dripped out of the joint and down the shaft leaving gaping holes in the joint, and because it was not fully secured, the cross head could be seen swaying in the wind! This problem was exacerbated by the fact that the mortar in the base had not gone off, and was so soft that it could be scraped out with a finger. So to secure the cross while the glue slowly set, an effective wooden bracing was constructed by Mr Ham from fencing materials (Fig 13).

7. Friday 24<sup>th</sup> June. After much discussion on the best method of securing the joint, it was decided to put a threaded stainless steel bar right through the cross shaft both above and below the joint and to bolt these in place with a steel bar on front and back of the cross. Using a portable generator to provide power, the holes were drilled and steelwork put in place, to make the joint absolutely rigid. Though undoubtedly effective, the metal work looked conspicuously bright and shiny, and the ends of the bolts were left protruding beyond the steel bars and nuts.

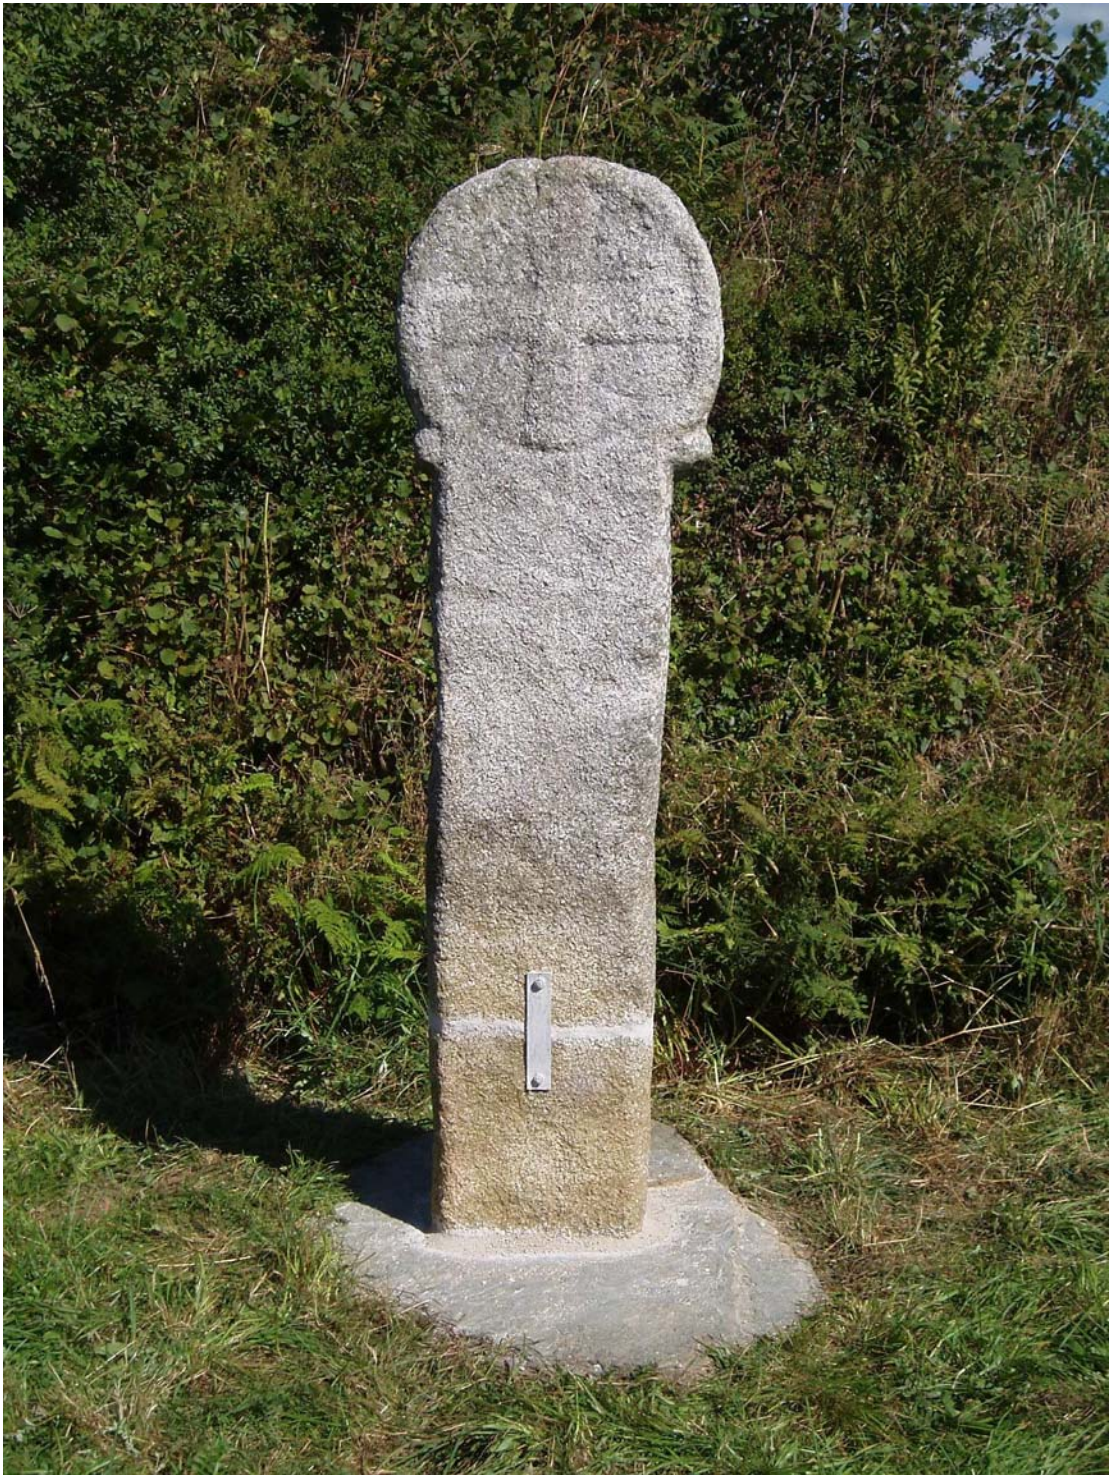
As a result of all this work, the cross which was formerly 1.5m high, now stands an impressive 2.24 metres above ground level, with another 0.73 metres buried below ground level in the restored base (Fig 14).

*Fig 15 The Cross Gates Cross restored*

8. Thursday 1<sup>st</sup> September. A final return was made to carry out aesthetic touches: to remove the drops of glue, cut the protruding ends from bolts, mortar the joint, remove and replace mortar in the top of the joint into the base, and smear mortar over the brackets to make them less conspicuous. Finally, the mortar was covered with mud to help tone it down.
