# St. Helen's Oratory, Cape Cornwall

## Archaeological recording during repair works

<b>Client</b>	<b>LUDU, Cornwall Council and The National Trust</b>
<b>Report Number</b>	<b>2010R153</b>
<b>Date</b>	<b>26 January 2011</b>
<b>Status</b>	<b>Final</b>
<b>Report author(s)</b>	<b>Adam Sharpe BA MIfA</b>
<b>Checked by</b>	<b>Peter Rose, Projects Manager, Ann Preston Jones</b>
<b>Approved by</b>	<b>Peter Rose, Projects Manager</b>

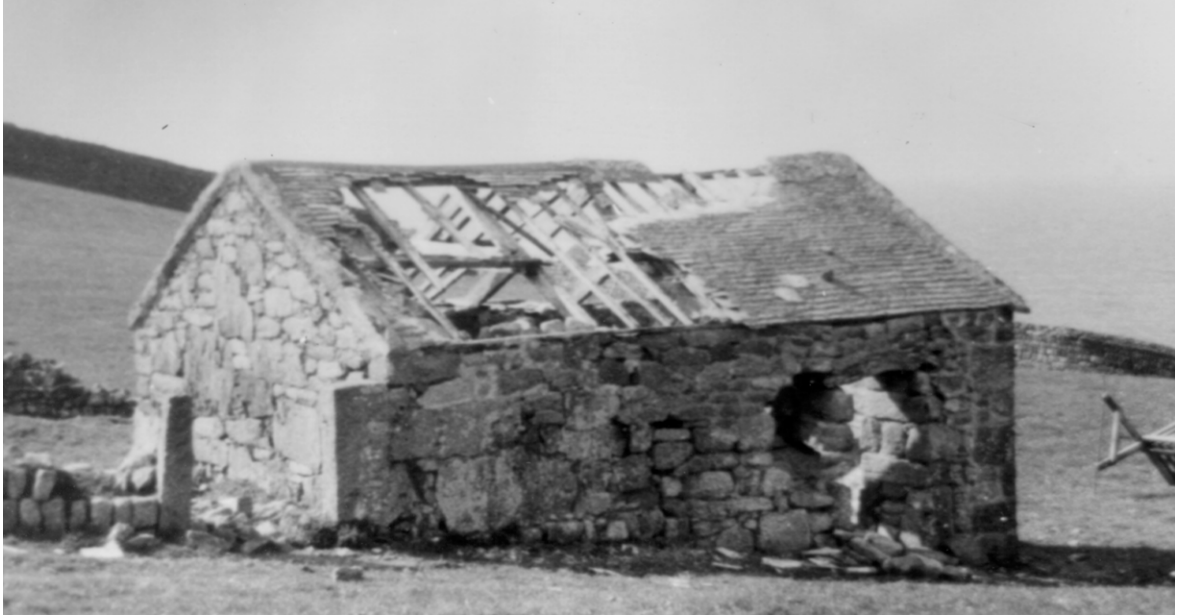
Little maintenance work seems to have been carried out the building from the 1960s by when this field had become agriculturally marginal. Its slated roof gradually disintegrated (see Figs 8 and 9), and eventually sections of its southern wall collapsed. These were rebuilt in 1985 by the then owner, Donald Payne of Nanpean Farm. However the rebuilt walling again collapsed in 1999, necessitating its reconstruction in 2001.

*Fig 8. A view of the Chapel from the south-east, of unknown date but probably the early 1960s, when the structure still retained some of its roof, and when the area of the wall adjacent to the door had begun to collapse. NT Collection.*

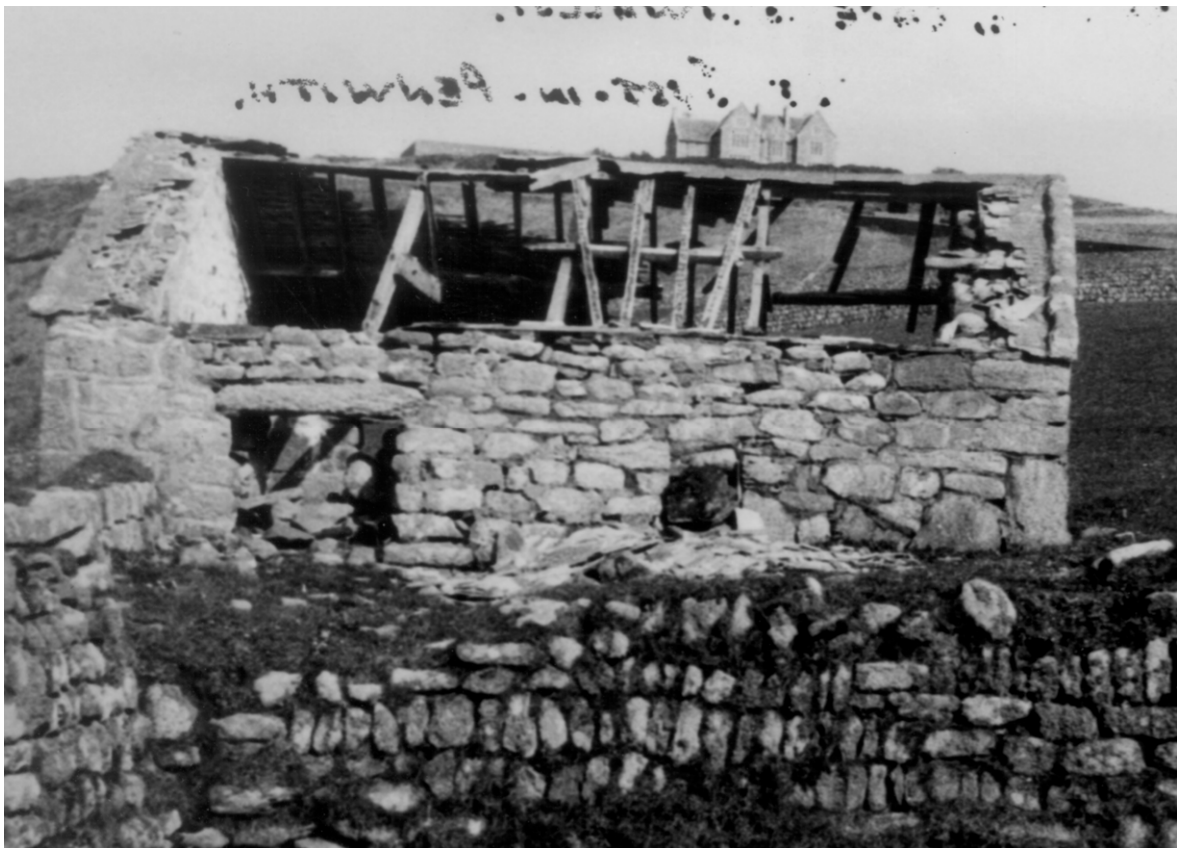
*Fig 9. A view of the Chapel from the west, again probably taken during the early 1960s showing the severe deterioration of the roof structure at that date. NT Collection.*

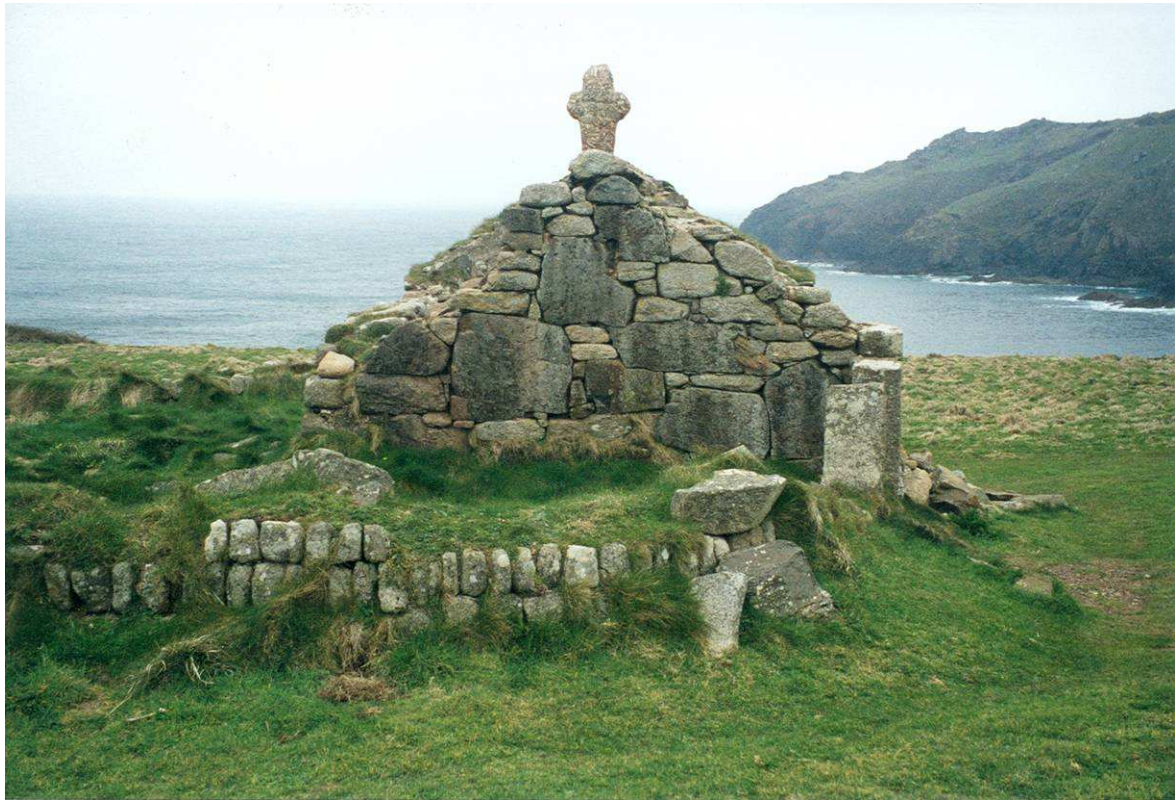
*Fig 10. St. Helen's Chapel from the south prior to works showing the massive stones used in the construction of this wall and the cross re-erected on its gable. HE Digital Image Archive.*

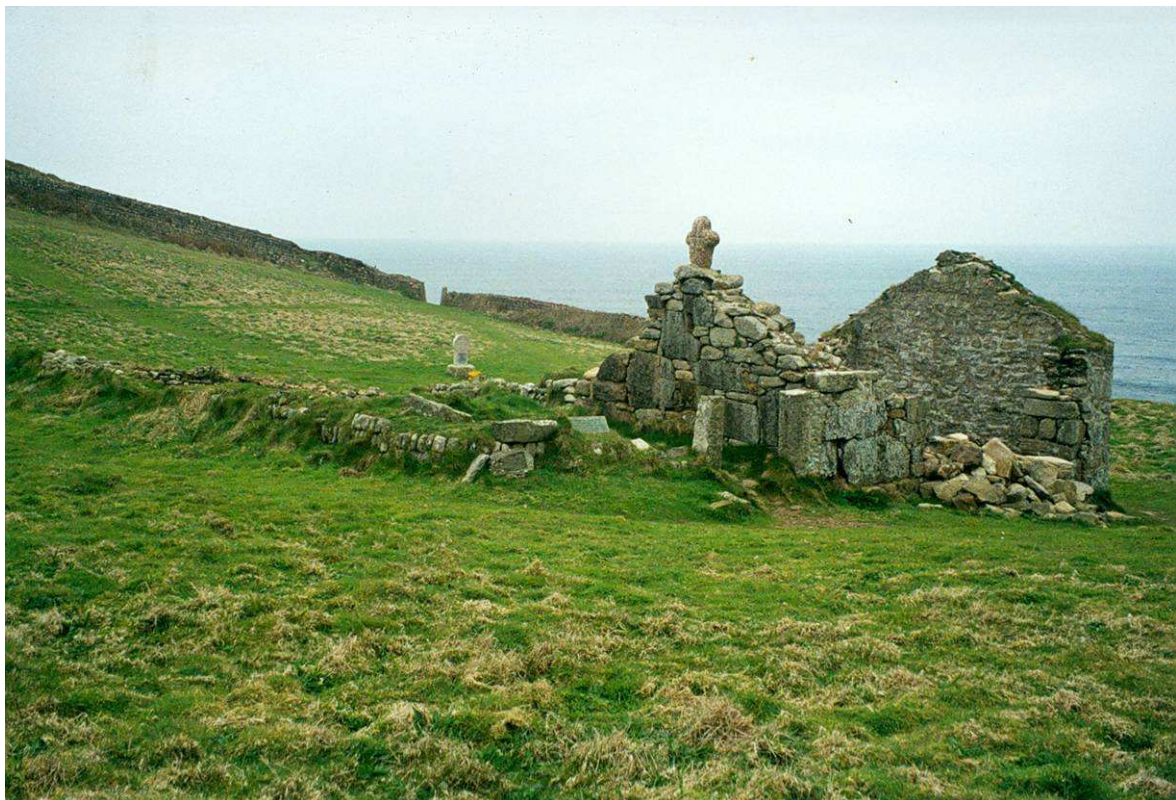
*Fig 11. St. Helen's Chapel from the south-east prior to works, showing the collapsed masonry adjacent to the doorway, and the low walls forming the enclosures to the west. HE Digital Image Archive.*

The works undertaken to the building in 2001 were limited to those parts of its fabric which had become unstable, or which required weatherproofing to prevent future deterioration. These were focussed, in particular, on its eastern wall, where the collapse of the masonry which had been replaced by Donald Payne in 1985 was extensive (see Fig 11). The rubble from this collapse was moved away from the foot of the wall, sorted, and re-set using as a guide a number of archive photographs combined with archaeological evidence (for example the original width of the doorway) to ensure the authenticity of the reconstruction. A limited amount of re-setting of lost stone was also undertaken on the southern wall.

1. Reconstruct the east wall of the building to its pre-collapse outline, using only masonry recovered from the rubble pile at the foot of the wall. Reference will be made, if possible, to any photos made of the building before the wall collapsed.

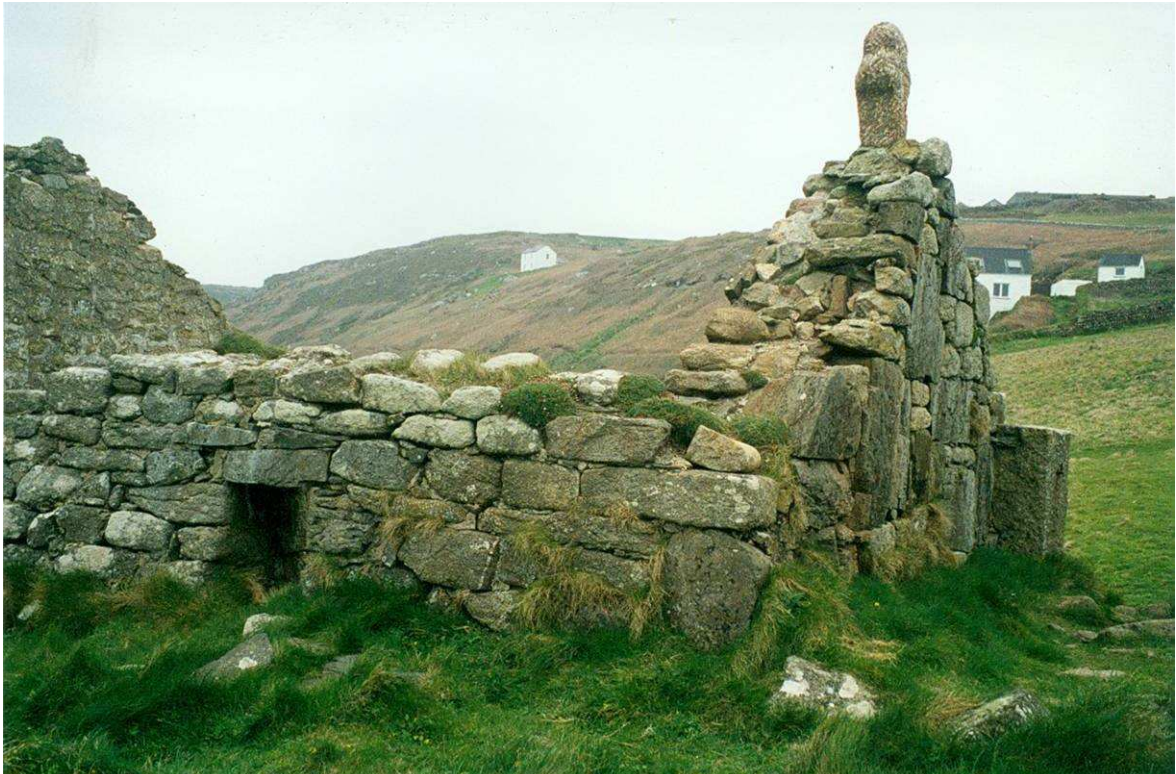
*Fig 12. St. Helen's Chapel from the west-south-west before works, showing the window, the smaller size of masonry used in this wall and the deterioration of the southern wall head. HE Digital Image Archive.*

2. Re-set loose stonework in the south wall of the building.
3. Replace a missing granite lintel over the window opening in the west wall and rebuild a small amount of masonry above.

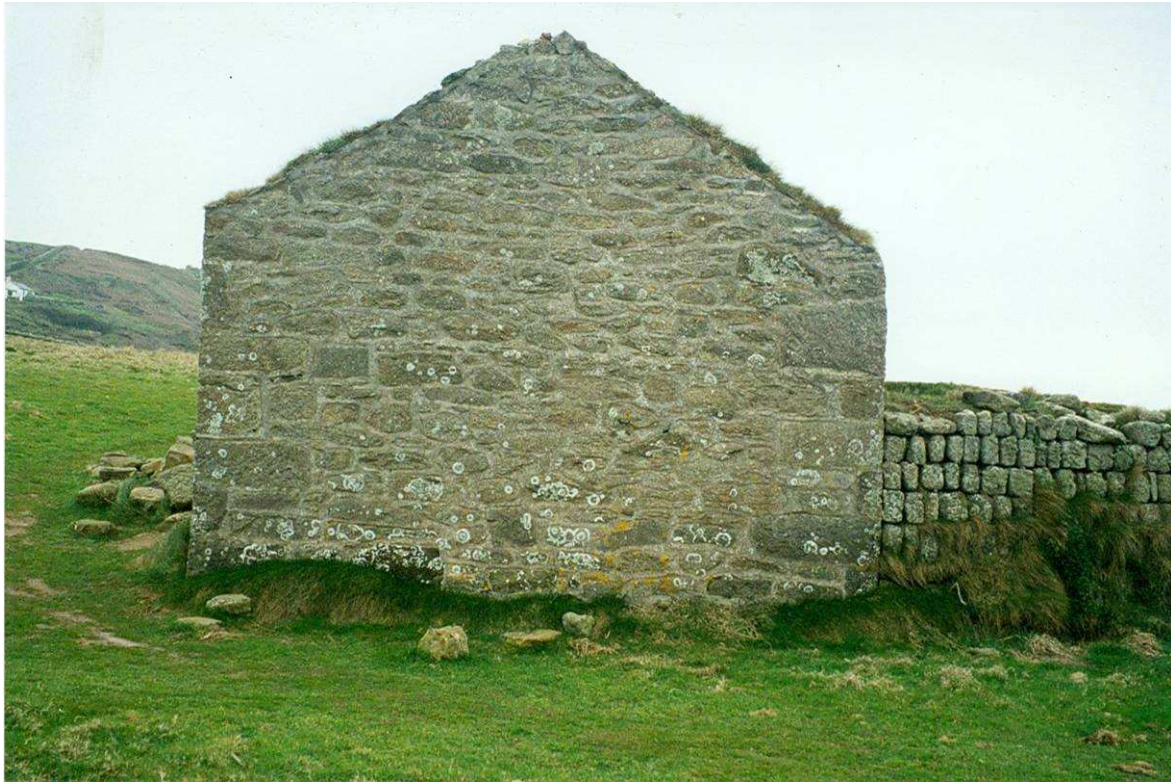
*Fig 14. St. Helen's Chapel from the north before works, showing the markedly different style of stonework used in the construction of this wall. HE Digital Image Archive.*

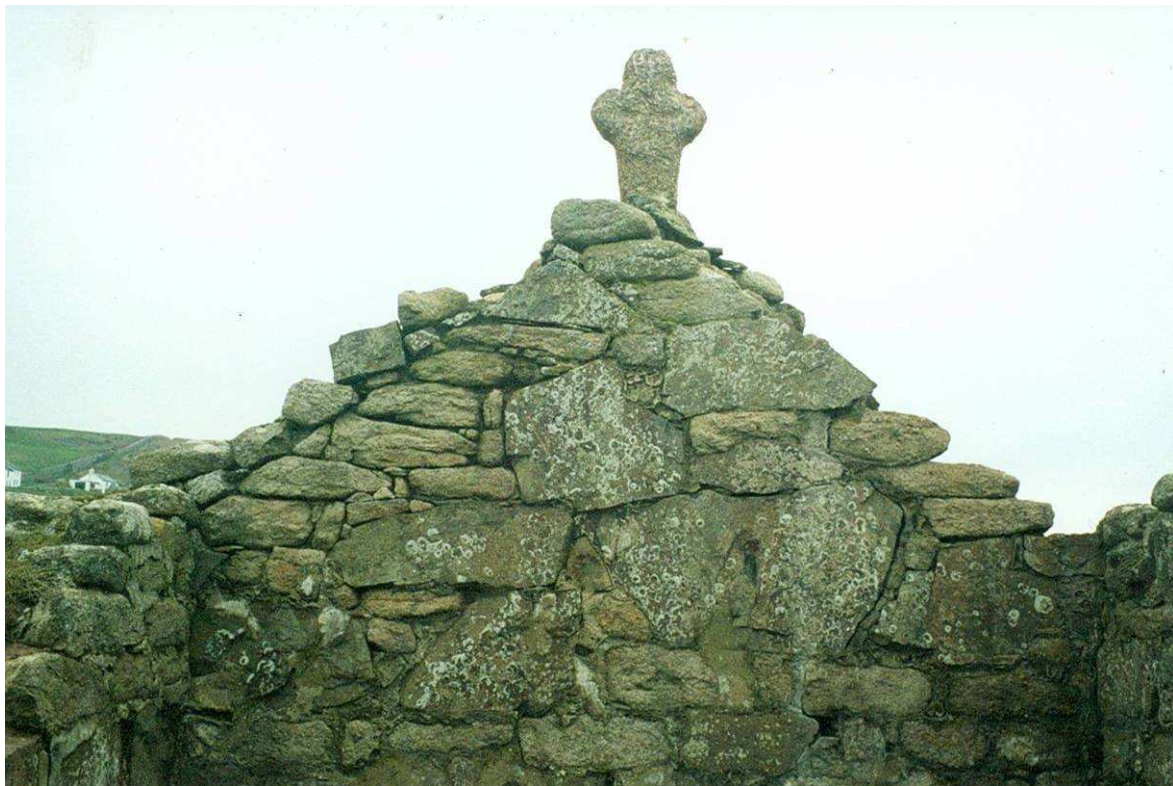
*Fig 15. The internal elevation of the southern wall of St. Helen's Chapel before works, showing some evidence for the original gable line having been raised in smaller stone (left). HE Digital Image Archive.*

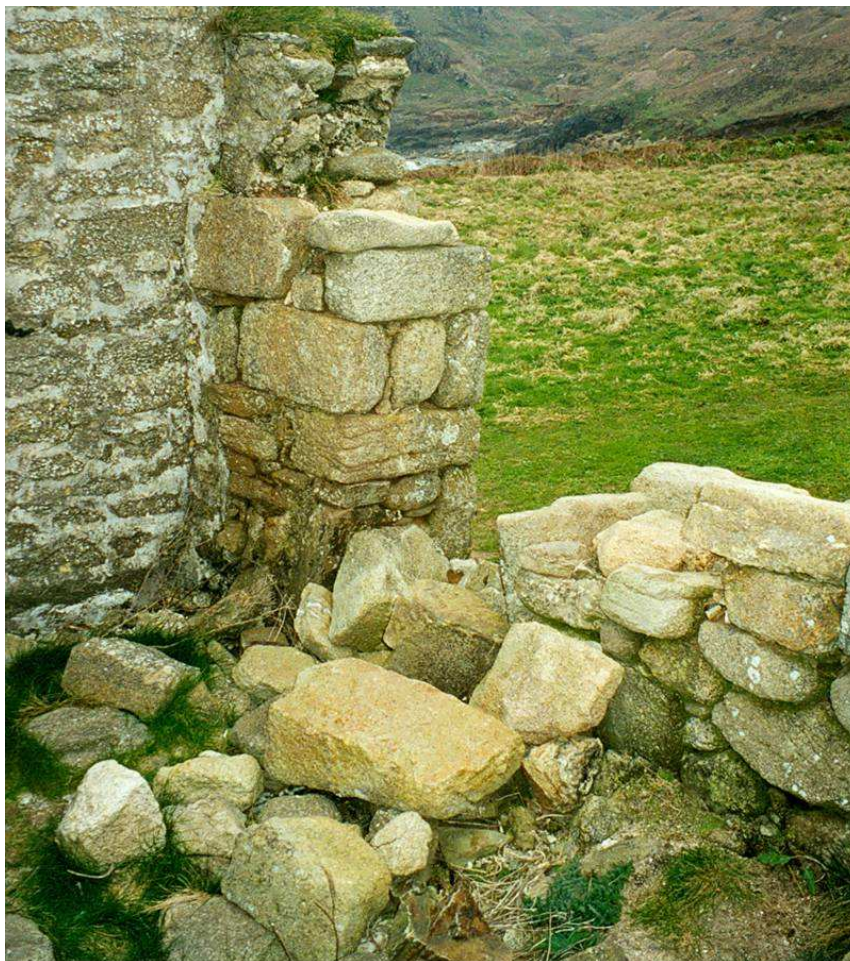
*Fig 17. The collapsed masonry adjacent to the doorway in the north-eastern corner of St. Helen's Chapel prior to works. HE Digital Image Archive.*

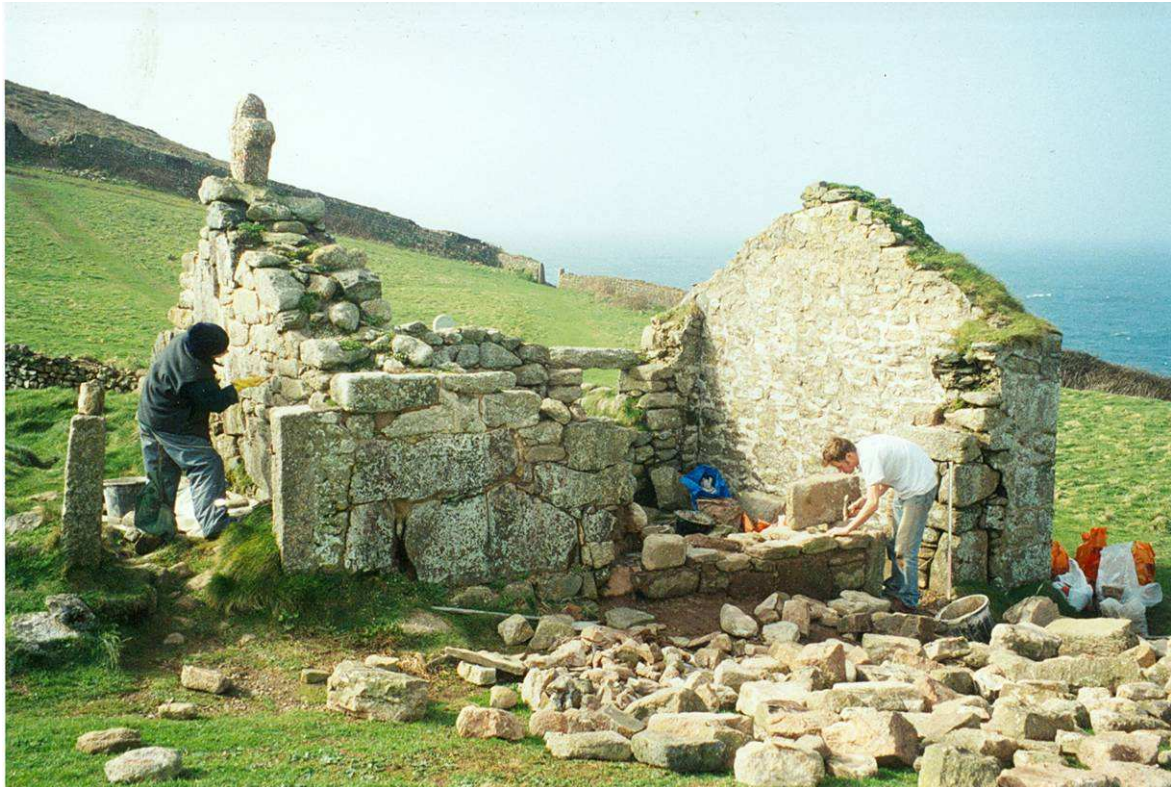
*Fig 18. An early stage during the conservation works. The foundation courses of the collapsed walling have been reconstructed, whilst repointing is under way on the southern wall. HE Digital Image Archive.*

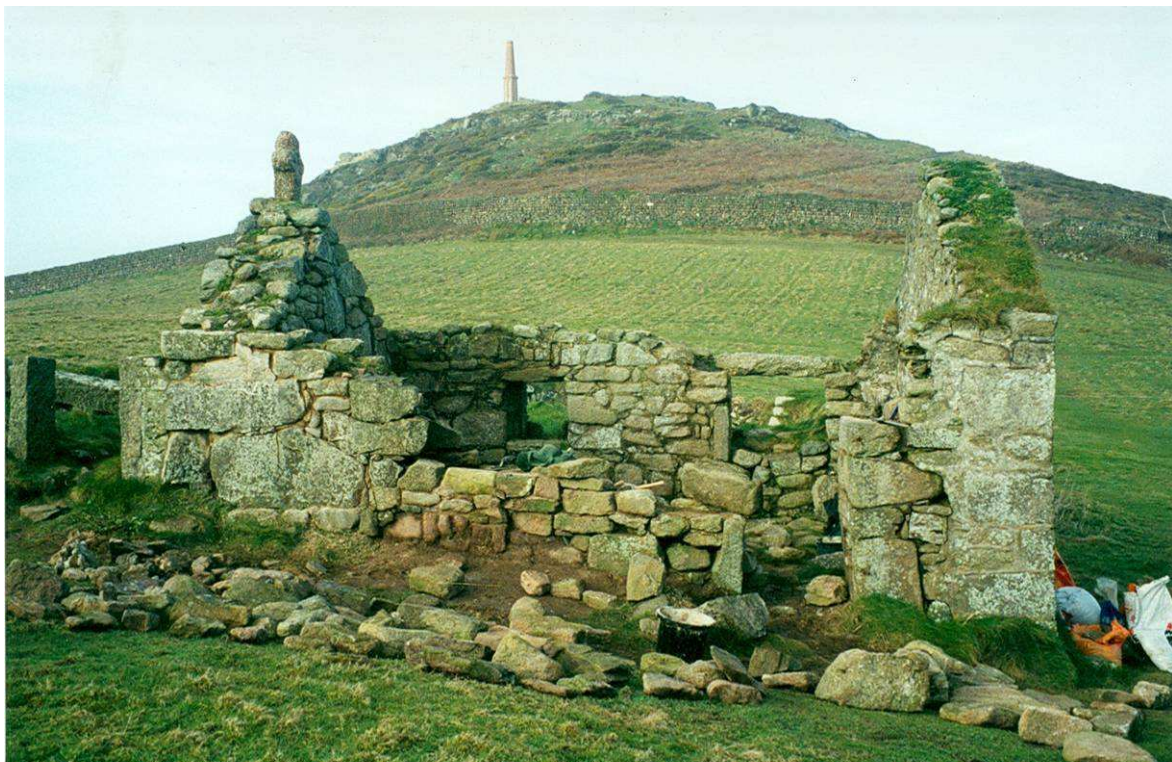
*Fig 19. A later stage during the reconstruction of the eastern wall and doorway reveal. HE Digital Image Archive.*

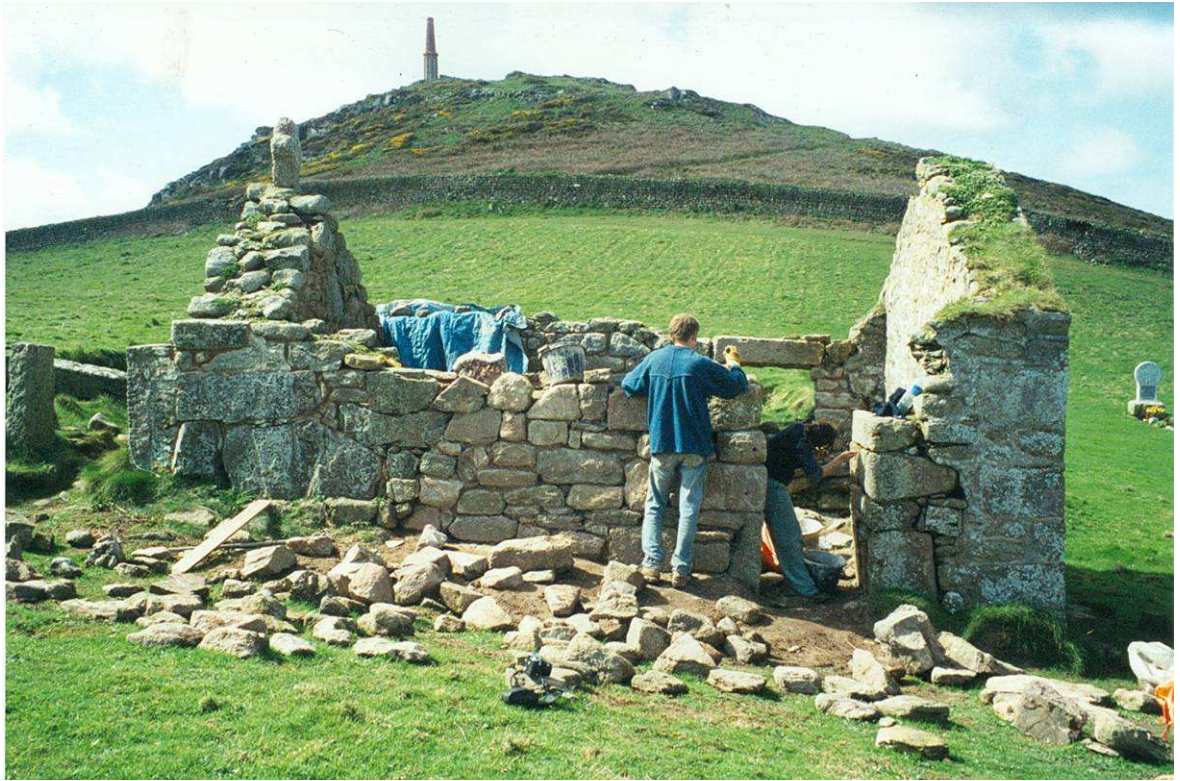
*Fig 20. The reconstruction of the collapsed section of the eastern wall approaching completion. HE Digital Image Archive.*

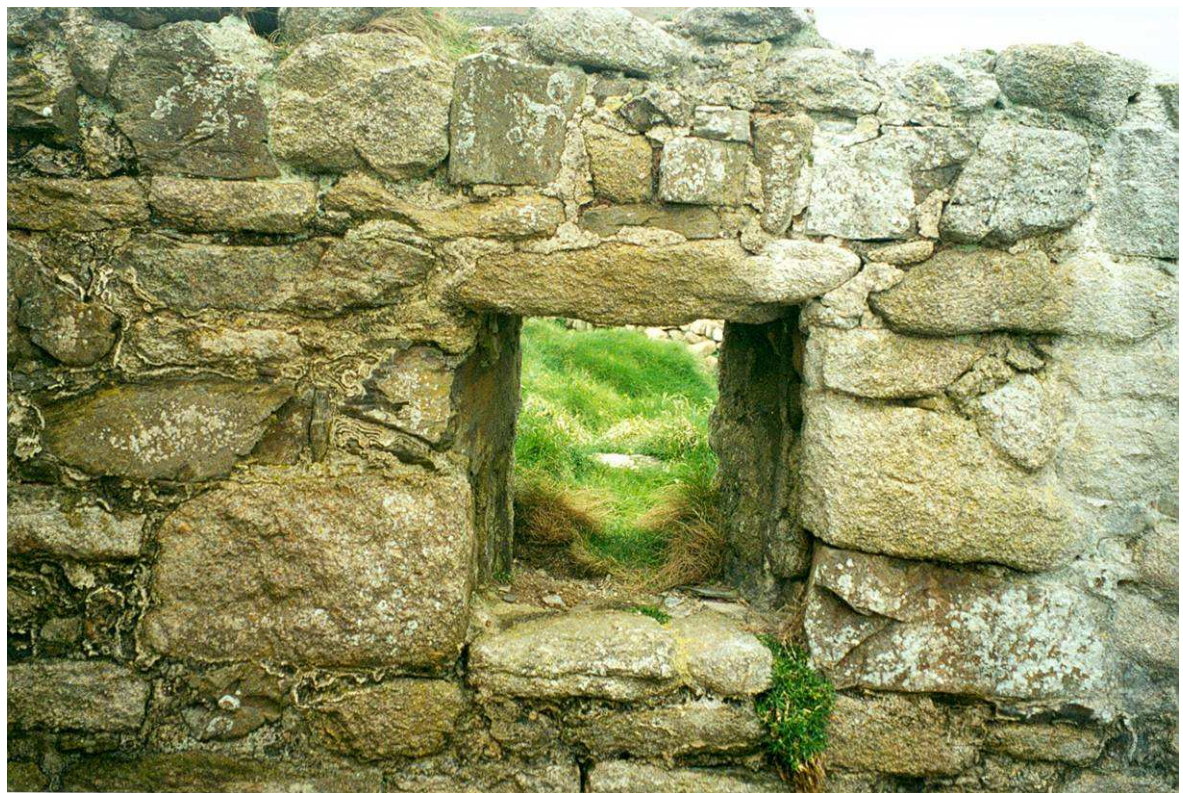
*Fig 21. The masonry over the external face of the window in the western wall. HE Digital Image Archive.*
