Trevelgue Head Cliff Castle, Newquay, Cornwall

Management Works 2001-2004

Historic Environment Service (Projects)

A Report for Restormel Borough Council
and English Heritage

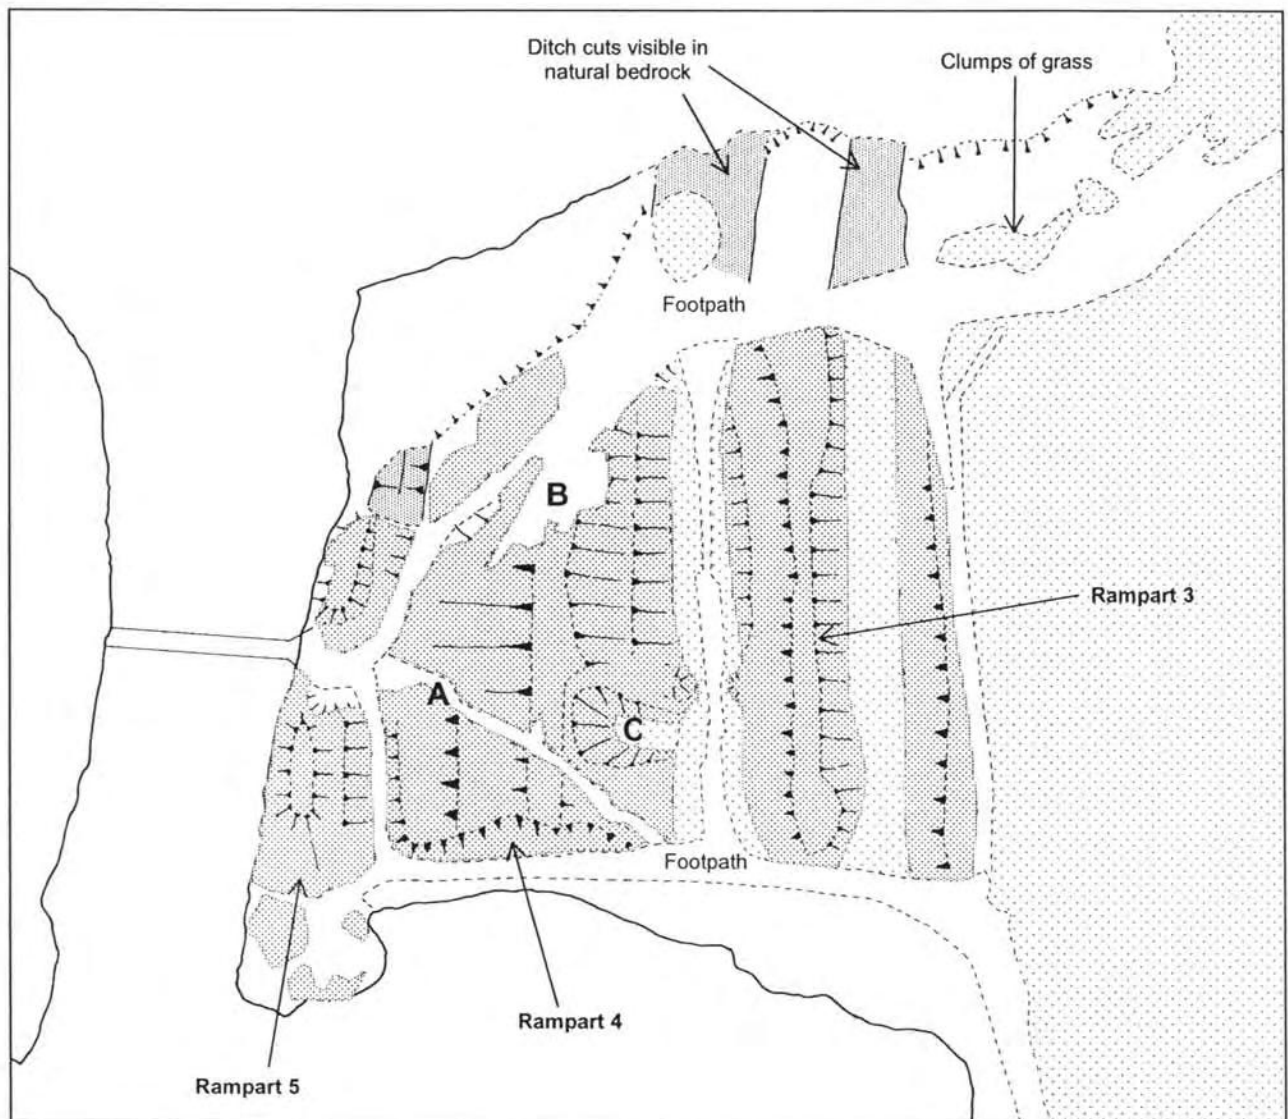
Fig. 6 2001 survey of ramparts 3-5 with annotations.

The above survey shows the two footpaths leading through or around the ramparts, as well as the two 'informal' paths leading between the main paths. It also shows the clumps of surviving turf which are being eroded to the north-east and south-west.

The three damaged area of rampart 4 infilled by this project are:

- A. Diagonal erosion scar across the rampart.
- B. Area damaged in 1980s.
- C. Area quarried out prior to 1907.

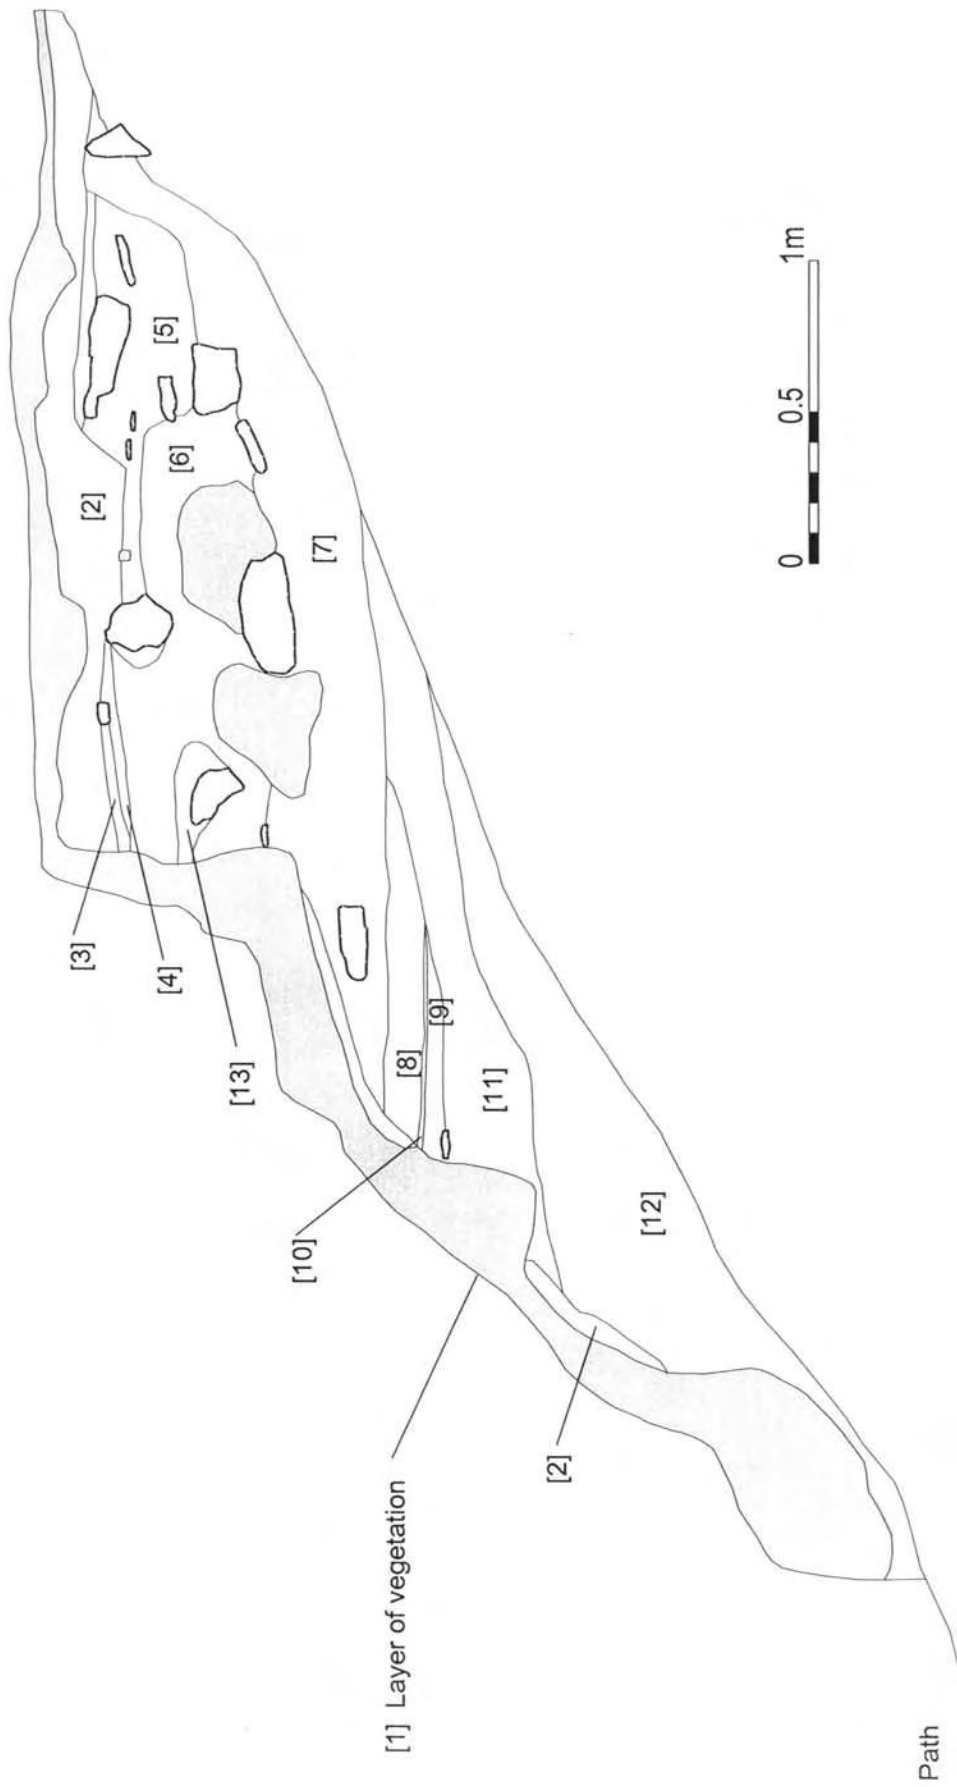
Fig. 7 Section through eroded central portion of rampart 6.

It was decided to concentrate works on the scar to the north of the footpath, initially caused by people who had clambered along the length of the rampart from the footpath and worsened by normal processes of erosion. Some 5.0m long, it had a maximum depth of 1.5m (Figs. 23 and 24). This feature was recorded in some detail prior to works, as it presented a good opportunity to consider the interior of the feature.

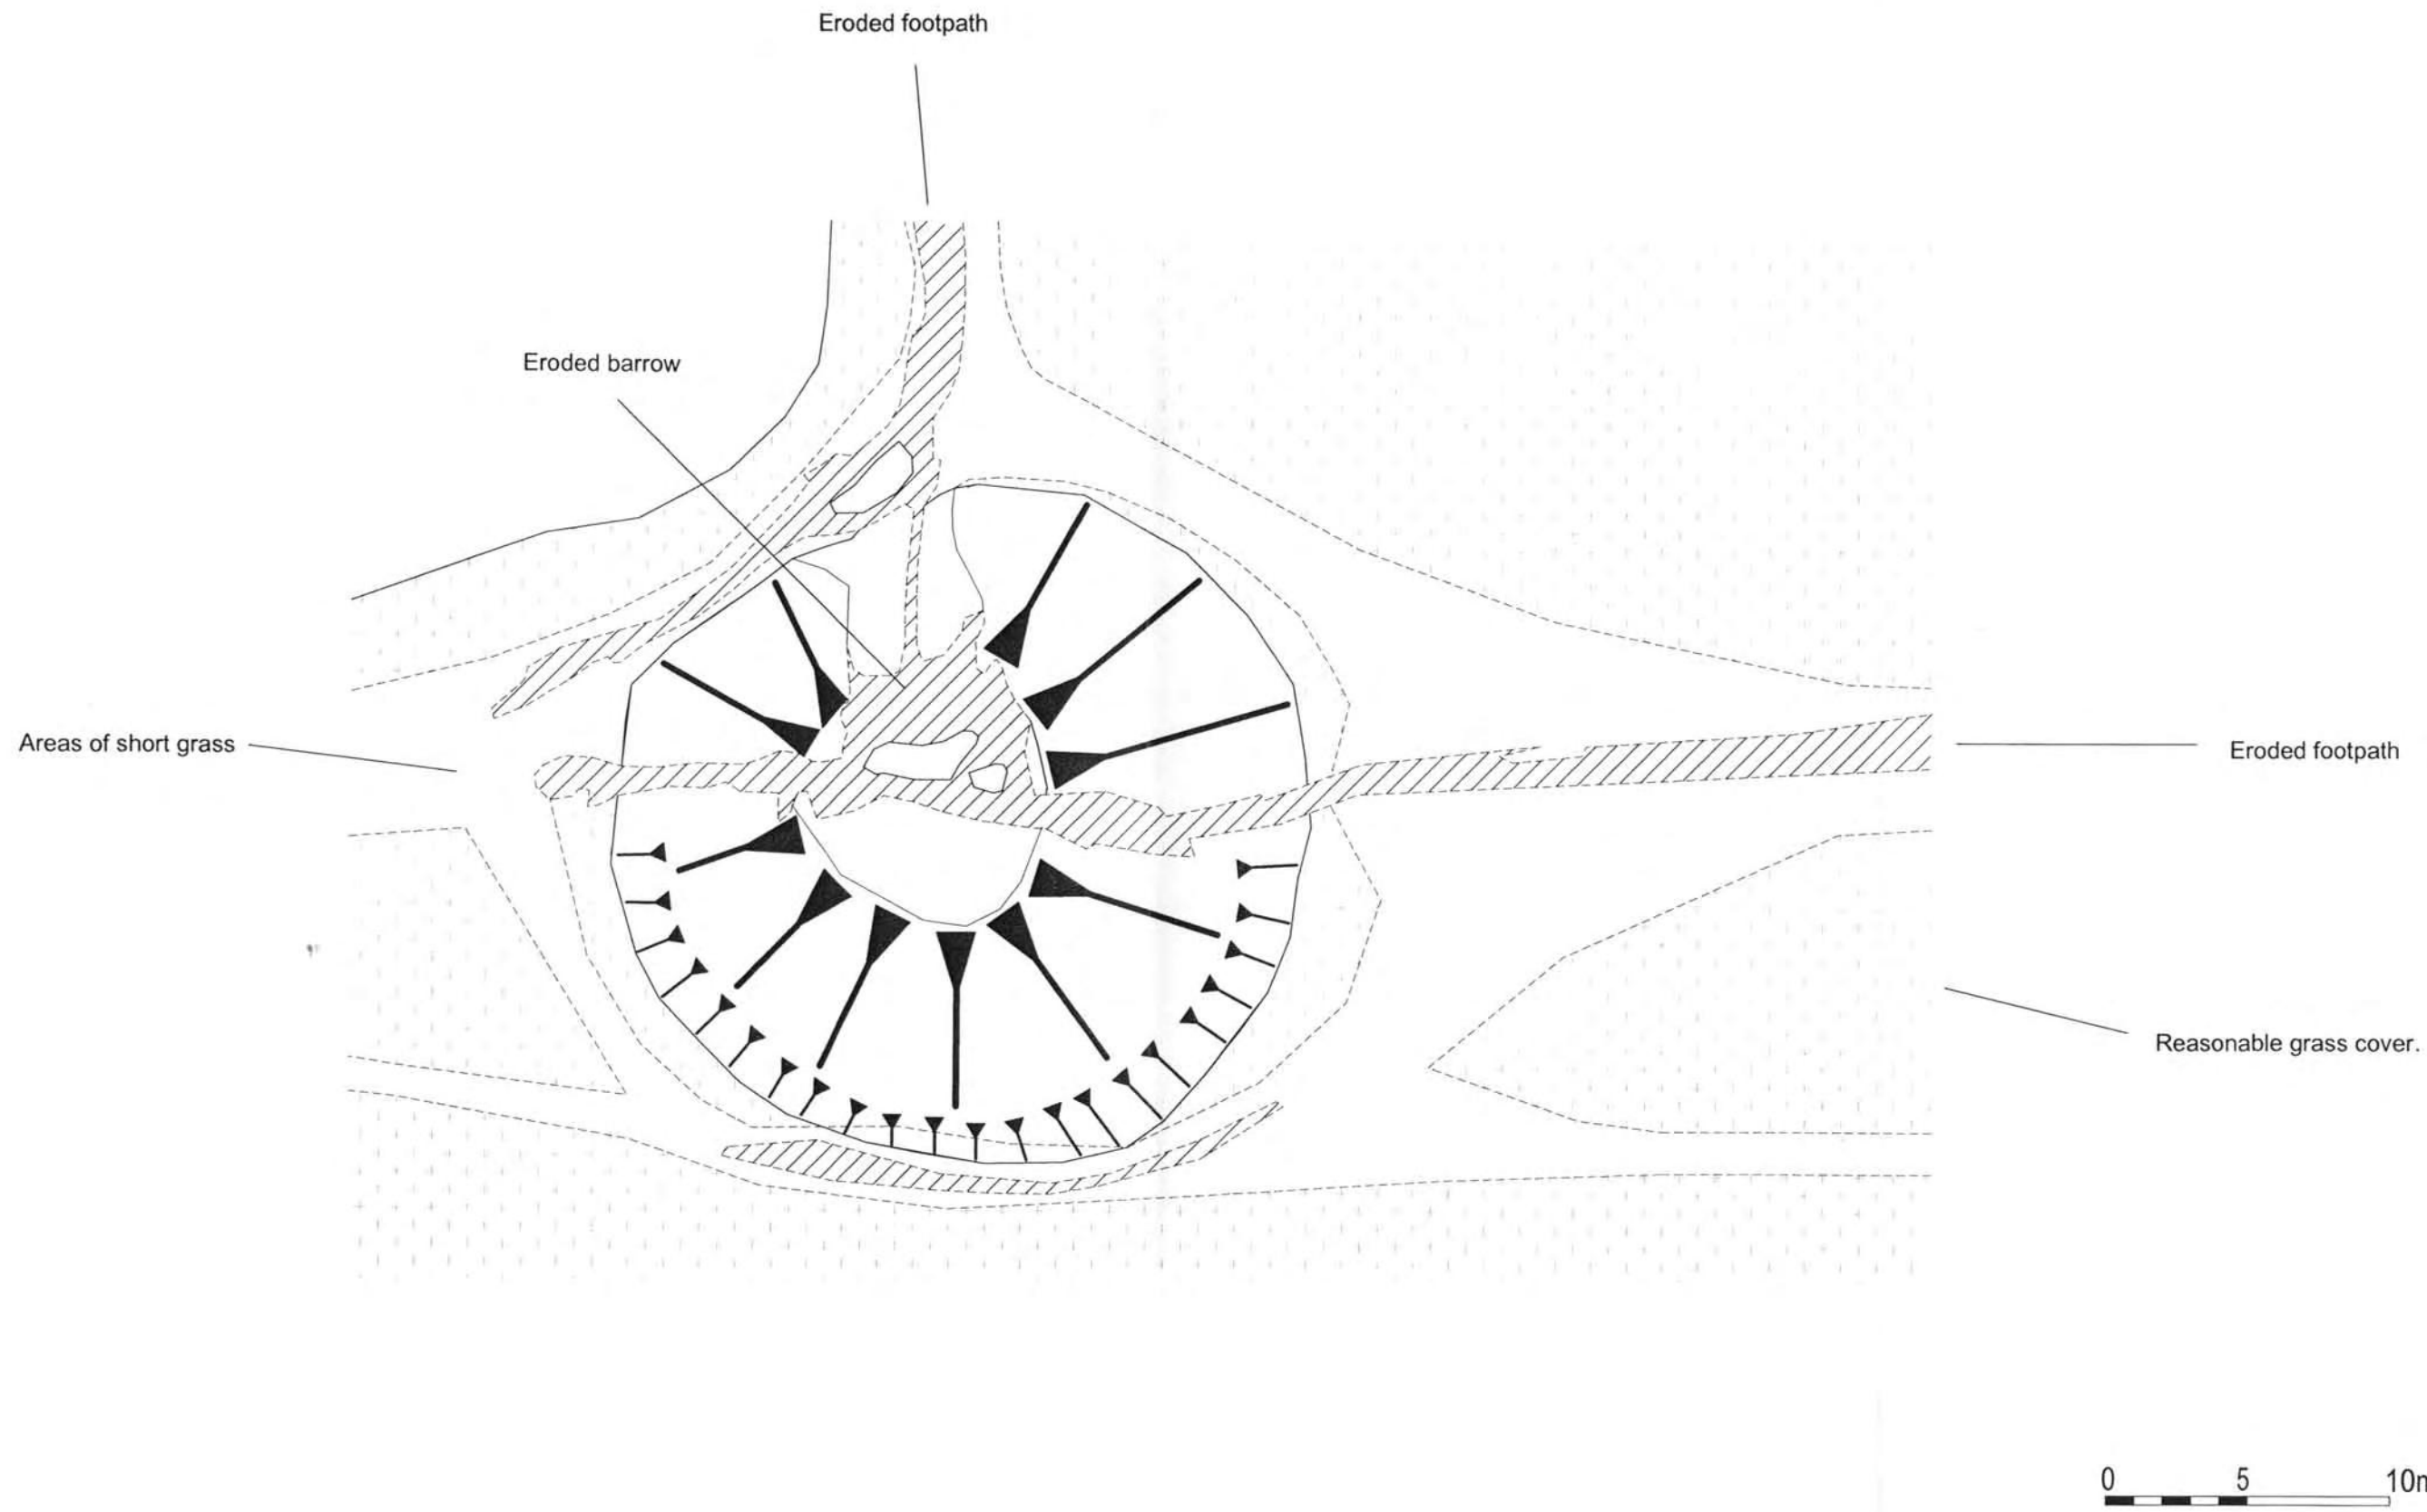
Fig. 8 Plan of Bronze Age barrow showing extent of scar damage.

On the southern and western flanks of the barrow, there were numerous small hollows and irregularities caused by rabbit activity. There were also two further eroded scars on the edges of the barrows where a lot of people had walked, and it was also very interesting to note areas of short vegetation where there had been considerable numbers of walkers.

An EDM survey of the barrow was carried out in October 2003, in advance of the conservation works. The main areas of erosion within and over the barrow were recorded, as well as the areas of eroded path. Existing areas of grass cover and existing paths were also noted (Fig. 8) and a profile of the barrow was also constructed (Fig. 9). In comparison with the earlier 1983 survey, it showed that the surviving clumps of turf to the north of rampart 4 and to south of rampart 5 had been further eroded.

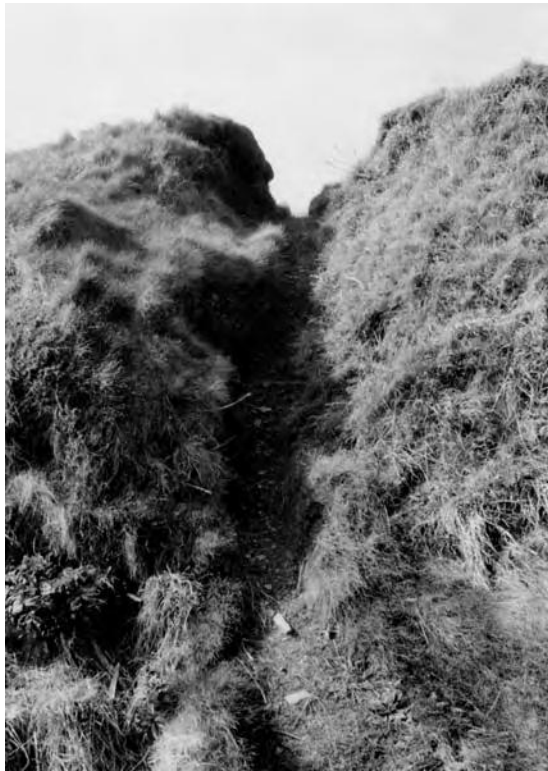
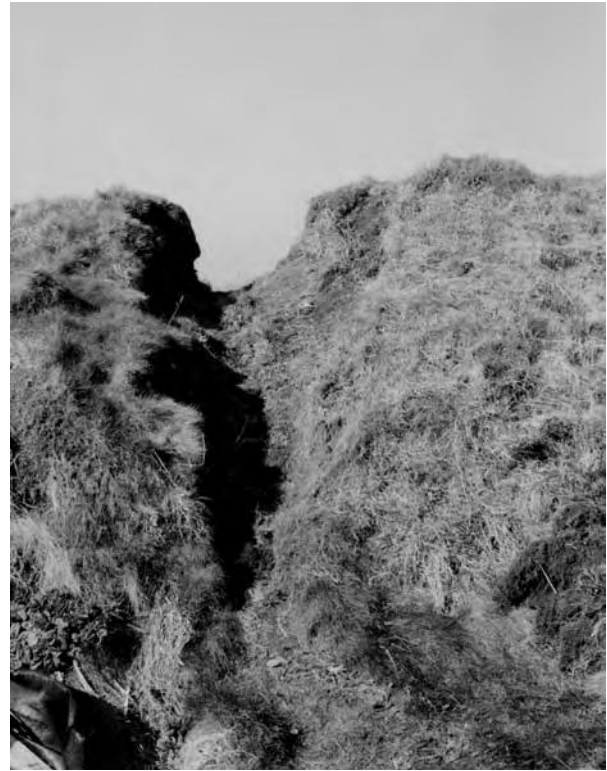
The damage to rampart 1 was a relatively small scar, which had a maximum depth of 0.4m and a similar width.

Figs. 10 and 11 Eroded scar on rampart 2 prior to works commencing and following the removal of vegetation.

The scars were repaired following the methodology set out in Section 3.1.2. Figures 10-15 show these conservation works being carried out with the various photographs illustrating the eroded scar prior to the works starting and following the removal of vegetation from within the scar, the construction of the wooden revetments, the infilling of the rampart in progress and the finished job, with the rampart covered with protective hessian netting.

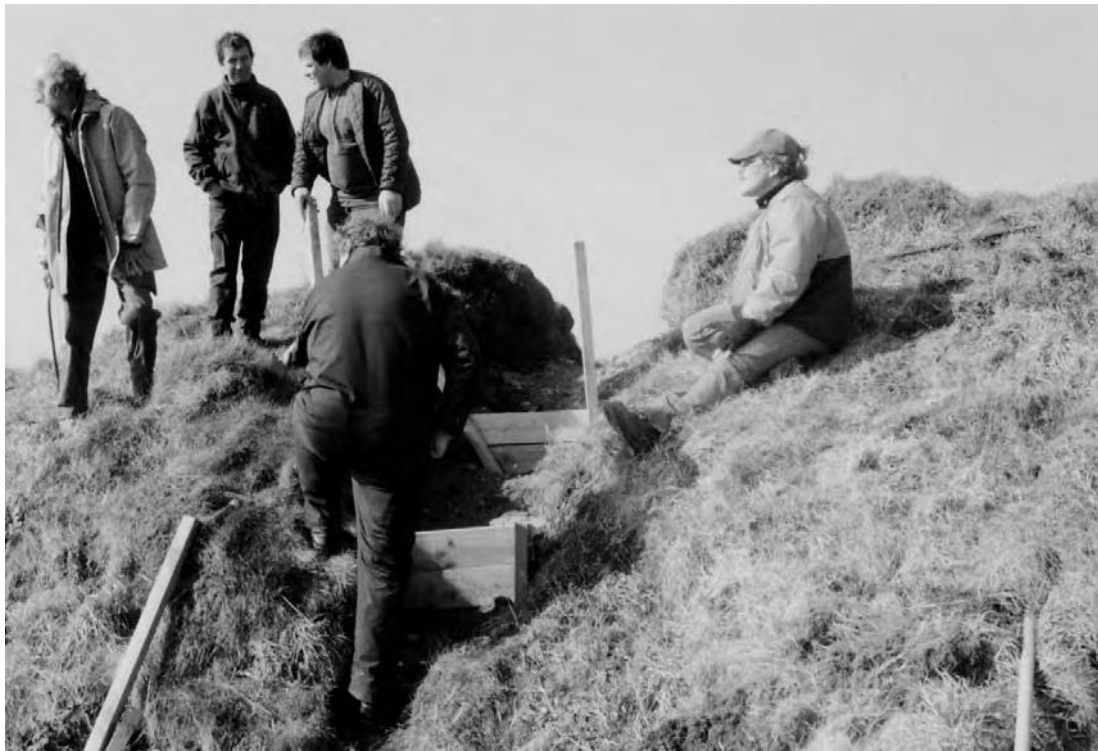
Fig. 12 Construction of wooden revetments into scar on rampart 2.

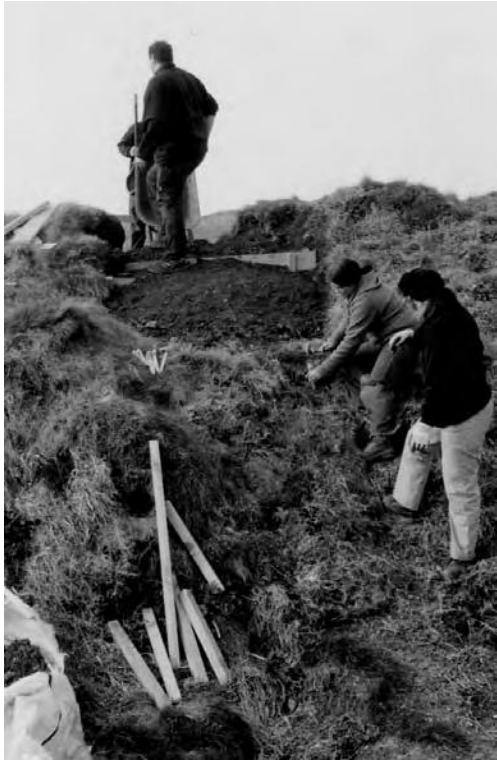
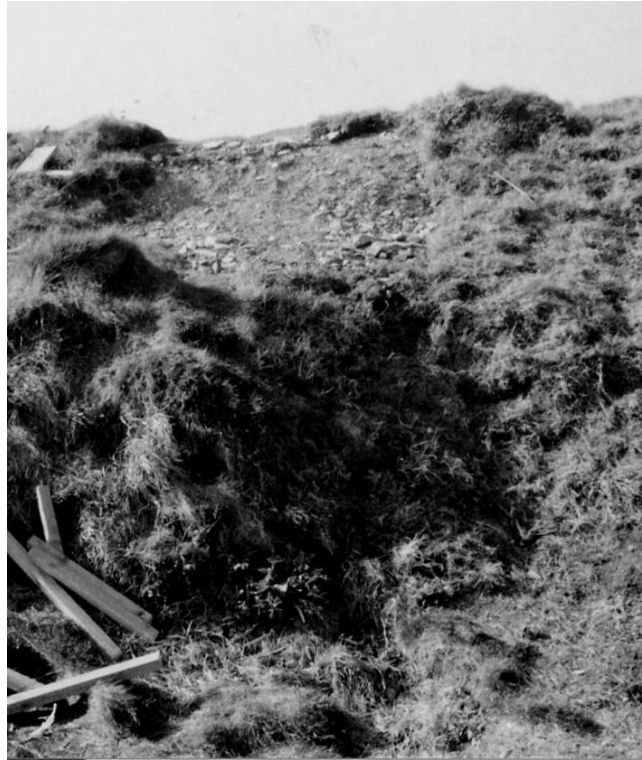
Figs. 13 and 14 Infilling of the rampart 2 in progress. Note how vegetation removed from the hollow has been replaced at the base of the scar.

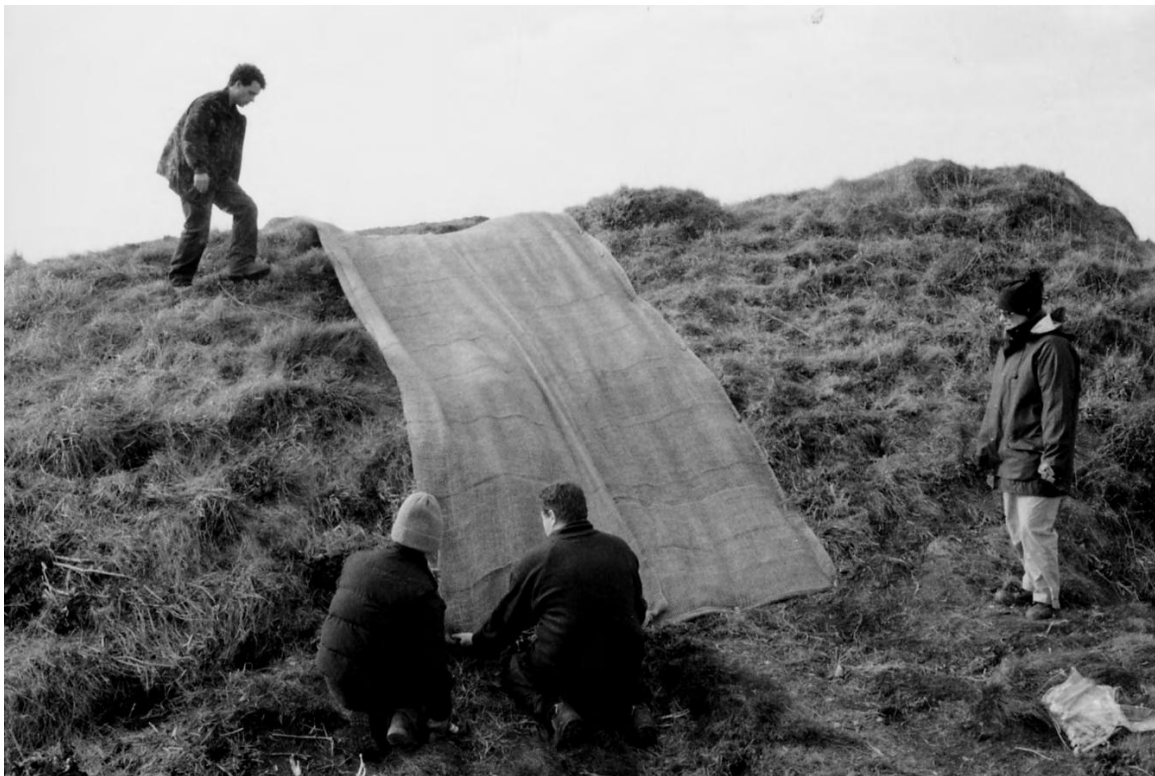
The repair work to the linear scars over ramparts 1, 2 and 4 were also successful in reprofiling parts of the monuments. However, members of the public have continued to walk/climb in these particular areas, either preventing new vegetation from growing or damaging that which has grown. In particular, the diagonal scar across rampart 4 has suffered considerable damage by visitors using it as a slide.

Fig. 15 Eroded scar following conservation, covered with bessian matting.

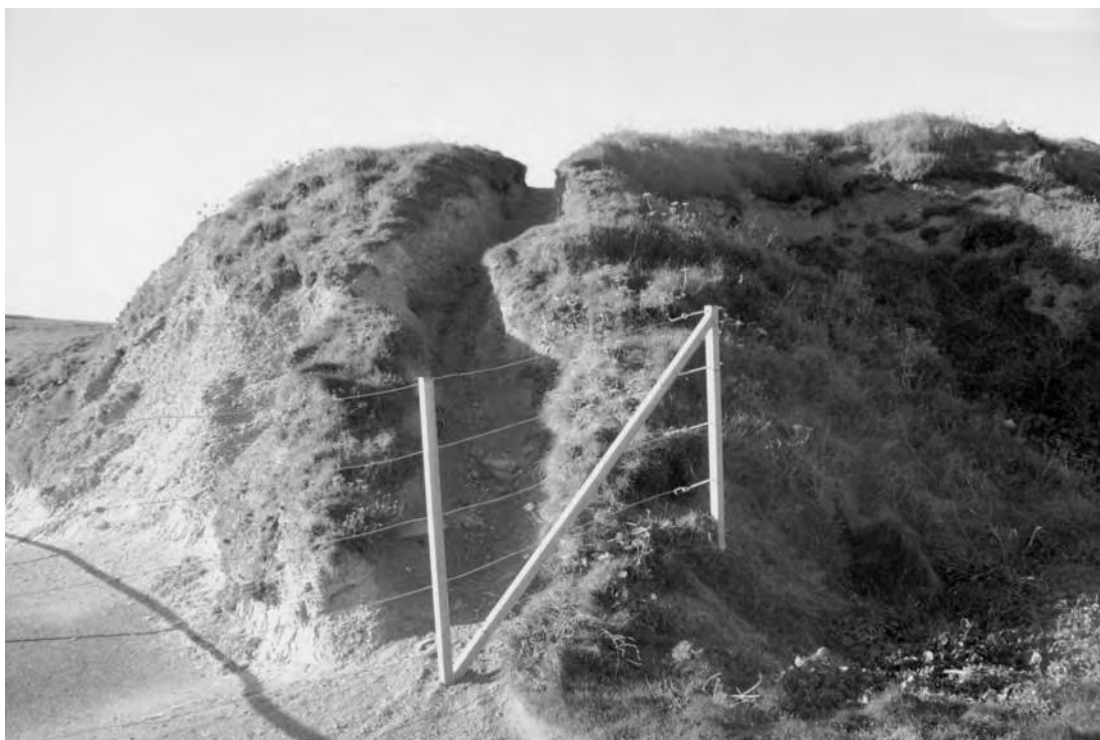
- A gully extending NW-SE path over the southern part of rampart 4, which had been used as a habitual route for mountain bikers.
- A levelled area at the northern end of the rampart, which had been created by Restormel Borough Council in 1988. This was still bare, over 13 years later, and in places had been further eroded by visitors.
- A large quarried-out section of the east-facing side of the rampart, in which a huer's hut had been recorded on the 1907 OS map. This was positioned to the immediate north of the eroded gully noted above.

Figs. 16 Eroded scar across rampart 4, prior to works commencing. Photograph taken from the east.

The diagonal eroded channel running across rampart 4 was the first damaged area to be repaired in November 2001.

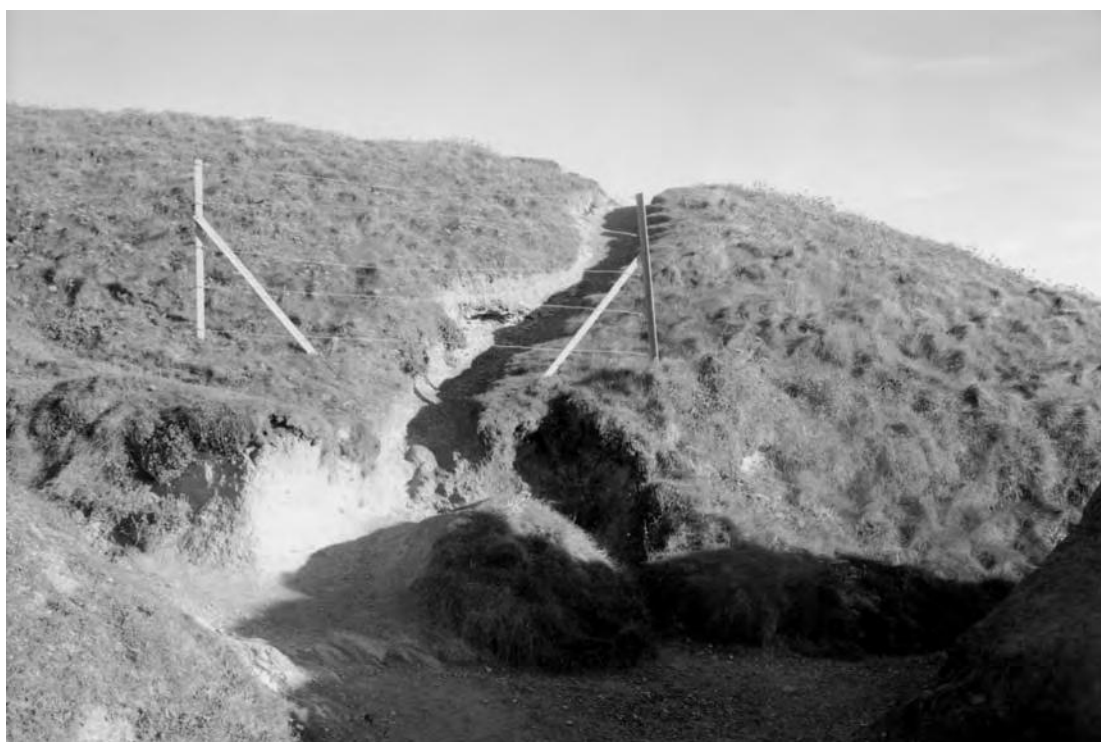
Figs. 17 Eroded scar across rampart 4, prior to works commencing. Photograph taken from the west.

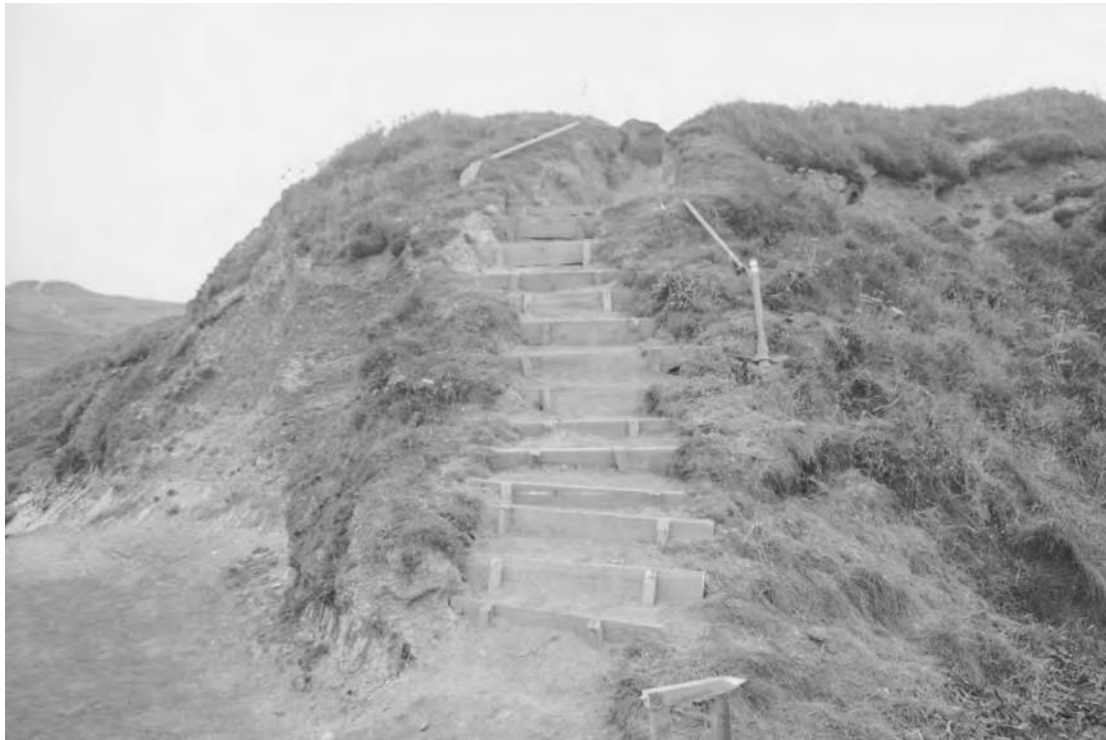
Figs. 18 *Infilling of scar across rampart 4. Photograph taken from the east.*

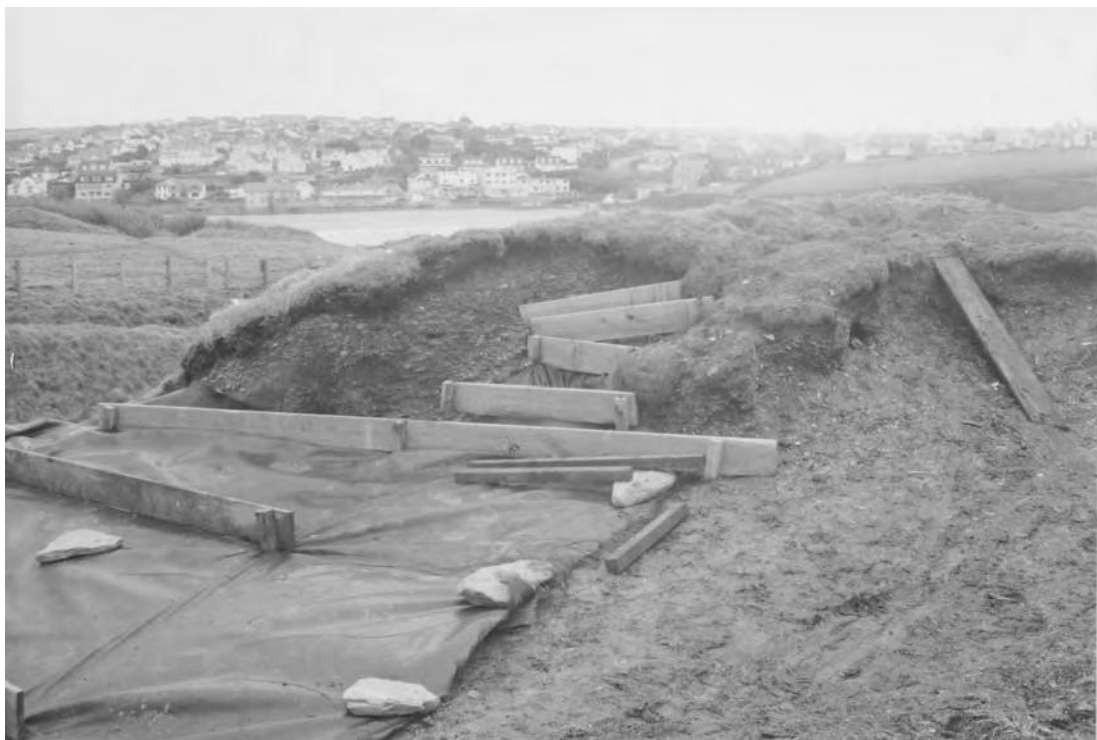
Fig. 19 *Infilling of eroded northern end of rampart 4.*

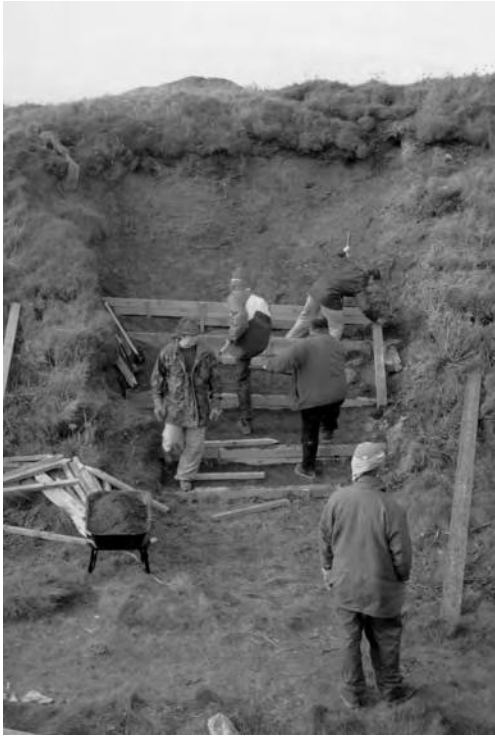
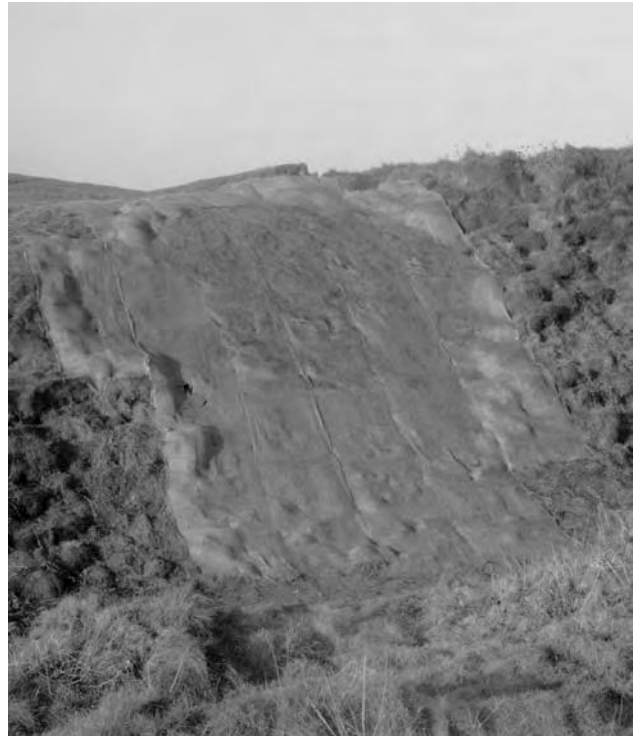
Figs. 20 and 21 An early stage of the infilling of the large hollow in rampart 4 and following its completion.

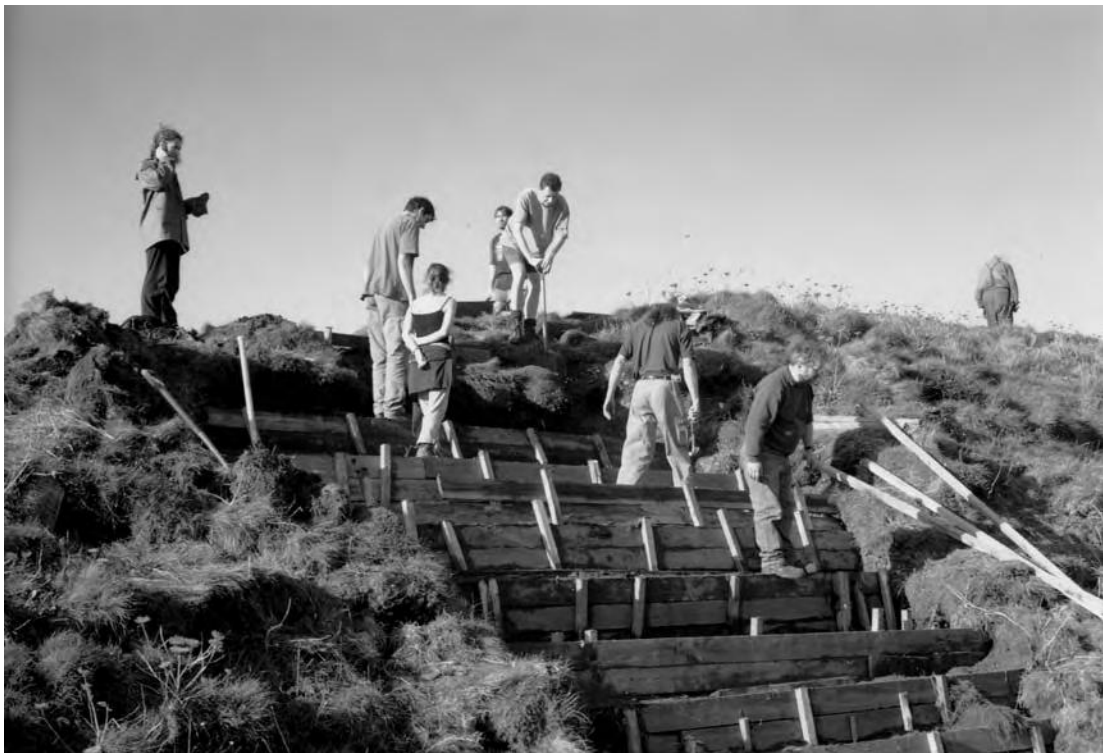
Fig. 22 The infilling of the large hollow in rampart 4.

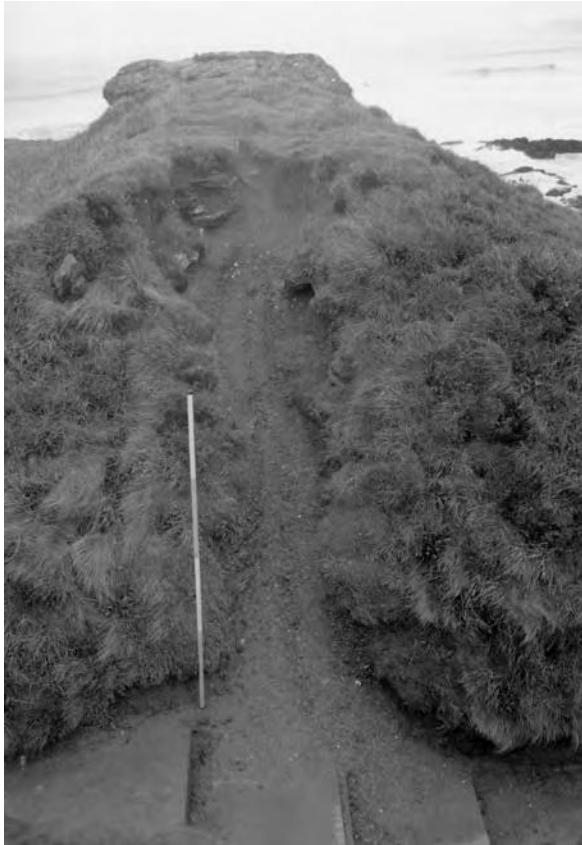
Fig. 23
The extent of erosion in rampart 6.

This hollow was infilled in the same way as the other eroded areas on ramparts 1, 2 and 4. The infilling was carried out to replicate the angle of the eroded face and profiled well. Indeed, the conservation work in this area was very successful and a healthy sward of vegetation quickly became established and continues to flourish. A south-facing section, it did not have to withstand the harsh north wind and salty sea blow, which has done such damage to those re-turfed or seeded areas around the new footpaths and steps (see Section 6).

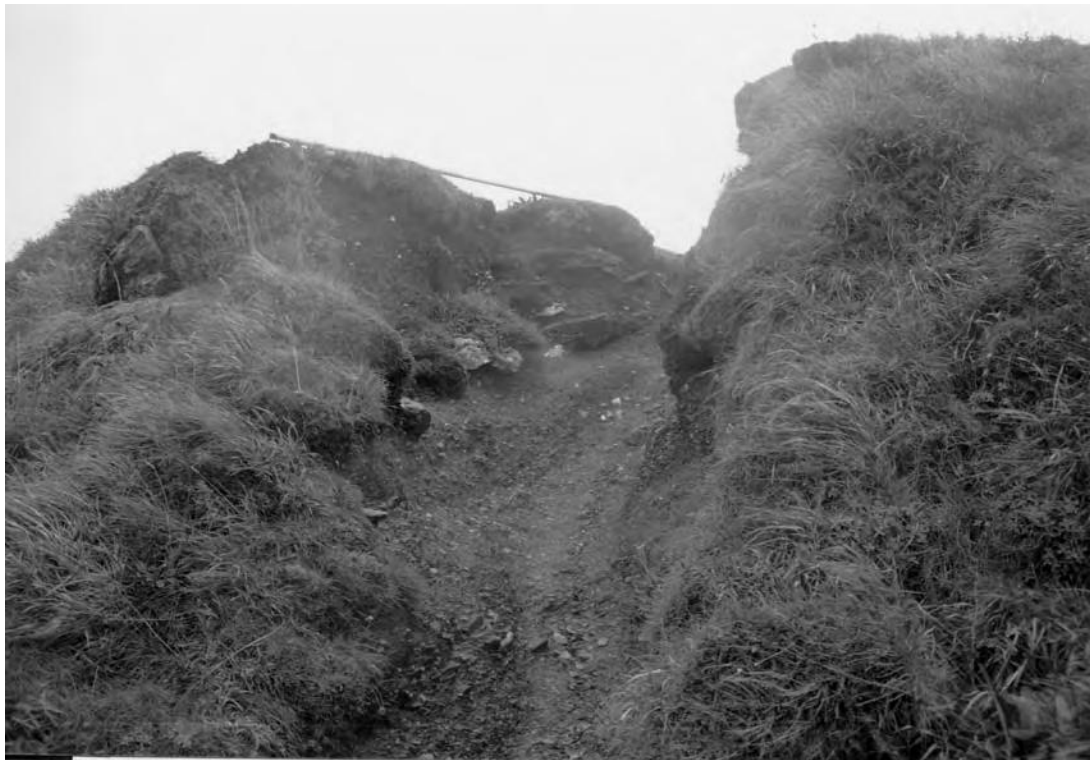
Fig. 24 *The extent of erosion in rampart 6.*

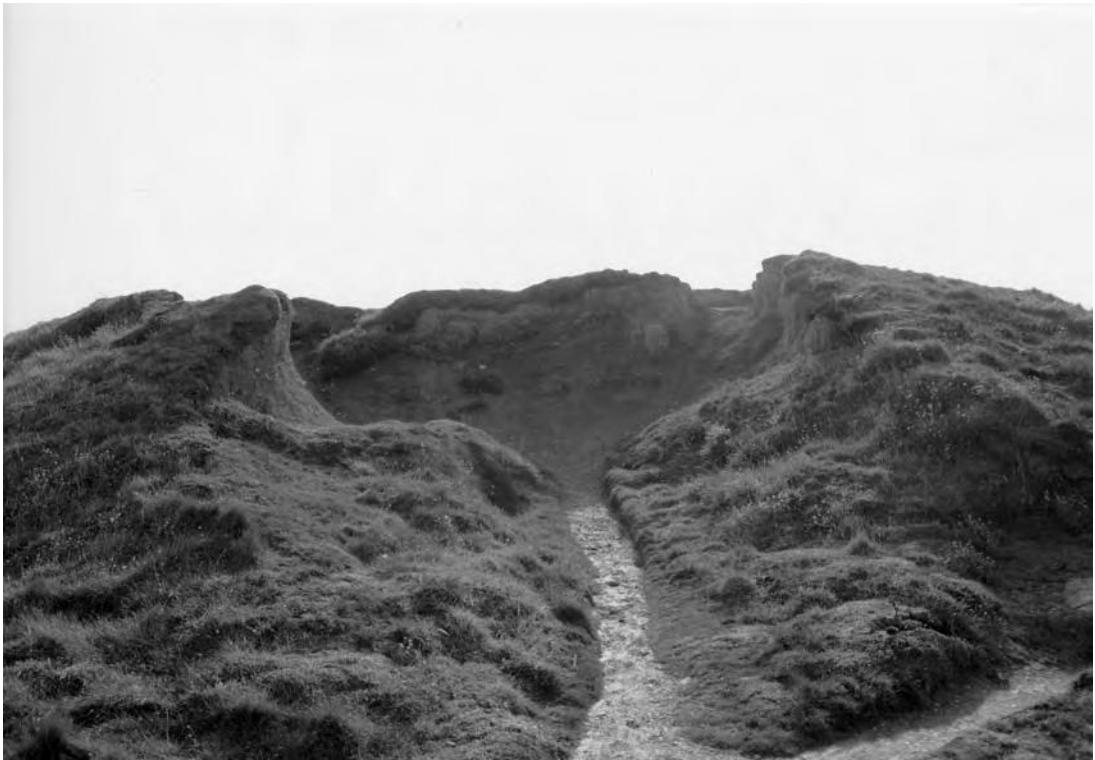
Fig. 25 *Eroded barrow from the north.*

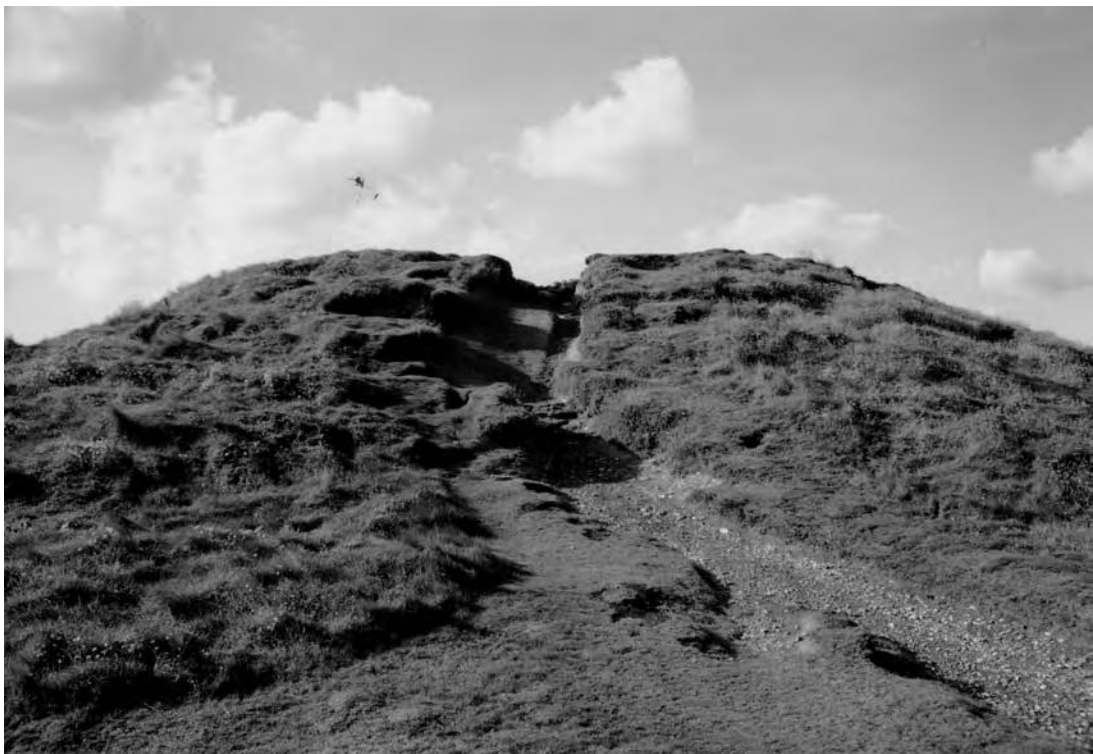
Fig. 26 *Eroded barrow from the east.*

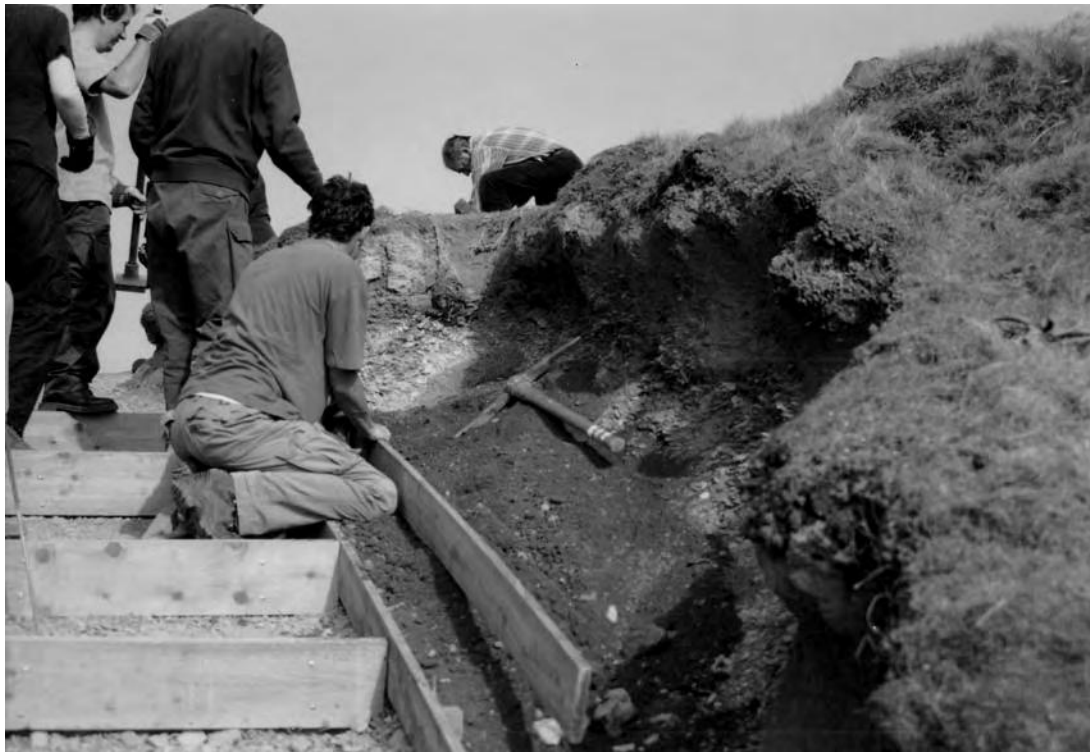
Fig. 28 Construction of steps through rampart 4.

During the repair works to ramparts 3-5, considerable discussion ensued as to the condition of the northern path through the fortifications. As noted previously, where the path led through rampart 4, the surface of the path was eroded natural shillet, which had been worn away by the feet of walkers and rain. A tricky slope for less agile walkers, particularly in wet conditions, it was decided to build steps through this actual rampart. To the east of this grouping of ramparts, walkers between the two paths had created a further permissive path which had become an eroded hollow. It was decided to formalise this desire-line and control further erosion by constructing a 1.0m wide footpath in this location.

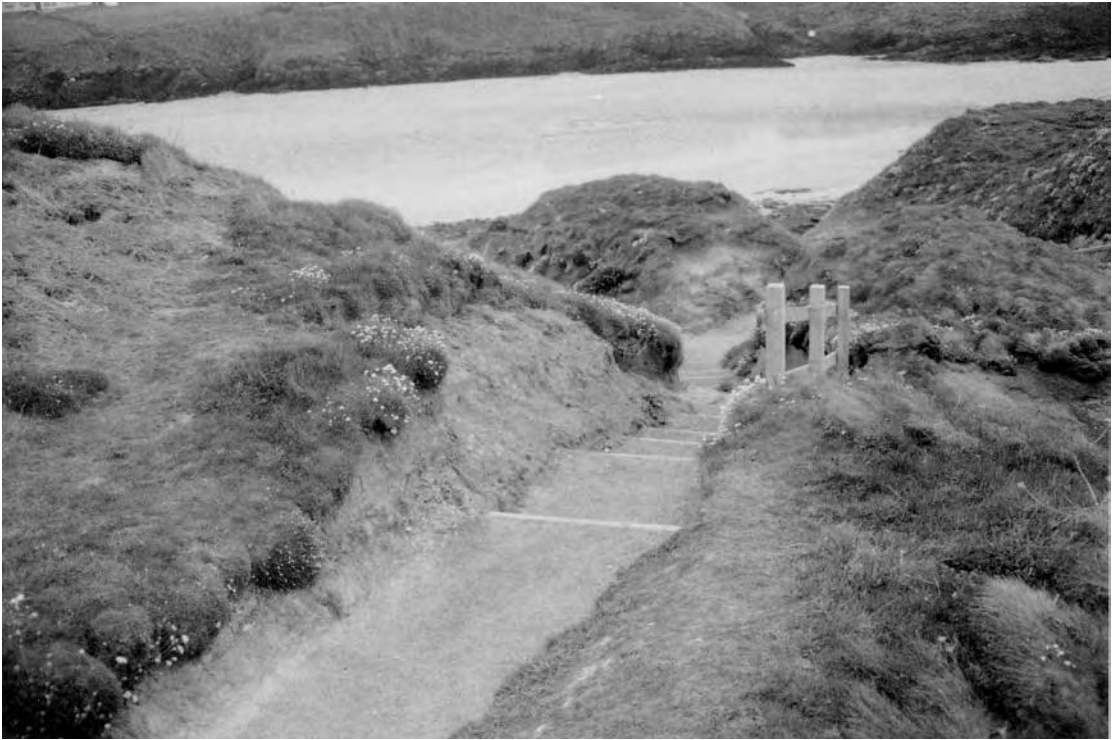
Fig. 29 Steps through rampart 4. Note infilled hollow to the left and safety fence to right of path.

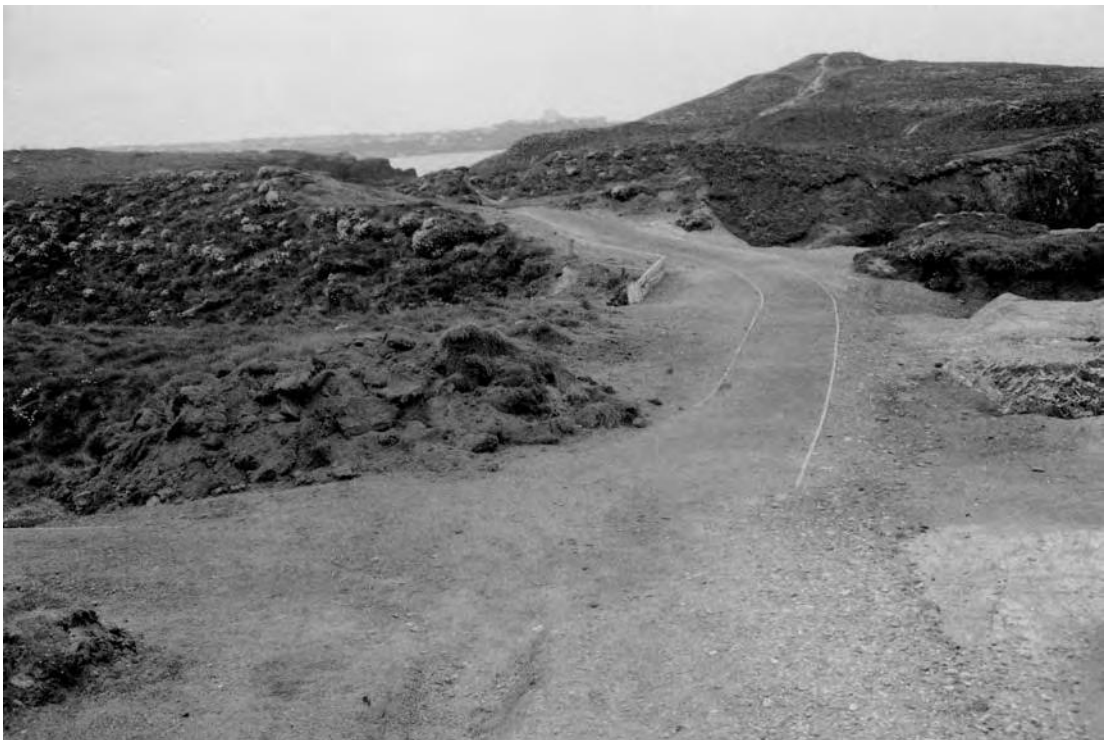
Fig. 30 Footpath through ramparts 3 and 4.
