Trevelgue Head Cliff Castle, Newquay, Cornwall

Management Works 2001-2004

Historic Environment Service (Projects)

A Report for Restormel Borough Council
and English Heritage

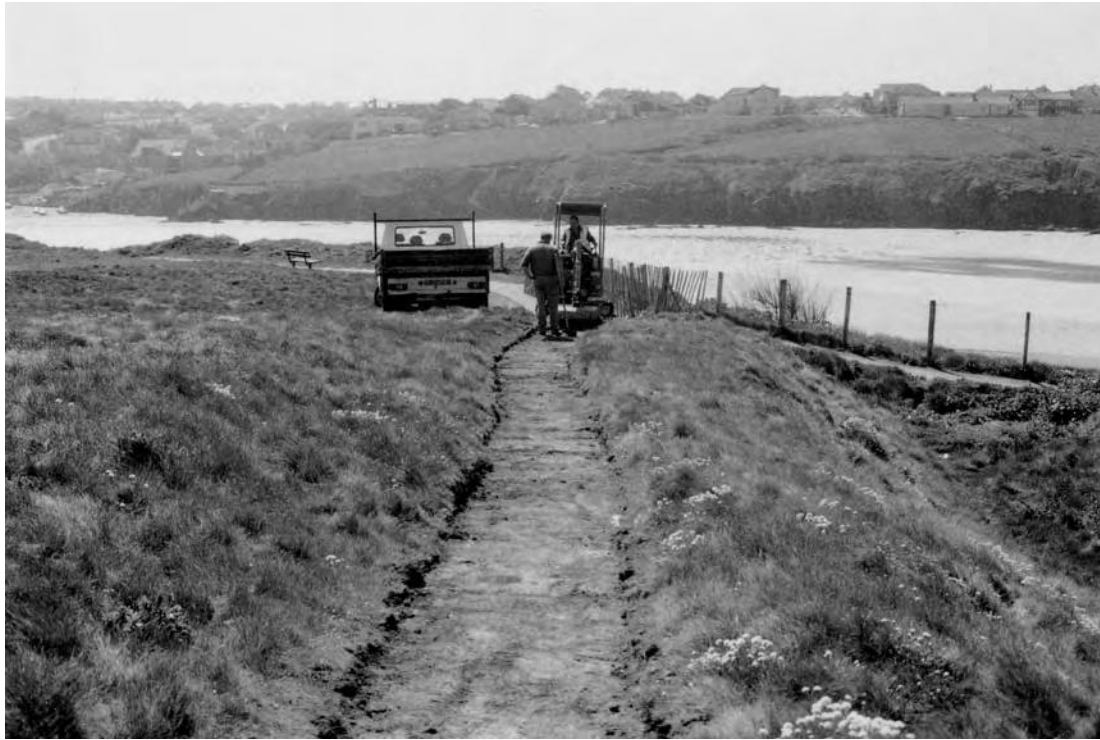
Fig. 31 Construction of new path to east of ramparts 3-5.

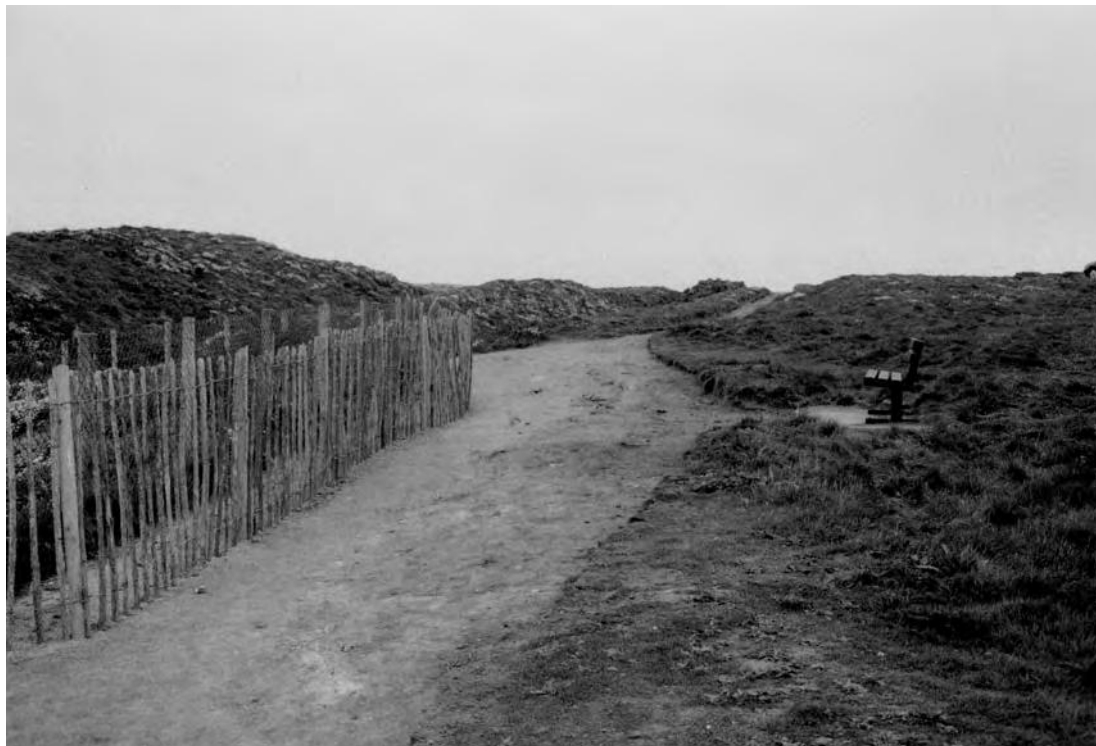
Fig. 32 Modified footpath to east of ramparts 3-5.
