Drakewalls Mine (east), St Ann's Chapel, Cornwall

Report on building conservation works

Report on building conservation works (2008)

Client	East Cornwall Regeneration Project
Report Number	2011R129
Date	December 2012
Status	Final
Report author	Colin Buck
Checked by	AJ
Approved by	AY

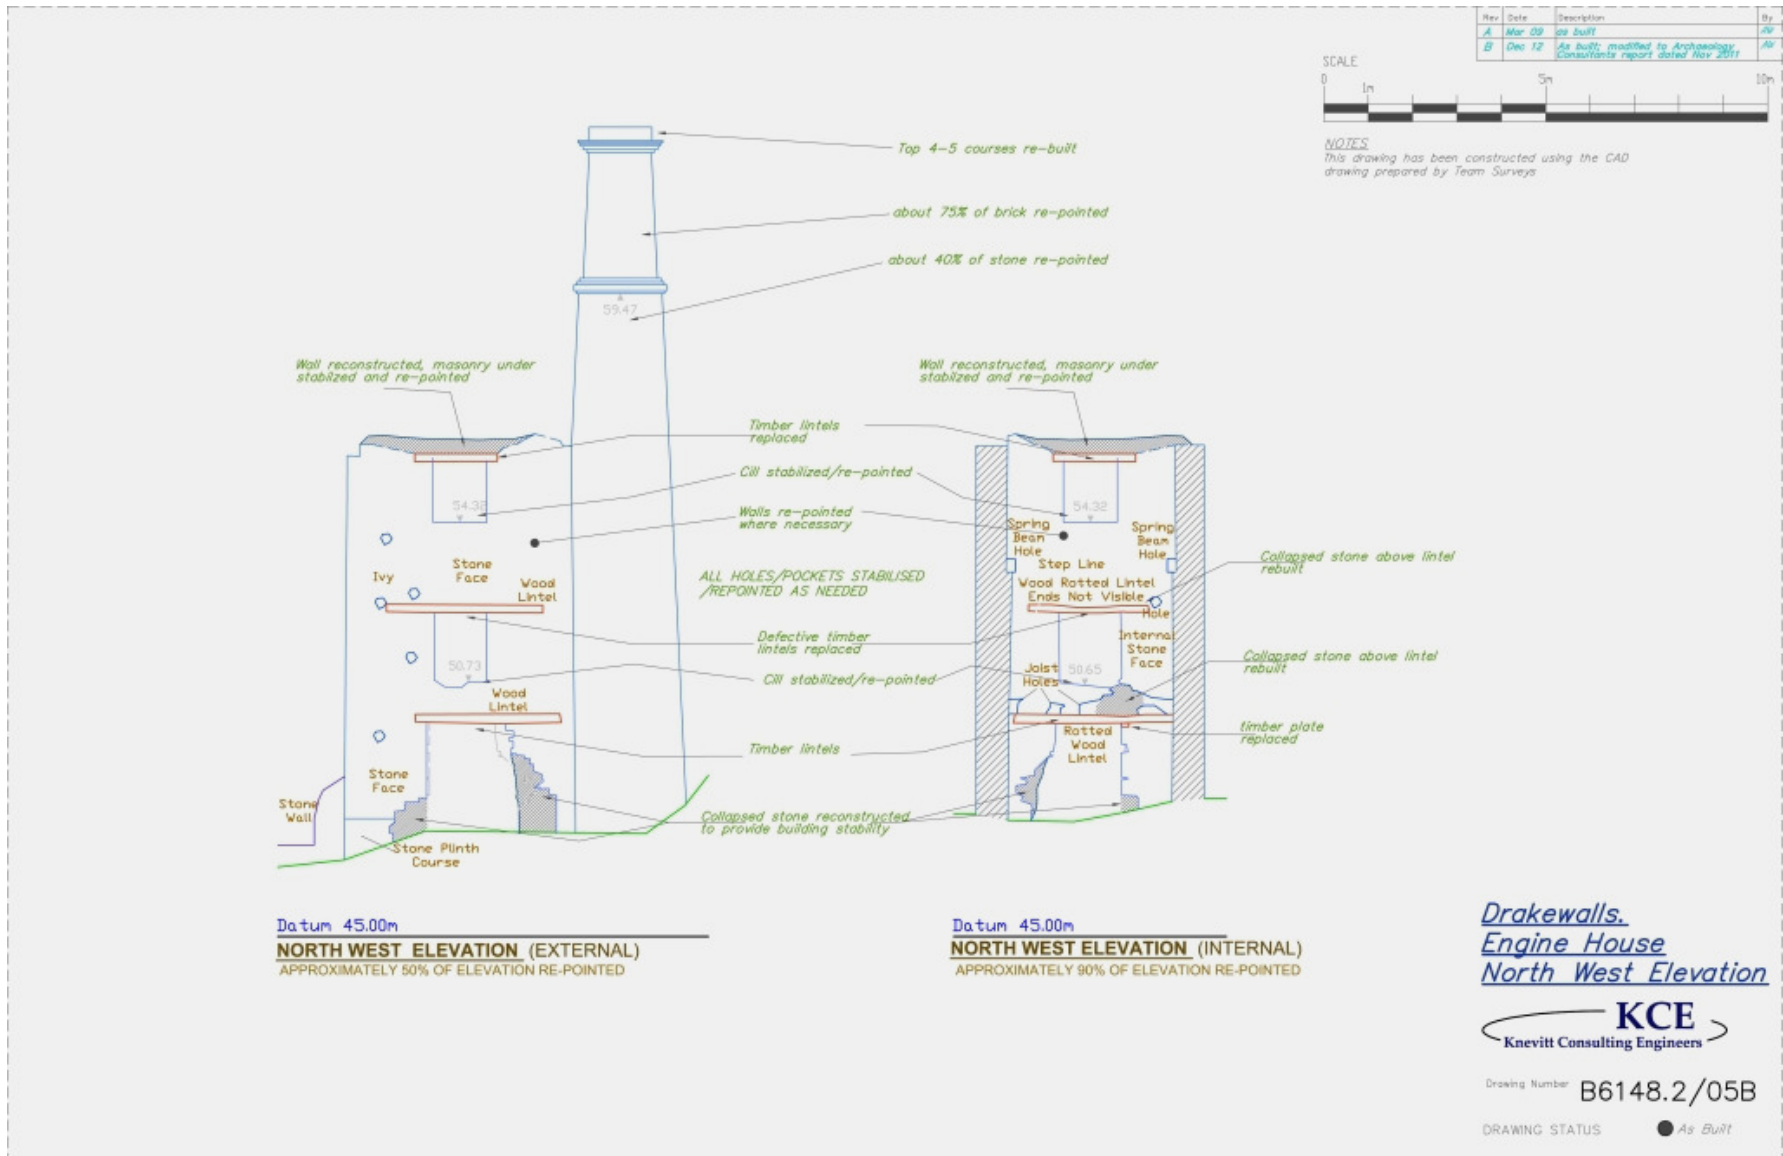
Figure 4 'As built' annotated North elevation survey of the rotary engine house after works (Kneivt Cons. Eng. 2008)

Following erection of the scaffolding, ivy and other vegetation was removed. The north, south and west elevations were all in need of structural repair. The 'As built' survey drawing (Figure 4) shows the details of the replacement of all the timber lintels above the window and door openings. The extent of the rebuild above the upper window opening can be seen (to provide more structural reinforcement), and replacement of missing masonry to the sides of the ground floor cylinder doorway. Photographs of this elevation shows the site before (Figure 5), and after works (Figure 6), visually shows the nature and extent of these works.

The masonry over the top of all the rotted timber lintels was carefully replaced with fallen stone from the building after new sections of tanalised Douglas Fir inserted to mimic the original timber specification. The top of the remaining walls were 'capped' and repointed. The walls were only repointed where there was a structural need to do so (mainly in the upper sections).

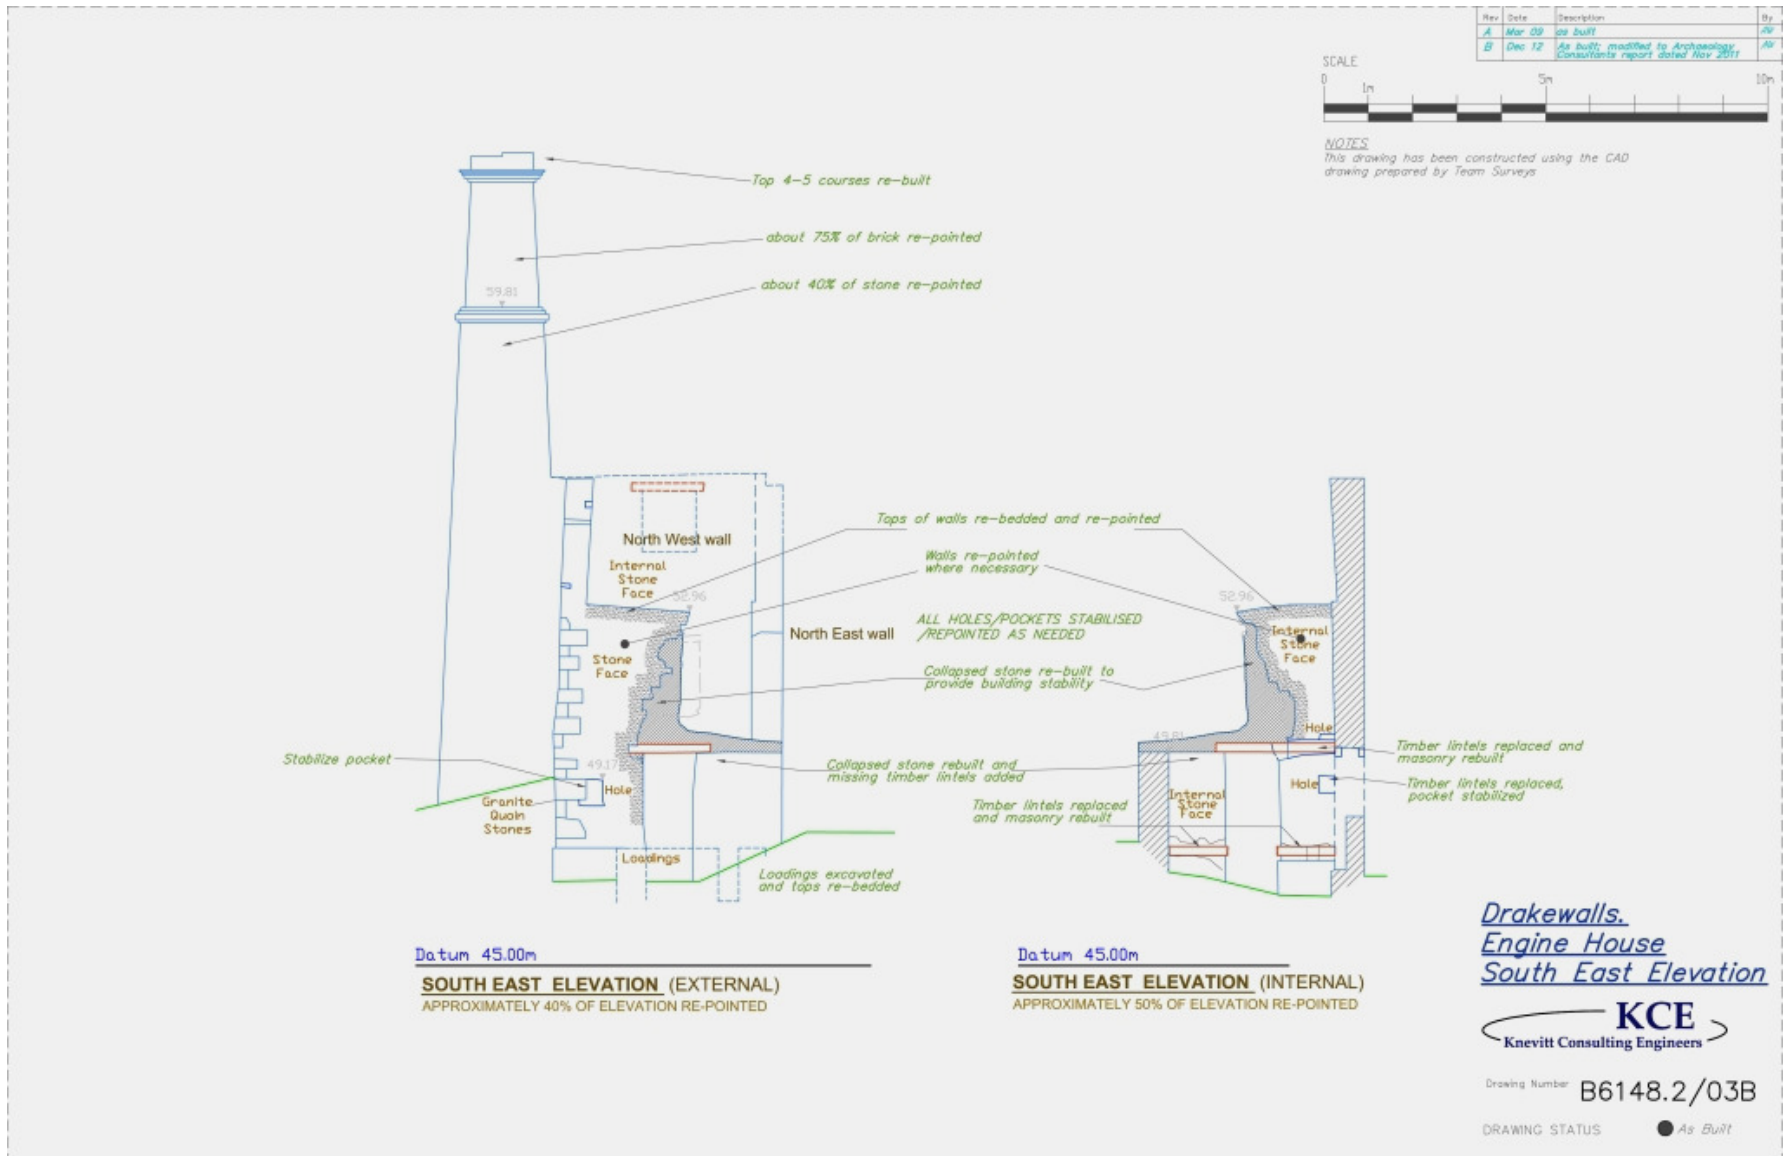
Figure 7 'As built' annotated South elevation survey of the rotary engine house after works (Knevvit Cons. Eng. 2008)

The south elevation was structurally in a poor condition. The extent of collapse can be seen by comparing Figure 8 with Figures 7 and 9. The original profile of this wall can also be compared to the rear cover image. The overhang part of the south wall was slightly reduced and additional masonry built underneath to support as much overhang as possible. In addition, the plug doorway opening lintel was reinstated (to support the masonry above), and additional masonry built over the lintel to provide additional support.

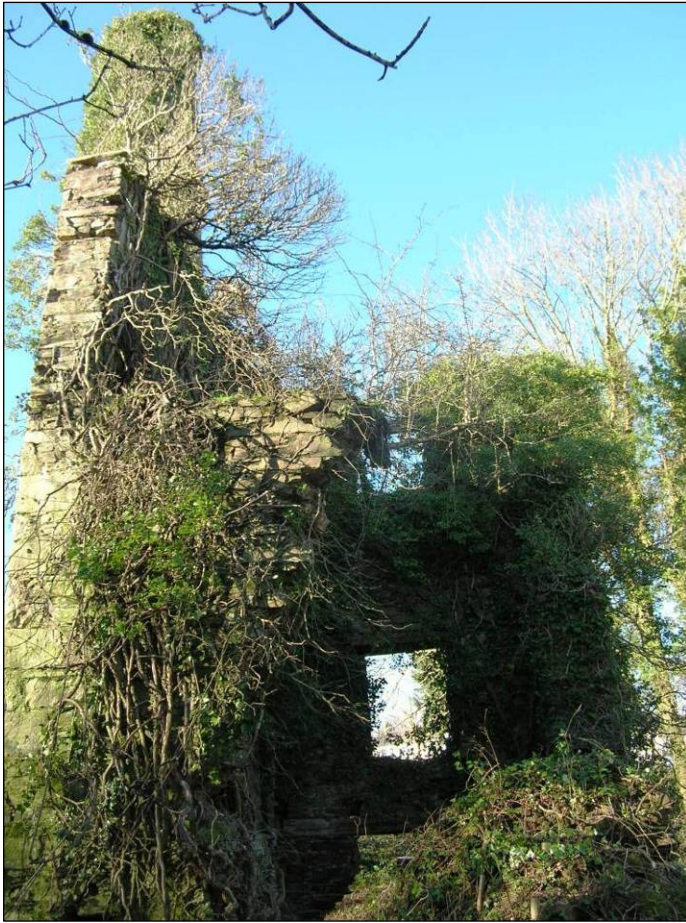
Figure 8 External south view of the rotary engine house before works © CC HE Projects 2008

The south (bob) wall elevation shows that the eastern half of the wall has collapsed and is suffering structurally as a result of its missing large timber lintels at the base of the wall but more importantly across the top of the plug door. Although the western part of the wall is extant it is rather unstable and the undercut collapsed section will need to be partly rebuilt after the lintel has been replaced. The north gable wall will require replacement of all of the timber lintels with new tanalised timber equivalents for the three openings, whilst the east wall (which has partly collapsed) now appears to be structurally sound and will need to be partially repointed. The exterior face of the west wall is showing signs of structural weakness as masonry above rotted lintels are moving downwards, pulling masonry away from the quoin stones.

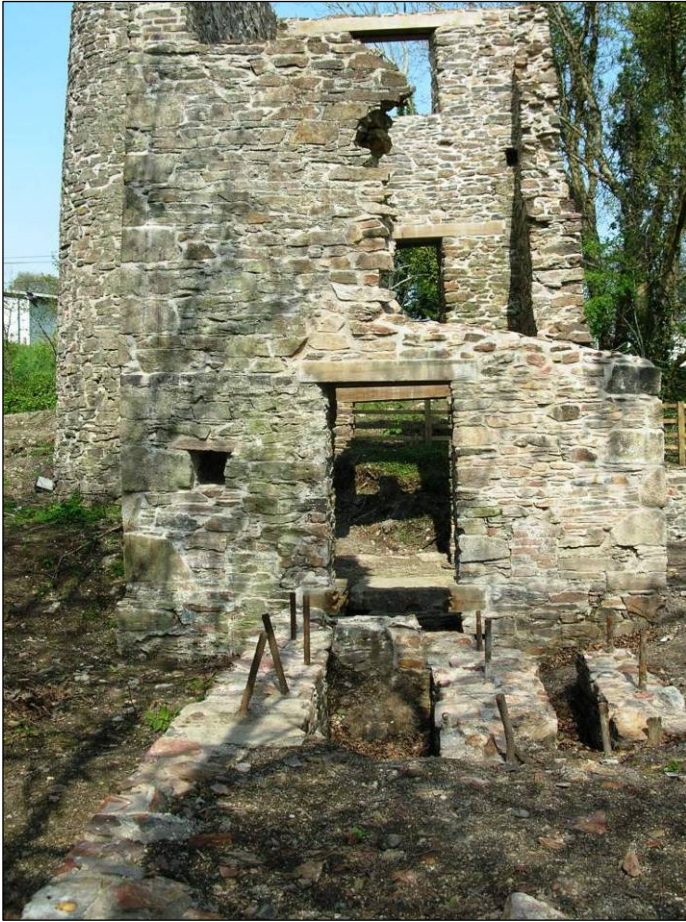
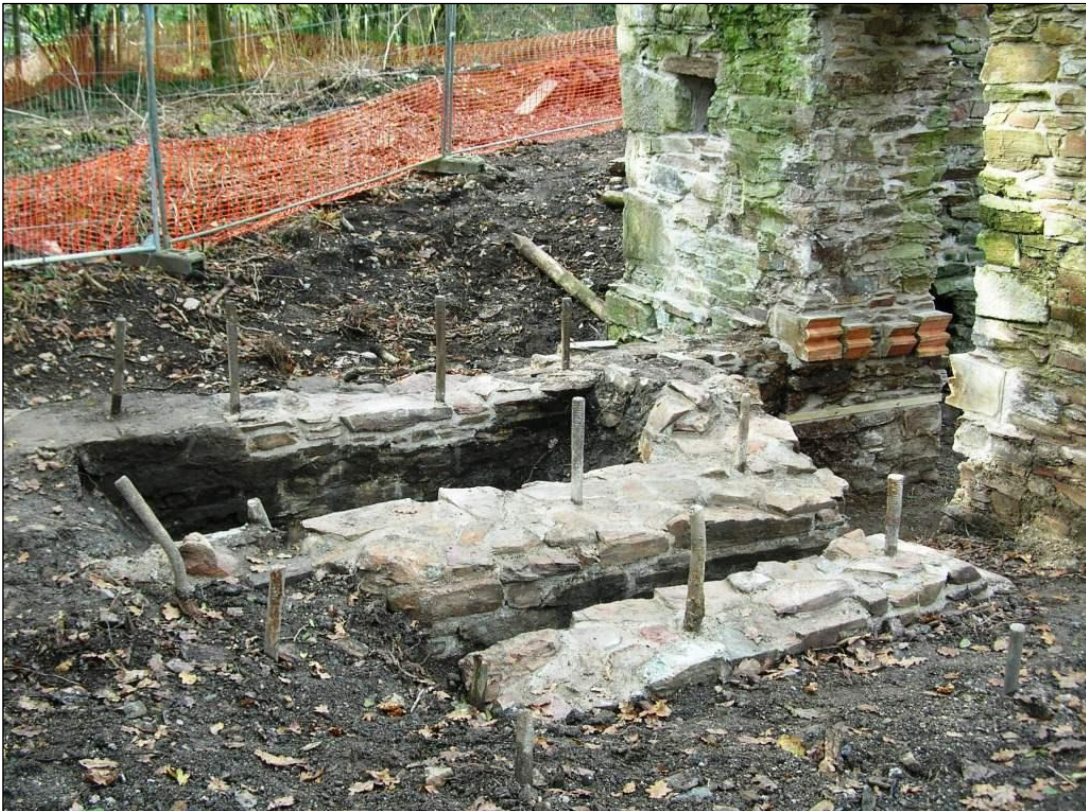
Additional funds were found after the main conservation works to the engine house had finished to expend on the excavation and conservation of the (partly visible) loadings south of the engine house. Work on this started on 22/09/08, using a mini-digger to carefully excavate the earth and masonry rubble (from the collapsed south bob wall), over the loadings and from the flywheel and crank pits. Following excavation, the plan of the loadings is shown on Figure 3. The long masonry wall (west side) is 0.6m deep, whilst the crank pit is 0.8m deep and 2.65m long. The flywheel pit is on its eastern side and is 1.25m deep, 0.33m wide and 1.9m long – although this was partially infilled after excavation to its floor for safety reasons. The long masonry wall was revealed and conserved, as well as its associated loadings wall return. The position of a number of protruding wrought iron bolts from the masonry walls are shown on Figure 3 (an 'as-built' measured survey plan of the winder drum loadings, with annotations detailing the extent of the conservation works). Photographs of the site after excavation are shown on Figures 12 and 13.

The agreed mortar specifications for the engine house were also used for the adjacent crank and flywheel pit with loadings masonry. The top of the remaining loadings and walls were 'capped' and repointed. The walls were only repointed where there was a structural need to do so (mainly in their upper parts). It is probable that the winder drum was located on the east side of this feature – marked by a solitary protruding wrought iron bolt. Unfortunately there was insufficient funding to excavate and conserve this feature – although little is visible of its former masonry sides. By 24/09/2008, all the major lime repointing works to winder drum loadings had been completed, the surrounding area landscaped to permit safe public access.

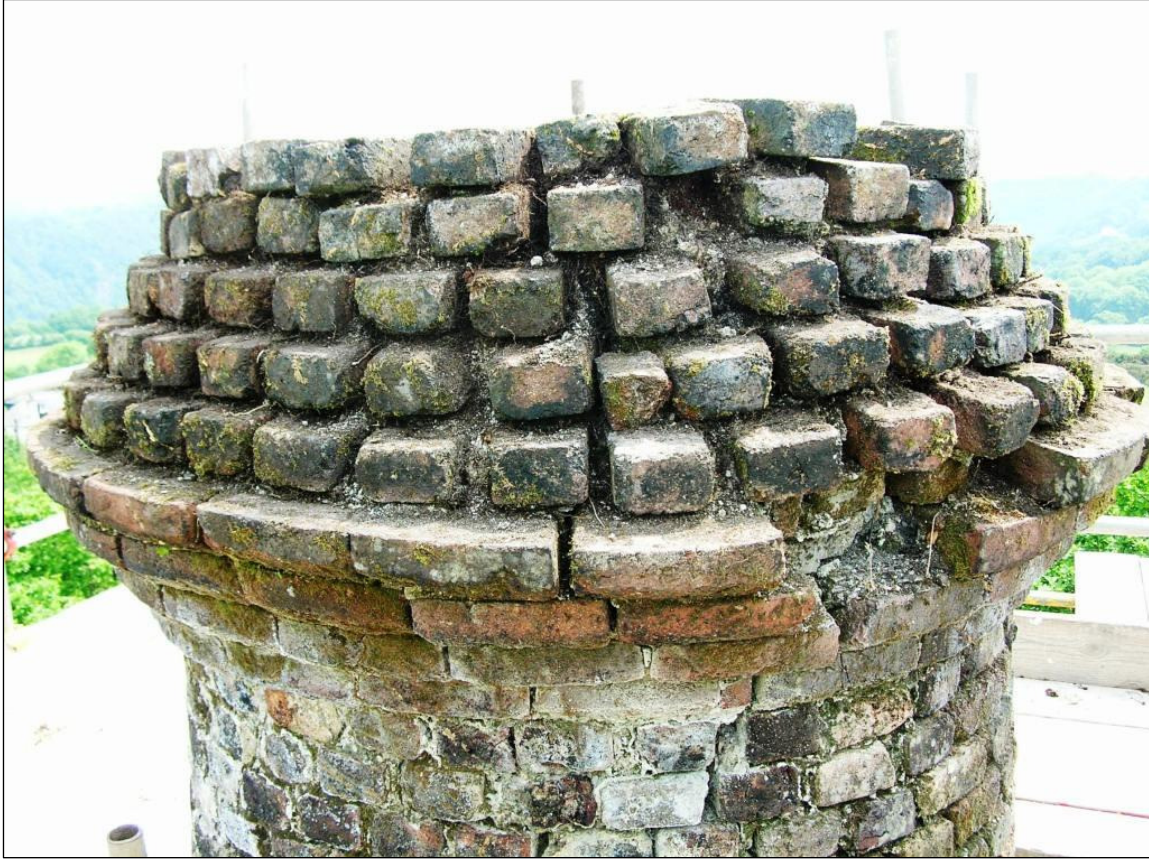
Figure 14 External view of the chimney top before works © CC HE Projects 2008

The main impact on the fabric of the building is likely to focus at the top of the chimney where weather erosion is more likely to have affected the stability of the masonry, but more particularly the lime mortar. Soft and crumbling mortar will be removed (to a maximum depth of 40mm), from the masonry walls following a detailed site assessment of the feature by the site contractors. Following approval of an appropriate mix of lime mortar and an aggregate to match the existing, the site contractors will repair any defective stone or mortar. This may entail renewing the top 'capping' of the chimney (approximately 12m high) – which has not been closely surveyed due to the dense ivy.

Ivy and vegetation covered and obscured part of this chimney (see front cover and Figure 8). Once scaffolding was erected the ivy was removed. The sides of the chimney were repointed with mortar, and rebuilt (especially at the brick top) where necessary, although some small openings were left for bat roosting and bird nests. Figures 14 and 15 show the top of the brick cornice both before and after works. Given the state of the brickwork, the top four brick courses needed to be entirely rebuilt.

Following removal of the ivy and a structural assessment, it is recommended that the chimney is repointed with a lime mortar where necessary and a lightning conductor attached. If the flue opening is visible it may need to be grilled.

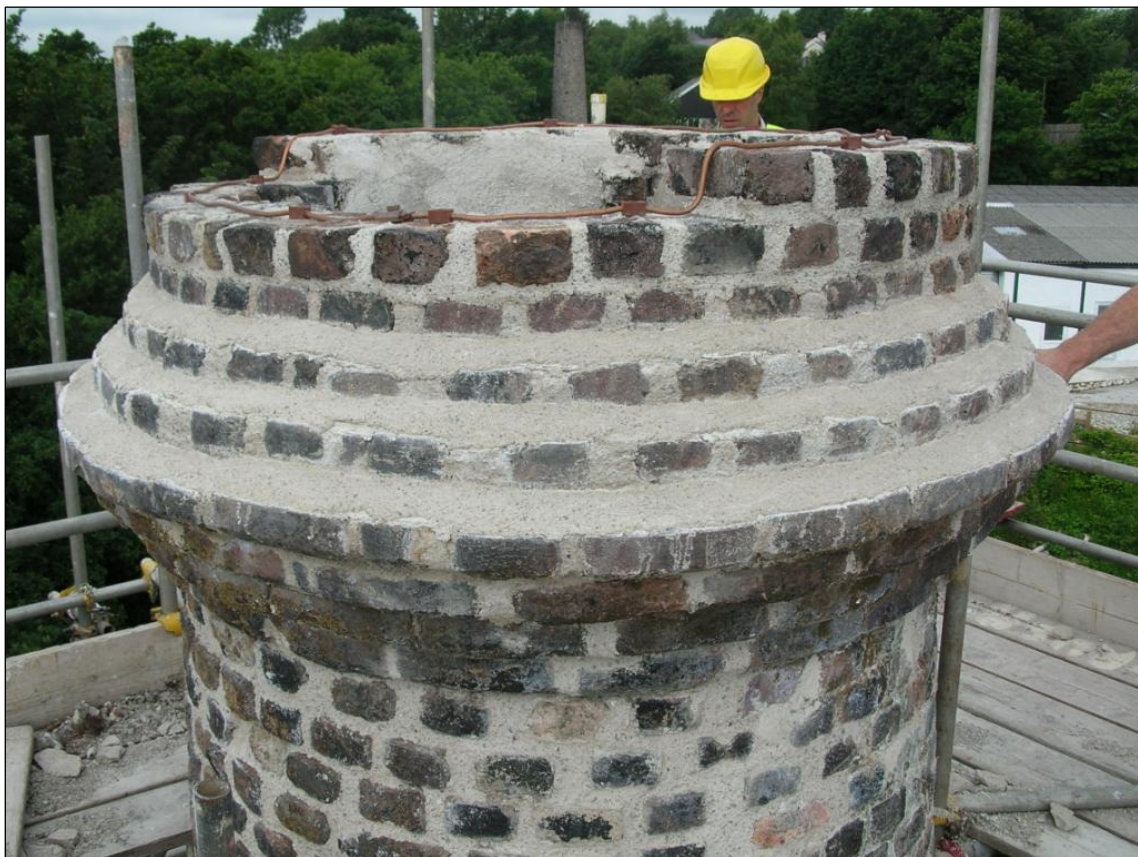
Figure 15 External view of the chimney top after works © CC HE Projects 2008

Before the scaffolding was removed in mid July 2008, a copper lightning conductor was fixed around the top brick course (see Figure 15) by contractors (Dawson Ltd), and connected to a copper tape that was fixed vertically into the internal side of the chimney, exiting through a small hole that had to be cut/drilled through the south-west side of the chimney.

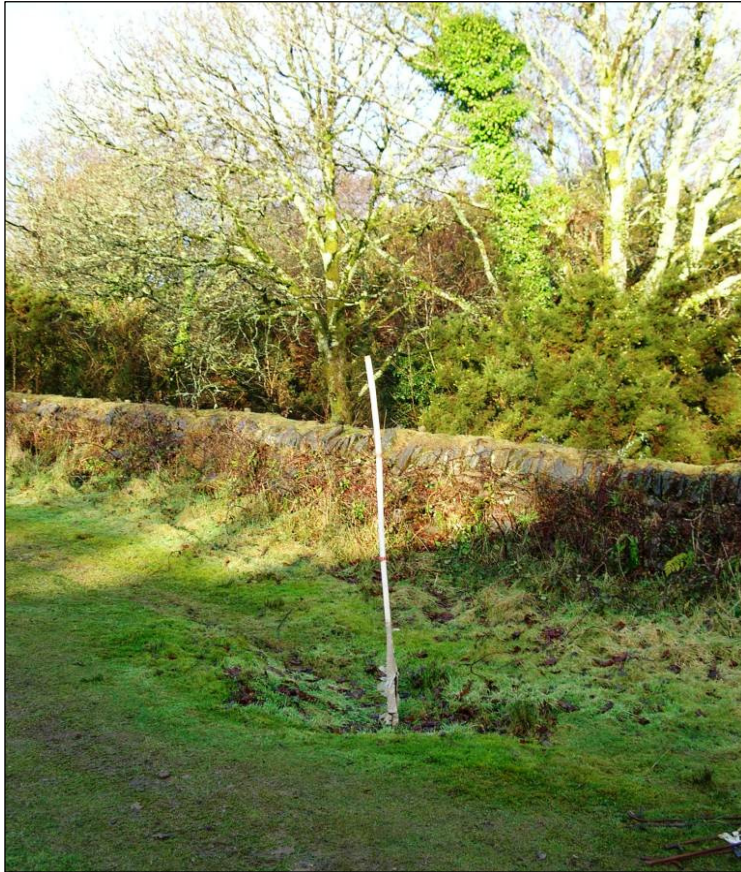
Figure 23 A view of the surface depression before site investigation (from the south east) © CC HE Projects 2009

During the excavation phase of the Tamar Valley Centre and the creation of temporary waste dumps (see Figure 22), a slight depression was observed. The site was temporarily fenced off during the site works. Sherrells Ltd (geotechnical mining engineers of Tavistock) were asked to undertake a small site investigation with a mini-digger. This took place on 13/01/2009. The small collapse was approximately 1.3m x 1.1m and 0.7m deep. It is sited 2.7m from the adjacent hedge encircling the south side of the gunnis (as shown on Figure 23). The feature was excavated to a depth of 1.5m and a length of 3.0m, with two trenches cut across the feature (see Figure 24). No definite conclusions were reached, except that it was probably a shallow pit or trench that had collapsed – possibly as a result of the previous landscaping works in 1995 that had covered a shallow void – which subsequently collapsed in late 2008. The site was backfilled.
