St. Ruan's Well, Grade, Cornwall

Conservation and Landscaping

March 2003

Report No: 2003RO27

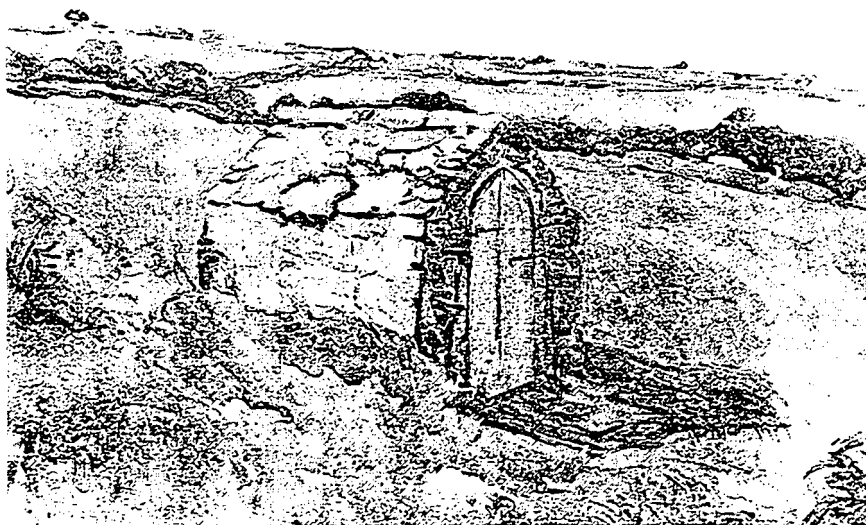
Figure 5. Copy of a watercolour of St. Ruan's Well, Grade, in about 1925. The watercolour is in the possession of Joanna Mattingly.

A photo held by the Royal Institution of Cornwall and a watercolour owned by Joanna Mattingly (reproduced here in Fig 5) shows the well at the same time as Henderson was writing. Again, it appears much as it does today, although the surroundings are grassy, not scrub-covered. The well has a simple plank door, which is padlocked. On the front elevation, the pointing with lines incised in it to emphasise the joints is visible, but in other places, for example on the right hand gable, the pointing is in poor condition.

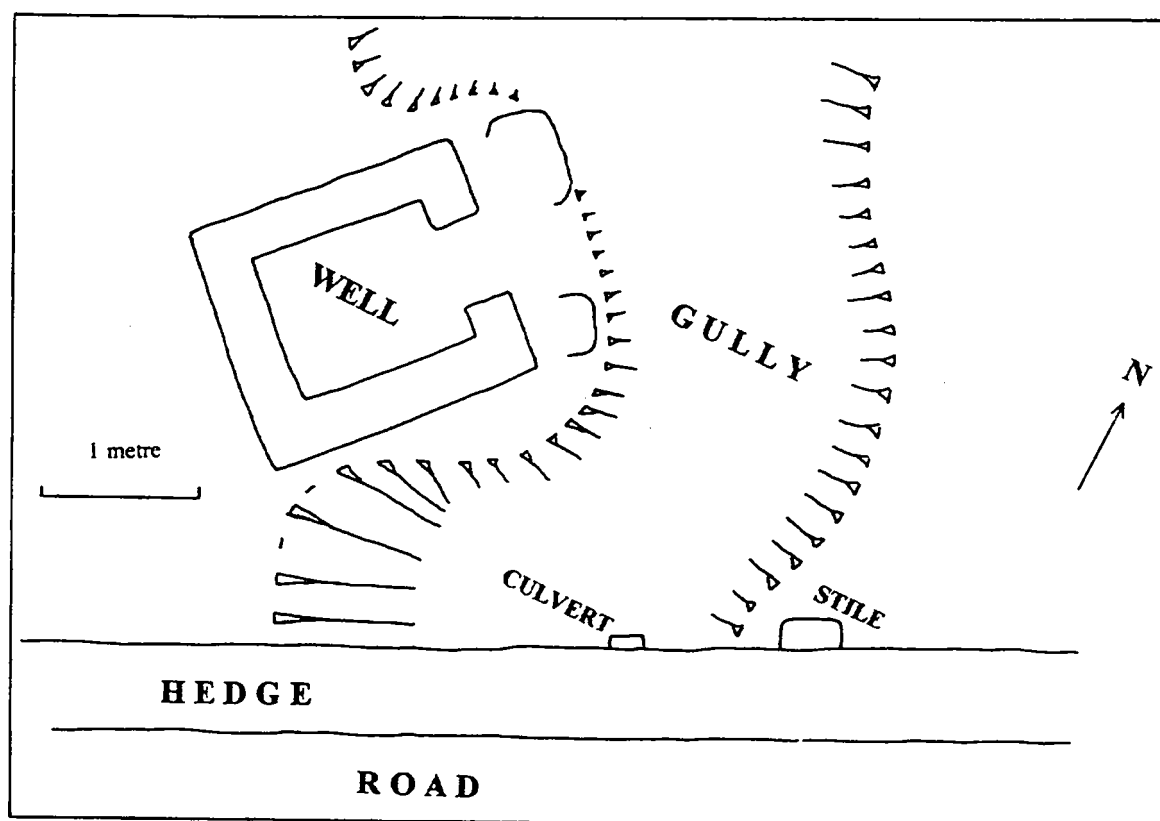
The setting of the well had also deteriorated. Access had become difficult because of gullyng caused by a thoughtlessly-sited drain from the adjacent road. Bramble, gorse and thorn had grown up, on and around the well, while very boggy ground added to the problems. Overall, the monument appeared overgrown and neglected.

Figure 10. Sketch plan showing the extent of gulying in front of the well-house, before restoration of the ground.

Over the top of the backfilled areas, a layer of three-quarter inch gravel and earth was laid, to help form a firm but well drained surface. A few larger blocks of stone were set randomly in this to form stepping stones, should the ground become boggy again in the future, and finally, grass seed was scattered over all the bare areas.

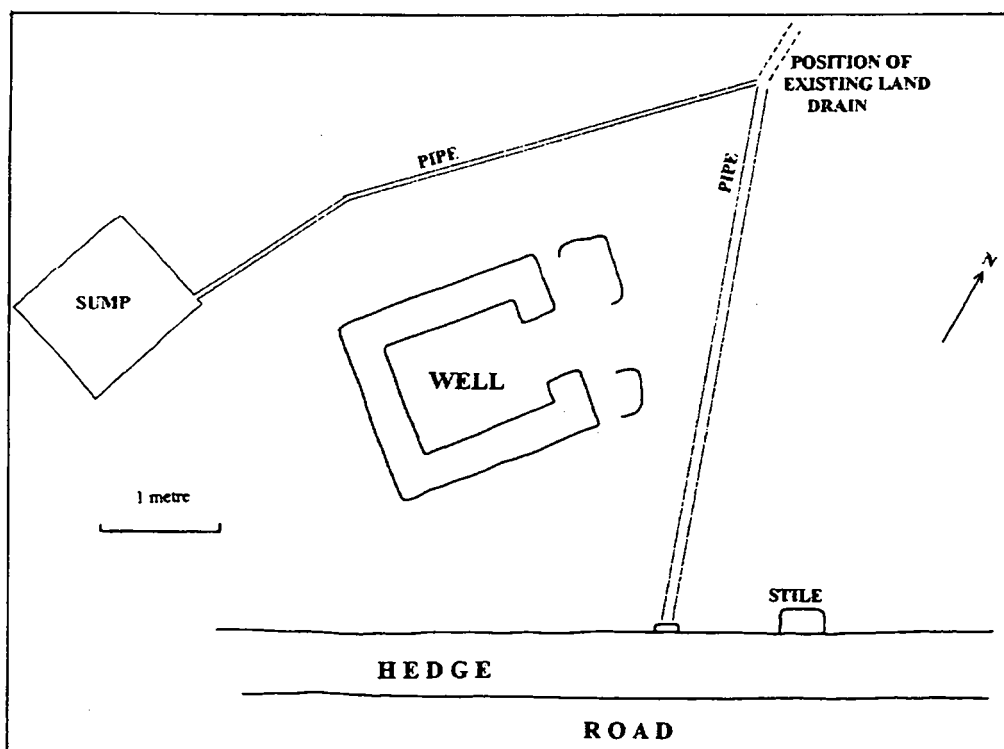
Figure 11. Sketch plan showing the position of sump, trenches and new pipework.

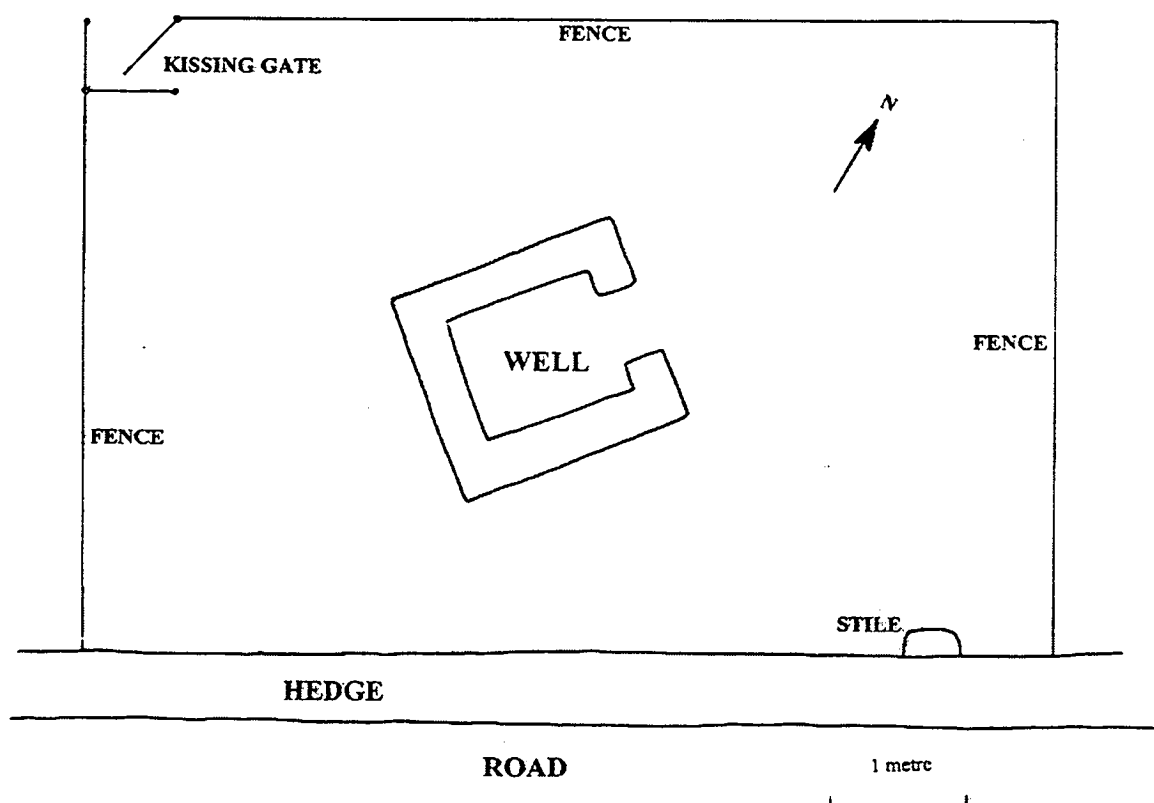
The size and shape of the enclosure created around the well is shown in Fig 12. Overall, it measures 8 metres by 5.5 metres and is at least two metres from the well-house in all directions. To accommodate the public footpath which leads into the enclosure from the road on the south, a small kissing gate was fitted in the western corner of the enclosure. Owing to the uneven fall in the ground towards the north, the fence proved difficult to fit

Figure 12. Sketch plan showing the position of the new fence and kissing gate.

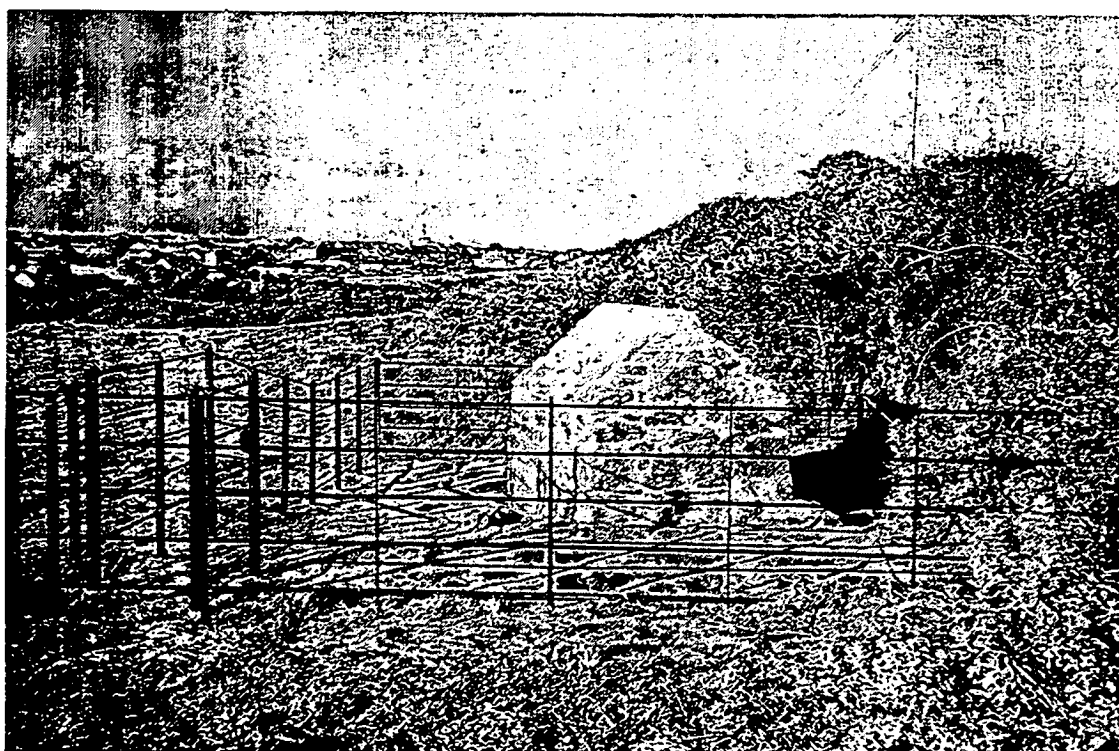
Figure 13. The new fence at St. Ruan's Well, Grade, shortly after construction and before tufting of the enclosure

to the slope and in places, particularly adjacent to the kissing gate, is perhaps a little too high. Nevertheless, this does not detract significantly from the appearance of the site as a whole.

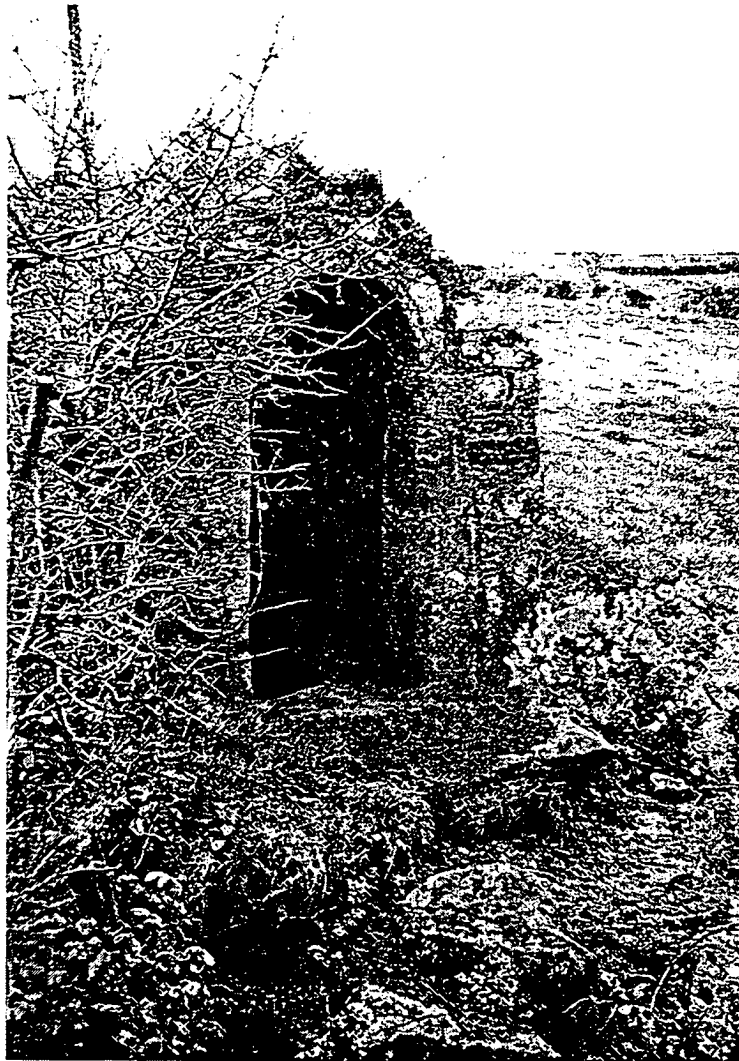
1. The largest areas of missing stones were to be found on the western edge of both roof slopes, and it was within these areas that the greatest bramble growth was found.

2. On the north-east corner of the roof's eastern slope, approximately four of the uppermost edging stones were missing.
3. Approximately 75% of the pointing mortar of the two roof slopes had either cracked or disintegrated, and most of the stones had become displaced due to the ingress of soil, water, and vegetation.

4. Excavation around the base of the walls revealed many entry points of mature bramble root systems. These were growing within the earth core of the walls, where they caused disruption to many of the adjacent stones. The bramble roots also extended well up into the roof structure, growing between the inner vault structure and the flat outer facing stones. This had caused some of the flat outer stones to disintegrate, and was clearly the cause of the areas of missing stone on the sides of the roof slopes.

Fig 14. The well-house in 1997, before repairs.

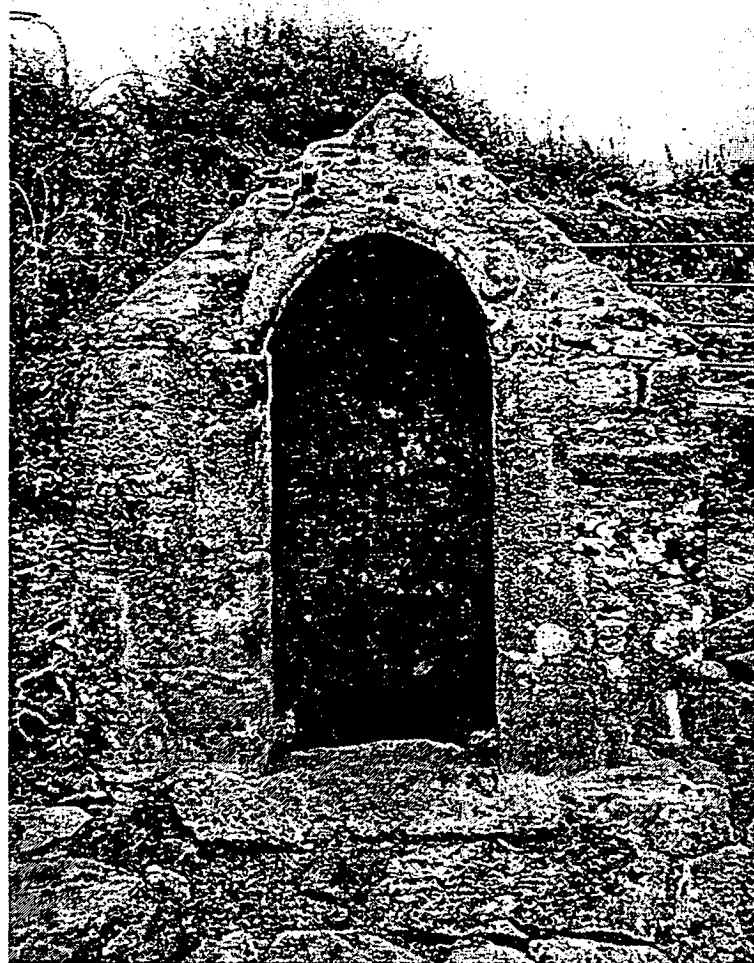
Figure 15. The well-house in 2001 following restoration (but prior to re-turfing of the enclosure)

3. All the outer facing stones of the roof and the four granite ridge stones had to be removed as vegetation penetration and mortar disintegration was found to be so extensive. These were set out on the ground in numbered positions, to enable them to be correctly replaced. All deteriorated mortar, and much earth and vegetation were then removed from the roof.

4. The stones were then replaced in order to plan the rebuilding of the roof. Some new stone was needed to fill holes and three of the existing slabs were re-aligned to fit the way the roof is believed to have been originally designed (ie with the long axis set vertically, not horizontally).

10. The facing stones of the roof were replaced individually, bedded on mortar of appropriate thickness.
11. The ridge stones were re-set in their original positions.

12. Finally, all stones on the roof slopes and ridge were re-pointed, followed by the open joints in the walling stones.

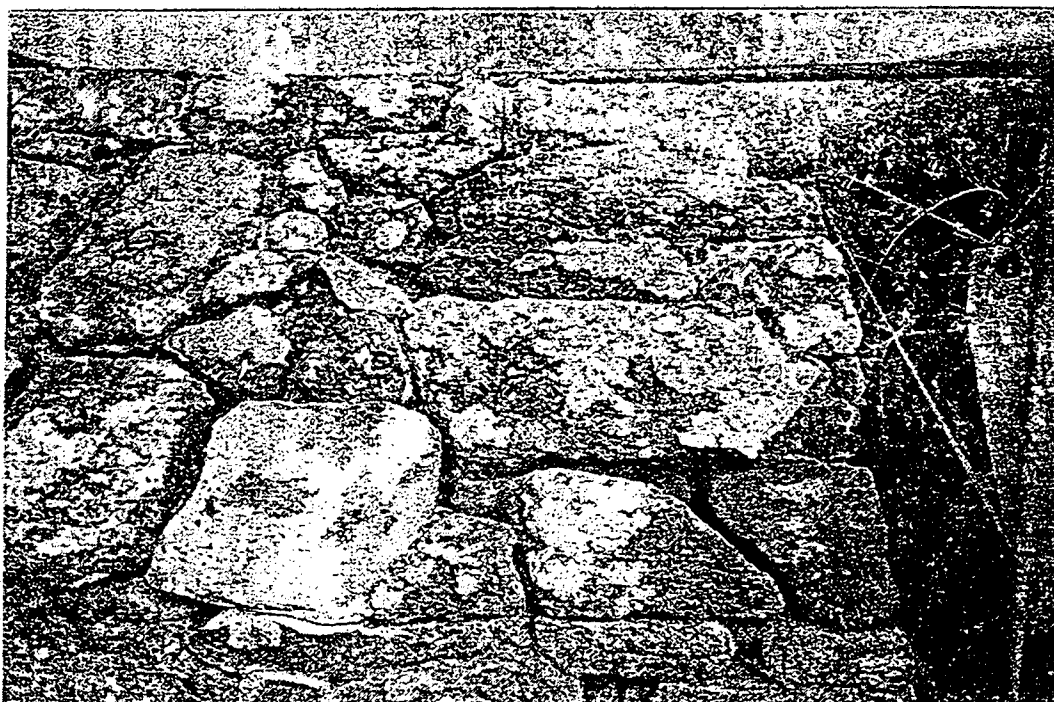
Above: The northern roof slope. The three horizontally positioned facing stones at odds with the vertical design. Also area of missing stones to the right.

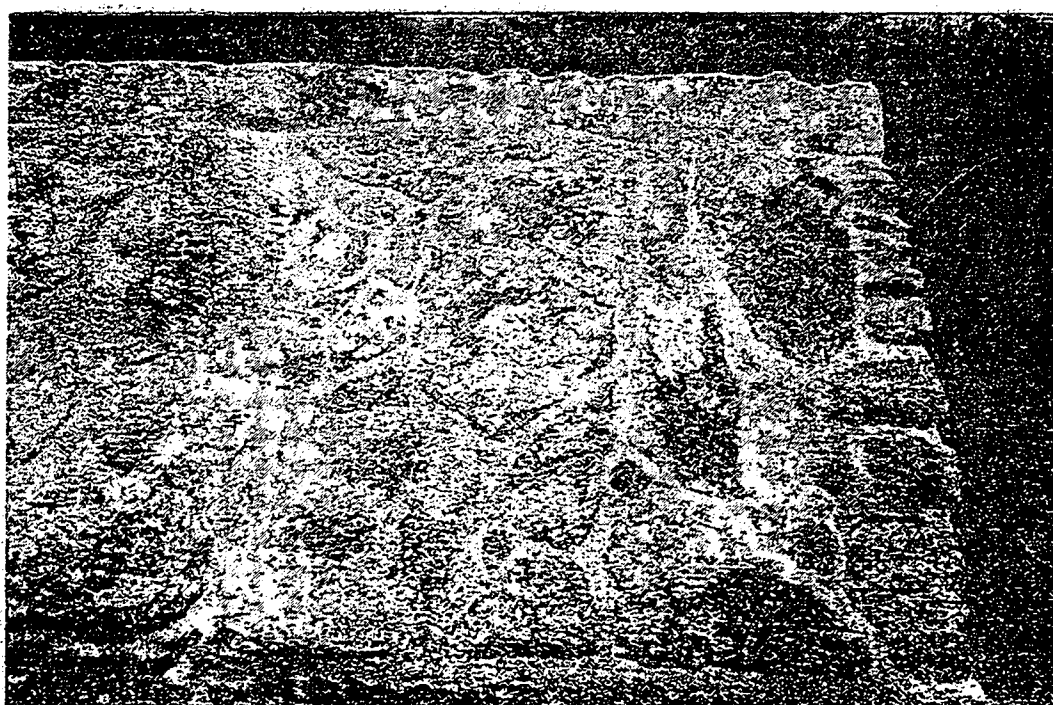
Below: After re-construction showing re-alignment of facing stones, and replacement stones on western edge of roof.

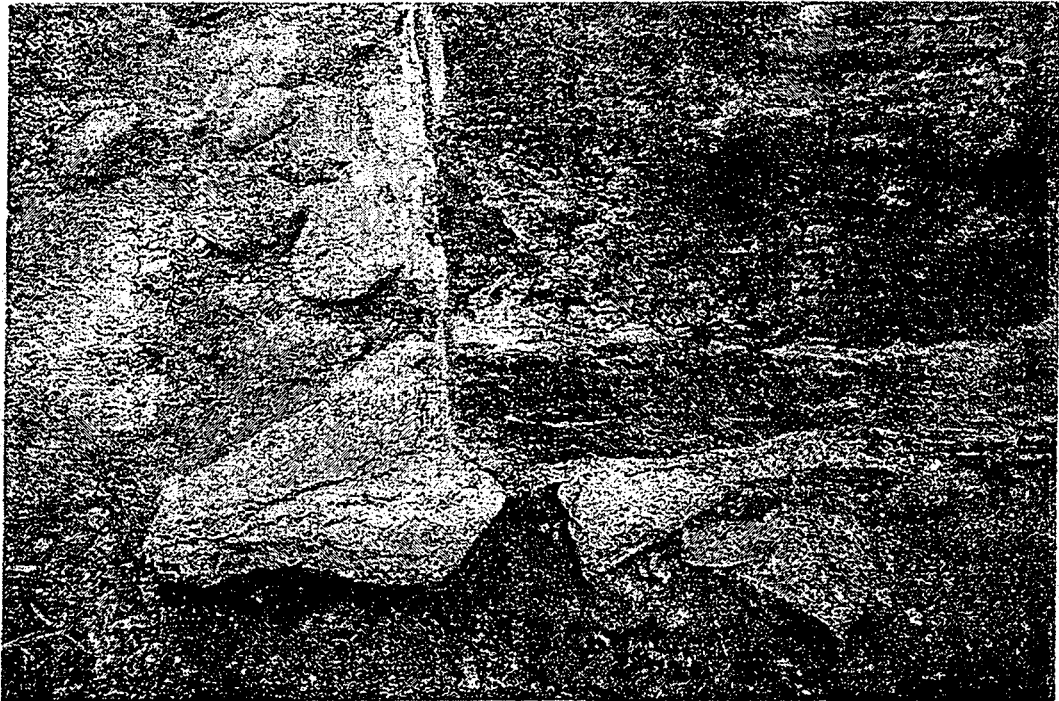
3. Outside the south-west wall, an area of small random stones was interpreted as possibly the covering for an earlier culvert.
4. Several pieces of evidence were found indicating that the southern end of the roof had been rebuilt at some time in the past. This evidence included:

Above: The south-west corner at foundation level showing the random nature of the supporting stones. Possible culvert covering in background on west elevation.

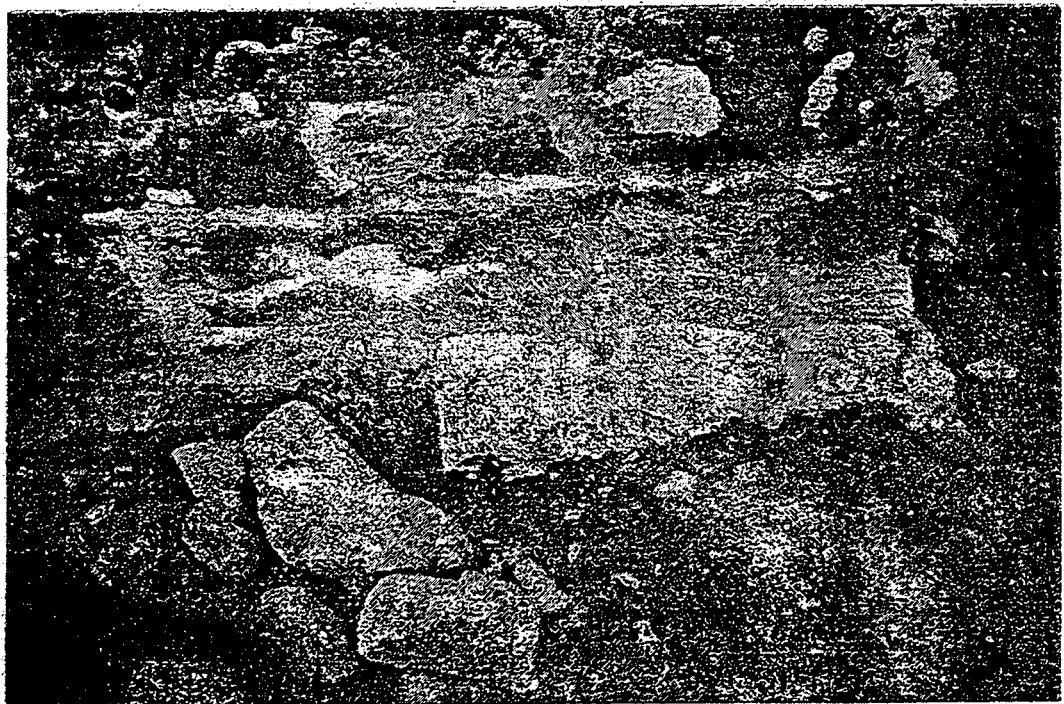
Below: Better quality supporting Serpentine stone in foundation of north elevation.

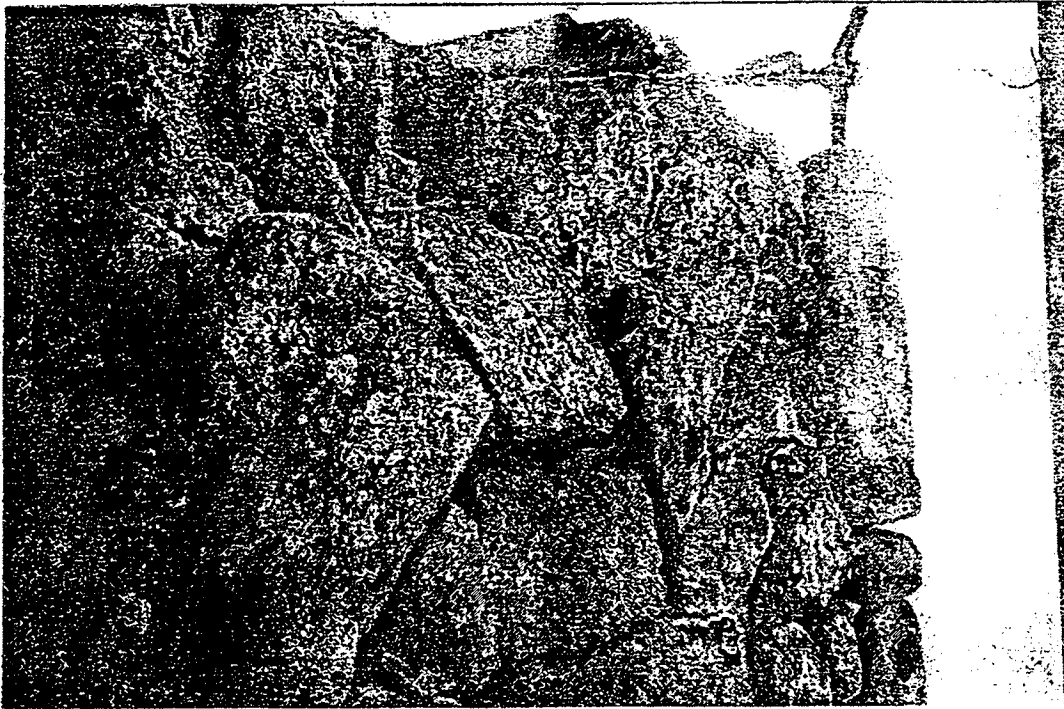
Above: The south-west edge of the roof, showing area of missing stonework, just prior to rebuilding.

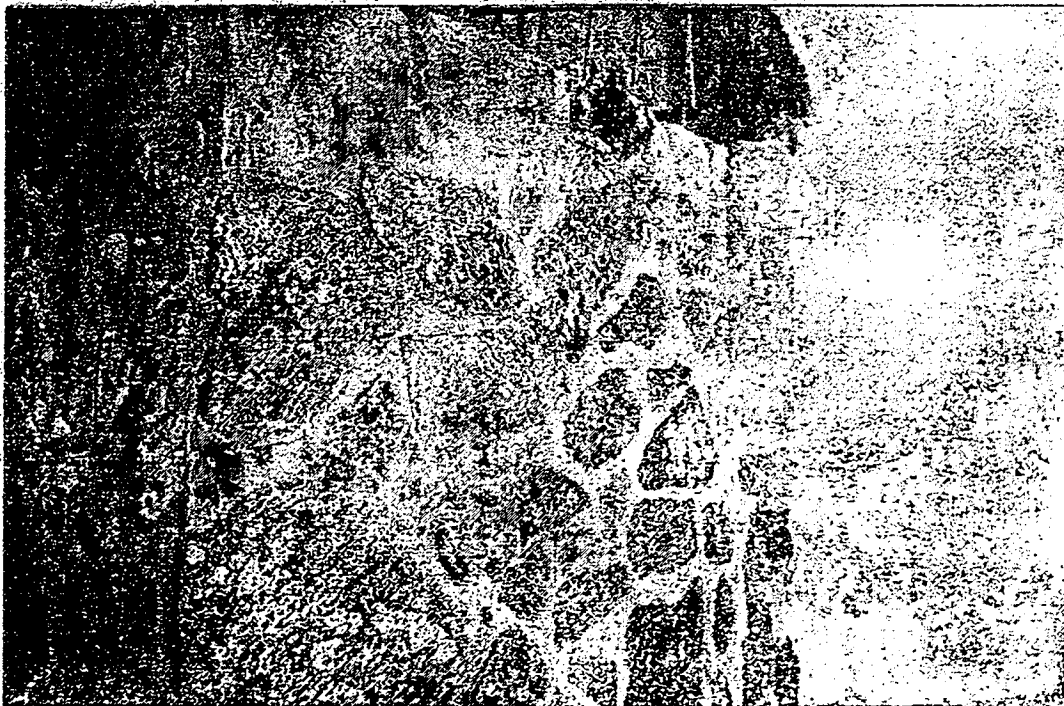
Below: After re-building and pointing.

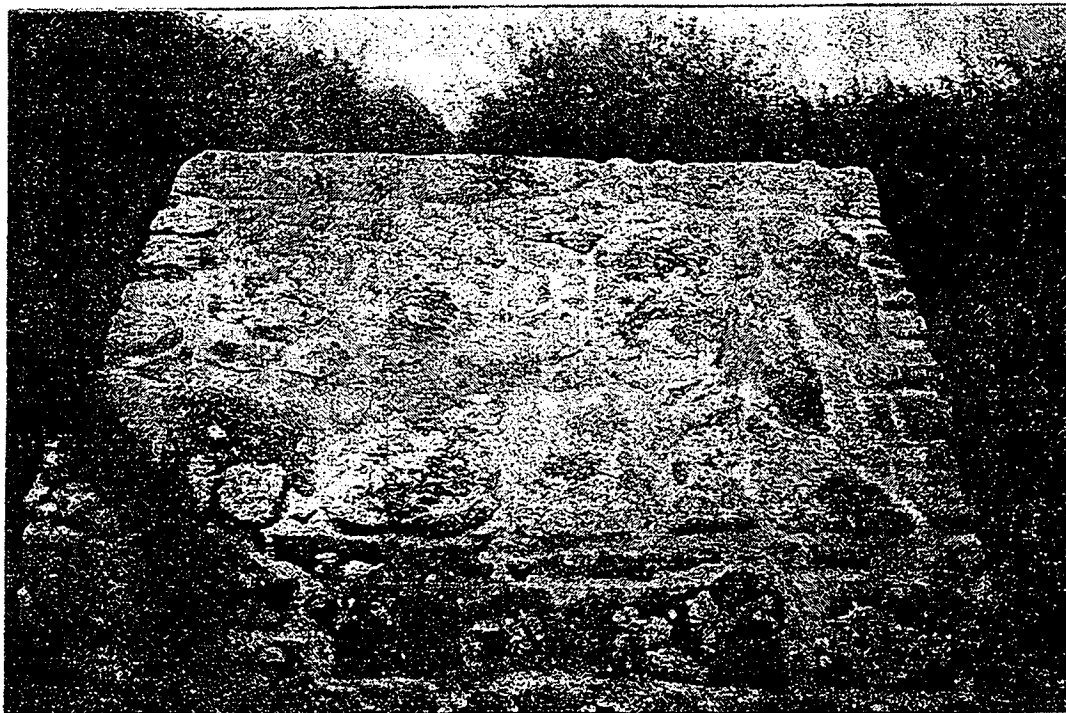
Above: The completed north facing slope of the roof.

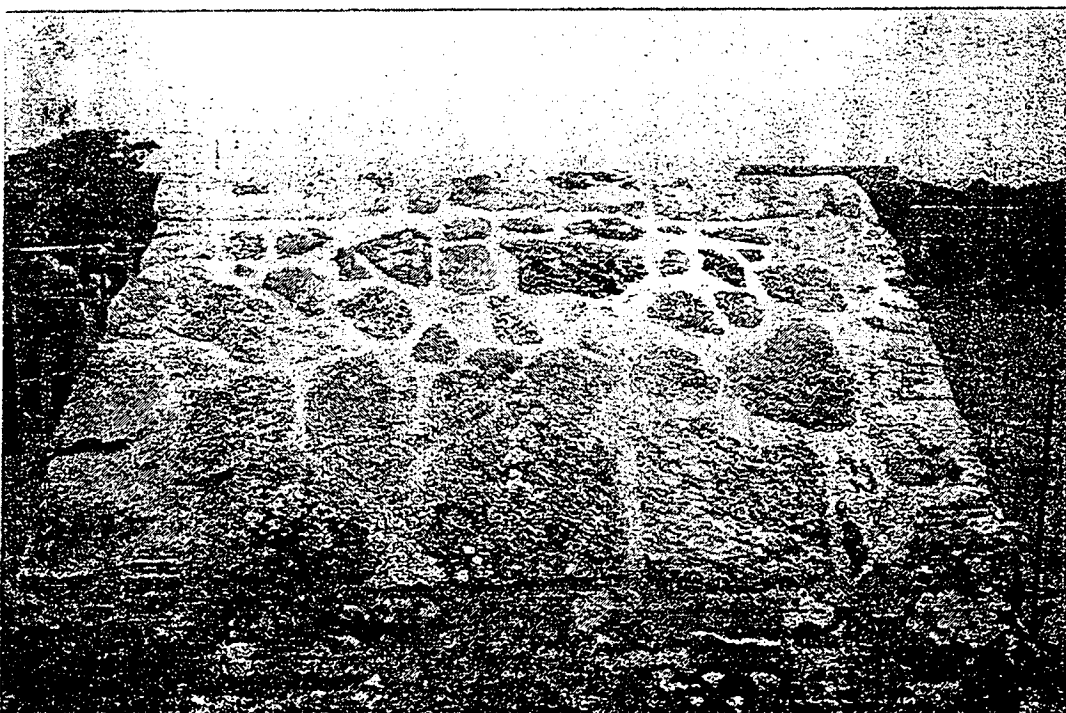
Below: The completed south facing slope of the roof.
