# St. Piran's Church, Perranzabuloe, Cornwall

## Excavation of test pits

September 2004

Report No: 2004R059

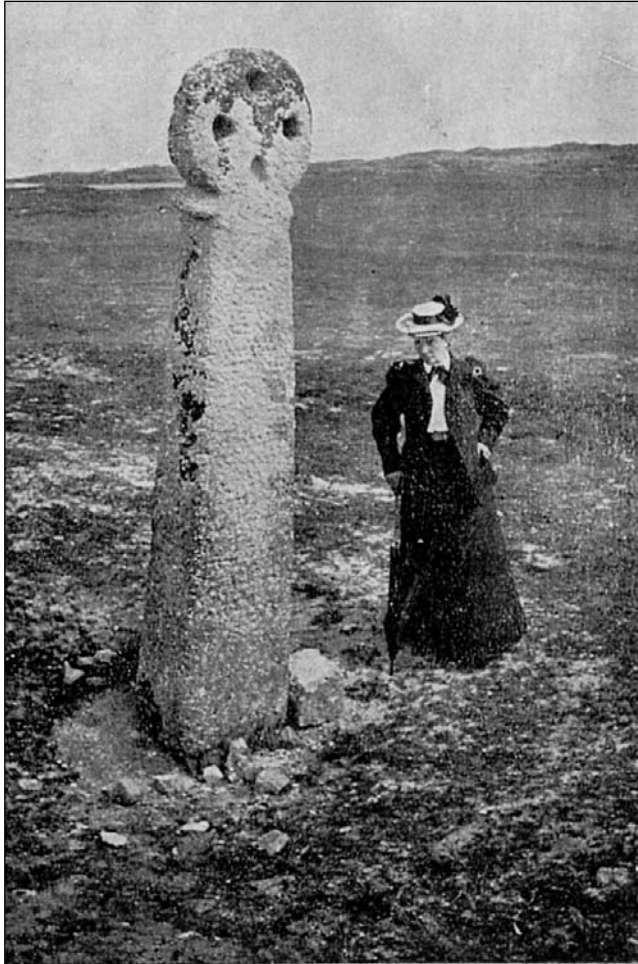
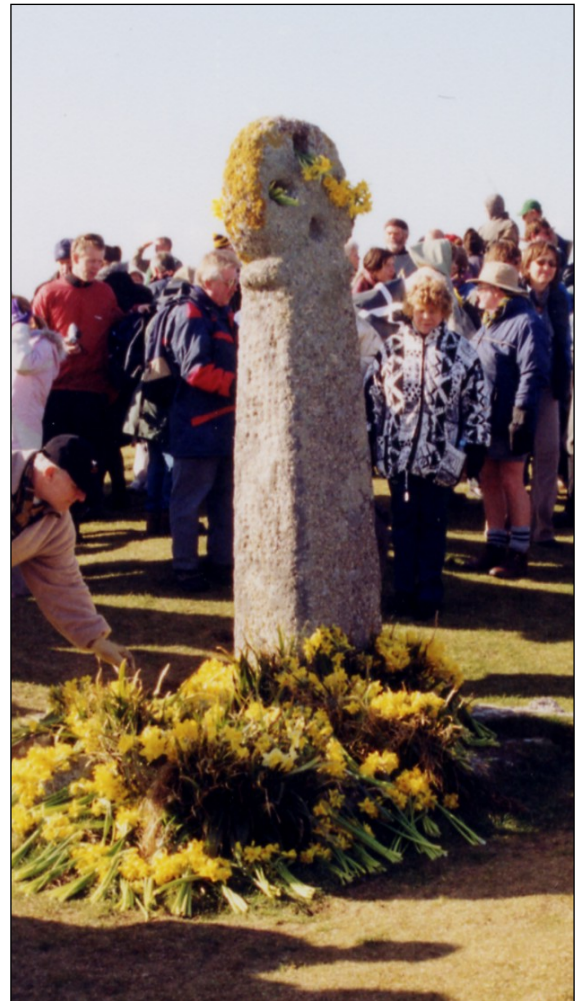
At the present time, levels within the church vary considerably (see Section 5.3). The east end, which was most thoroughly excavated, is lowest while the deposits in the west end are up to 1.5 metres higher. Comparison with historic photographs from the early 1920s (Figs. 3 and 4) do however show that there has been a considerable build-up of sand in the eastern part of the building since the end of that early excavation. Trenches along the northern wall of the nave and around the remains of the tower as well as along the position of southern wall of the nave aisle can still be noted, which demonstrates that the profile of the landscape in this area has otherwise remained relatively stable since Dexter's excavation.

*Figs. 5 and 6      St. Piran's Cross c. 1890 and 2004, showing ground levels have changed.*

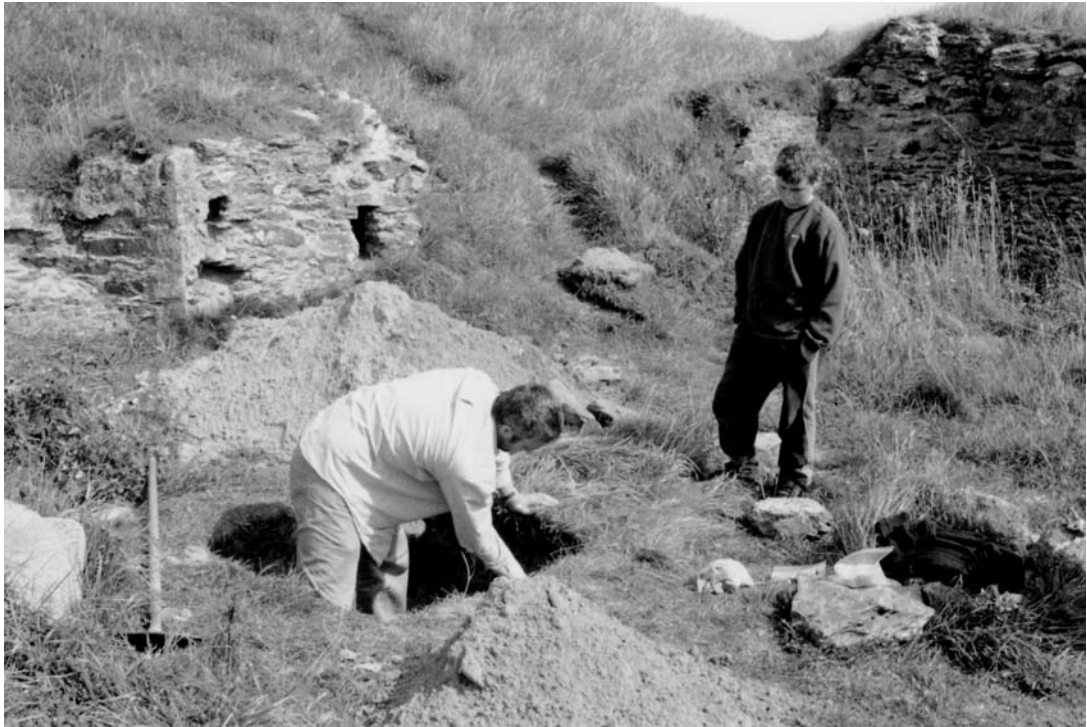
The test pit did encounter evidence of both the chancel floor and disarticulated human remains. Originally 1.0m<sup>2</sup>, the test pit was extended to the west by 0.3m in order to more fully understand the remains of the floor layer that was found.

*Fig. 7      Excavation of test pit 1.*

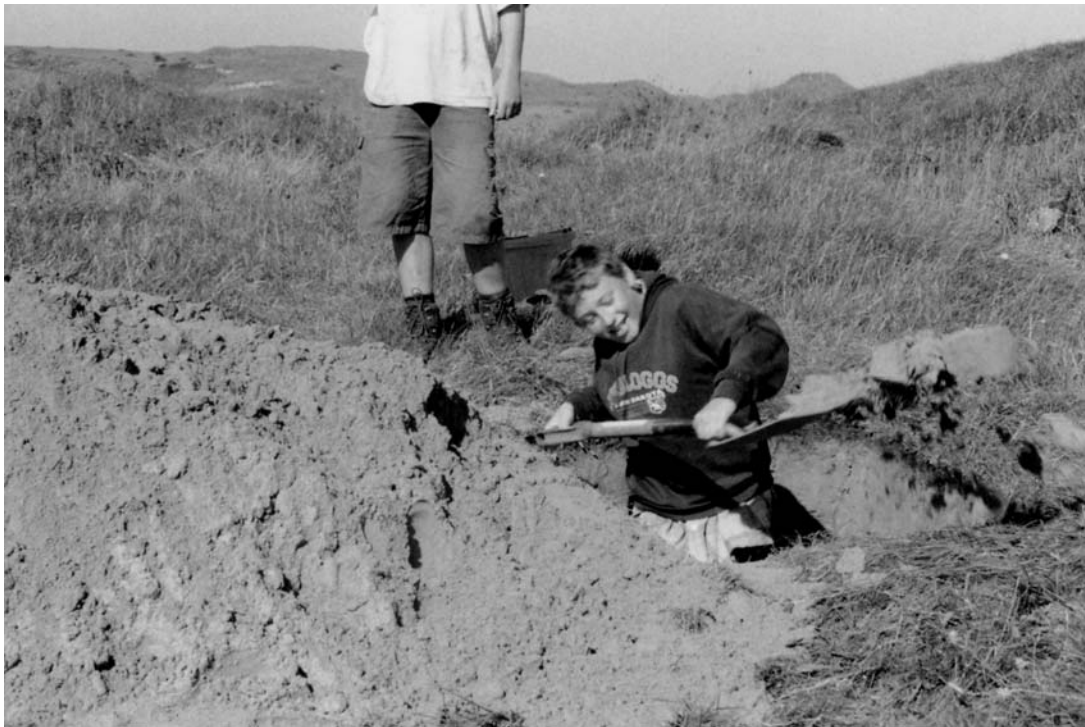
It was 1.0m<sup>2</sup> and excavated to a maximum depth of 1.8m in its south-west corner, through a very clean dune sand. There was a slight top soil layer [1] top, 0.05m deep, while the top 0.2m of the sand layer was darker [2] than the sand below. Unlike the first test pit, no fragments of human bones were recovered, although there were occasional small stone pieces and small slate pieces, none of which were retained. Whereas the sandy layer identified in test pit 1 has accumulated following the 1917-1920 excavation, the sand in this test pit had not been disturbed by Dexter and had built-up during the early years of the 19<sup>th</sup> century, soon after the abandonment of the church.

At the base of the sand deposit, a demolition layer [3] was encountered. It was a light brown soil and included slate pieces and mortar fragments. Two small and well cut slates were recovered; the layer was not otherwise excavated.

*Fig. 8      Excavation of test pit 2.*

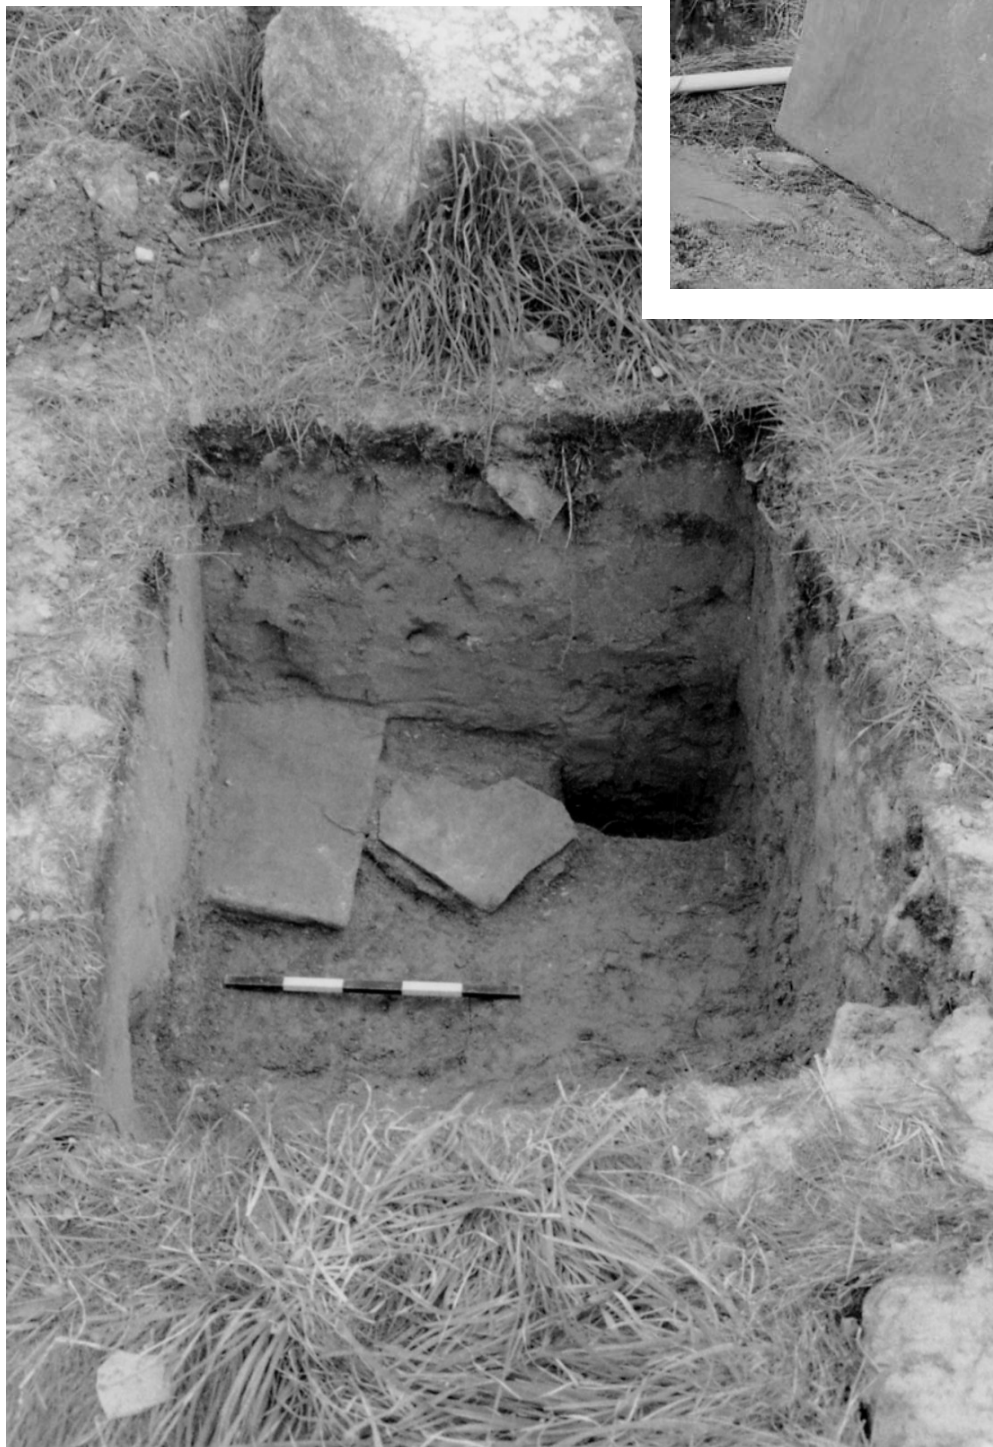
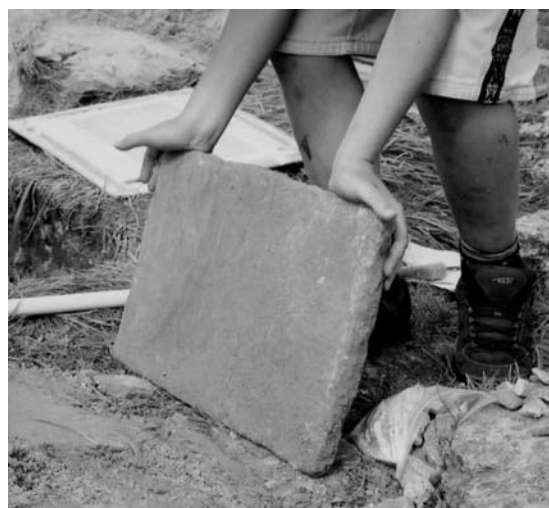
In the south-west corner of the test pit, the excavation encountered a top soil layer [1] less than 0.1m deep and then a deposit [2] made up largely of windblown dune sand. This overlay a gritstone slab measuring 0.48 by 0.33m, itself bedded onto a silty clay layer [5] containing human bone. The slab was clearly *in situ*, lying parallel to the northern wall of the chancel and surrounded by small elongated pieces of mortar that had obviously been laid in the cracks between the slabs (Figs. 9, 10 and 12). An irregular piece of slatestone was uncovered next to the slab, but this was debris and not part of the floor surface.

*Figs. 9 and 10 Test pit 1 photographed from the east showing floor slab and the same floor slab once lifted.*

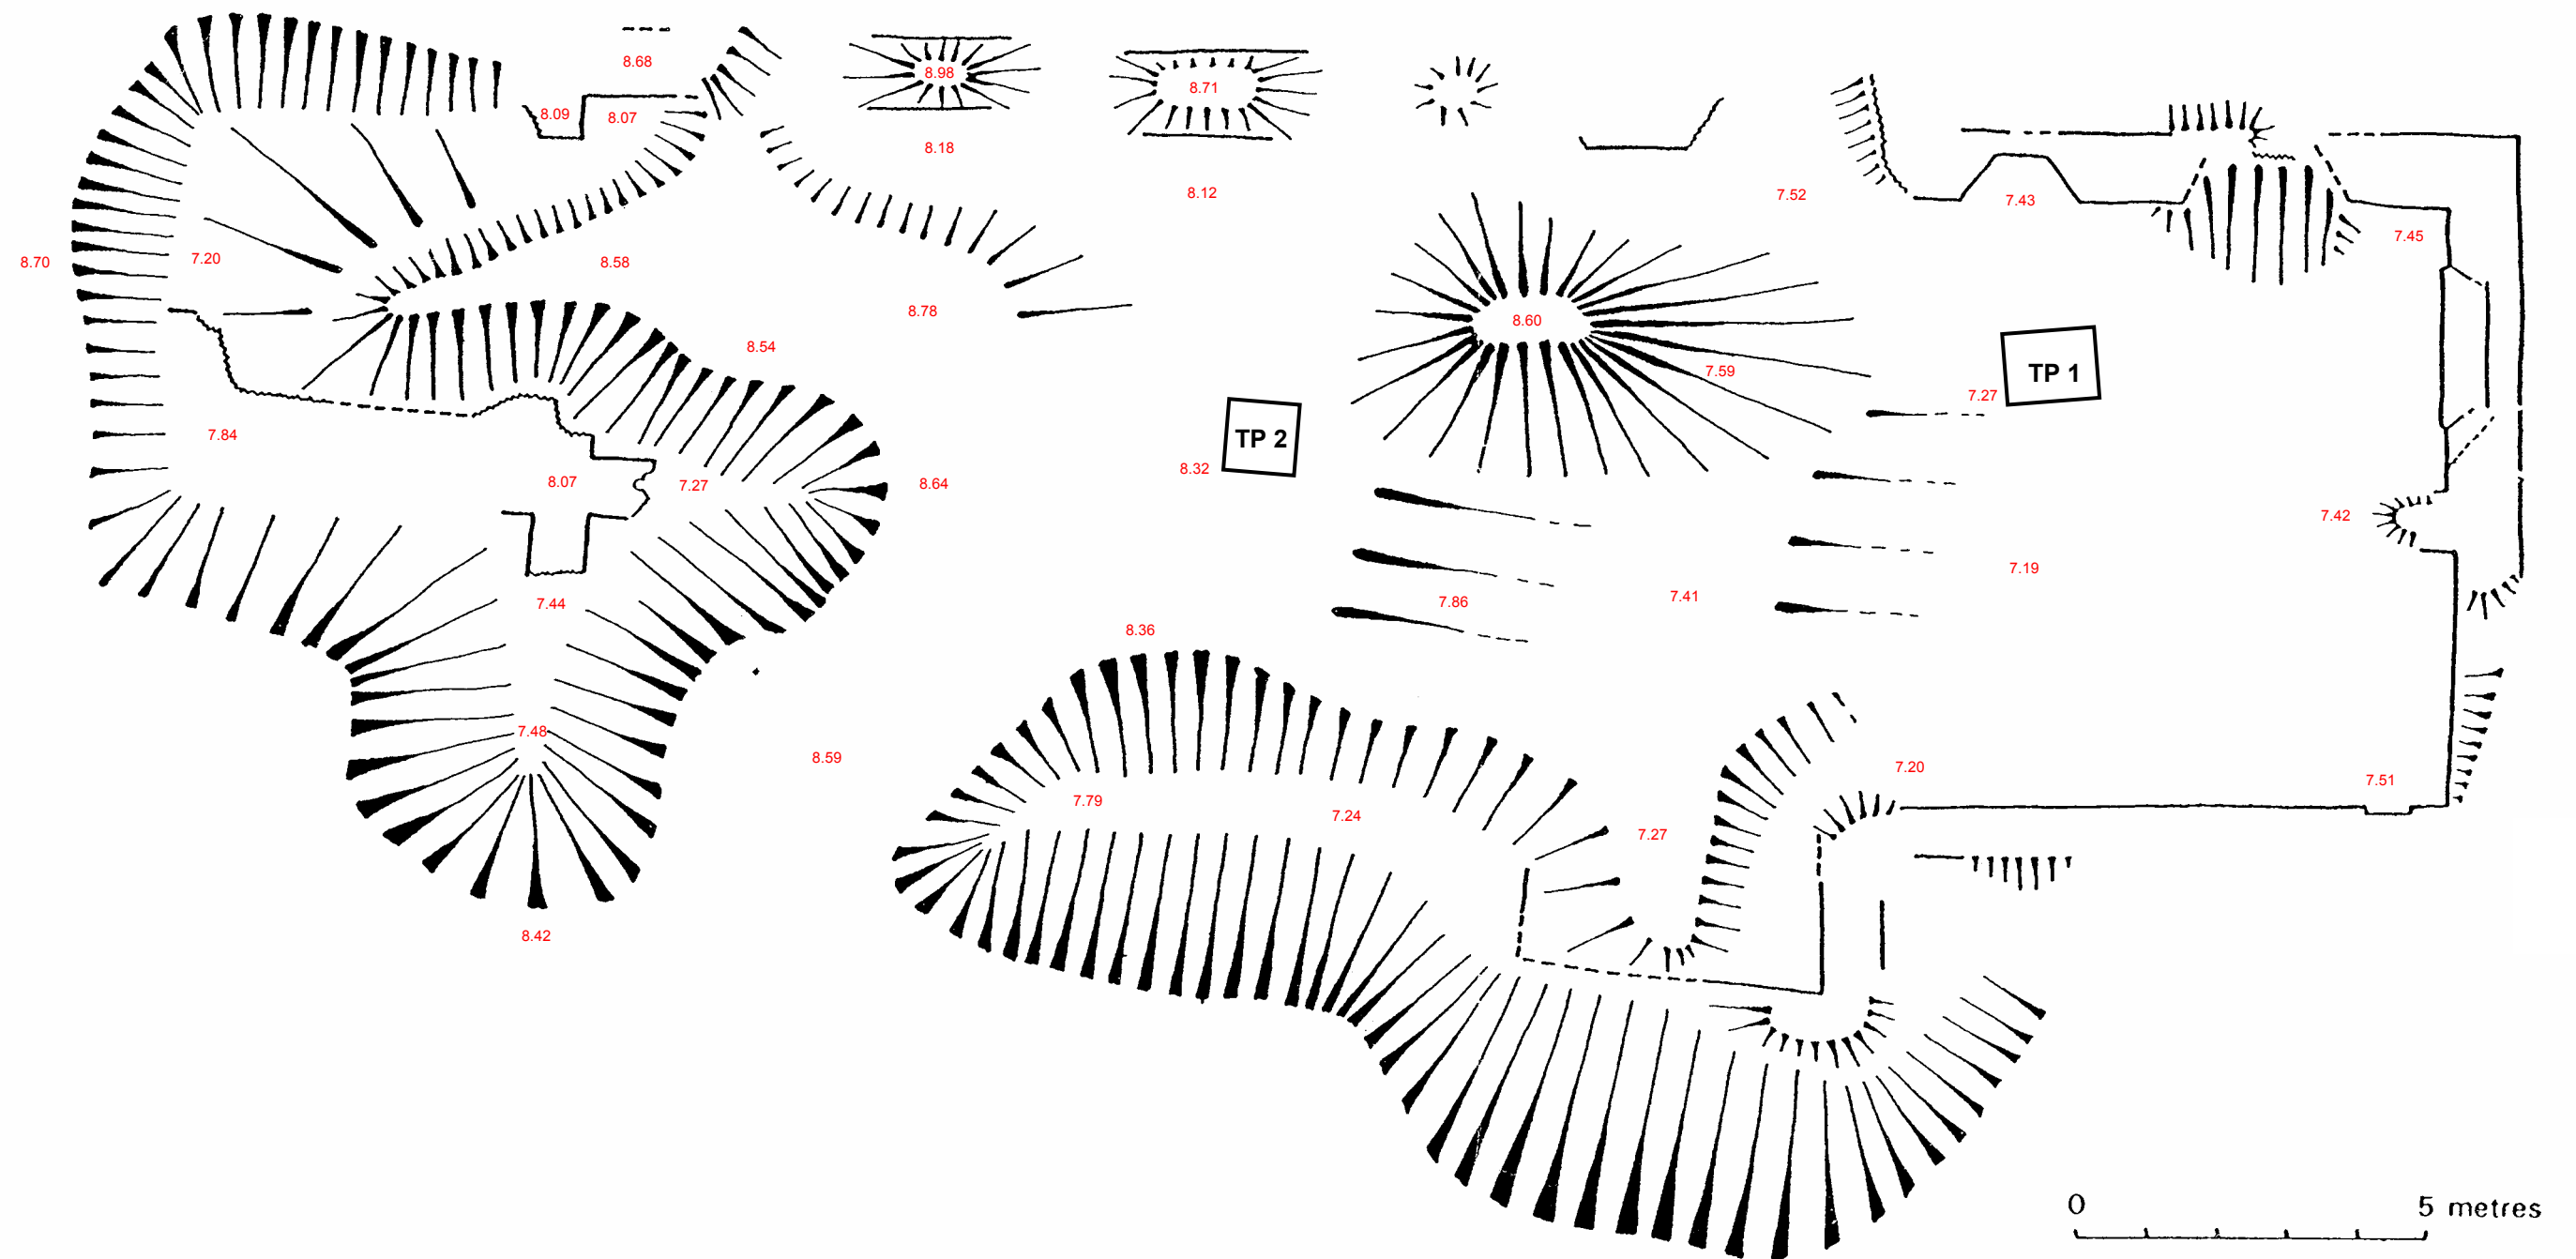
The floor level identified in test pit 1 was at approximately 6.65m, while the demolition layer in test pit 2 was encountered at 6.5m. This shows that the chancel end of the church was raised above level of the remainder of the interior of the building, as would be expected. This also suggests that the amount of demolition debris overlying the floor level of the nave is likely to be quite limited.

The height of the sand fluctuates throughout the interior of the structure. In the chancel, it varied from 7.27-7.45m, while in the chancel aisle it varied from 7.19-7.51. In both cases, the extent of sand was greater around the interior of the walling, which it had built up against. There was a greater amount of sand in the western part of the church, which varied from 8.78m at the highest point to 7.27m along the base of excavated walling and 7.20m where the tower has been excavated.

Fig. 11 Location of the test pits and relative ground levels within the interior of St. Piran's Church.

Test pit 1 demonstrated that the majority of human bone remains were in the bottom half of the sand deposit. It is suggested that the buffer layer at this end of the church should be at least 0.3m thick and it would probably be sensible that the excavation should not proceed beneath an identified ground level of 7.0m. The western end of the church could also be excavated to the same level as at the chancel end. In the west end, this would mean that up to 1.8m of sand would be removed and there would still be a buffer of 0.5m over the identified demolition layer (assuming its height is relatively consistent).

If the excavation had the aim of creating a new floor level at 7.0m, this would mean that the walling along the northern edge of the nave would be visible to a height of 1.68-1.98m above the new ground level, and comparable to the height of the walling already visible at the chancel end. The south-east corner of the tower would be visible to a height of 1.07m.

Using the difference in levels to estimate the amount of sand to be removed, it is clear that approximately 250 cubic metres of material would need to be removed from the church. Care will need to be taken when excavating at the chancel end of the church and much of this will need to be done by hand. It would be sensible to use a mini-digger in the western part of the church however to remove the large amount of the clean sand that is anticipated.

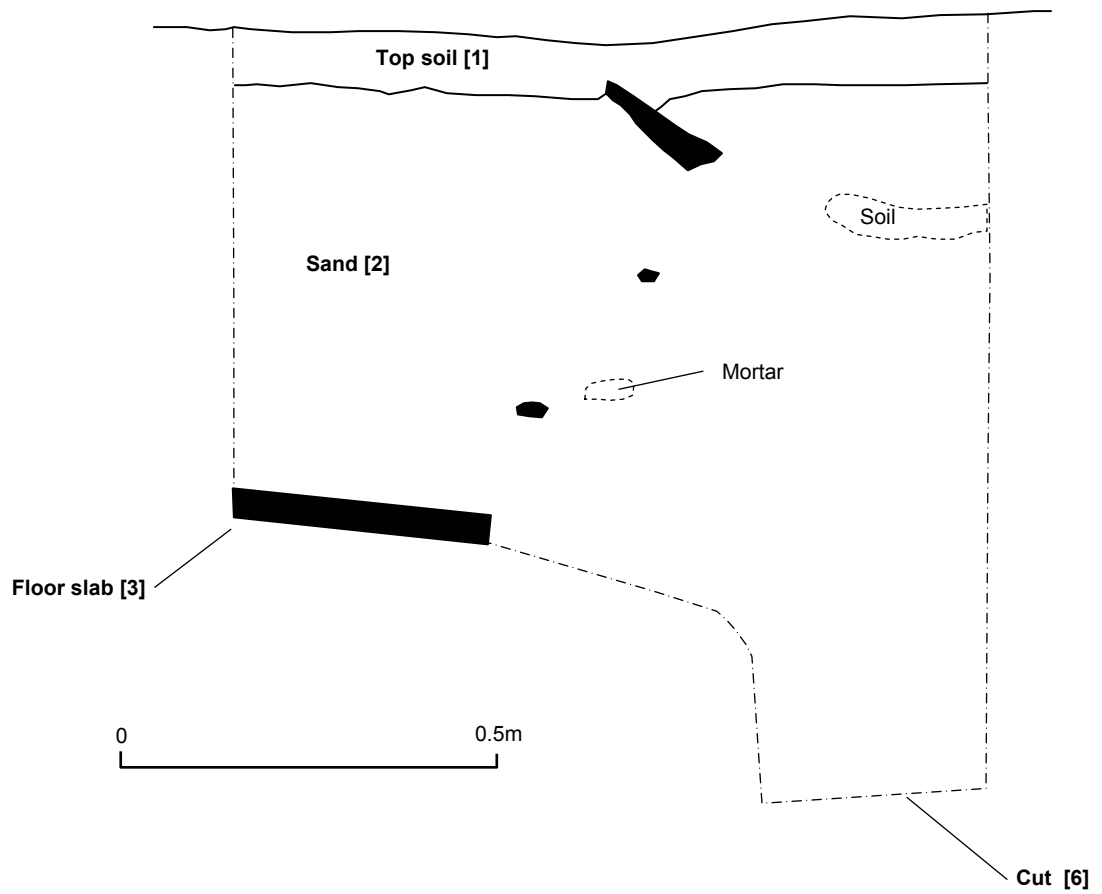
It is clear from the evidence that in 1917-1920 Dr Dexter had excavated down to, at least, the level of the floor encountered in this test pit. The build-up of 0.6m of 'sand' obviously took place in the decade following the excavation. The pockets of material containing human bone within the sand and in layer [7], in particular, reflect on the condition of the site following Dexter's excavation. Figs. 3 and 4 show that the site was left in a very poor condition and presumably there were areas of disturbed earth containing bone and other remains, loose within the structure, that then became mixed in with the sand, as it partly infilled this end of the church.

*Fig. 12 East-facing section of test pit 1.*
