Report No: 2014R052

# *Royal Anne* Galley Marine Environmental Assessment The Lizard, Cornwall

# **Phase 4: Inspection and Monitoring**

Client	English Heritage	
Report Number	2014R052	
Date	' September 2014	
Status	nal	
Report author(s)	Kevin Camidge and Charles Johns	
Checked by	Andy Jones	
Approved by	Ian Oxley & Mark Dunkley

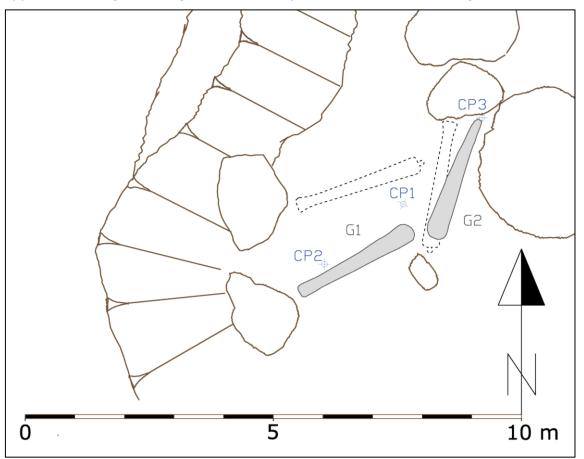
As soon as the two iron guns (G1 and G2) were relocated in June this year it was apparent that their relative positions had changed since October 2010 (Fig 3). Further investigation showed that the muzzle of Gun 2 had moved about 0.55m to the west — the gun had been rotated about its breach. The other gun (G1) had moved 1.6m to the south and had been rotated by about 10°. The surface of this gun is also now free from concretion, showing an area of exposed and actively corroding iron on its surface. This is probably where the gun was previously concreted to the seabed, this part now being uppermost, the gun having been rotated by about 180° about its long axis.

Fig 3 Plan showing the relative positions of Guns 1 and 2. The dashed outlines show the guns as they were in 2010; the solid outlines shaded in grey show the guns as they were surveyed in June 2014. The new control points installed in 2014 are shown in blue (CP1, CP2 and CP3)

Both guns are in poor condition, and are missing their buttons and trunnions. The lack of trunnions in particular suggests that these guns have been subject to movement and erosion since their deposition in 1721. When surveyed in June 2014, Gun 1 showed several areas of active corrosion where concretion had been removed from the surface of the gun, possibly during the winter storms of early 2014. Recording of the guns began by filling in the CISMAS underwater gun recording form, although unfortunately due to the poor state of these guns only a few of the usual measurements were possible (see Table 2 below).

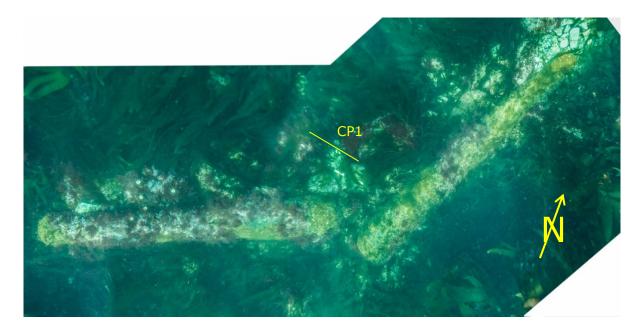
Fig 4 2D photomosaic of Guns 1 and 2. Survey control point 1 is visible near the centre of the picture. The scale (between the two guns, partly obscured by weed, next to the yellow line) is 0.5m long

The next stage in the recording was the production of a 2D photomosaic of the guns produced from a number of overhead underwater photographs (Fig 4). This was necessary as the underwater visibility was not great enough to allow both guns to be captured in a single photograph – even with a wide-angle lens. The photomosaic was then scaled and used to produce the new outline plan of the two guns.

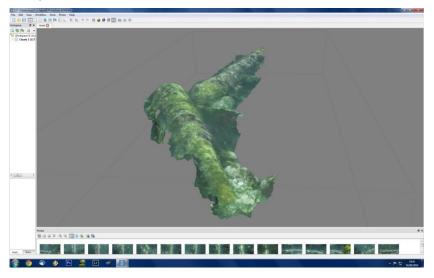
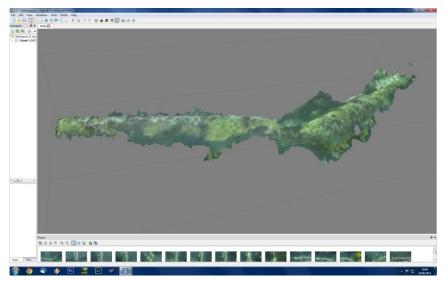
Finally, by way of an experiment, an attempt was made to produce a 3D model of the guns (Fig 5). The conditions were far from perfect, with a profusion of weed and kelp moving in the water making a series of aligned photographs very difficult; the weed moves between camera positions and confuses the alignment software. Normally all weed is removed before attempting 3D photo modelling (McCarthy and Benjamin 2014) but this was impractical in the time available. An alignment was attempted using over 100 underwater photographs processed using Agisoft Photoscan software. The results were never going to be good as the viewpoints were limited by the upstanding weed growth around the guns and by adjacent large rocks. The resulting 3D model has a number of visible lacunae (caused by weed) but it exhibits reasonable dimensional accuracy. CISMAS intends to experiment further with this technique underwater (we have had very good results producing accurate 3D models of cannon and anchors on land).

Fig 5 Screen shots of the 3D model of the two guns. Each shot shows a different viewpoint of the model

The two iron guns on the site were surveyed (to establish their new position) and drawn by means of a 2D photo-mosaic. A 3D photo model of the guns was also made; this proved to be reasonably accurate but the resulting image was unsatisfactory due to lacunae caused by the abundant weed growth around the guns.

The artefacts newly exposed on the seabed should be photographed and added to the site plan. A satisfactory 3D model could be made if the weed growth was cleared from around the guns before the photographs were taken. This would take at least two days' diving to achieve. Given that a satisfactory scaled 2D photomosaic has been made of the guns it is possibly not worth the expense of producing a better 3D model although subsequent 3D modelling of guns on the site of *HMS Colossus* in Scilly in July 2014 resulted in very satisfactory 3D models once the guns in question had been de-weeded (Camidge 2014).

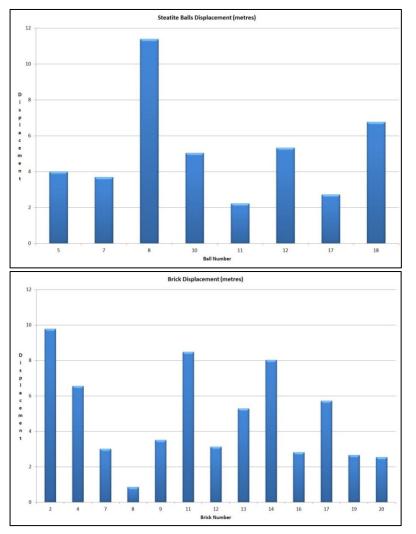
What is remarkable for such a high-energy site is the high percentage of the dispersal objects relocated within 10m of their starting position (Fig 7). Those who know this site all predicted that most—if not all—of the dispersal objects would be lost. What is even more surprising is the distribution of the dispersal objects as recorded in October 2010 (Figs 9 and 10 below). With the single exception of sphere 8, the objects had been sorted into two distinct areas; the bricks had all been moved to the east while the spheres have all been moved to the west of their original positions (Fig 12). This 'sorting' of the dispersal objects was a most unexpected result. As the two types of object have similar densities (2408kg/m<sup>3</sup> and 2735kg/ m<sup>3</sup>) the differentiation was likely to be due to their different size and shape. This theory was bolstered by the fact that the granite block SS1 measuring 0.2mx0.35mx0.25m and weighing 30kg was moved by 5m to the east between deployment and recovery—thus behaving in the same way as the bricks. Why the smaller spheres had been moved in a different direction is not clear. The following comments were received from Jon Rees, principal oceanographer at Cefas:

*Fig 7 Charts showing the distance of each brick and sphere from their starting point (October 2010)*

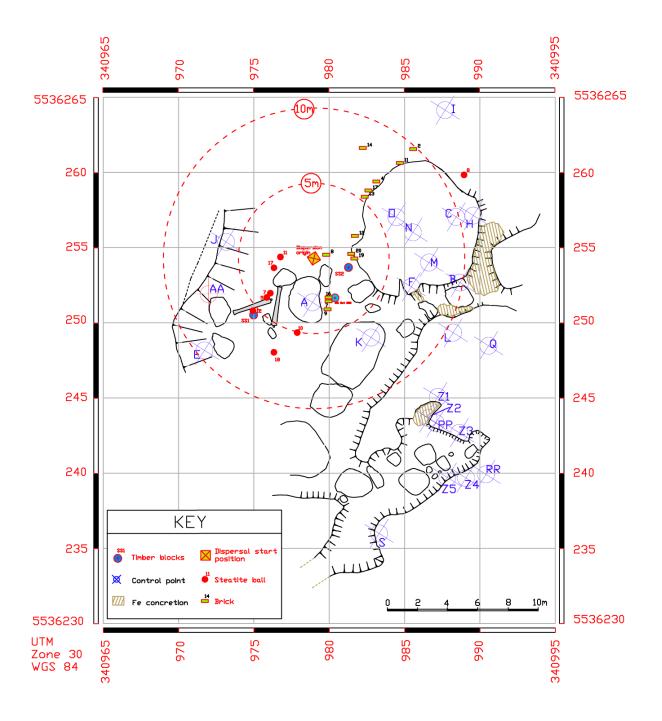
*Fig* 9 *Site plan showing the positions of the dispersal objects (deployed 16 April 2009 and their positions 18 months later, on 16 October 2010)*

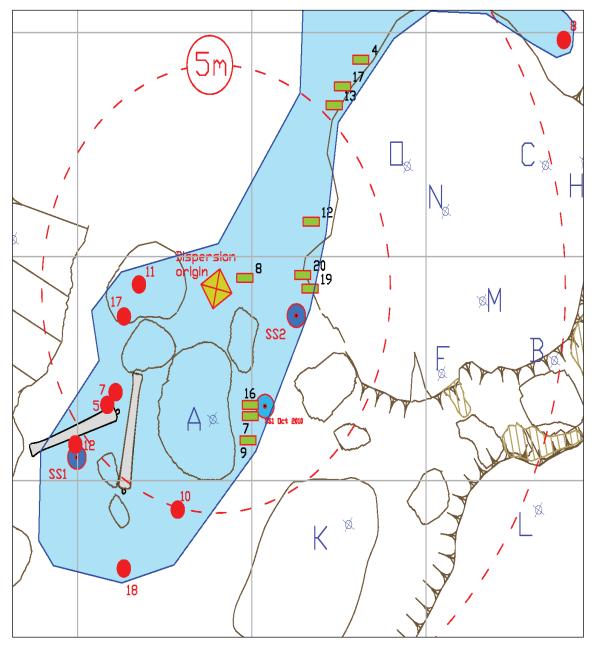
The dispersal objects now all occupied a narrow corridor aligned north-east/south-west (see Fig 10). This perhaps suggests that the main forces acting on these objects are aligned in a similar direction. This is also surprising as the main observable force acting on the site is the prevailing swell which invariably sweeps the site from west to east, which is different from the observed movement of the dispersal objects. The key to understanding this may lie in the sub-surface terrain of the area around the site. Plotting the rocks which break water at spring lows shows that the site lies in a long north east — south west gulley, which may well channel the swell and current along this alignment (Fig 11). Without proper measurements of water movements over the site, it is not possible to be certain; but the position of the dispersal objects in 2010 would seem to indicate this.

Fig 10 The dispersal objects in October 2010. Note that they all fall within the northeast / south-west corridor outlined in blue above. The grid squares are 5m; north is top of the page

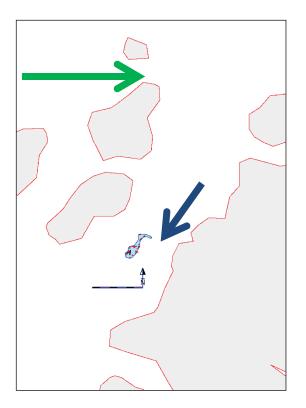
#### Fig 11

The outline of the dispersal corridor is shown (blue arrow) relative to the rocks which dry at low water. This demonstrates how the dispersal objects form a pattern which aligns with the deeper water running northeast / south west through the site. The scale bar is 30m long with 5m divisions. The green arrow indicates the direction of travel of the prevailing swell

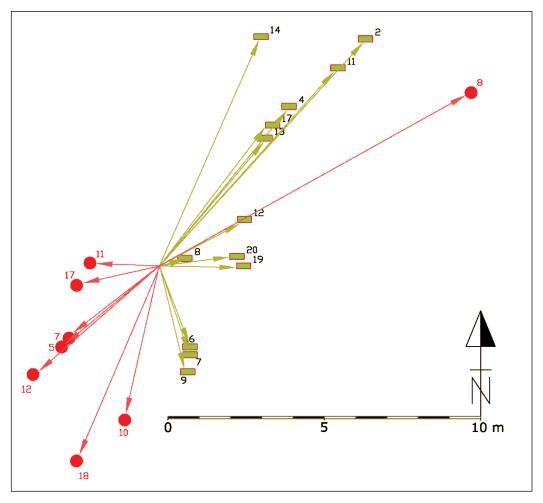
It has been suggested (EH comments on first draft report) that the differential movement of the two types of object (bricks and spheres) may have been caused by the spheres rolling downhill, while the bricks have reacted to water movements. This is an interesting idea. The impression given to the diver of the seabed in the area of the dispersal trial is that of a flat bottomed gulley. However, reference to the contour plot of the area (Fig 8) shows that the area where the majority of the spheres were observed in 2010 is in fact a shallow depression, while the majority of the bricks have 'travelled' uphill. This may account for the differentiation seen in 2010. By 2014 the spheres had all left the shallow depression and were all found (albeit only three of them) on higher parts of the seabed. We should perhaps be careful not to speculate too much on matters which are clearly the province of an oceanographer. It may be worth undertaking a small study of the data in collaboration with someone with expertise in the area of seabed sediment transport.

*Fig 12 Dispersal objects: movement, clearly showing how the bricks and spheres have been differentially moved. Bricks are shown in yellow and spheres in red*

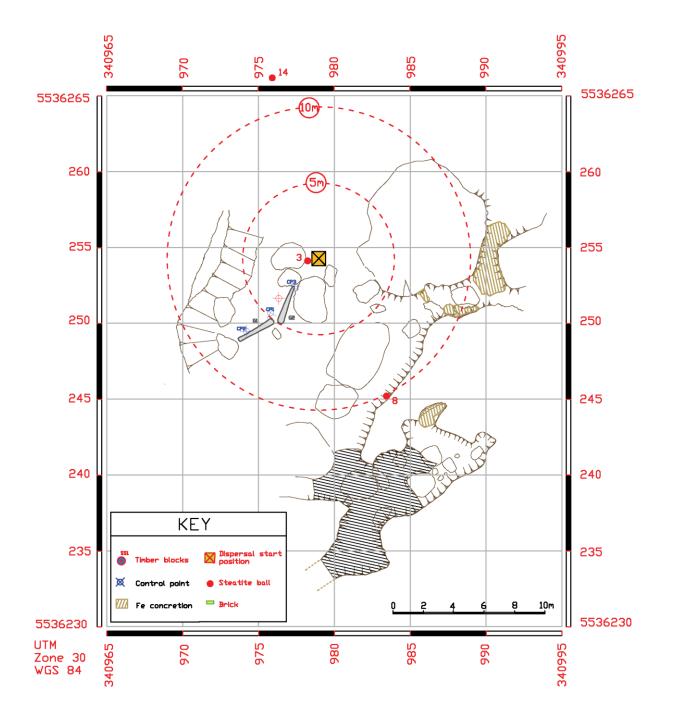
Of the 40 dispersal objects originally placed in 2009 only three were located in 2014 (Fig 14). Interestingly, all three of the objects located were steatite balls (Fig 13). None of the bricks were found at all, despite the bricks being by far the larger of the two object types deployed. All four divers were involved in searching for the objects, and in total six man-hours were spent searching. In the final stages of the search the search area was extended out to a radius of 15m from the starting position (as deposited in 2009) (Table 5). There are a number of possible explanations for the paucity of dispersal objects located in 2014. The objects may have been dispersed beyond the area searched; they may have been buried and are no longer visible on the seabed or a combination of both of these factors. What is also of note is that two of the three balls located this year were not found in October 2010 – these were either buried or outside the 10m radius searched in 2010.

The only dispersal object located in 2010 and in 2014 was the steatite ball number 8. It may not be coincidental that this ball was the single exception to the southerly grouping of balls noted in 2010 (see Figs 9 and 10). Ball 8 has moved 15.63m in a south south west direction between 2010 and 2014. Because of the small number of objects located, it is difficult to draw any conclusions about the distribution of the dispersal objects in 2014 – except to note that the three balls located all lie roughly within the same 'corridor' as seen in the 2010 distribution (see Fig 10). Although it is perhaps not surprising that the majority of the dispersal objects have lived up to their name (i.e. had been dispersed) it is hard to account for the fact that no bricks at all were located in 2014. No evidence of bricks being colonised by kelp as holdfasts has been observed on any occasion – so this cannot be advanced as a likely cause of the absence of any of the 20 bricks from the search area in 2014.

*Fig 14 Site plan showing the positions of the three dispersal objects located in 2014, steatite balls 3, 8 and 14. Note also the new positions of the iron guns G1 and G2*

Given the paucity of dispersal objects found this year it is probably not worth specific searches for them. However, if searches are made for exposed artefacts (as suggested above) then any dispersal objects located during the process should be plotted on the site plan. Study of dispersal data by oceanographer/expert in seabed sediment transport might be considered.

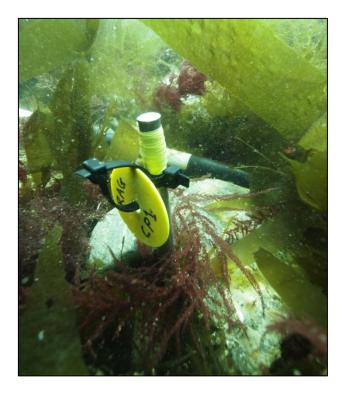
None of the existing survey control points were found intact during the 2014 survey. This is not really surprising; during the excavation of the site the control points required regular replacement. Most winters saw the loss of many of the points. It was, however, possible to see where control point A (to the west of gun 2) had been, due to iron staining of the rock it had been driven into. Three new control points consisting of 12mm diameter stainless steel rods 0.4m long were driven into the seabed in the area around the iron guns (see Fig 15). The position of each of the control points is given in the Table 6 below.

Fig 15 Survey control point CP1 in position on the seabed

The majority of the existing survey control points on the site had disappeared, due mainly to the action of mobile rocks rolling over the site. The previous positions of two of these existing points were found and used to position three new control points on the site – CP1, CP2 and CP3. These have been placed in the gulley containing the iron guns

in the hope that they will last longer; however, they should probably be considered as only having a life expectancy of two or three years at the most on this site.
