ENCLOSURE WALL AT GLASNEY COLLEGE, CORNWALL

Archaeological recording and repair work

December 2003

Report No: 2003R081

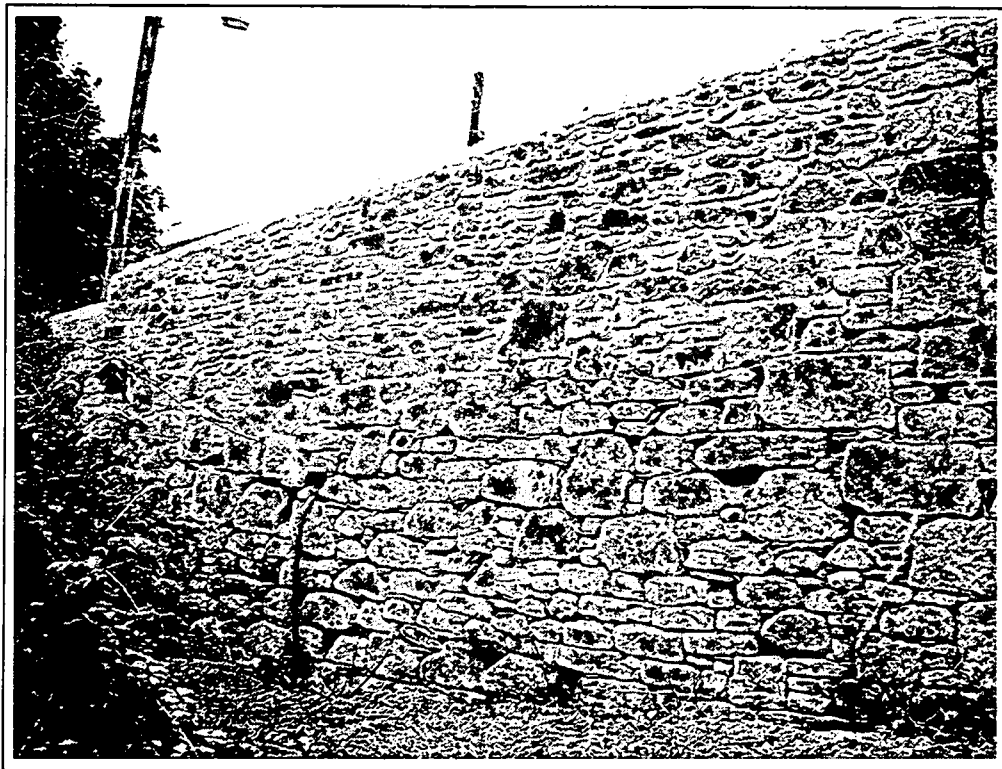
Cover illustration

The walling following repair works.

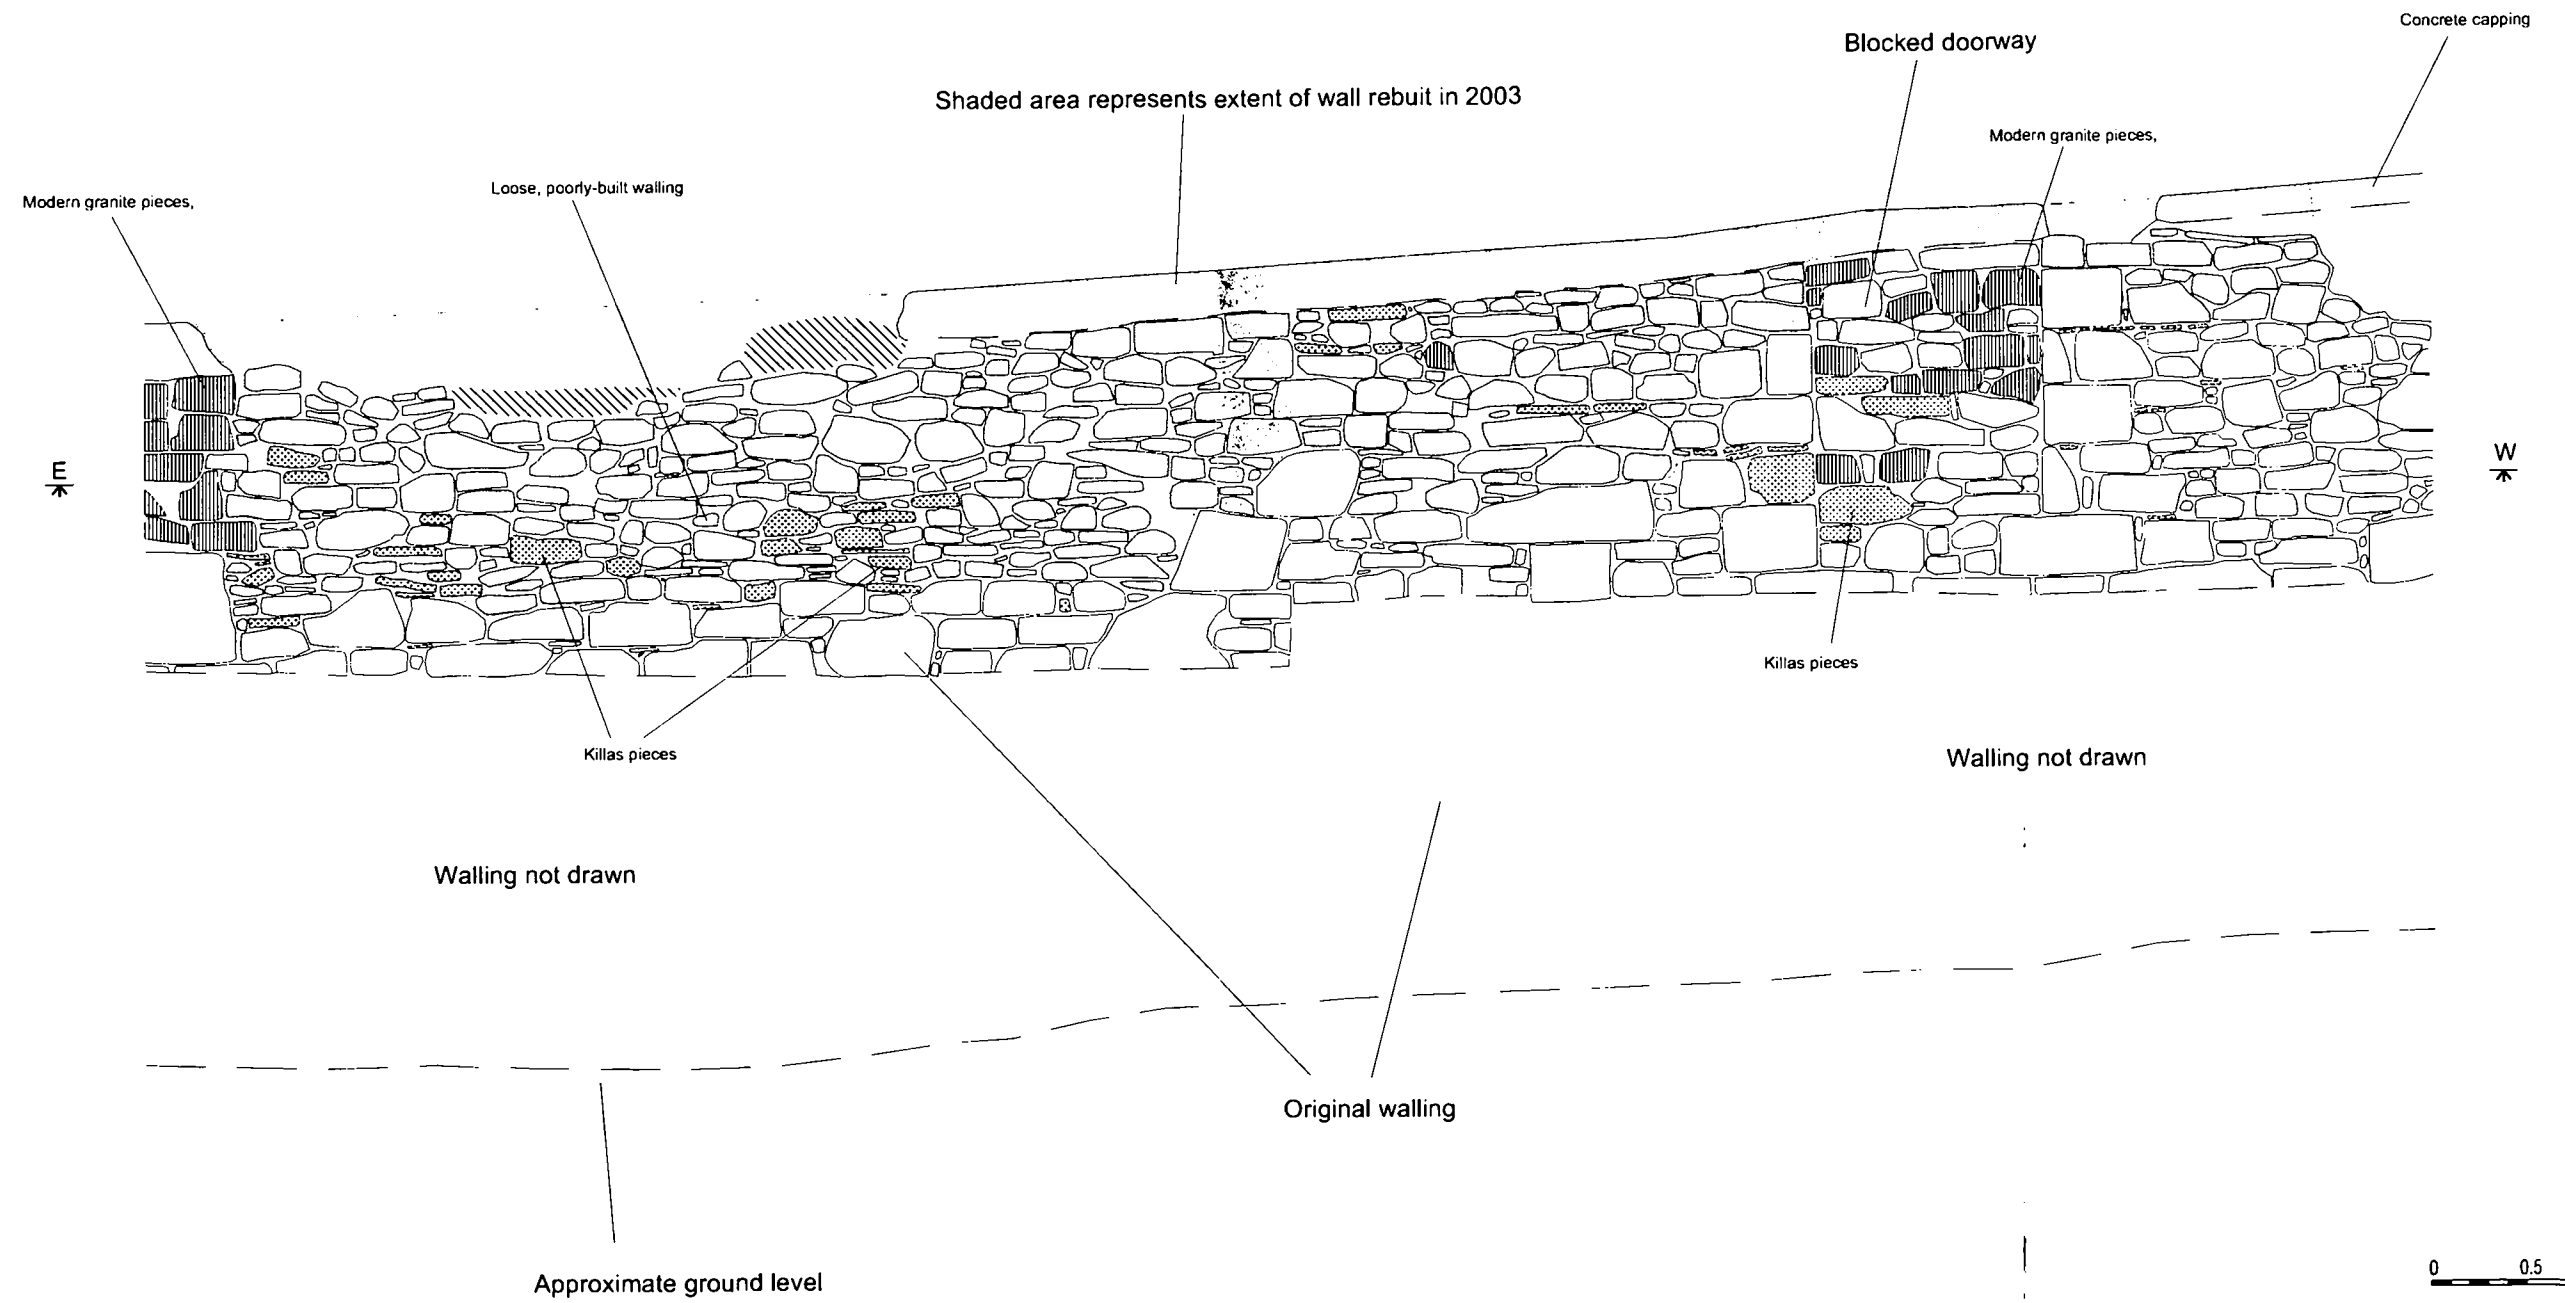
Figure 4 Detailed drawing of walling prior to repair works

Figure 4 shows the extent of walling affected by the repair works, with the rebuilt section shaded in grey. Figure 5 meanwhile shows the various distinct components or phases of walling as referred to below. The detailed examination of the walling reinforced comments about the walling made in the original damage report by Ann Preston-Jones.

1. The wall was rebuilt in a style similar to that of the original construction using adjoining sections and the CAU elevation drawing as a guide. Large stones near the retaining part of the wall or by the blocked opening, which needed to be taken down, were replaced in their original positions.

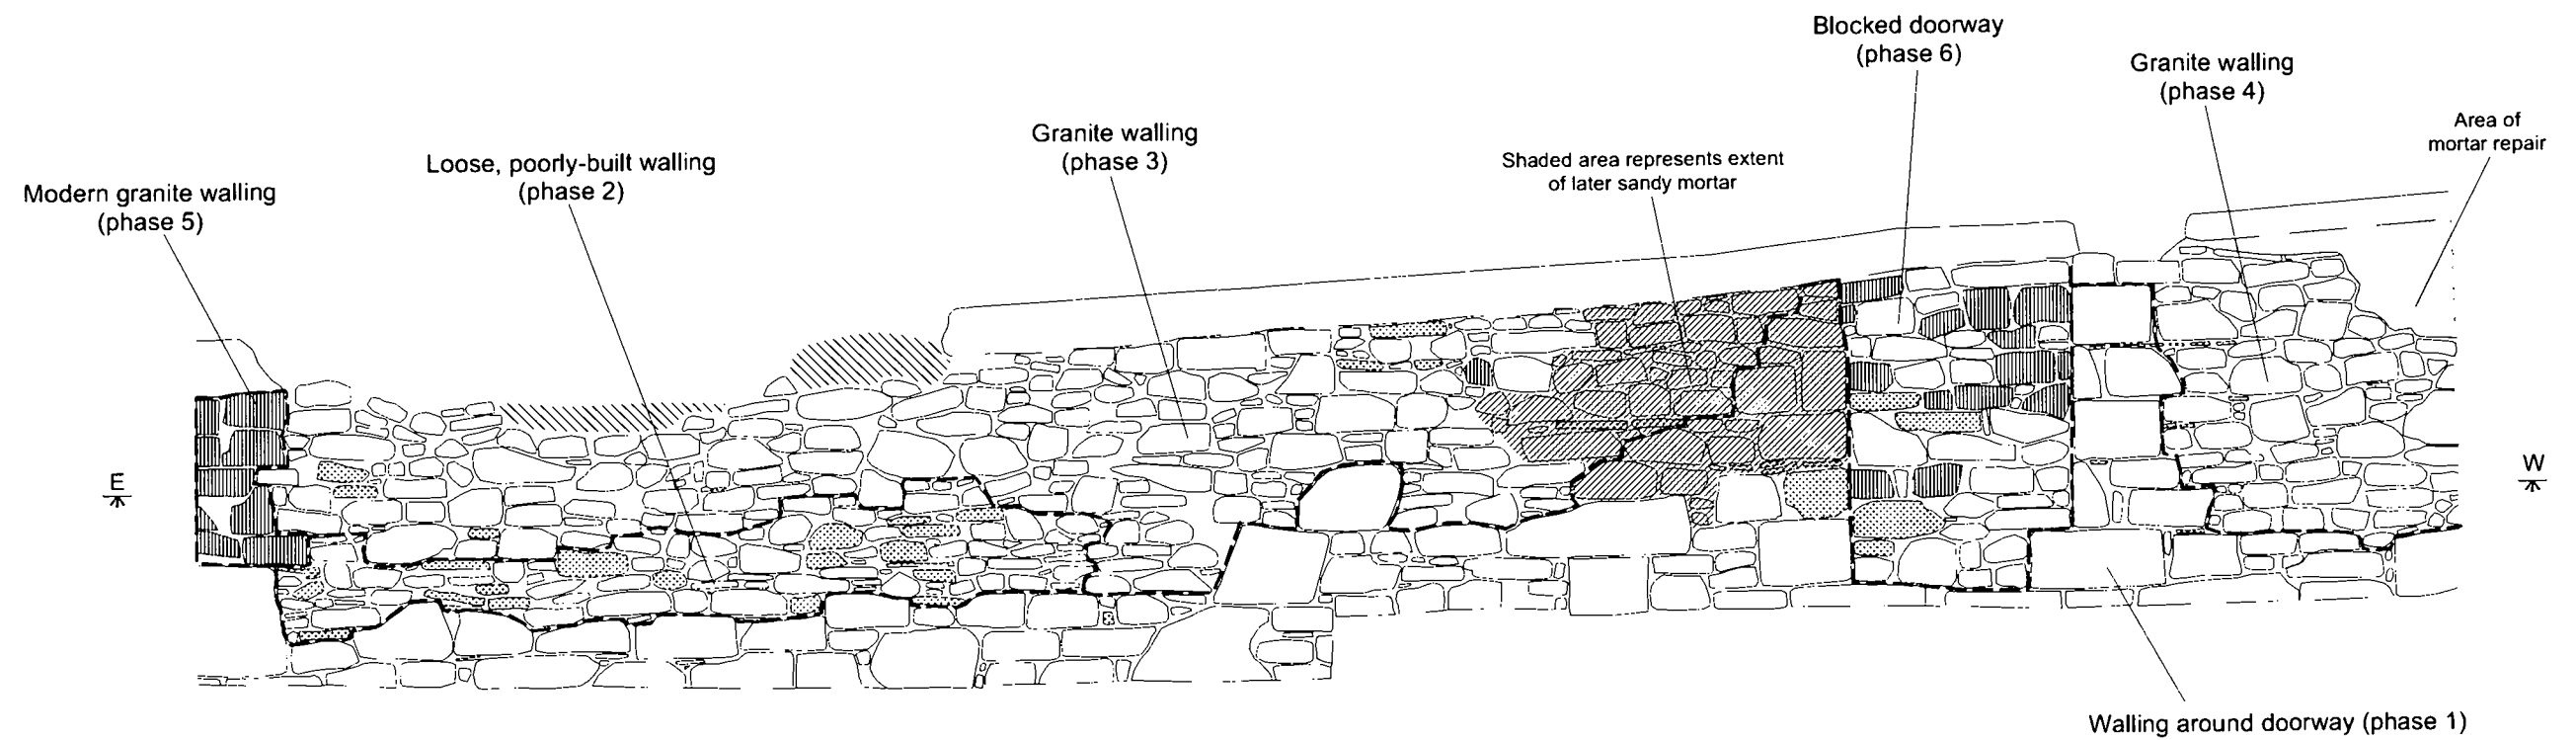
Figure 5 Detailed drawing showing distinct areas of walling.

The bottom 2.0m – 2.5m of walling, which broadly equates to the actual retaining wall below the level of the road (Glasney Terrace), is a well constructed and very well preserved dry stone wall (phase 1). It is made up of large granite blocks, interspersed with smaller but well placed granite pieces. There is no indication that it was ever mortared.

The parapet contained a number of obvious phases of rebuild and/or repair, all of relatively recent date. Near the actual area of collapse, there was a large area of small stones of very poor quality (phase 2), which were roughly placed and unstable (see Figure 7). This area of stonework contained smaller granite pieces and, interestingly, a greater proportion of killas pieces. It had also been badly affected by the invasive roots of ivy and other vegetation.

Larger granite pieces (phase 3) had been placed on the top of this section of weak walling, and along a considerable length of the wall, which is almost certainly another phase of rebuild. This walling, around the collapse, was also of a very poor character. To the west, the walling improved in quality but was still less substantial than the retaining wall, containing occasional pieces of killas or red brick, as well as evidence of some small voids. A distinct area of mortared repair could also be noted in this area. Much of this walling, to the east of the blocked doorway had a pronounced lean and was therefore rebuilt.

To the west of the doorway, the wall was constructed of similar stone but was in better condition (phase 4). A small area was being pushed out by roots from a buddleia. The plant was removed and the walling in this area reinstated. One area of earlier repair could be recorded where a concrete render was visible.

To the east of the collapsed section of wall, there was a further piece of rebuilt wall (phase 5). This was made up of angular grey white, shiny granite blocks of a very recent date, laid within a sandy mortar.

The blocked 'doorway' (phase 6), measuring 1.6m high and 1.2m wide, was also recorded. On the southern side, the footings of this opening respected the level of the road while to the north, there was a drop of 2.0m from the base of the gap to the ground level of the field.

The stonework which fills this gap comprised a considerable number of angular grey white, granite blocks and killas pieces, suggesting a relatively late date for its infill. These stones were within a very hard blue-grey cement which was very distinct from the surrounding wall.

The retaining wall and stonework around the blocked doorway (phase 1)

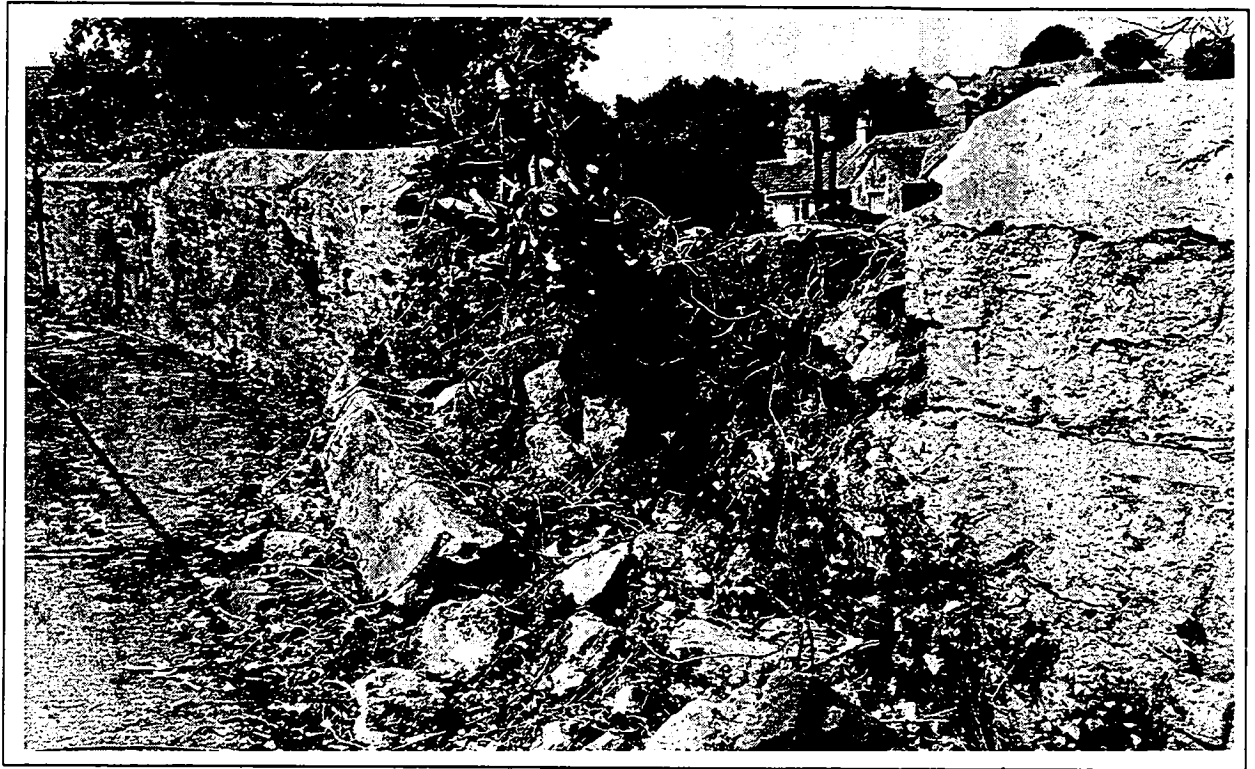
A small section of the parapet collapsed in March 2002 as a direct result of disturbance caused by a *Buddleia* growing within the walling (Preston-Jones 2002). In 2003, Cornwall County Council's Transportation and Estates Section stepped in and agreed to accept responsibility for repairing this area of damage and the future maintenance of the wall as a whole.

“The damage is to the south (road) face of this wall ... where a 3m length of wall has collapsed and fallen into the road. A further section of this leans, resulting in a damaged length of overall 6 to 7 metres. There is no apparent damage to the north side of the wall. The wall at this point is built of small slate, with an earth and rubble core, cement pointing and a triangular cement coping, a large chunk of which has fallen off as a single piece.”

Fig. 6 Photograph of collapsed walling.

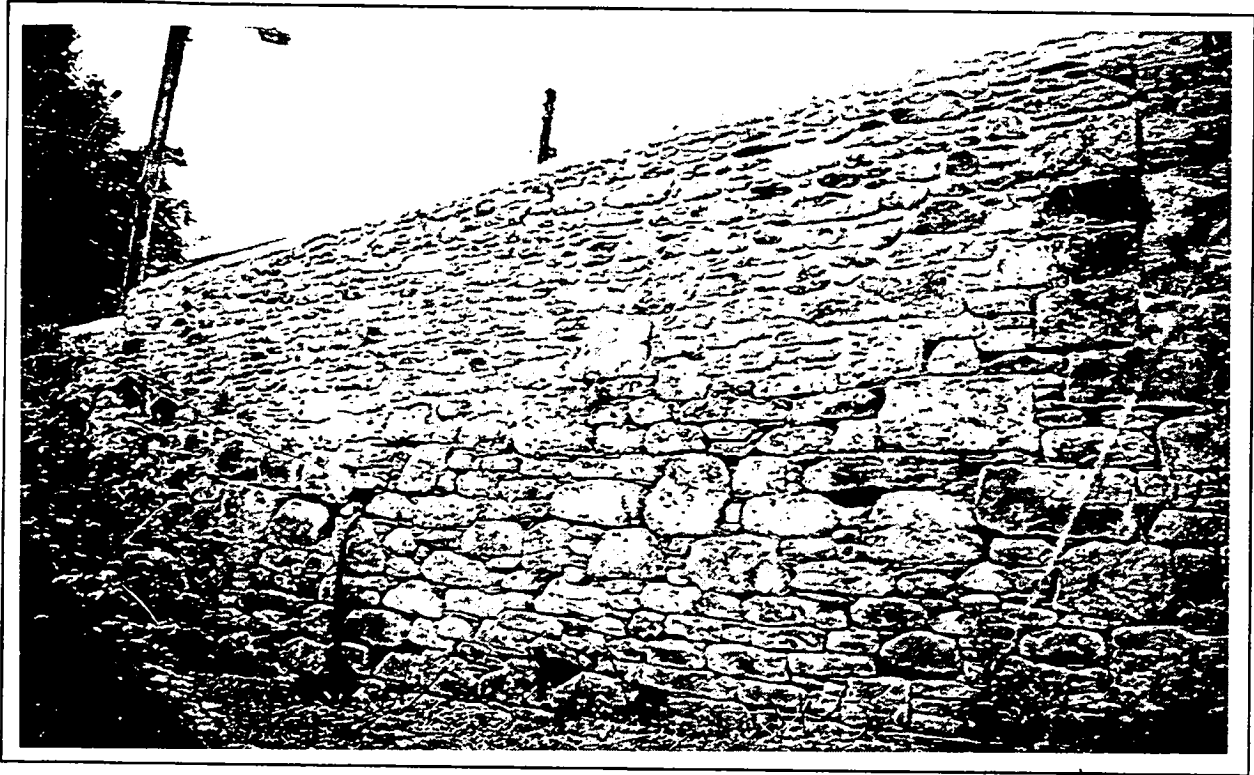
Fig. 8 Photograph of walling following repair works (from north).

2. The wall was rebuilt mainly using materials retrieved from the damaged area of wall.
3. As the original walling appears not to have been mortared, the initial view was that the replaced stones would be bedded in mortar, but this mortar would be kept well back from the face of the wall to retain the appearance of the dry-stone construction. Due to the smallness of many of the granite pieces replaced, this was not easy to achieve.

4. The stark and imposing nature of the triangular concrete capping was also assessed. The replacement capping for the repaired section of wall was constructed using laid stonework.

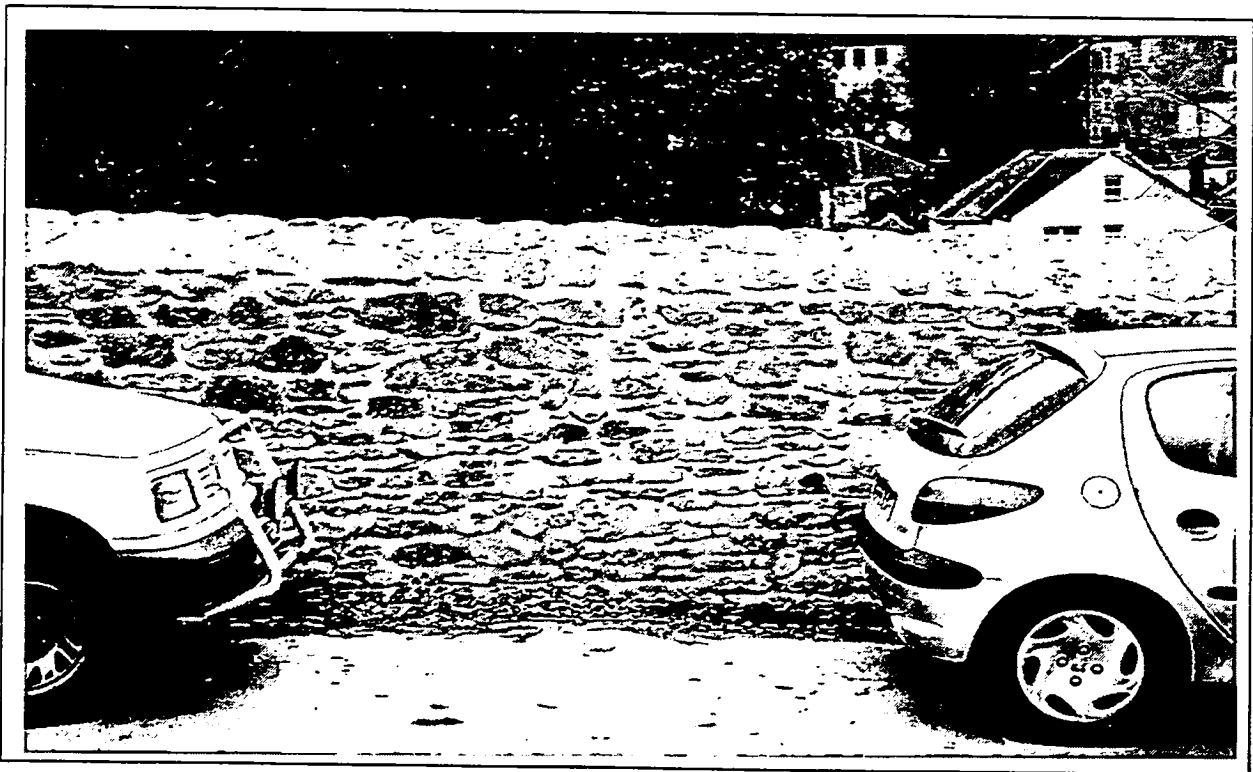
Fig. 9 Photograph of walling following repair works (from south).
