Madron Well, Cornwall

Repair of vandalism

December 2003

Report No: 2003R085

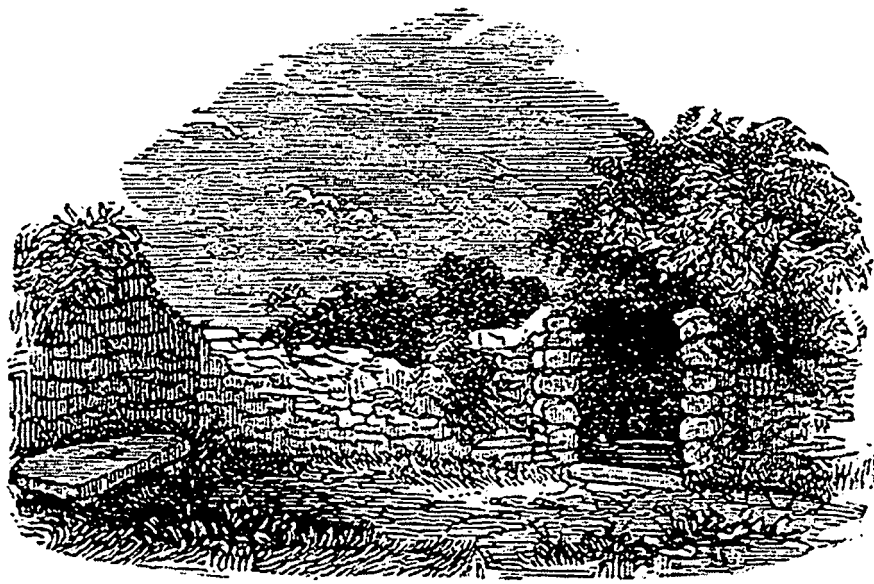
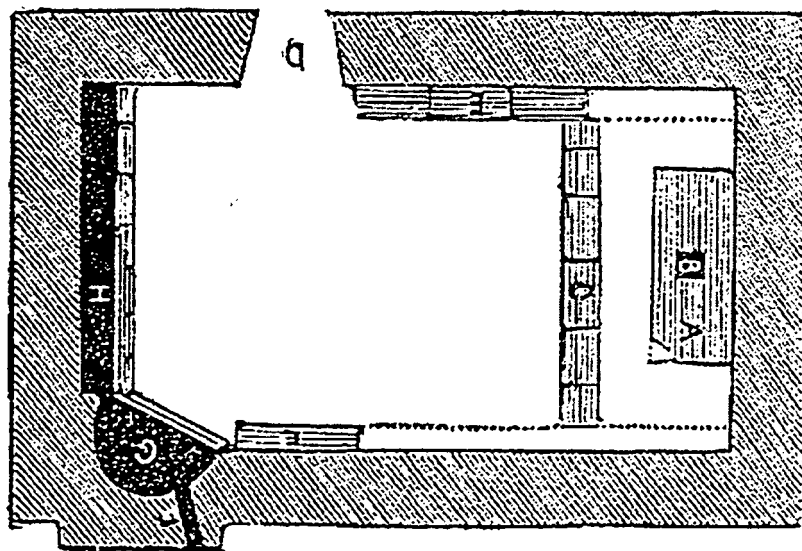
4. The stone bench was in very poor condition and evidently rebuilt. In fact, it is possible that the bench along this wall is a modern fabrication, for Blight's plan of the chapel does not depict a bench along the west wall (Fig 3). The bench incorporated a chamfered slab of granite, similar to the slabs used for the tops of the benches along the north and south walls, but this piece was found in one of the bottom courses of the bench.

Fig 3. JT Blight's 1856 sketch and plan of Madron Well

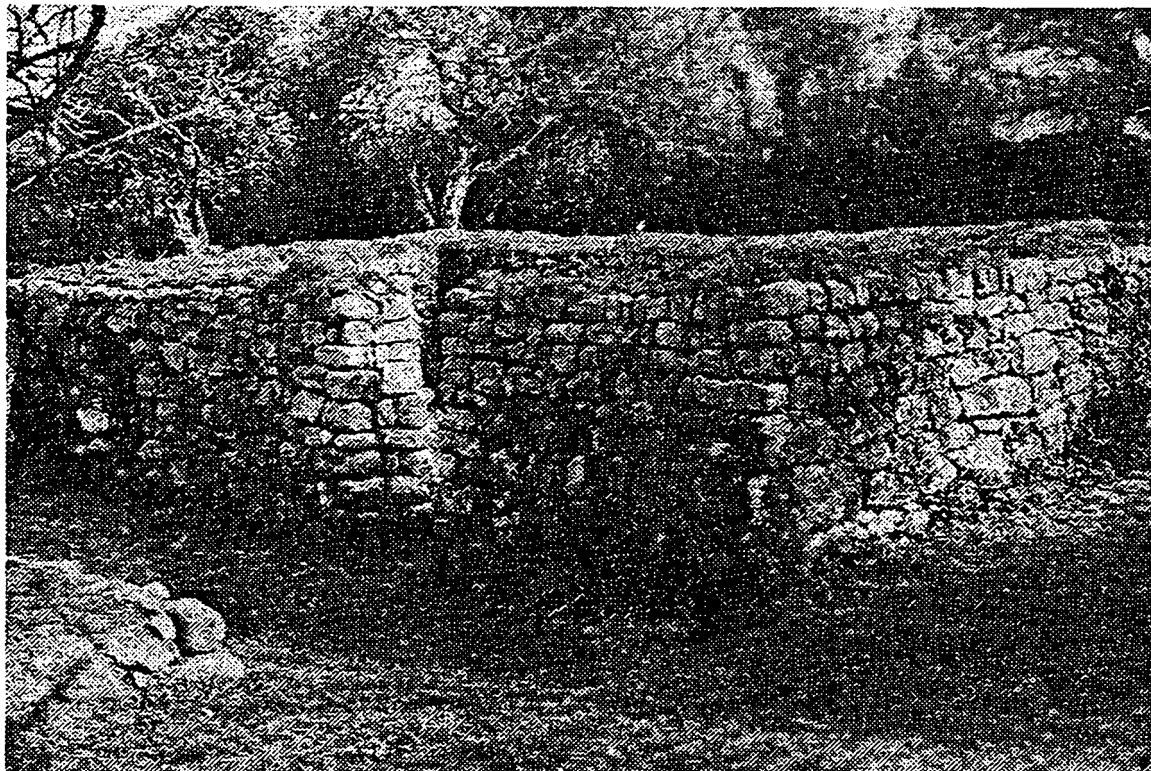
Antiquarian accounts of the building, the results of previous limited work here (Preston-Jones 1999 and 2000), and a superficial examination of the building itself, make it clear that at least parts of the building have been rebuilt over time. To take an obvious example: Blight's mid 19th century sketch of the chapel shows the south and west walls in a low ruinous condition, with a tree apparently growing out of the west wall, and his plan indicates that the stone bench, particularly along the south wall, was fragmentary (fig 3). Sedding in 1909 notes that although 'the highest point of the east wall is about 10 feet above the ground, the side walls are considerably lower'. Yet 'the stone seats of the nave were perfect'. And a photo in Lane Davies 1970 book on *The Holy Wells of Cornwall* (page 67) shows the results of a recent 'restoration' in which the whole appears to have been rebuilt in the style of a Cornish hedge (Fig 4).

Fig 4. The 1960s (?) restoration of the chapel (photo from Lane Davies 1970, 67)

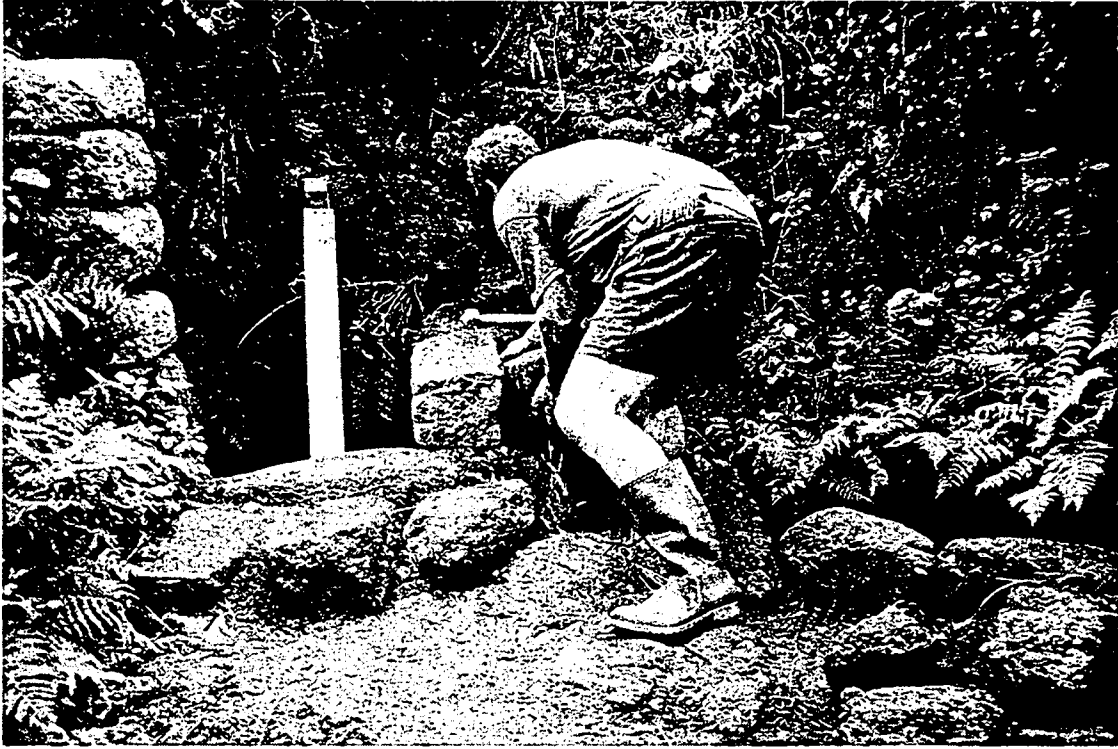
Fig 7. Work in progress

6. The wall was built up from here, using weathered granite and a hydraulic lime mortar based on NHL 5. On the very top was placed one of the chamfered stones discovered in the course of dismantling the bench next to the cistern wall. The final height is similar to that of the wall on the opposite side of the cistern (see fig 7).

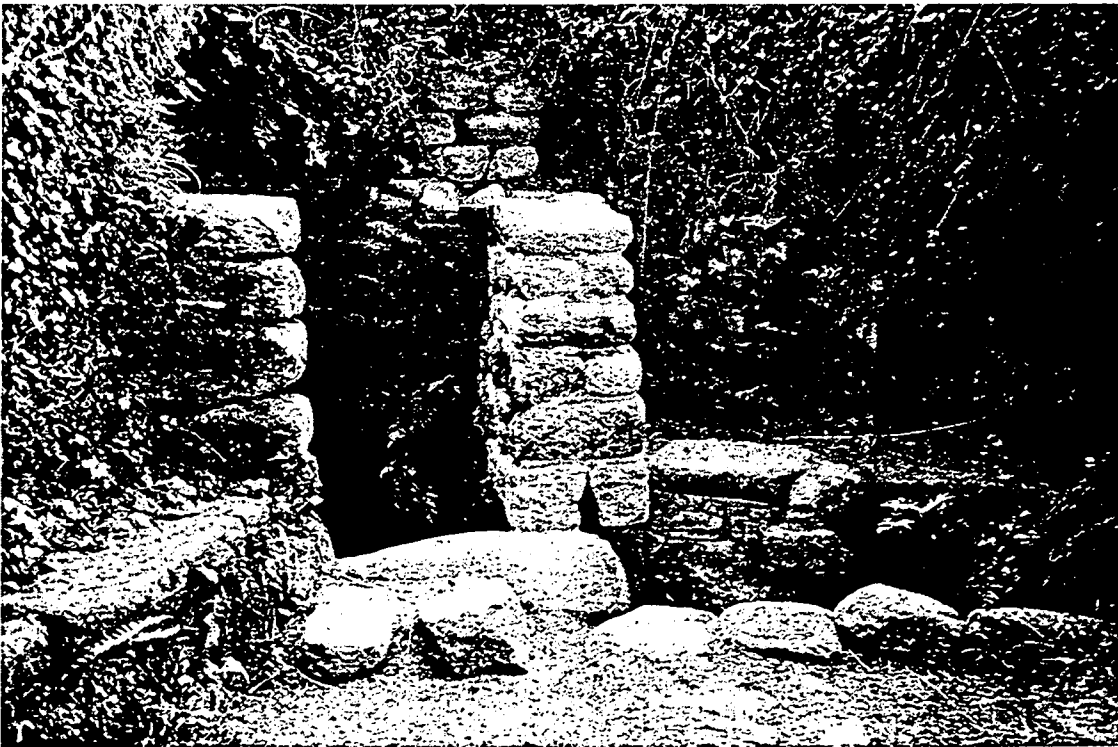
Fig 8. The repaired wall and bench

7. The damaged west wall of the chapel was rebuilt, bedding the stones in a hydraulic lime mortar.
8. The stone bench immediately adjoining the cistern wall was rebuilt and a slab of chamfered granite, found at the bottom of the wall when it was dismantled, was restored to its correct position as a seat.
