# Pendrea Cross, St Buryan, Cornwall

## Restoration and repair

January 2004

Report No: 2004004

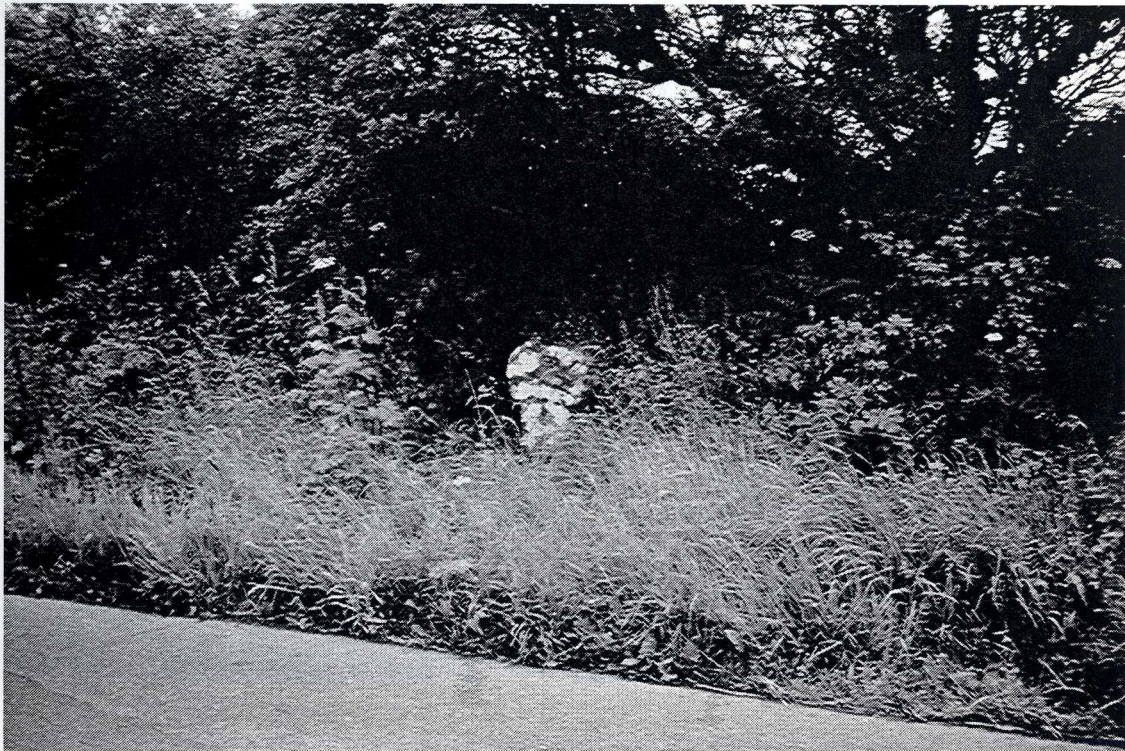
When the Pendrea Cross was Scheduled by English heritage (EH) in 1994 it was considered to be 'stable under its present management regime' (Kestle 1994). Yet by 2001, when problems were first reported by Katy Hooper of Penwith District Council, its condition had deteriorated markedly. Fig 4 shows the cross before conservation. The following were the main points of concern:

1. The cross was loose.

Close examination of a photo taken when the cross was restored in 1959 (Anon 1960) shows that it was simply pinned to its new base (rather than being socketted in) and the joint cemented. However, by 2001, the cement had partly broken away, and the cross was able to rock slightly on its pin. This was of concern in itself, but there was the additional worry that the material the pin is made of was not known. It was assumed that water would be getting into the open joint, and if the pin was of iron this would be corroding and expanding and could eventually split the stone.

2. The base of the cross was completely buried.

Photos taken in 1959 when the cross was restored show that at the time, the new base stood about 0.25m high above the ground. By 2001, and in fact for some years previously, it had been completely invisible, the top being just below the turf and detectable only by probing. This was assumed to be the result of a gradual accumulation of leaf litter, etc, over the years, or of a deliberate raising of the level of the verge in line with road surfacing and improvements.

3. Vegetation growing from the nearby hedge was starting to overwhelm the cross: in particular a hawthorn hung over and obscured it.

Of these problems, the most serious was the first. The reason why the cross became loose is not known. It is known from EH reports to have been stable until relatively recently. However, a potential context for this damage might have been one of the many cabling and trenching operations carried out along this road within the last five years. The cross could have been knocked over and dislodged from its base by one of the many telecommunications companies which have recently been laying fibre-optic cables along here. Because it had become so obscured by vegetation, it could have been righted and a rapid repair made, before the problem was even noticed.

*Fig 4. The Pendrea Cross before restoration in June 2003*

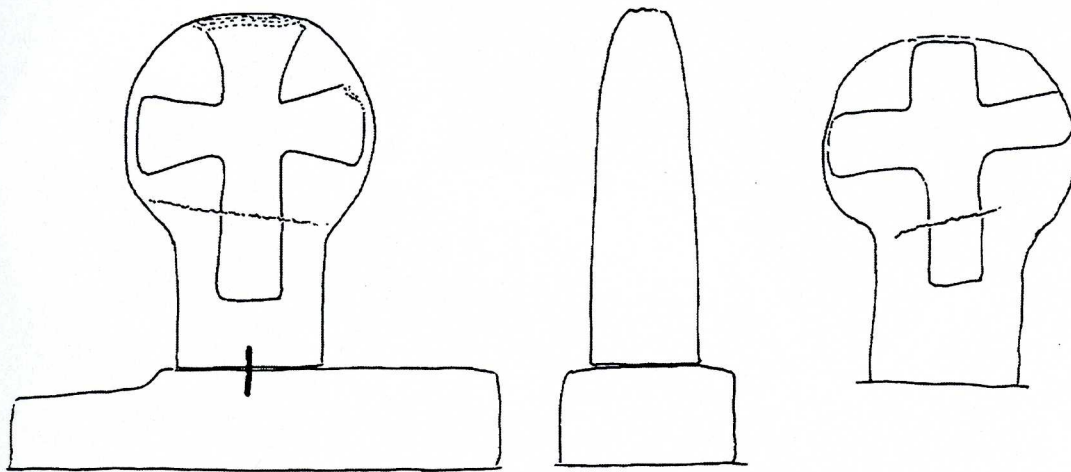
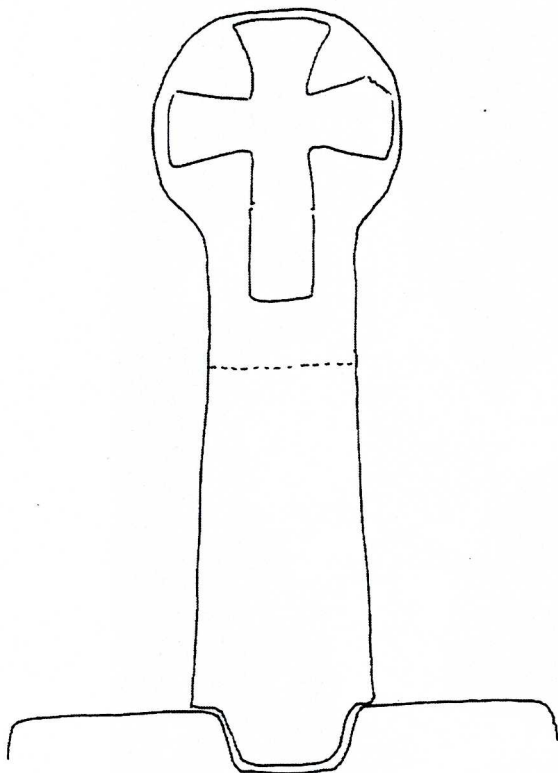
On the other hand, the Pendrea Cross may have been fated to be supported by an inadequate base, for the new base which was provided when the cross was originally restored in 1959 was a block of granite, possibly part of an old gatepost, approximately 0.9 metres long by 0.35 metres across and 0.25 metres high.

Figure 6 includes drawings of the cross and its base as they are now, and the cross as may have been if originally fixed to the Pendrea cross-base.

*Fig 6. Drawings of the Pendrea Cross now (above), and as it may have looked originally (below)*

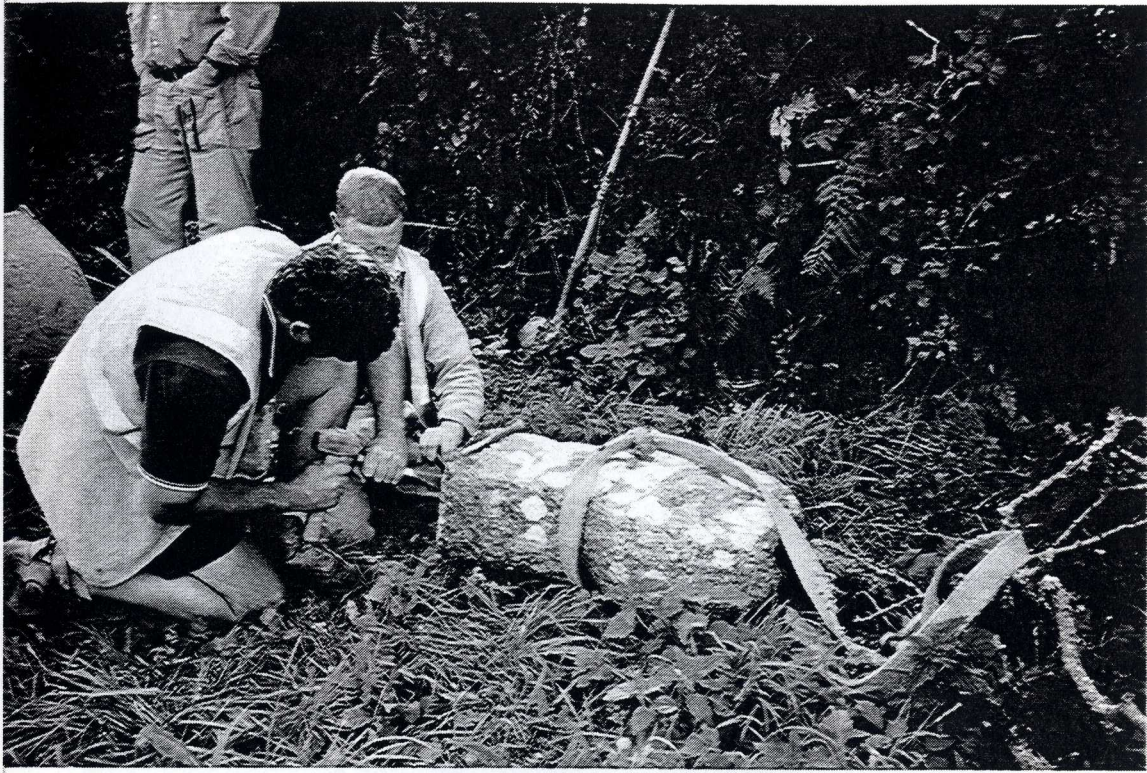
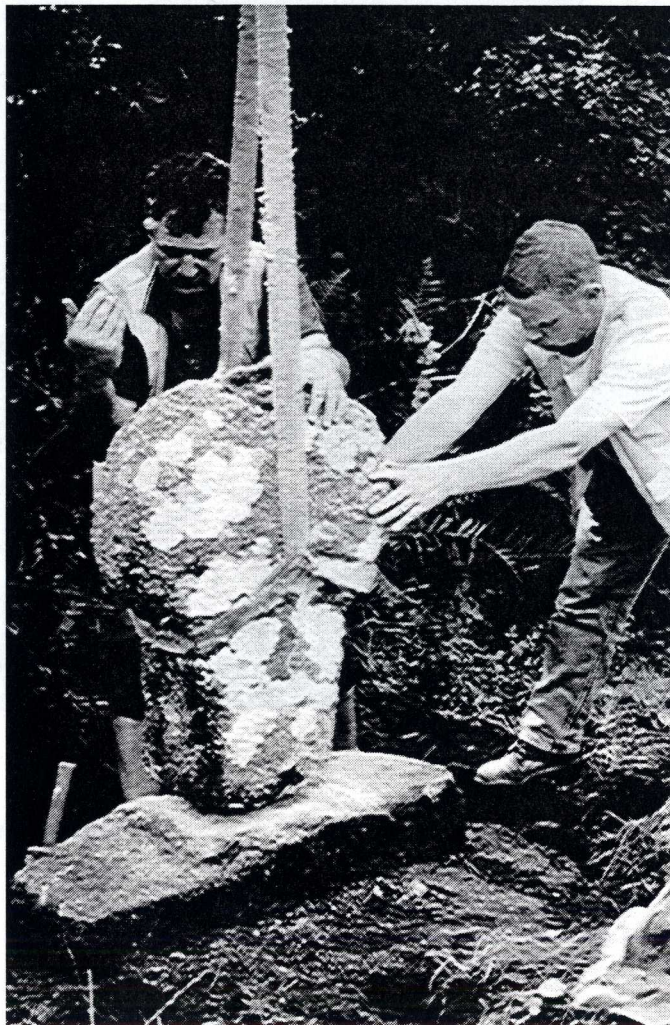
First of all, branches of the overhanging tree were cut back, to make the operation easier, and to help display the cross more fully. Using strops, the cross was then lifted to test how securely or otherwise it was attached to its base. In the event, it lifted easily, to reveal a three-quarter inch square steel pin, protruding three inches from the bottom of the shaft. It could now be seen that when the cross was set up in 1959, the bottom of the shaft had been cut level, and bedded in cement, to help it fit snugly on the new base.

The steel pin was found to be set very securely into the shaft but by contrast was loose in the base, and in fact pivoting slightly on the pin, perhaps because the pin-hole had not been cut quite deep enough when the cross was set up in 1959. At the centre, at the point where shaft and base were united, there was some very slight corrosion to the pin. This was considered to be of very recent origin, and probably the result of water penetrating the joint, following the recent damage to the cement mortar joint. As the pin was still so securely fixed into the shaft and was otherwise in good condition, it was decided that this pin should be retained for the time being: the risk of damage in actually removing it being possibly as great as the damage likely to be incurred by leaving it. So long as the joint between shaft and base remains water-tight, there should be no further corrosion: although this is a point which *must* be monitored in the future.

*Fig 7. Restoration work in progress*

The old cement bedding mortar was chipped from the base of the shaft and the top of the base, and both were then lightly dressed to provide a good surface for the new mortar to key to. The cement, which had been fixing the pin into the base, was drilled out, and the pin-hole deepened slightly, so that the cross would not rock on its pin in future.

Work then turned to the base, and the cross was temporarily laid aside, until its final restoration. The ground around the granite base was excavated away to reveal the concrete plinth which has been described above. As this appeared very modern and was considered to be doing a useful job in helping to stabilise the potentially unstable granite base, it was decided to retain the concrete and move the base and plinth as a whole. They were lifted and dragged forward by about one metre, to a position on the verge where the cross would be more visible, less likely to become engulfed by vegetation again, but would still be safe from traffic. After considerable manoeuvring, the base was satisfactorily positioned so that it would provide a firm and level base for the cross, and so that as much as possible of the granite base remained visible, while the cement plinth stayed hidden beneath the ground.

At this point, the cross was lifted back onto the base for a trial fitting. After manoeuvring to ensure that both cross and base were as upright/level as possible, the cross was lifted off again and preparations made for the final fitting. This involved filling the pin-hole in the base with a stone glue and spreading a very thin layer of fine lime mortar over the base, to bed the cross on (which was already a very close fit). The cross was then lifted back onto its base for the last time, and after further careful adjustment to ensure that it was properly vertical, the joint between base and cross was mortared with a hydraulic lime mortar (NHL 5, with a mixture of New Milton, Doble and Clevedon Farm sands).

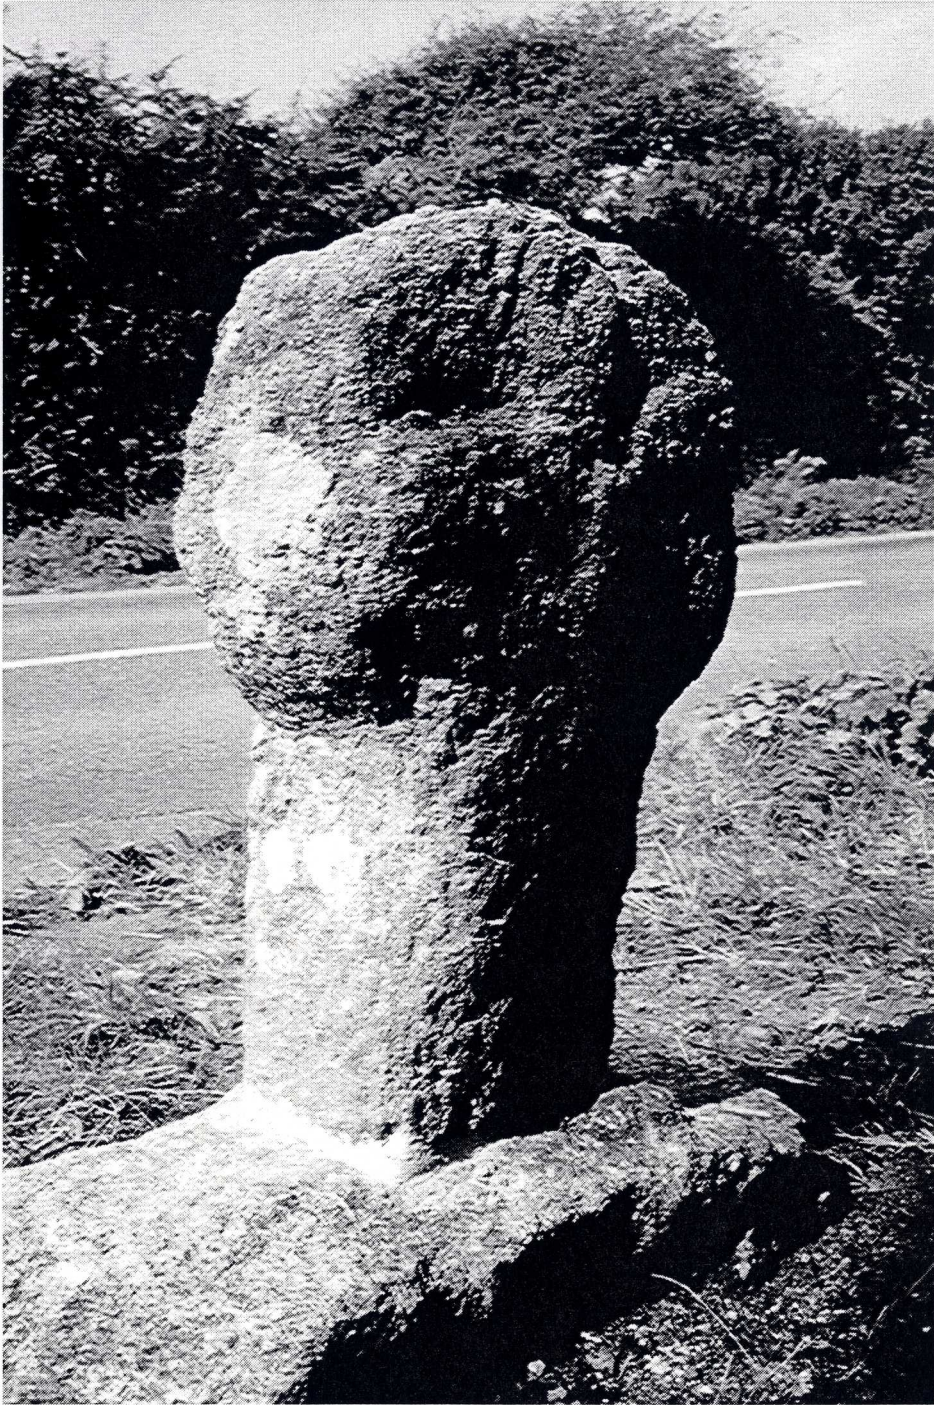
Following the conservation work, the Pendrea Cross is a far more prominent feature on the verge of the road leading from St Buryan to Porthcurno and St Levan (Fig 7). With its base, it now stands 0.9 metres high, is set back 1.5 m from the edge of the road and a metre out from its former position. Following the care that was taken to ensure that it is firmly bedded and levelled, securely pinned and mortared, it should also be stable for many years to come. However, there are a number of recommendations for future monitoring and management, which will help ensure that it remains this way.

*Fig 8. The restored cross*

1. The cross must be monitored to ensure that the joint remains mortared. Although the pin is of steel, not iron, it is not stainless steel, and will therefore be more vulnerable to corrosion if water were to get into the joint.

2. Under normal circumstances, the cross should be safe from vehicles encroaching on the verge. However, if there is any further intensive roadside work of the sort that took place in St Buryan a few years ago, this cross could again be vulnerable. The situation should be regularly monitored and if there is any fear for the safety of the cross, further boulders could be placed on the verge to provide a better degree of protection.

3. The granite base onto which the cross was bedded in 1959, which was possibly created from part of an old gate post, is of inadequate size to support the cross properly. If further repairs are ever made at some time in the future, consideration should be given to supplying a new granite base-stone of more substantial proportions, together with a new section of shaft. Together, these would restore the original proportions of the cross.

4. The vegetation growing from the hedge at the rear of the verge, though cut back on this occasion, is all too likely to grow out again. This should be monitored, and when necessary, should be trimmed back so that the cross remains visible.
5. Finally, it should be noted that although the cross has been moved slightly, it is considered that it is still within the two metre constraint area that applied to the former location, and that the cross is therefore still protected by Scheduling.
