KENNALL VALE GUNPOWDER WORKS, CORNWALL

Repair work to leat

July 2003

Report No: 2003R055

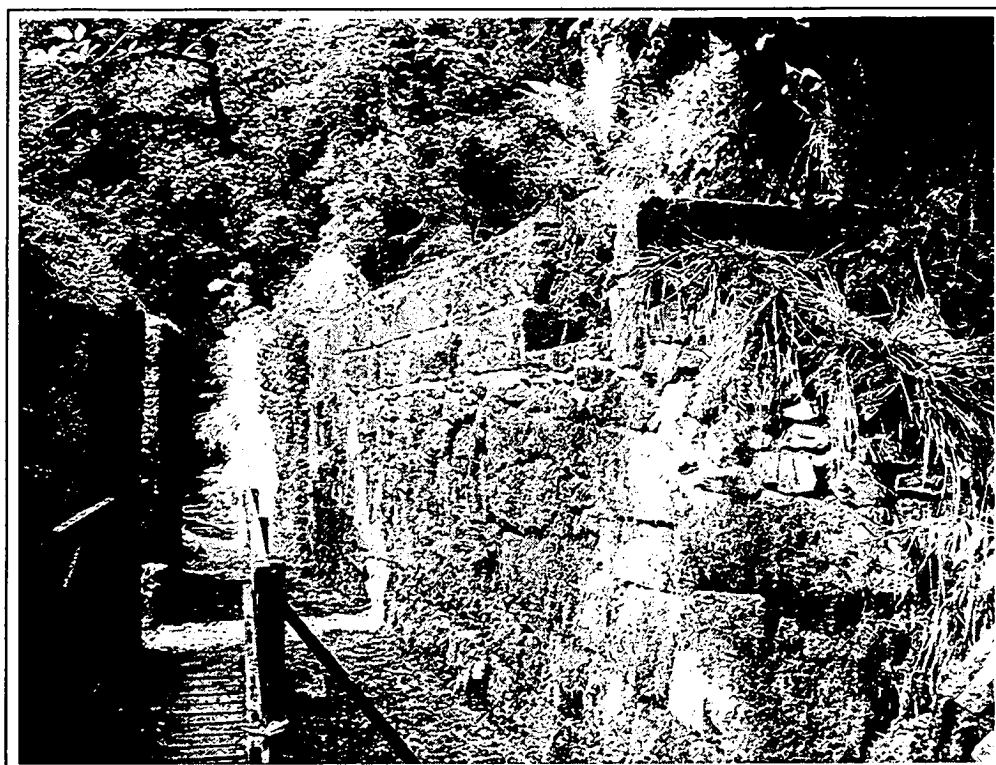
The leaf following repair works.

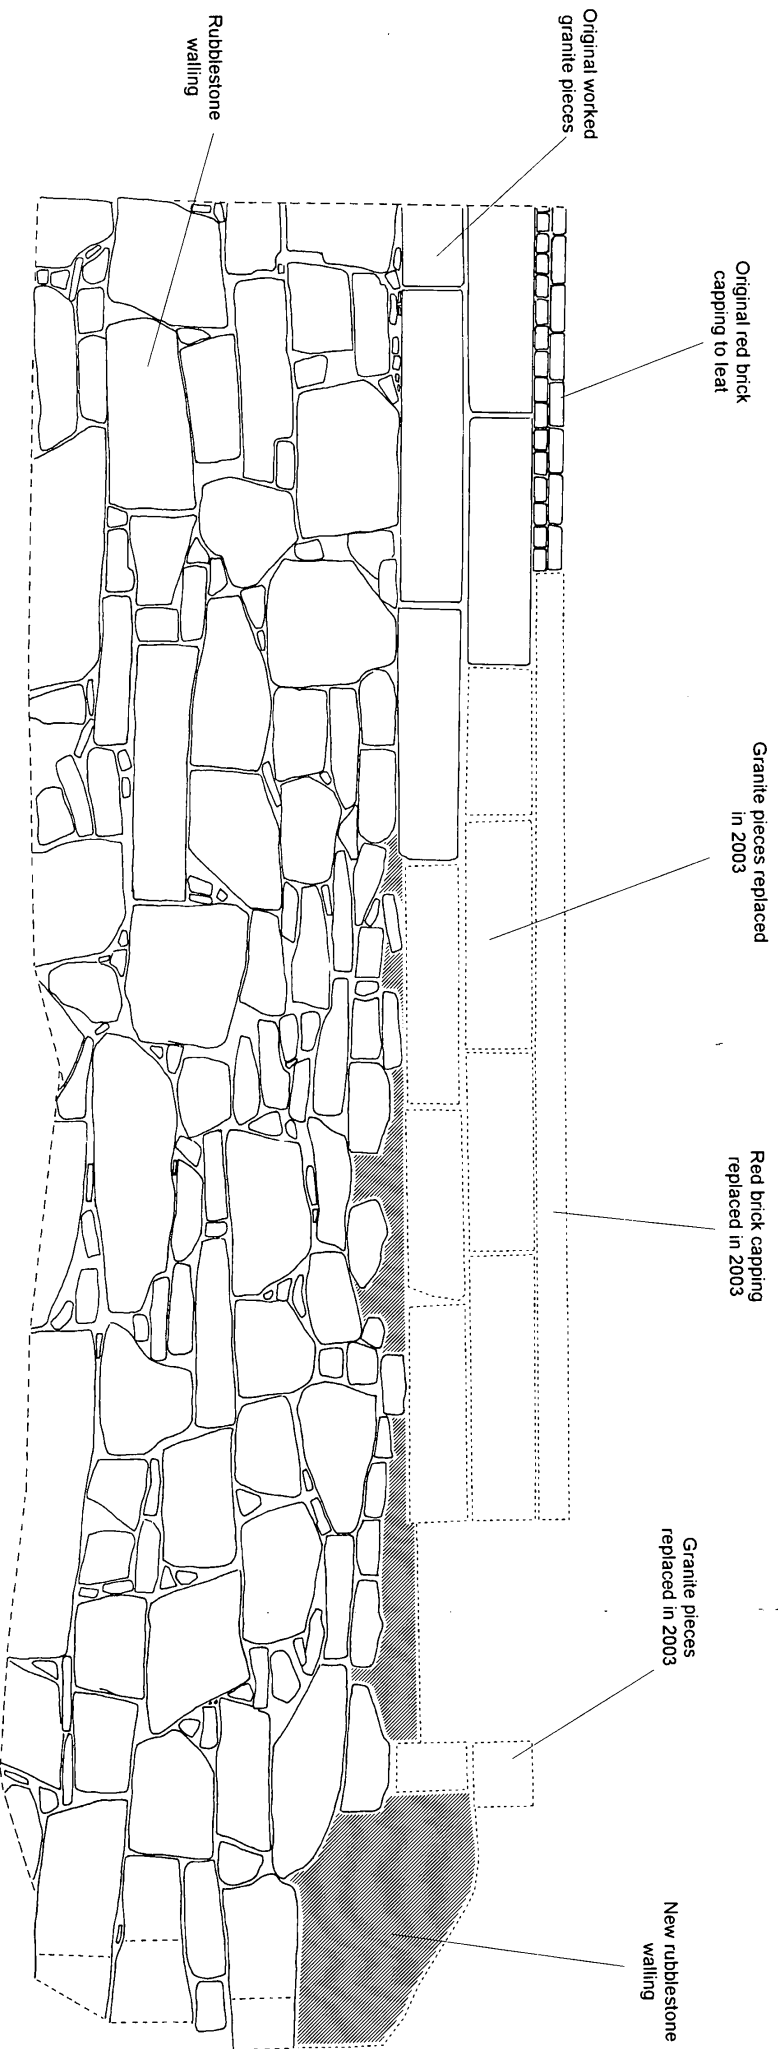
Fig. 5 The repaired leat at Kennall Vale.

A six metre long section of the leat and its walling was damaged in November 2000, when a tree rooted into the bank above was blown over in a storm. The damaged section was the end of one section of leat, where it would have fed into a launder feeding an overshot waterwheel between mill buildings 30 and 31.

The fact that the leat wall had already been weakened by tree-root action may have contributed to the damage (see the English Heritage Field Monument Warden's Damage Report; Preston-Jones 2000). A footpath used in the past for access to the mills, and now by visitors to the reserve, runs between the leat and the mill-pair which the leat served. Following the accident, debris was cleared to one side of the path, and the leat temporarily blocked just upstream to prevent water spilling onto the path.

Fig. 5 shows both the extent of the upstanding remains, as well as the extent of the rebuilding which was sketched onto the main drawing, following the completion of the repair work.

1. The wall to be rebuilt in the style in which it was originally constructed using adjoining sections and the CAU elevation drawing as a guide.
2. The wall to be rebuilt using only materials retrieved after the damage to the wall in November 2000.
3. Although the wall may originally have been mortared, all trace of this has now washed out (other than a few bits of more recent repointing) so that it now looks like a dry-stone construction. It is suggested that this appearance is retained, so that although the replaced stones will be bedded in mortar, the mortar is kept well back from the face of the wall.
4. Any roots growing in or near the section of wall to be rebuilt should be cut and treated with a herbicide to prevent re-growth.
5. The mortar to be a hydraulic lime mortar (NHL 3.5) in a 1:2.5 mix with a well-graded sharp sand (Cornwall Lime Company's New Milton sand).

The mix for the lime mortar, as noted above, was agreed in advance following advice from Stephen Tucker (SMT Associates). The works were then carried out largely in line with the original brief, between the 26th and 30th of May 2003. Mark Nicholls of Cornish Stonework and two colleagues were responsible for the works, and winched each of the

In hindsight, it is noticeable that two stones had slightly chamfered ends and would have been positioned next to the opening where the launder would have been. Only one of these stones was re-erected in its original position, though this does not impact on the external appearance of the monument. At the same time, the visual impact of the mortar bed between the stones was kept to a minimum although practical considerations meant that it had to remain visible.

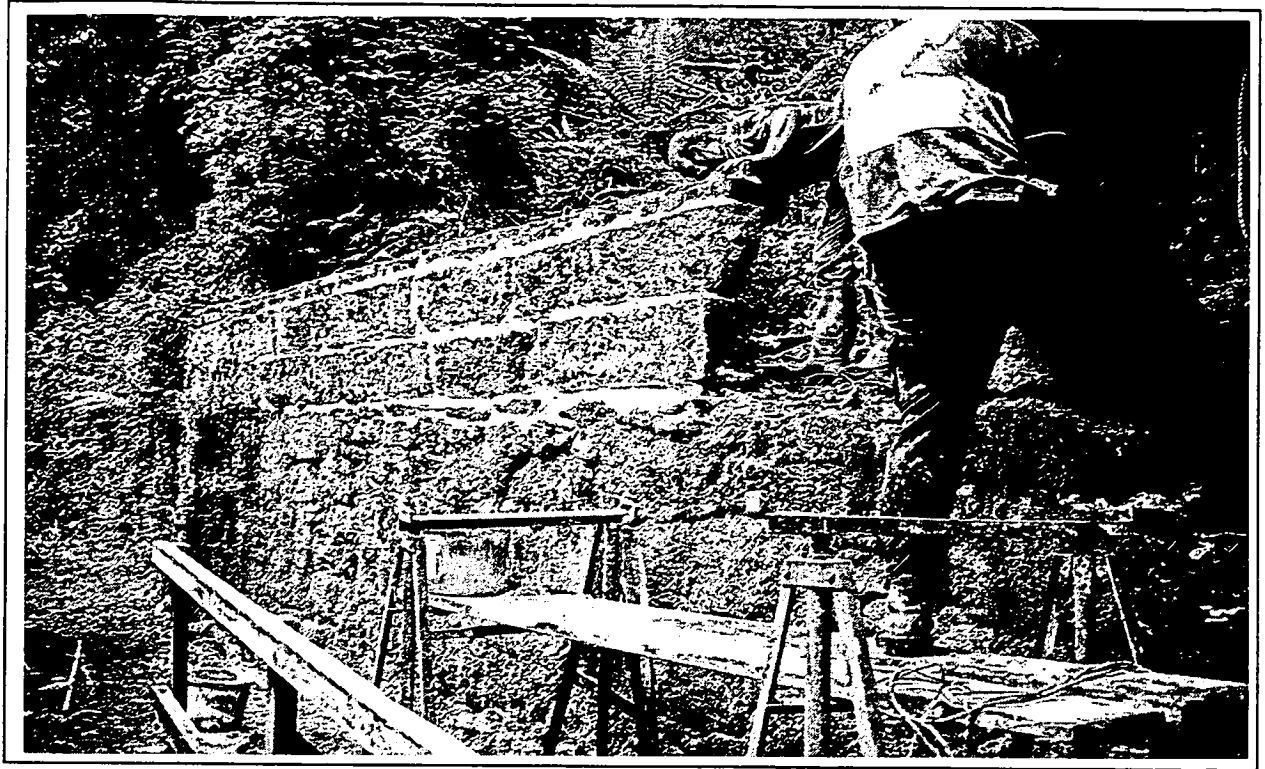
Fig. 6 Photograph of repair works in progress

large granite blocks to the top of the walling to be relaid. Working through the loose rubble on the path, the stones were laid one by one.
