Wheal Call, Kenidjack, St. Just, Cornwall

Archaeological recording of the dressing floors prior to works

Client	The National Trust
Report Number	2012R014
Date	17 December 2012
Status	Final
Report author	Adam Sharpe BA MIfA
Checked by	Andy Jones
Approved by	Andrew Young MIfA, HE Projects Officer

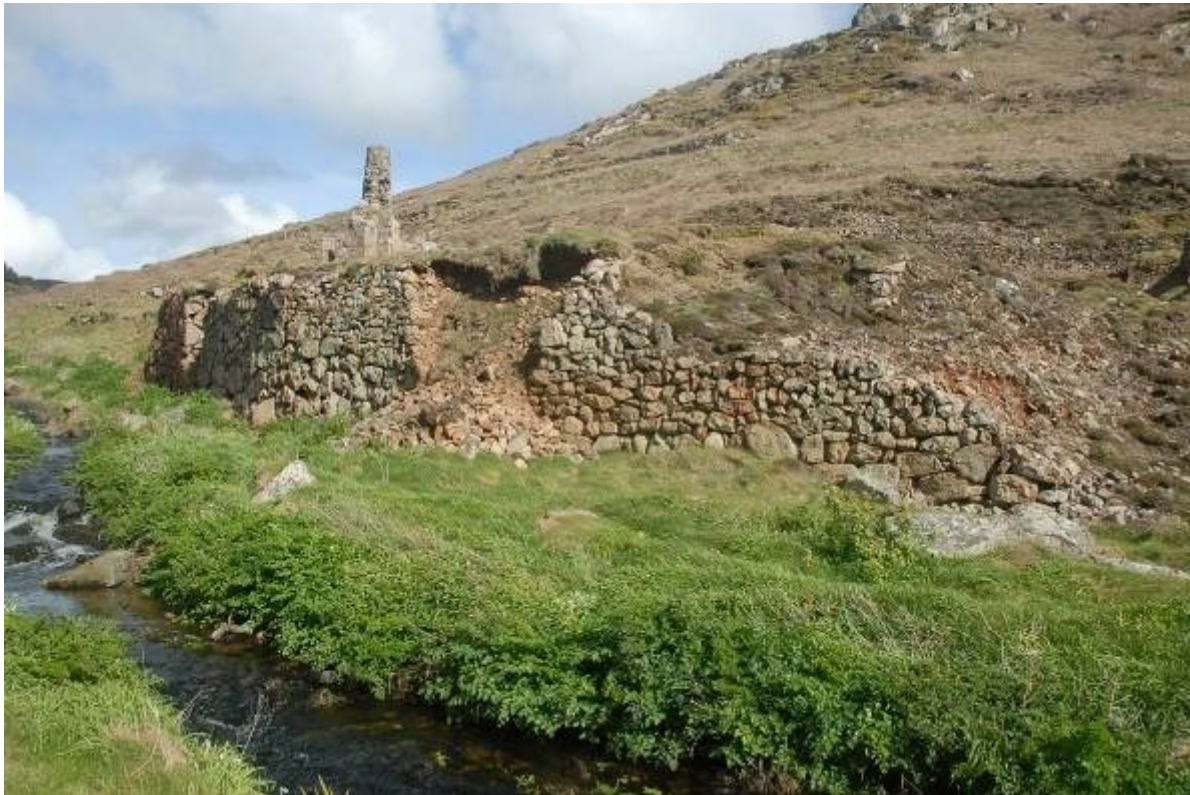
Fig 16. The dressing floor retaining wall from the north west, showing the area of collapse.

Funds have already been identified to make good the recent area of collapse in the dressing floor revetment wall, though other sections of this feature should be monitored for further indications of weakness and incipient failure. Some thought may need to be given towards stabilising the broken ends of the walling through localised rebuilding. The repairs should be in dry stone masonry with earth packing, as in the original construction. The collapsed material should be excavated away from the foot of the wall, sorted and the rebuild carried out so as to match original coursing, where this exists.

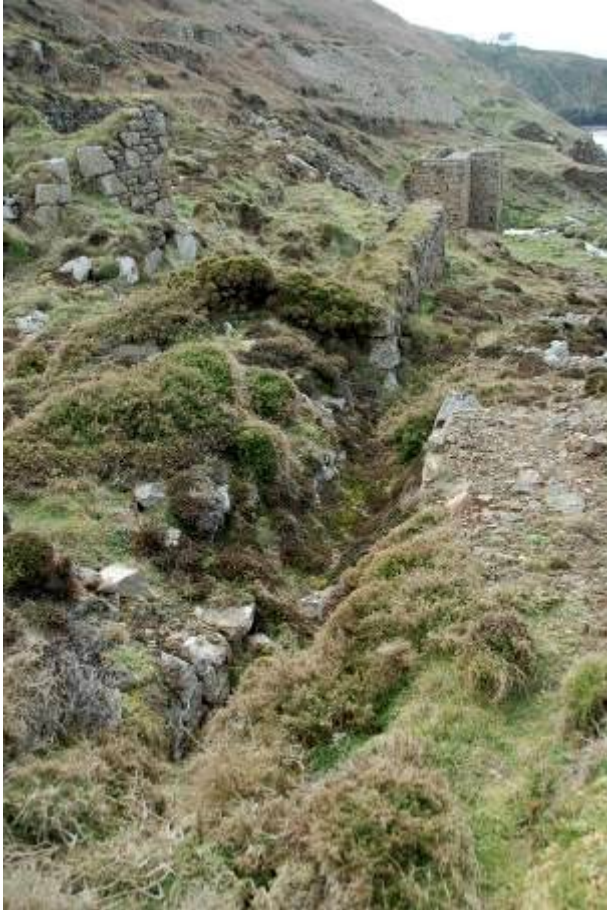
Fig 17. The flat rod trench running across the dressing floors from the Great Wheel. The collapsed end of the tunnel from the east is more or less at the point from which this photograph was taken.

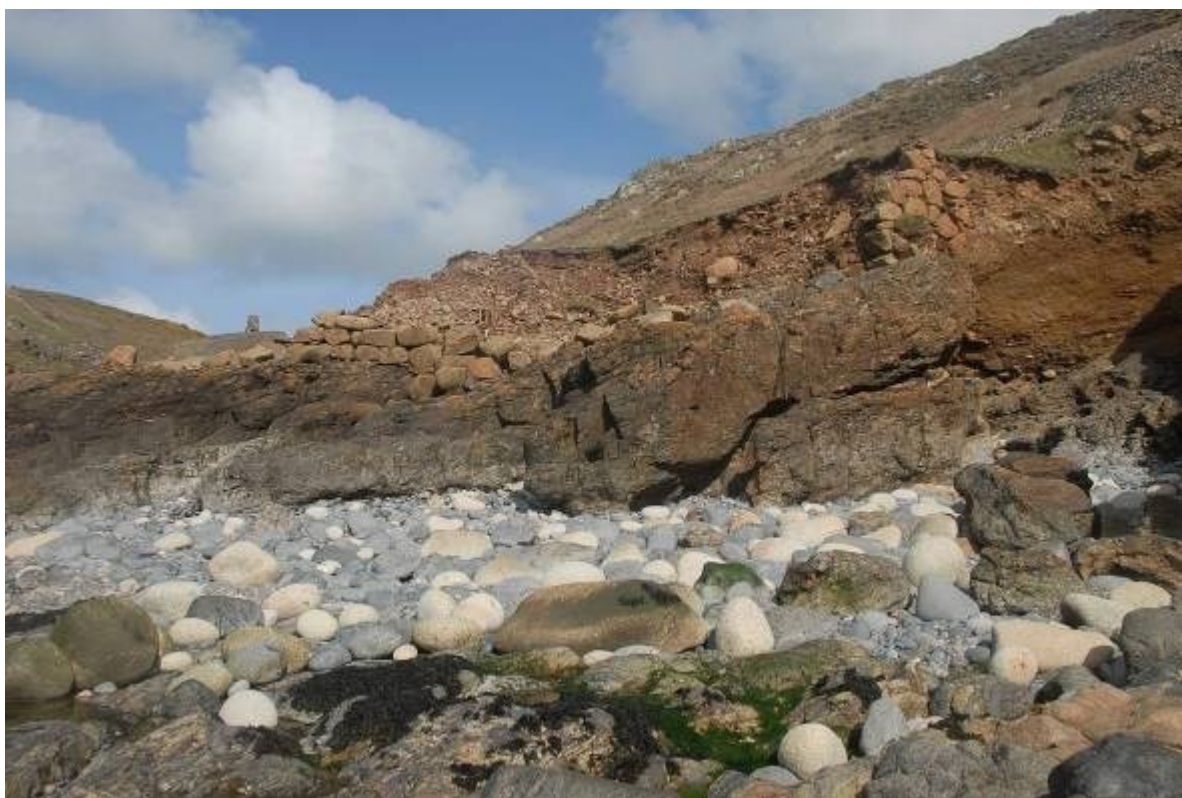
Fig 23. The remains of the boulder wall which formerly retained dressing floors above Porthledden, but is now very much eroded away.

The boulder wall which formerly revetted the lowest part of the Wheal Call dressing floors is probably now beyond repair without the expenditure of very large amounts of money, and a strategy of managed retreat is probably now the only sensible option. However, it should be noted that erosion of the mine waste deposits and archaeological features constructed on them (and contained within them through a build up of deposits during the operation of the mine) appears to be progressing year on year (this amounting to 7.5m since 1907, most of this having taken place within the past two decades), and there can be no doubt that within a few years this material will have been almost completely washed away by sea action, potentially leaving the Wheal Call Great Wheelpit exposed. Some consideration should be given to periodic monitoring of the erosion and for the recording of features which are already exposed and likely to be lost to this process, or, in the case of buried sections of timber launder or other early mine features, which will be revealed by future erosion. Ongoing erosion will also eventually destroy the access route from the valley bottom to the path leading past Praze Shaft towards Cape Cornwall.

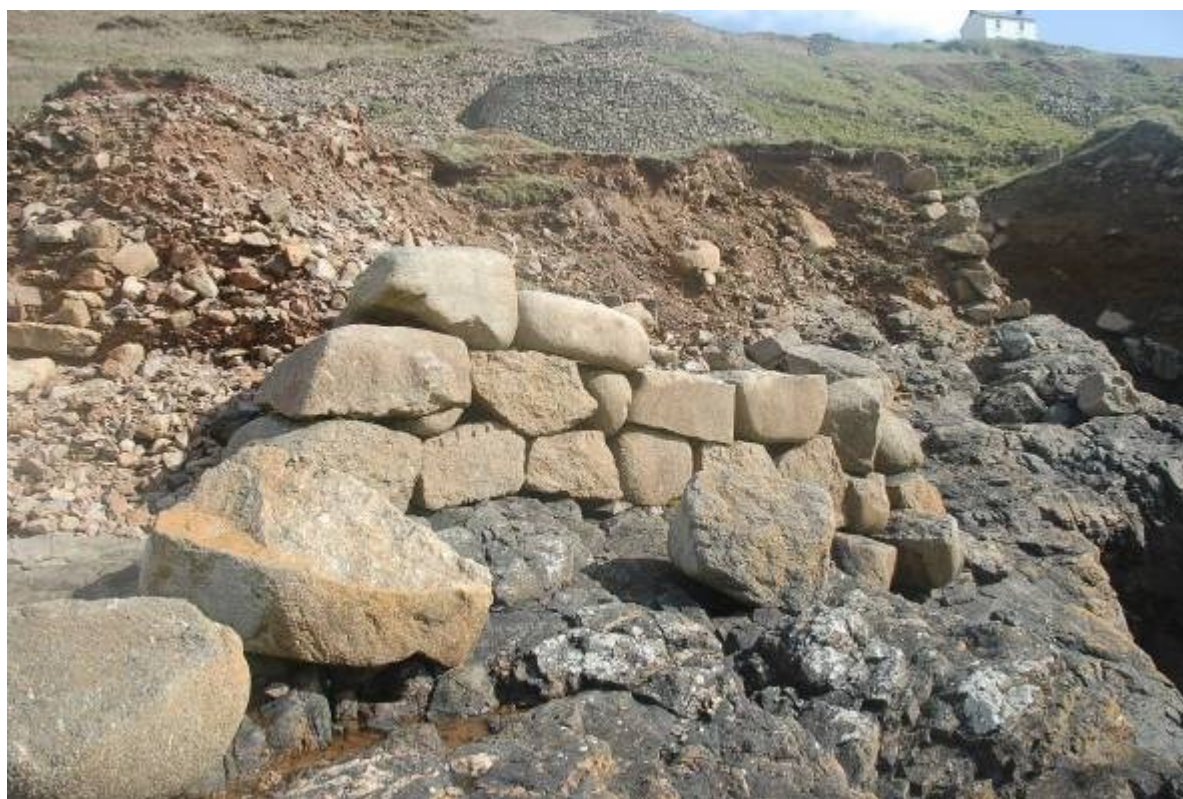
Fig 24. Another view of the remains of the boulder retaining wall, showing the substantial erosion which has taken place to the deposits which it formerly retained.

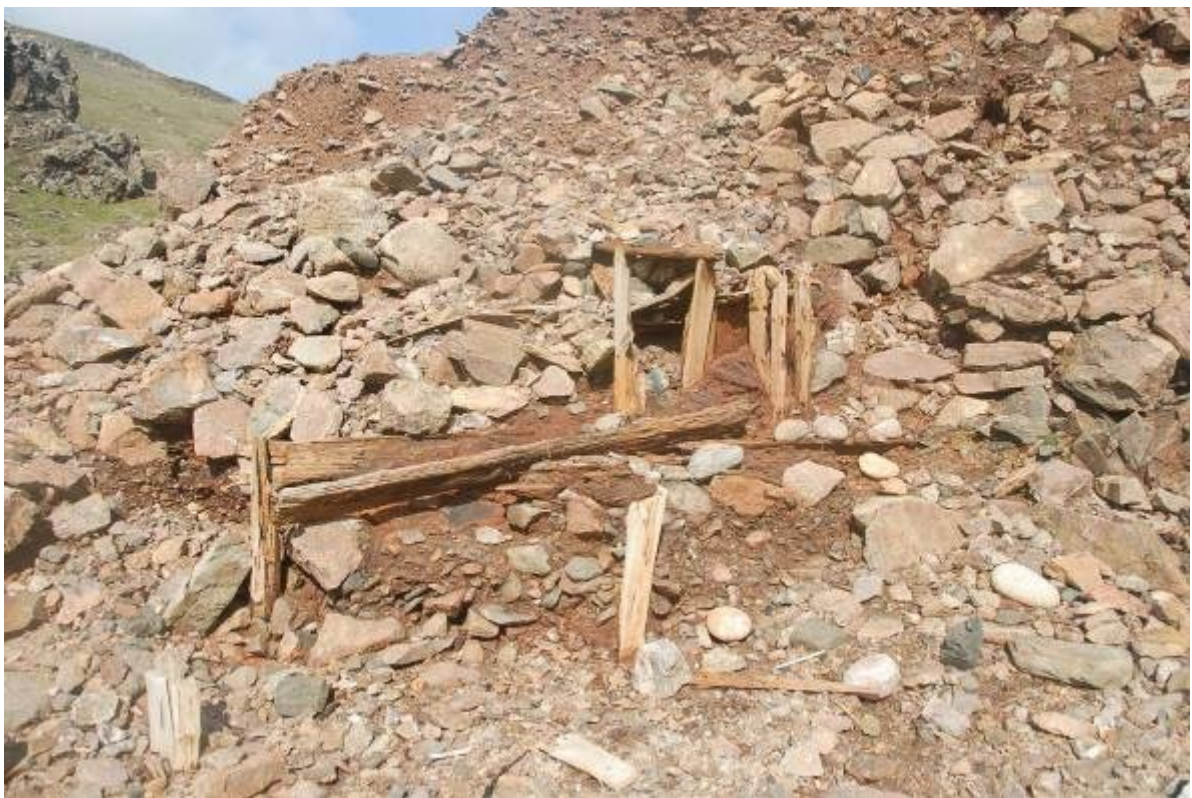
Fig 25. Early timber features including a launder eroding out of the base of the deposits formerly retained by the Porthledden boulder wall.

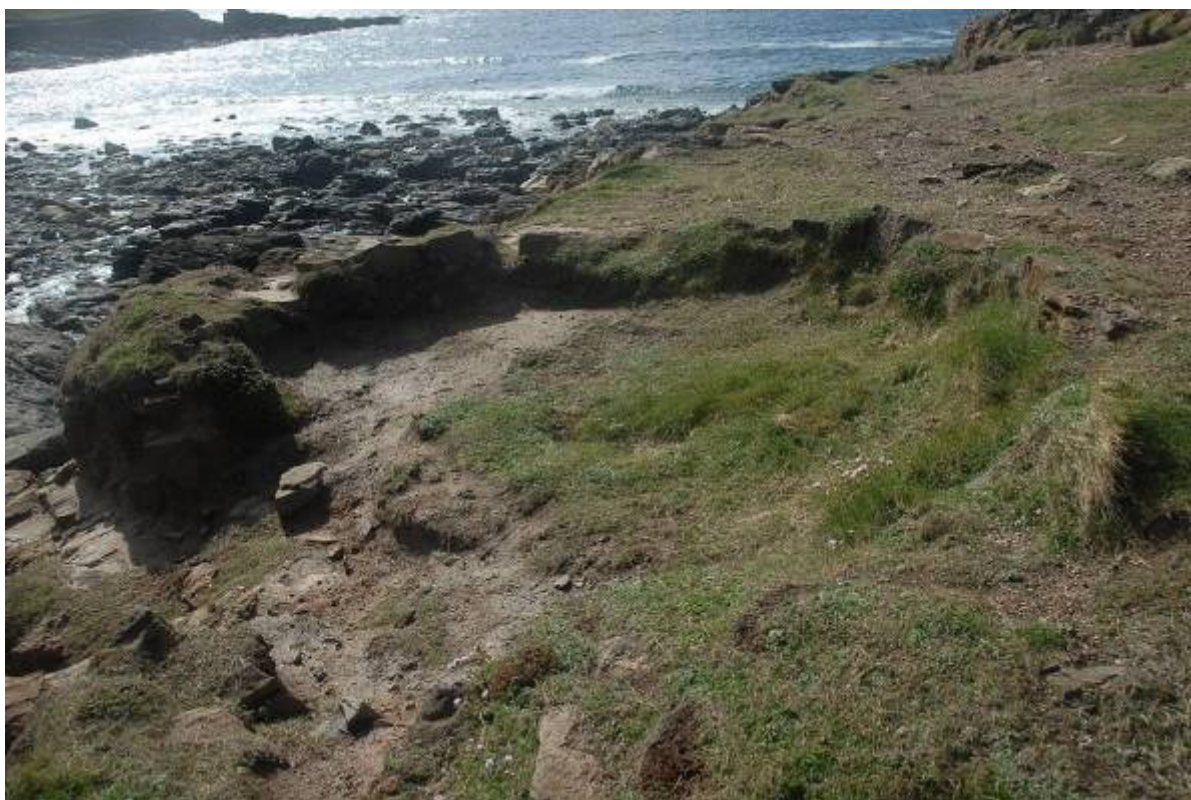
Fig 26. An eroding tributers' round buddle set just above Porthledden. A further example has now almost completely disappeared.

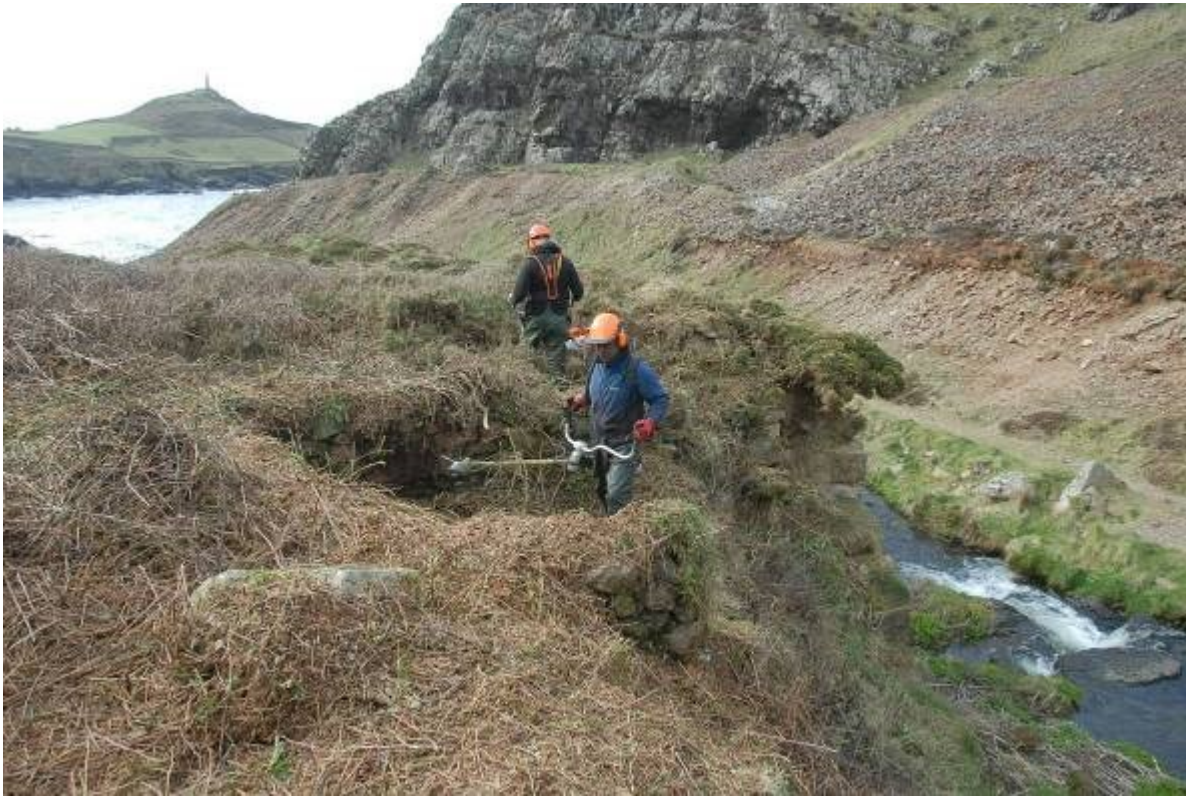
The product from the steam stamps appears to have been passed to a series of parallel settling tanks to their north west, some parts of whose walls were revealed during vegetation clearance in 2012 (Fig 27); these were not depicted by the OS in 1877. Again, these features had been damaged following the closure of the mine. The majority of the lengths of the tanks are now infilled with rubble and soil and are obscured by gorse, though their northern ends have now been made visible through vegetation clearance. The collapse of the north eastern end of the dressing floor revetment wall has clearly truncated the ends of some of the tanks.

Fig 27. Kernow Maintenance Services brush-cutting vegetation from the remains of the settling tanks sited on a levelled area retained by the adjacent walling.

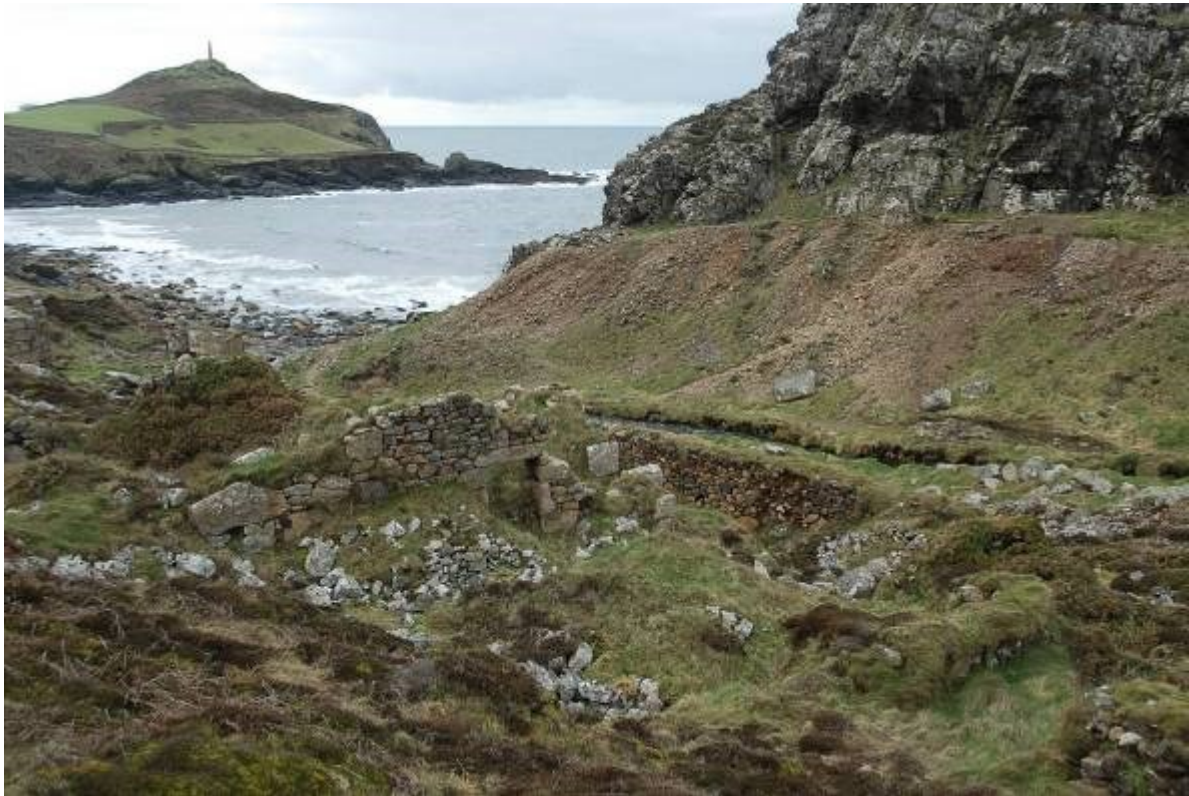
Fig 29. An overview of the calciner and adjacent structures from the south east, showing the dilapidated state of most of these buildings.

The reverberatory arsenic calciner at Wheal Call represents one of a tiny number of surviving examples of this type of formerly more or less ubiquitous mine structure. A conjoined pair of calciners of this type was consolidated by the NT at Wheal Coates, and represents the best-preserved in Cornwall. There are also examples at Wheal Edward (substantially demolished) Wheal Ellen, Porthtowan (overgrown and substantially collapsed) and Tywarnhaile, Porthtowan (another pair, in fair condition but lacking public access).

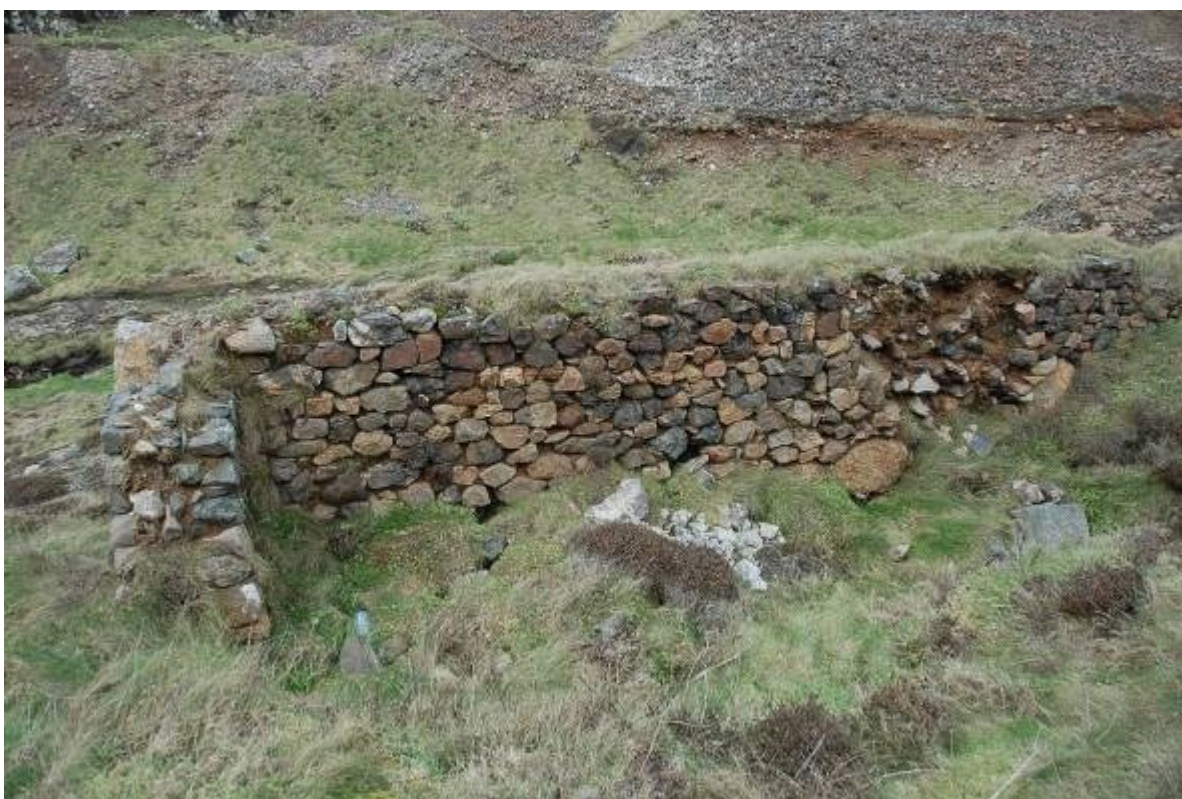
The structure immediately downslope, measuring 5.6m x 4.5m in plan, standing to a maximum of 3.25m is integral in construction with the calciner on its northern elevation, though of less robust construction, but its walling clearly butts the calciner on the southern side. This may suggest a rebuild during the life of the building. Like the calciner, it was constructed of semi-coursed rubble mine waste, partly-shaped water-rounded beach cobbles and occasional fragments of broken brick set in a soft lime mortar which has suffered significant erosion; some areas of facing have collapsed as a result. All wall openings and wall corners are framed with roughly-squared granite quoins.

Fig 34. The dressing floor building immediately downslope (north) of the calciner, showing its partial survival.

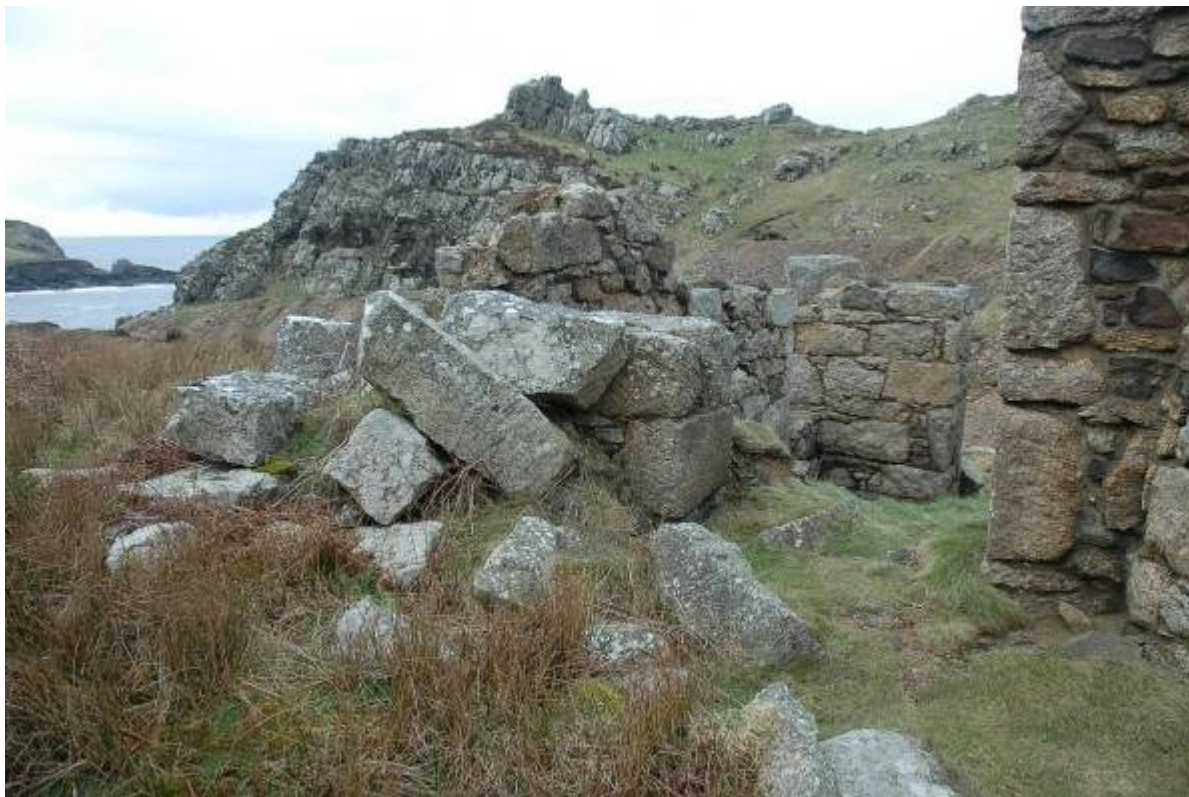
Fig 38. The remains of the substantially demolished rear wall of the stamps engine house, showing the remains of the original cylinder opening.

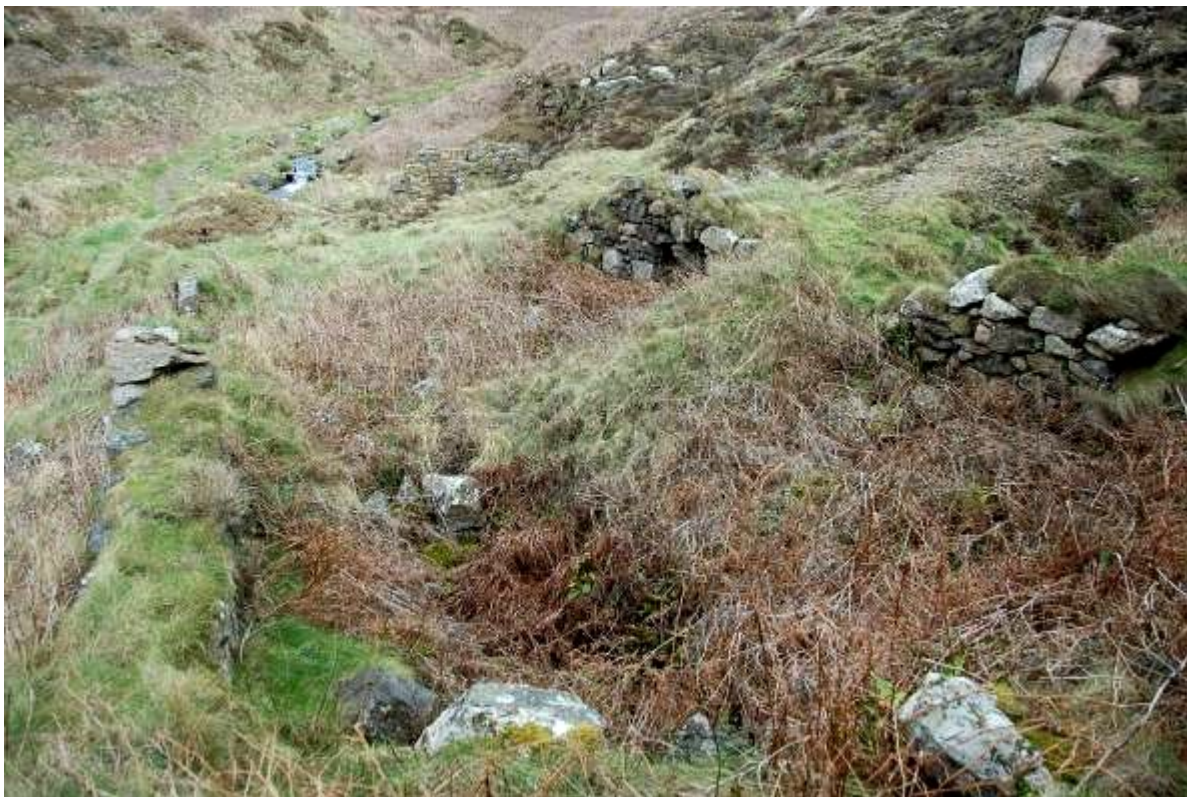
Fig 40. The low remains of the stamps engine boiler house. A collapsed adit leading into the outcrop workings on the hillside to the right runs beneath the centre of the building.

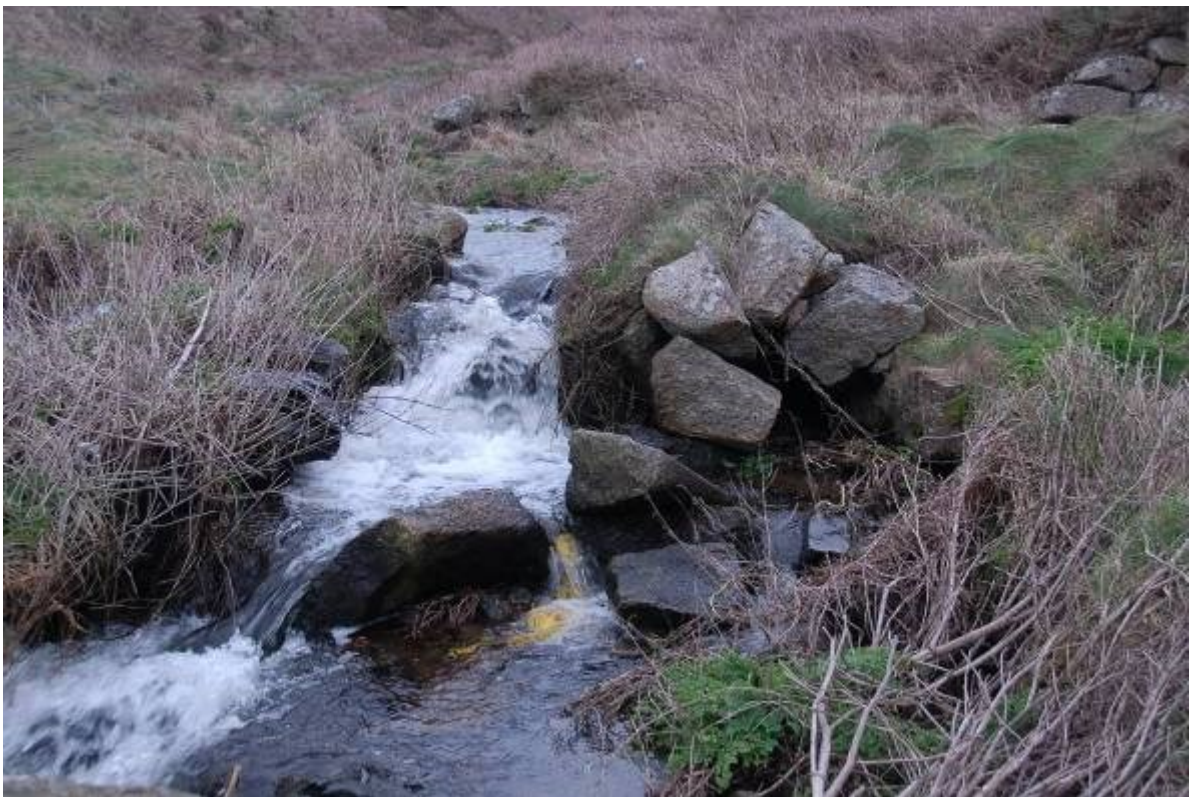
Fig 42. A collapsed section of the culvert which carried the Kenidjack Stream under the dressing floors, this part originally of arch headed form.

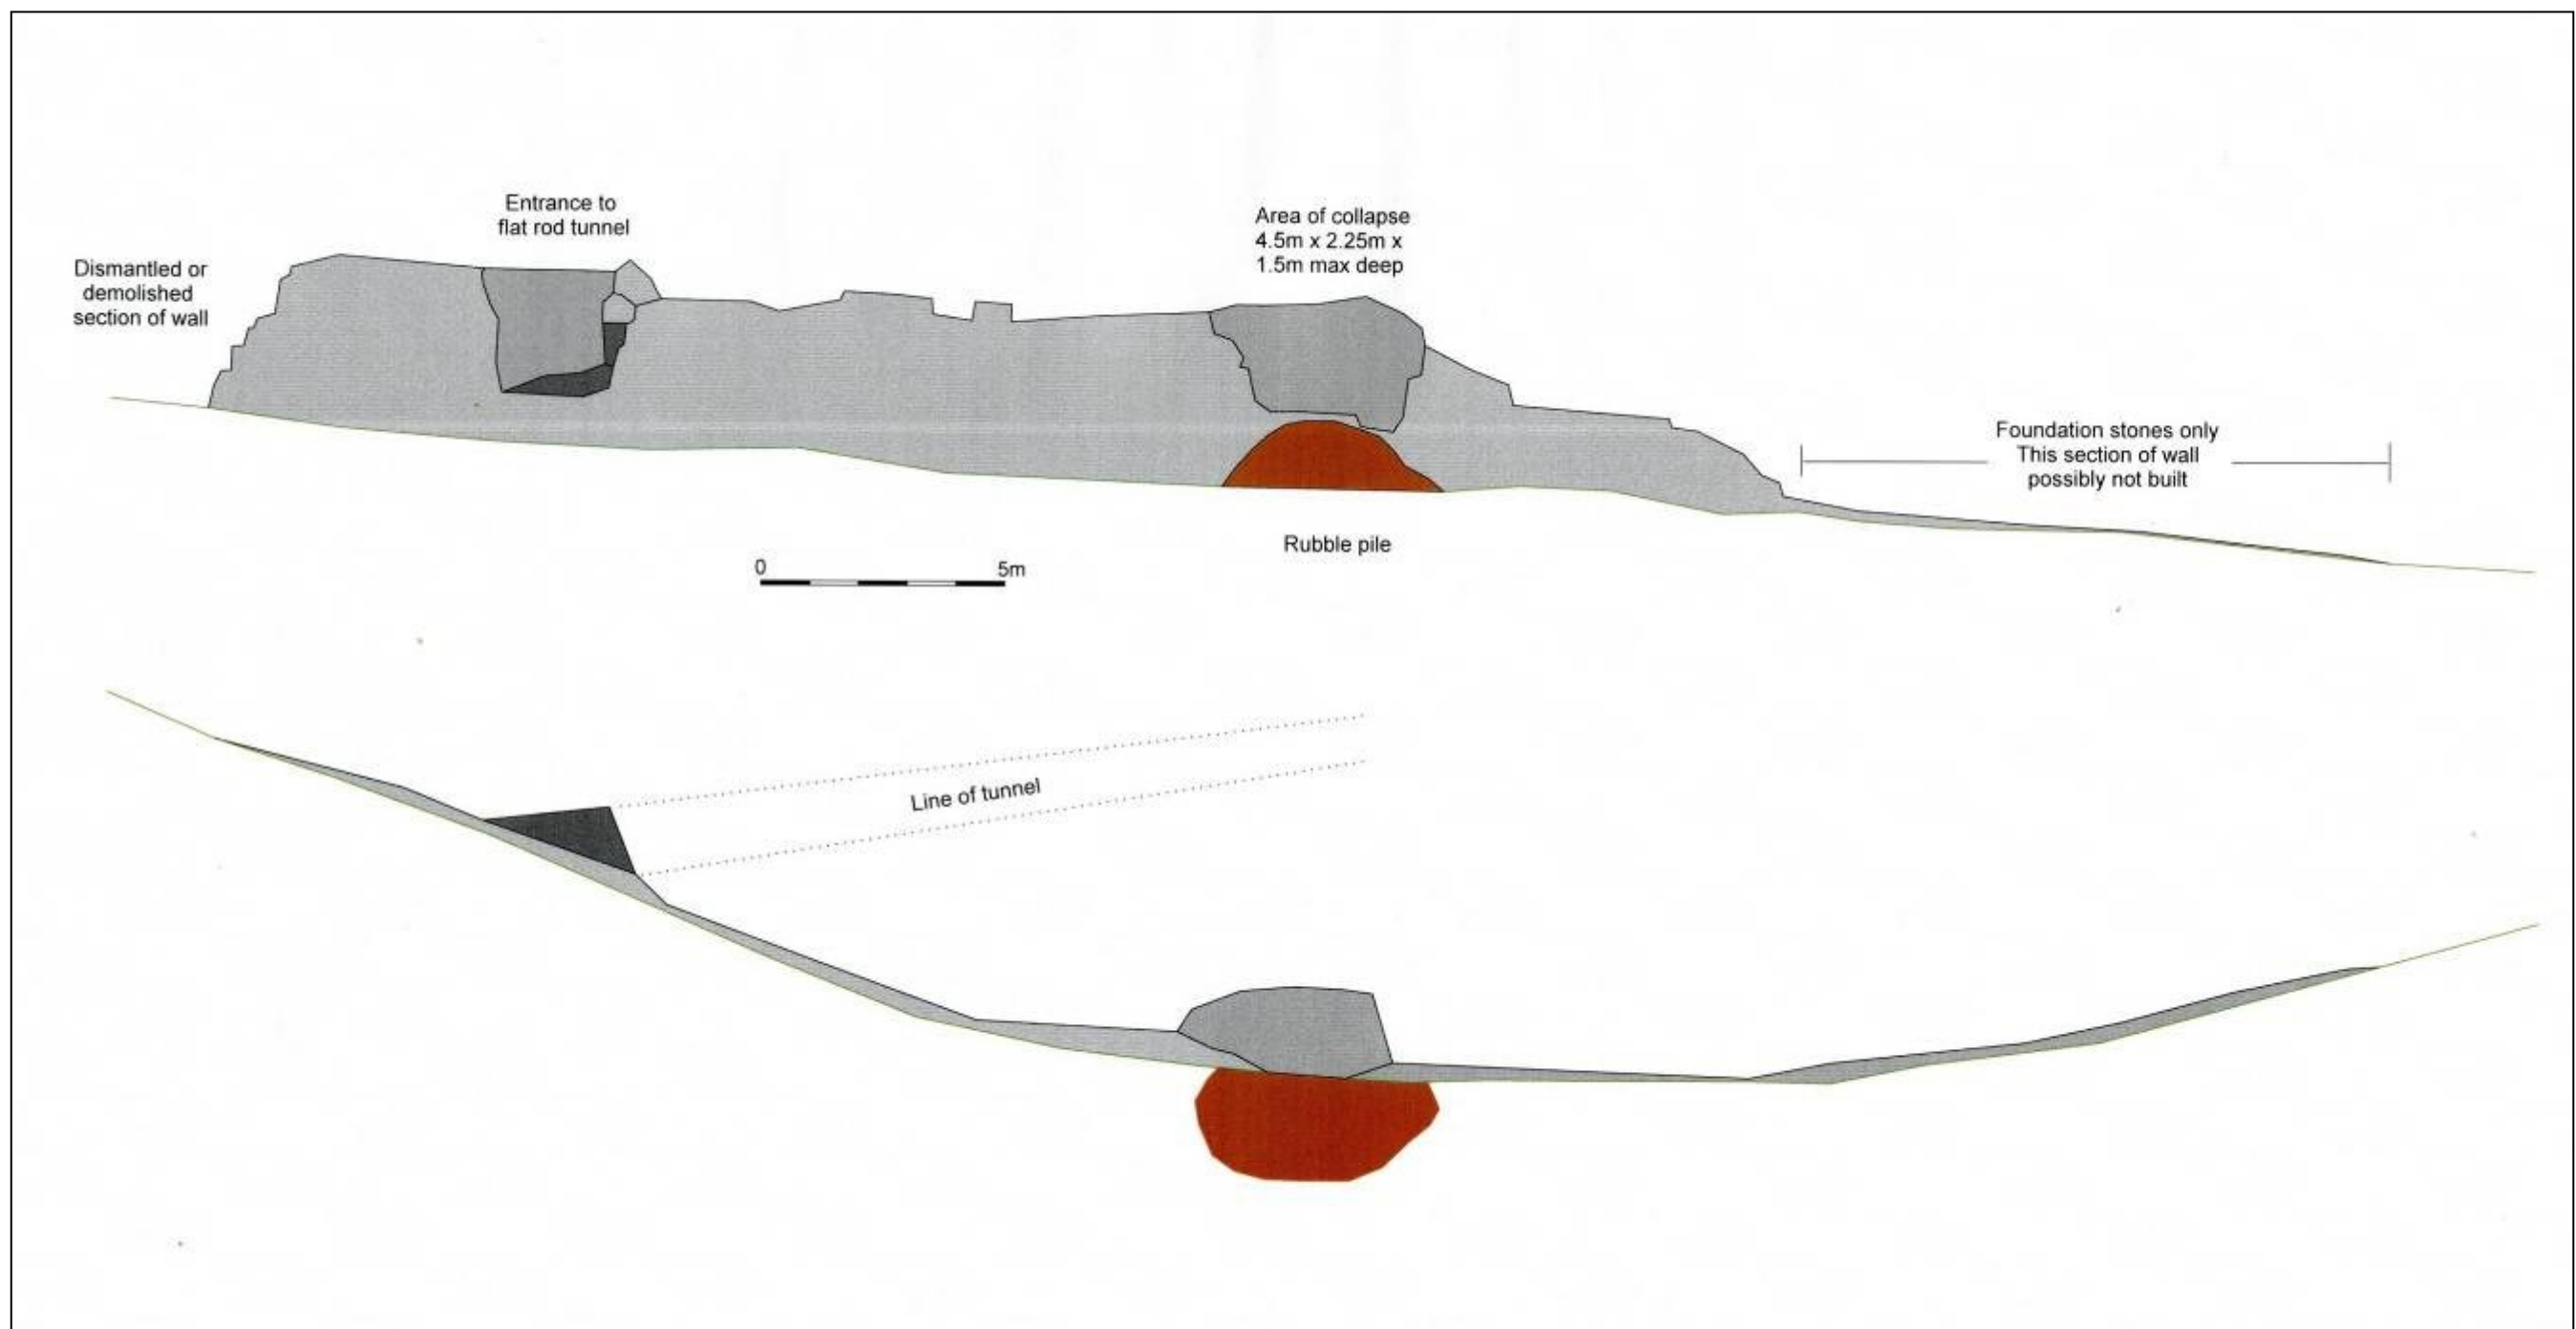
Fig 48. Elevation (top) and plan (bottom) of the Wheal Call dressing floor retaining wall, showing the entrance to and route of the flatrod tunnel (left), the recently collapsed section of facing (centre) and the section which never appears to have been completed, although foundation stones were laid.
