Helland House, Mabe, Cornwall

Historic building record and archaeological watching brief

Client	Mr and Mrs T Ellemann
Report Number	2012R053
Date	October 2012
Status	Final
Report author(s)	Nigel Thomas, with a contribution by Carl Thorpe
Checked by	Jacky Nowakowski
Approved by

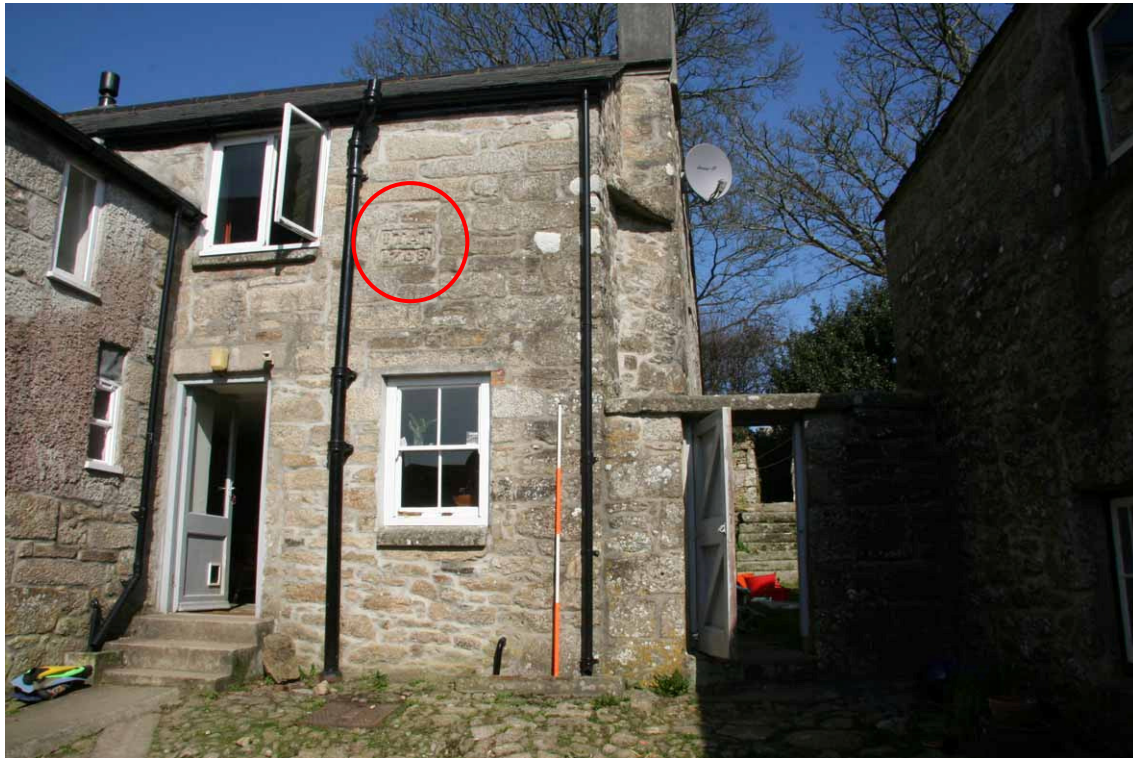
Fig 9 Rear wing of the farmhouse

Note the date-stone inscribed 'IT AT 1708' (circled) within former window opening

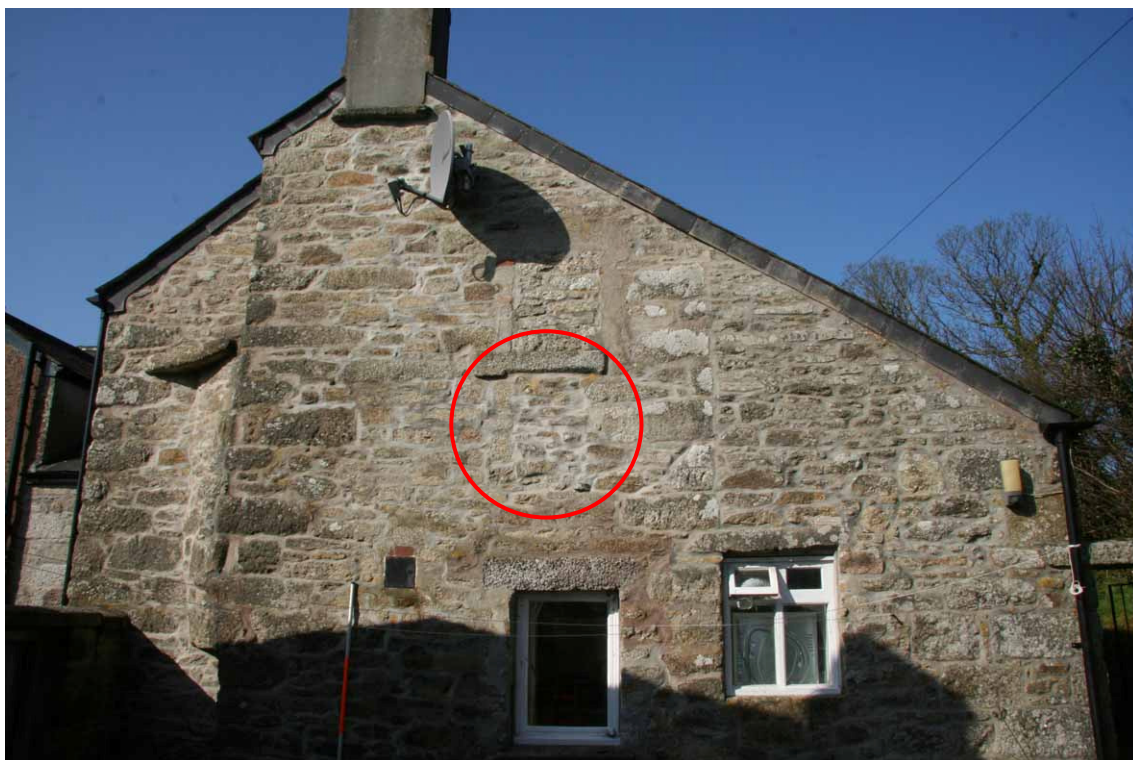
Fig 10 Gable of farmhouse rear wing, with 19th century dairy lean-to towards the right
A blocked earlier window is shown circled (and is also marked in green on Fig 39)

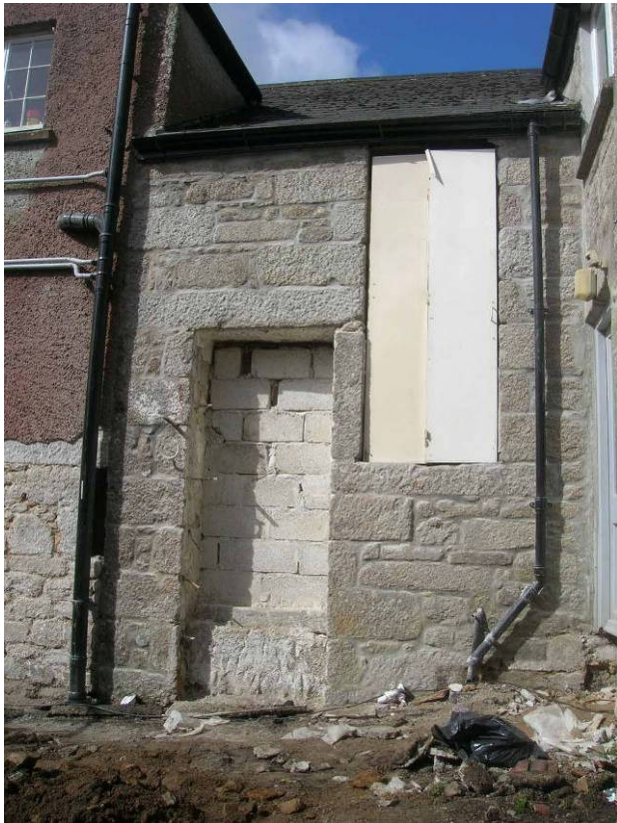
Fig 11 Rear stair hall of farmhouse, masonry exposed after removal of modern roughcast render

The relatively finely dressed door jambs and lintels indicate investment in the 18th century

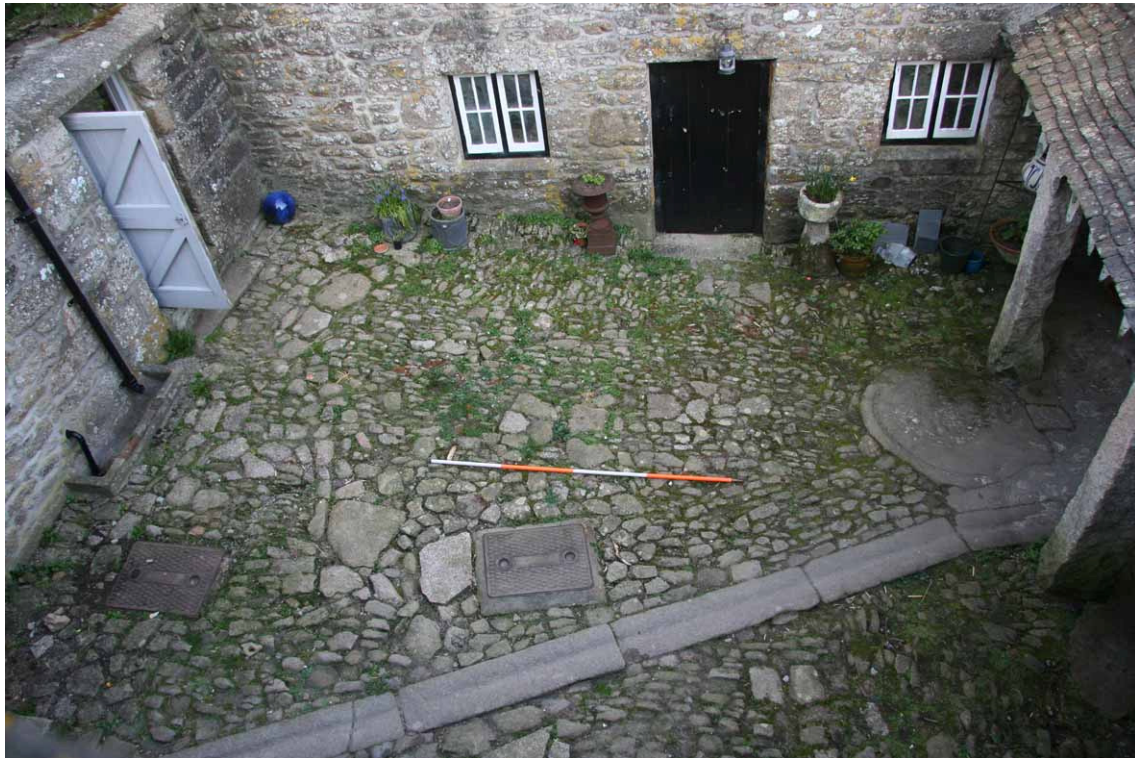
*Fig 13 Paved domestic courtyard viewed from farmhouse
A circular cider press base (at right, centre) has been reused in the paving*

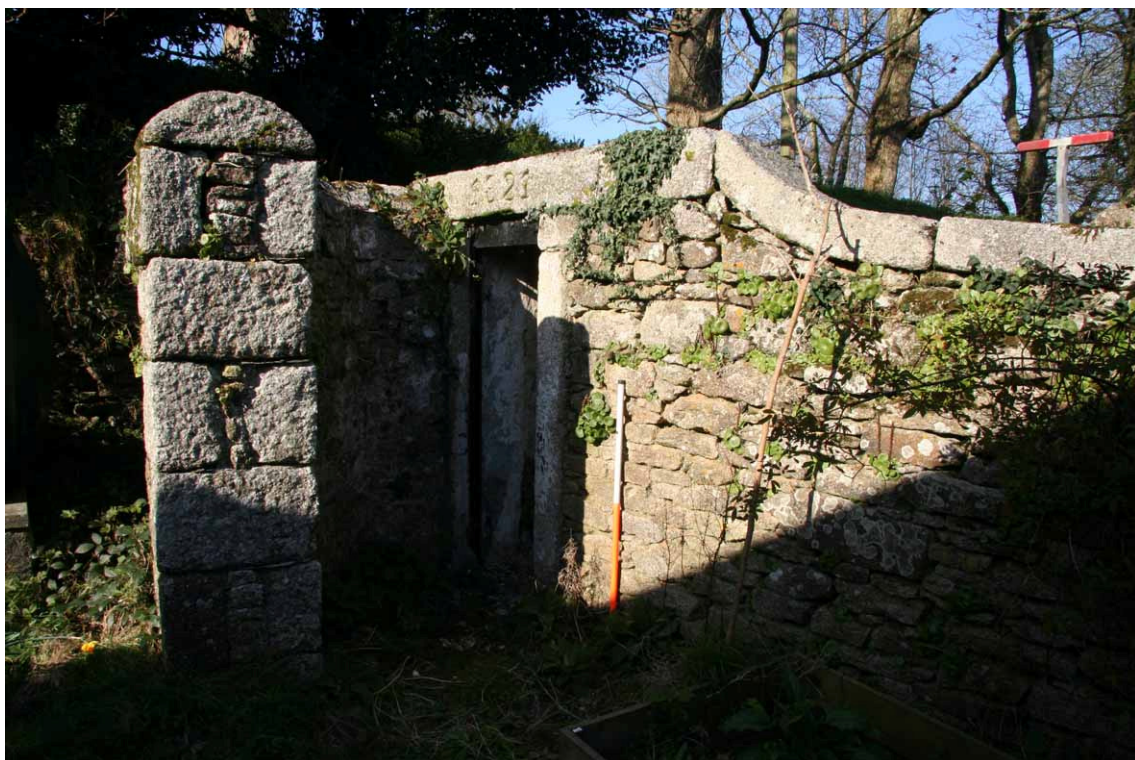
*Fig 14 Granite-built earth closet, with date 1821 cut into lintel
Its construction appears to be integral with the coping on the kitchen garden wall*

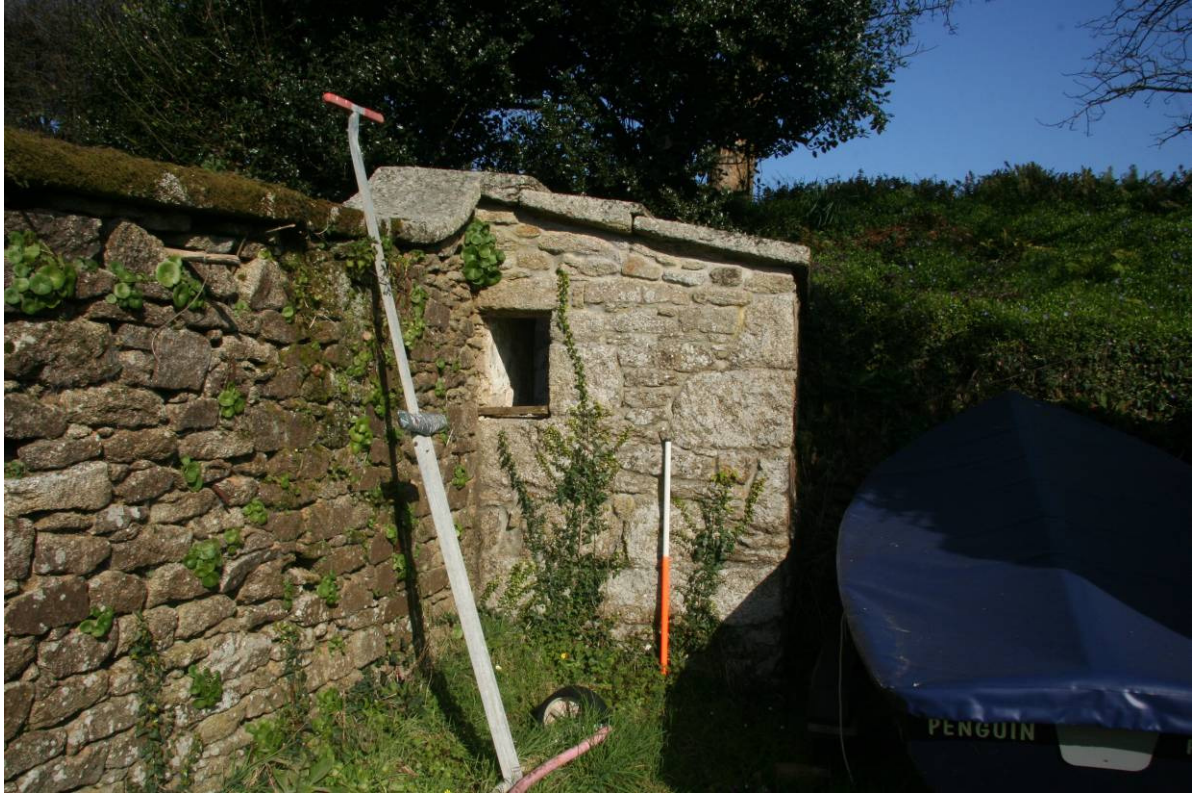
*Fig 15 The earth closet, viewed from the farmyard, with kitchen garden wall to left
Note the very unusual, if not unique, overlapping granite slab roofing*

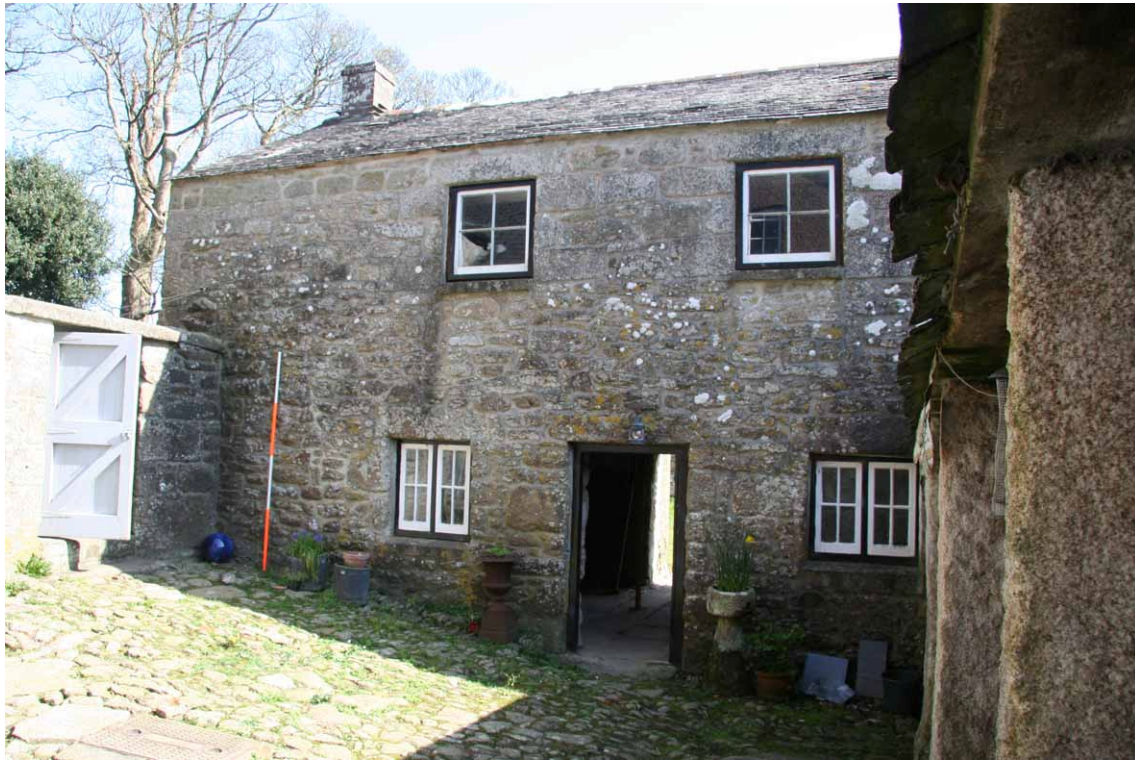
Fig 17 Front of cottage viewed from the courtyard

The walls were heightened, and upper windows repositioned, in the 19th century

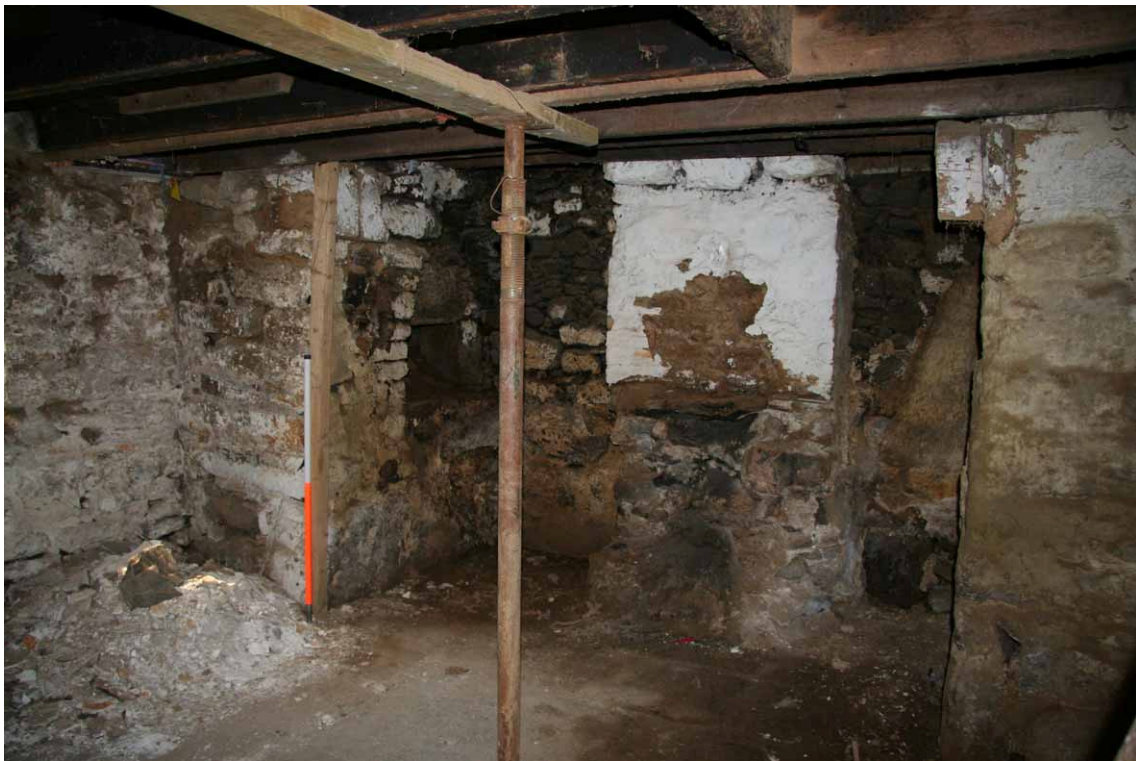
Fig 20 Cottage fireplace (with inserted central flue for washhouse)

There is clear evidence for the reuse of the building as a washhouse in the form of a truncated masonry base for a 'copper' (a circular wash-boiler, later examples are usually made of cast-iron). Above the base is a narrow single flue, built of brickwork within the larger chimney. The upper part of the original chimney breast has been removed and the timber fireplace lintel cut back. This lintel now survives as stumps within the earlier masonry. The original chimney stack has also been removed and replaced by the narrow brick chimney (Fig 25). An area where the slate roof covering has been extended over the former chimney is still visible.

The wooden lintel for the fireplace has been cut away (with masonry above removed) but the ends have been left in situ

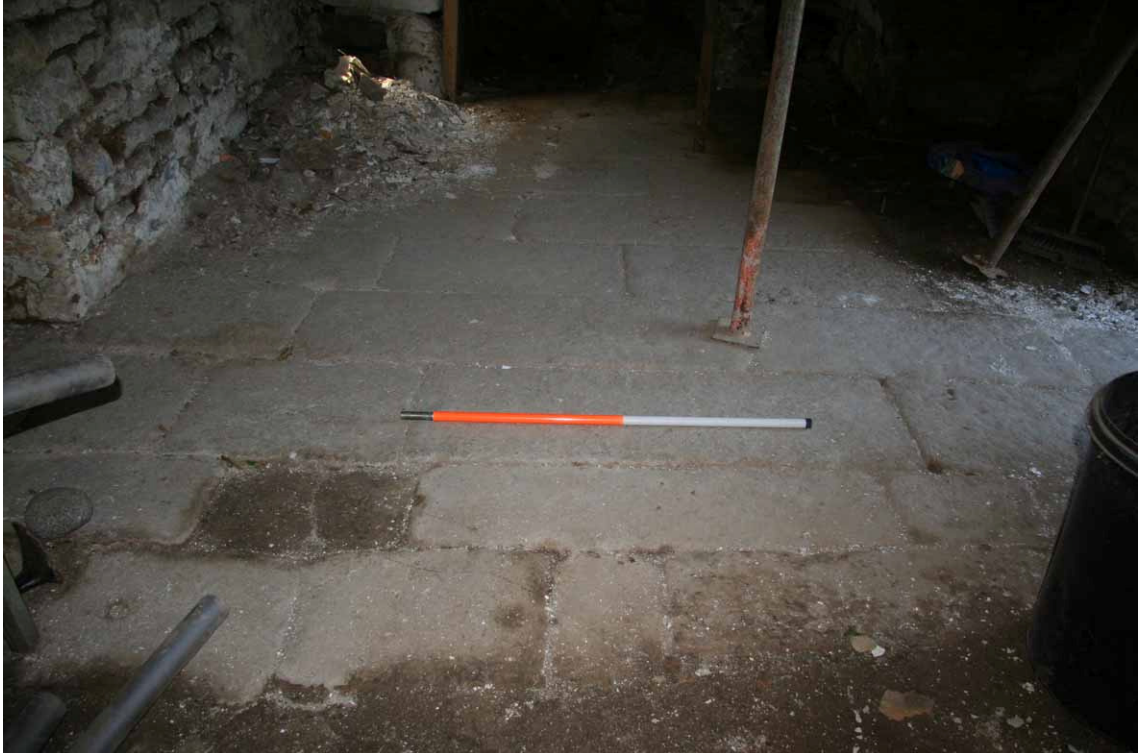
Fig 21 Granite paved floor of the cottage

The northern room and passage of the cottage has squared granite paving laid in rows (as flagstones, Fig 21). Close to the front door is a cheese press stone, reused as a paver (Fig 23). A rectangular space alongside the rear wall where there is an absence of paving is the site of a stairway to the upper floor. This appears to be a replacement stair for another in the recess close by.

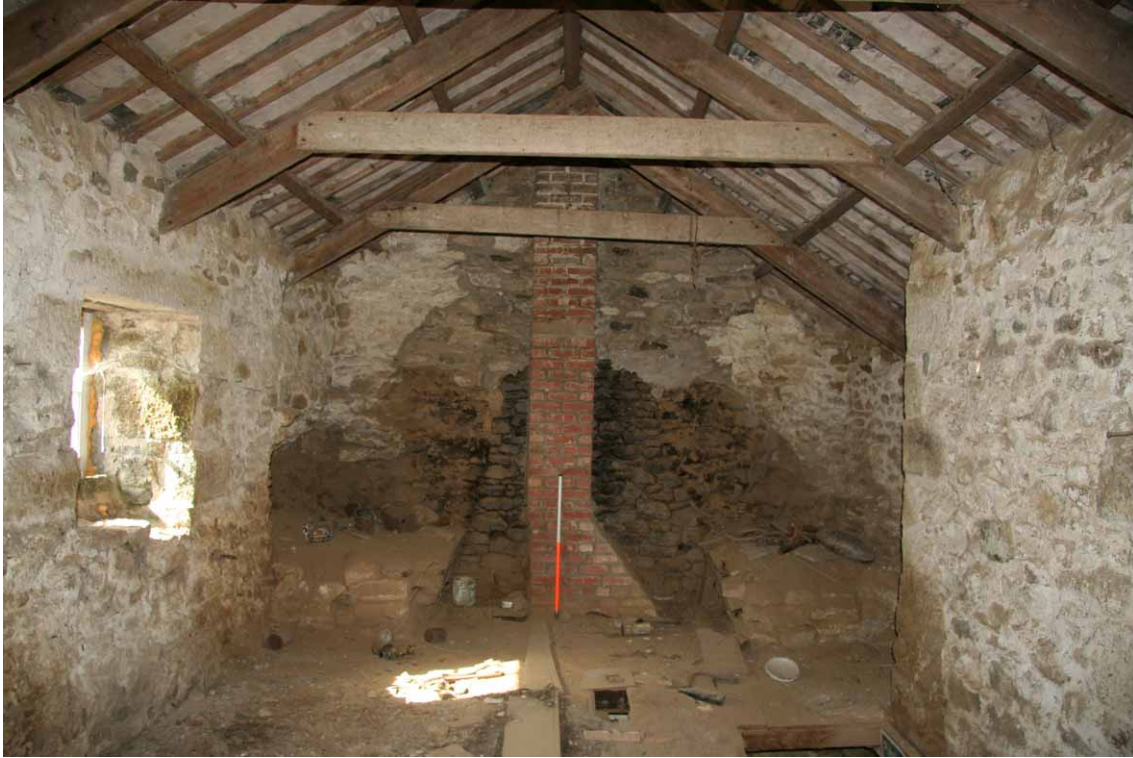
Fig 25 First floor of the cottage

The upper storey could not be examined in great detail due to the extremely weak floor structure. On the upper floor the lime-washed walls do not have any clear indications of any subdivisions for upstairs rooms. The beams which support the upper floor are narrow and rather insubstantial timbers and are replacements for an earlier floor structure; the floor was most likely renewed when the walls were heightened. A painted

The line of the earlier lower gable can be clearly seen. Masonry from the chimney breast has been removed but the wide flue can be seen. The narrow brick flue was added when the building was converted to a washhouse

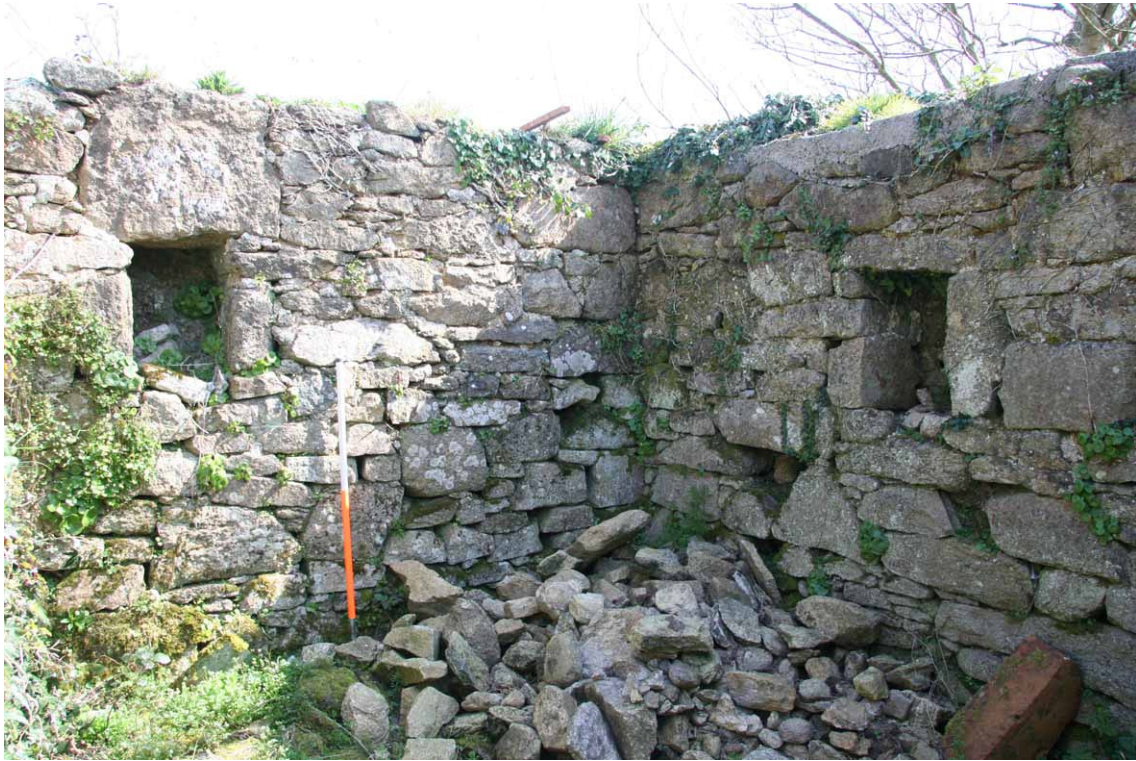
Piggery 2 is clearly multiphase and its south and east walls are part of an earlier structure which incorporated four bee boles which faced into the former farmyard. Three of the bee boles are integral with the construction of the wall but the other is an addition (see Fig 31). Bee boles are recesses for skeps (woven straw bee hives). Bee skeps were replaced by the invention of wooden hives with removable combs patented in the US in 1853 (see Wikipedia) and introduced into Britain around 1862 (Robertson and Gilbert 1979). It therefore appears likely that the piggeries were built in the 1860s when new more efficient designs of wooden bee hives became available.

Fig 31 Bee hole recesses in earlier farmyard wall, later incorporated within Piggery 2

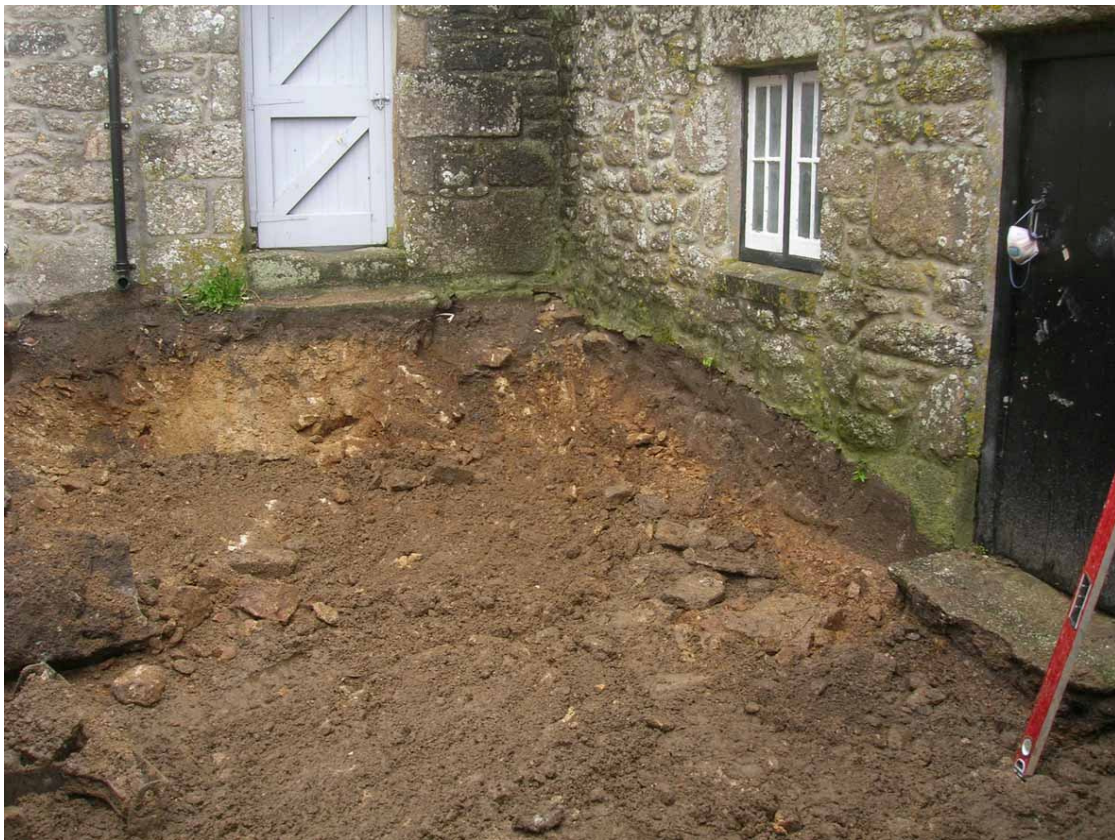
Within Area A it appears that the cobbles forming the present surface of the yard had been laid onto a levelling layer immediately above decayed bedrock. There was no evidence for any earlier courtyard surfacing, though it is possible it was originally just scraped bedrock. This is suggested by the fact that the neatly faced exterior walling of the washhouse / cottage continued on below the current cobbled level of the yard for a depth of circa 0.30m. The foundations for this wall were directly onto the bedrock.

Fig 32 The shallow nature of deposits encountered in the courtyard, as revealed in the watching brief

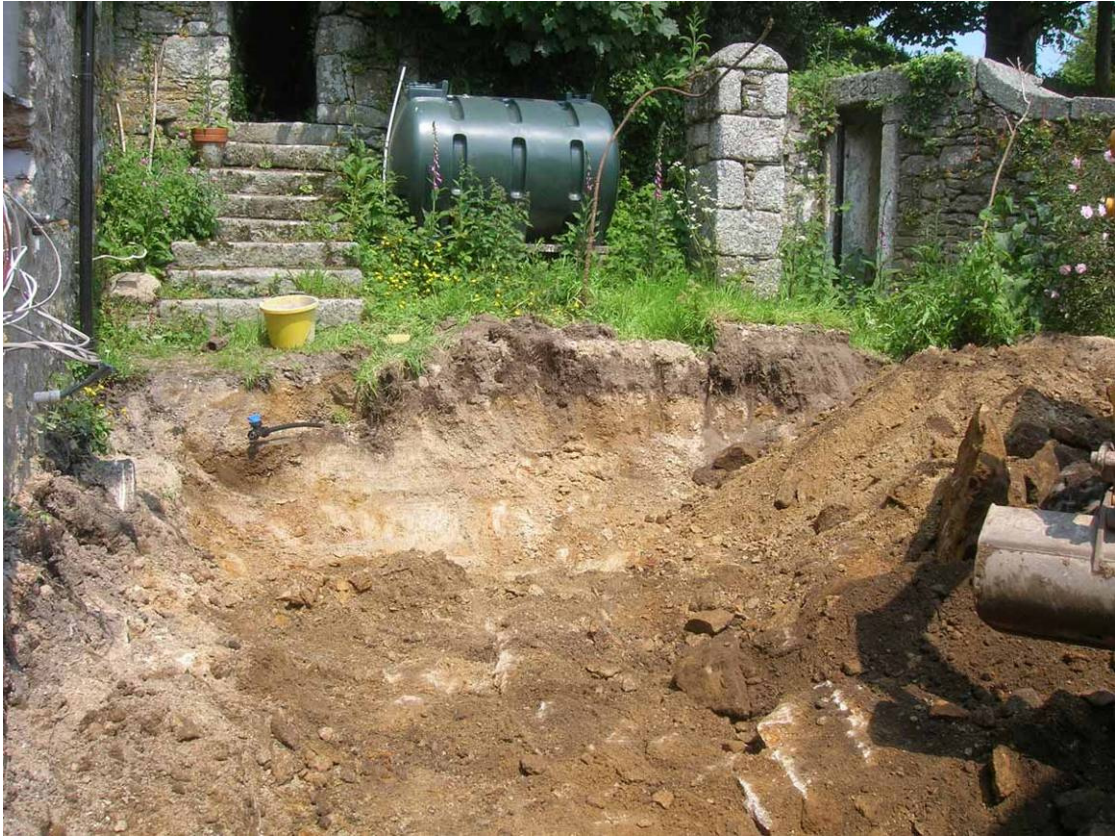
Fig 33 Soil profile within the garden area, revealing topsoil/garden soil immediately above natural decomposed granite

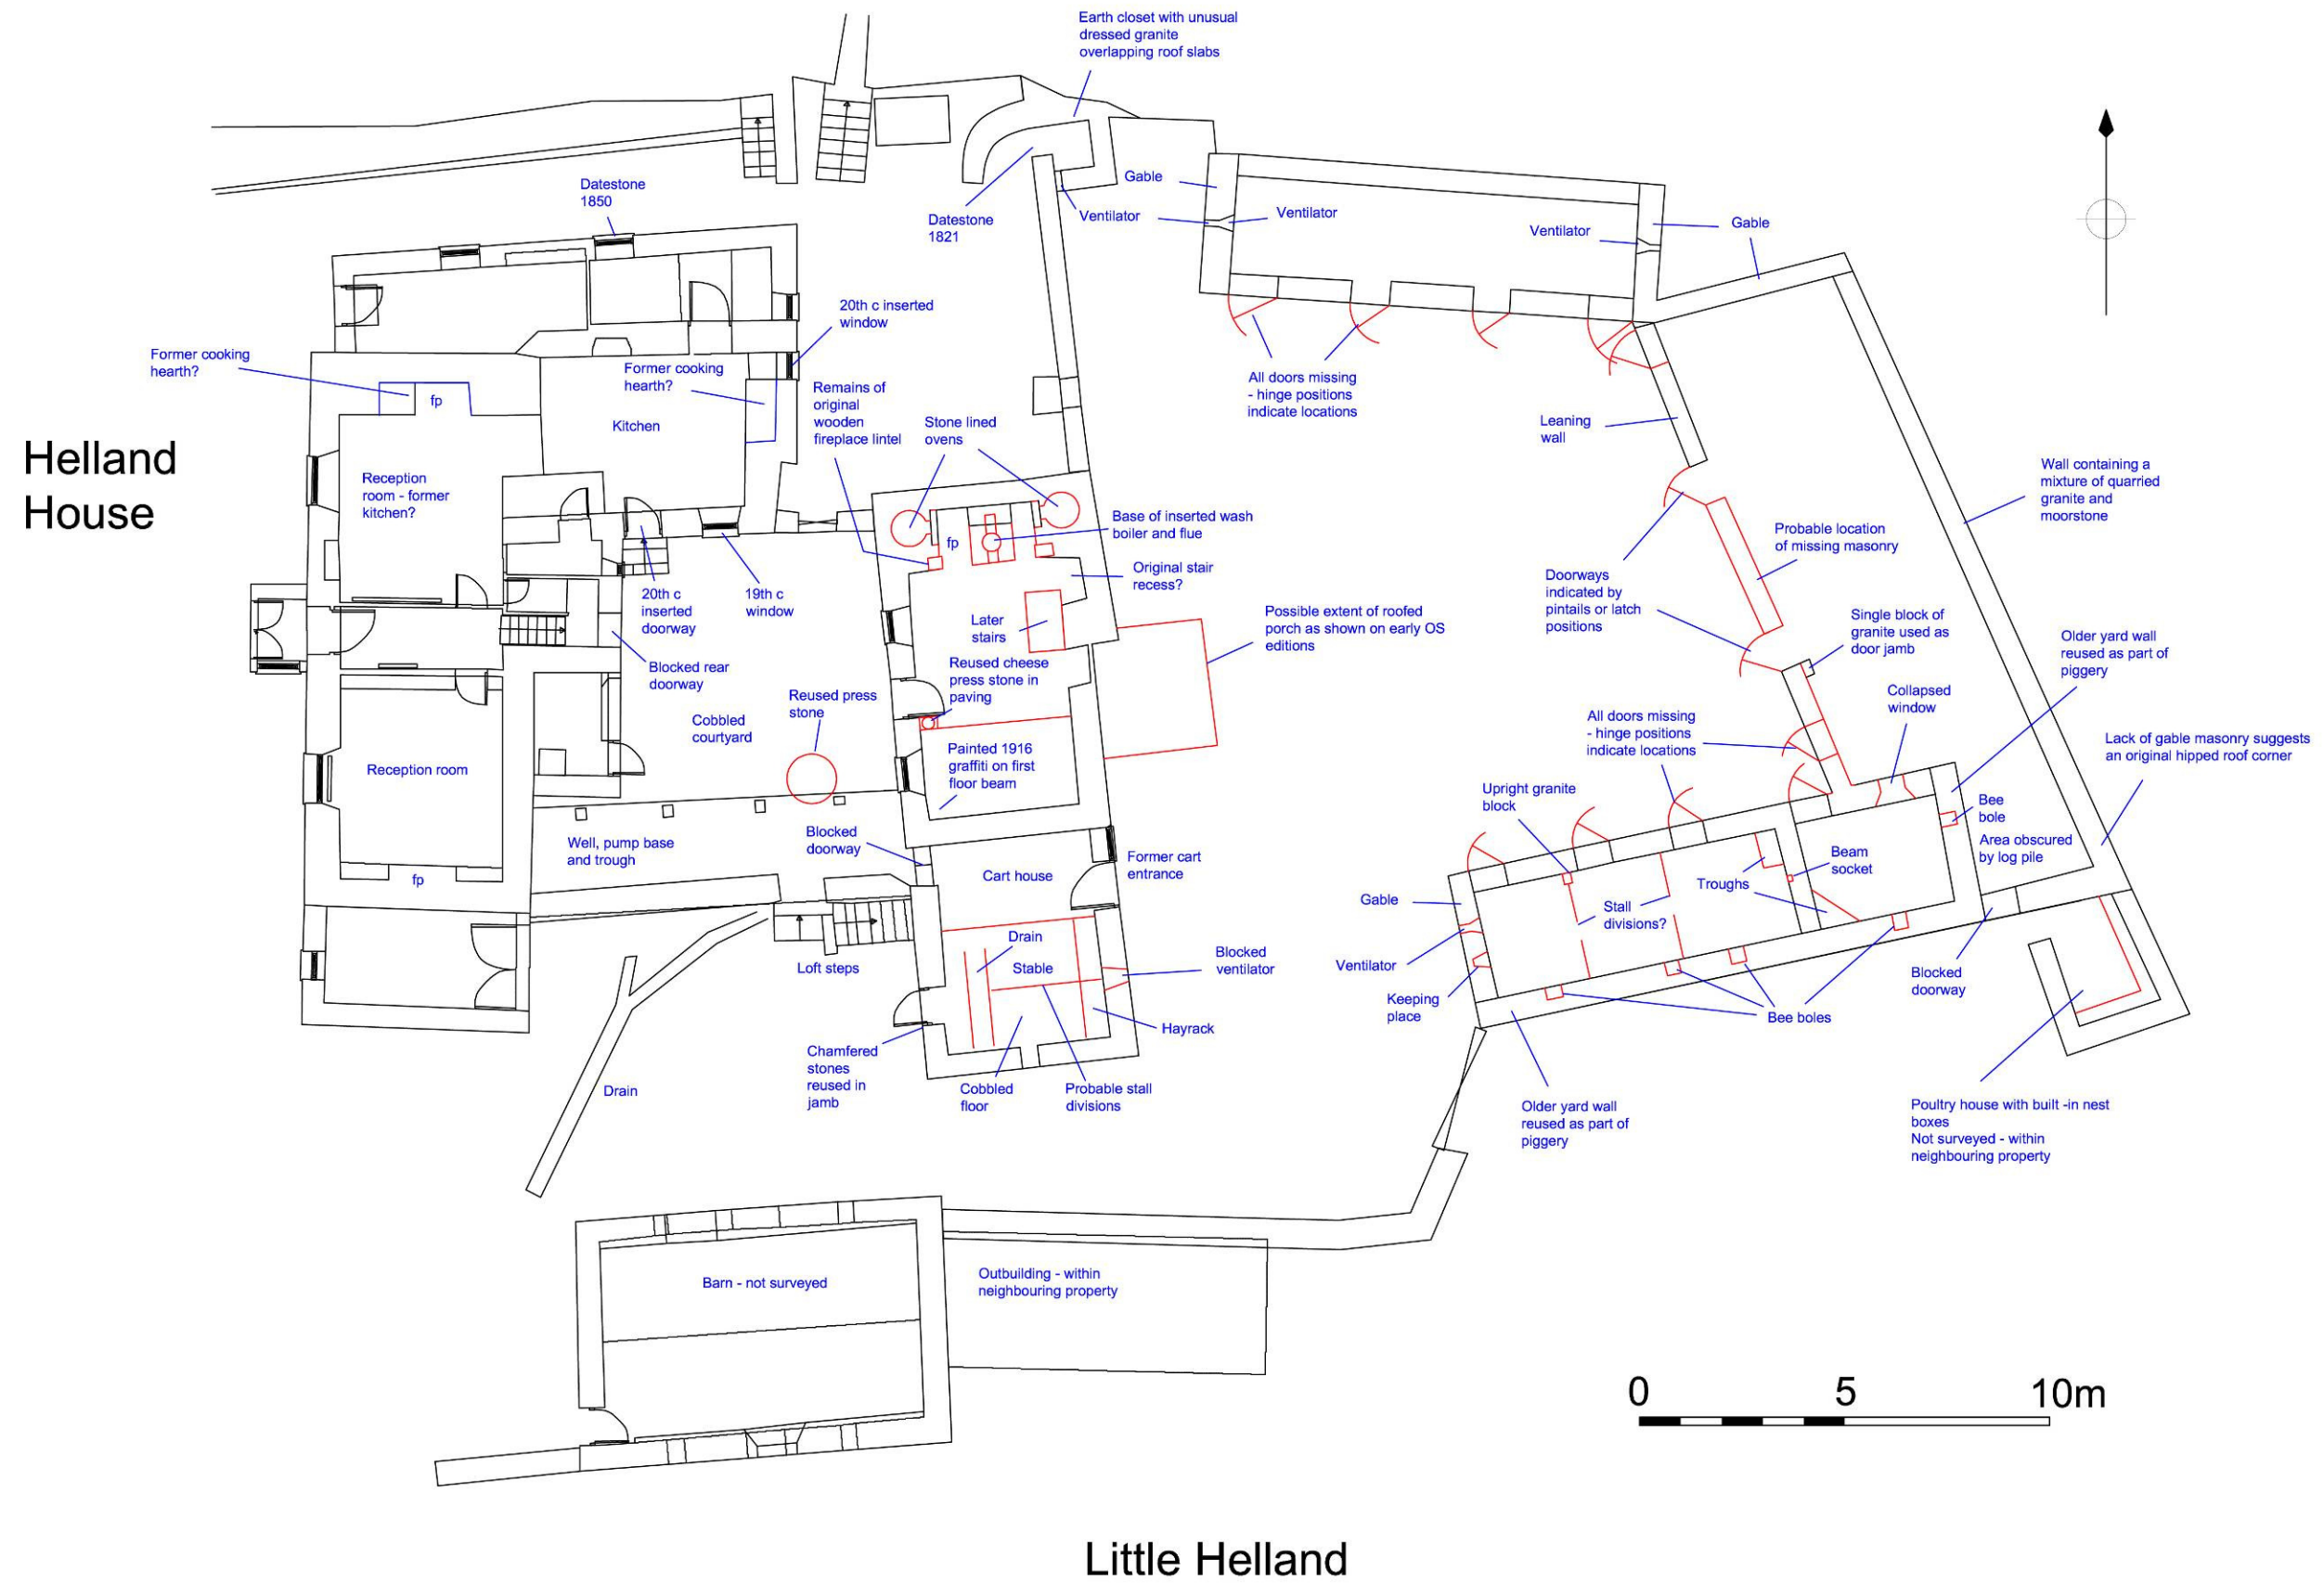
Fig 38 Plan of farmhouse and related features

The largest building of the group lies on the eastern side of the farmyard and is oriented northwest-southeast. It measures some 15.7m by 4.5m internally and has a gable at the northwest end. Its doorways face onto the farmyard but a length of masonry towards the centre of the west wall is now missing. Evidence of pintail (iron) hinges and latch hole positions on the surviving jambs of the walls enable at least plan reconstruction of the missing doorways and the masonry between them (see Fig 38).

The functions of this building are not now known but it was probably used as loose boxes or similar animal housing. A (now blocked) doorway at the south end gave access to the southern farmyard and an adjoining poultry house (now within Little Helland) (Fig 38).
