# Castle-an-Dinas Mine, St Columb Major, Cornwall

## Archaeological assessment

<b>Client</b>	<b>Mr and Mrs David Chambers</b>
<b>Report Number</b>	<b>2012R087</b>
<b>Date</b>	<b>December 2012</b>
<b>Status</b>	<b>Final</b>
<b>Report authors</b>	<b>Colin Buck and Nigel Thomas</b>
<b>Checked by</b>	<b>Andy Jones</b>
<b>Approved by</b>	<b>Andrew Young</b>

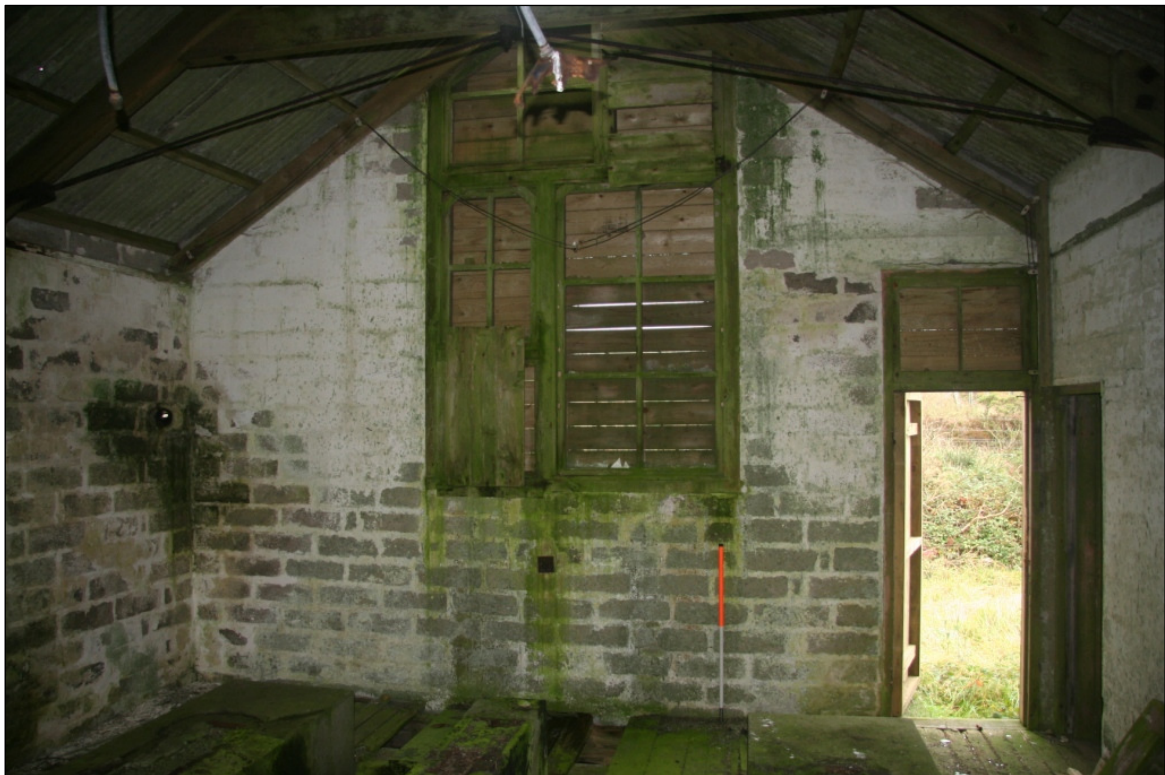
Figure 14 Internal view of the winding engine house (Site 3.1) © CC HE Projects

The steam winder house is of almost two storeys, the basement of which only houses the central concrete foundation plinth together with its holding down bolts. At the perimeter of the concrete foundation the basement is separated from the main room by a wooden boarded floor fixed upon timber joists. Timbers are now largely rotten and the floorboards are missing at the southwest corner.

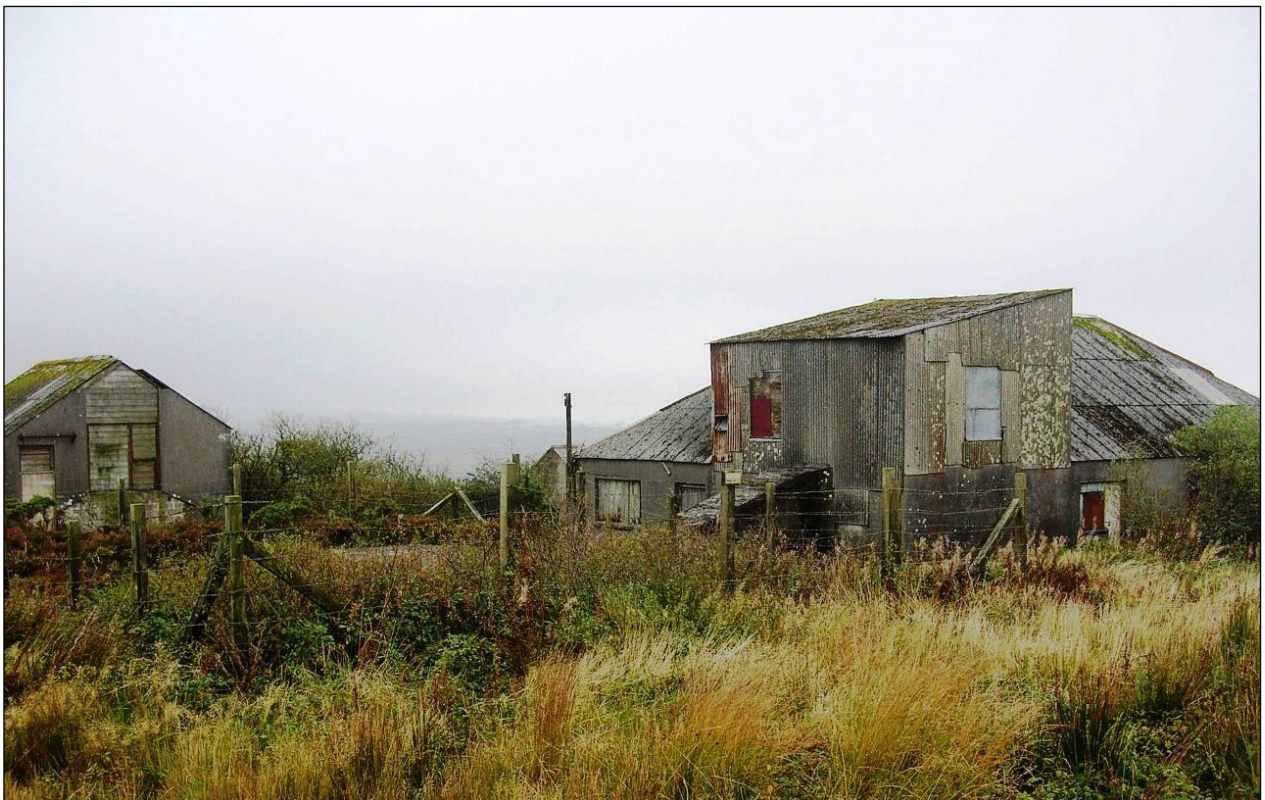
Figure 16 South Shaft complex in 2012. The ore-bin, shaft headgear and chimney have all gone (© CC, HE Projects)

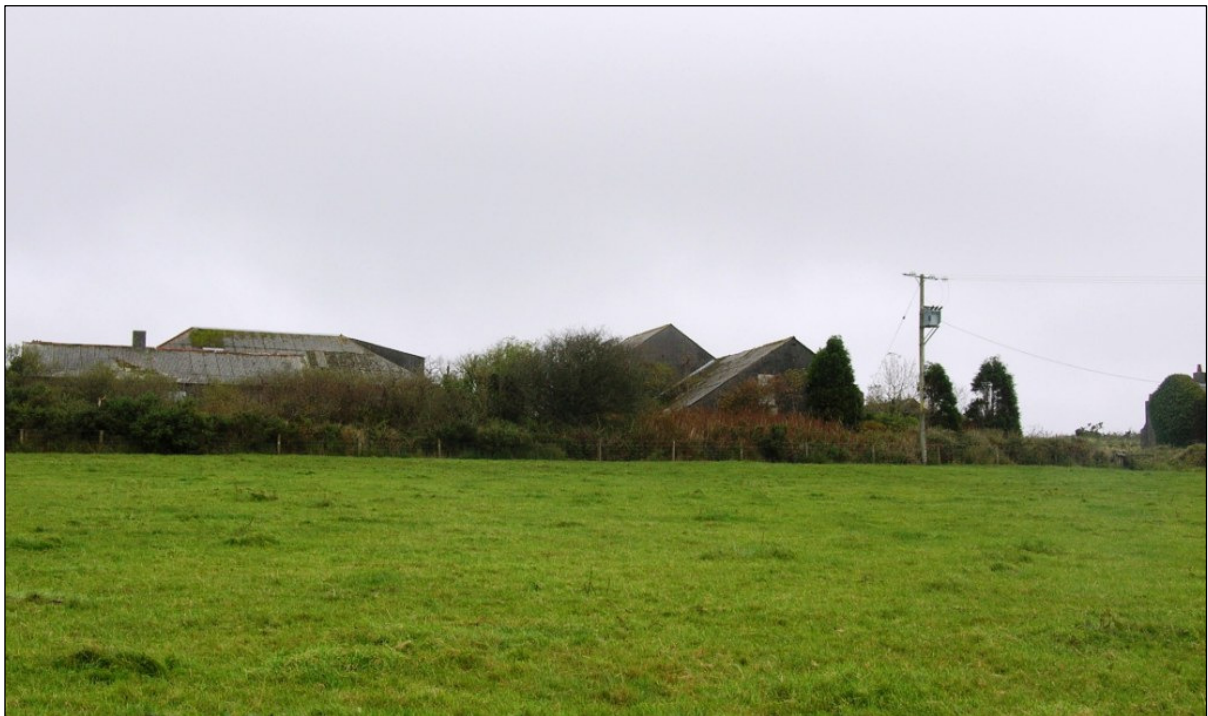
Figure 21 South Shaft complex in 2012 from the south. The ore-bin, shaft headgear and chimney have all gone (© CC HE Projects)

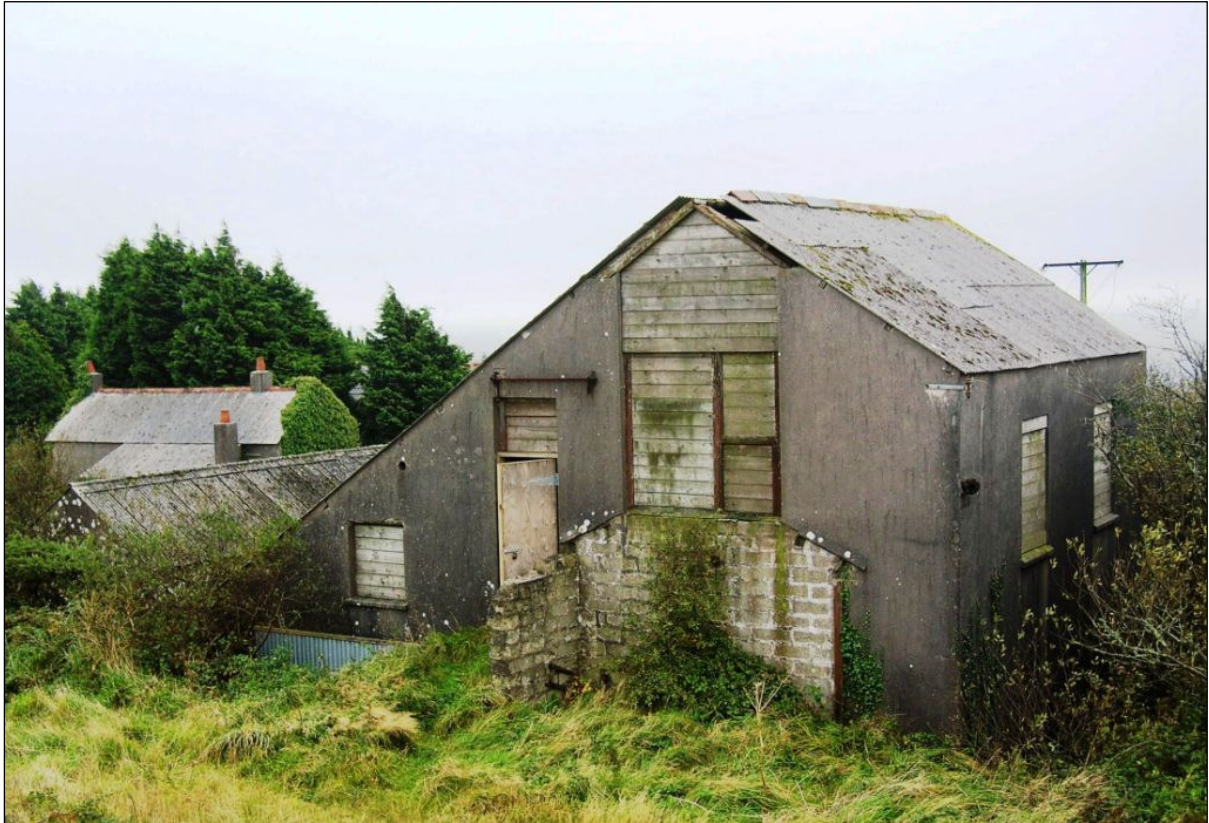
Figure 24 The winding engine house (Site 3.1), boiler house (Site 3.2), and auxiliary boiler house (Site 4) from the north (© CC HE Projects).

Although largely intact the roof of this complex is in poorer condition than other buildings at South Shaft. The ridge tiles need urgent reinstatement and broken or missing sections of the asbestos sheeting need replacement.

Other exterior repairs include replacement of missing render on the south side of the boiler house and on the flue/chimney base. This would protect the underlying concrete block-work from further erosion/weathering and help to prevent damp penetration. If the roof can be repaired/the building made watertight then the wooden floor inside the steam winder house could be renewed with like-for-like timber.

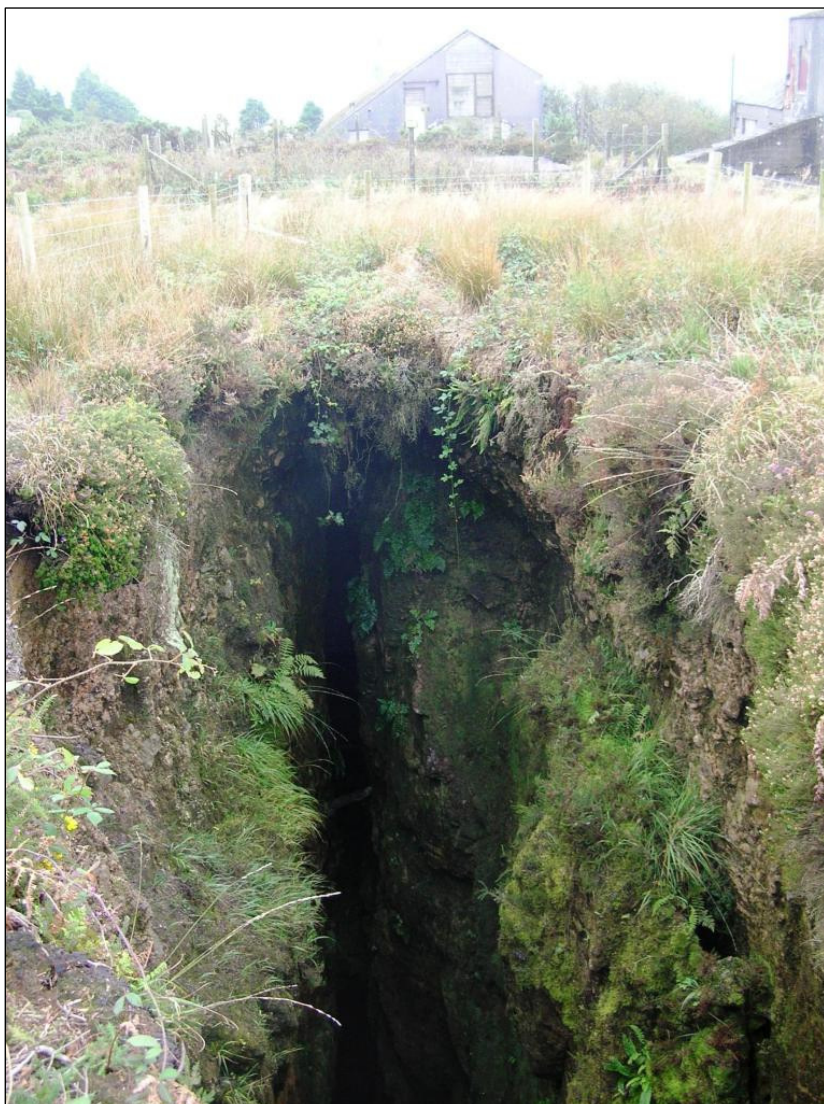
The collapse that has occurred at this site could occur at any point from north to south, however, the section shows that the stoping sites are closer to surface on the north side of the hillfort; an area of ground that already has much linear fencing.

*Figure 29 A view from the north of the surface collapse of the ground above the stope (Site 12) (© CC HE Projects)*

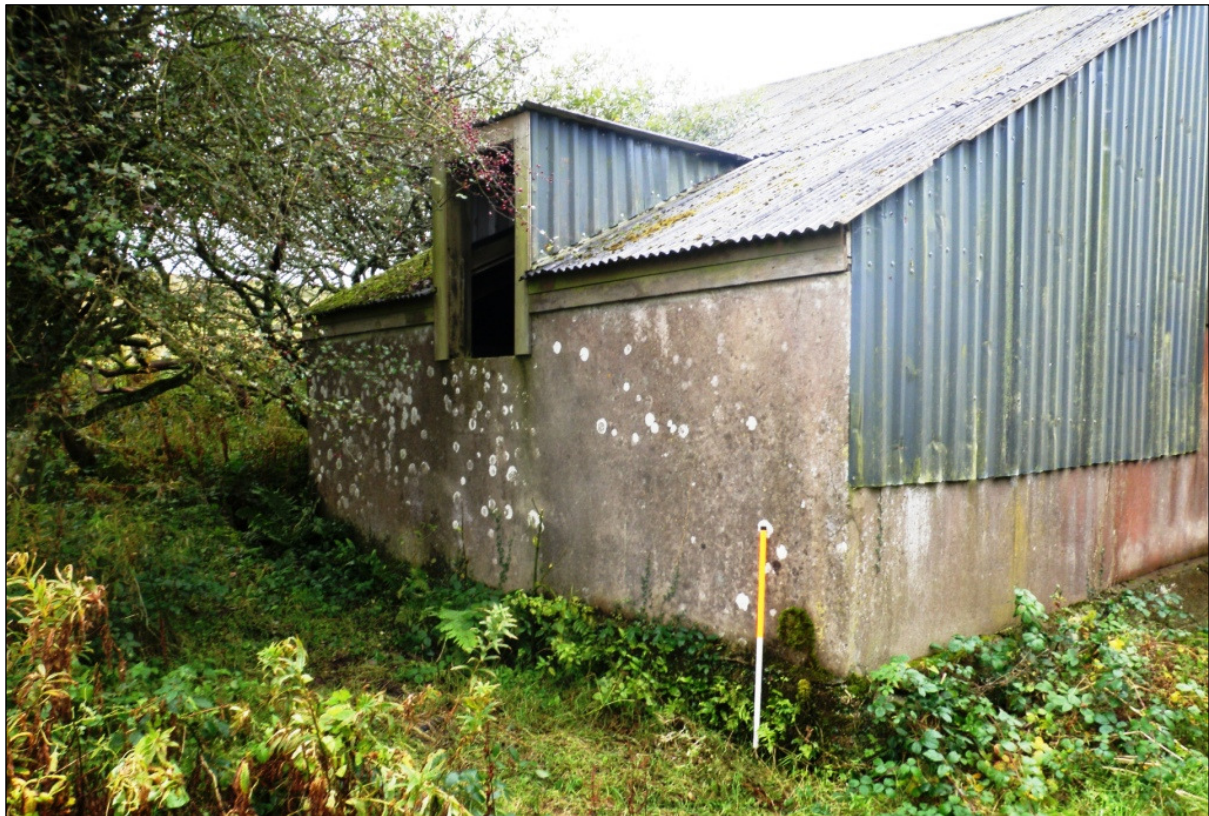
Figure 31 Winding engine house complex (Site 41) east side showing the opening for the winding wire (© CC HE Projects)

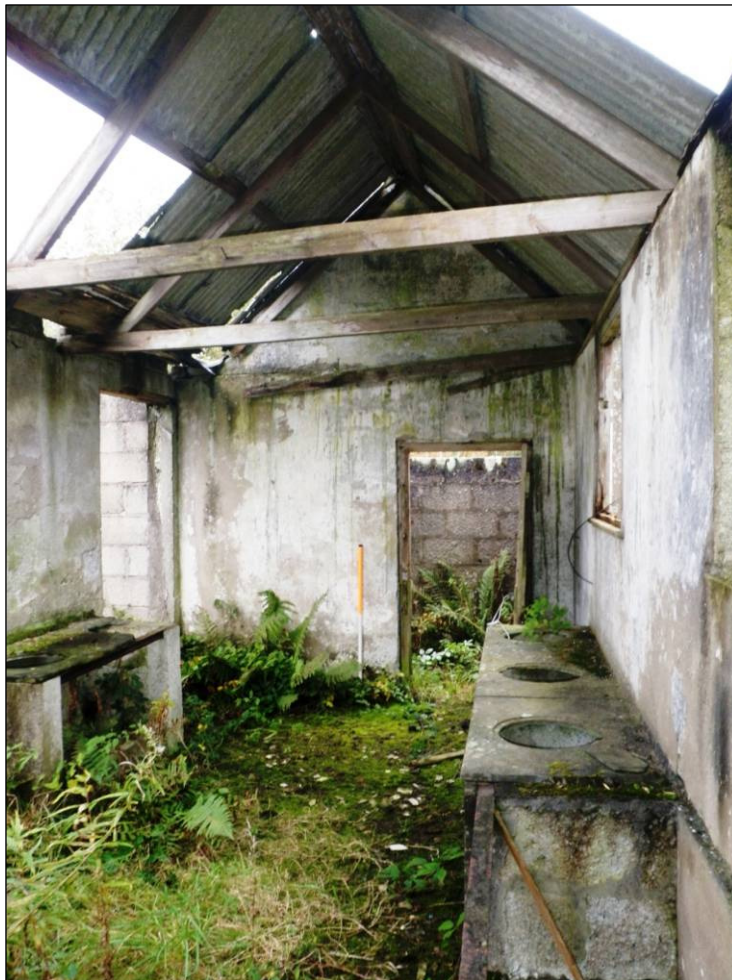
The washroom roof is slowly collapsing as the ridgeline timbers have failed. It may be appropriate to remove the remainder of this roof for safety reasons and for security of the masonry structure. However, removal of the roof would expose other elements, such as the surviving wooden door, to become subject to increased weathering and accelerated decay. It may be appropriate to search for grant aid to enable complete re-roofing of the building – as a long-term preservation measure.

*Figure 32 A view from the east of the Miners' Dry wash house (Site 43.1) (© CC HE Projects)*
