**POLTESCO MILL**

**ARCHAEOLOGICAL ASSESSMENT  
AND  
INTERPRETIVE HISTORIC  
BUILDING SURVEY OF THE MILL**

**ARCHAEOLOGICAL ASSESSMENT  
AND  
INTERPRETIVE HISTORIC  
BUILDING SURVEY**

**HE Report No.**  
**2013R013**

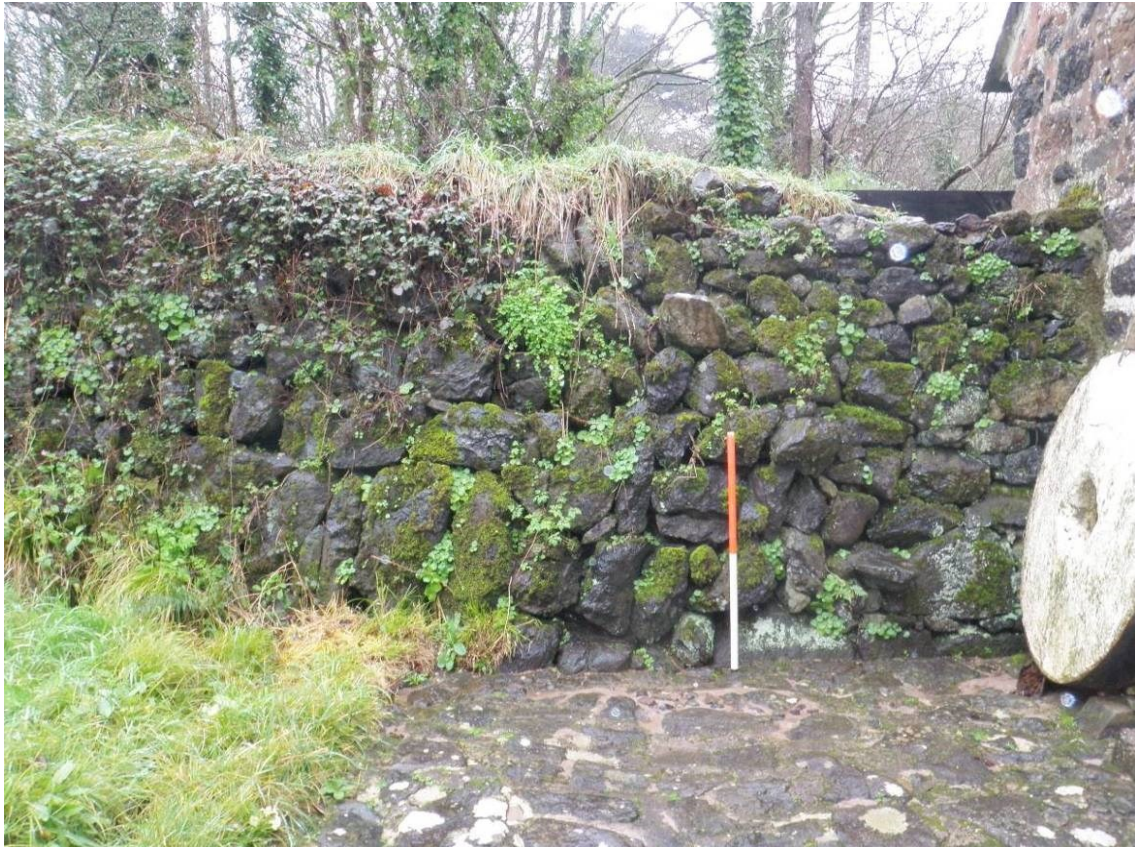
*Fig 23: Poltesco Mill tailrace, part of leat 92520 looking west*

Repairs to the leat and tailrace may be required when sections of the stone lining become dislodged from time to time. A small area of walling in the tailrace has collapsed and will need repairing; any repair works should be carried out in consultation with the custodian.

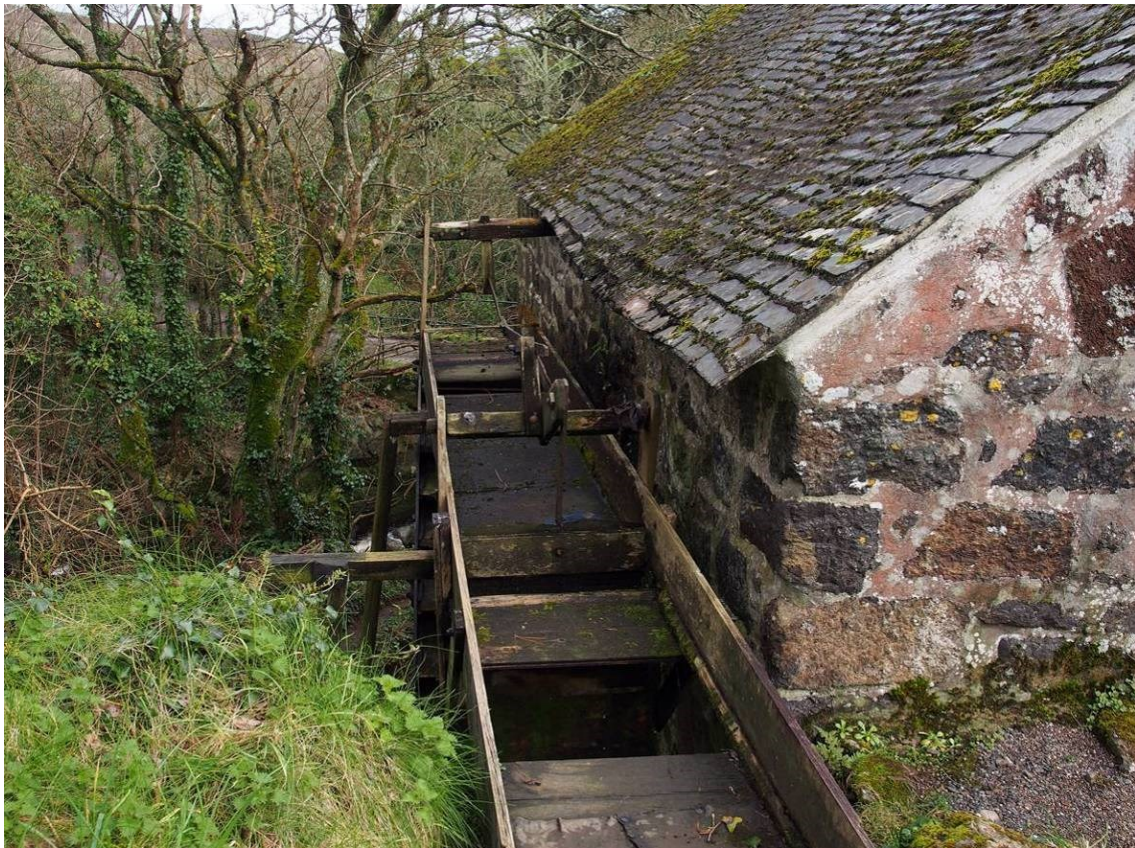
*Plate 10 View of the launder feeding the wheel (note missing boarding caused by flood damage in 2012)*

- Replace roof covering
- Repair internal machinery
- Repair buckets on the water wheel
- Repair timber launder

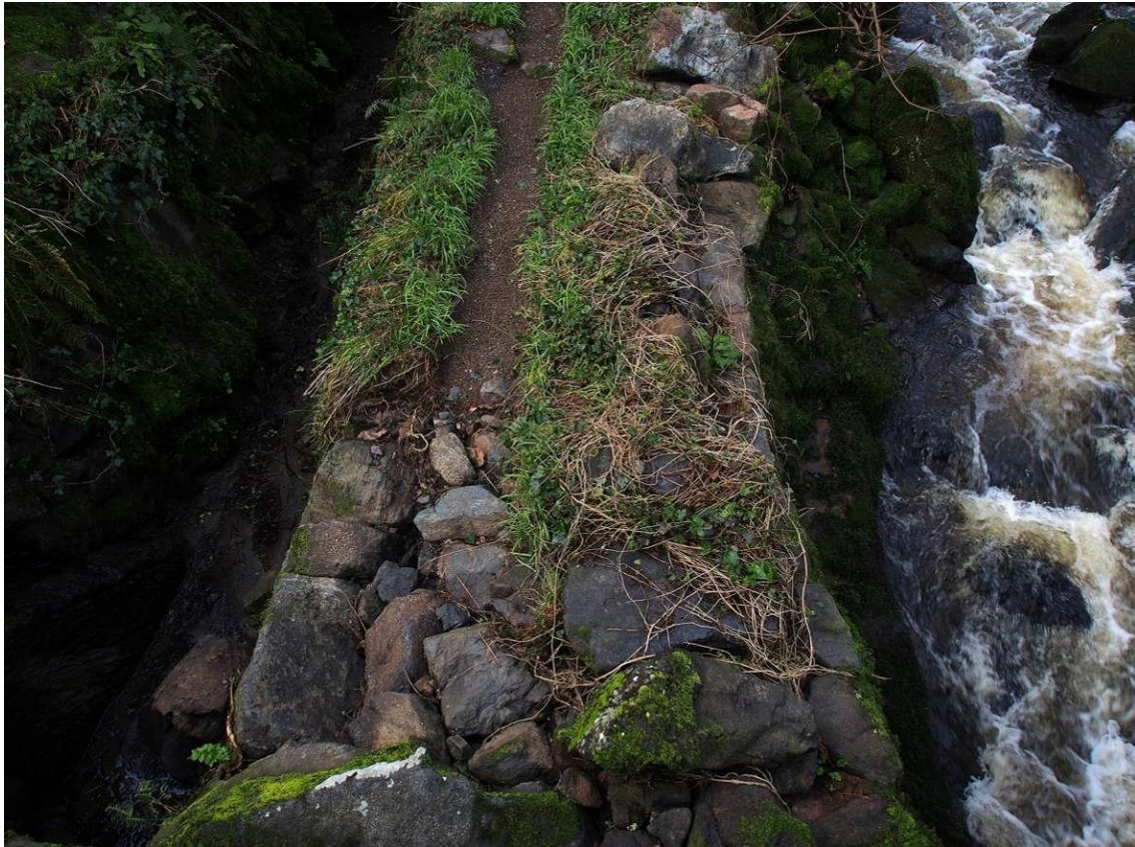
*Plate 14 The wall separating the tailrace from the adjacent stream. Flood damage in November 2012 has displaced the upper course of stones (left)*

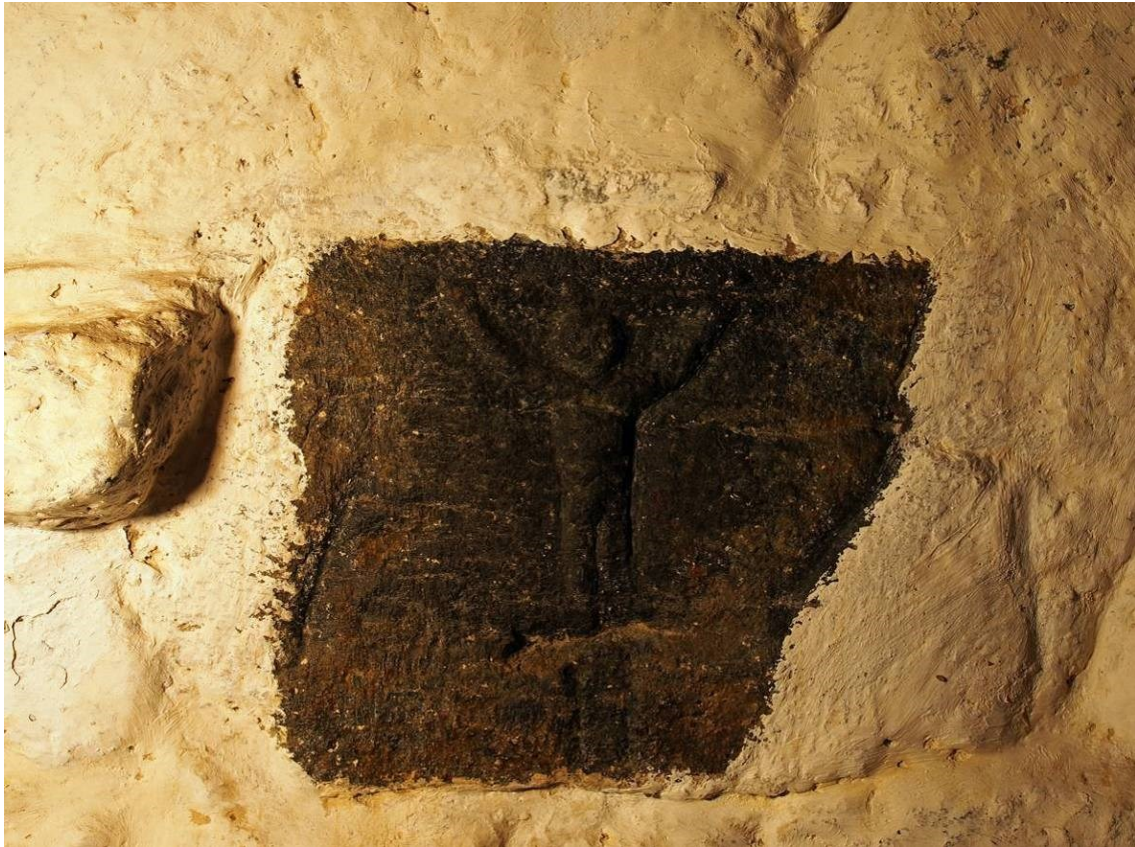
*Plate 39 Crucifixion figure in relief carved onto a stone incorporated into the NW wall (this part rebuilt in the 1860s)*

Ensure that the carved figure is not over-painted or accidently damaged. Make a 1:1 drawing of the figure as a record.
