Tavistock Canal, Devon

Archaeological impact and recording report

Tavistock Canal – Impact assessment and archaeological recording during a program of repair works

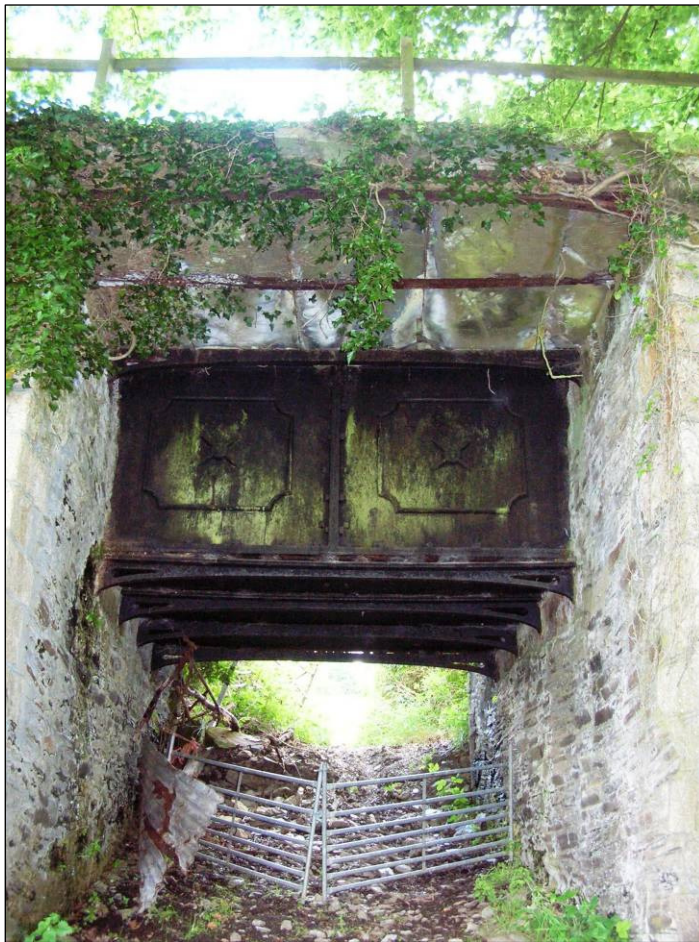
Patch repointing to the sides of the bridge under the aqueduct in recent years has occurred, however more often than not this has been using cement, using a variety of styles. At the northern end of the side walls the stonework has been leaking for some time where water is leaking from the junction of the wrought iron plates with the canal bed. This has caused the masonry to be soft, and the stonework made weak – causing a noticeable dip on either side.

On the south west side of the aqueduct a high vertical retaining wall supports the tow path and masonry for retaining remnants of steps, to allow pedestrians walking the towpath to access the lower field. Some of this vertical retaining wall has areas of lime mortar pointing that is loose.

Figure 13 A view of the canal aqueduct bridge before works
© CC HE Projects

After dialogue with the TVMHP manager, the structural engineer, the landowner of Shillamill Farm, the Devon County Archaeologist and consulting project archaeologist; the TVMHP agreed to fund replacement of the centrally located rusty wrought iron lintel, and to undertake limited lime mortar repointing where structural stability of the adjacent walling could be compromised.

Site impact of the replacement lintel was minimised by matching most of the original profile of the replacement item as far as could be possible from an 'off the shelf' steel equivalent (in order for the project to be cost-effective), with the original wrought iron lintel.

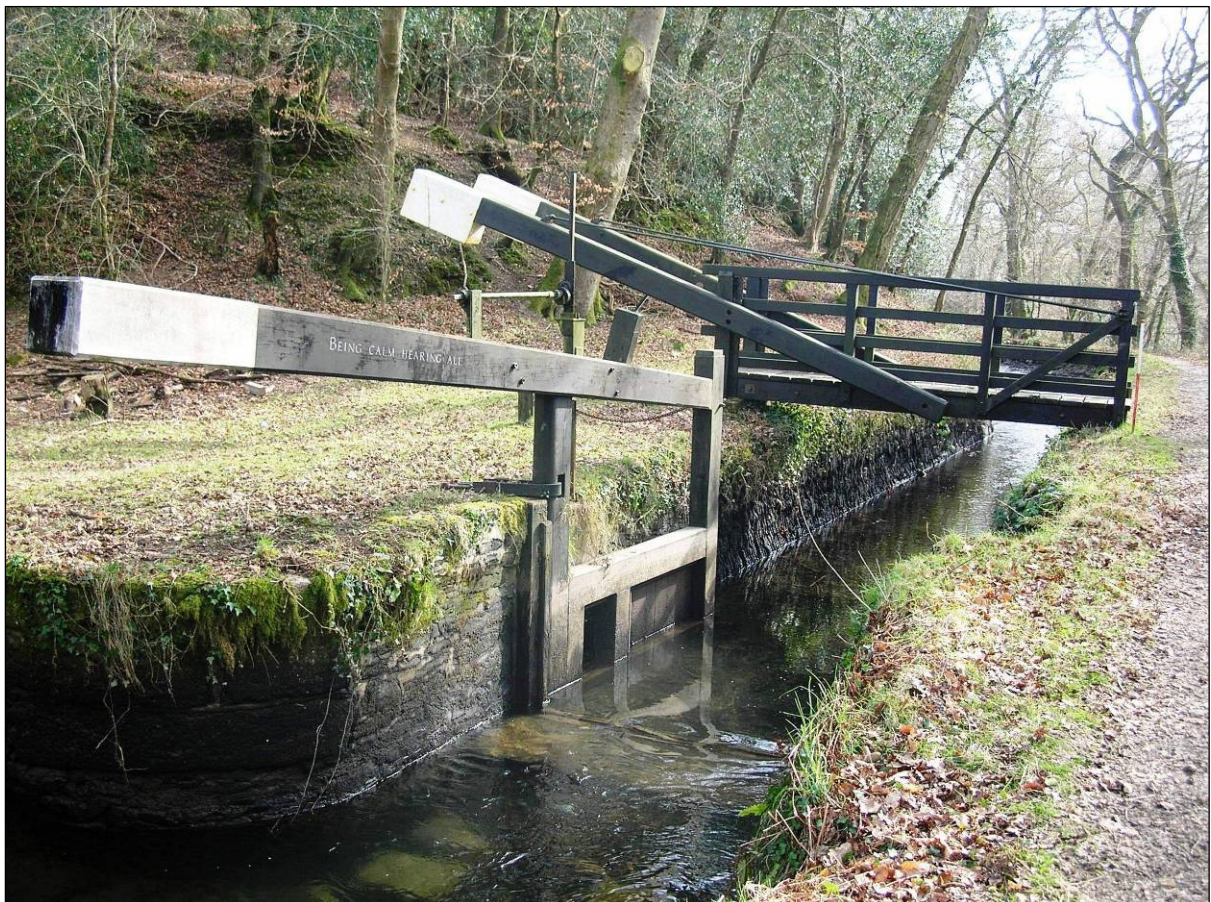
Figure 16 A view of the canal lock gate and bridge after works © CC HE Projects

The TVMHP agreed to fund replacement of the timber components that were rotted or had broken or snapped off. This includes the large timbers to open the bridge and the Lock gate. The TVMHP tendered for experienced Carpenters to assess both features and to price for the production of making and erecting replacements.

Site impact for the replacement timbers was minimised by specifying exact replacements with the existing timbers (previously replaced in 1998).
