Report No: 2013R073

Pengersick Castle, Praa Sands, Cornwall

Archaeological watching briefs and historic building recording 2011-12

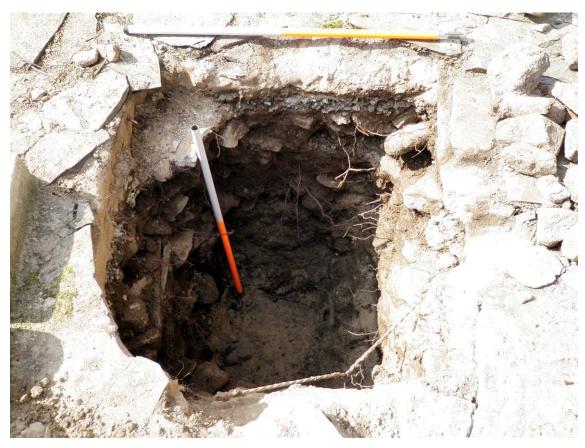
Fig 12 Drain test pit 2

Beneath the rubble was a layer of sand, acting as bedding for the drain pipe (7). The top of the pipe was encountered at a depth of c1300mm from the surface but the sides of the drain trench were not found in the test pit.

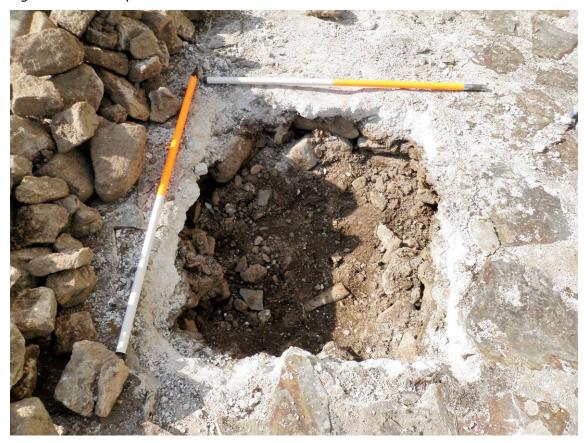
Fig 13 Drain test pit 8

Test pit 8 was a 1000mm by 1000mm (and 585mm deep) pit (see Fig 13), cut through modern slate crazy paving (1). The paving was found to be bedded in cement mortar up to 60mm thick (12). Beneath the mortar was a layer of dark grey gravel/chippings, similar to that found in Test pit 2 (4). Below the gravel was a mass of loose stone rubble, mostly lumps of 'fist' to 'head' size granite (13). Some of the rubble had traces of lime mortar and plaster, so was indicative of demolition material. Other material included lumps of cement mortar, occasional roof slate fragments, a fragment of ceramic drain and a piece of cast-iron drain pipe.

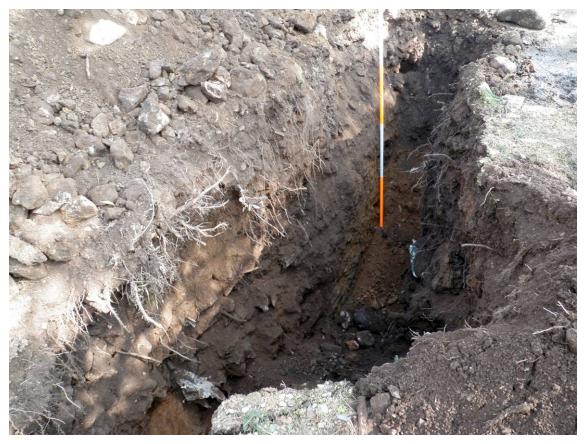
Fig 14 Drain test pit 9

The eastern part of Test pit 9 was very different in character and comprised a trench ($c1500 \mathrm{mm}$ wide with its western edge $c1000 \mathrm{mm}$ from the base of the boundary hedge line) [11] infilled with loose stone rubble, loamy dark brown soil and fragments of plastic sheet (10) was cut into the natural. This was traced down with the machine bucket to almost 2m depth. In the bottom of the trench were re-deposited larger pieces of building stone.

It was not possible to accurately record the trench sides due to the depth and the extremely loose nature of the fill, some of which collapsed during excavation of the trench. The material is evidently the soakaway from the rainwater drain; the plastic sheet was presumably originally put over the soakaway fill to prevent excess soil from entering it. The line of the soakaway is due south from the inspection cover and Test pit 2.

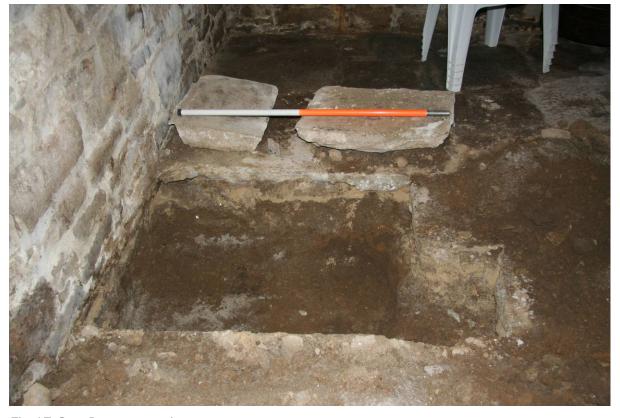
Fig 17 Gun Room test pit

Beneath the granite paving of the Gun Room (20) was a layer of building sand (21) used as bedding for the stones. Beneath this was a layer of dark grey sandy silt containing broken fragments of concrete and painted cement (22). Another thin layer of building sand (23) was revealed beneath. Layer (24) comprised sandy silt with pieces of granite and other building rubble. A third tip of building sand (25) was revealed beneath the rubble.

The test pit within the floor has revealed conclusively that the granite paving was re-laid in the 20^{th} century, and that bedding materials for the paving extend to at least a metre below the present surface. As no traces of foundations were revealed in the adjacent (south) wall, it can be determined that the tower's wall masonry extends deeper and that archaeological material may survive at greater depth.

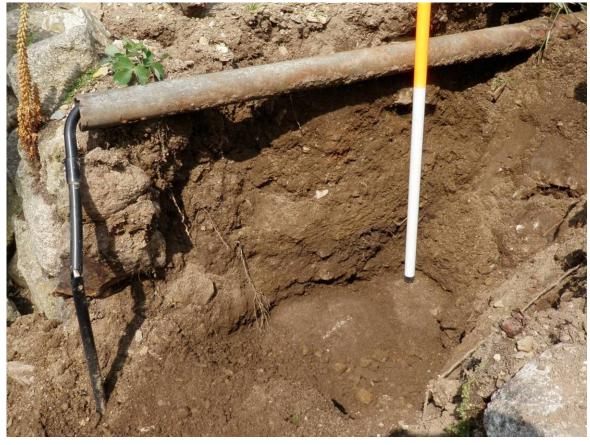
A narrow slot 300mm wide and approximately 1m deep was dug into the edge of the lower terrace, in order to bury an exposed electrical conduit (Figs 23 and 24). This revealed stratigraphy including two worn granite stones (29) overlain by a build up of topsoil (28) and subsequent material to construct the terrace (27) (see Fig 25). The location, level and nature of the stones suggest they are part of a path that once linked the hall entrance and the eastern courtyard gateway (as shown by William Borlase, see Fig 3).

The evidence of the worn granite stones beneath the lower terrace strongly suggests that parts of old paving within the gardens survive here (and probably elsewhere) in the gardens. It appears that (at least within the revealed section) historic paving became buried by the build up of topsoil before the present terraces were created.

Fig 24 Slot cut into the lower terrace, showing probable paving at base of section

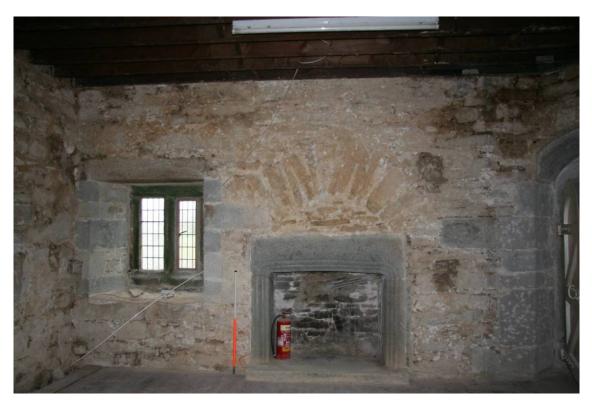
Fig 26 View of the third floor fireplace in the tower after modern finishes had been removed

Construction details such as blocked put-log scaffolding holes are clearly visible to the right of the fireplace

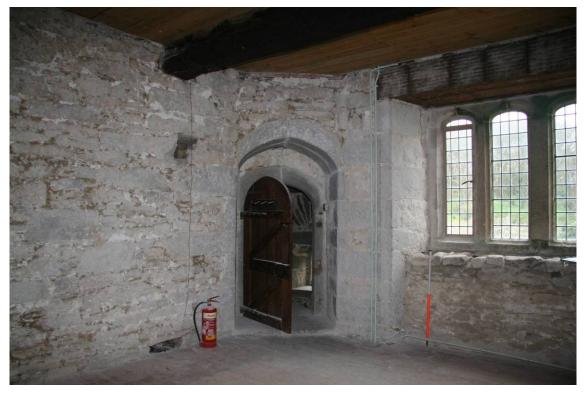
Fig 27 View of the doorway and window of the second floor

A granite lintel over an original principal floor beam socket can be seen to the left of the fire extinguisher. Another original principal beam can be seen supporting the floor above

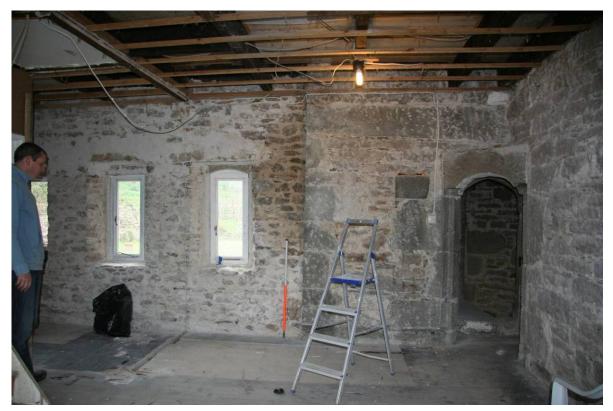
Fig 28 Interior of the first floor room adjoining the tower

Masonry centre and left is of the 1920s domestic extension; the doorway (right) is an original upper floor access from the tower into the former adjoining wing.

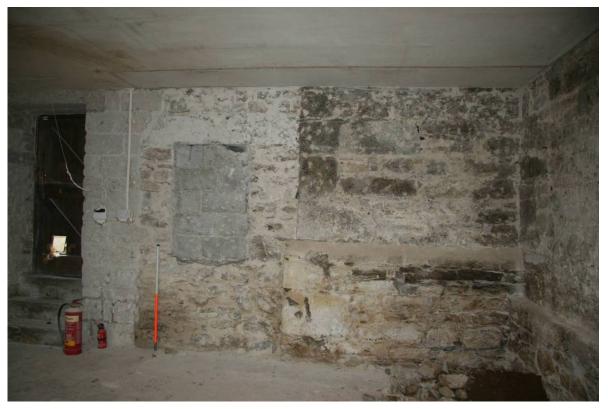
Fig 29 The ground floor 20th century kitchen

Plinths of the original masonry toward the right might suggest this space was originally intended to be exterior, but the evidence from the room above conflicts with this
