# **Structures at Taylor's and Davey's Shafts, Consolidated Mines, Gwennap, Cornwall**

## **Historic Environment consultancy during consolidation works**

<b>Client</b>	<b>Gwennap Parish Council</b>
<b>Report Number</b>	<b>2013R077</b>
<b>Date</b>	<b>24 October 2013</b>
<b>Status</b>	<b>Final</b>
<b>Report author</b>	<b>Adam Sharpe BA MIfA</b>
<b>Checked by</b>	<b>Dr. Andy Jones</b>
<b>Approved by</b>	<b>Andrew Young MIfA</b>

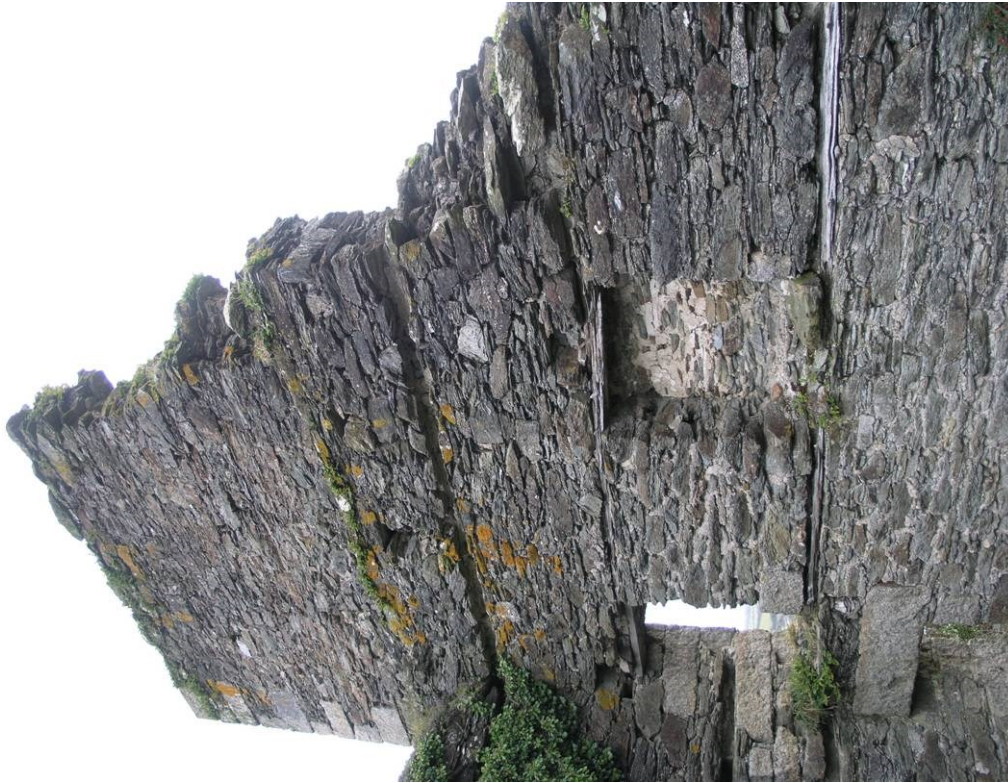
The upper sections of the eastern wall had distorted somewhat due to the rotting of some of the longitudinal timbers built into the wall faces, particularly within the internal elevation, and the loss of support to masonry above these, but the masonry had not moved to a degree where it was judged that it had become significantly unstable, requiring dismantling and reconstruction. Some limited failure of the masonry over the failed lintel above the northern first floor window had occurred on the outer elevation; the rear window had been historically infilled with masonry which had provided support to the stonework above the lintel, despite its deterioration. The northern reveal of the girder opening remained visible, but to the rear of this feature all walling had collapsed down to about a third of its original height at the southern end of the building. On the internal elevation of the eastern wall, although several longitudinal timbers had rotted away, these had been of no significant depth, and although some limited stone loss had occurred, no major movement of the masonry had occurred.

Fig 13. The internal elevation of the eastern wall, showing the two window openings (the rearmost blocked on the outside face) and the two longitudinal timbers whose decay had significantly contributed to the deterioration of the structure.

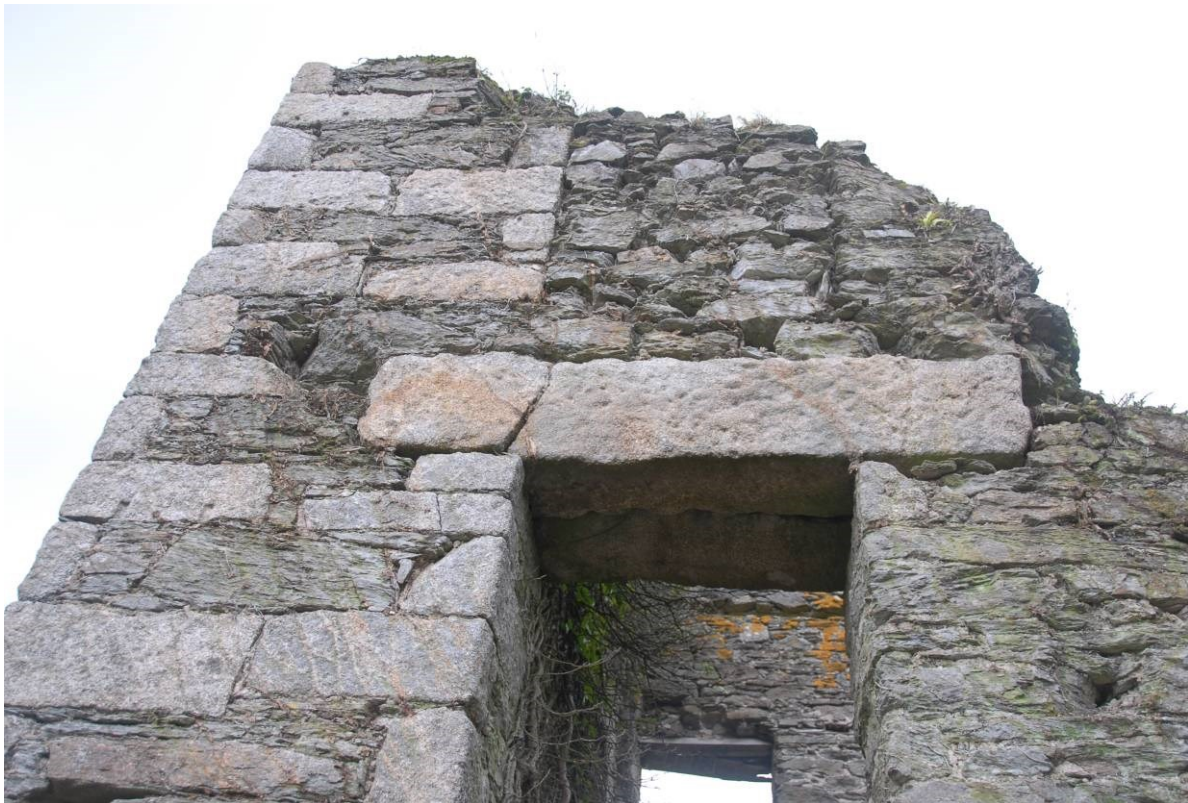
*Fig 20. The cracked lintel over the boiler house door on the western elevation of Taylor's engine house.*

*Fig 24. The lintel over the boiler house door following drilling and pinning to restore its structural integrity.*

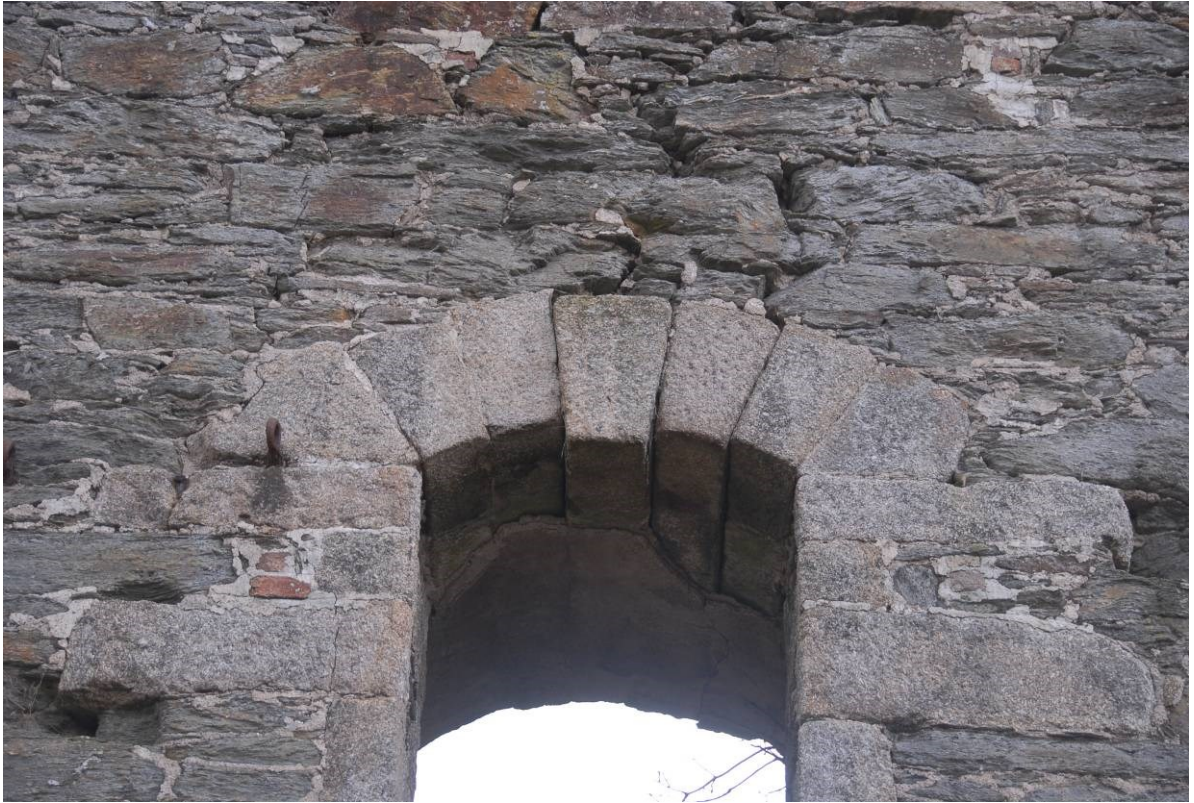
*Fig 21. The dropped voussoirs over the plug door opening in the northern elevation of Taylor's engine house. Note also the remnant plasterwork in the crown of this opening.*

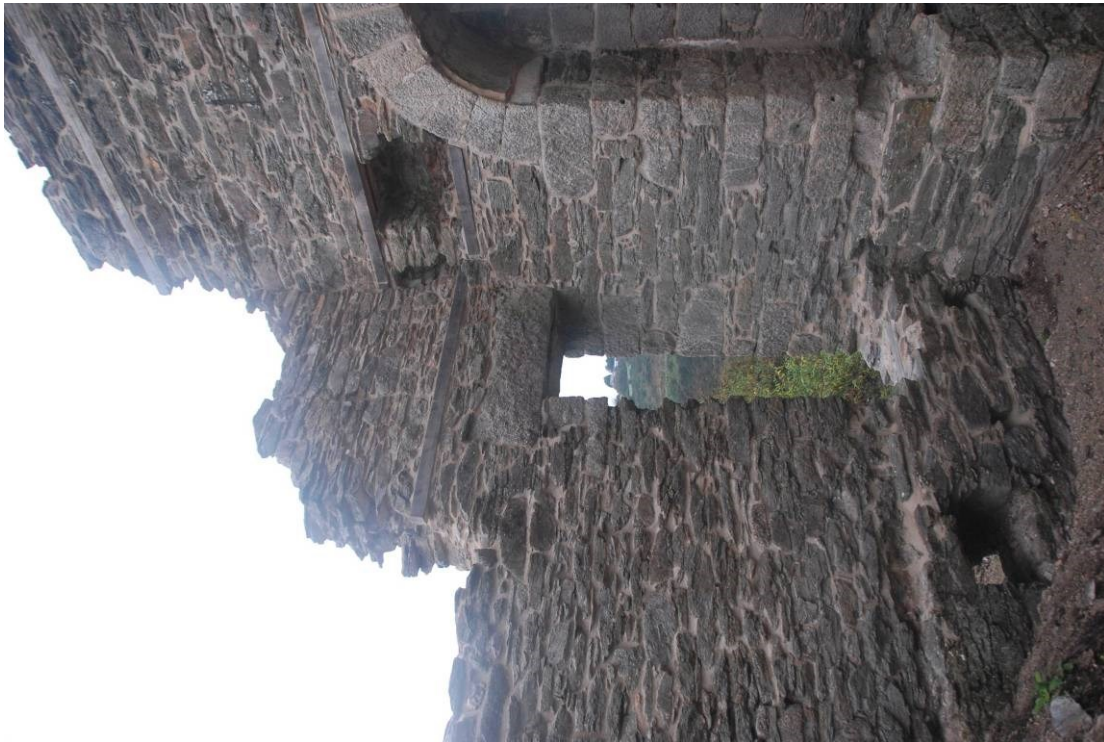
Fig 31. The western internal elevation of Taylor's engine house, showing the reconstructed masonry above the replaced lintel.

With the scaffolding in place, the masonry infill to the rear of the of the middle floor western wall window was carefully taken down and reconstructed, recessed stainless steel helicoil bed jointing being installed to tie the replacement panel into the adjacent masonry. All the surviving original decayed incorporated timberwork on the inner face of the building was removed and replaced in oak, this consisting of lintels and cills to the substantial wall pockets for the middle floor bearer timbers and a further full width timber set into the wall just below its head (Fig 28). On the western wall, an inset timber was replaced at the height of the cill of the middle floor windows (Fig 31); others full length timbers were replaced on the inner face of the eastern wall, these forming lintels and cills for the middle floor windows; another was set into the wall in the original socket below the top of the bob wall. On the external eastern elevation new lintels were provided for both original window openings.

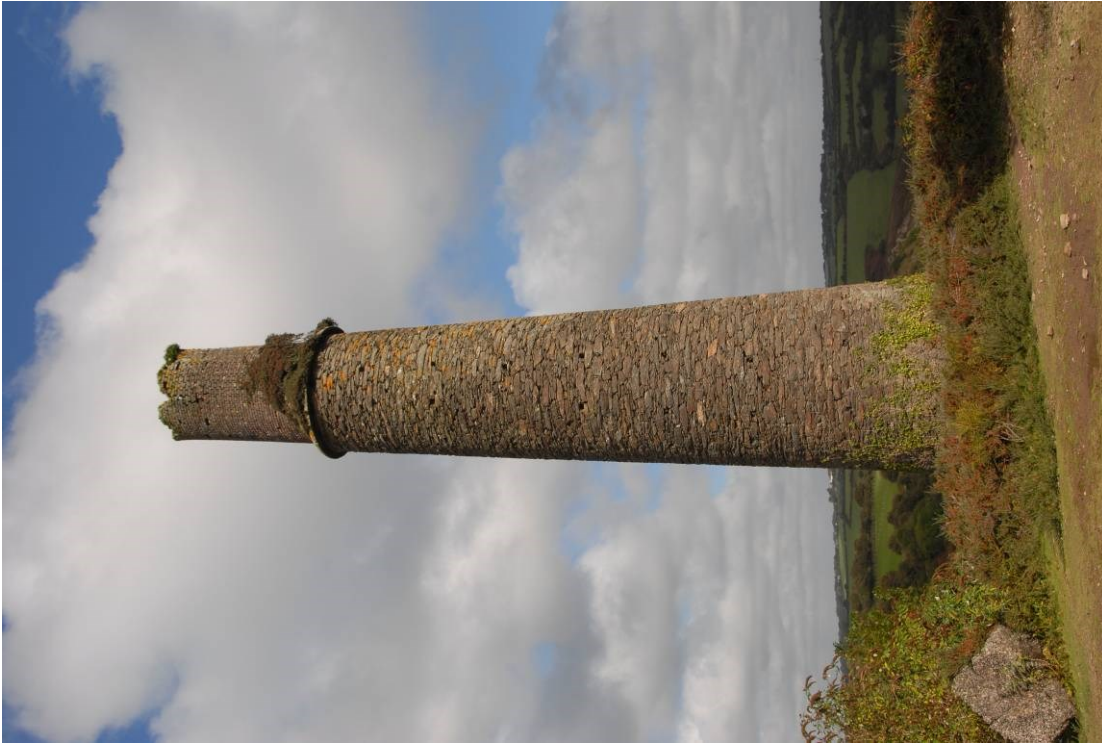
*Fig 36. Taylor's chimney from the west prior to works, showing the poor state of the brickwork and the cotoneaster which had begun to grow above the drip ring.*

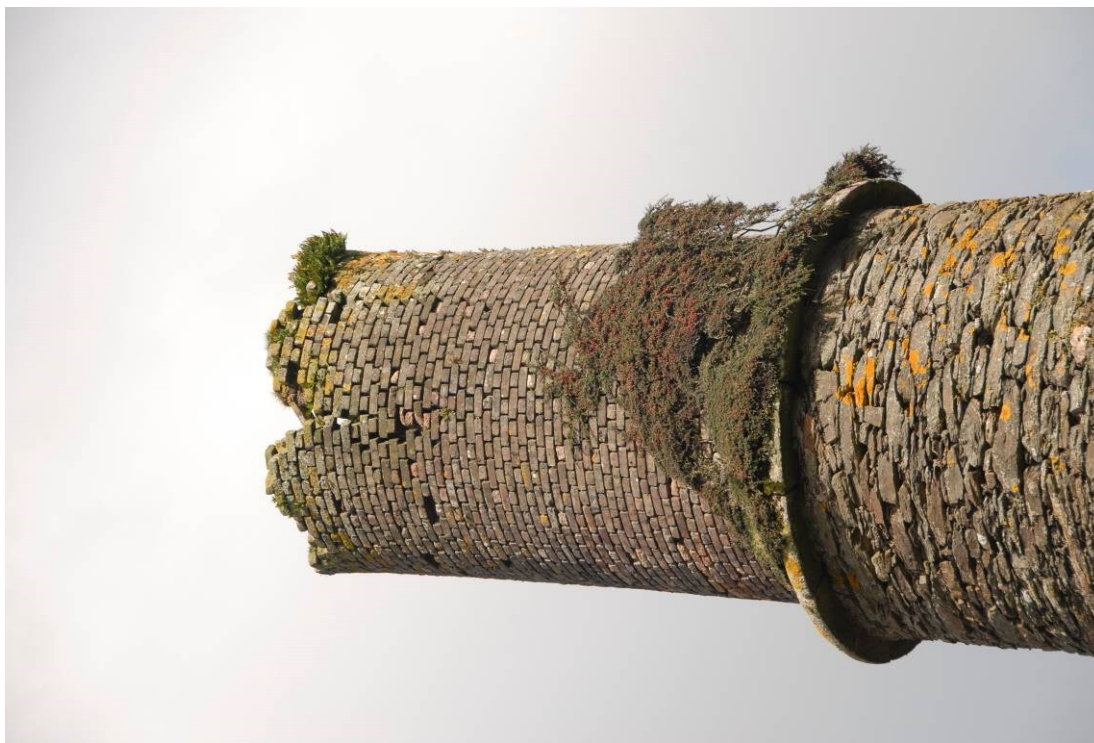
The chimney was the first structure to be conserved at Taylor's Shaft, work commencing in early February 2013 and being completed by early May. A full scaffold was constructed off ground level at the chimney base, whilst an access bridge and walkway were built to connect the level ground adjacent to the compound to the west to the main scaffold structure. This access way was secured to prevent unauthorised access. A preliminary inspection of the chimney was then undertaken, revealing that the top five courses of the chimney where the greatest failure had occurred had been constructed in header courses nine inches deep. The mortar bedding on these courses had failed to the point where the joints had opened up loosening the brickwork, with the result that some bricks had fallen to the ground below and others were found within the interior of the chimney. The upper profile of the chimney was ragged. The remainder of the bricks in these courses could be picked off by hand (Fig 39). The chimney at this level was 1.8m in diameter internally. Below this level, the brickwork was one and a half bricks thick over a height of 2.5m, the mortar bedding becoming increasingly sound further down its height.

Fig 37. Taylor's chimney brickwork from the west, showing its poor condition.

Following the inspection, it was decided to prioritise the reconstruction of the loose brickwork to lessen the chances of vandalism to these components, given that this part of the chimney had been rendered readily accessible following the construction of the access scaffold. In order to facilitate the installation of the lightning conductor, it was decided to reconstruct the top profile of the chimney with a level profile, utilising both the bricks still remaining *in situ* on the chimney top, and any which could be recovered from the ground below, together with a relatively small number of new bricks where the originals had deteriorated to the degree where they could not be re-used after cleaning. These were used on the interior of the chimney to prevent them being visible (Fig 40). The top thirty two of the sixty one courses were dismantled, cleaned of adhering mortar, temporarily stored on the scaffolding lifts and rebuilt as twenty nine complete courses of

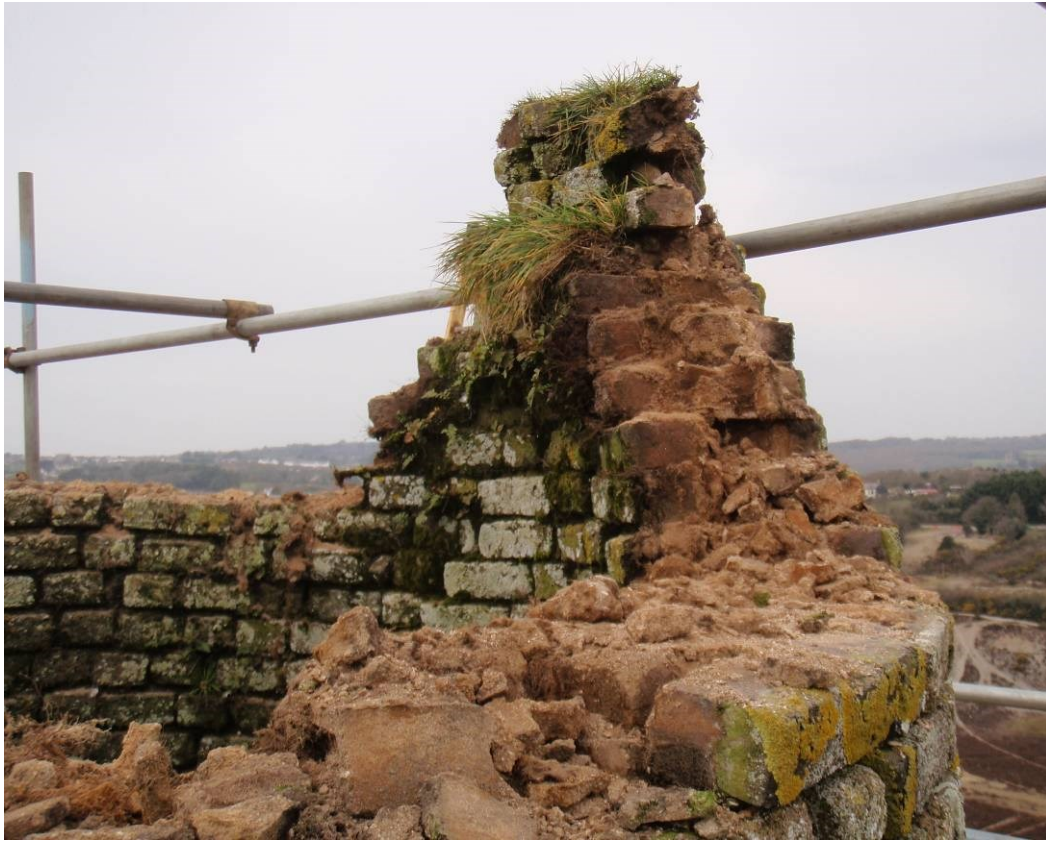
*Fig 39. The condition of the upper courses of the chimney brickwork, much of which could be picked off by hand.*

brickwork, recessed stainless steel bedjoint reinforcement being installed at intervals to help to tie the courses together. As soon as the mortar had cured sufficiently, the lightning conductor was fixed to the crown of the top brick course and the upper scaffolding lifts were dismantled.

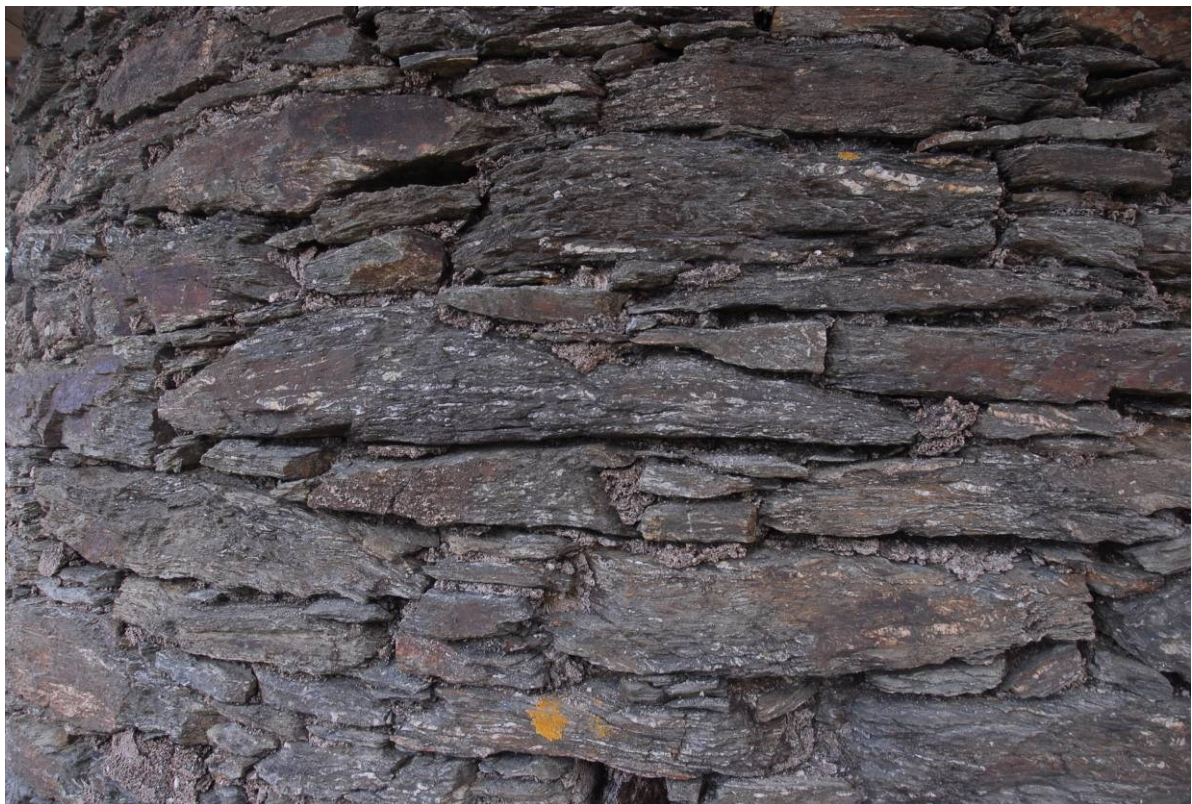
*Fig 44. Much of the pointing on the lee (northern and eastern) sides of the chimney had been eroded away. Note also the elongated shaped stones used in the structure.*

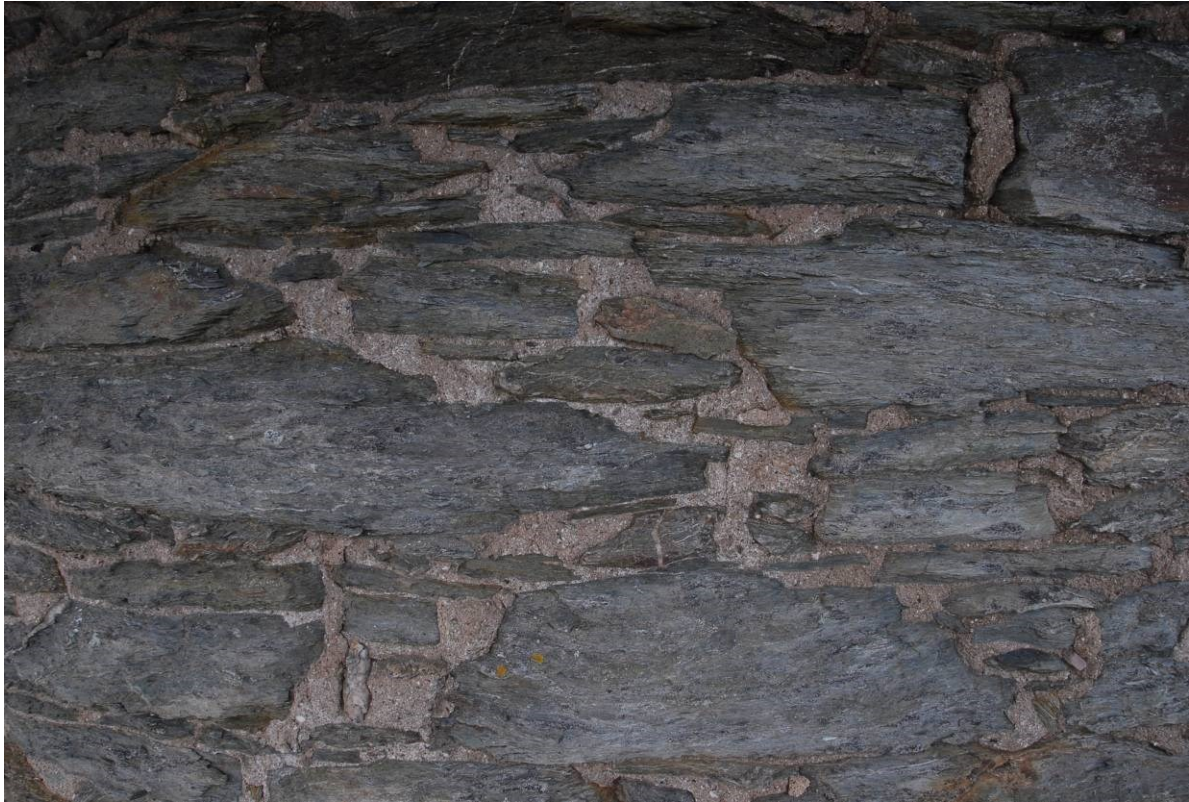
*Fig 45. Remnant pointing on the lower part of the chimney. Detached sections of this were removed and patch pointed, but tight joints were left as found.*

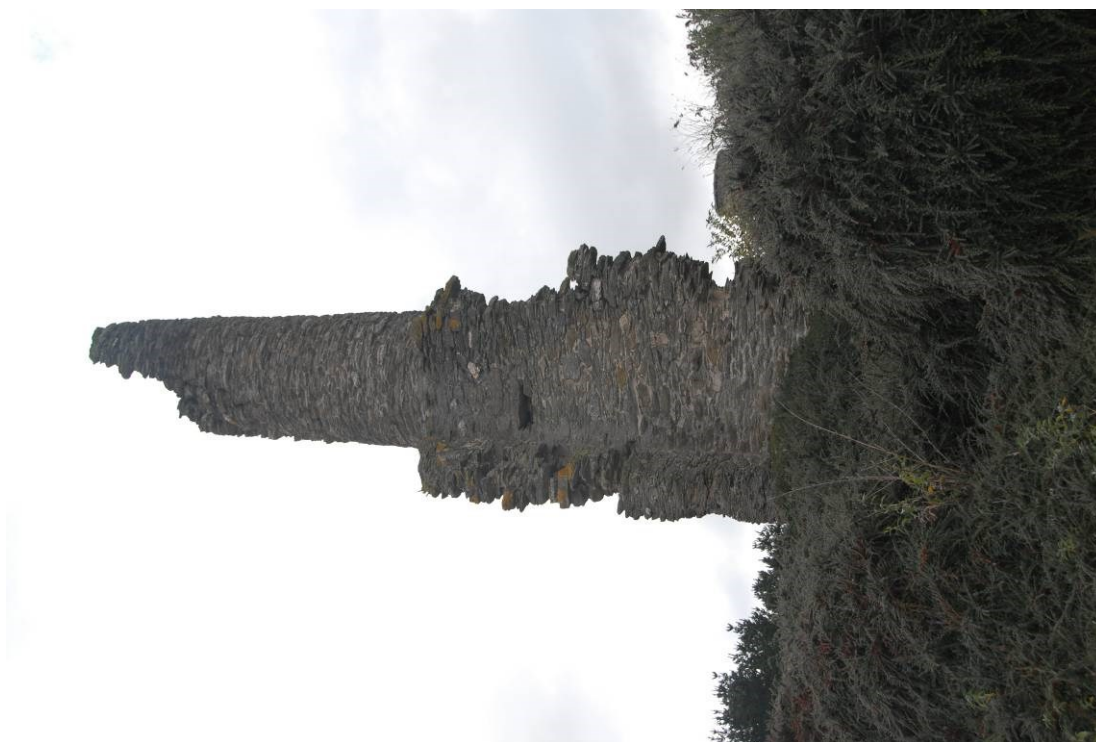
*Fig 52. Another view of Taylor's whim, showing the poor state of the broken masonry at the edges of the walls.*

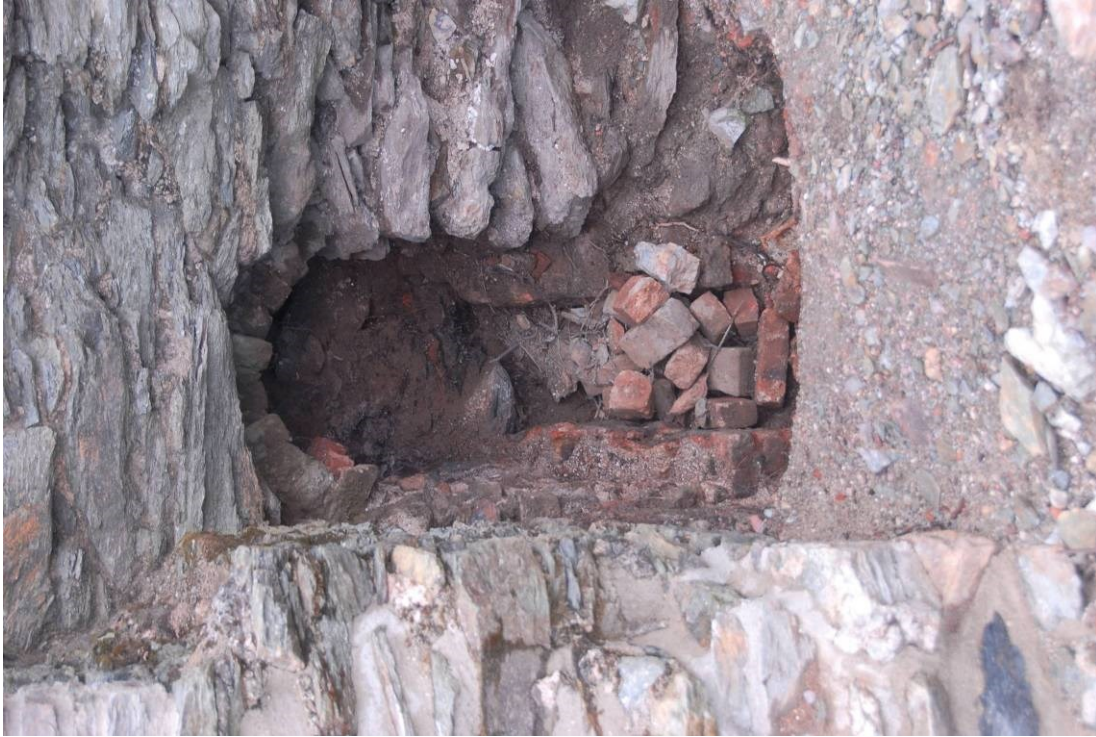
*Fig 54. The condition of the flue from the chimney into the former boiler house prior to works.*

*Fig 66. The repaired flue connection between the chimney and boiler house at Taylor's whim (compare with Fig 54).*

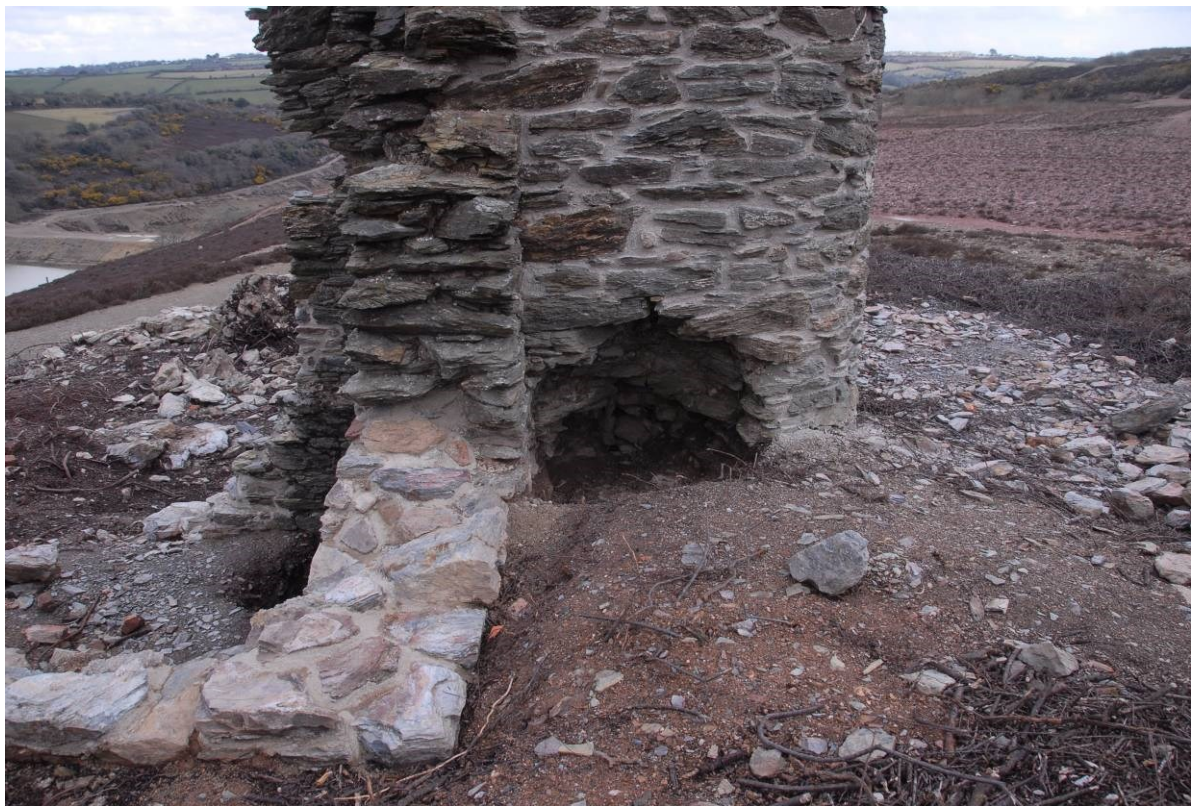
*Fig 56. Repointing under way on the lower part of the chimney and the remains of the boiler house walls (left). Note also the collapsed ash clearance hole at the base of the chimney.*

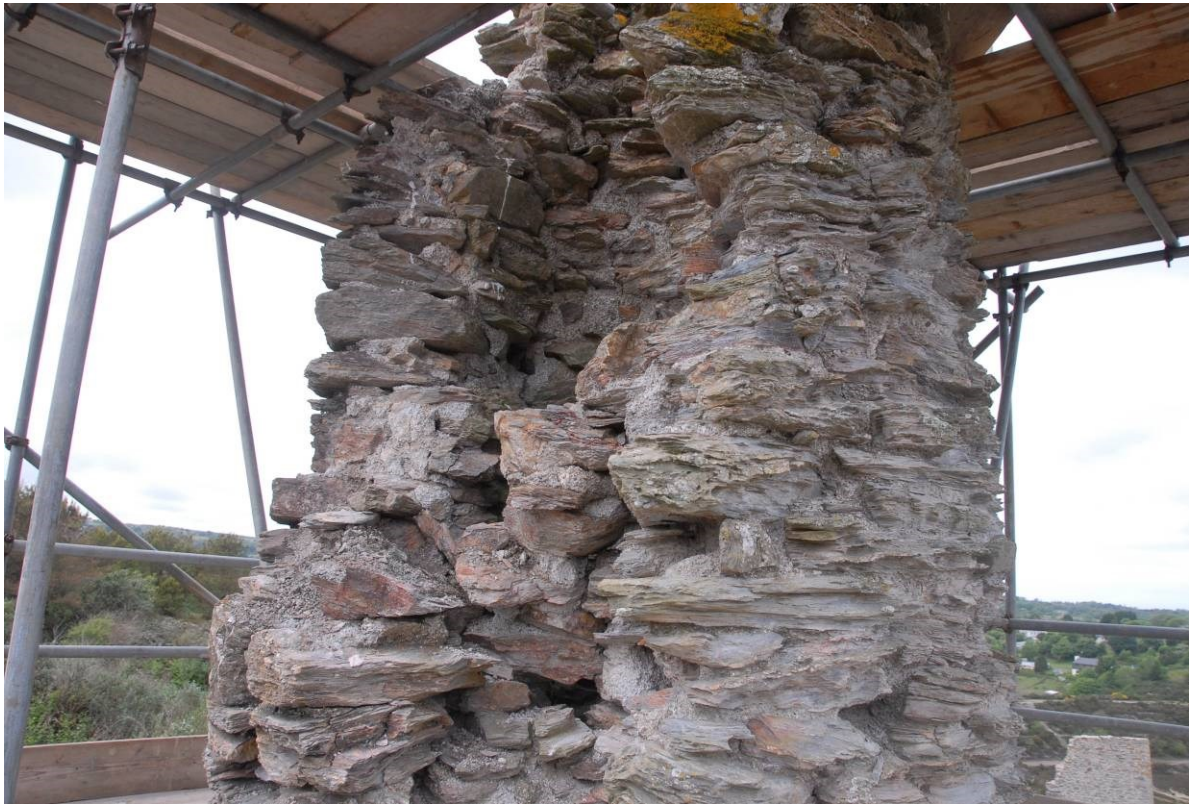
*Fig 59. The extremely poor state of the upper part of Taylor's whim chimney prior to works.*

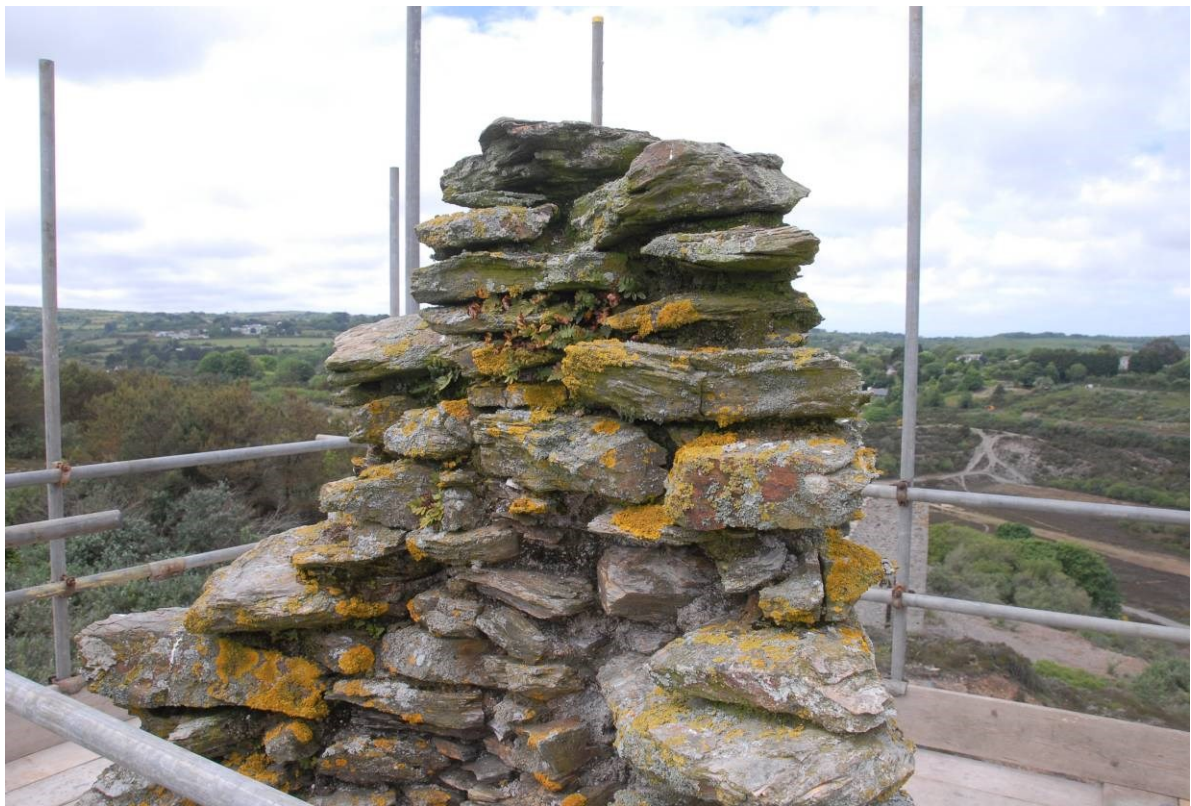
*Fig 60. The topmost section of Taylor's whim chimney, showing the almost complete loss of pointing, and the extremely ragged profile.*

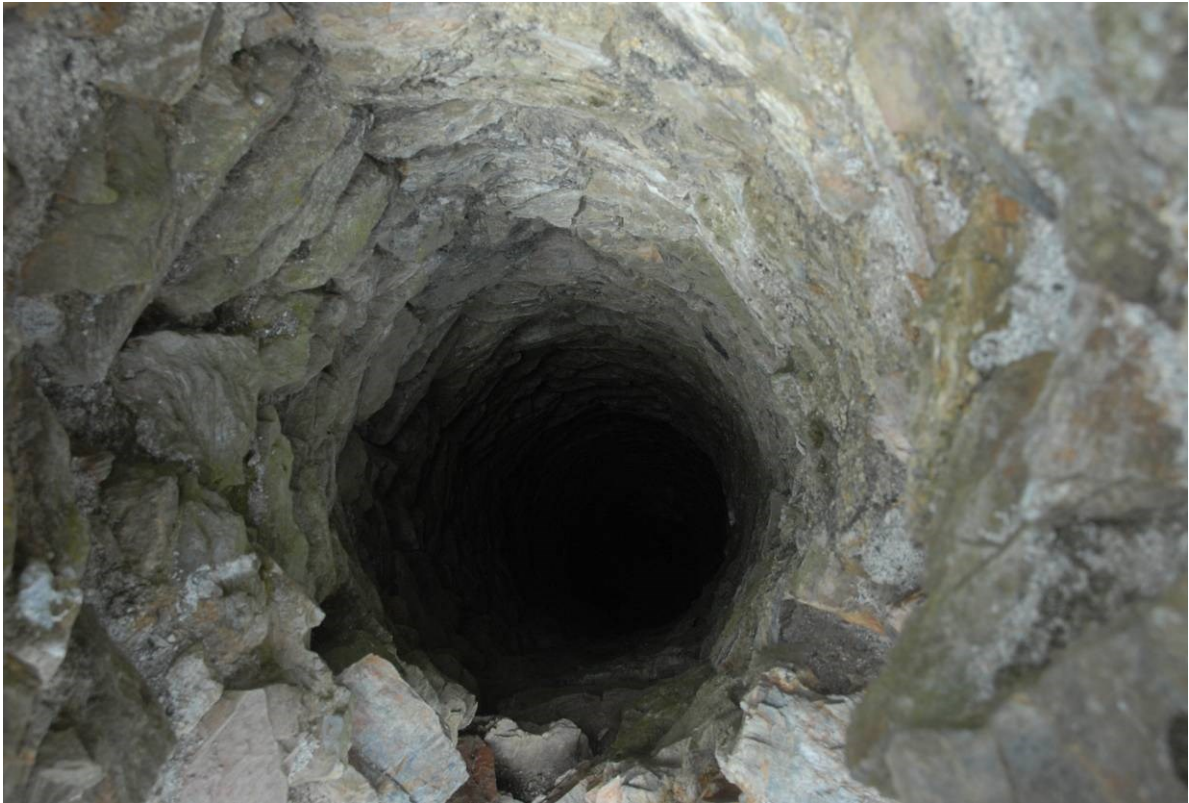
*Fig 61. The interior of Taylor's whim chimney, showing the almost complete loss of its pointing.*

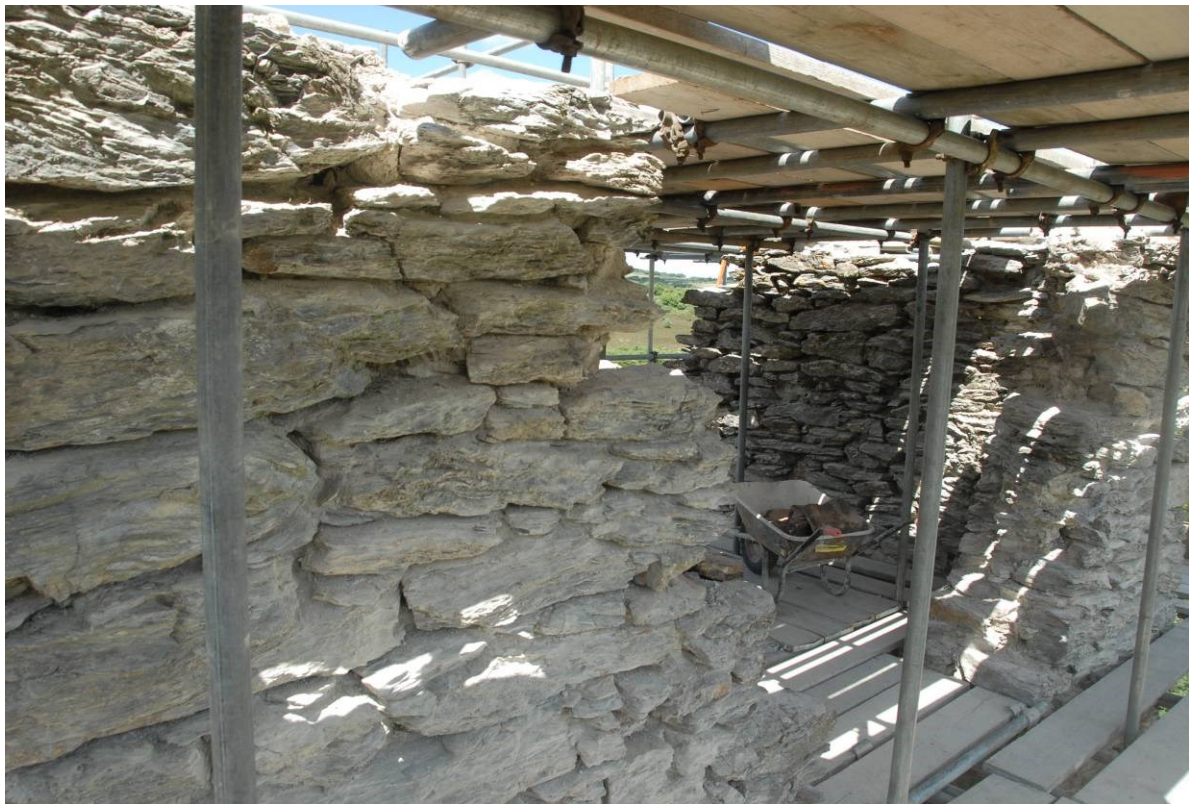
*Fig 76. A closer view of the condition of Davey's whim masonry, showing the very substantial loss of pointing which had occurred.*

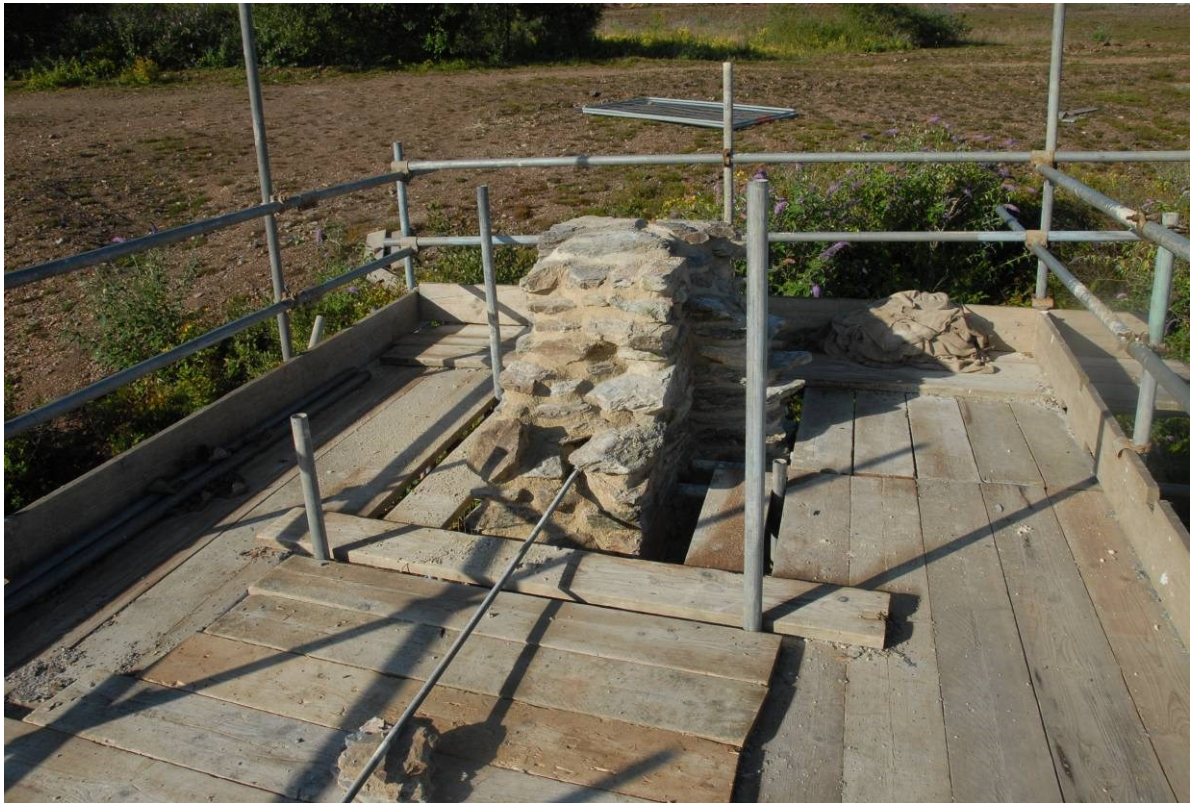
*Fig 77. The rebuilding of the formerly unstable south eastern wall incorporated a tie bar through the wall cores.*
