New Cook's Kitchen Shaft, South Crofty and Chapple's Shaft, Cook's Kitchen, Pool, Cornwall

**Historic Environment Consultancy during
conservation works to structures**

Client	Cornwall Council
Report Number	2013R080
Date	04 February 2014
Status	Final
Report author	Adam Sharpe BA MIfA
Checked by	Dr. Andy Jones MA MiFA
Approved by	Andrew Young MIfA

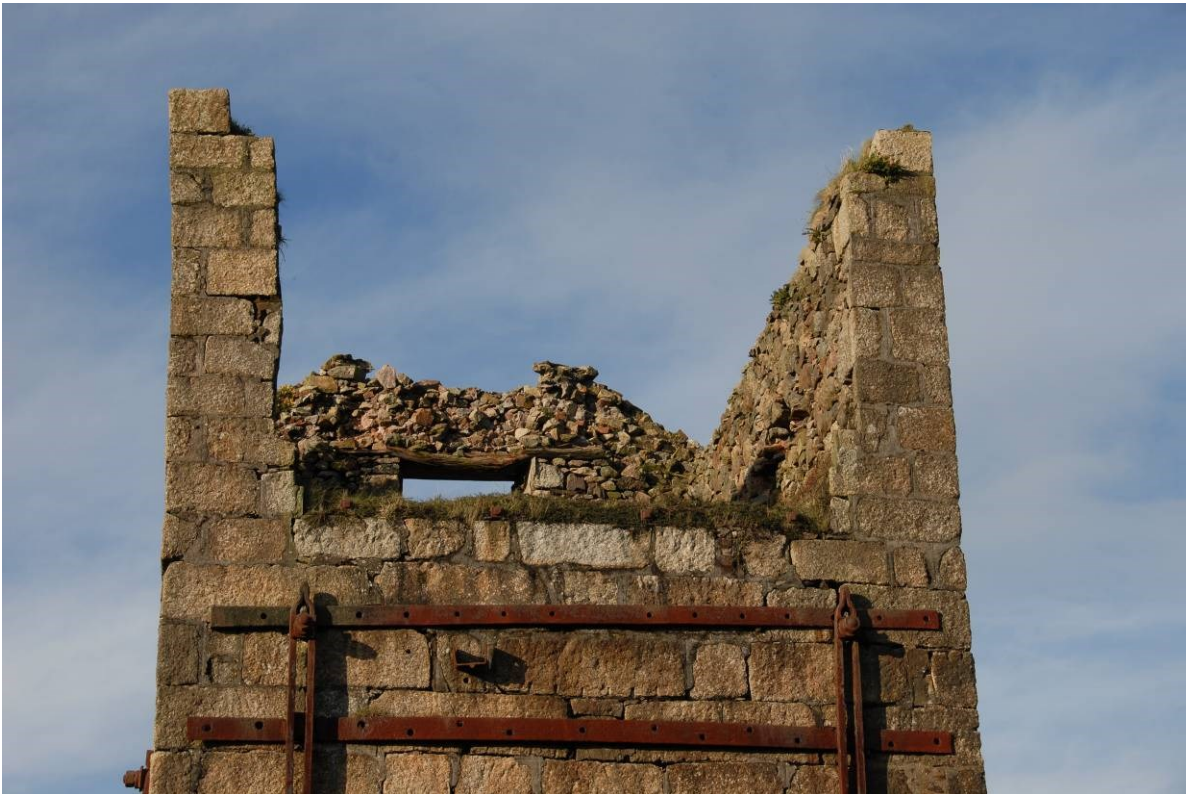
(Fig 27), most of the remainder of the wall openings are flat-headed, unusually having timber (rather than granite) lintels, their eventual decay introducing significant areas of weakness into the structure (Fig 30, 34). Paired openings on the ground floor to the rear of the bob wall measure 1.75m high x 1.65m wide to the west, this being a window, as it has an arched head with projecting brick courses above it, and 2.30m high and 1.0m wide to the east, this being the doorway between the engine house and the boiler house (Fig 27). There are windows on the middle floor on both the eastern and western elevations (these measuring 1.45m high x 1.30m wide to the east and 1.60m high x 1.30m wide to the west). All of the windows have brick external facings at their bases (Fig 50) and formerly had cement-faced sloping internal cills. Some appeared to have originally had longer lintels, this being indicated by brick infill panels (Figs 44 and 45). The girder openings measure 0.99m high and x 0.75m wide, the easternmost being closed off with a panel of masonry, indicating that the girder had been taken out from the house to the west during the dismantling of the engine.

Fig 30. Clear indications of the problems experienced by this building in the form of failed timber lintels and the loss of supported stonework.

- Replacement of all lost or failing lintels using new hardwood (preferably green or air dried oak).
- Full replacement of all failed pointing using an approved lime mortar.

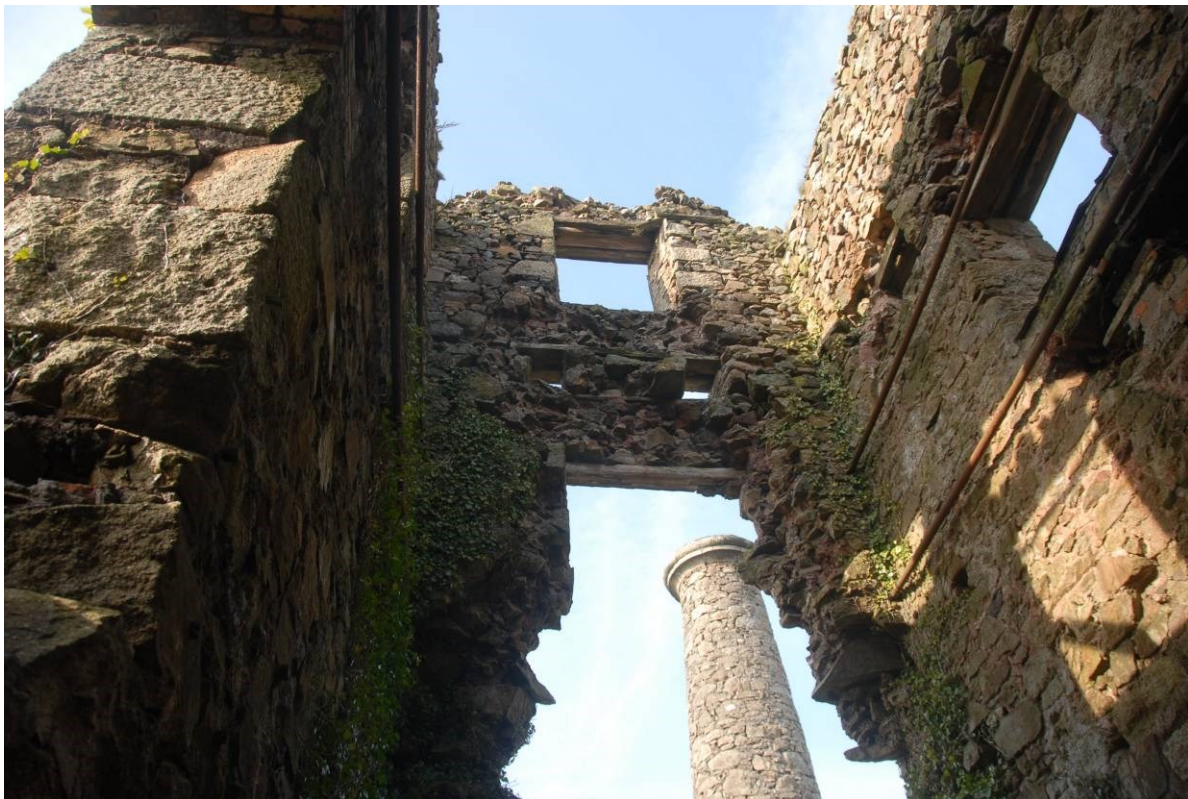
Fig 31. The upper section of the bob wall (south wall) of the engine house showing the upper pattrass plates and the very poor condition of the inner face of the gable to the northern wall.

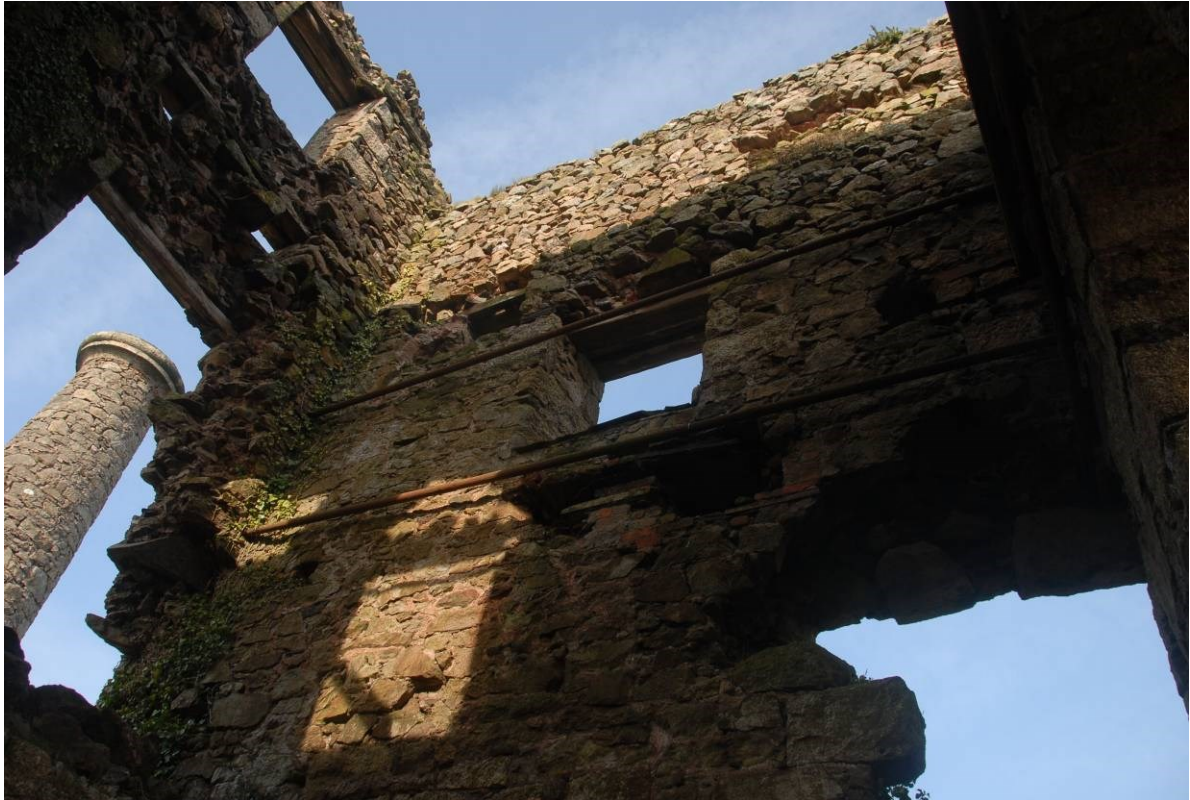
Internally, the stonework was in much poorer condition than externally, as the failure of timber cills and lintels had led to localised collapses and loss of masonry (Figs 32 and 33). Wall sockets indicated the positions of many of the original floor joists. Full access was not allowed to the interior of the building prior to its scaffolding, but Sharpe and Massie's 1991 report indicates that the majority of the problems with this building were concentrated in the rear (northern) wall, much of whose internal face had been lost to collapse. On the external elevation of this wall the two lower openings (the cylinder door and the middle floor window) had coalesced through collapse (Figs 28, 32, 49). A further area of concern was the racking of the leading edge of the western wing wall, which, in 1991, had been thought might require remedial attention over and above repointing and crack stitching.

Fig 32. Looking up at the internal elevation of the northern wall of the engine house showing the catastrophic loss of stonework which had occurred on its inner face owing to the failure of timber lintels.

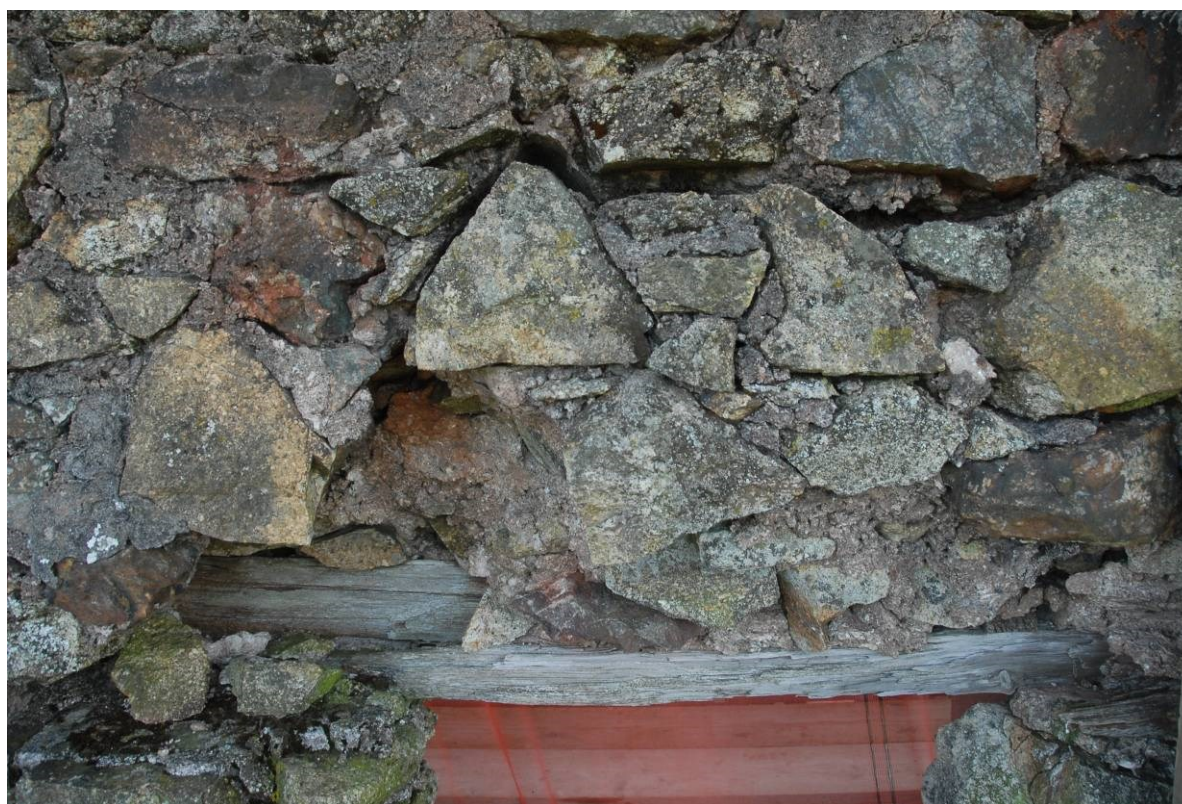
Fig 47. Precarious and barely supported loose masonry where a lintel had rotted out completely.

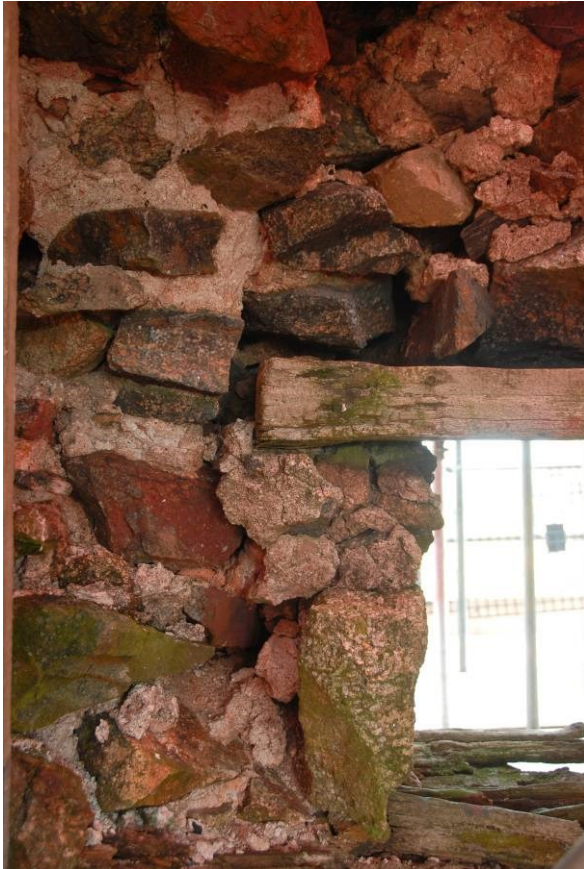
Fig 48. An arch failure in the masonry over a failing lintel.

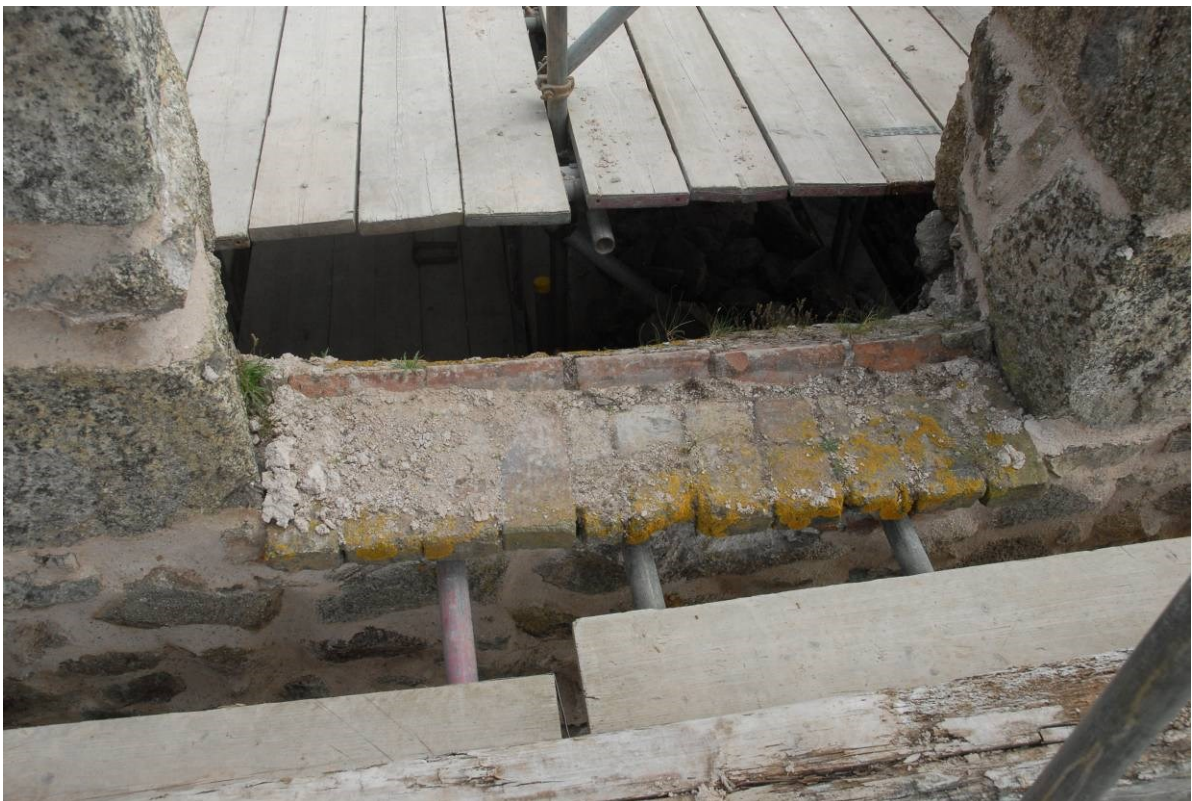
Fig 49. The internal wall skin adjacent to the spring beam opening was found to have been completely lost.

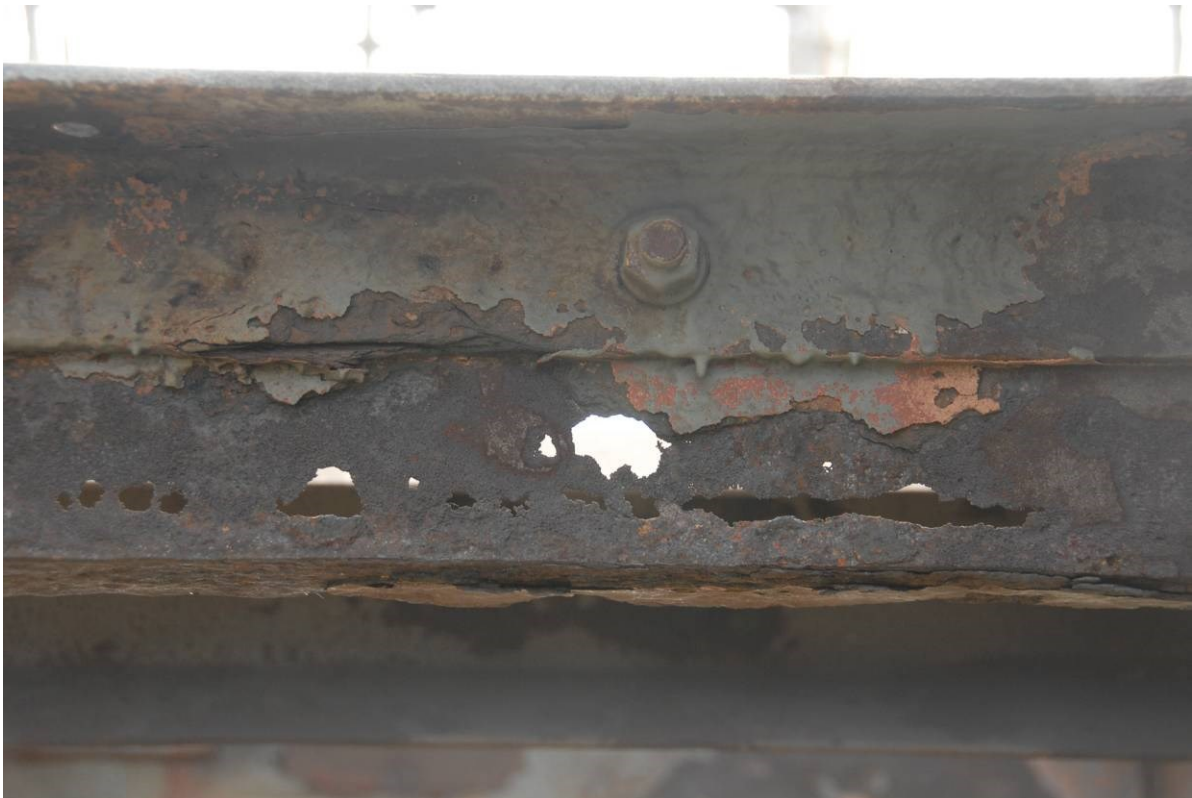
Fig 97. Corroded diagonal bracing members in the older south headframe. This steelwork was replaced.

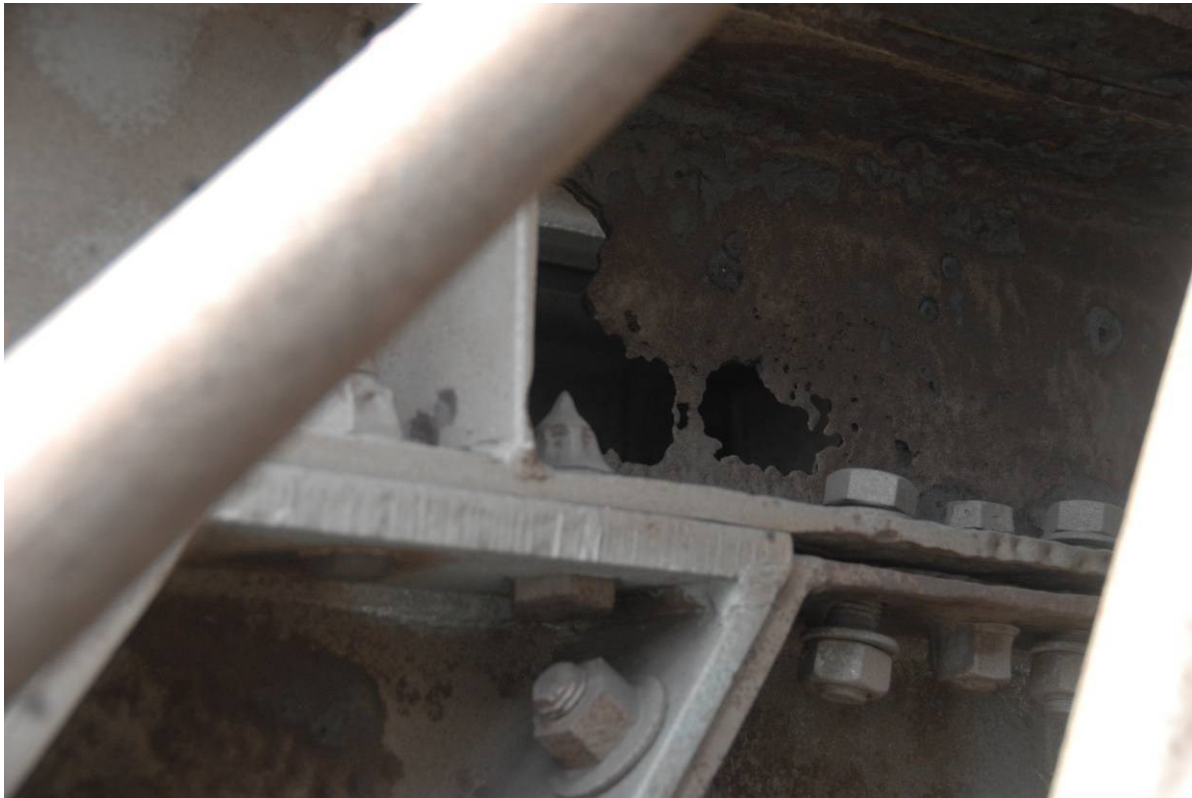
Fig 98. Some of the advanced corrosion to the steelwork was clearly evident in advance of grit blasting.

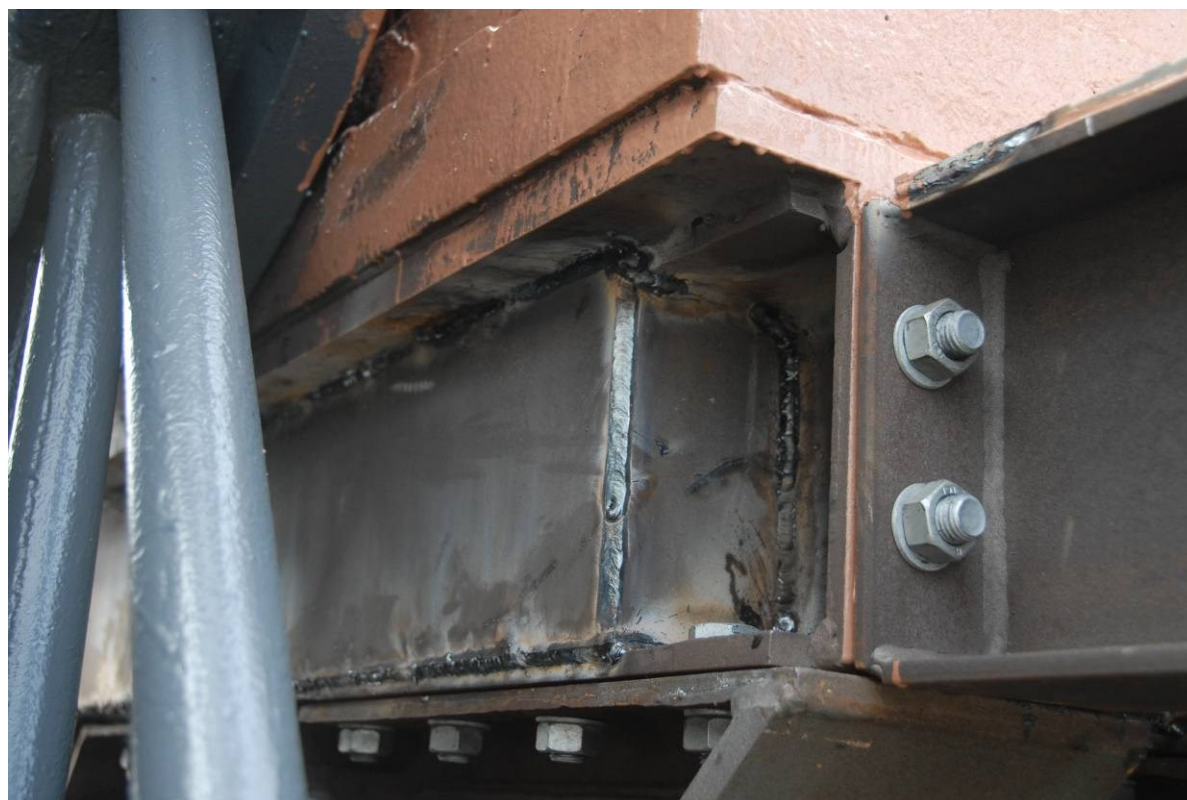
Fig 107. A plated patch on an area of corrosion on the web of a section of structural steel.

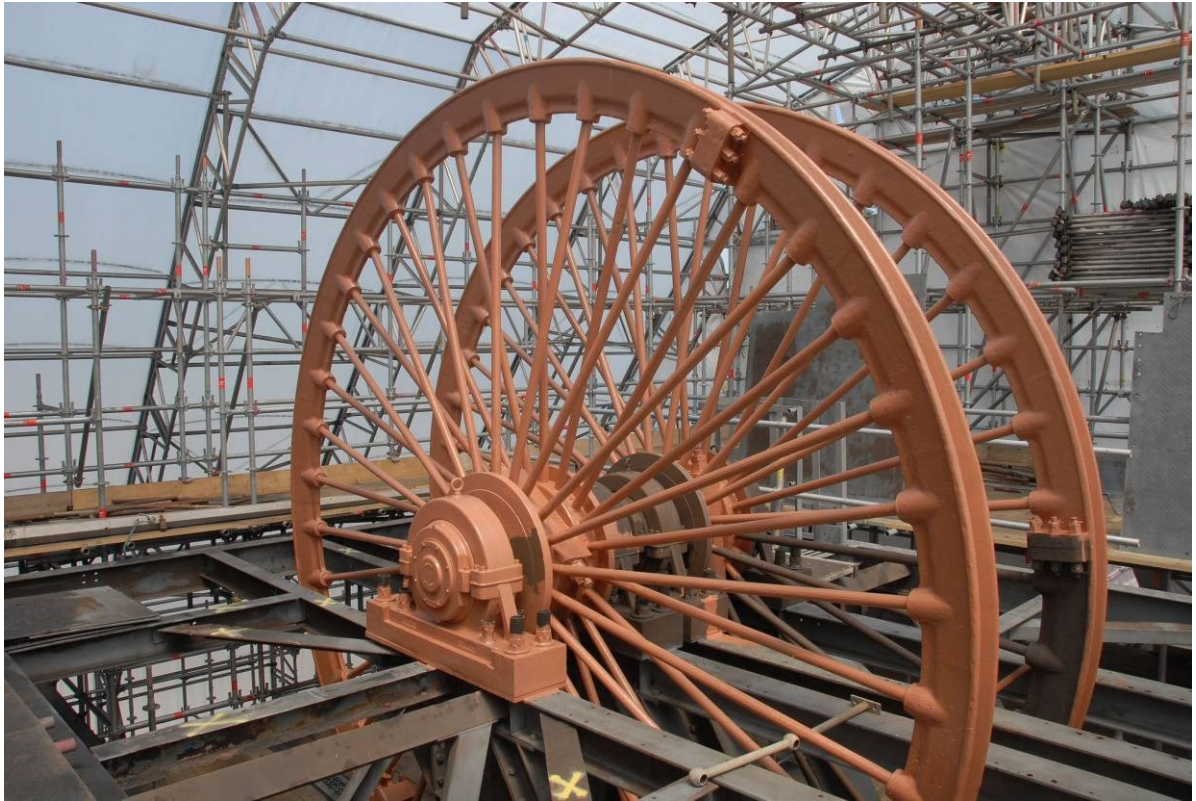
Fig 108. A box section patch repair to one of the horizontal supports for the south headgear sheave wheels.
