# **Tolgus Arsenic Works, Cornwall**

## **Report of archaeological management work**

### **Report of management work: roof repairs, scrub clearance and recording**

<b>Client</b>	<b>English Heritage, Cornwall Heritage Trust</b>
<b>Report Number</b>	<b>2014R048</b>
<b>Date</b>	<b>June 2014</b>
<b>Status</b>	<b>Final</b>
<b>Report author(s)</b>	<b>Ann Preston-Jones, Adam Sharpe</b>
<b>Checked by</b>	<b>Jacky Nowakowski</b>
<b>Approved by</b>	<b>Andrew Young</b>

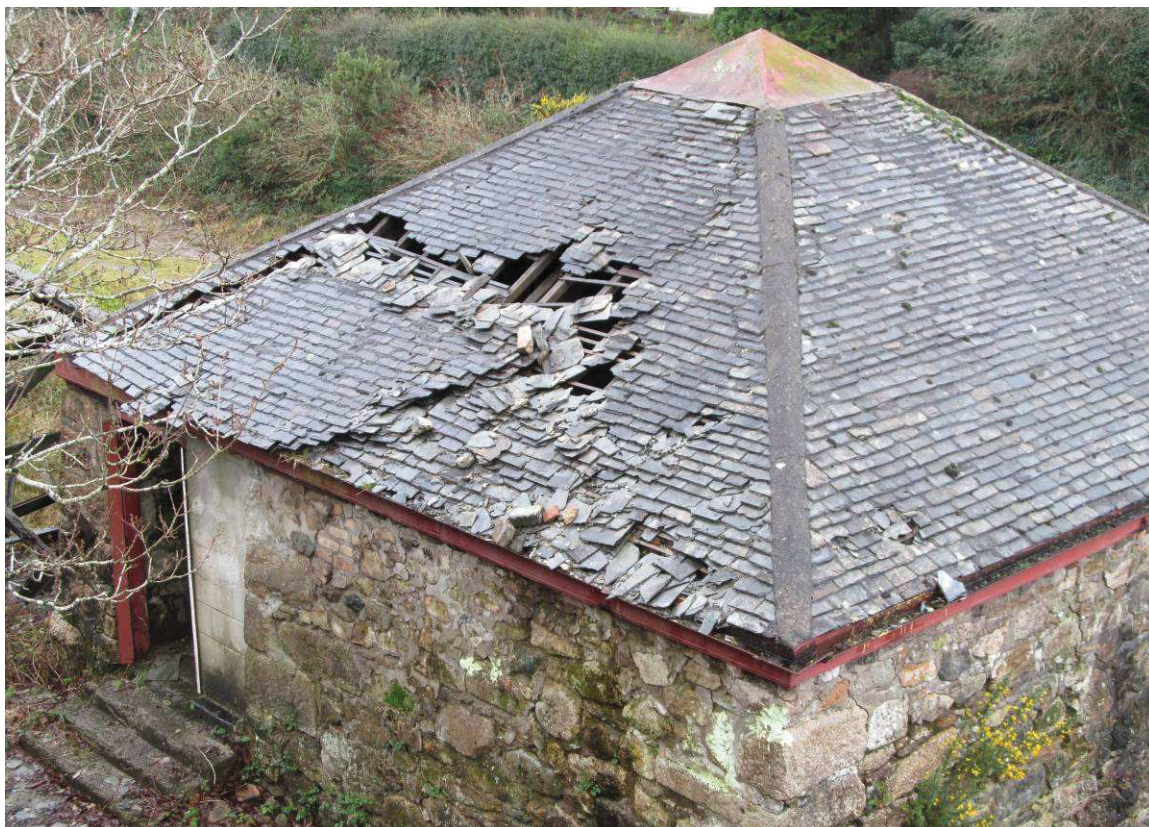
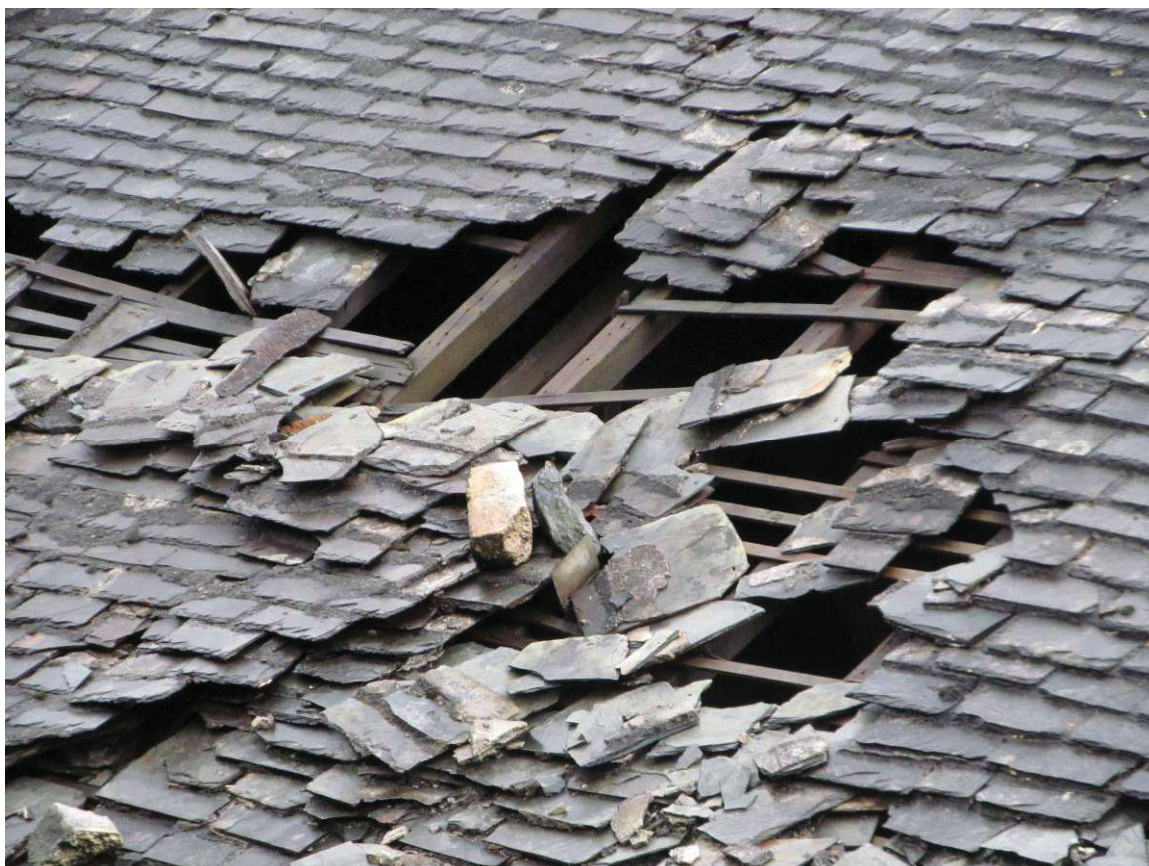
Some of the building's problems, like blocked and leaking gutters, and the cracked cement ridges of the hipped roof, were the result of natural deterioration and neglect. For the same reason, vegetation like Buddleia and gorse was growing from the walls, whose pointing was cracked or missing. But side by side with this, the calciner's roof had been a target for vandalism over the last few years, with bricks being picked off the flues above and thrown down onto the building. Inevitably, the damage to the roof allowed rain water in, threatening important internal fittings. In addition, there was open access to the upper floor, which was used as a den and focus for anti-social behaviour, with associated litter, graffiti, and fires being lit on the floor (Figs 5-10).

*Fig 5 Tolgus arsenic works: the damaged west face of the calciner roof in January 2014: the lower, more detailed, image shows a brick from the flues lodged on the roof*

The original specification had been for a marine ply covering over the damaged west side of the roof, to simply protect the interior of the building. Following discussion with English Heritage and potential contractors, this was modified to repairs to the scantle slates; but in the event, circumstances dictated a third approach to repairing the damage, which is outlined below.

Work began on 30<sup>th</sup> January, with the expectation of simply repairing the scantle roof. However, once work started on removing the slates, they were found to be in very poor condition; moreover, because they had been secured with a hard mortar, they could not be easily removed without damaging them, and would have been impossible to re-lay properly. Moreover, the roof as a whole was found to be in worse condition than originally thought, with the top of this side of the roof cracking and liable to slip. The cement ridges were also cracked and slipping and this was starting to affect slates in the adjoining roof elevations. There was also damage to the roof elevation to the right (S side), where more slates had been dislodged since the original specification was drawn up (Fig 8). Fortunately, the wall plate was found to be in reasonable condition, as were the rafters, for the most part.

- Removing all damaged and insecure slates
- Carrying out some small scale *ad hoc* repairs to rafters
- Covering with 2 x 3mm external ply, as this size could be slipped in under the edge of the slates at the edges of the roof which did not have to be removed. A double layer was used, siliconed together and with sheets overlapping so as to help with waterproofing.
- This was then finished with a heavy grade of shed felt, to ensure that it is fully water-proof. Being grey this also has the effect of making the repair less obvious.
- Expanding foam was squeezed in around the edges and then finished with cement to hold it all in place and make the joint secure and waterproof. The use

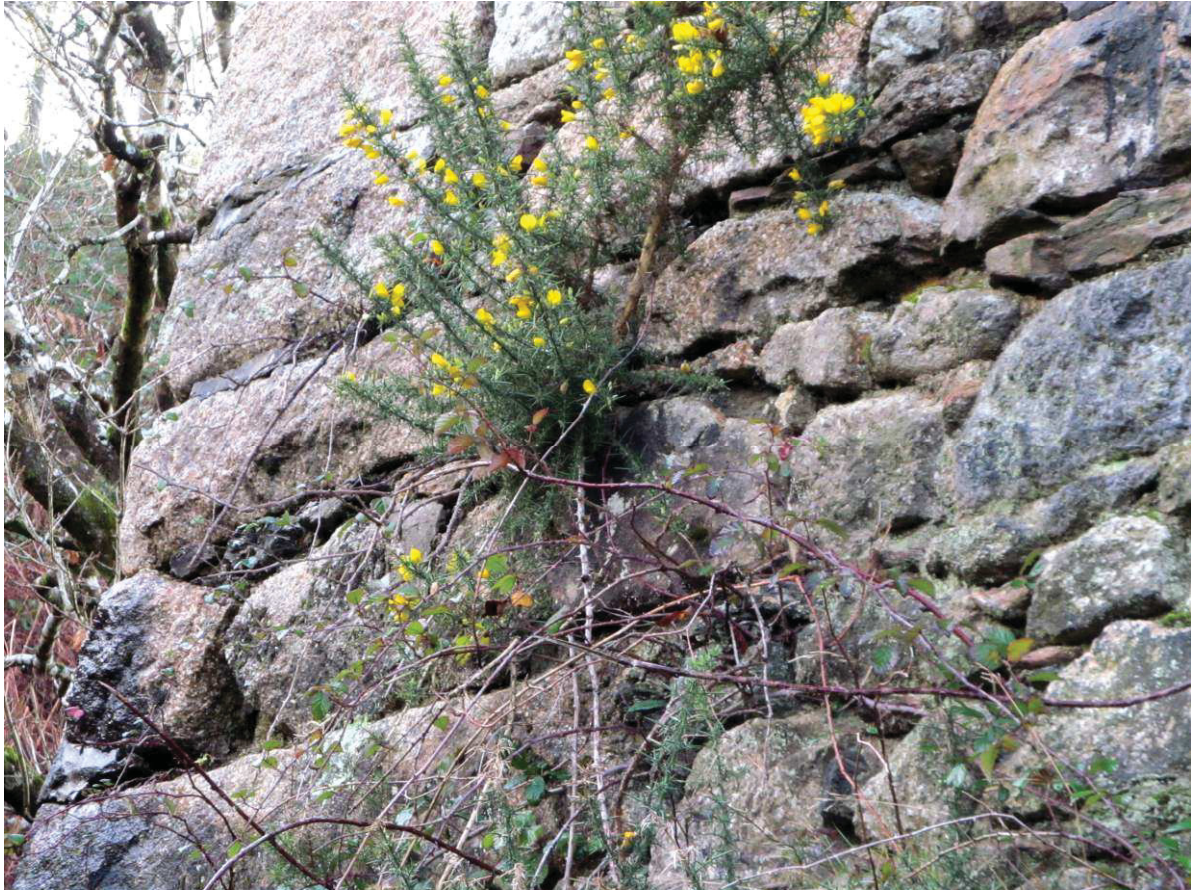
*Fig 6 Tolgus arsenic works: vegetation growing from cracks in the stonework*

TCV's Youth programme team subsequently visited on two further occasions to clear further scrub, including – where accessible – from the walls of the building.

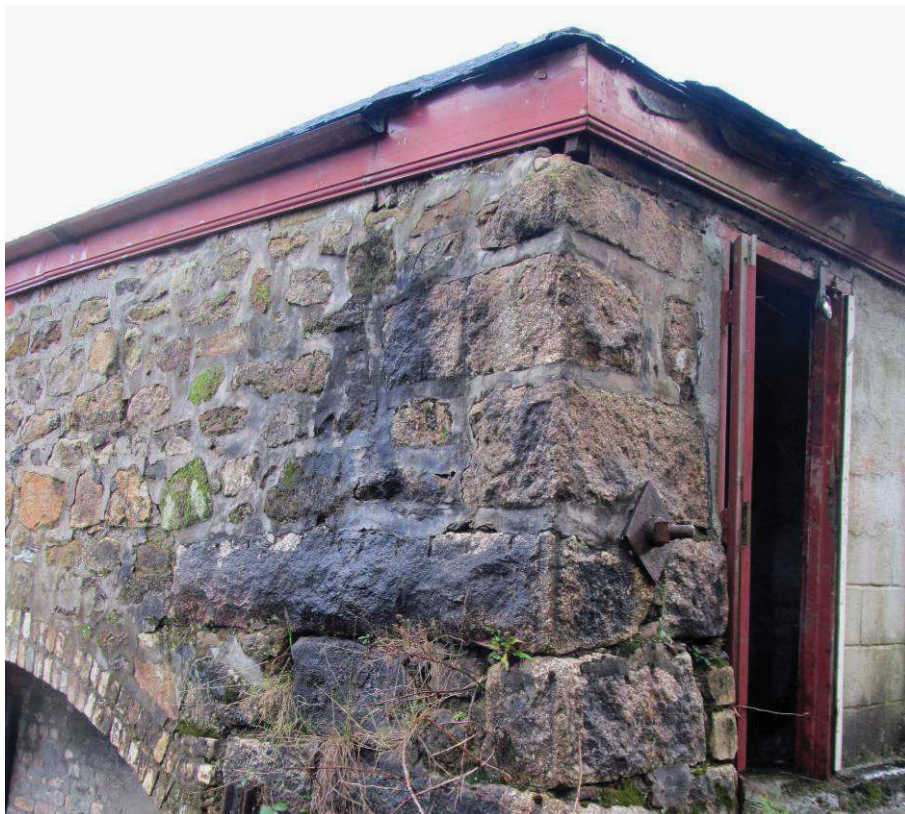
Close inspection also showed up the poor condition of the old cast iron gutters. They were broken or missing in places and blocked with moss and pieces of slate. The problem this was causing is seen in stains on the stonework below, where water was overflowing or running down the walls where the gutters were missing (see Fig 7).

*Fig 7 Tolgus arsenic works: missing gutter at NW corner. Water running down the stonework has caused the staining seen on the wall*

- Where damaged or cracked, the cement hips on the W elevation were re-pointed.
- The time saved by employing this method was then spent on dealing with the rainwater goods and filling other holes in the roof, to keep the building dry and watertight.
- The gutters all around the building were cleaned out and the downpipe checked to ensure it was draining correctly.
- Much time was spent in trying to source either matching reclaimed cast iron gutter or something of similar style in plastic, to replace a missing section on the west side. As nothing suitable was easily available locally, a new metal gutter was ordered to replace the missing section.

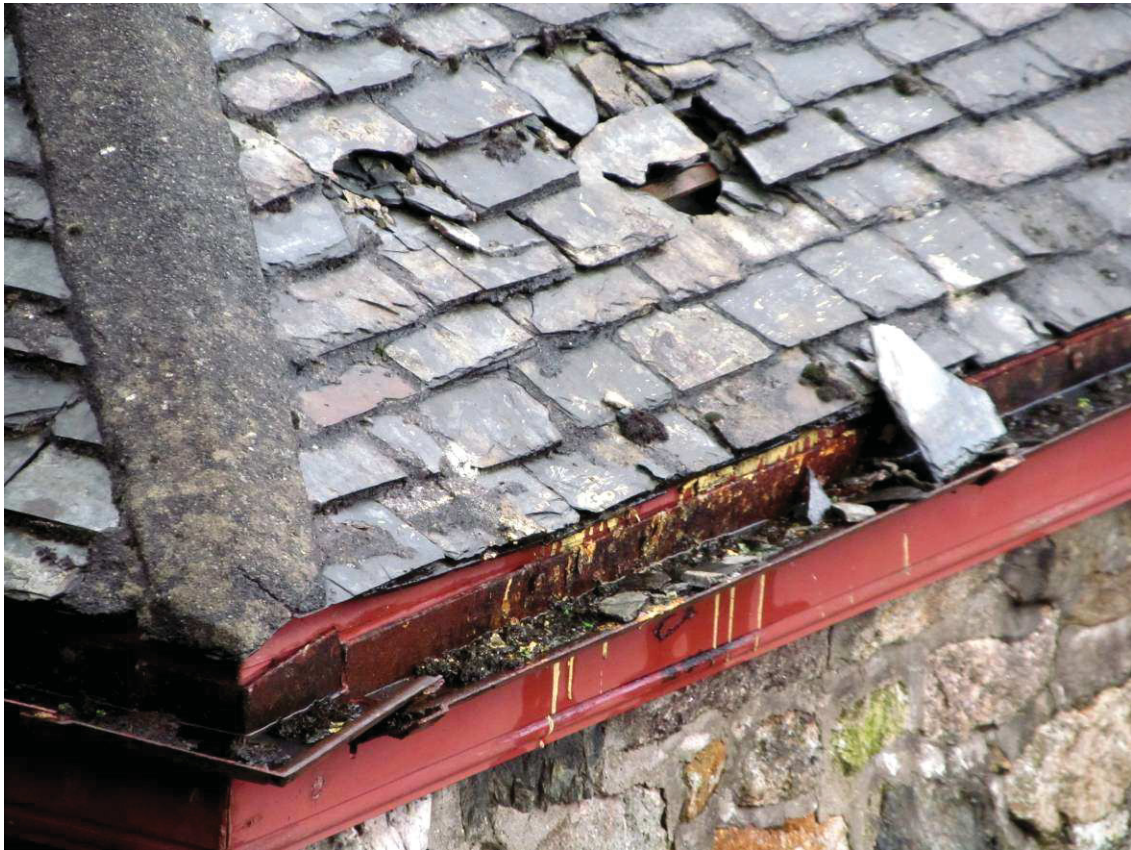
*Fig 8 Tolgus arsenic works: missing slates on south face of roof, blocked and broken gutter*

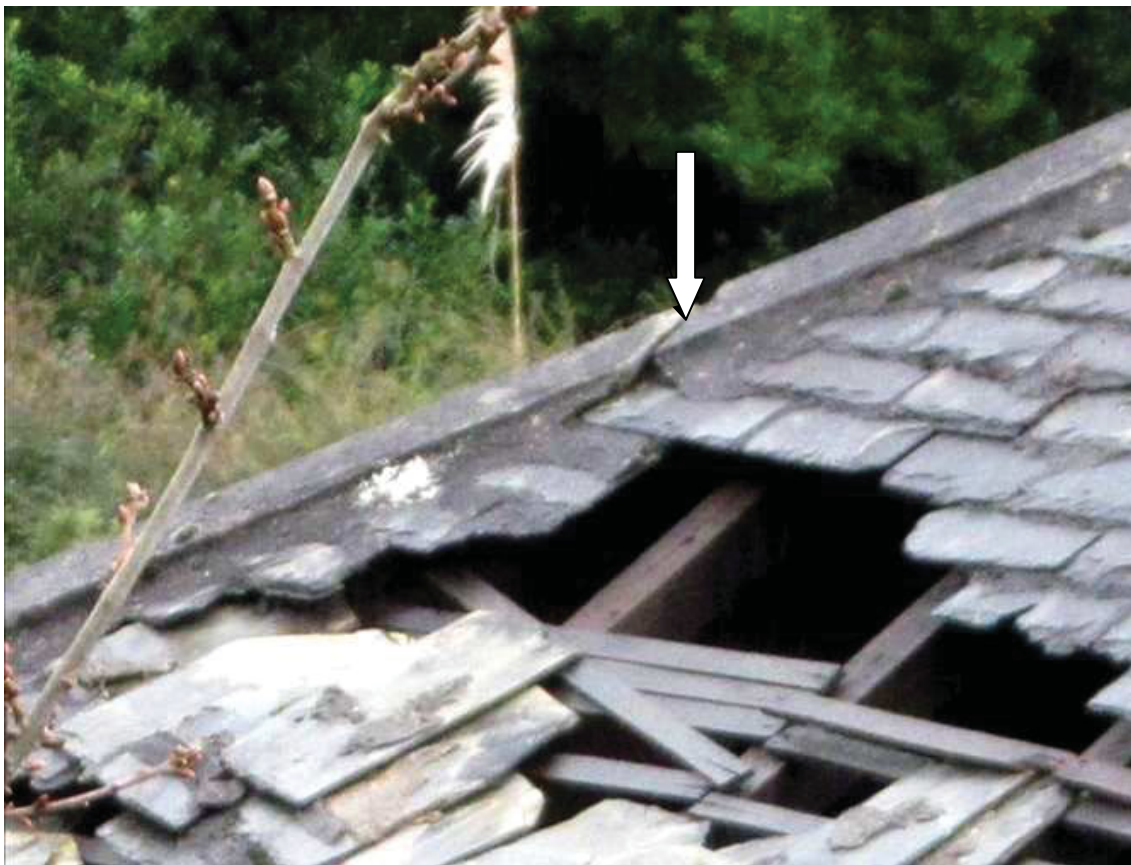
*Fig 9 Tolgus arsenic works: cracked cement hip*

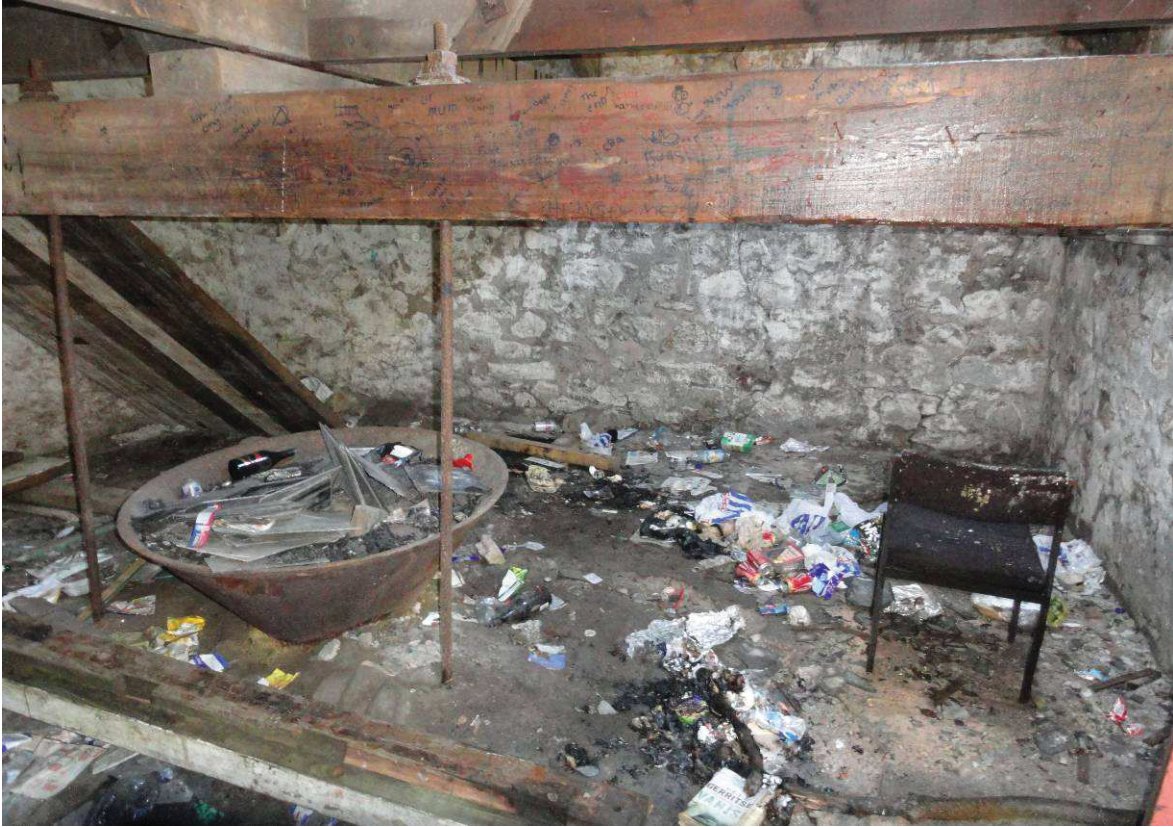
*Fig 10 Tolgus arsenic works: rubbish resulting from rough sleeping in the calciner's upper room*

The initial work was undertaken by TCV on two days in January 2013. The inside of the calciner was cleared of all rubbish, which was put into a small skip for removal from site. Much tall gorse was cut from the labyrinth, and burnt on a site well away from the scheduled area. However, as well as opening up a view of the flues, the scrub clearance also had the effect of revealing fly tipping which has come over the wall from the Old Portreath Road over the years. This included two old freezers, a settee, a TV and a carpet which, without the use of lifting equipment, could not be as easily removed as the gorse.

Once all work was completed, Melroy Youlton blocked access to the interior of the calciner's upper floor with cement-filled oil drums, to prevent access and help protect the building until a permanent solution to its management can be agreed.

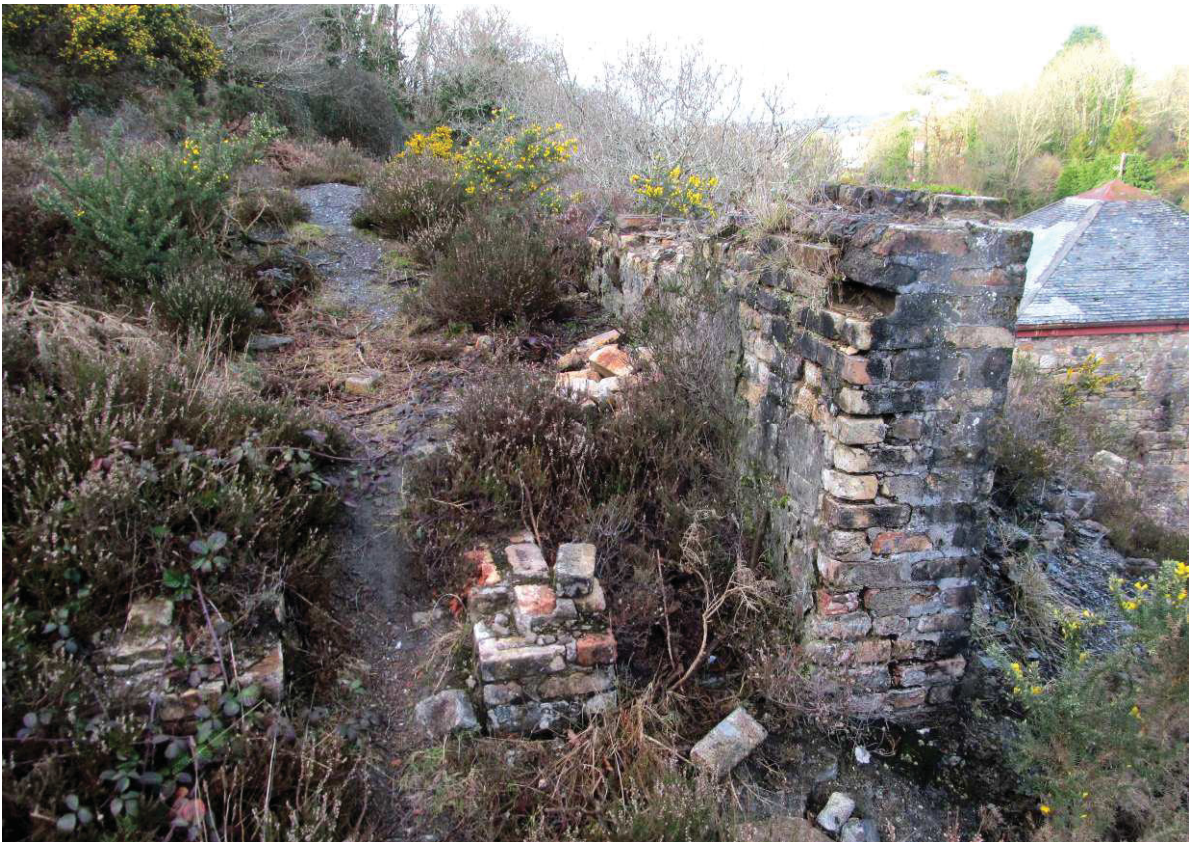
The calciner's flues, which rise up the slope behind the calciner, are in poor condition, the brick- and stone-work damaged and loose, the roofs of the flues collapsing in places (Fig 11). Although mainly covered in heathland-type vegetation, there was much invasive European Gorse and other scrub and fly-tipping from the Old Portreath Road. The flue runs under the road before heading for the chimney and some subsidence in the road at this point suggests that the flue beneath may be collapsing.

*Fig 11 Tolgus arsenic works: the damaged and collapsed brickwork of the flues*

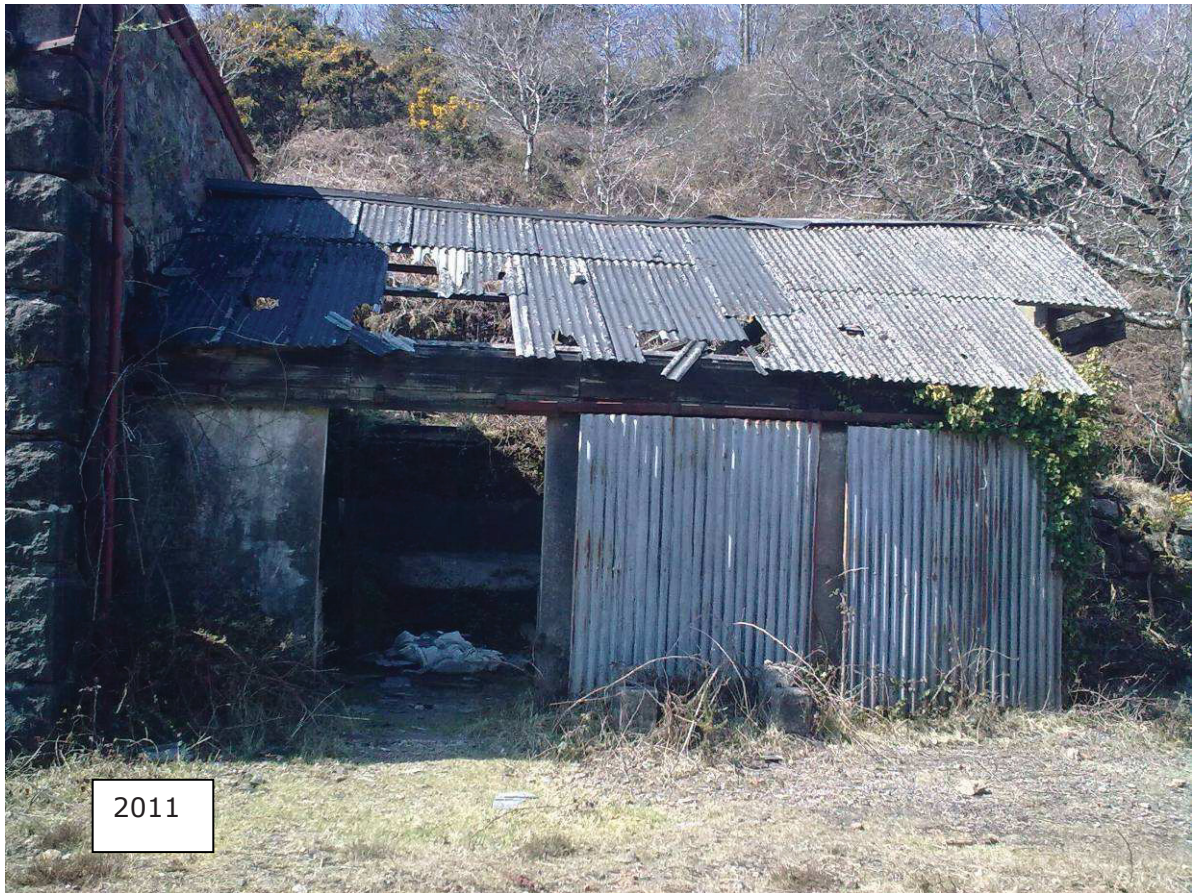
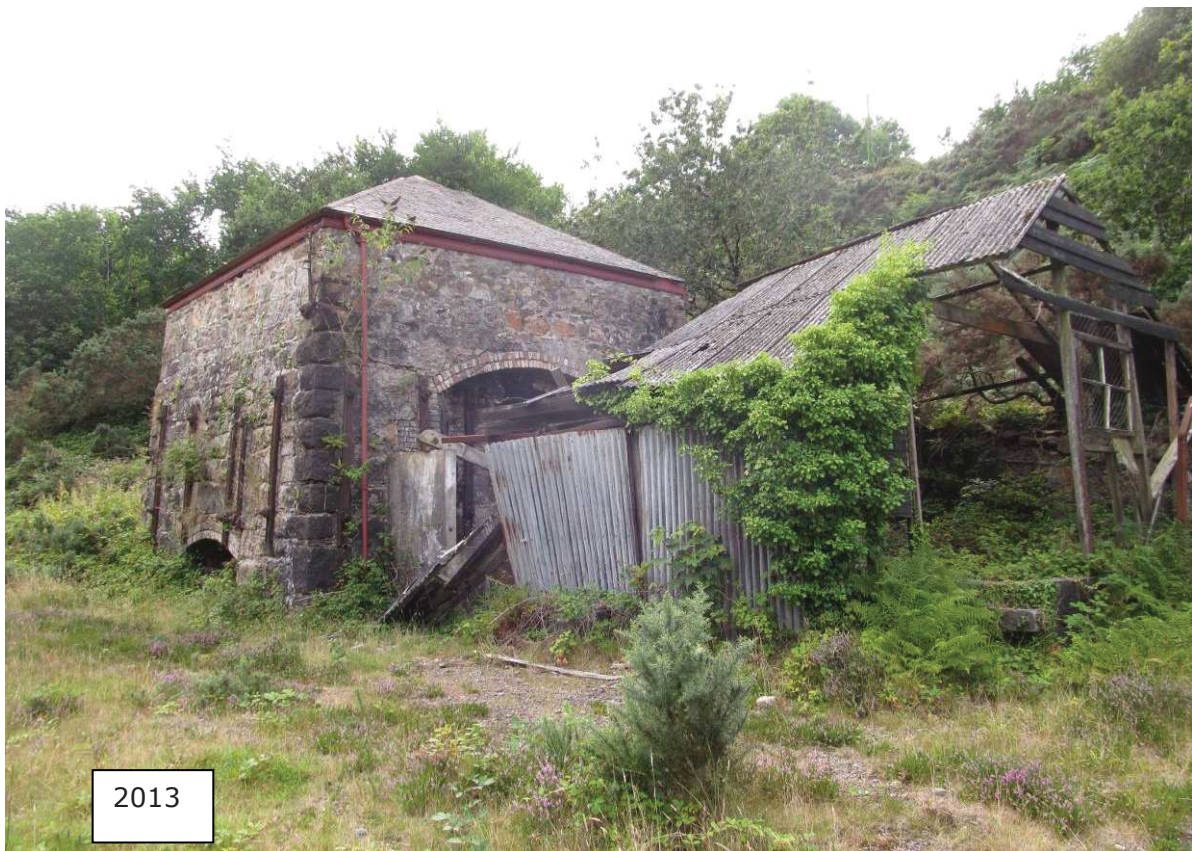
Following vandalism, the fuel store attached to the side of the building, a less solidly constructed structure of timber, concrete, galvanised iron and asbestos, was (and remains) in dangerous, half-collapsed condition (Figs 12 and 13), and as a result was subject to enforcement action. Because of its unsafe condition, temporary Heras fencing was erected some years ago; but this was stolen almost as soon as it had been put up (Melroy Youlton *pers comm*).

The survey of the remains of the building indicates that the majority of its superstructure has deteriorated to the point where it is incapable of salvage or repair. As this structure is an integral element of the Tolgus Calciner Scheduled Monument, its replacement has been proposed. However it should be noted that any work to remove the existing structure and build a replacement would require agreement with English Heritage and Scheduled Monument Consent.

*Fig 12 Tolgus arsenic works: the collapsing fuel store beside the calciner in 2011 (above) and 2013 (below)*

The timber elements of the building should be carefully dismantled, preferably using a small crane to avoid damage to the floor and blockwork walls, or to the calciner structure. Any surviving ironwork attached to the timbers should be recovered for reuse and its original locations noted and photographed. The corrugated steel sheet doors should be recovered and inspected to determine whether they are capable of re-use. No demolition should take place to the concrete walls forming the eastern elevation of the building, nor to the concrete base, stub walls and containment bins within the building.

The building should be re-constructed on a like-for-like basis using new or salvaged materials, the northern end of the building being reconstructed using appropriately-sized ship-lap timberwork on a studwork frame (as also the closer boards on the eastern and western elevations below the rooflines). Halved railway sleepers should be used for wallplates, and trusses and purlins should be fashioned from tanalised timber. Thought may need to be given to limiting the potential for the decay of the new western wallplate (the current example consists of a halved sleeper part buried in the ground surface) and a cast concrete strip may be an appropriate alternative at this location.

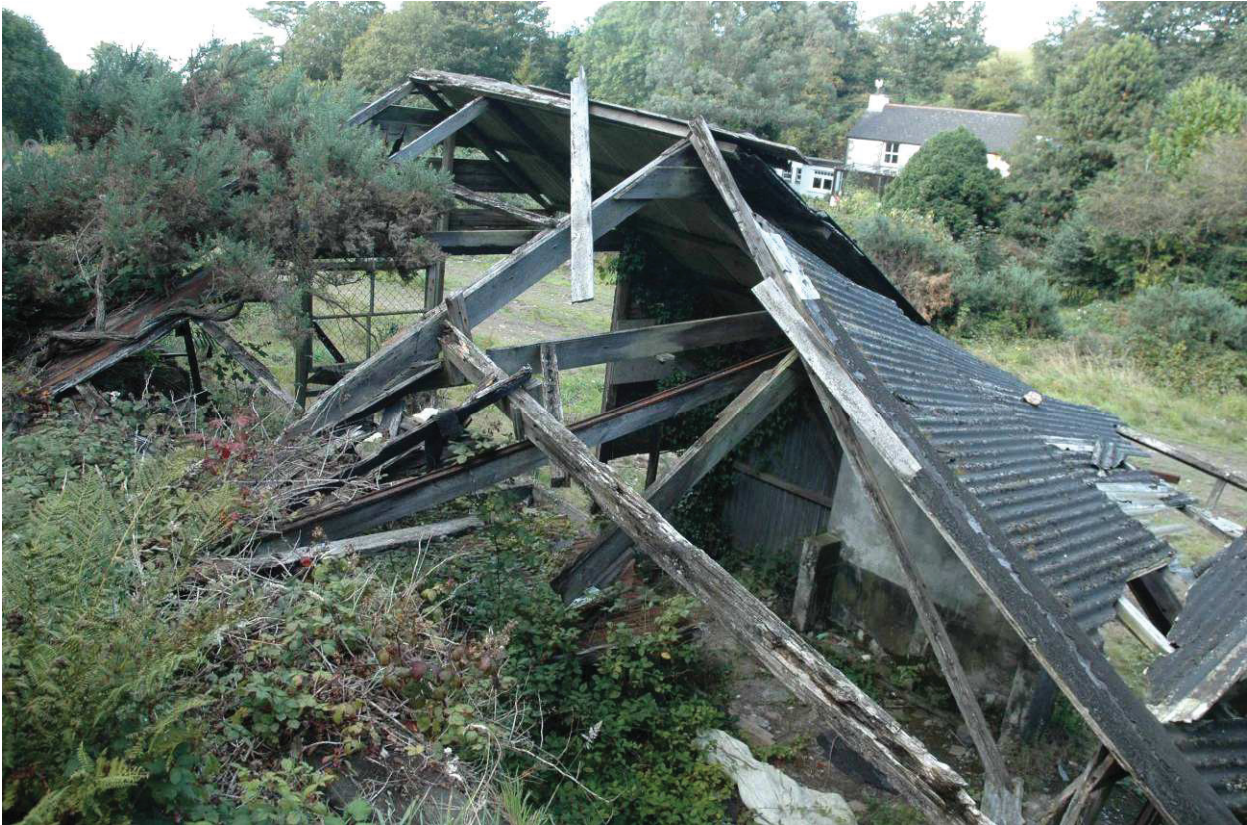
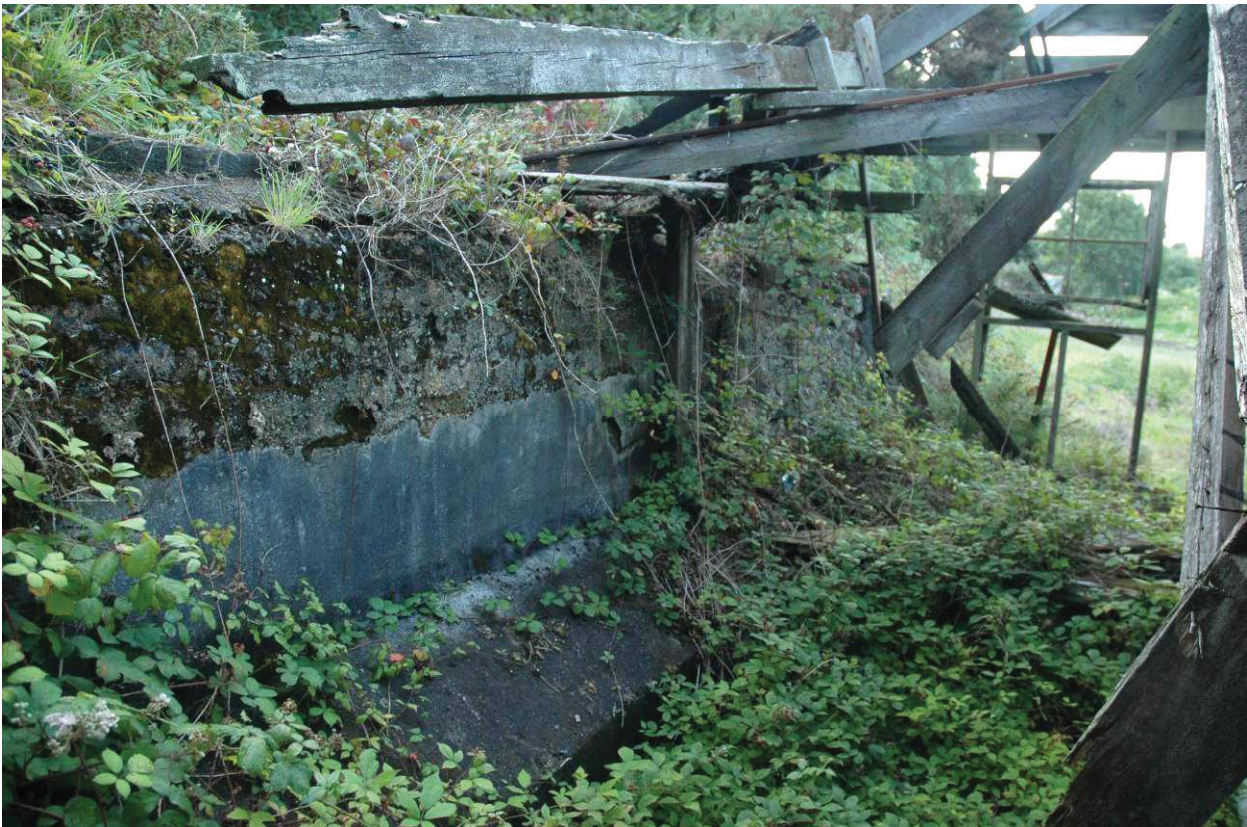
Fig 13 Tolgus arsenic works: the damaged roof of the fuel store (photos: John Gander)

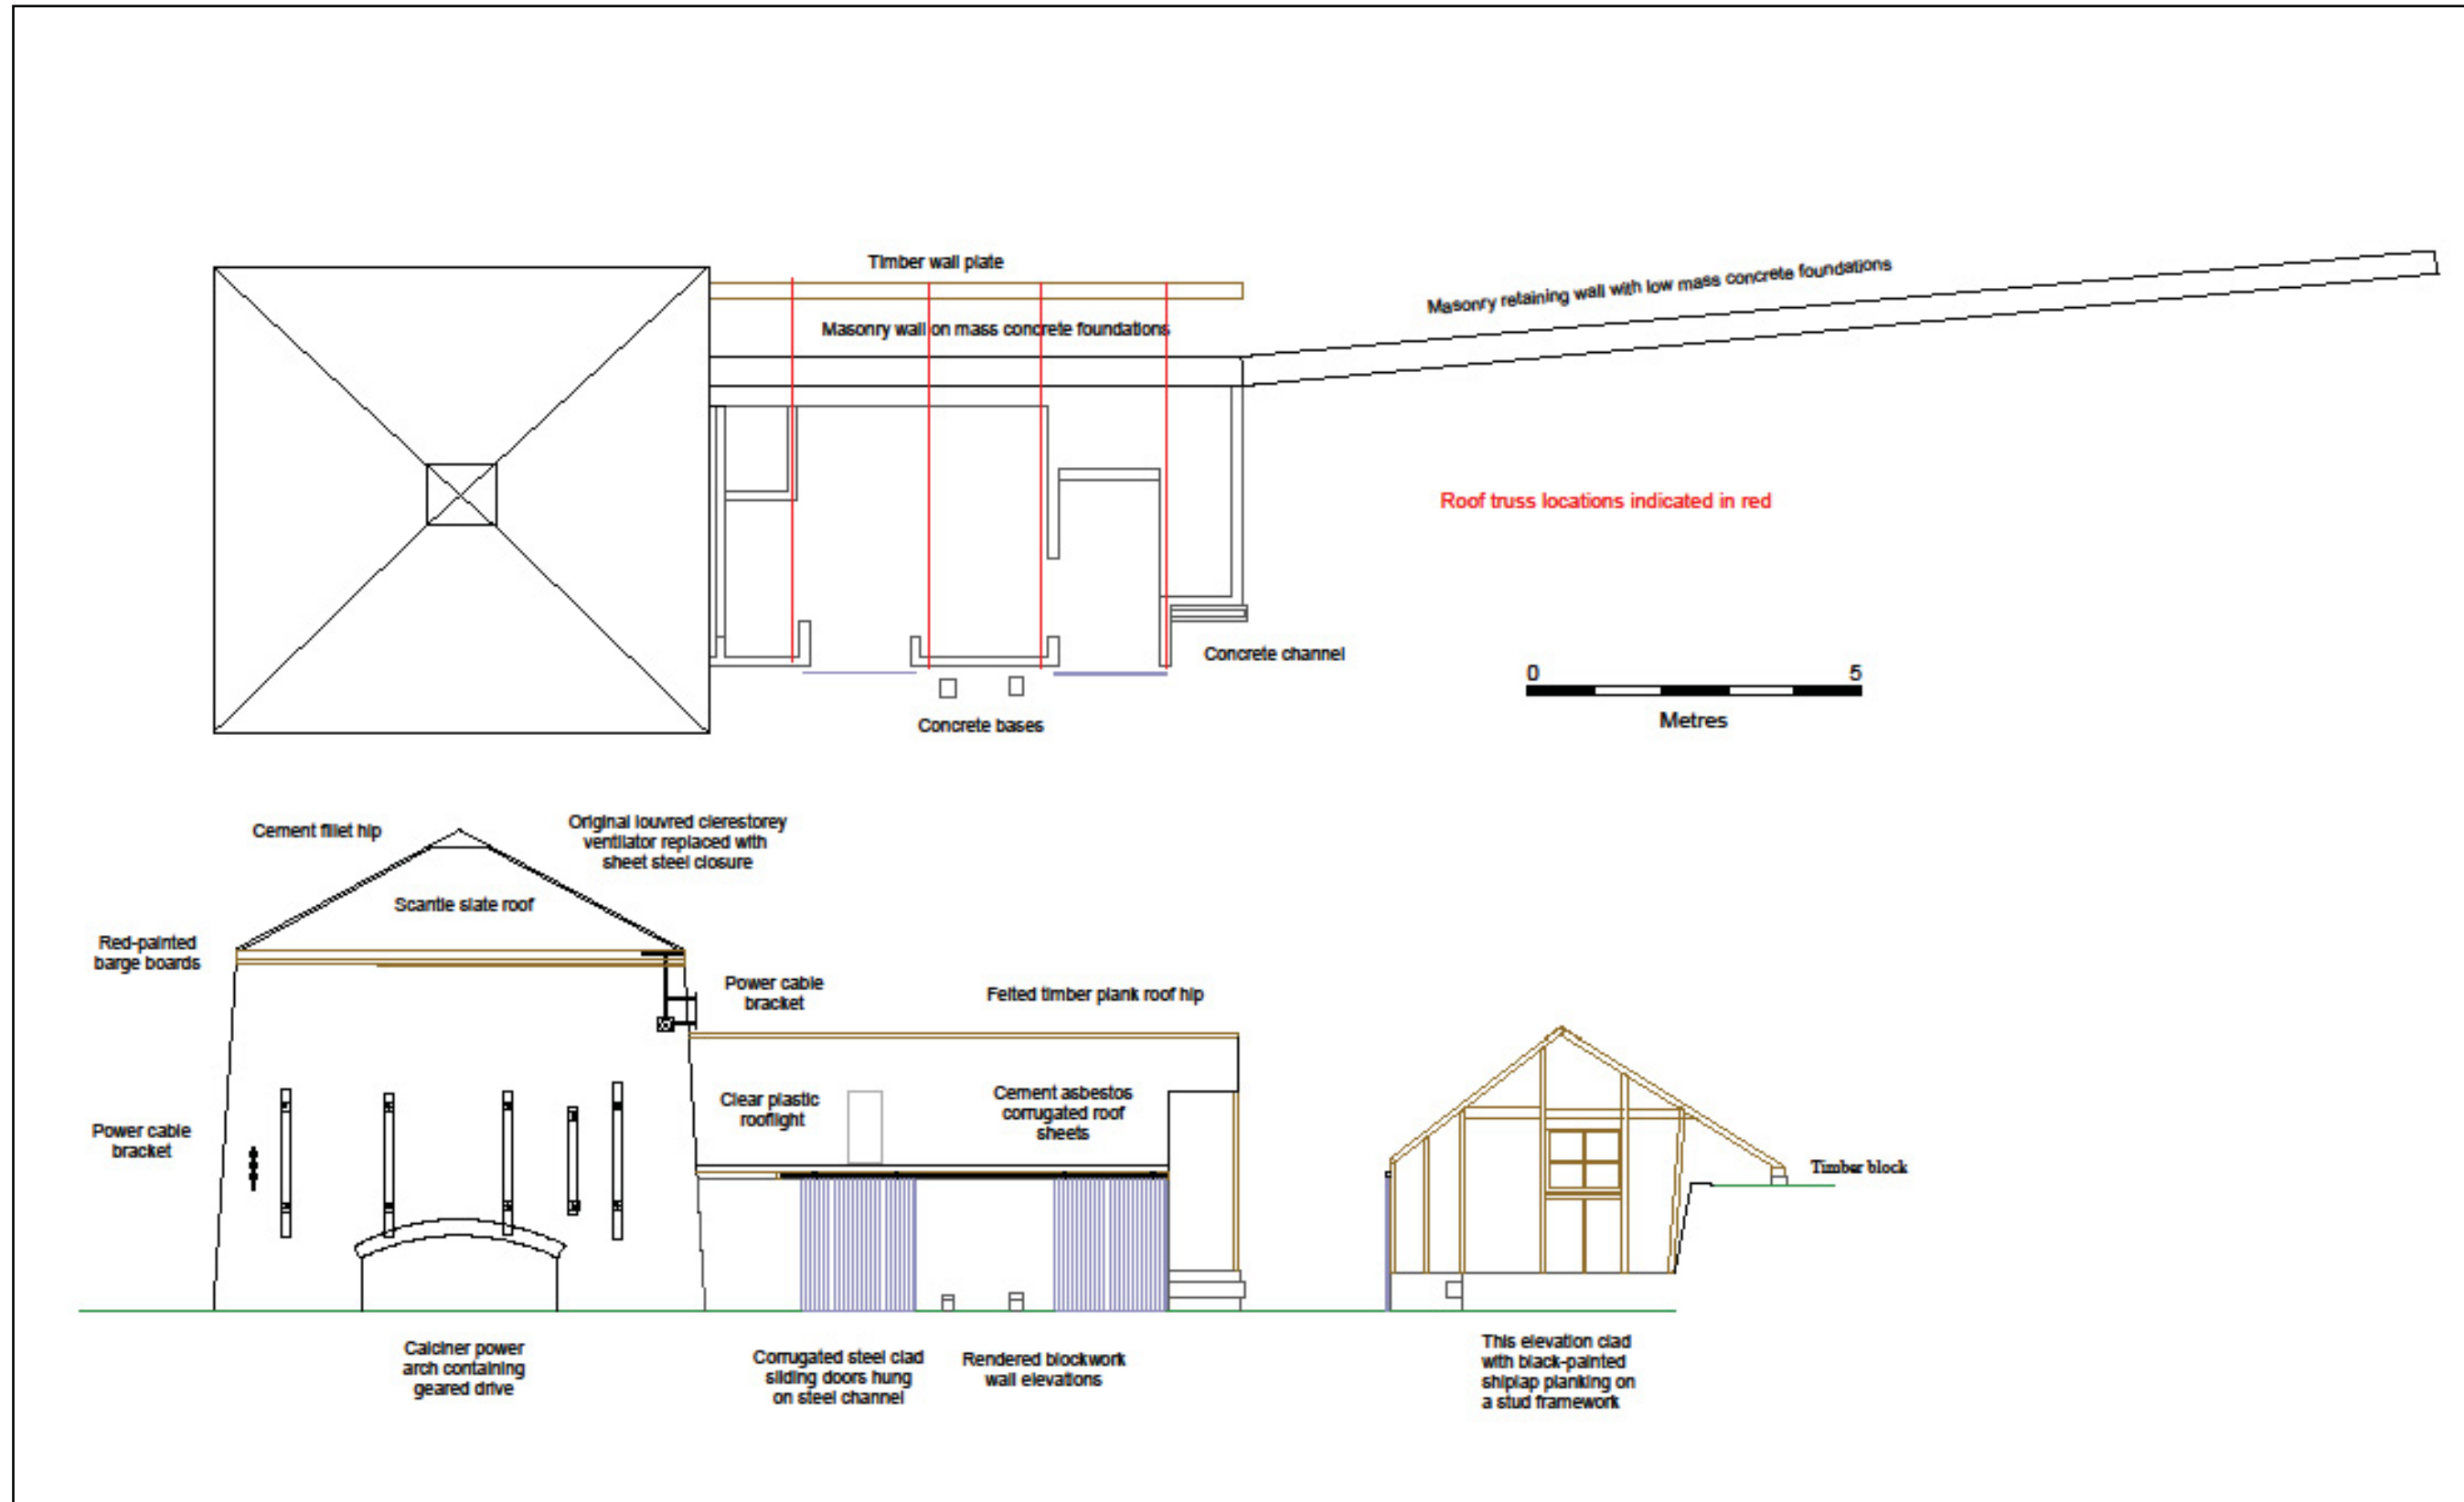
Fig 16 Plan of the calciner and shed/ fuel store, to aid reconstruction of the shed

The fuel store at Tolgus Arsenic Works is a shed of vernacular construction built against the northern elevation of the calciner (National Monument No 1021240) at SW 69018 43046 within the Scheduled area and covered by the designation. The building served as a coal store and shelter for the calciner operative, is of unknown construction date, probably incorporating parts of a building dating from the period when the calciner was first erected on this site in 1933, though clearly much modified and patched during its lifetime. The works here operated until at least 1945, though was subsequently abandoned (the date when this occurred is not known). The building measures 7.95m long x 4.45m wide in plan, though its roof spanned an area 5.83m wide, extending to the west to cover part of the adjacent revetted bank next to the access track on this side. The roof is gabled and stands to 4.24m high, with an eaves height of 2.0m.
