Glasney College, Penryn, Cornwall

Report of conservation management work

Client	English Heritage, Cornwall Heritage Trust
Report Number	2014R012
Date	July 2014
Status	Final
Report author(s)	Ann Preston-Jones
Checked by	Jacky Nowakowski
Approved by	Andrew Young

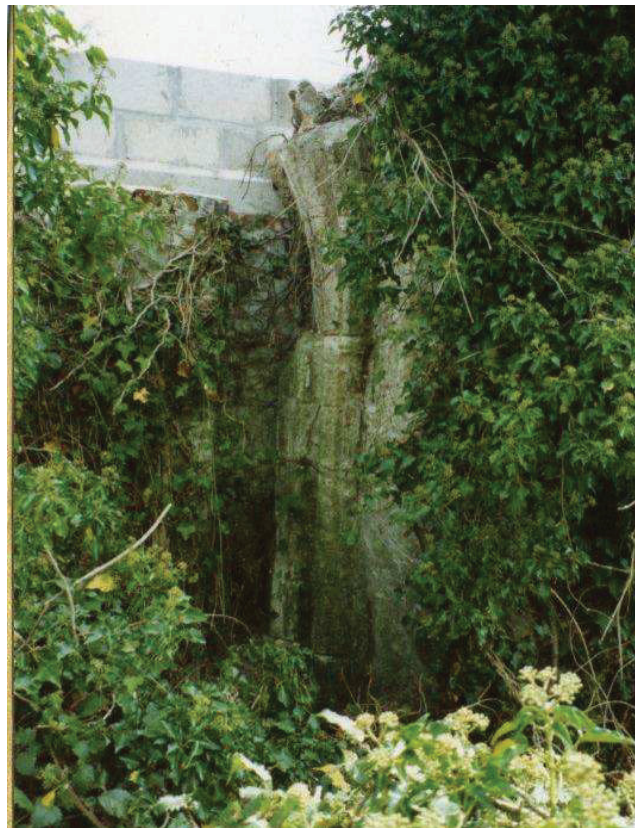
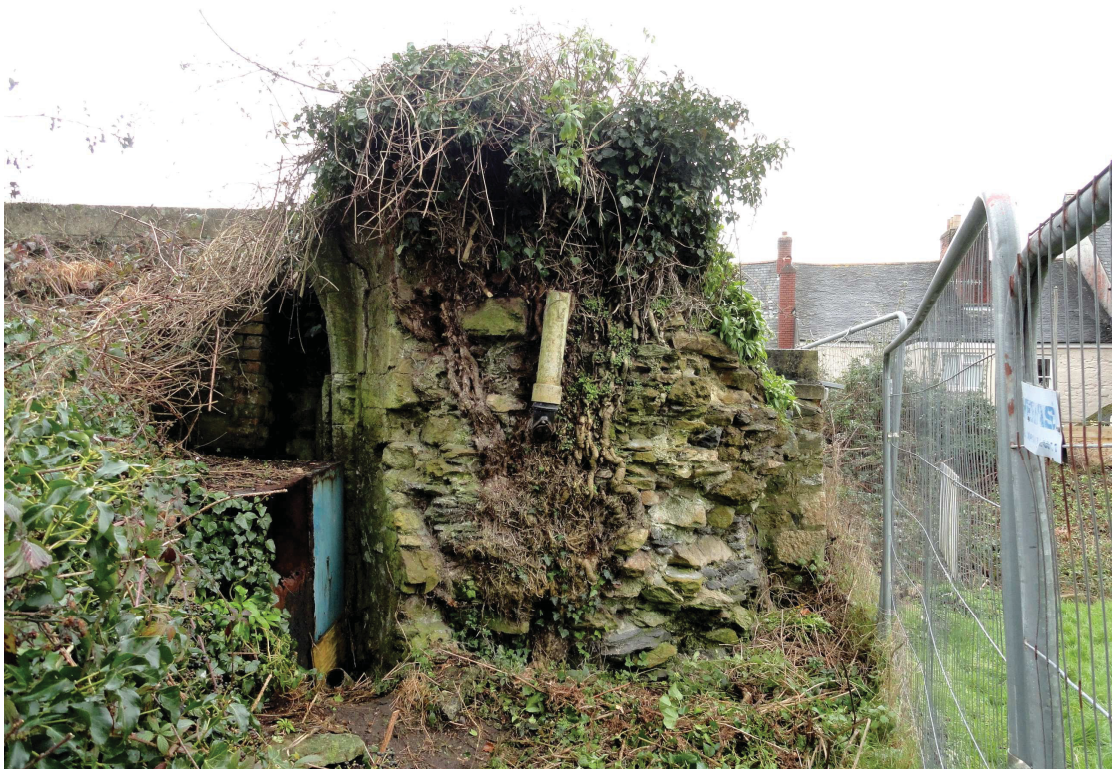
The fragment of upstanding stonework which was the focus of this project had been long neglected and was in very poor condition. The main problem was vegetation growth, particularly ivy, and it was not until work started on consolidation of the ruin that the full extent of the damage and threat associated with the uncontrolled growth of this plant became apparent (see below, 11-12 and Fig 12). Over the last two decades, occasional attempts had been made to clear and manage the vegetation but as this had the effect of making access easier to adjacent Bohl's Yard, the wall was always allowed to grow over again (Figs 8 and 9).

Fig 8 Photos showing the condition of the wall before conservation work. Above in 1987, courtesy of Barry Searle; below, in 2011 from behind the Heras security fence. The old oil tanks are visible on the left, and the security fence separating the wall from the playing field is on the right. In the centre, the stove pipe can be seen emerging from the wall, which has a thick thatch of ivy

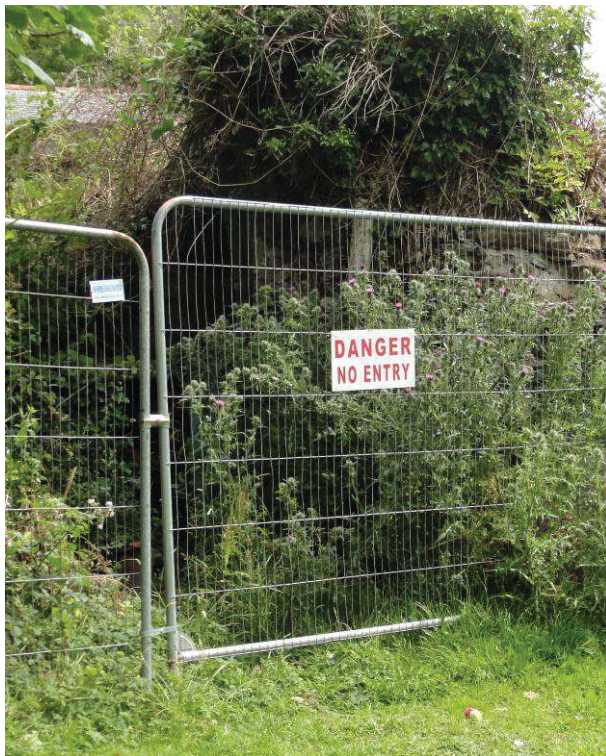
The wall behind the security fence and hidden by ivy

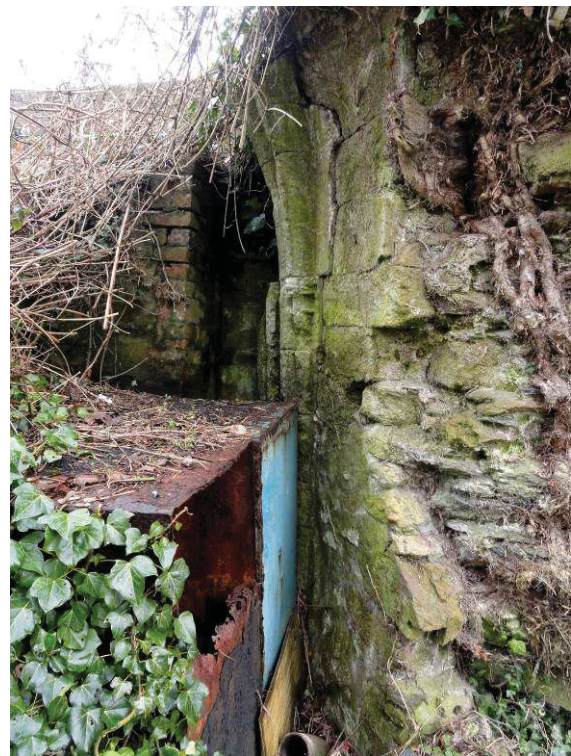
The wall with the oil tank to the left

Crack in masonry resulting from ivy growth

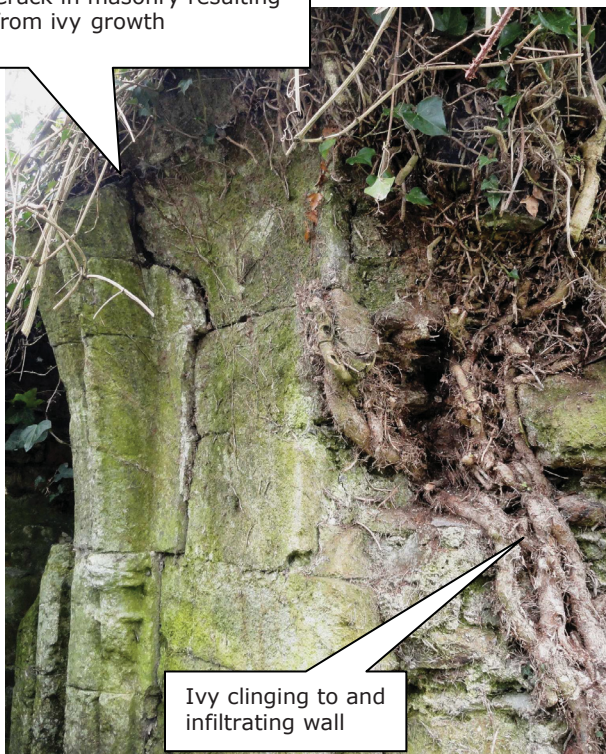
Ivy clinging to and infiltrating wall

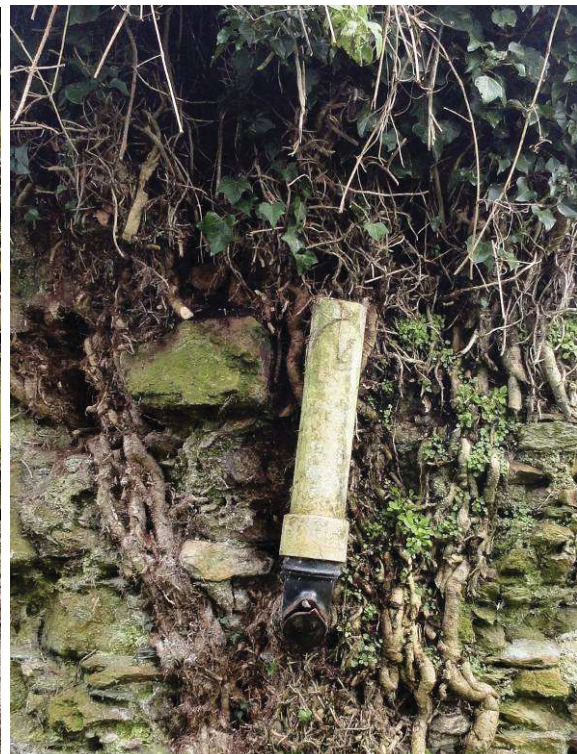
- This block of masonry has suffered from a lack of maintenance and much of the stonework is overgrown with and penetrated by ivy
- Some of the stonework is cracked and loose as a result of root penetration, notably near the top of the window arch
- Because of illegal access and security issues between the playing field and the property to the north, vegetation is in fact encouraged, old oil tanks and more recently a Heras security fence, have been positioned to help prevent access. This of course makes maintenance more difficult
- As a result of the former use of the structure as the gable wall of a cottage and later workshop, the pipe of an old stove emerges through the wall and has provided a route for the penetration of ivy

The carved window arch, showing cracking due to ivy penetration and (right) the stove pipe emerging from a putlog hole. Both also show the extent of ivy roots on the wall

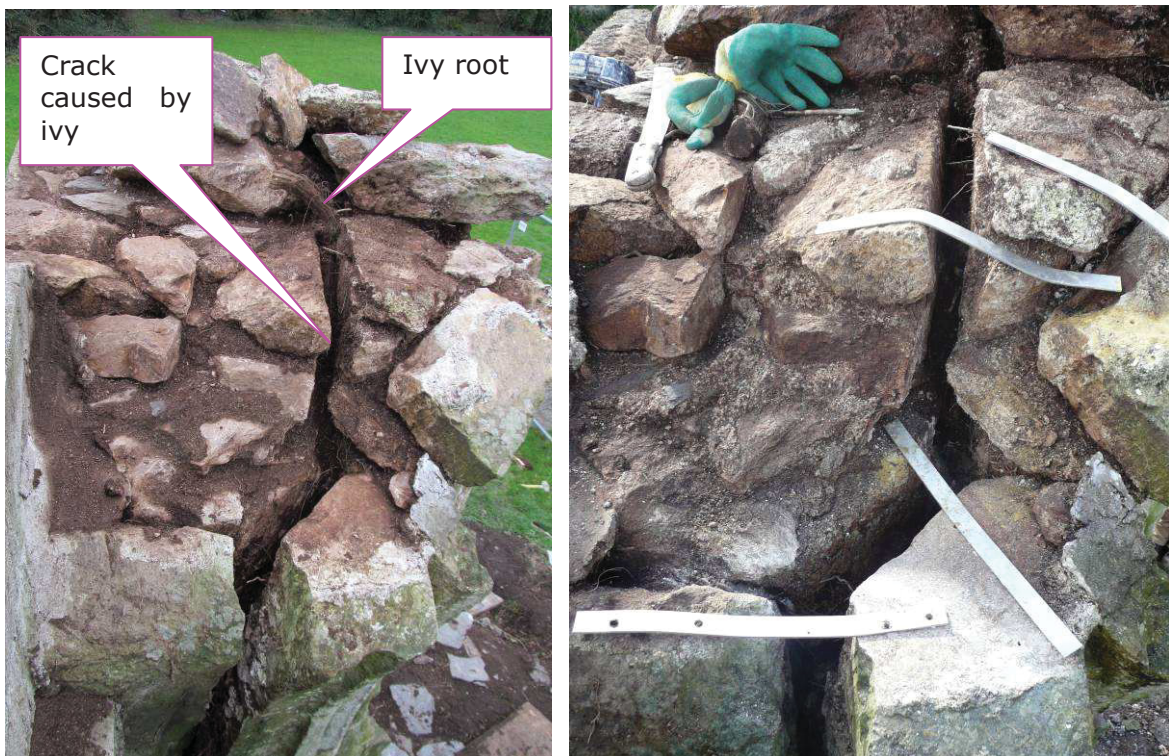
Removal of the wall capping revealed the full extent of damage done to the wall by the ivy which had covered it for many decades. An extremely alarming crack was found, where the ivy had forced apart the stonework. The stem of ivy had grown to more than 10cm across and literally split the wall in two, resulting in the massive crack seen in Figure 12 (below). The growth emerged in two main places, on top of the wall, and

This work has confirmed how urgent the need to repair the wall was. It has also demonstrated the enormous potential of ivy to damage historic fabric. Ironically, it is actually a possibility in this case, that the ivy had been deliberately planted to enhance the ruin!

Fig 12 On the left, the crack caused by ivy and on the right the strapping fixed to stop any further movement of the crack. The crack was filled with stone and mortar and a wall capping was then built over this to hide the strapping and help shed water from the wall-top

In summary, the work involved clearance of remaining ivy, other vegetation and loose stone, use of stainless steel straps to fix unstable dressed stones, and to secure a massive crack, whose presence appears to have been the result of ivy penetration. Any ivy that proved impossible to remove was treated with weedkiller. Selective repointing was carried out to secure and protect the stonework and a stone capping constructed to protect the top of the wall. The dressed Beer stone of the window was cleaned using water in hand sprays and soft brushes.

Wednesday 13th. *The weather was milder and we began by fixing stainless steel straps to the dressed stone. We fixed the stones which had been pushed out by the ivy to large, solid stones further in towards the middle of the ruin. All this was done at the top of the ruin so it will not be seen from below. We used stainless steel strips 3mm thick and 25mm wide, varying lengths, these were fixed with anchor bolts drilled into the stone. After this work the dressed stones felt solid, there was no movement on the smaller pieces at the top (Fig 12).*

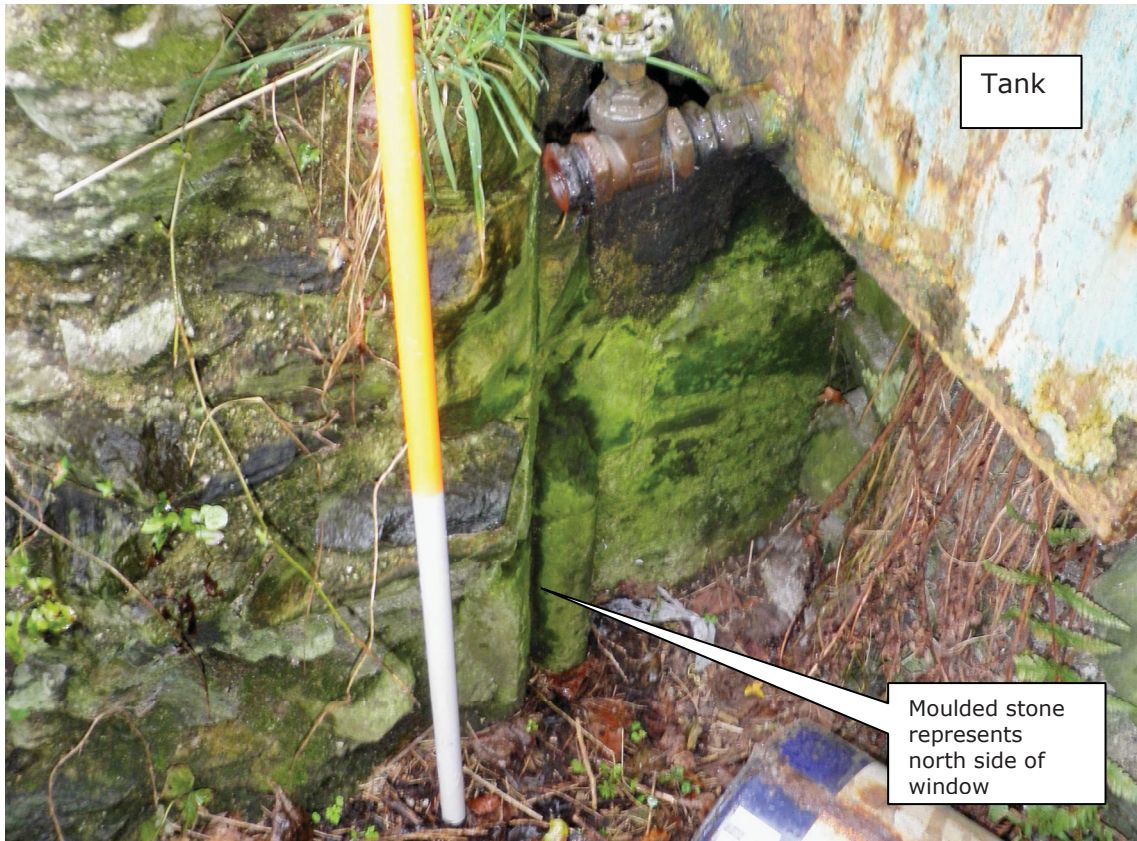
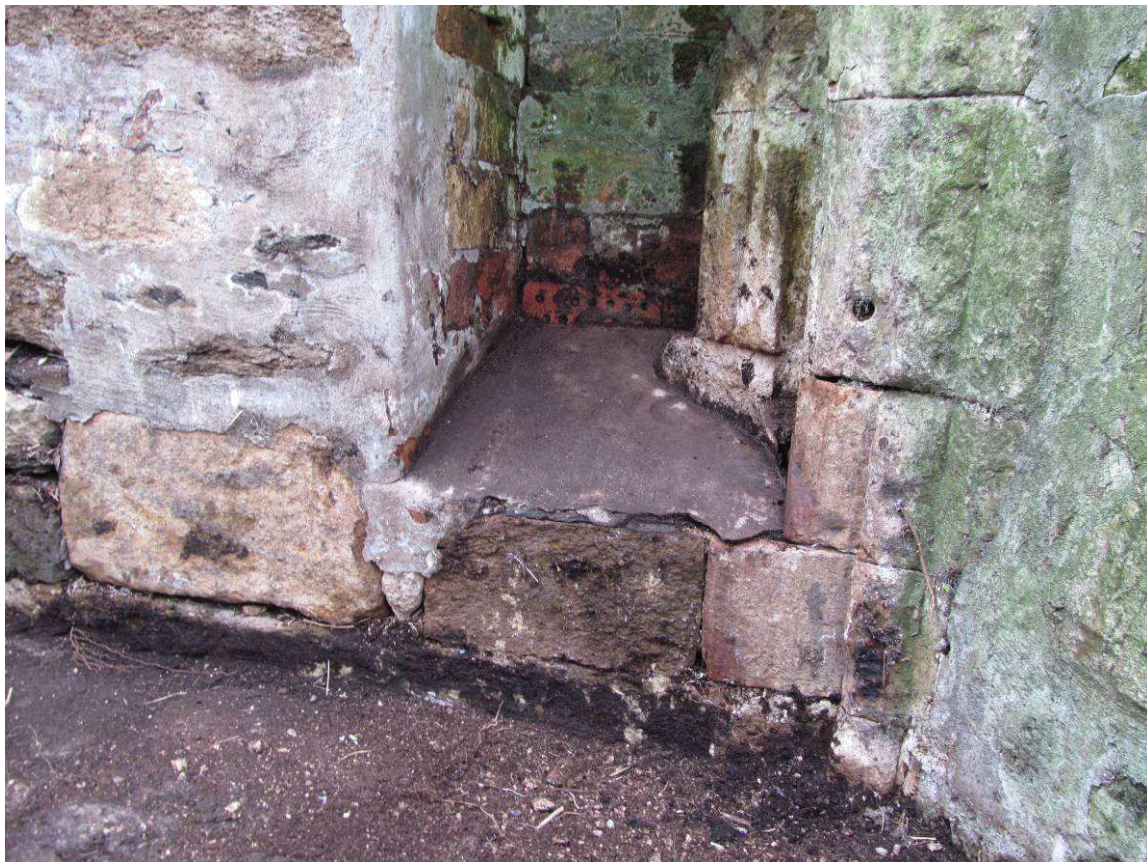
Fig 13 Above: detail of north side of window, in Bohl's Yard, beside the oil tank which has now been removed; and below: detail of the sill, also in Bohl's Yard, before removal of concrete

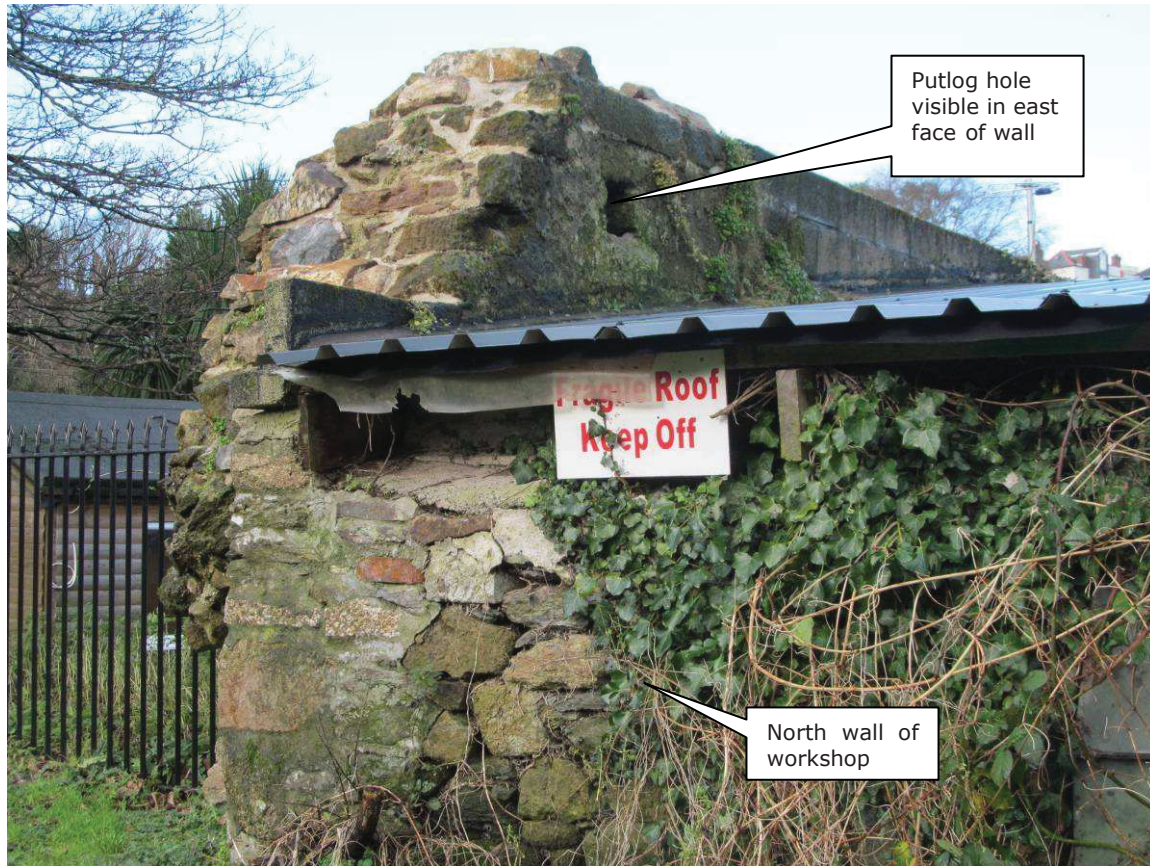
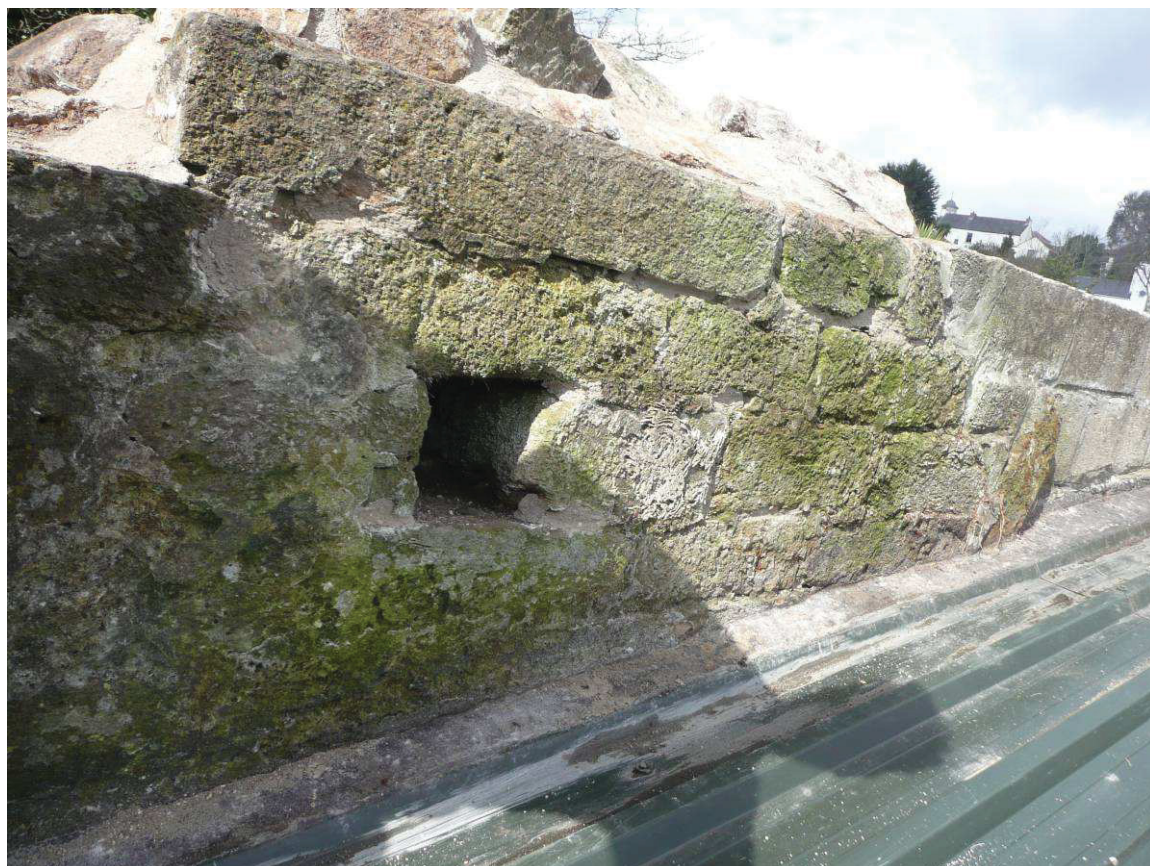
Fig 14 The east face of the wall visible above the workshop roof, with external ashlar face extant and putlog hole visible

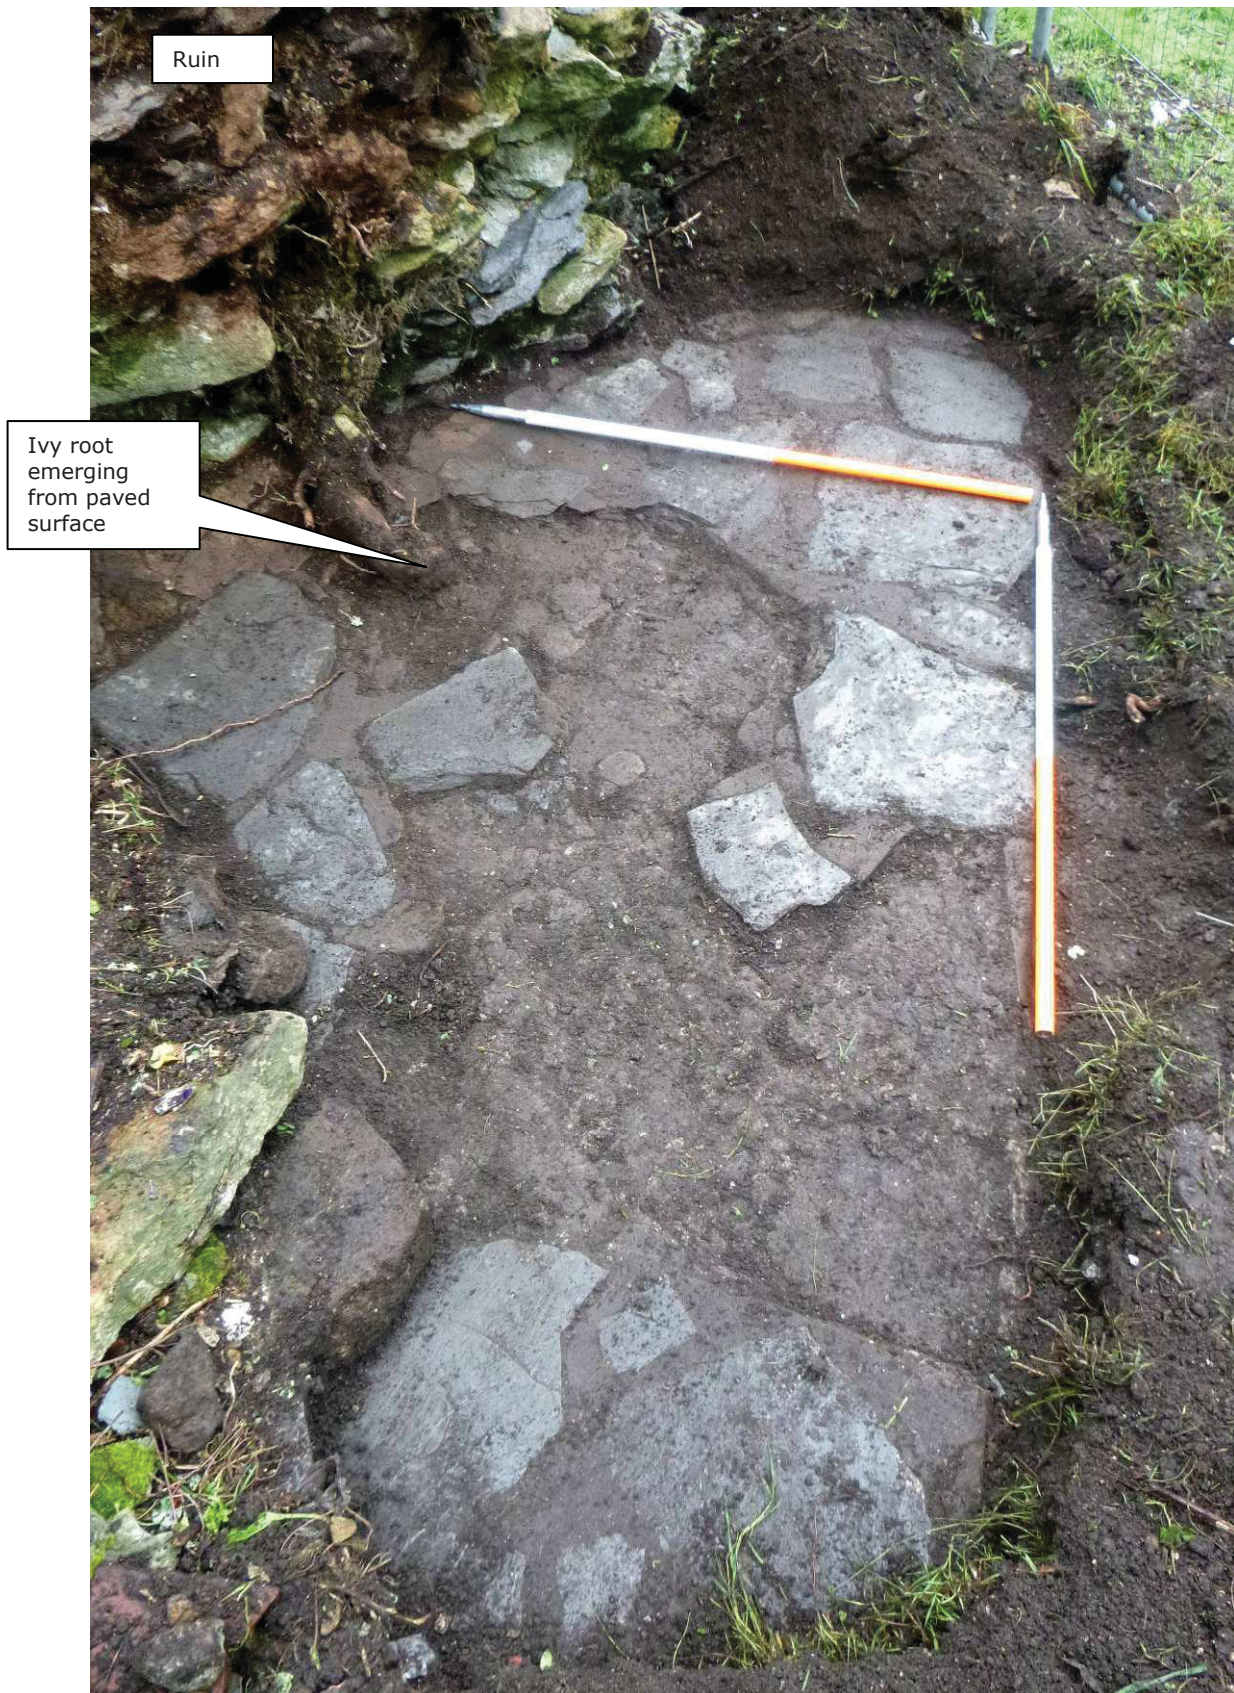
In the event, the excavation came down very rapidly onto a paved surface. This was hidden beneath a humic layer of decayed vegetation and modern rubble, approximately 20cm thick. Within this layer were also found a mixture of artefacts including an Edward VII (1901-10) halfpenny, blue and white china, bits of glass (including some very thick plate glass, possibly from a shop window), batteries, and a spark plug. The paved surface consisted of large irregularly-shaped slabs of slate, set in a cement mortar and bedded on a concrete footing up to 10cm thick. One possible medieval carved stone was incorporated into the sub-base. The surface was damaged in the middle of the exposed area, with slates missing, but at either end was better preserved (that is, at the SW and NE ends). The trench was widened beyond the original one metre square to 2.5 to 1.6m in order to gain more information. Widening the trench revealed that the surface extended right up to the base of the ruin, and had an edge set at an angle to the orientation of the church, that is SW - NE. As the feature is built with cement, it is assumed to be relatively modern, and possibly post 1907, as there is nothing to suggest its presence on the second edition Ordnance Survey map (Fig 4); but as it had long been covered with plant material and stones dumped on the edge of the field, must date back several decades.

Fig 15 Hand excavation for a post-hole for the new fence at the foot of the ruin revealed a paved surface. The large ivy root can be seen emerging through the paving at the foot of the ruin

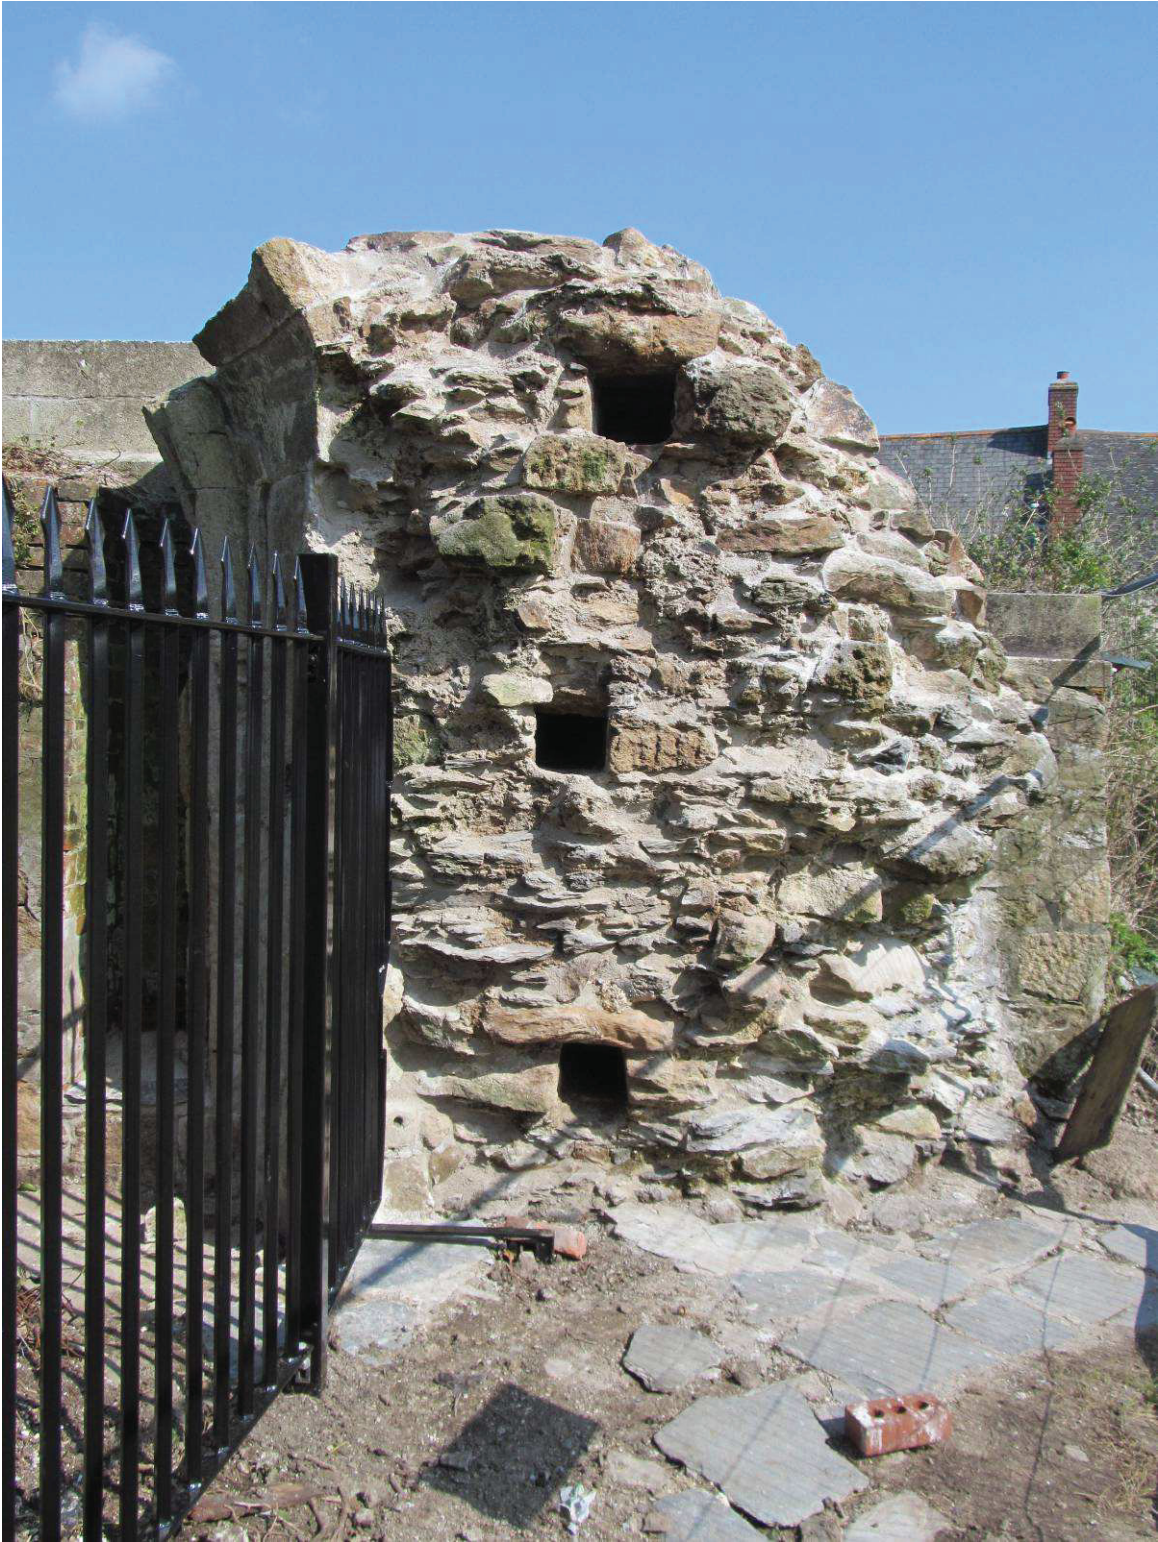
Fig 18 The almost completed project. The slate plinth can be seen at the base of the wall. This has now been covered over to protect it.

It was decided that although not ancient, this plinth represented a phase in the history of the site and should be preserved if at all possible. However, given that the original purpose of the 'dig' had been to locate a suitable hole for a fence post, this posed problems on where to locate the post-hole. Eventually, it was decided to excavate further in the hole from which the ivy was emerging, as the existence of the ivy here was considered likely to have caused disturbance to any below-ground archaeology in the area.
