Trelowarren Double Lodges, near Helston, Cornwall

Historic building survey and assessments

Client	PDP Green Consulting Ltd
Report Number	2015R007
Date	May 2015
Status	Final (Revision A) – Appendices revised since Jan’15 issue
Report author(s)	Jo Sturgess (with assistance from Matt Terrell of pdp Green Consulting)
Checked by	Nigel Thomas
Approved by	Andy Jones

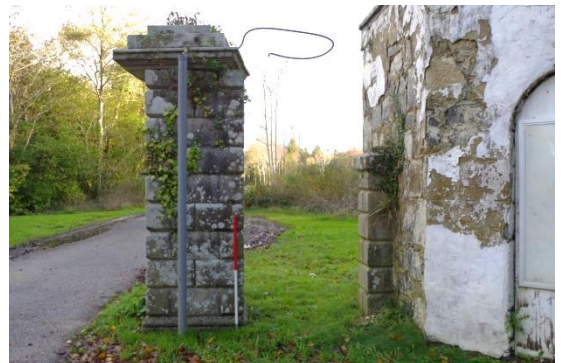
Fig 39 South-west elevation of free-standing gate pier.

The existing gate piers are most probably an early 19th century insertion. The top of the remaining, large, free-standing pier has undergone damage causing the upper stonework to become dislodged and the finial shown on an early photograph is now missing. A distorted iron bar is attached to the upper courses which may once have supported a lamp over the pedestrian gate. It is suggested that the upper courses are reinstated to their original positions and secured.

Note the dislodged coping stones.

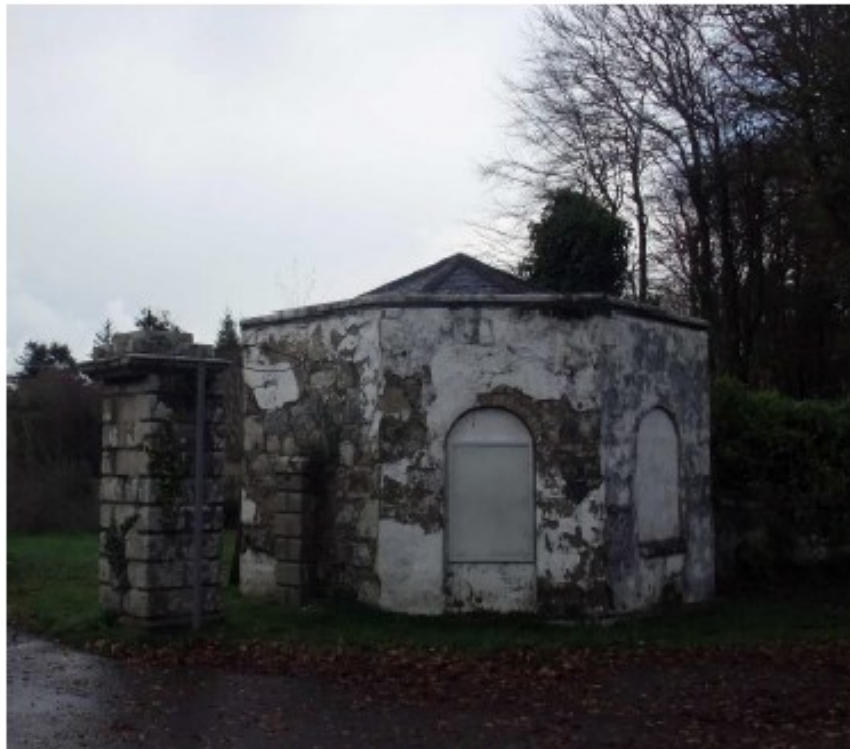
Figure 1. Southern Lodge

1. The southern lodge appears to have suffered the most damage and the roof timbers are almost all saturated to the extent that the roofing felt had become brittle and easily crumbles. Although the roof was extremely wet and offered little opportunities for use by bats there were areas suitable for use by bats, such as gaps behind plaster and the chimney flue leading into a brick built chimney. A careful and thorough search of all areas within the lodge was undertaken; no evidence of use by bats was noted within this lodge at the time of this assessment.

Although no current evidence of roosting bats was found within the southern lodge it cannot be assumed that bats are not present when works commence. Care should therefore be taken during the work as bats could roost unseen deep within crevices in the structure, particularly under ridge tiles, beneath wall plates, or between or above lintels. If any bats are discovered during the work they must not be handled: works must stop immediately and advice sought from CEC (tel 01872 245510).

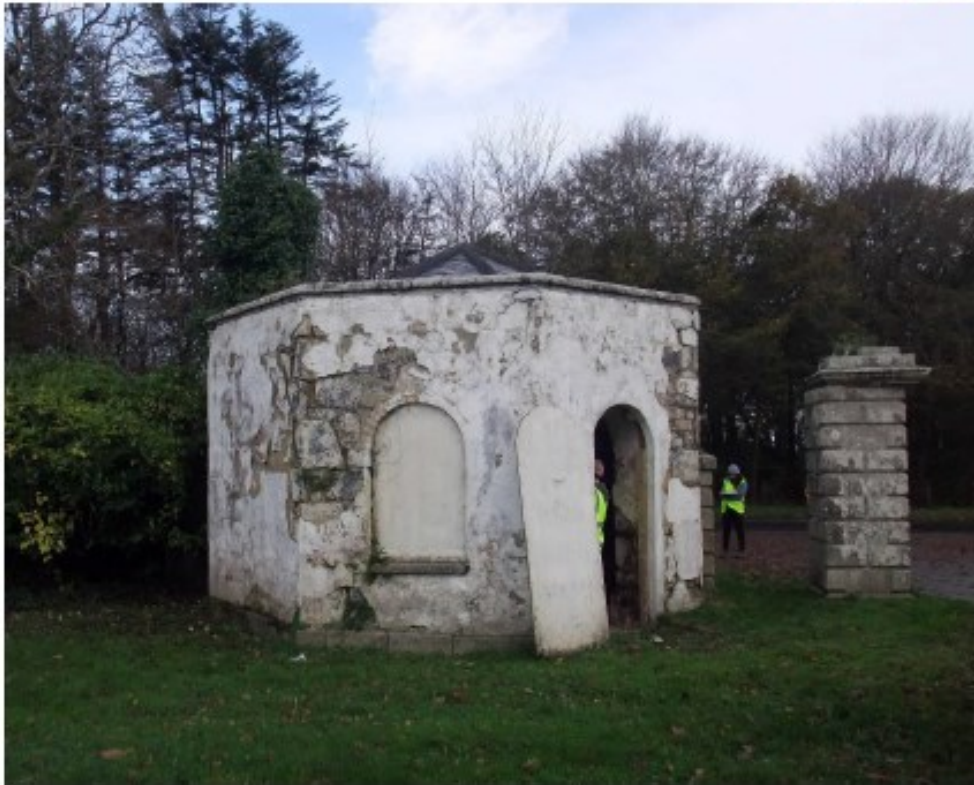
Figure 2. Northern Lodge

2. The northern lodge is in a similar state of repair as the southern lodge but also has a small hole within the roof where several slates have slipped or been removed. The interior of the building also has an open fire place with chimney flue leading onto a brick built chimney, which were inspected using an endoscope and torch. The tops of walls within this lodge also provide a relatively dry, dark feature which offers some potential for use by bats. No evidence of use was found within these features. Within one of the boarded windows, a large number of old moth and butterfly wings, together with droppings (<5) from use by long-eared bats, was found close to the window ledge. The evidence found suggests that long-eared bats have in the past gained access into the building and utilised the interior as a night/feeding roost. The missing roofing slates may continue to offer entry into the building but the number of droppings found and old moth/butterfly wings suggests that this is not the case.

As evidence of bats has been found within the northern lodge access will need to be provided as part of any planned works to the building, and should take the form of a 'letter box' type with a minimum of 150mm x 50mm gap.

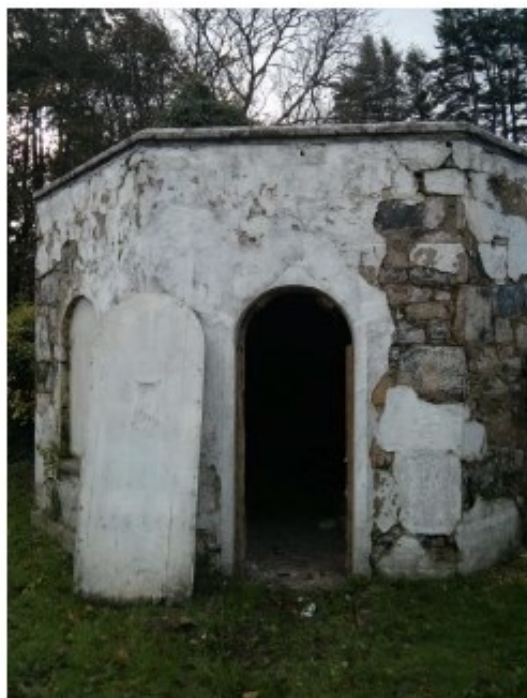
- 4.1 The external elevations of the lodge were found to be free of significant defects. There was some crazing to the render in areas around windows and doors but none was considered to be structurally significant. There were no signs of any crack patterns that could be considered related to structural movement within the bearing strata below the foundations. (Plate 1).

Plate 1: General view of entrance elevation showing missing sections of render.

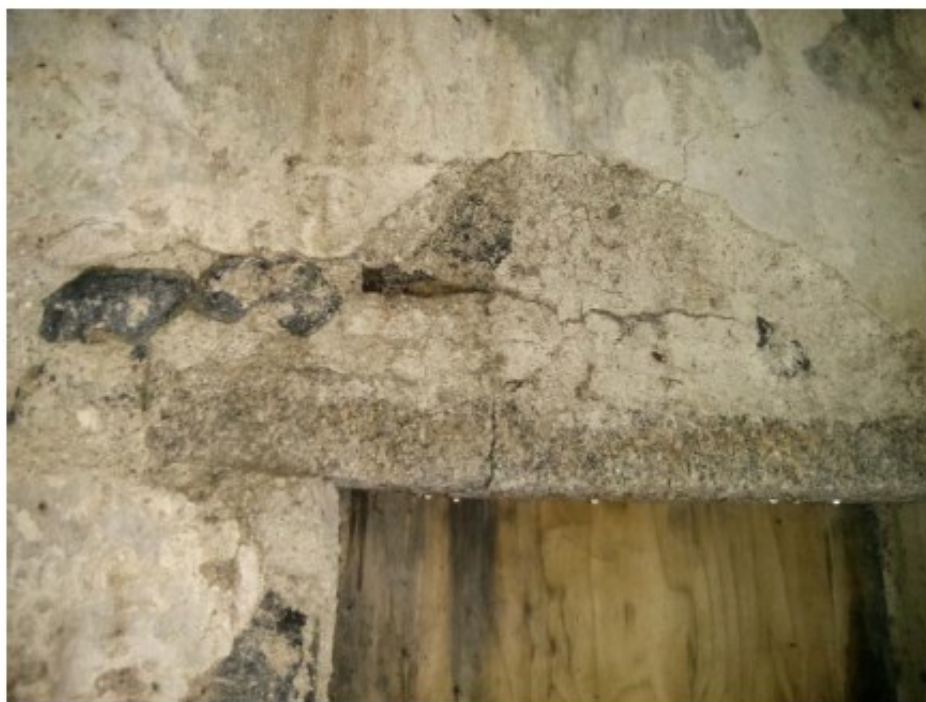
Plate 2: Crack to underside of granite lintel.

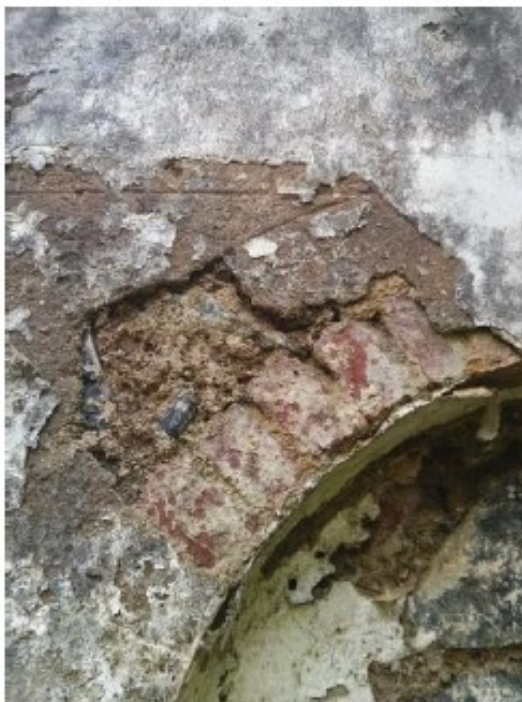
Plate 3: Exposed brickwork to arch, note incised lines in render.

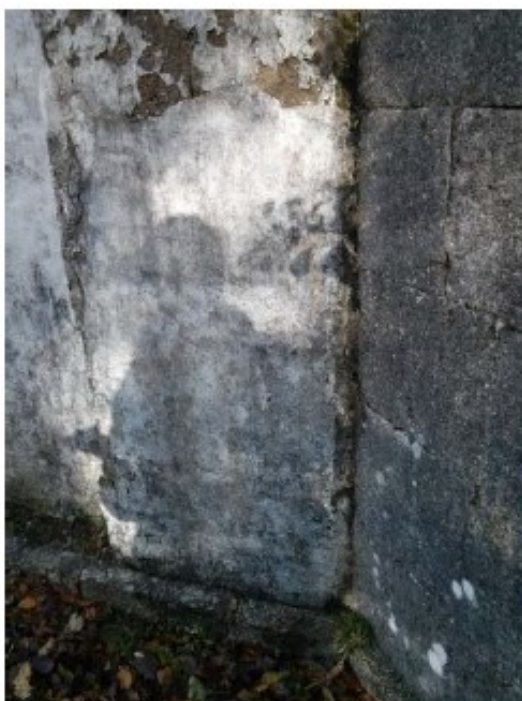
Plate 4: Granite plinth to base of wall, note junction with flanking wall.

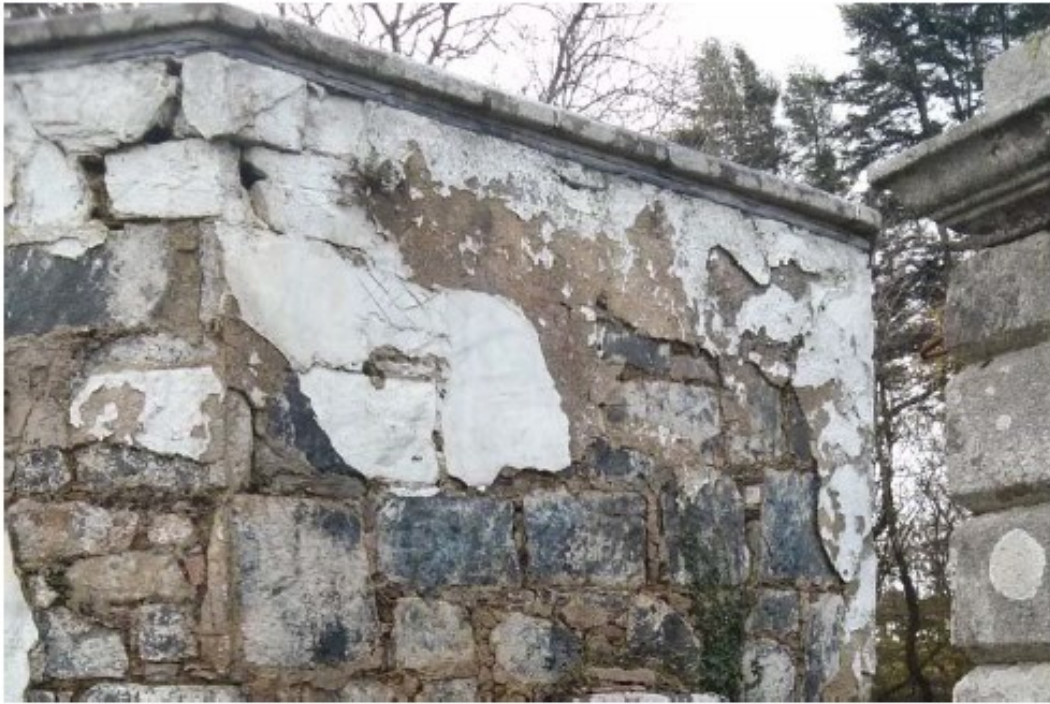
Plate 5: Displaced stone at parapet level. Note large areas of missing render.

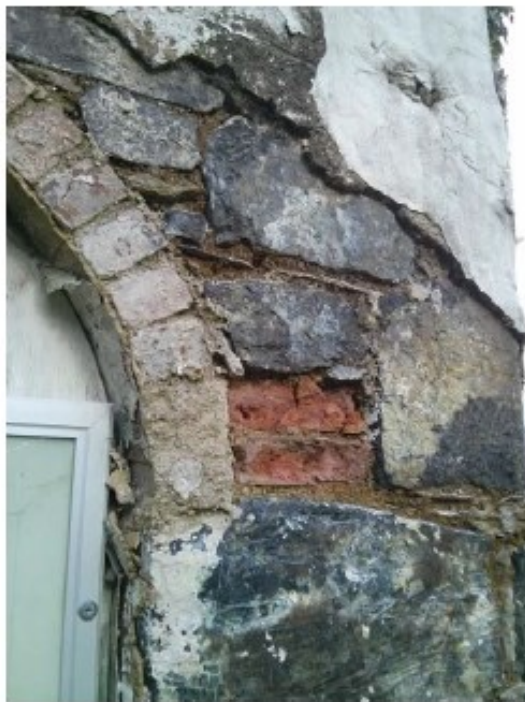
Plate 6: Damage to brick arch and missing render.

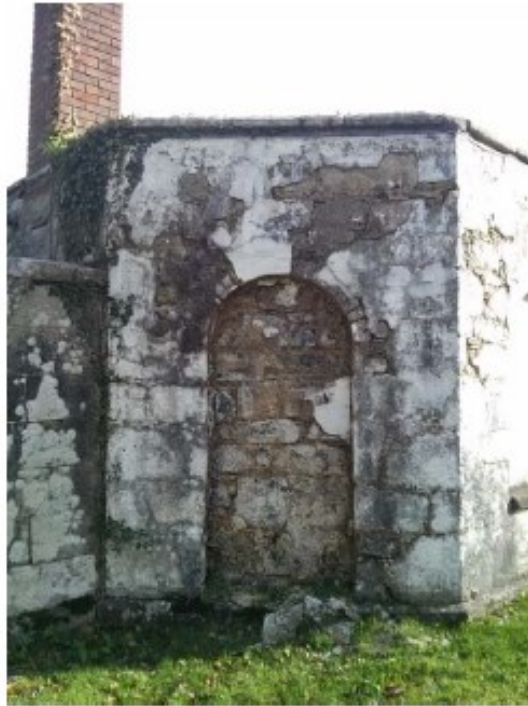
Plate 7: Fallen areas of render, note ivy growth at eaves.

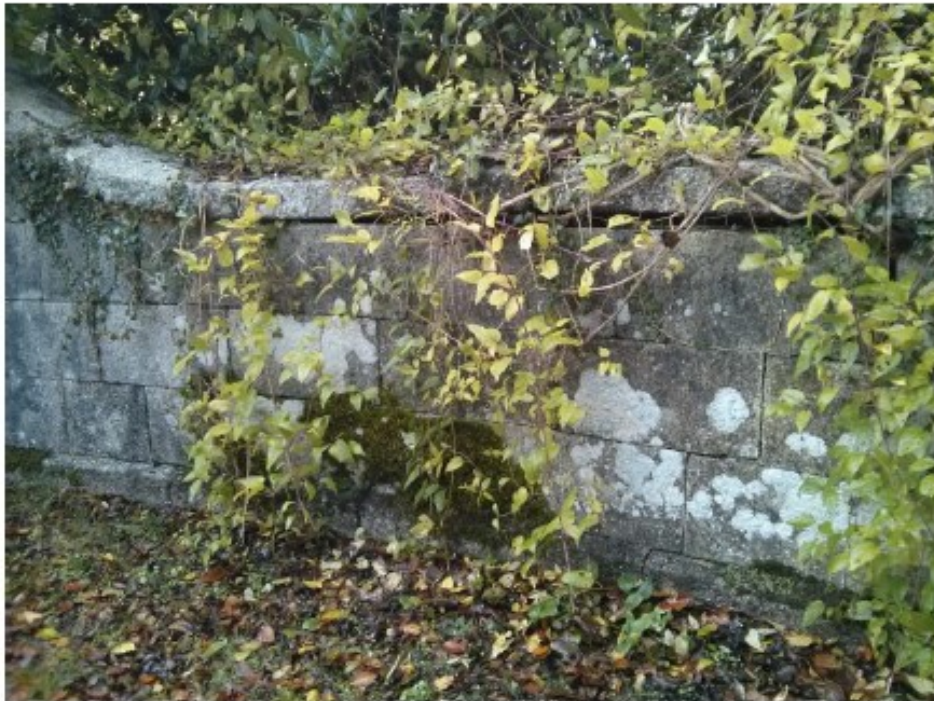
Plate 8: Displaced coping stones.

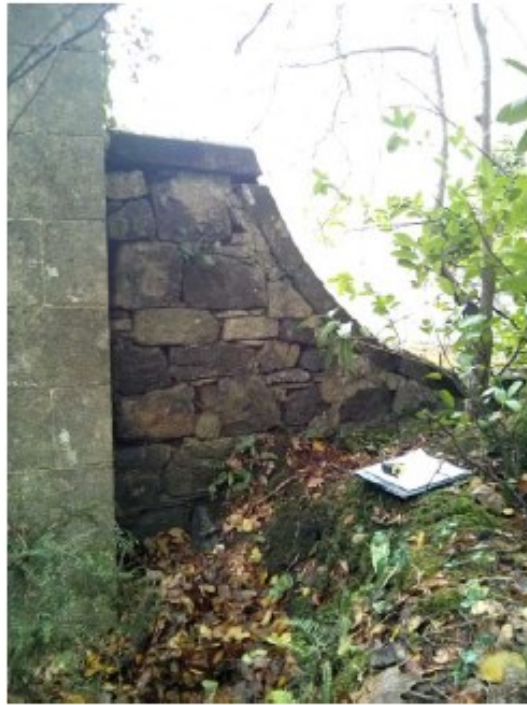
Plate 9: Mortar loss to wall adjacent to terminal pier.

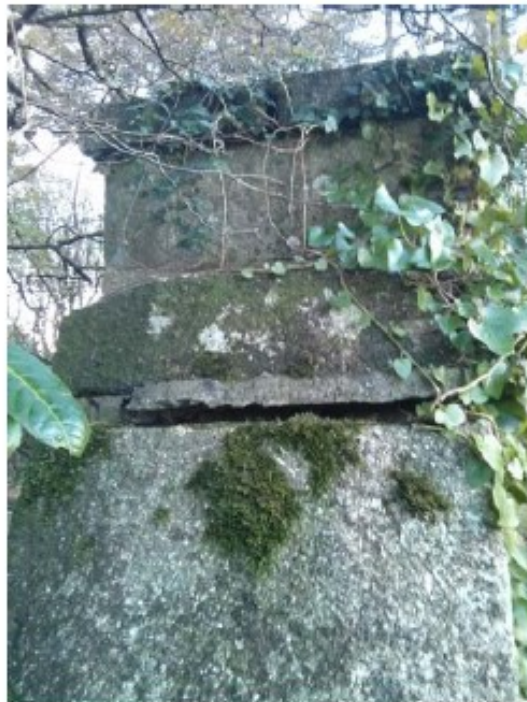
Plate 10: Coping stone in need of rebedding.

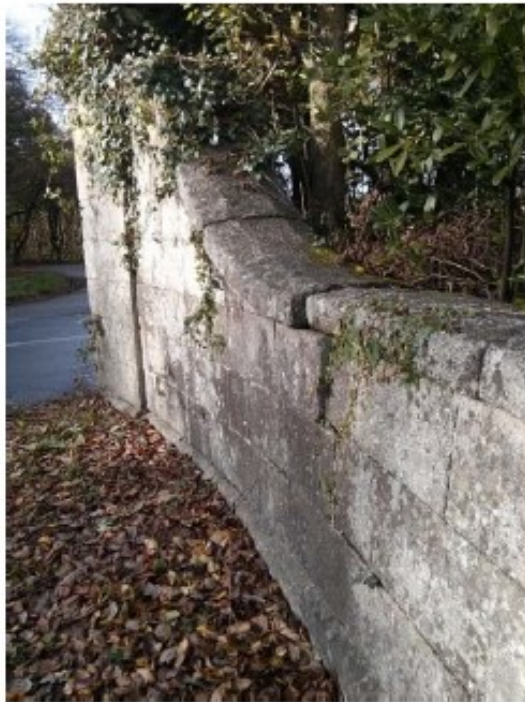
Plate 11: Displacement to North West Flanking Wall.

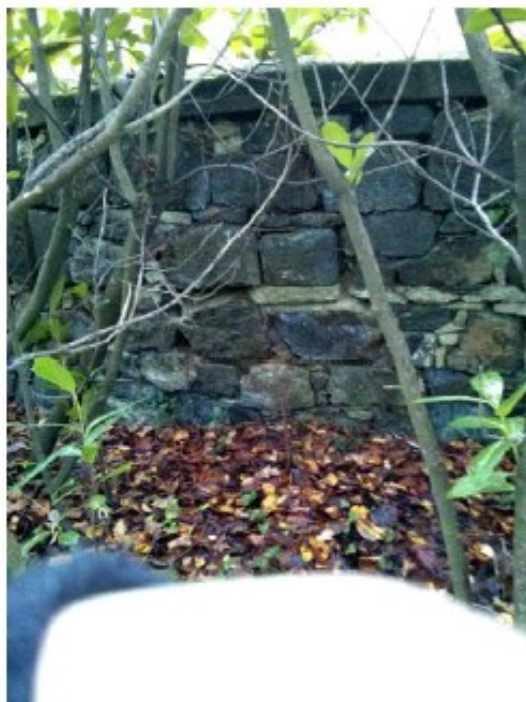
Plate 12: Mortar loss to rear face of North West Flanking Wall.

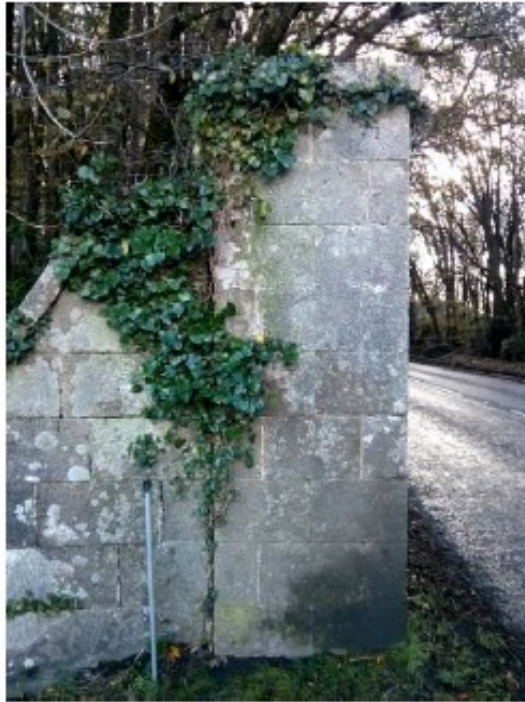
Plate 13: South East Wall Terminal Pier (showing lean)

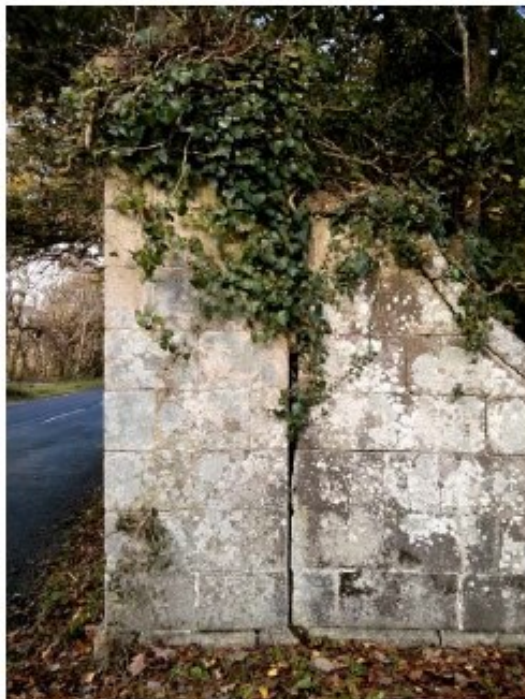
Plate 14: North West Wall Terminal Pier (showing lean)

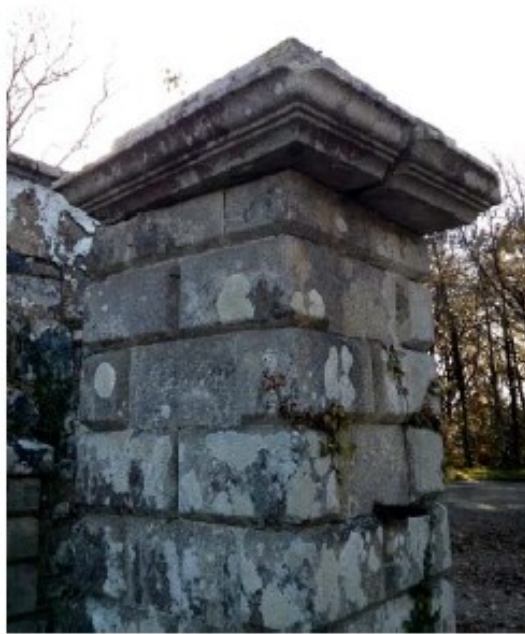
Plate 15: Granite Gate Pier (Note displaced cap stones)

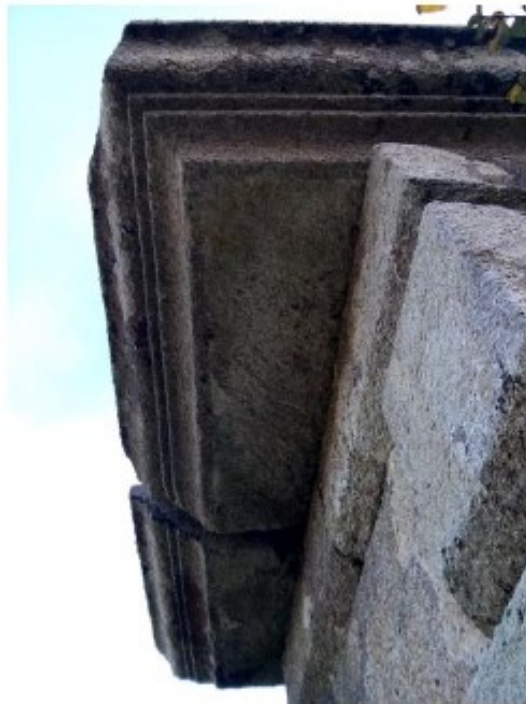
Plate 16: Extent of displacement of cap stones.

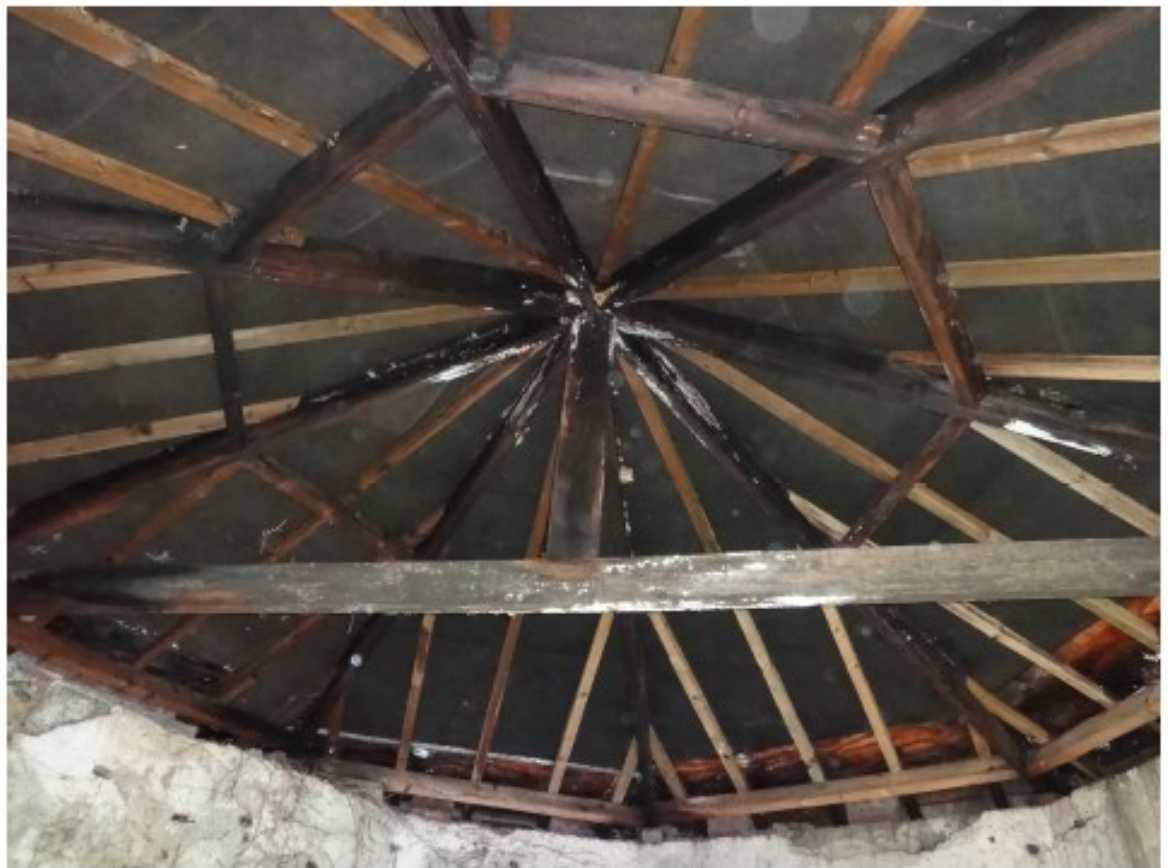
Figure 2. Roof structure to the SE Lodge; note extent of water staining & fungal growth to timberwork, November 2014

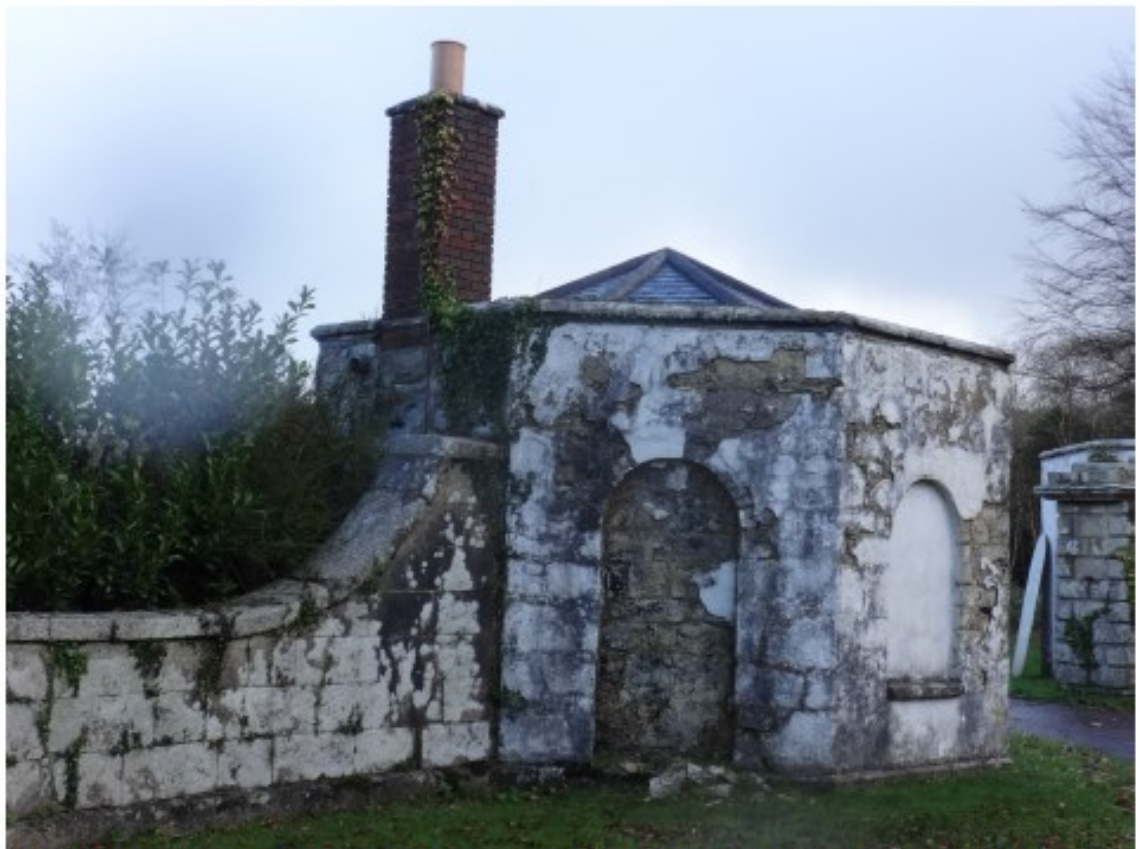
The painted render to the elevations of both lodges is failing, exposing the serpentine rubblestone substrate. This remaining render appears to be original (20-25mm thick), with some areas having receiving a further skim type coat of cementitious render, presumably an early 20th Century repair to prevent further deterioration of the original finish. Incised lining is evident in the remaining render finishes, adopted to imitate horizontal ashlar coursings. It will be necessary to record the size, depth, profile, positioning, etc of these lines prior to removal of the existing render finishes, so that they can be replicated in the replacement render.

Figure 3. NW Lodge showing degradation of the render finishes and underlying stonework, November 2014

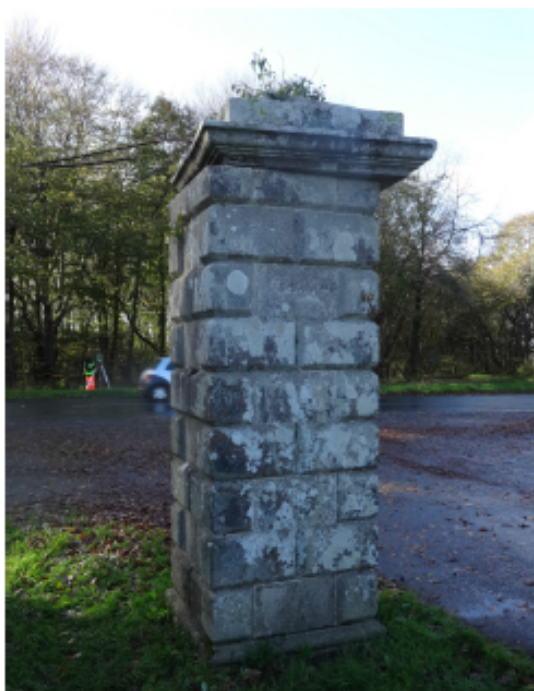
Surviving iron pintail hinges in the existing piers that once supported the pedestrian and vehicle gates show differing degrees of erosion. Expansion of one pintail on the northern lodge has expanded with rust, pushing the stonework of the gate pier apart. If they are deemed to be reusable it is suggested that they remain *in situ*. If not they should be replaced like-with-like.

Figure 4. Displaced capping to remaining main gatepost, with corroding 'pintail' hinge and former lantern support remaining, November 2014. It is important to note that the gatepost capping has been hit and displaced further since this photo was taken.
