# **Penmadow House, St Germans, Cornwall**

## **Historic building record**

<b>Client</b>	Mr Jon Elwell
<b>Report Number</b>	2015R013
<b>Date</b>	January 2015
<b>Status</b>	Final
<b>Report author(s)</b>	Eric Berry, with contributions by Nigel Thomas
<b>Checked by</b>	Jacky Nowakowski
<b>Approved by</b>	Andrew Young

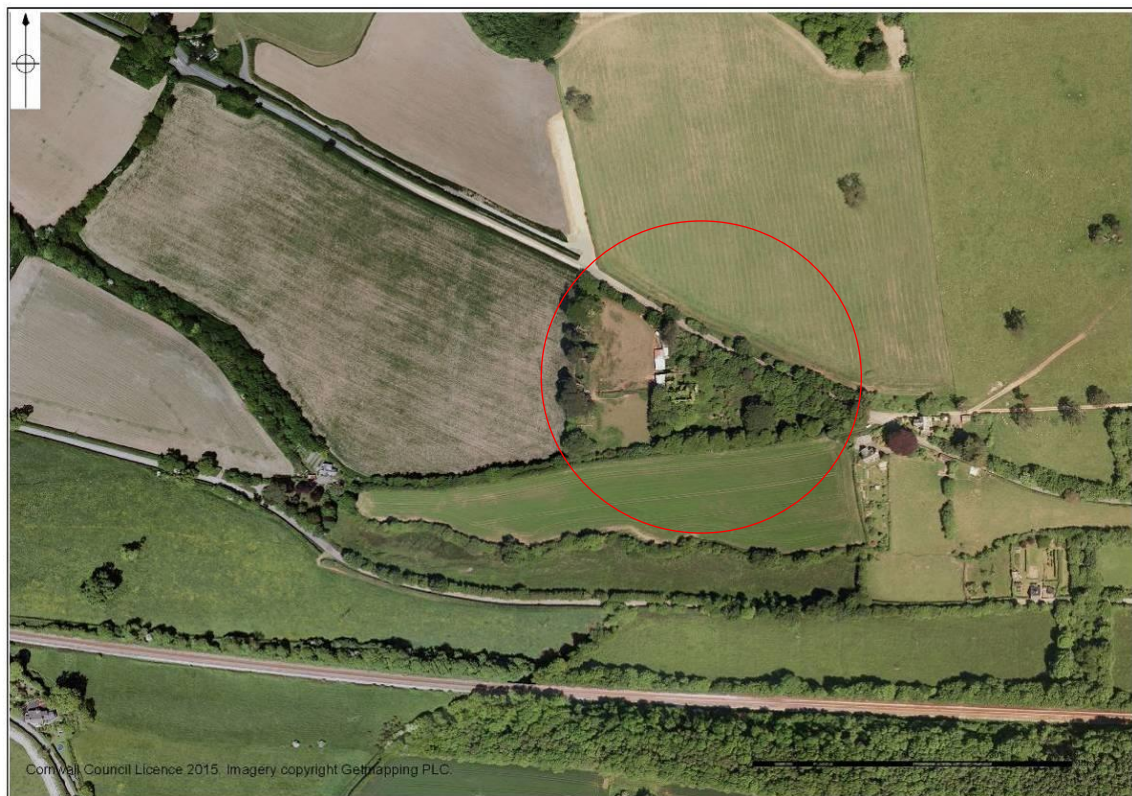
Fig 6 Air photo showing the abandoned ruins of Penmadow House, 2005.

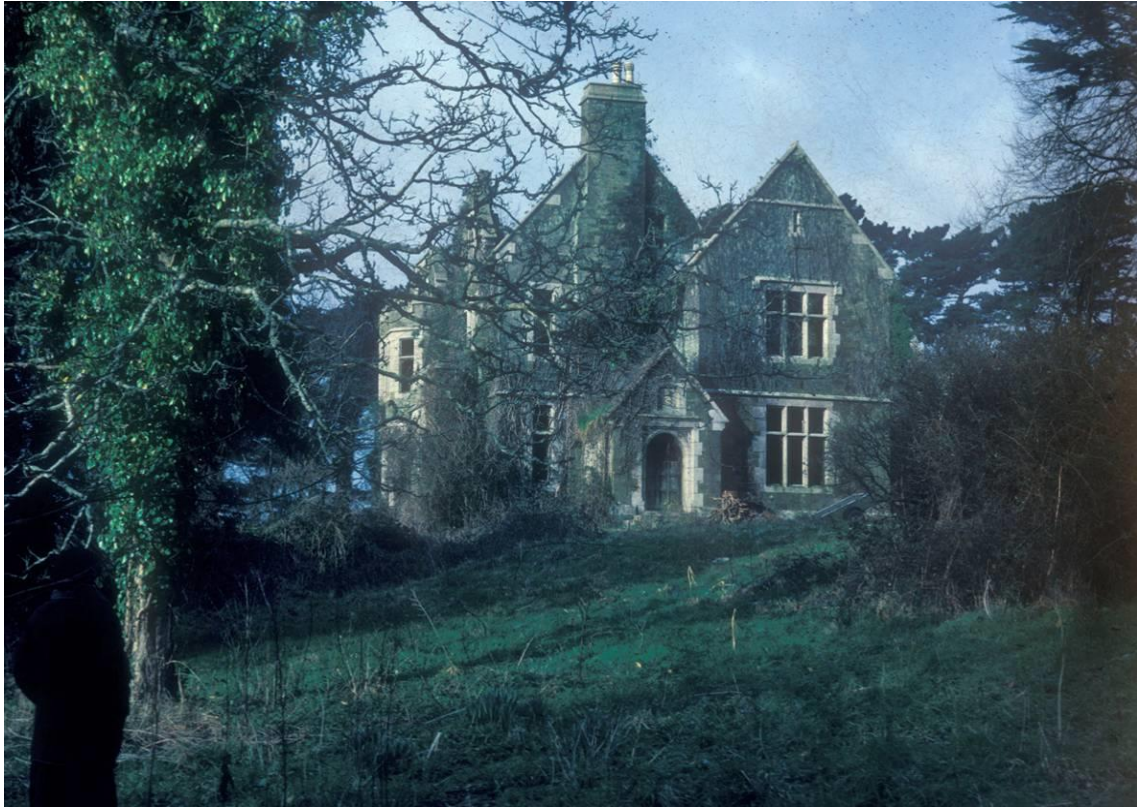
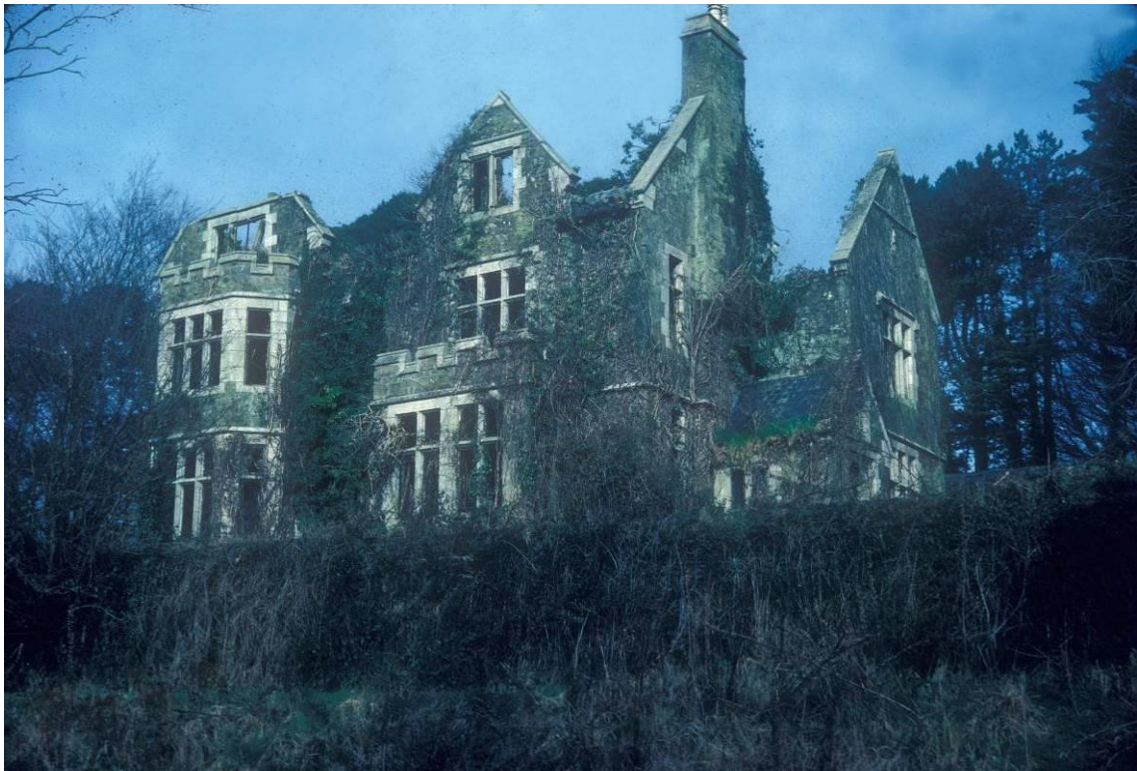
*Fig 8 Two views of the ruined house at Penmadown c1988 from east (top) and south east (bottom).*

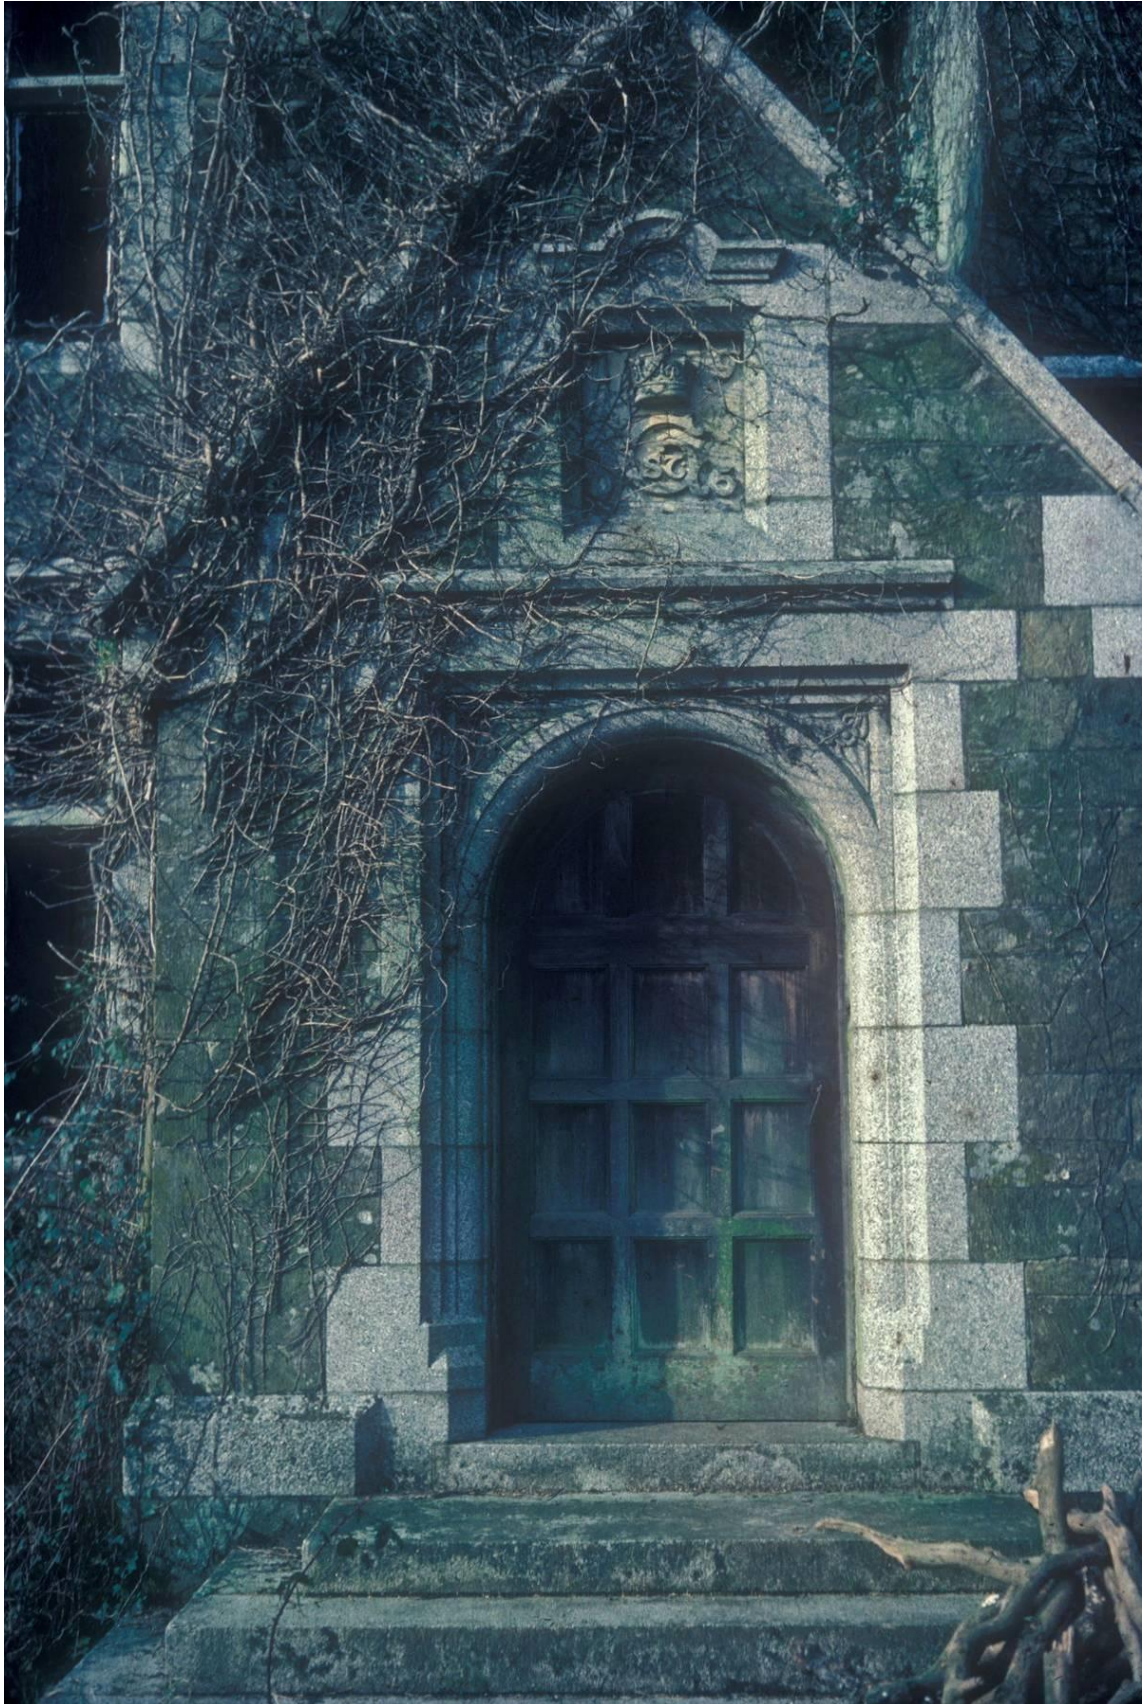
*Fig 9 Overgrown entrance porch (still with extant original wooden door) at Penmadow c1988.*

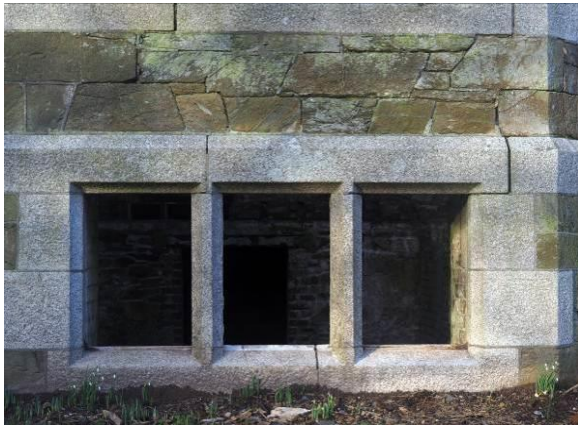
Fig 33 W basement window (iron frame remains).

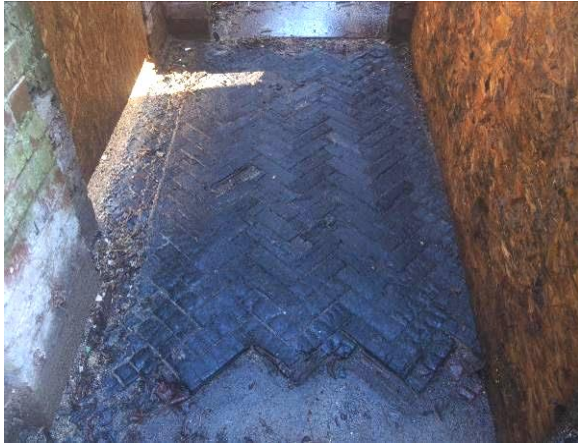
Fig 61 E-W corridor, remains of charred herringbone parquet floor.

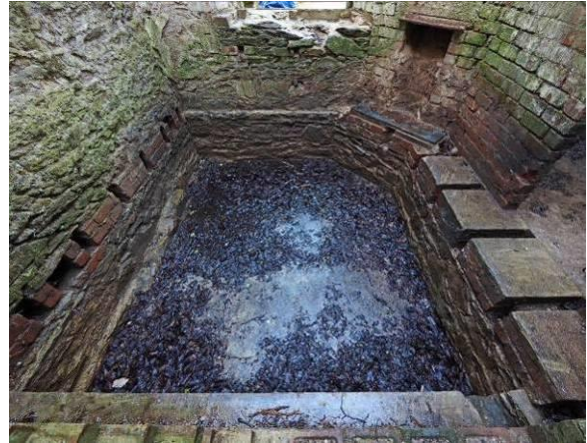
Fig 62 Butler's pantry suspended floor remains.

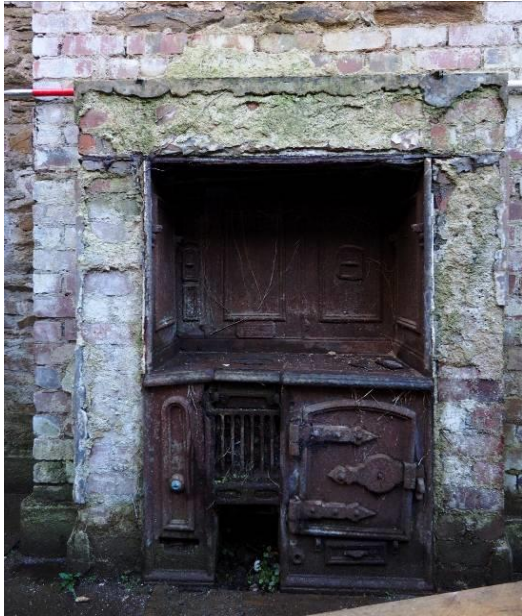
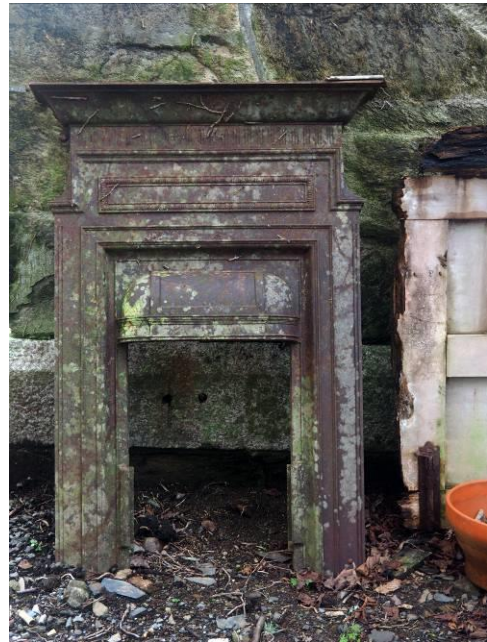
Fig 72 Cast-iron fireplaces.

Beyond the kitchen is a single-storey wing that contains a heated scullery. An almost complete cast-iron cooking range is still extant (Fig 72).

(left) in situ cooking range within scullery and (right) displaced bedroom fire surround.

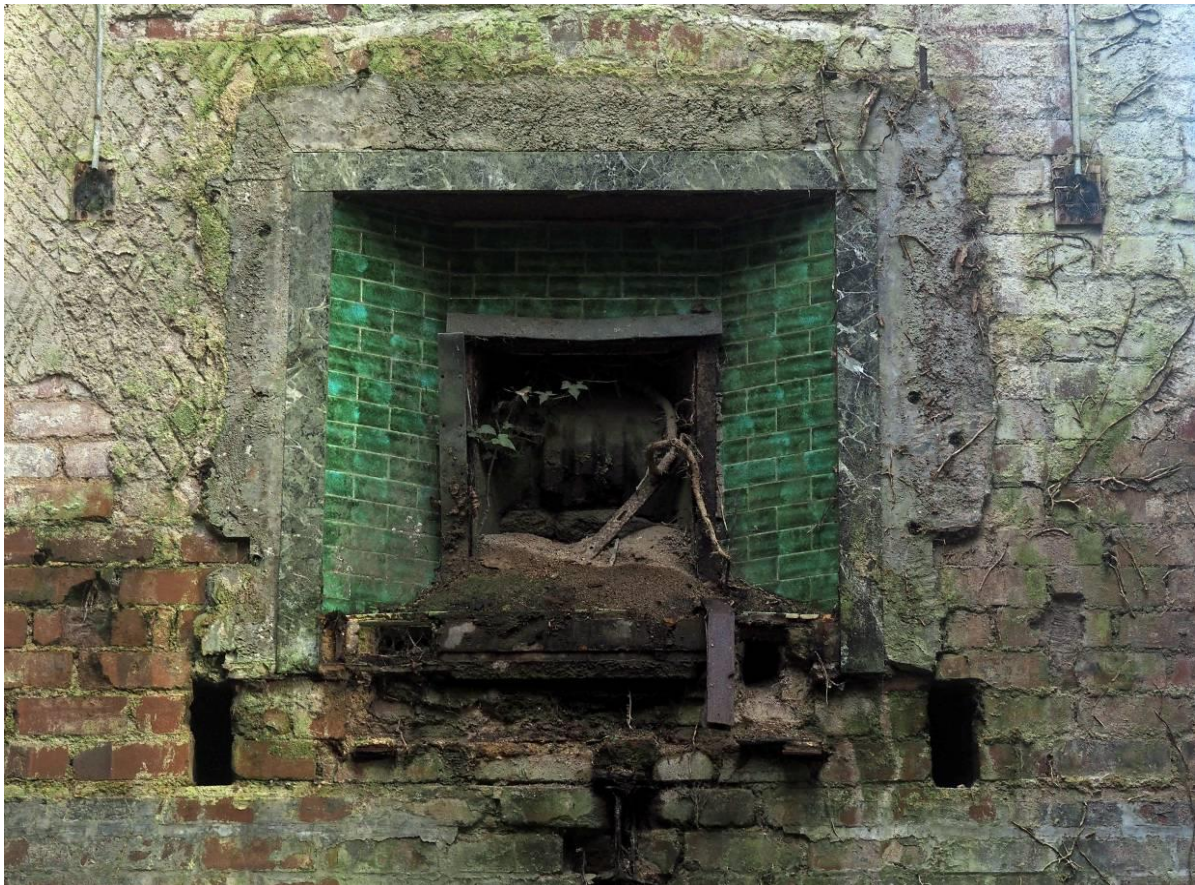
Fig 73 Fireplace within principal bedroom on first floor.

As well as green glazed tiles this fireplace has faux marble decoration. The edge and fixings for the missing mantle/surround can still be seen. The concrete hearth has since dropped away. Note the remains of the electric service bells on each side of the fireplace.
