Trease, Pendeen, Cornwall
The results of an archaeological watching brief during a
second phase of conservation works

Client	The National Trust
Report Number	2016R005
Date	19 May 2016
Status	Final
Report author	Adam Sharpe BA MCIfA
Checked by	Dr. Andy Jones MCIfA
Approved by	Andrew Young MCIfA

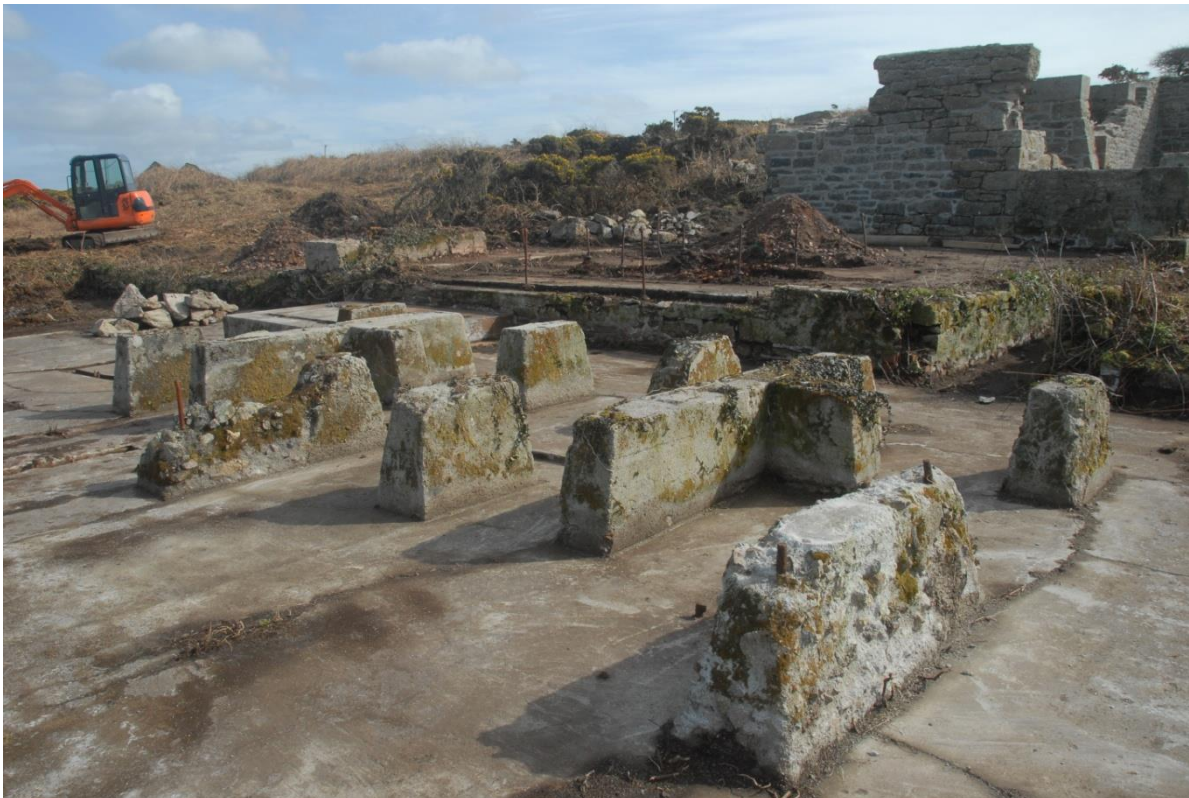
Fig 12. The Pinder Table floor in the mill. The poor condition of the concrete from which some of the plinths had been constructed is clearly evident.

A range of works were required within this area including repairs to those machinery plinths which had originally been constructed of poor quality concrete, the repointing of masonry walling, the installation of grilles over open channels, and the installation of new timbers in the four slots in the floor at the lower end of the dressing floors where vanning tables had been sited, and those which had originally held the substantial foundations for the Californian Stamps. The amorphous hollow in the floor of the boiler house was to be infilled with granular material and the tank in the north-western corner was proposed to be grilled over. A further safety grille was to be installed between the two northern mill engine loadings. Some minor repairs were required to broken sections of concrete flooring, whilst the edges of the floors and the site of a piece of unidentified machinery at the head of the lower floor were to be backfilled and underpinned with concrete grout where these areas had become voided and unsupported.

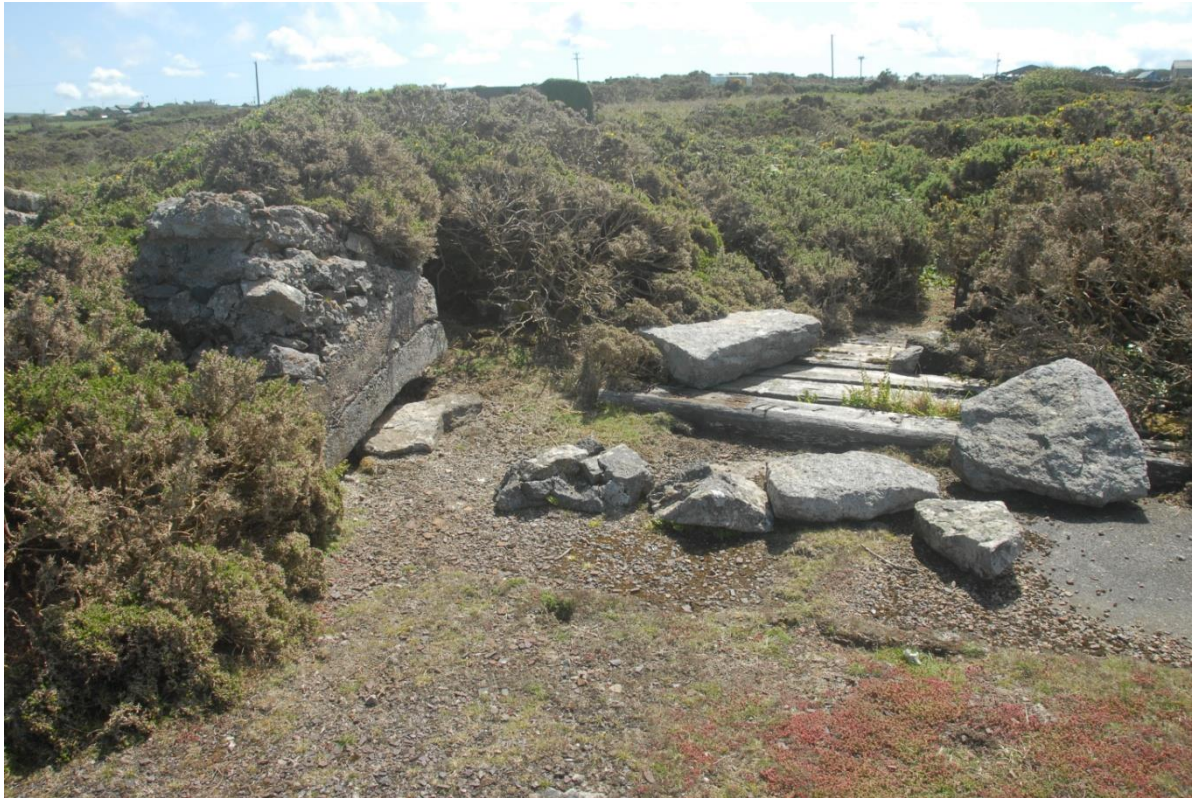
Fig 16. Trease Shaft prior to the clearance of the gorse which had encroached on it. The shaft is open to water at a depth of about 10m under the timber sleepers.

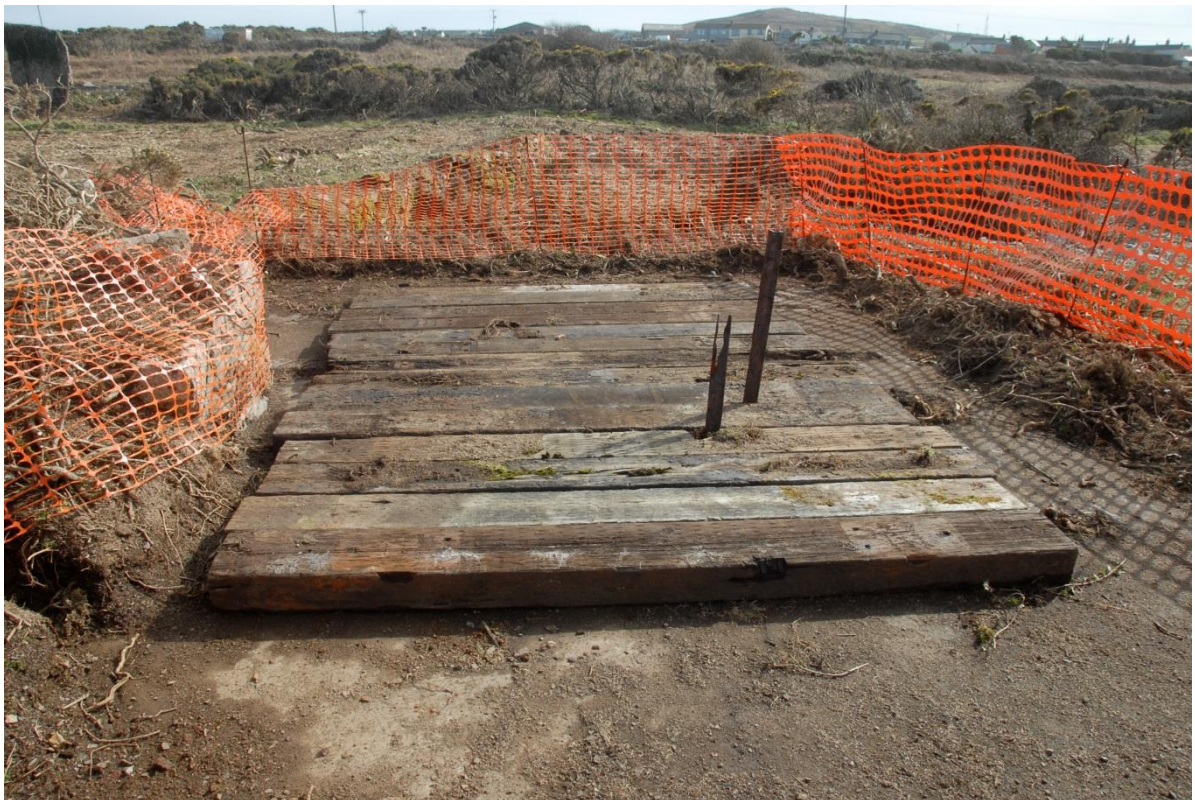
Fig 17. The Trease Shaft sleeper cover following the clearance of scrub vegetation. Paired tramway rails reused as shaft guides protrude through the cover. The sleepers were to be replaced by a galvanised steel grille (see Fig 86).

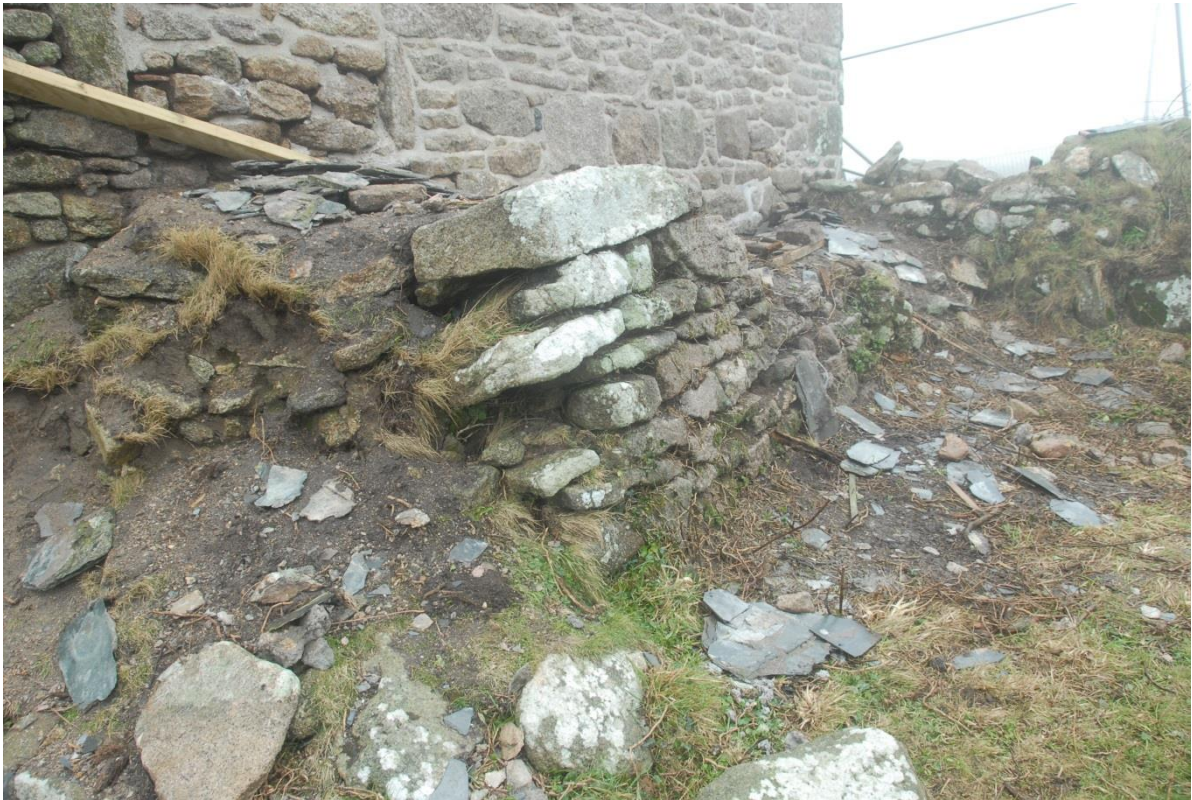
Fig 30. The poor condition of the ramp which formerly gave access to the upper floor of the field barn.

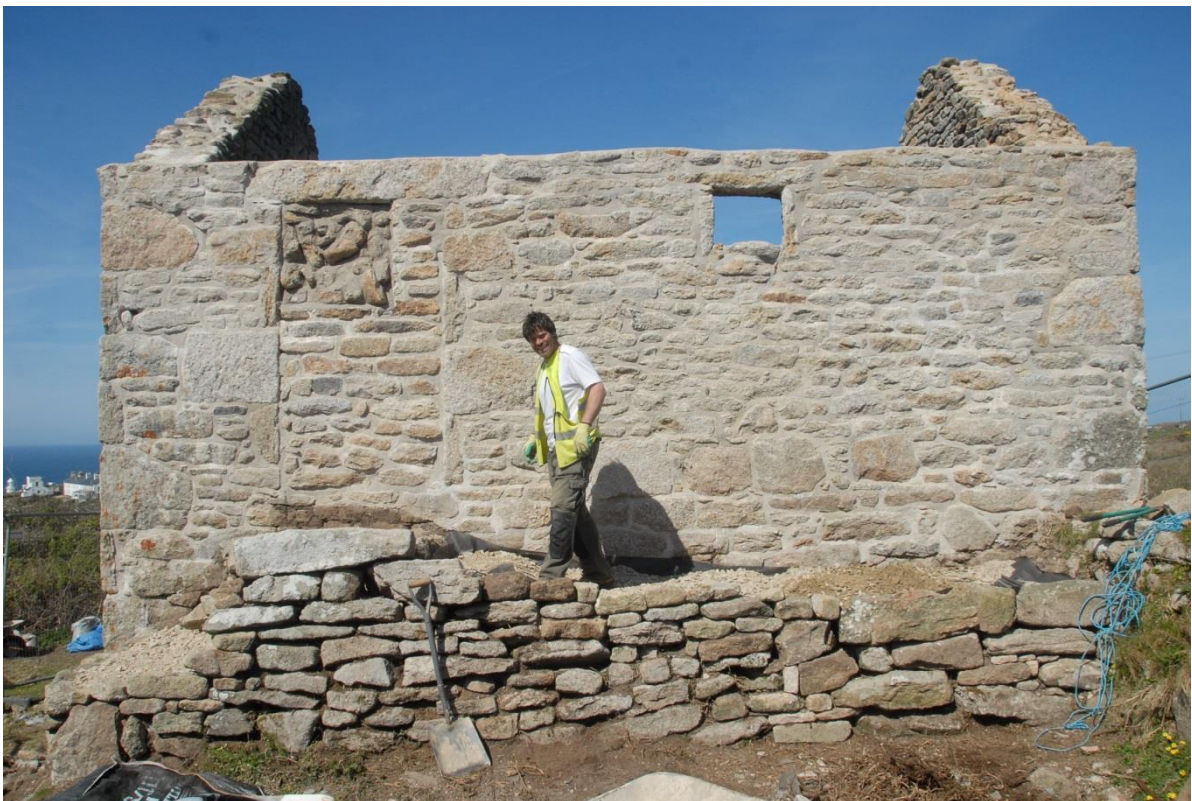
Fig 31. The repaired barn access ramp.

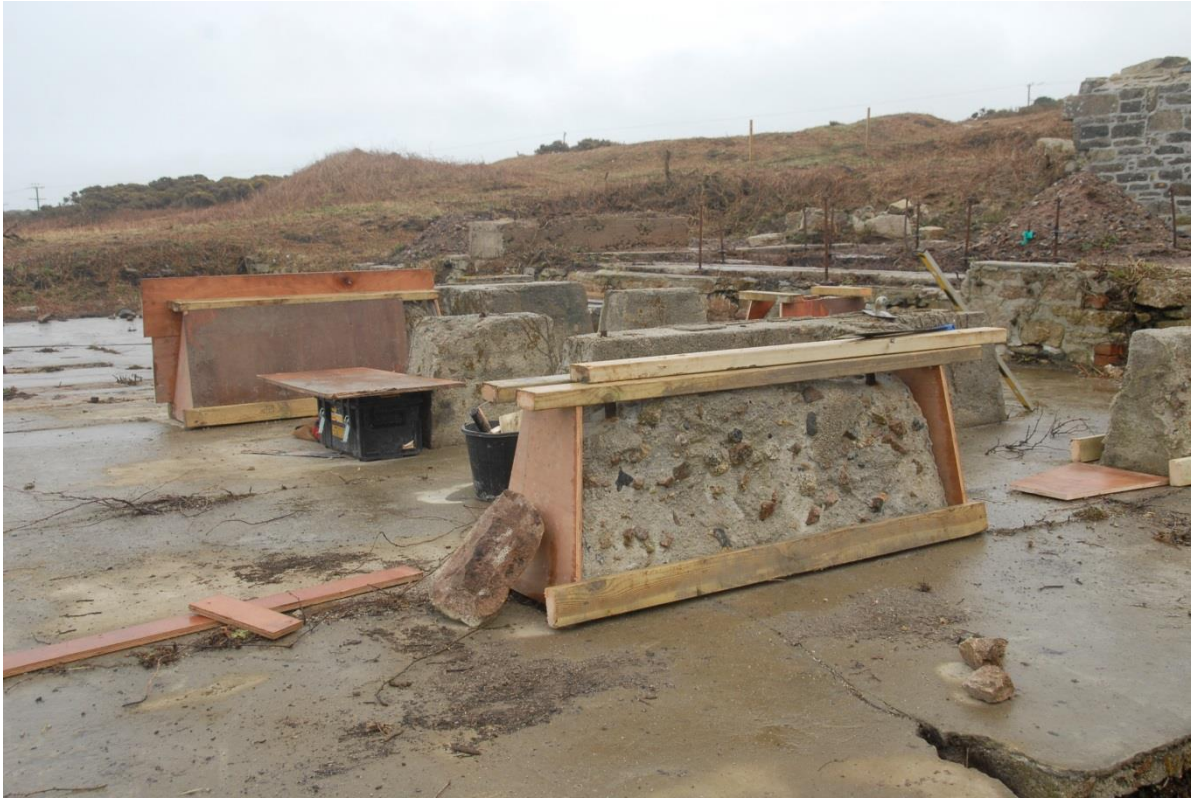
Fig 34. Formwork in place around the most decayed of the Pinder Table mountings on the middle mill floor.

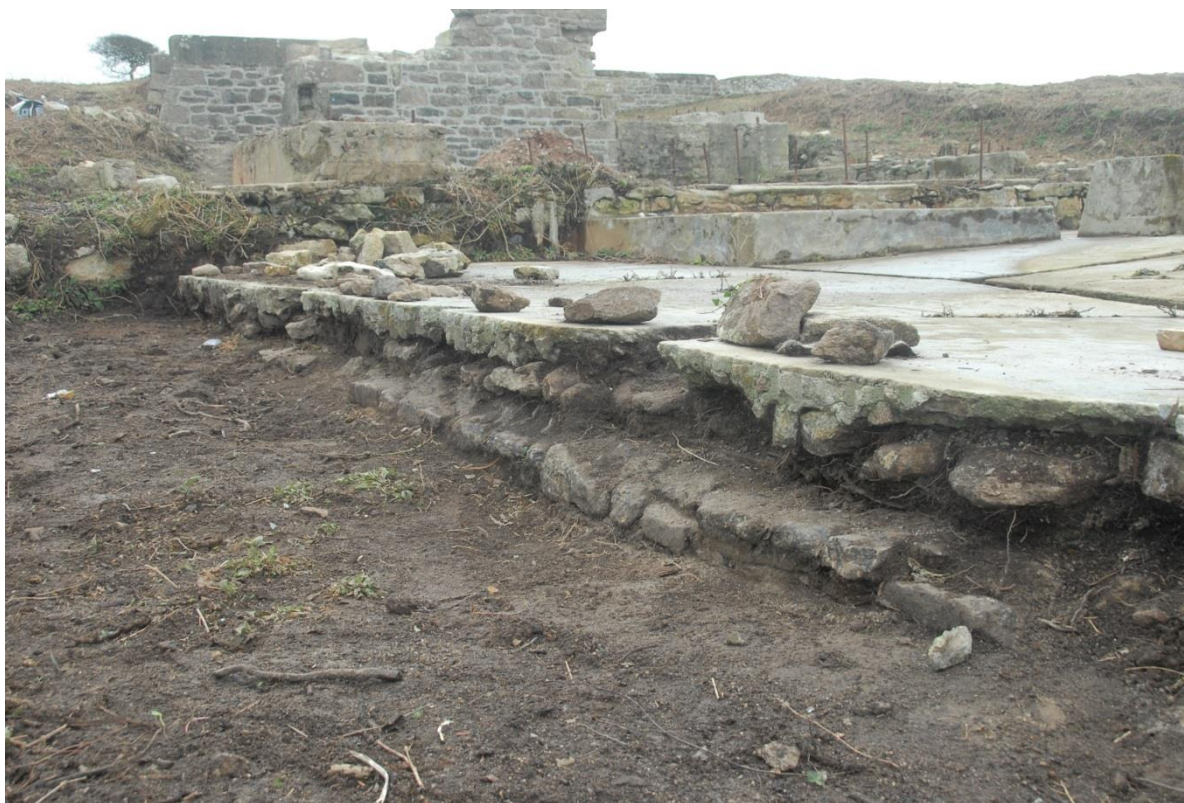
Fig 36. The badly undercut eastern edge of the middle mill floor prior to works.

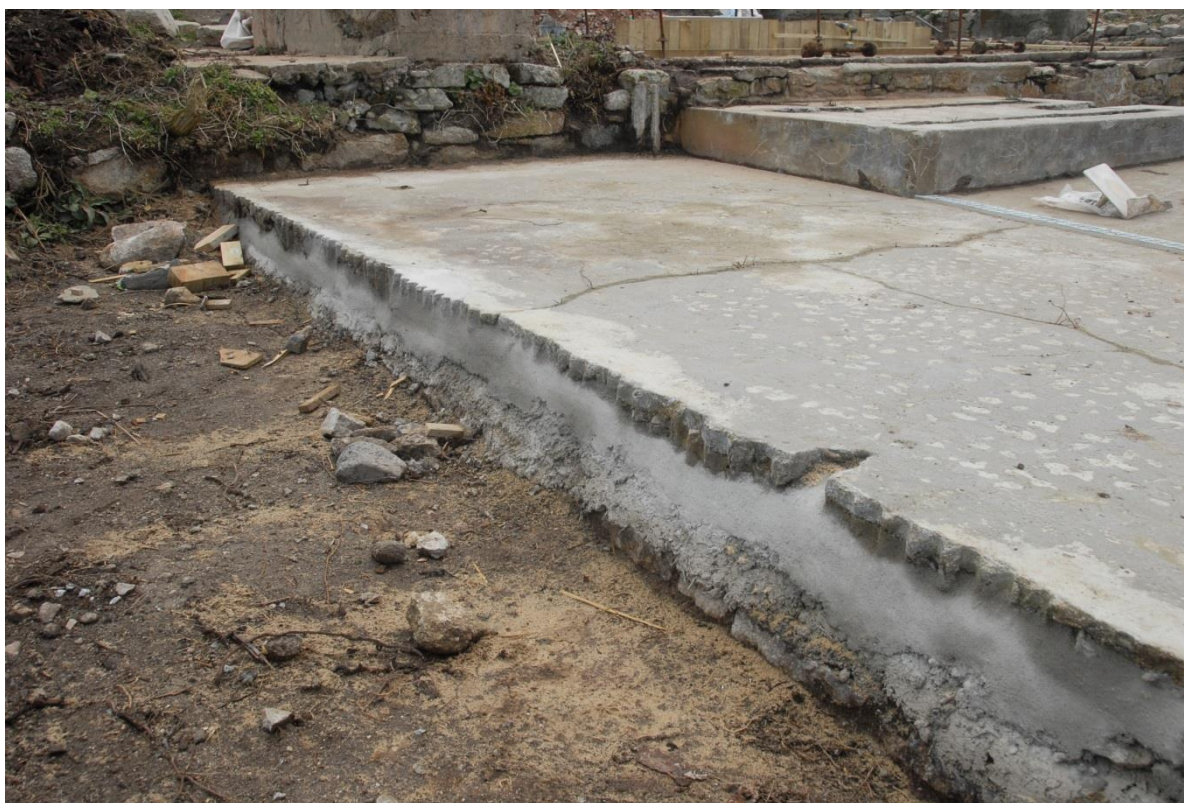
Fig 37. The concrete underpinning works to the edge of the mill floor.

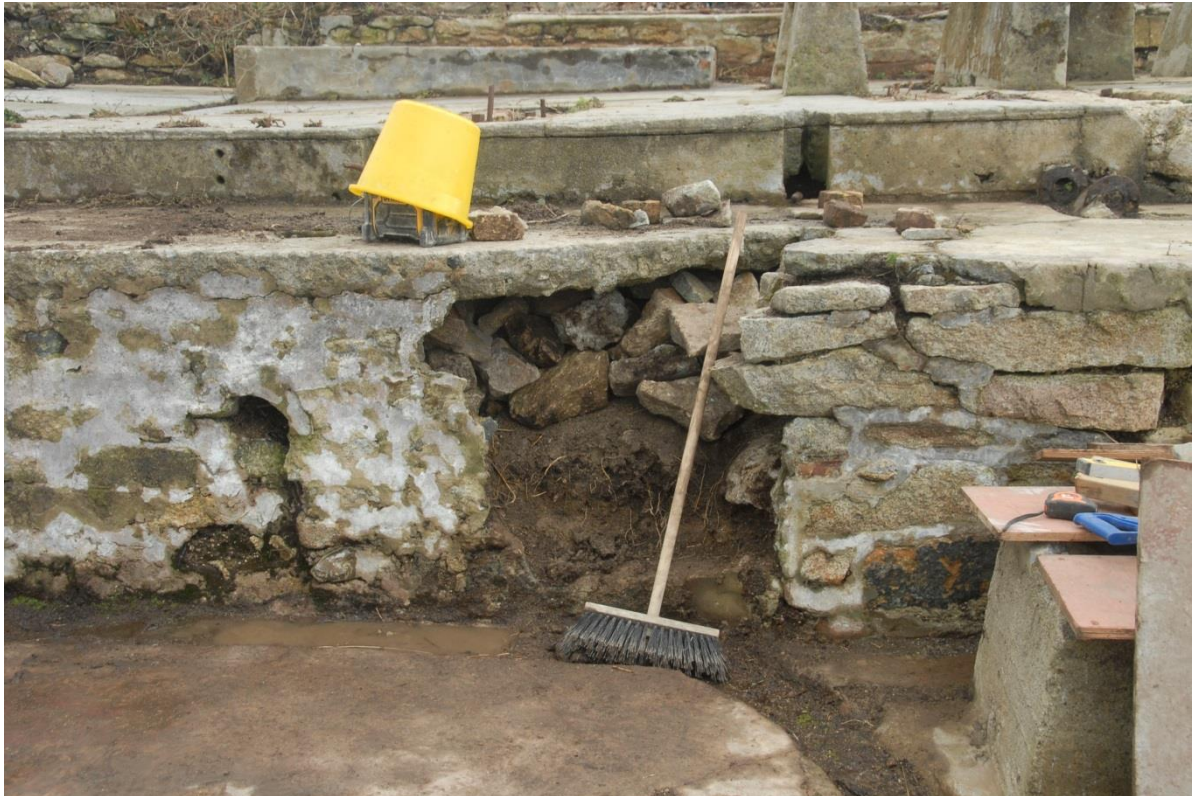
Fig 38. The significantly voided area at the rear of the lowest mill floor during its packing with loose stone and mortar to backfill it.

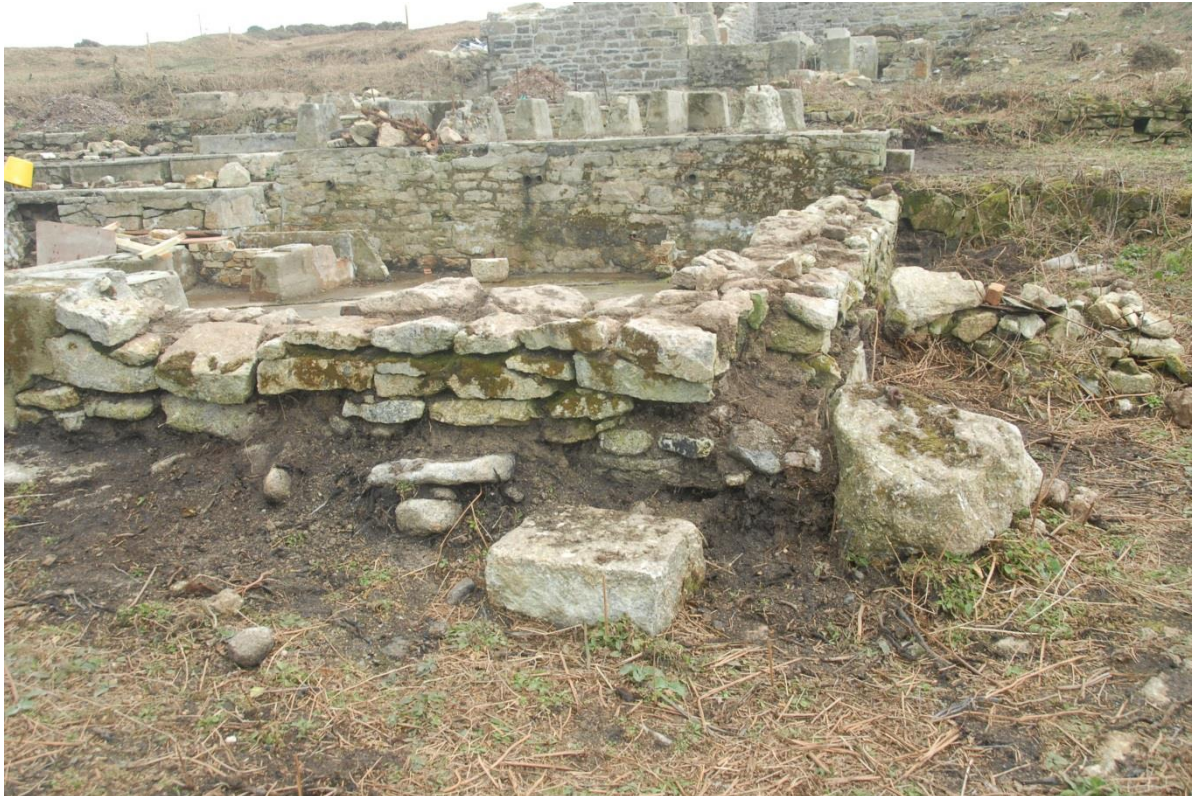
Fig 42. The very poor state of the walling which supported the lower section of the Trease mill building prior to works.

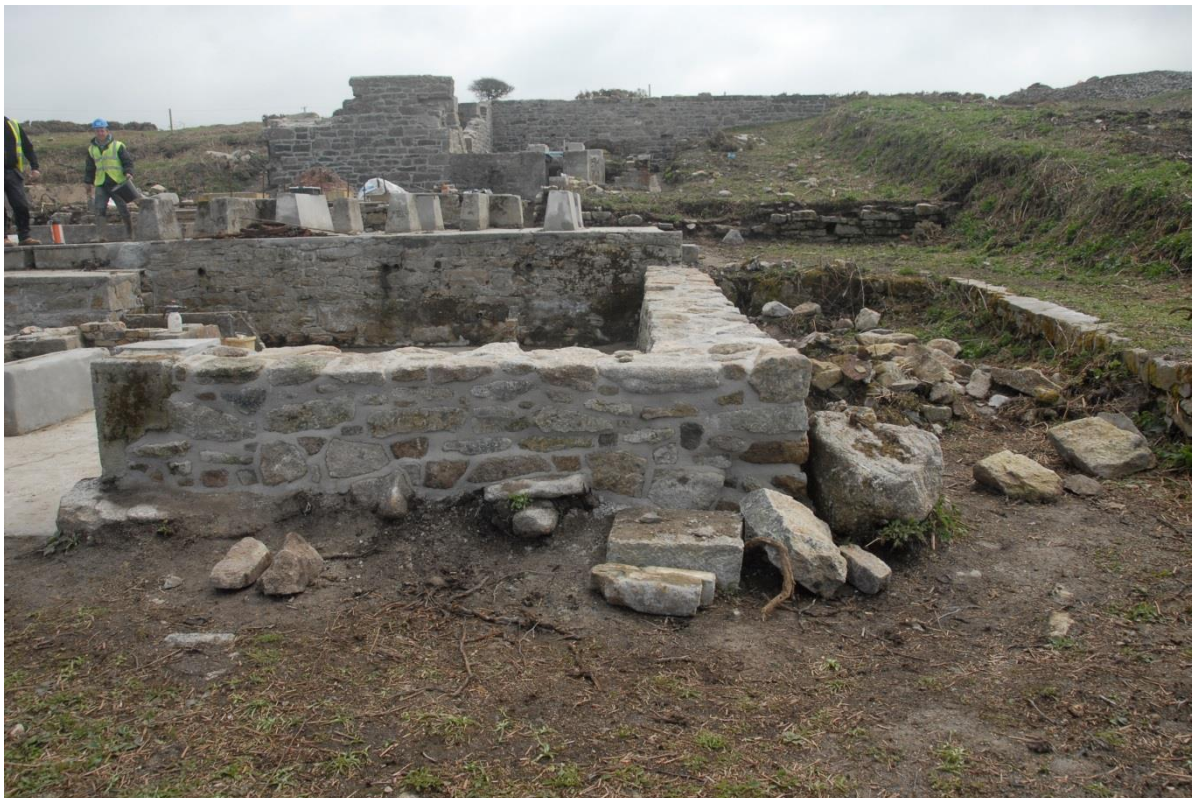
Fig 43. The completed work to the walling around the lower mill floor.

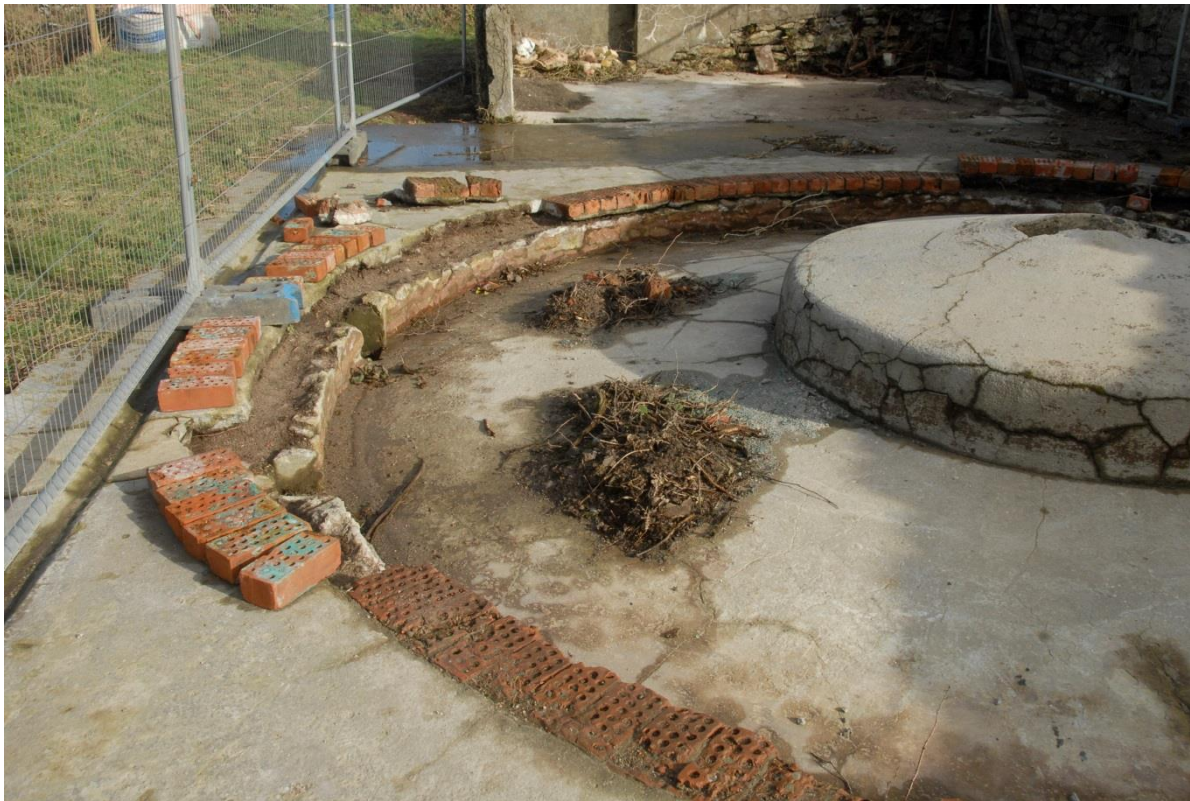
Fig 52. The buddle on the tin floors following the cutting out of its damaged brickwork. Salvaged bricks are being readied for the repair works.

Repairs were required to the brickwork facings of the two larger buddles. In this part of the site and a root barrier was to be installed external to the northern buddle, the larger open channels were to be plank-lined and covered with grilles to remove trip hazards, broken sections of concrete flooring were to be cut out and replaced and the walling of the settling tanks on the northern side of the tin floors was to be repaired. The wall extending to the east of the tin floors and the building at its eastern end were to be repointed and repaired where required, as was the southern wall of the tin floor building where a localised collapse had taken place.

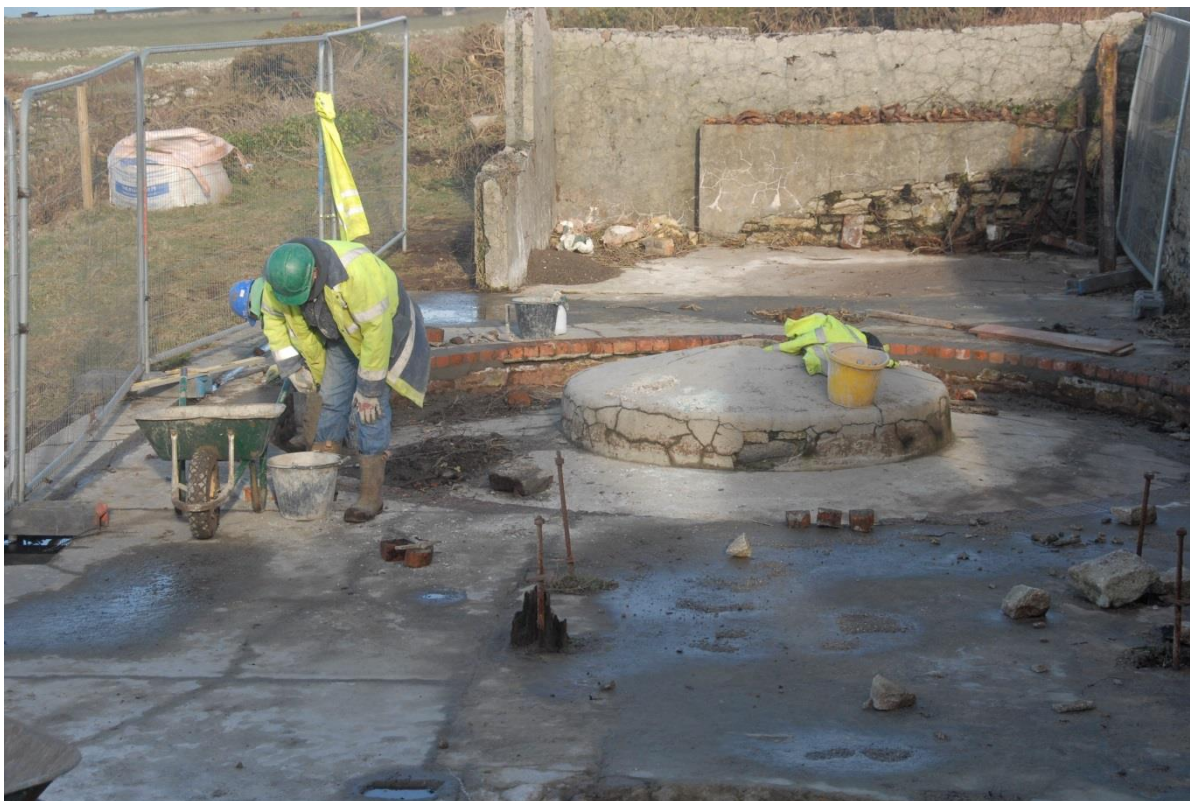
Fig 53. Work in progress during the repair works to the buddle on the tin floors.

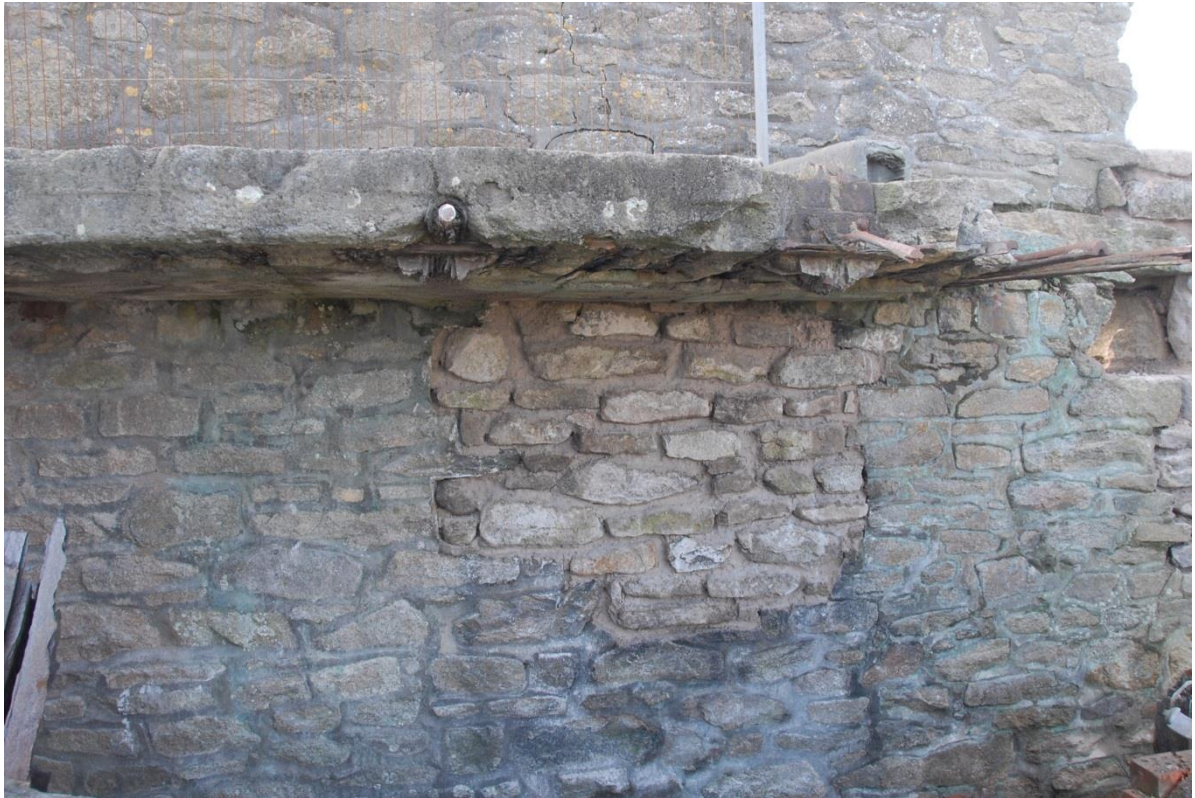
Fig 54. The rebuilt damaged section of the eastern wall of the southern dust chamber.

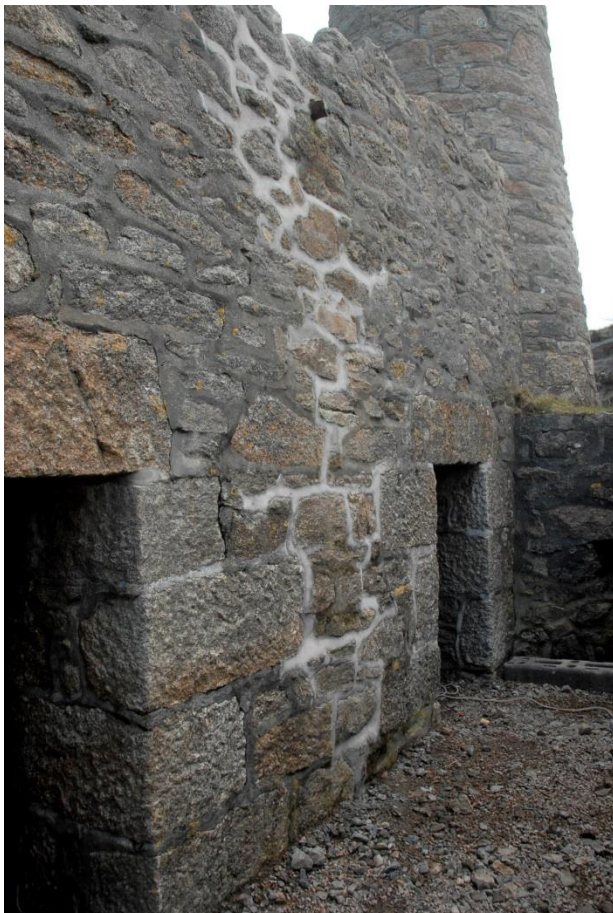
The NT Buildings Department was concerned about the cracking and probable destabilisation of the northern and western walls of the northern dust chamber, it being considered that this had been caused by unconstrained side thrusts imposed by the arched concrete roof of this building on the heads of these walls. Although no active movement cracks were evident, it was decided that a long term solution would be required to strengthen these walls, and as a result a specialist company based in Bodmin was contracted to install Cintec reinforcing bars in grout-filled oversized drill holes through the cores of these walls over their full heights (Figs 62 – 64). In addition, one 5m long horizontal bar was to be installed along the length of the northern wall of the northern dust chamber to tie its masonry together. The outer sections of the cores from the drilling works were retained to disguise the drilled entry points for the Cintec bars.

Fig 57. Patch repairs to a major crack on the western wall of the dust chambers.

This work was undertaken at the beginning of March 2016, prior to the repointing and helicoil stitching of the cracked joint fills (Figs 57 & 65). This was a prolonged process given the need to accurately and securely set up the drilling unit at right angles from the wall and to ensure that the drill holes were correctly aligned and the necessity to repeatedly withdraw and clear the core drill at the tip of the rods before extending the drill string in 300mm steps. The first hole to be drilled was the 5m long x 50mm diameter horizontal hole through the length of the north wall of the building roughly 600mm down from its wall head. The drilling team then moved onto the technically more difficult 75mm diameter sub-vertical holes through the core of the wall and spaced along its length. With these, the team experienced repeated problems with extracting the cores as some slipped from the drill head back into the drill holes, whilst in other areas the drill path ran partially between the inner and outer wall skins, and the small rubble stones incorporated into the wall core were converted to gravel by the drilling process, making this material almost impossible to extract. Penetrating rainwater over the course of a century had also created a number of voids between stones in the wall core, which the drill tended to try to follow rather than the desired line. Finally, each vertical drill hole required a new rigid set-up based on bespoke scaffolding, each of which took time for the drillers to erect. As a result, the drilling programme was rather more protracted than had initially been anticipated, and after some discussion between the site archaeologist and the engineers, the vertical drill

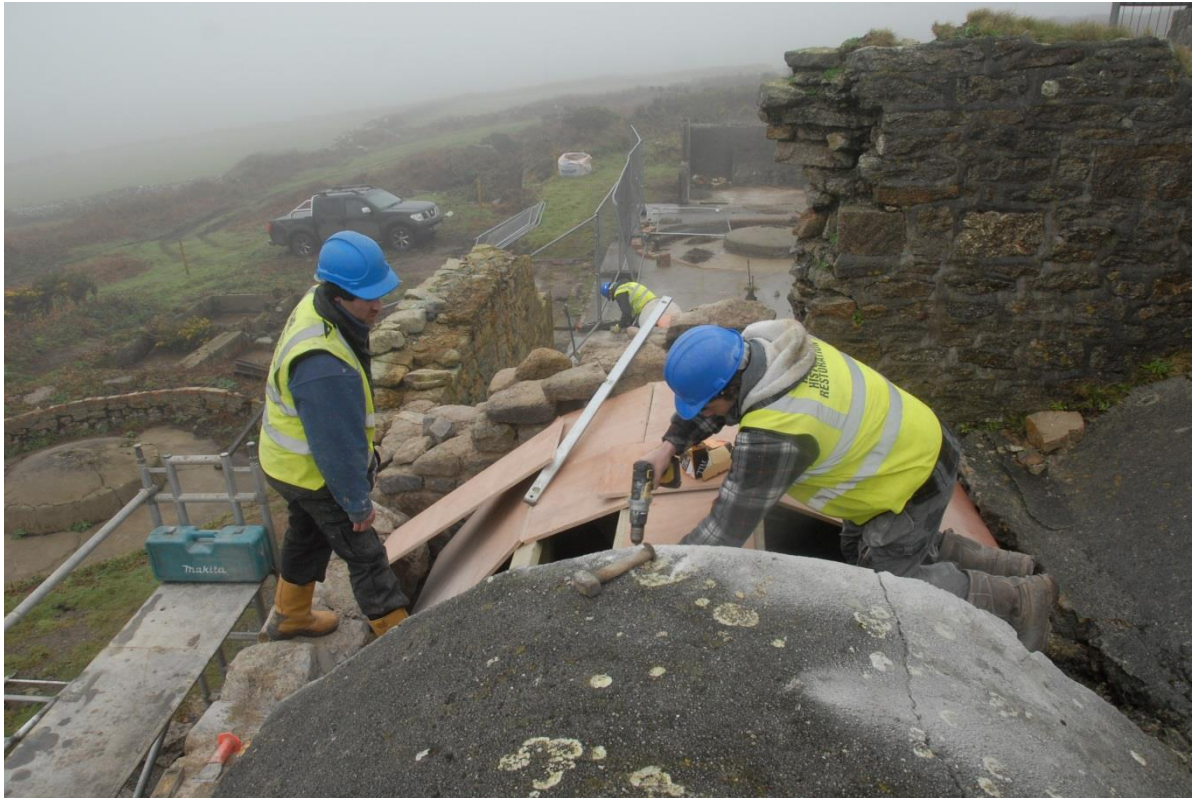
Fig 58. Making up the formwork on which the replacement section of the northern dust chamber roof would be cast.

This, in turn, enabled a strongly-constructed Acro prop and timber-supported plywood formwork to be erected on which the replacement section of the lost eastern end of the northern dust chamber roof could be cast (Fig 58). The poor quality and, in places, rough finish of the underside of sections of the original roof clearly indicated that this structure had never been intended to be the permanent feature of the site which it has become, having now survived for over a century. Each dust chamber roof had clearly originally been cast in three sections, stones having been laid over the original timber formwork and weak concrete cast over these, before a 35mm thick skin of stronger concrete was skimmed over the roof as a whole, as was revealed during the cutting back of the broken edge of its remaining section. As a result, shrinkage cracks had developed along the edges of the original joint lines on both roofs, which had allowed water to percolate into the interior of the dust chambers.

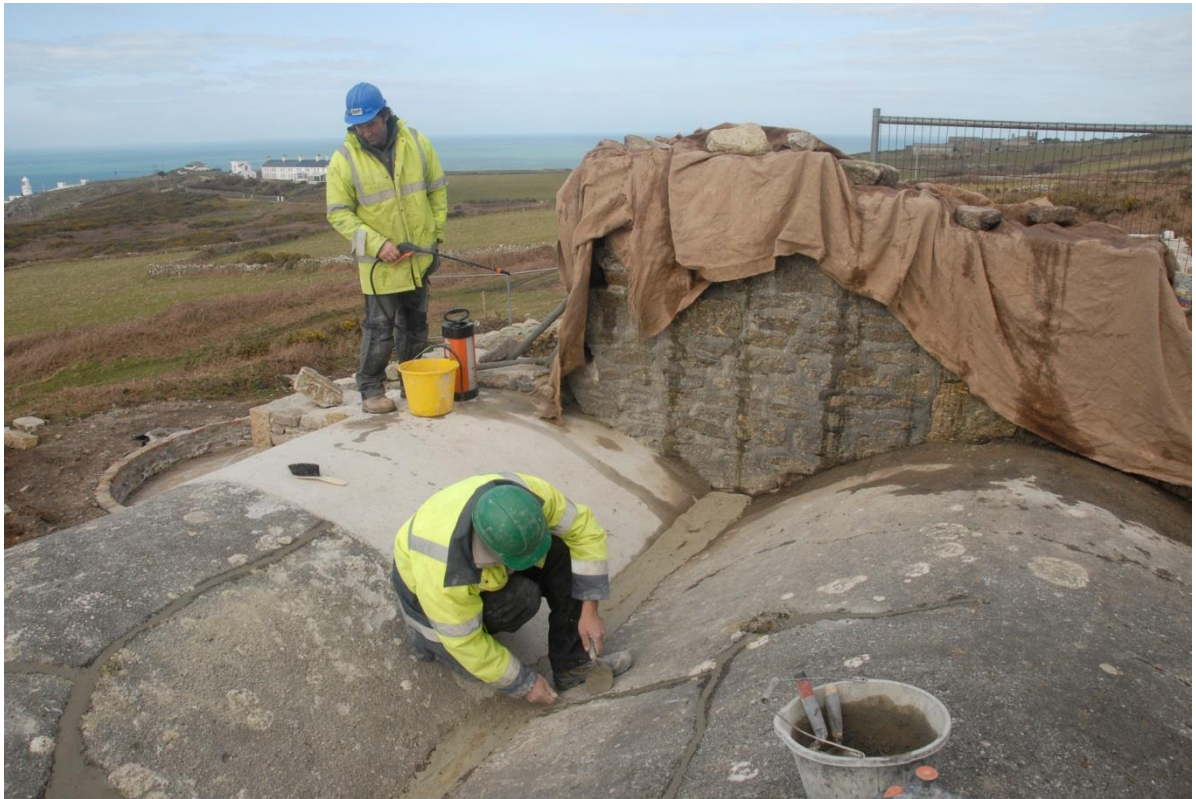
The leakage of rainwater through the original construction joints in the roof was clearly evident during the winter of 2015/16, and it was noticeable that erosion and degradation of the concrete at these interfaces had taken place. The original roof concrete was also found to be permeable, resulting in spalling of the weak concrete facing forming the underside of the roofs. As a result, the original construction joints were partially cut out and repaired and a proprietary waterproofing solution (Fosroc Brushbond FLXIII) was applied to the upper surface of the whole of the old section of

Fig 60. Grouting cracks in the roof of the dust chambers prior to the coating of the whole roof with Fosrok Brushbond to waterproof it.

the roof following the removal of all loose surface matter and the grouting of cracks and joints (Figs 60 & 61).

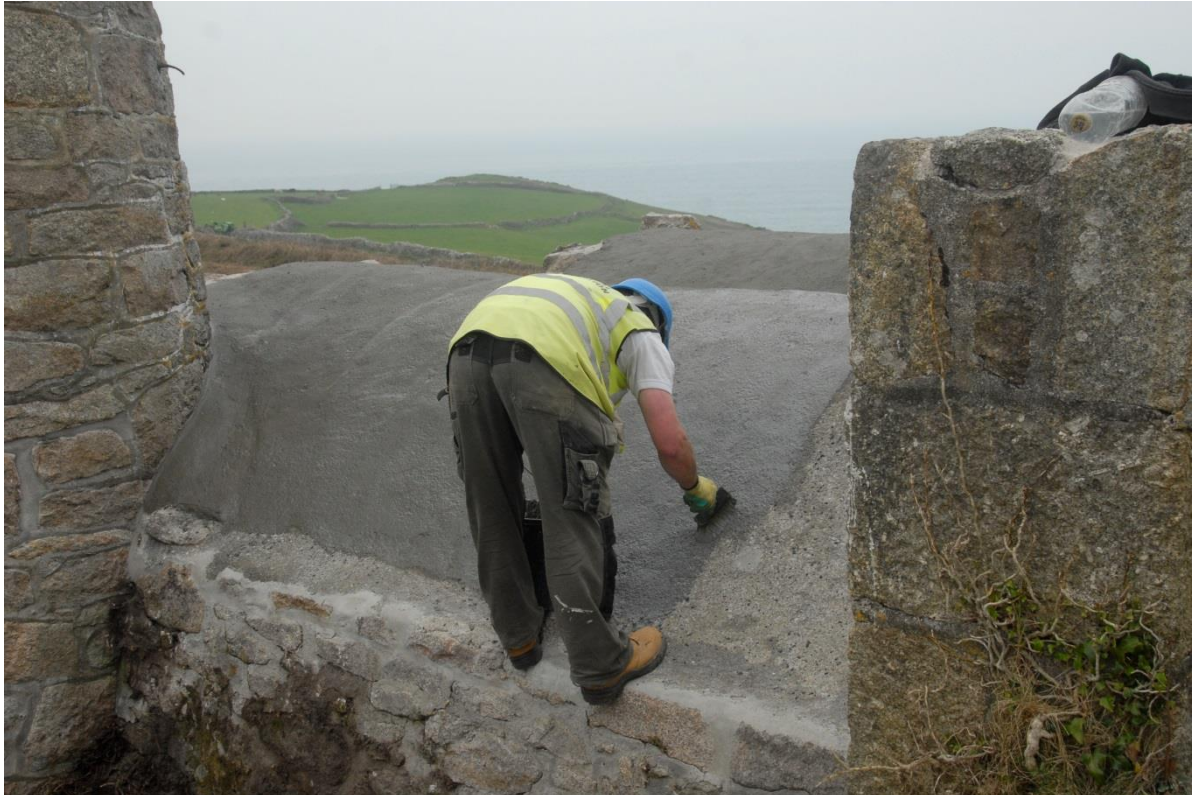
Fig 61. Applying the Fosrok Brushbond to the dust chamber roofs.

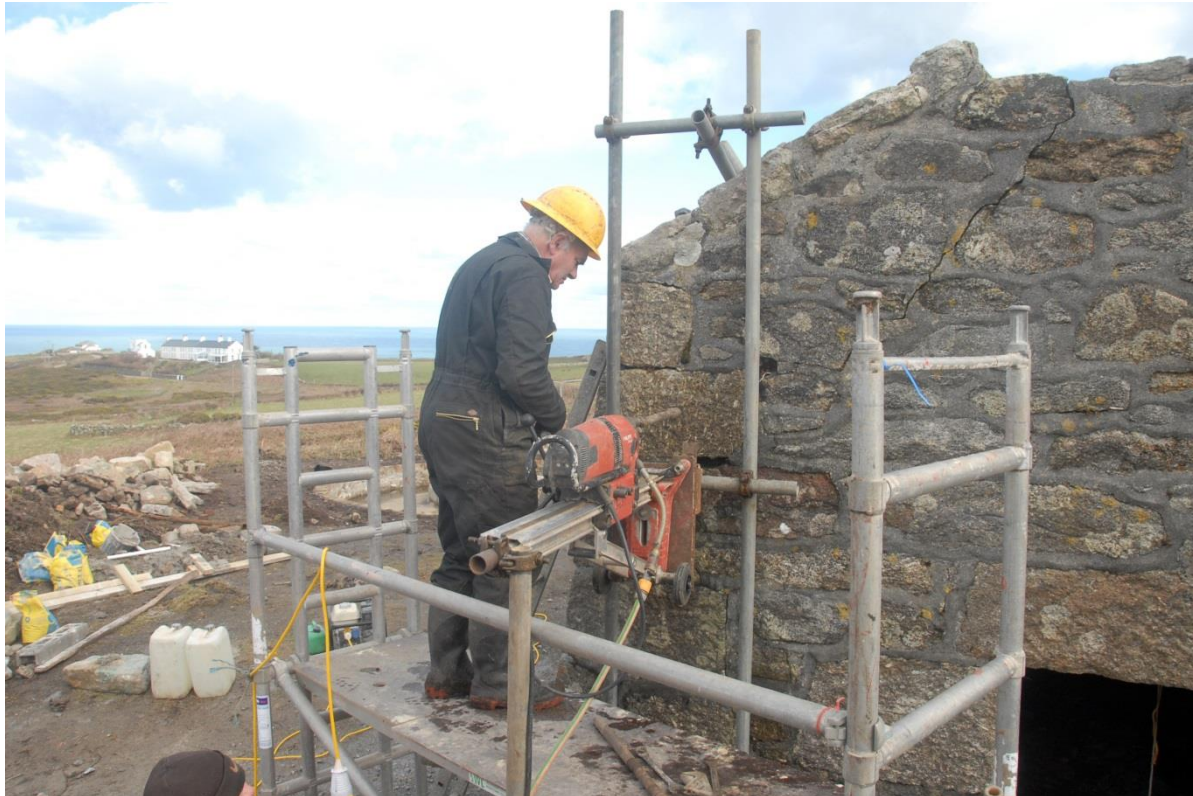
Fig 62. Drilling the five metre horizontal hole near the head of the dust chamber northern wall which would take one of the Cintec reinforcing bars.

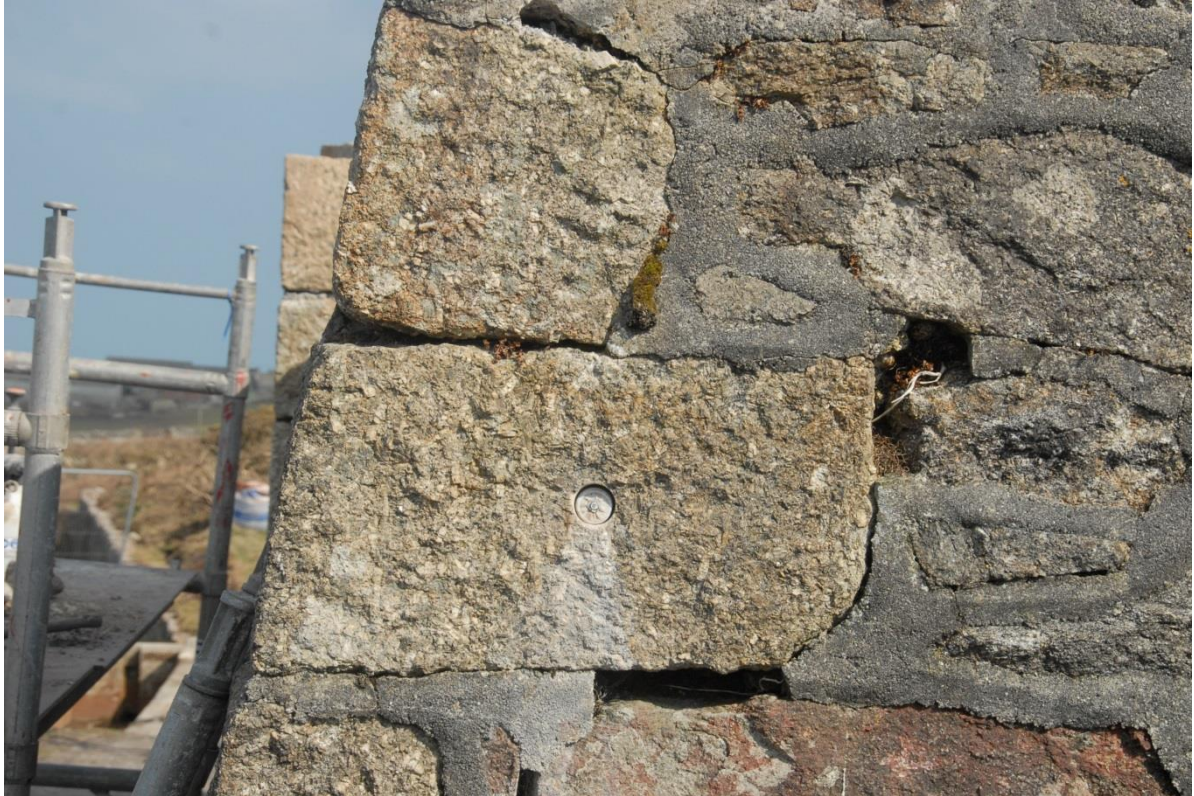
Fig 64. The only visible evidence for the Cintec reinforcing bars installed into the northern dust chamber wall (centre).

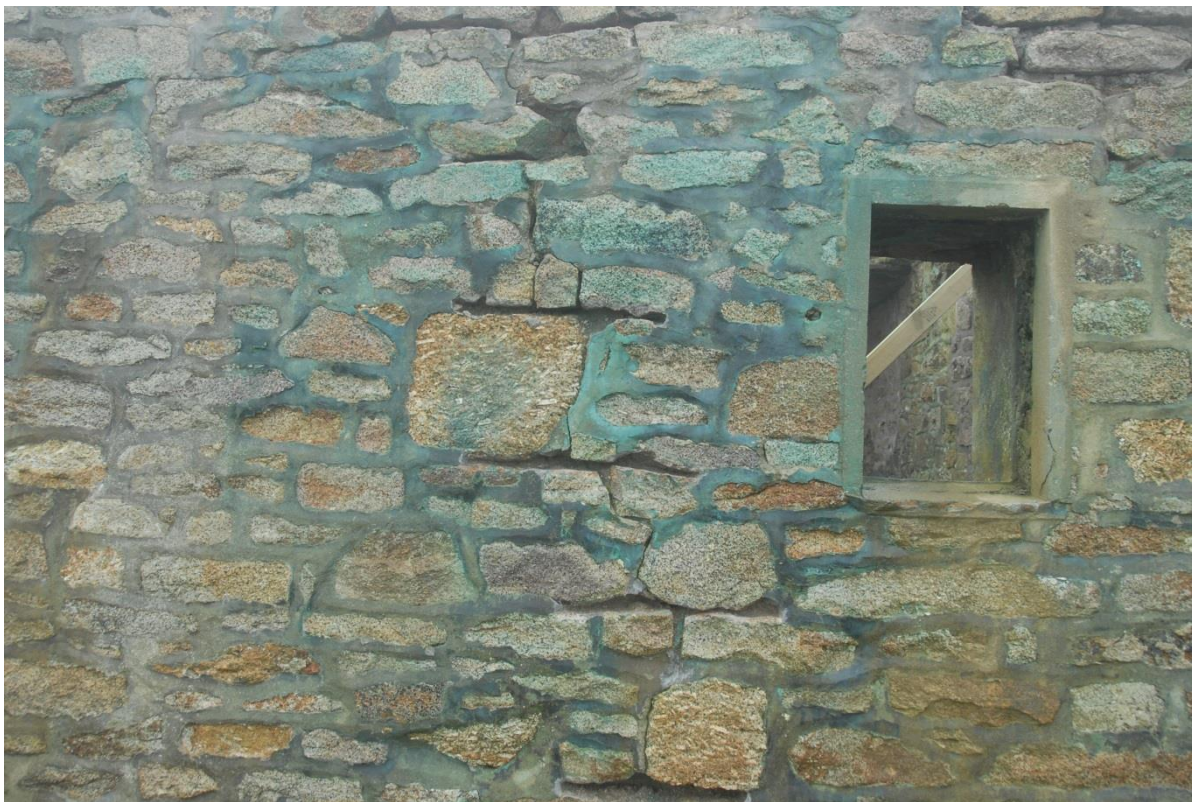
Structural cracks in the calciner building and the northern walling of the dust chambers where the arsenic soot had been collected required stitching with stainless steel helicoil bars and reinforcing with regularly-spaced vertically set stainless steel bars. The roof of the northern dust chamber was to be reconstructed to confer additional stability to this element of the structure, as also was a section of the eastern wall of the calciner building and its incorporated flue opening. Ivy was to be stripped from the chimney and any minor repairs found to be required undertaken. The calciner bed was to be re-formed using salvaged bricks and reinforced lime concrete, rusted-out steel supports under the walkway were to be removed and replaced, all internal and external walls were to be repointed where required and capped (except in those limited areas where Nationally Rare bryophytes had been recorded), and a steel safety barrier was to be installed at the entrance to the walkway. The furnace was to be partially reconstructed and the corroded iron hearth door frame provided with a stainless steel support. The capping stones on the walling defining the edge of the walkway to the west of the dust chambers were to be re-set and any live ivy and bramble roots within the structure as a whole were to be removed or spot treated.

Fig 65. Joints crossing a vertical crack in the calciner enclosure northern wall cut out to receive helicoil bedjoint reinforcement.
