Trease, Pendeen, Cornwall
The results of an archaeological watching brief during a
second phase of conservation works

Client	The National Trust
Report Number	2016R005
Date	19 May 2016
Status	Final
Report author	Adam Sharpe BA MCIfA
Checked by	Dr. Andy Jones MCIfA
Approved by	Andrew Young MCIfA

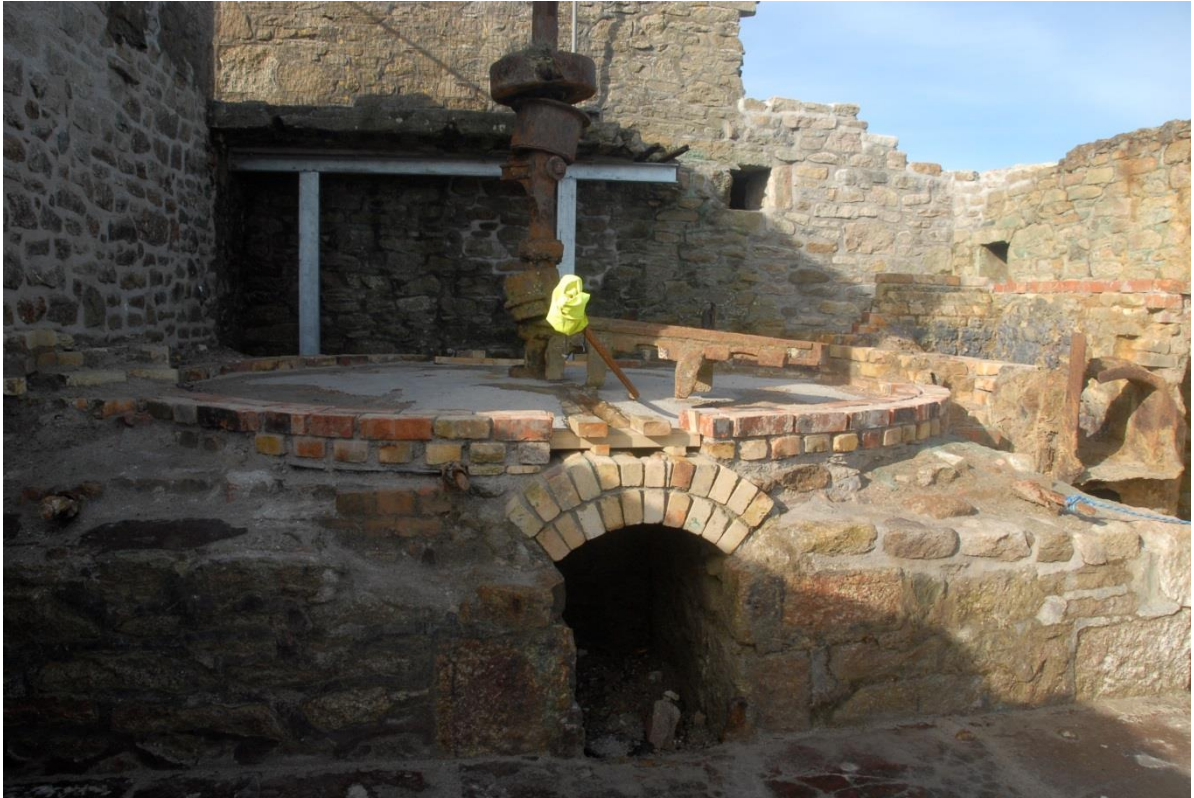
Fig 69. The reconstructed brickwork around the base of the calciner bed and over the discharge vault and (background) the replacement steelwork support to the walkway which formerly accessed the calciner feed hopper.

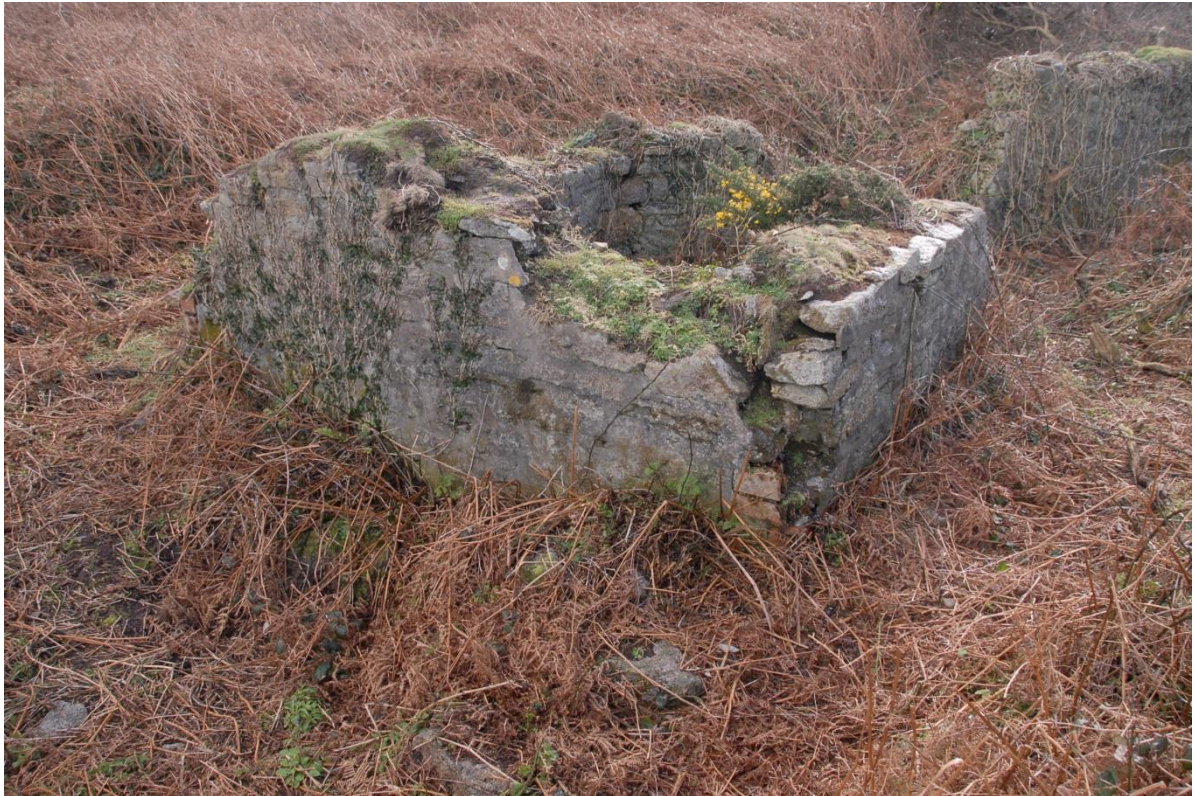
Fig 79. The probable powder house from the north east prior to works, showing the poor state of its masonry at this time.

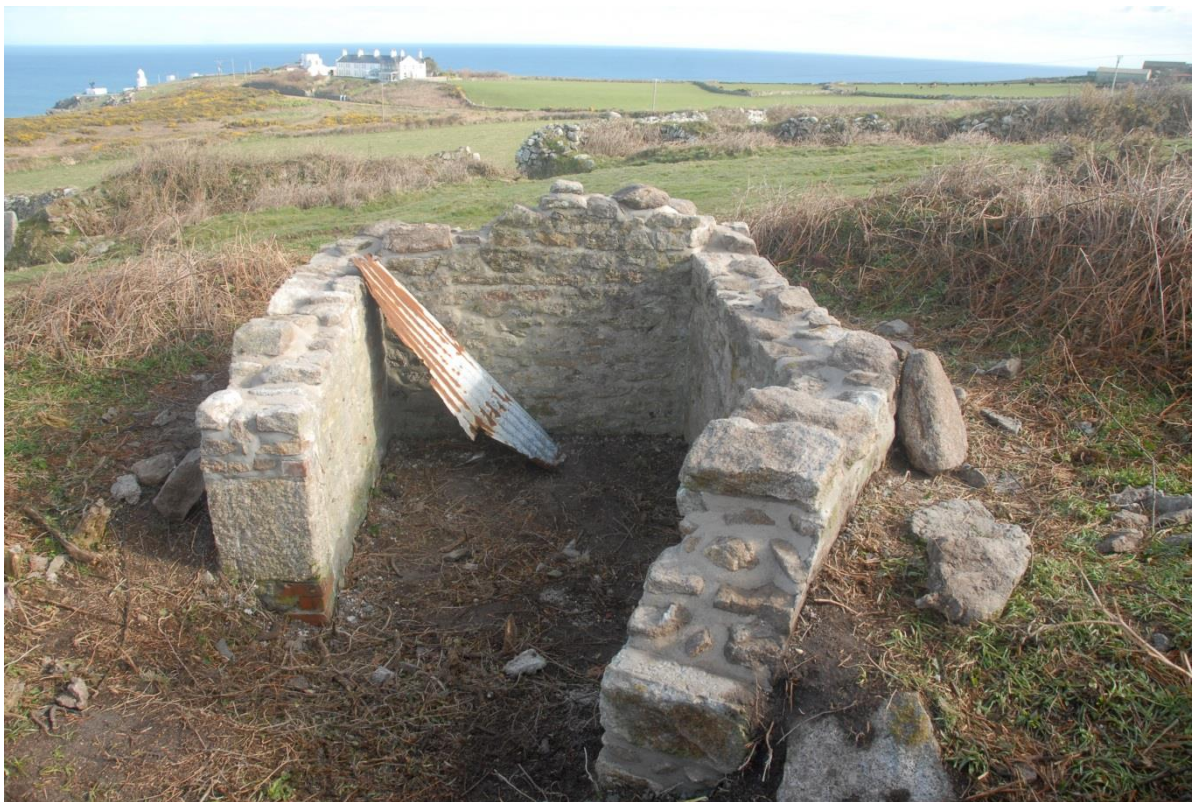
Fig 80. The completed conservation works to the probable powder house.

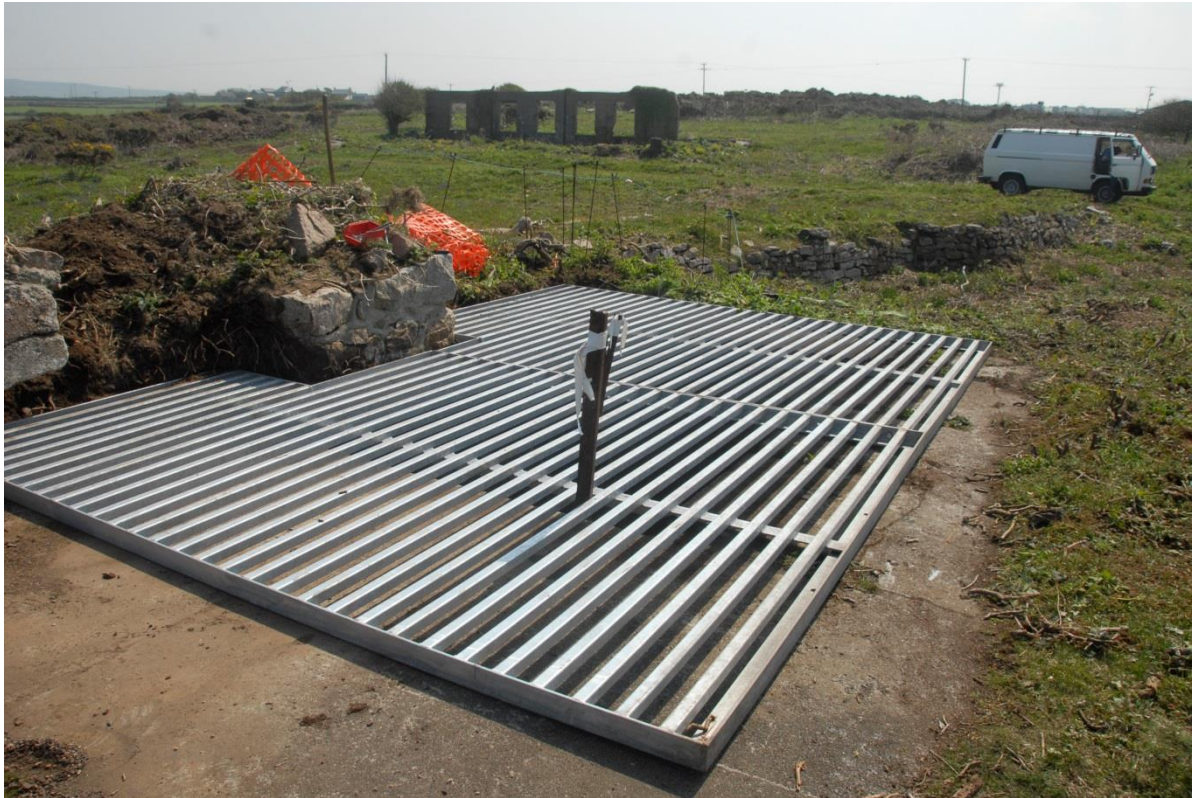
Fig 86. The completed Trease Shaft grille in place.
