Poltesco Mill House, Cornwall Historic building record

2015R036

The National Trust

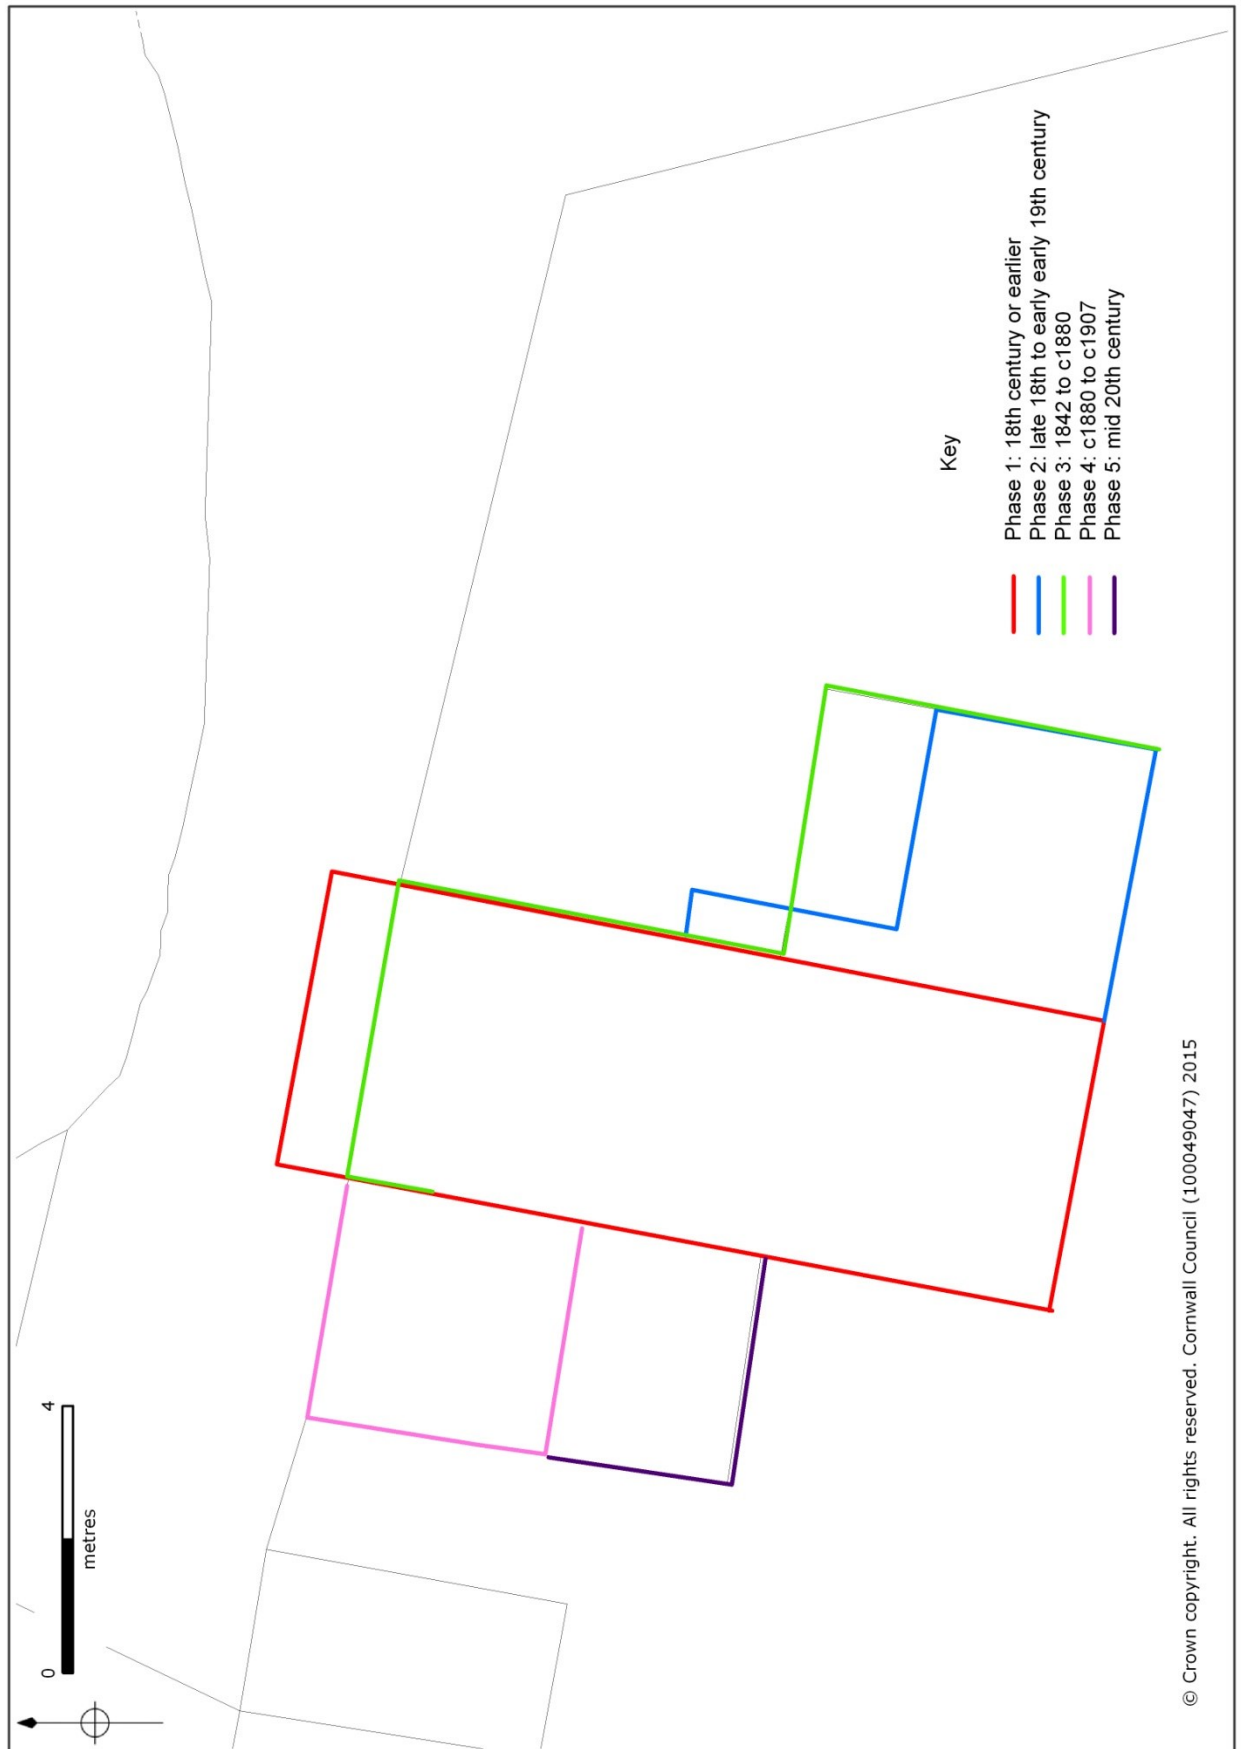
Fig 13 Phase plan of the Mill House

During the survey five major phases of construction and remodelling were identified. Although the initial construction date remains unknown it seems likely that the house was first built in the 17th or 18th century. The first available plans of the house were surveyed in the second half of the 18th century in c1770 (see Figs 4 and 5) and from these plans it is clear that the original building was a rectangular structure aligned north-south. For a basic plan indicating the locations of the numbered phases of the house see Figure 13.

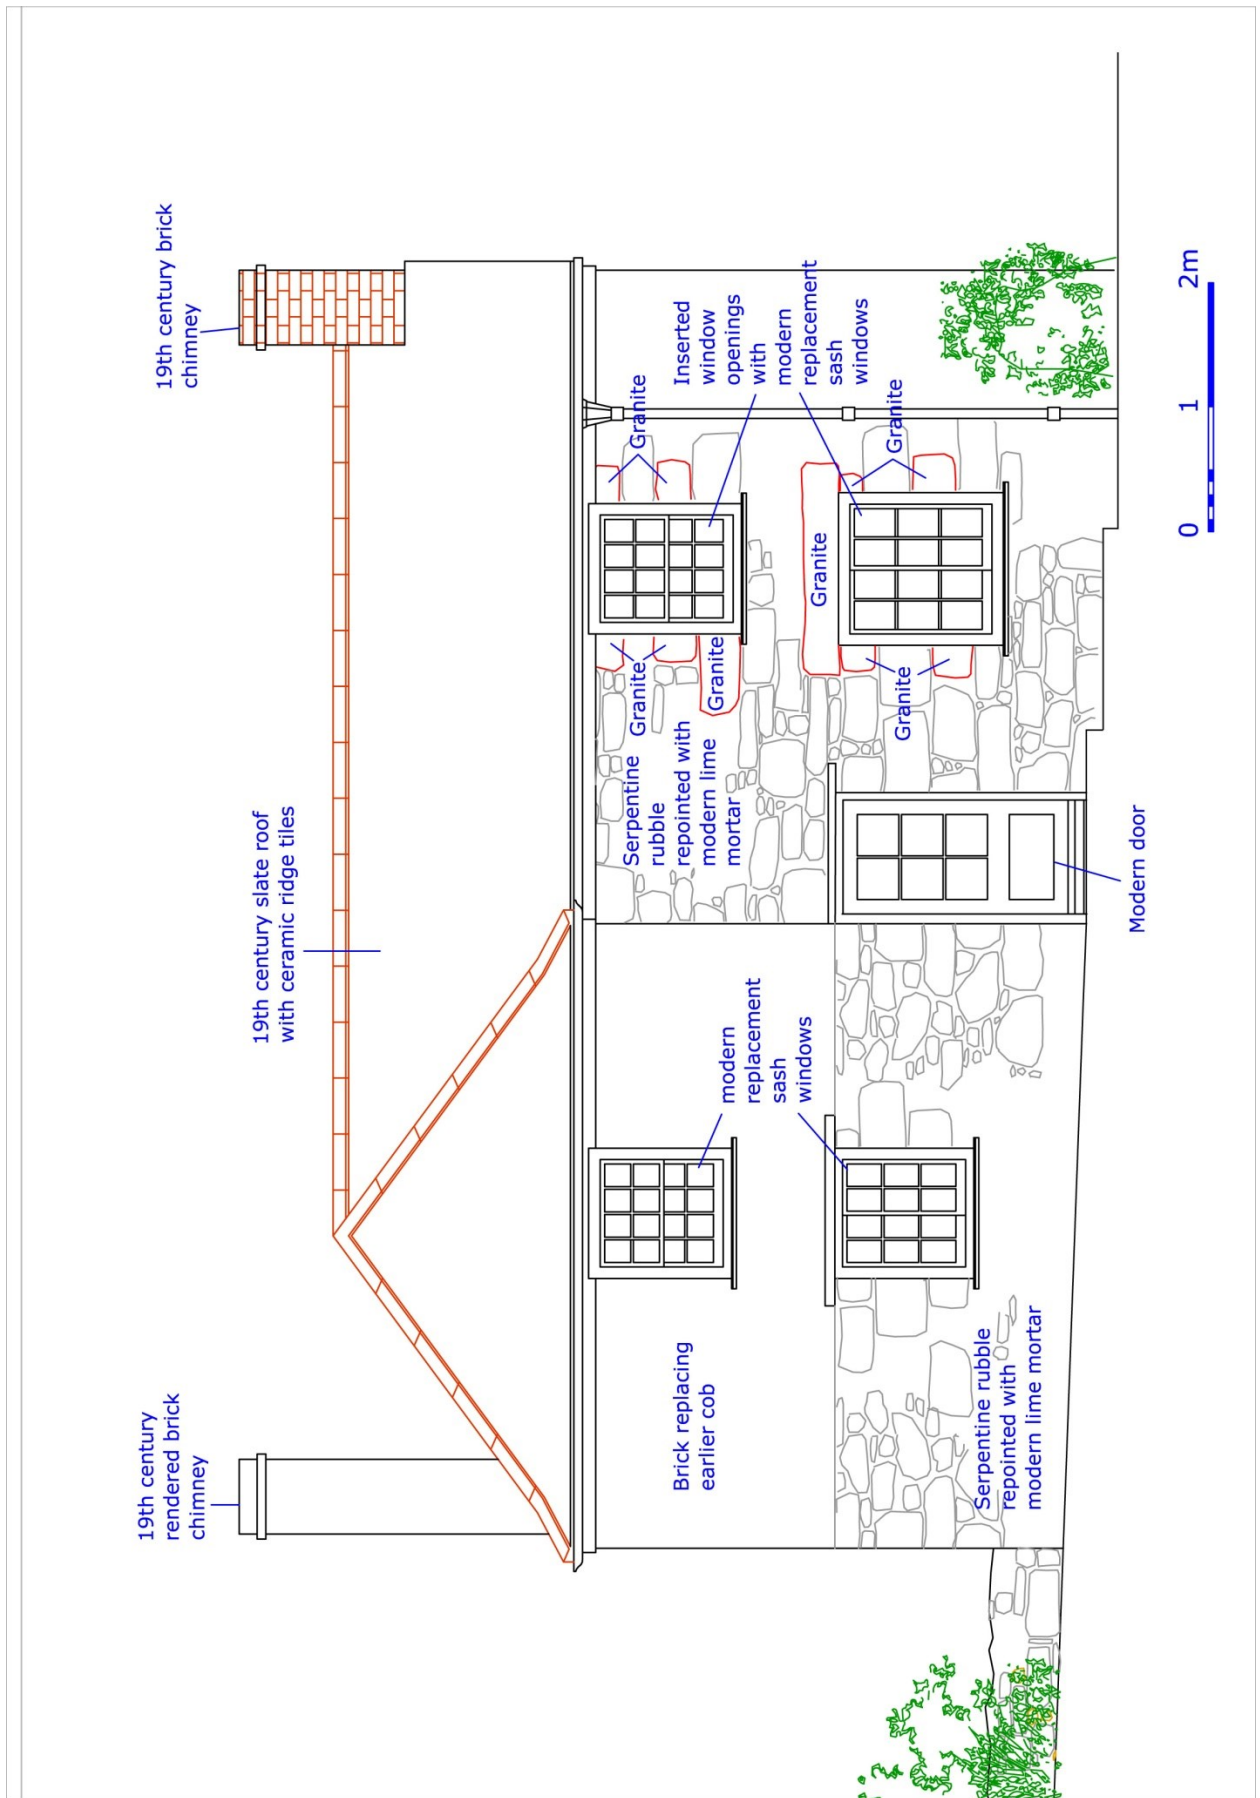
Fig 16 East (front) elevation

This elevation comprises the phase 2/3 east wing to the south and the altered phase 1 wall to the north. The east wing elevation is probably part of the phase 3 build comprising serpentine rubble wall at ground floor level and white painted brick at first floor level. The two window openings are part of the phase 3 build but now have replacement modern sash windows to match those that were removed.

The phase 1 serpentine rubble wall to the north has most probably been refaced or partially rebuilt since the two large window openings are clearly later 19th century insertions with granite used in the jambs and a granite lintel in the ground floor opening. Both sash windows are modern replacements to match those removed. The front door opening appears to be original with serpentine jambs and a replacement timber lintel. It now has a modern half-glazed door.

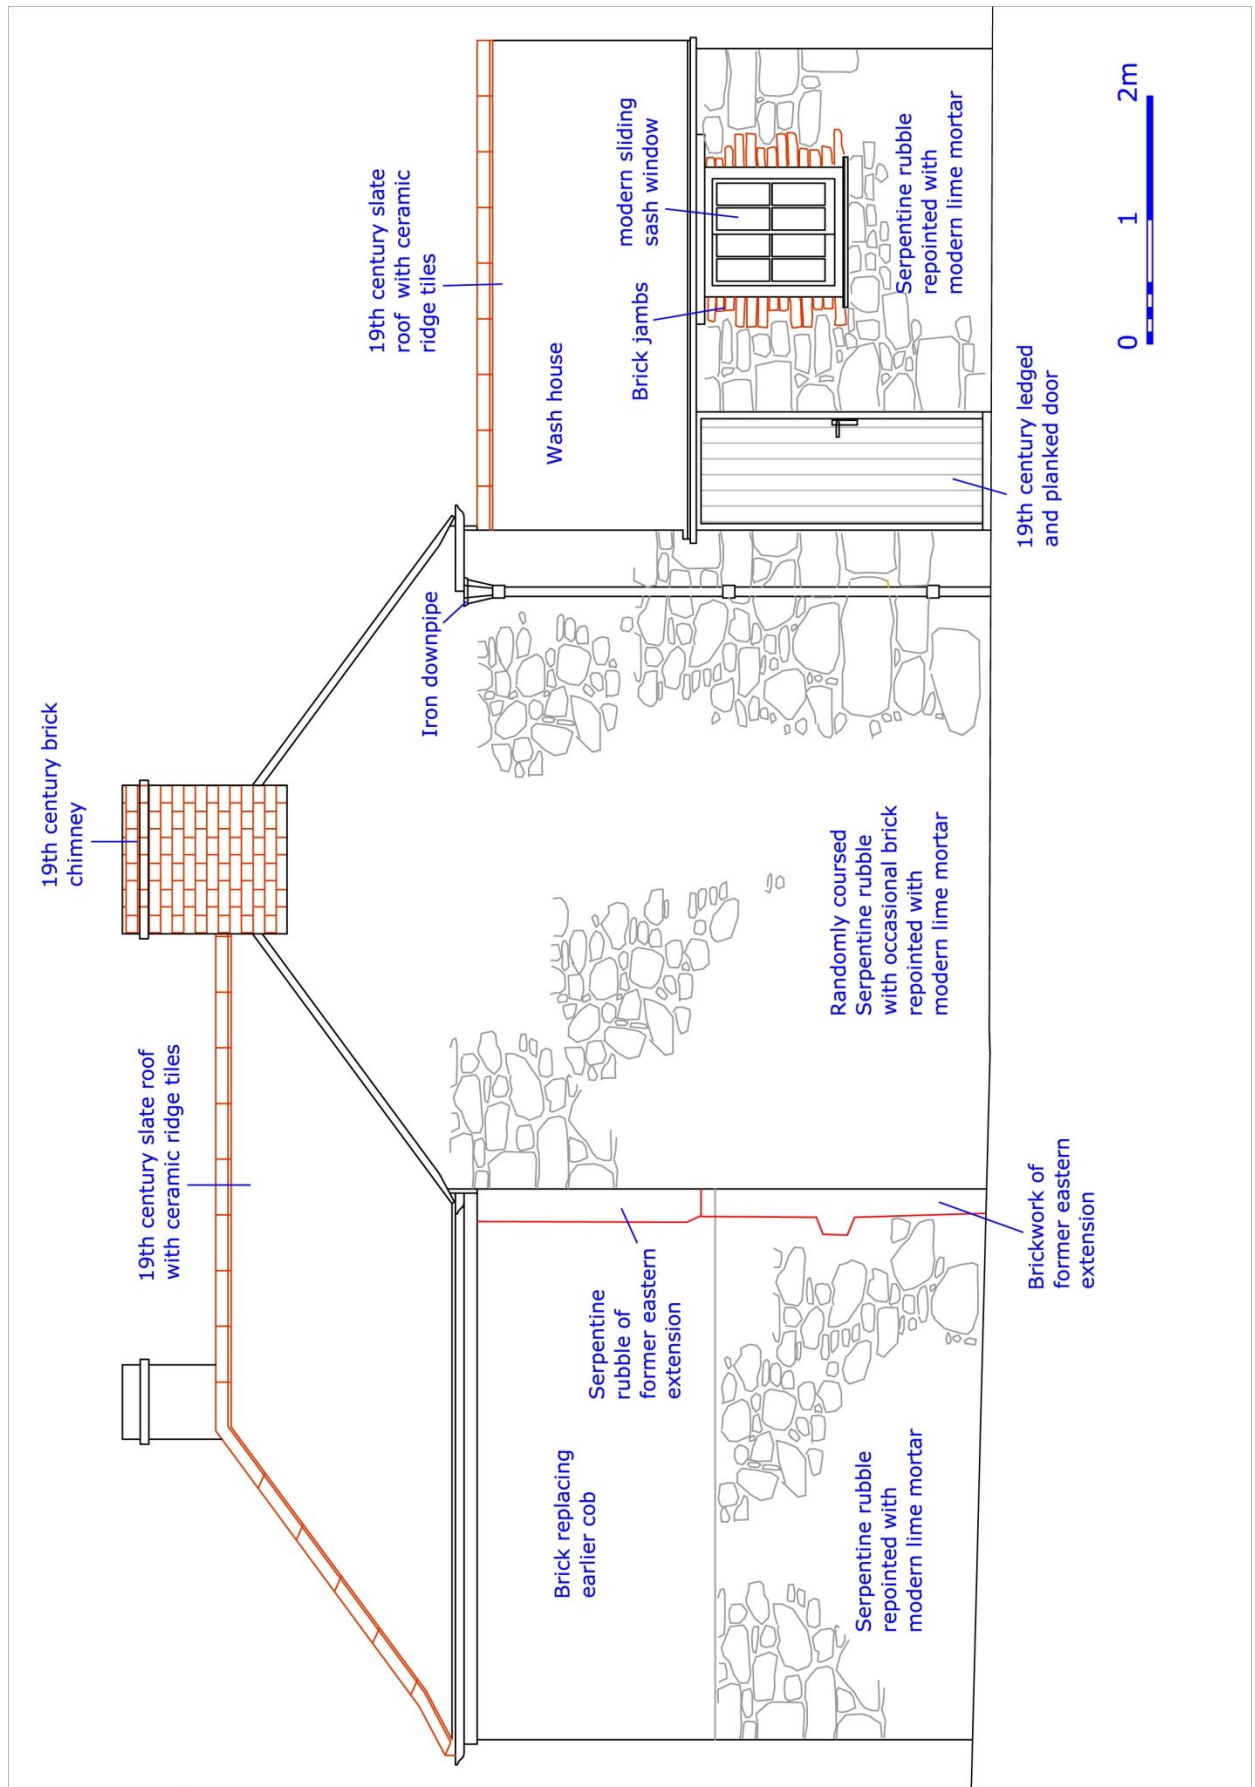
Fig 17 North elevation

This elevation comprises the phase 2/3 east wing to the east, the phase 3 rebuild of the phase 1 north wall and the north wall of the phase 4 wash house/ dairy extension. The east wing elevation is part of the phase 3 build comprising serpentine rubble wall at ground floor level and white painted brick at first floor level, although at the point where it meets the phase 1 house, a narrow strip of earlier walling relating to the phase 2 possible porch structure survives.

The north gable of the original house was probably rebuilt during phase 3. It is constructed from serpentine rubble but has occasional brick used as snecking and a brick-built chimney.

The phase 4 wash house/ dairy is also constructed from serpentine rubble and has original openings including a window opening with brick jambs and a modern sash window and a door opening with serpentine jambs, timber lintel and 19th century ledged and braced door.

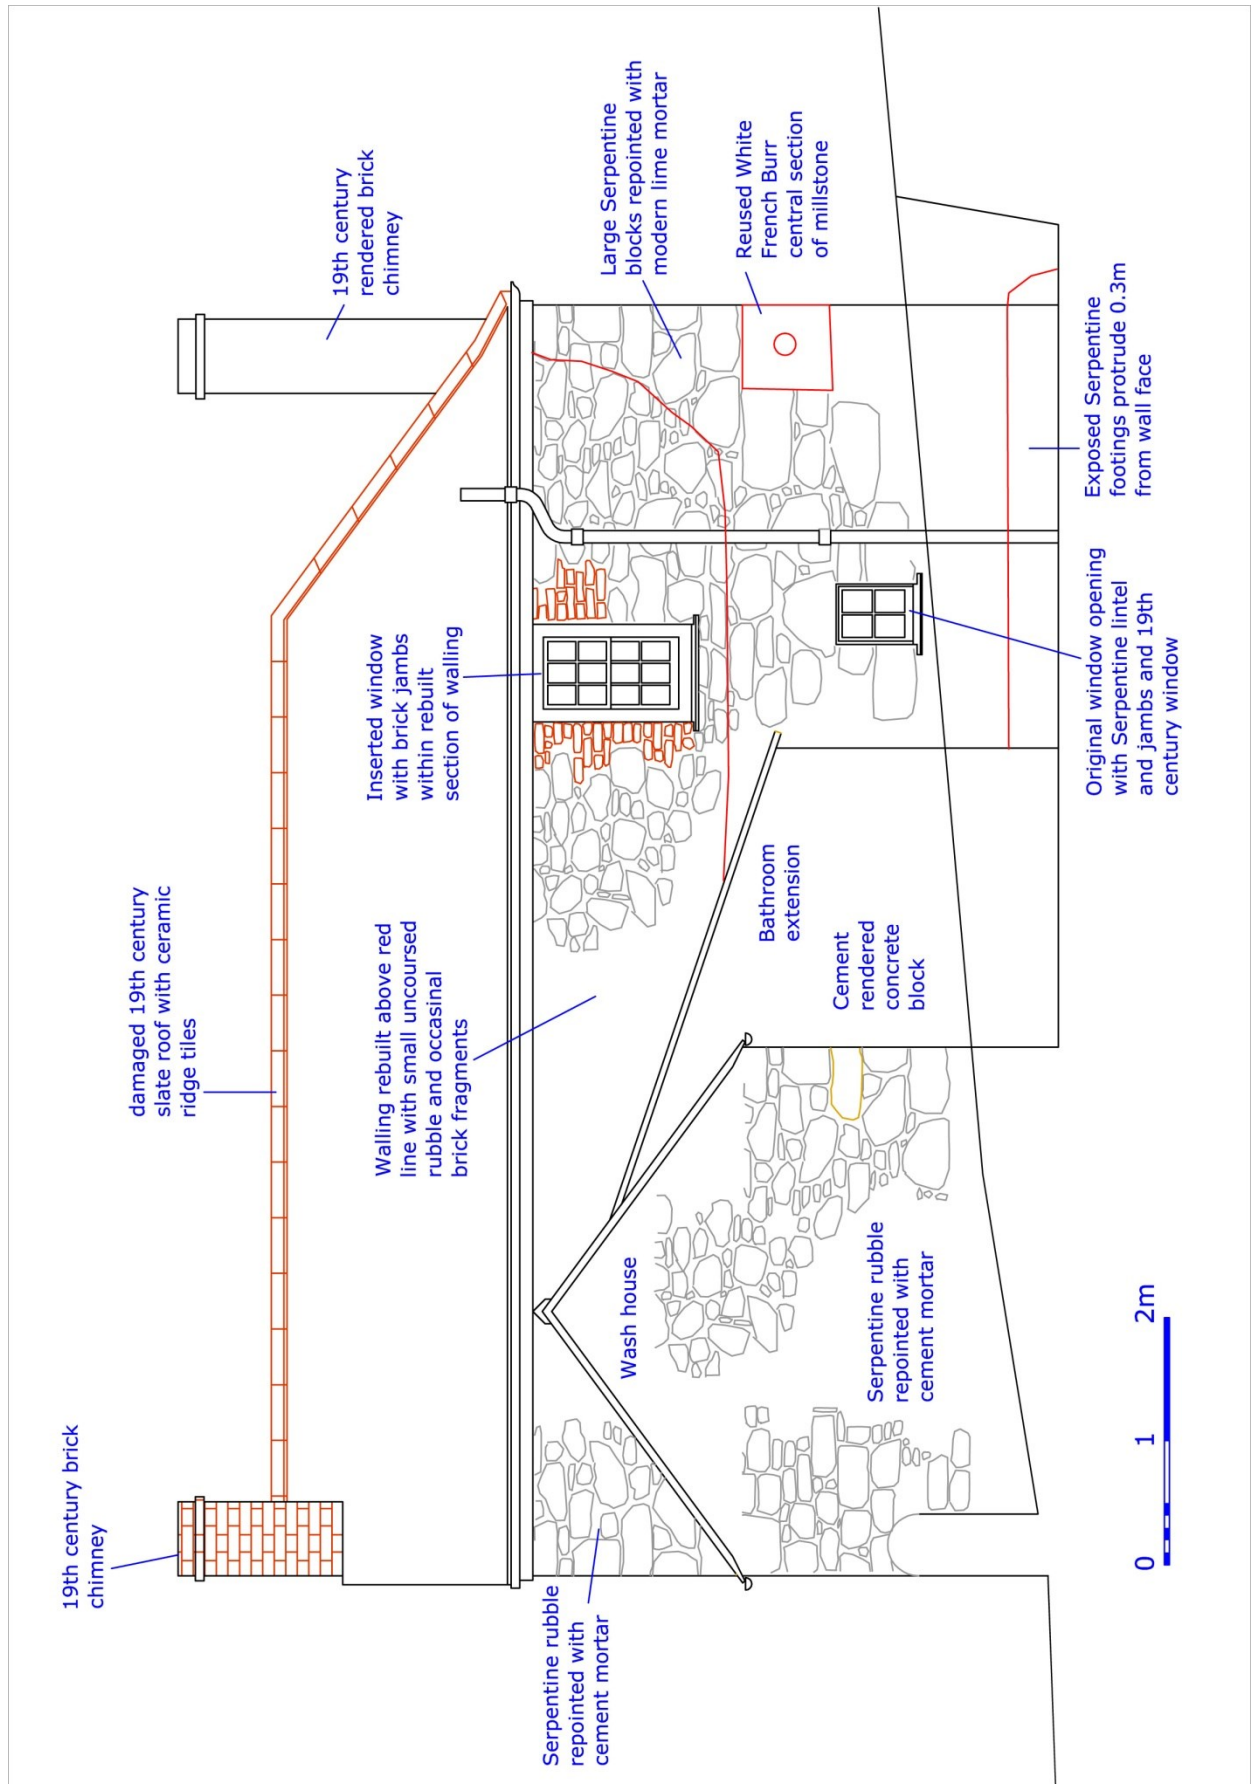
Fig 18 West (rear) elevation

This elevation comprises the west gable of the phase 4 wash house/ dairy extension, the phase 5 bathroom extension and the phase 1 west wall. The west gable of the wash house/ dairy is constructed from serpentine rubble and has been repointed with a cement mortar. The chimney on this gable shown on old photographs (Figs 11 and 12) has been removed.

The phase 5 concrete block-built bathroom lean-to has been finished with a cement render.

Behind these two extensions lies the west wall of the phase 1 house. Much of the first floor walling has been rebuilt (probably during phase 3 when the north wall was rebuilt). It is constructed from small, un-coursed serpentine rubble containing occasional fragments of brick and within this rebuild a window opening has been inserted. The first floor window opening has brick and serpentine jambs and a modern replacement sash window. The phase 1 walling below the upper rebuild is very different in character; it is built from large, roughly coursed serpentine blocks and contains a small, original window opening towards the south end. This opening has serpentine jambs and lintel, a slate sill and contains a 19th century four-pane window. Incorporated within the south quoin there is a square central section of a composite millstone made from granite (c17th or 18th century). At the base of the southern half of the wall the footings have been exposed. They comprise very large, serpentine blocks which protrude approximately 0.3m from the face of the wall.

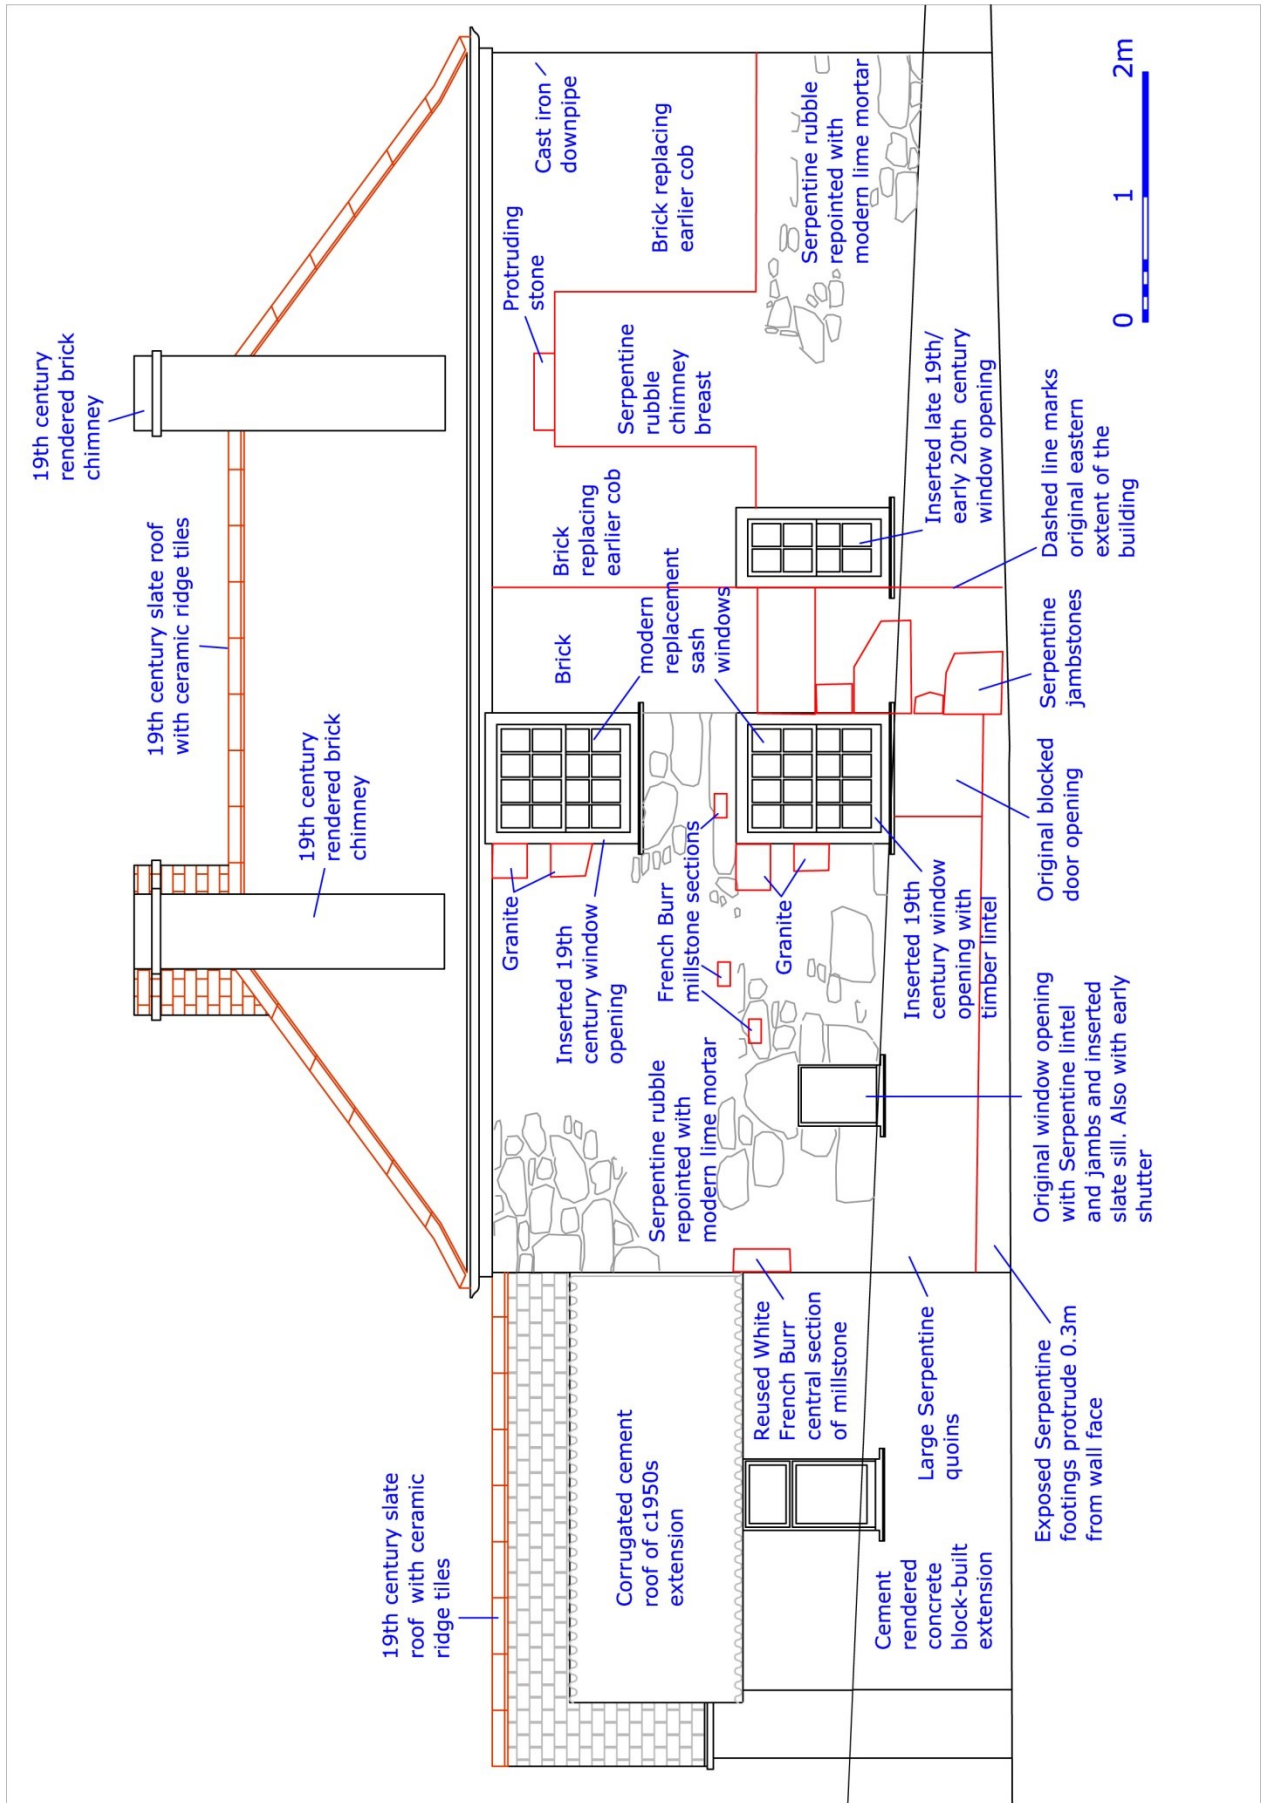
Fig 19 South elevation

This elevation comprises the phase 1 south wall to the west and the phase 2/3 east wing to the east. The phase 1 building would originally have extended as far as the narrow inserted window in the east wing. The phase 1 wall has an original, small window opening at ground floor level to the west with granite jambs and lintel and an inserted slate sill. It has an internal 18th or 19th century shutter and modern timber ventilation grille. To the west of this, two large window openings were inserted during phase 3 after the removal of the original phase 1 front (east) wall. This is also evidenced by the use of granite in the west jambs. Both openings have modern replacement sash windows designed to match those that have been removed. The ground floor window opening has been inserted in the position of a phase 1 door opening which can be seen as a blocking between two straight joints in the walling below the sill. A cement rendered brick chimney stack springing from the roof just to the west of the two windows was also inserted during phase 3. The breast is incorporated within the width of the wall and serves an inserted phase 3 fireplace at ground floor level. At the base of the phase 1 half of the wall the footings have been exposed. They comprise large, serpentine blocks which protrude approximately 0.3m from the face of the wall.

The east wing elevation is probably part of the phase 2 build comprising serpentine rubble walling at ground floor level and white painted brick at first floor level with the exception of a serpentine rubble-built chimney located in the central part of the east wing elevation. This rubble chimney structure does not extend to the full height of the present wall, falling 0.4m short, which indicates that it is likely to have belonged to a slightly lower phase 2 structure. The first floor brick walling is likely to be a phase 3 replacement of phase 2 cob walling. The narrow window at ground floor level to the west of the chimney is an insertion, probably added during phase 4 in the late 19th or early 20th century.

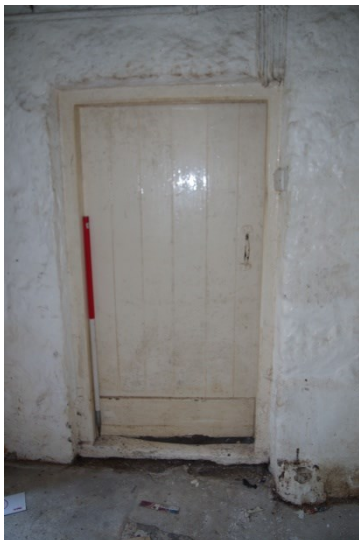
Fig 35 Former back door from kitchen showing differing wall widths either side

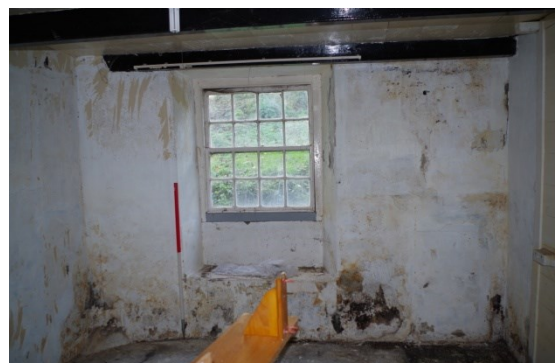
Fig 55 Interior study looking south showing truncated former front wall to left, blocked inserted fireplace to right and former door opening with inserted window

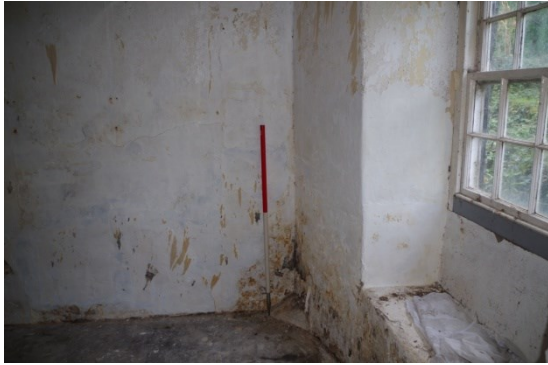
Fig 56 Interior study showing remaining base of demolished front wall

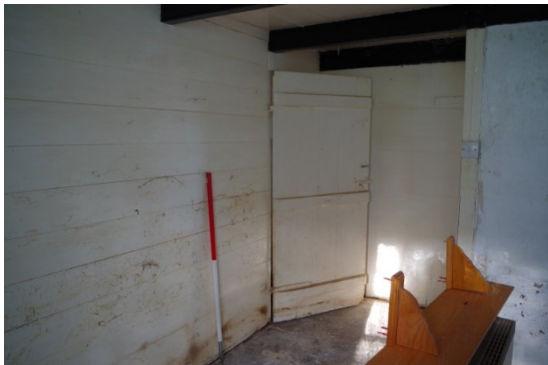
Fig 57 Interior study showing inserted 19th century planked wall

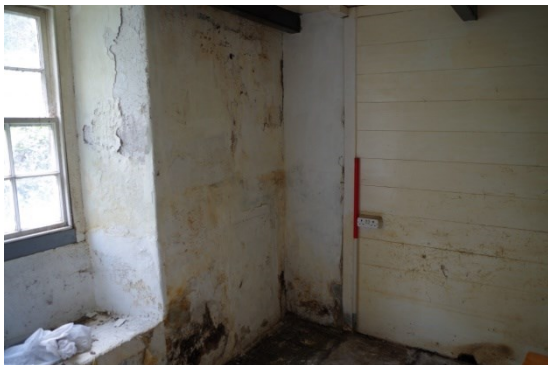
Fig 58 Interior study looking south-west showing inserted 19th century planked wall abutting earlier partition
