Dodman Point, St Goran, Cornwall Archaeological Assessment and Management Plan

Archaeological Assessment and Management Plan

Client	Miss E Letcher
Report Number	2014R086
Date	June 2015
Status	Final
Report author	Dr Fiona Fleming ACIfA
Checked by	Charlie Johns
Approved by

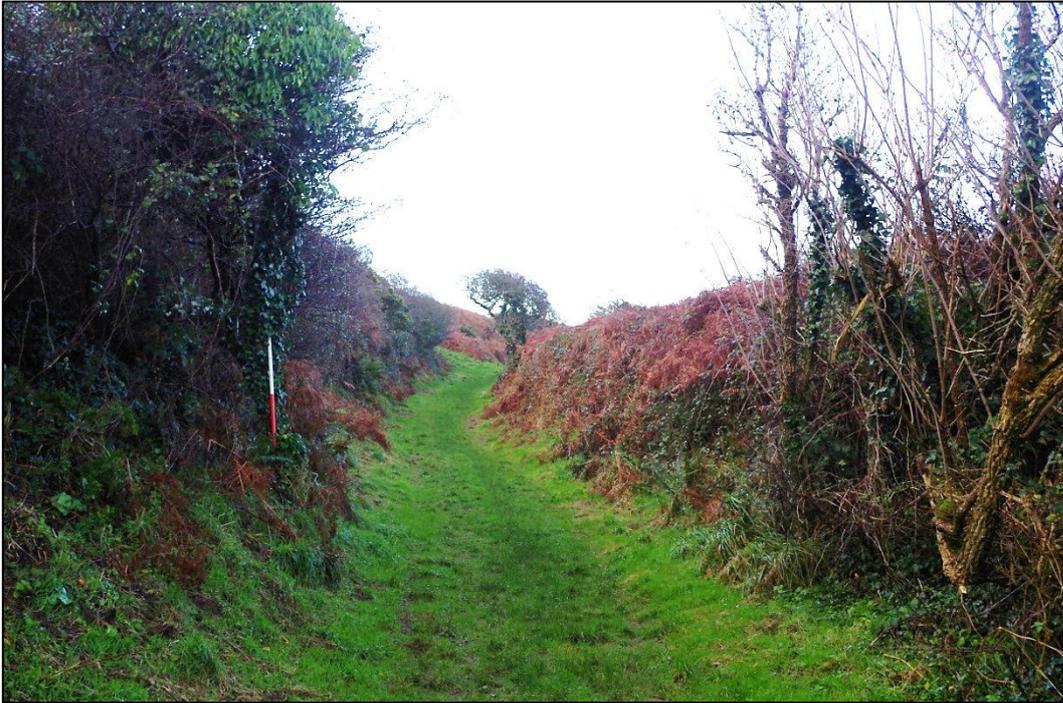
Fig 3 Looking westwards along the trackway between The Bulwarks. The ramparts are under cover of bracken and scrub with some small to medium trees and these are encroaching onto the trackway

The clearance of the majority of bracken and scrub (around 80% in total) from The Bulwarks is recommended to restore the visual experience of the prehistoric ramparts and interior ditch. Clearance of scrub from the trackway and the up casting or removal of slumped materials would open up the trackway to provide better and drier access to the headland, hopefully avoiding the need for further breakthrough of the ramparts by walkers attempting to access the headland and coastal paths. This approach would be relatively un-intrusive and could still allow for some scrub cover to be maintained for nesting birds and other wildlife. In particular, retaining some cover in the area of The Bulwarks inhabited by the protected fairy shrimp would be optimal, although this could lead to this part of the trackway being less accessible at times.

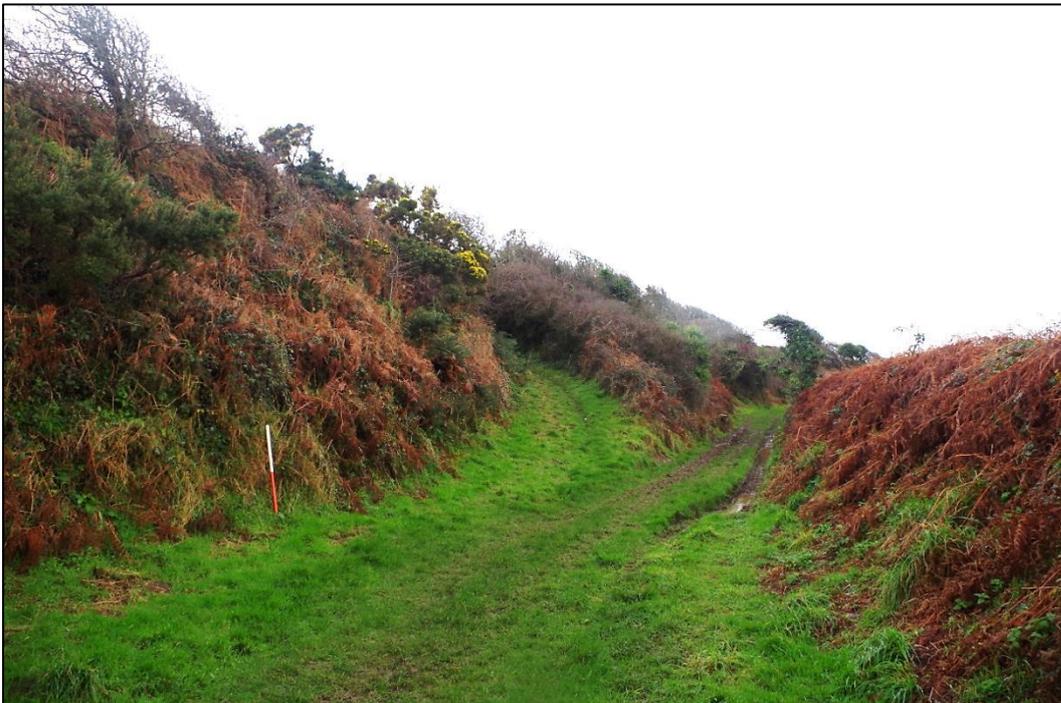
Fig 4 Looking southwest towards one of the field lanes cut through the southern rampart of The Bulwarks. Some slumping of rampart materials is apparent and rampart materials may have been used to bolster the field lane to the west

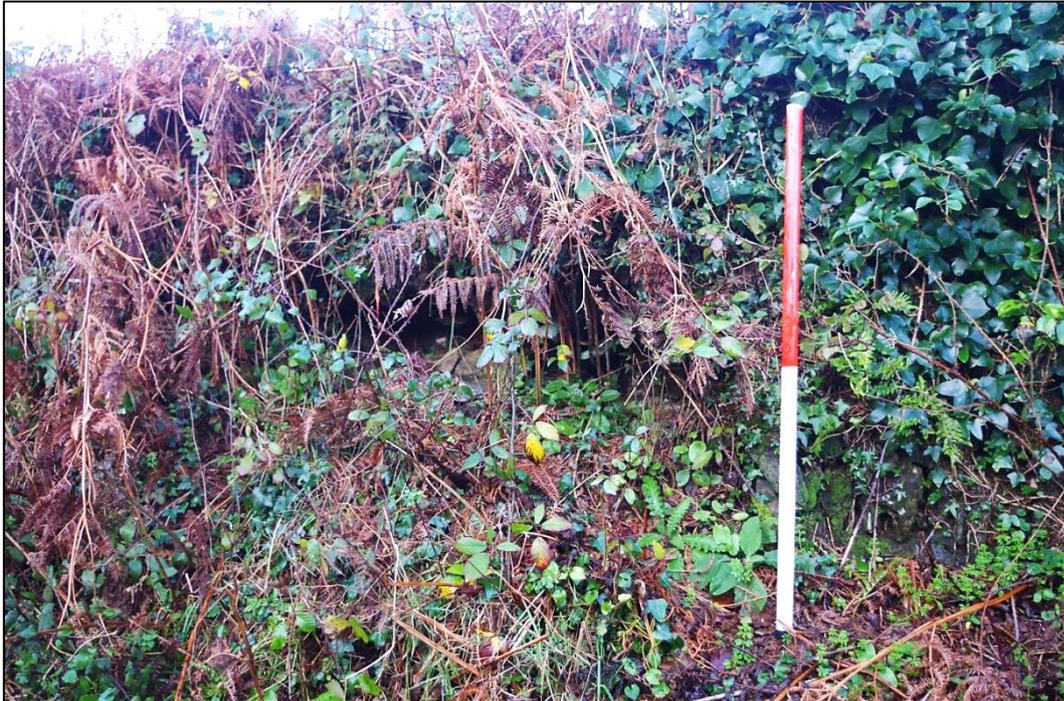
The extent of any potential damage to The Bulwarks through animal burrowing or erosion is not easy to assess given the present level of vegetation cover. Some burrows are visible through the vegetation (Fig 5) and there are some areas of the bank that have eroded out or been subject to patch repairs. Some slippage has occurred in places and areas of overburden from the banks are visible on the trackway (Fig 6). Three areas of urgent need have currently been identified (Figs 7, 8 and 11), although others may become apparent once vegetation clearance commences. A programme of targeted erosion repair and archaeological recording is recommended for the areas currently identified. Erosion repairs and any associated evaluation and recording will require Scheduled Monument Consent before works begin.

Fig 5 Signs of animal burrows in the Cornish hedging of the northern rampart of The Bulwarks

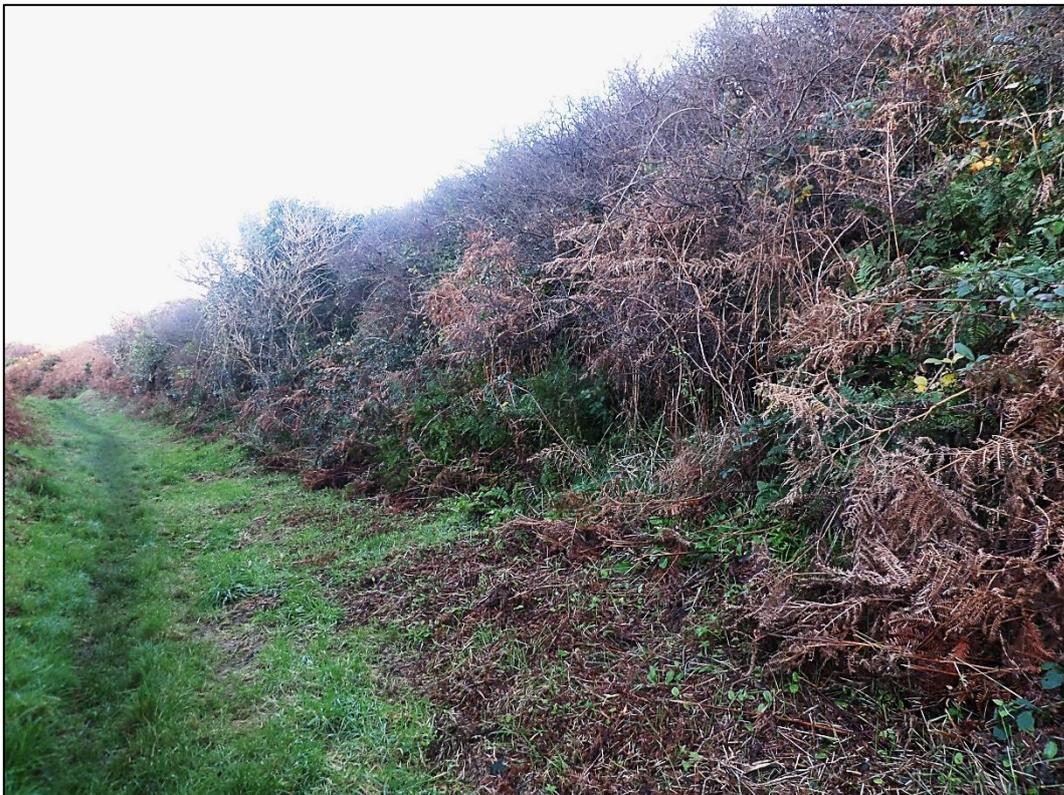
Fig 6 Slippage of materials from the southern rampart of The Bulwarks onto the trackway, looking east

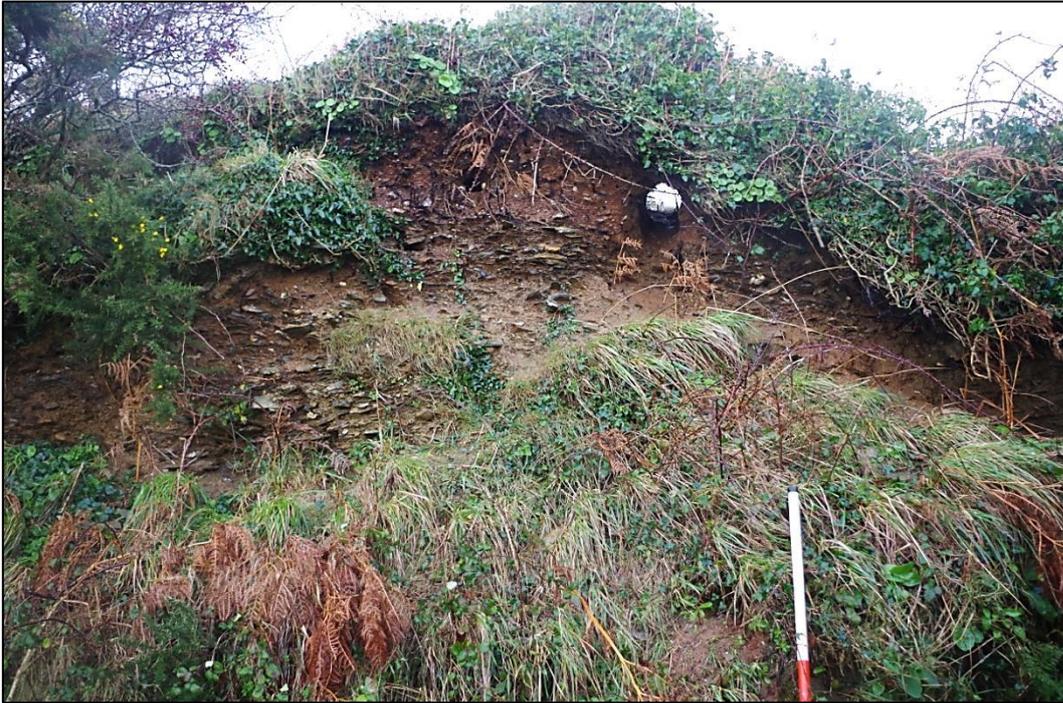
Fig 7 Severe erosion and animal burrowing on part of the southern rampart of The Bulwarks, looking southeast from one of the field lanes

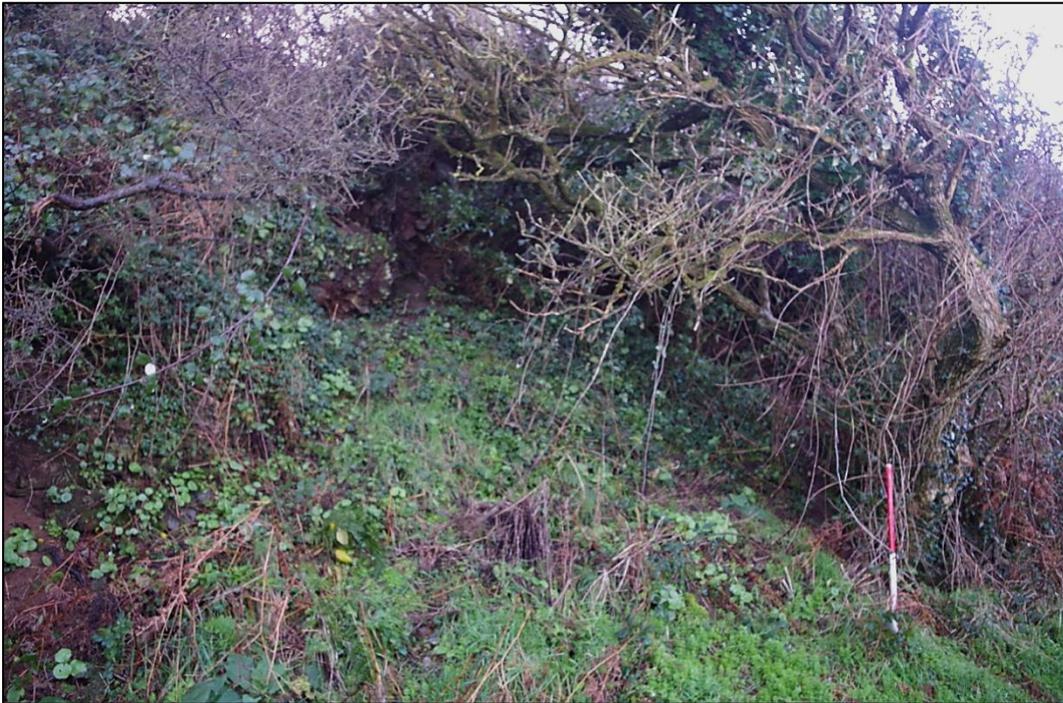
Fig 8 Eroded profile of the southern rampart towards the western end of The Bulwarks, looking southwest; small scrubby trees and bracken are obscuring the view

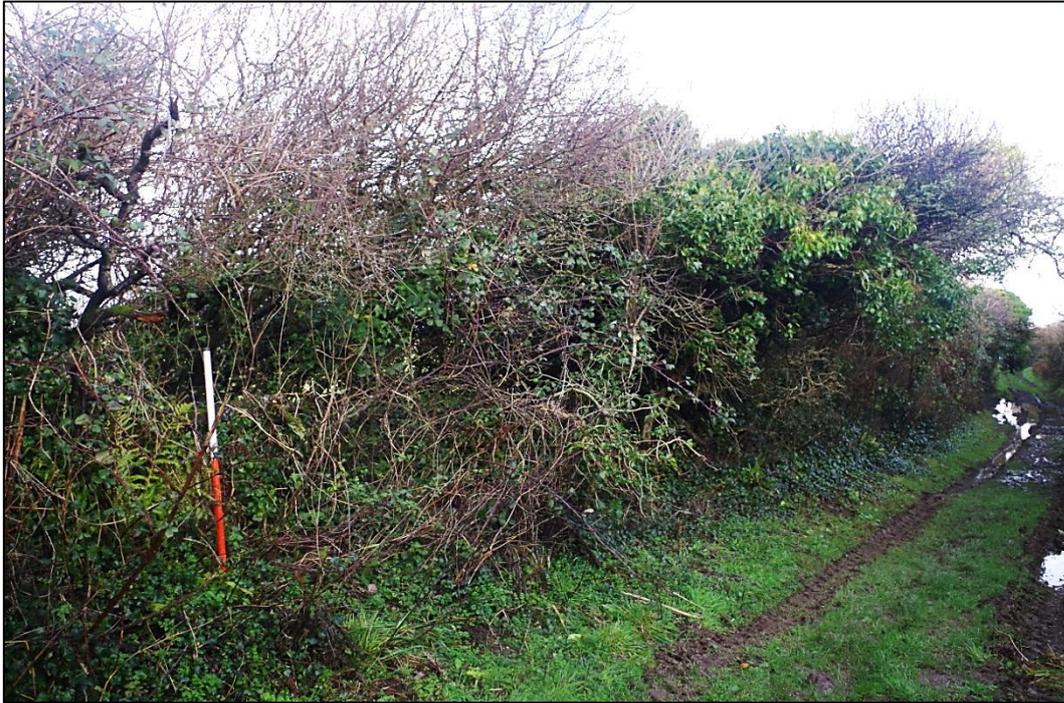
The northernmost rampart has been modified along much of its line for re-use as field boundaries, with sections of Cornish stone hedging facing parts of the inner bank along the trackway and former ditch (Fig 9). Along these sections the vegetation cover is notably less than where sections of the earth and stone ramparts remain. There has been some damage by animal burrowing, although this cannot be fully assessed at present. Blackthorn and gorse top the Cornish hedge and there are some breaks in the walling where access to the western end of the trackway has been created by walkers. Bracken predominates along the sections of surviving rampart (Fig 10).

Fig 9 Cornish hedging has replaced sections of the northern rampart of The Bulwarks, obscured here by the cover of scrubby trees and some bracken, looking northwest

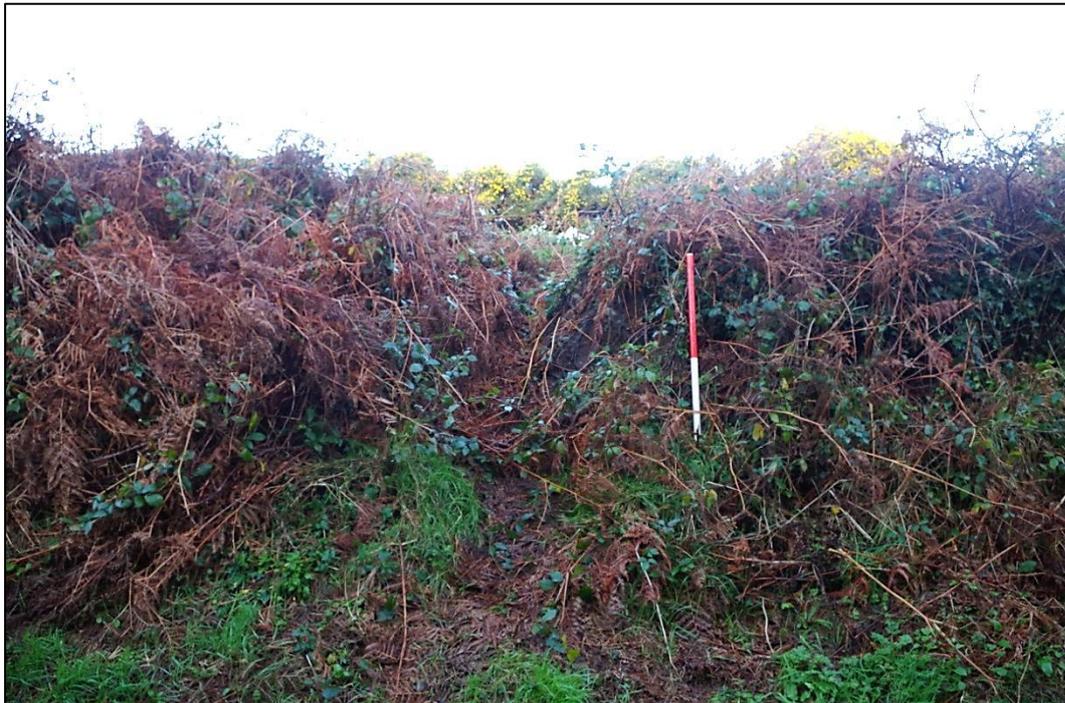
Fig 10 A break in the Cornish hedging of the northern rampart of The Bulwarks created by walkers seeking alternative access around the trackway, looking north. Bracken and ivy cover the walling which is topped by gorse

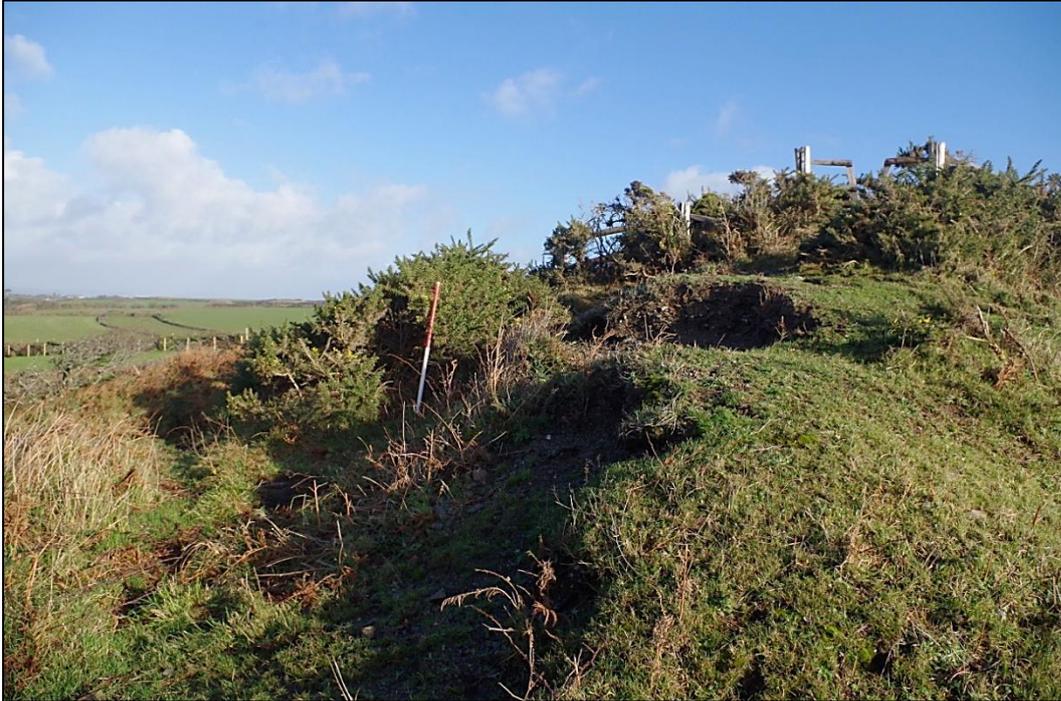
resulting spread of pedestrian traffic and now unrestricted movement of grazing stock along the coastal path (Figs 11 and 12). The ramparts on the eastern side fare better (Figs 13 and 14), although minor erosion along the coastal path should continue to be monitored in this area. There is also some visitor erosion around the area of the cross on the headland, which should be monitored for signs of deterioration.

Fig 11 Looking northeast across the western section of The Bulwarks on the west side of Dodman Point. The coastal path crosses the ramparts here and walkers and stock movement have caused severe erosion to the profile of the ramparts in this area

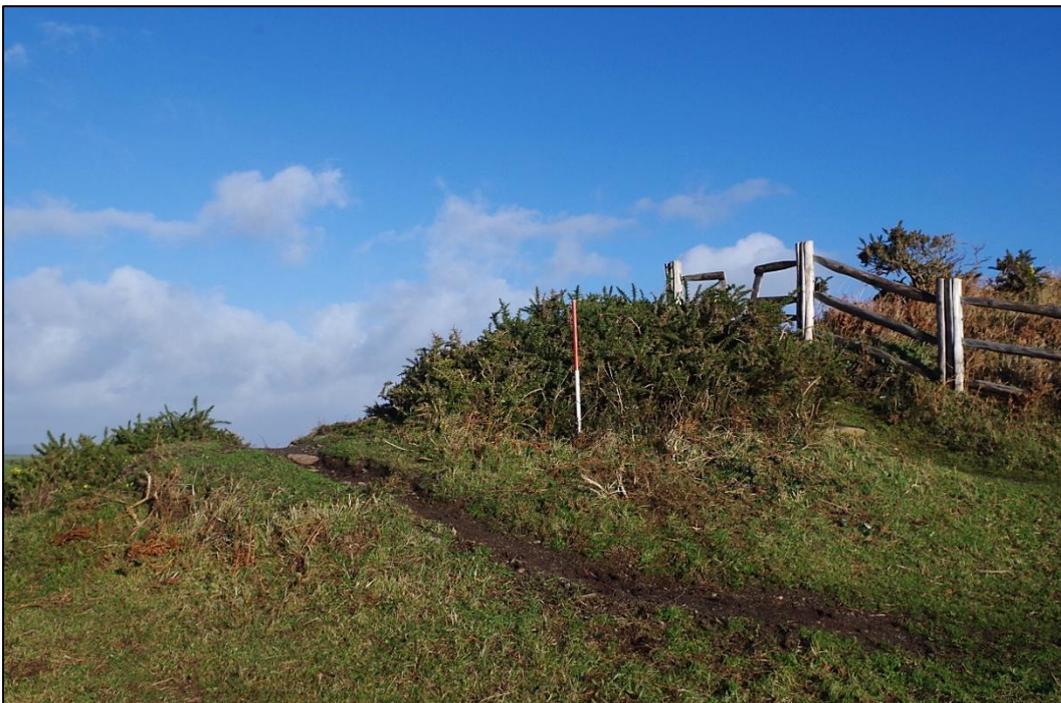
Fig 12 Looking northeast across the western section of The Bulwarks on the west side of Dodman Point where a worn path has been created by stock roaming freely along the coastal slopes

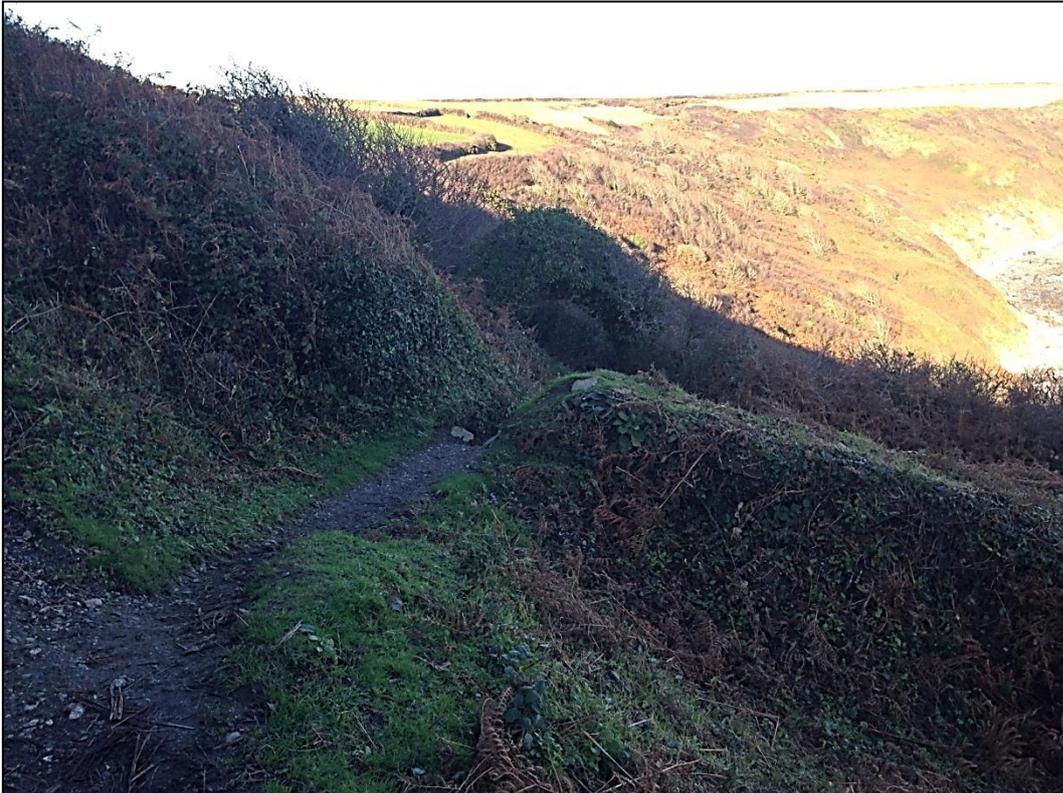
Fig 13 Looking north along the coastal path on the east side of Dodman Point where it crosses The Bulwarks. The path has caused some erosion but vegetation in this area has been cleared under the National Trust's scrub clearance programme

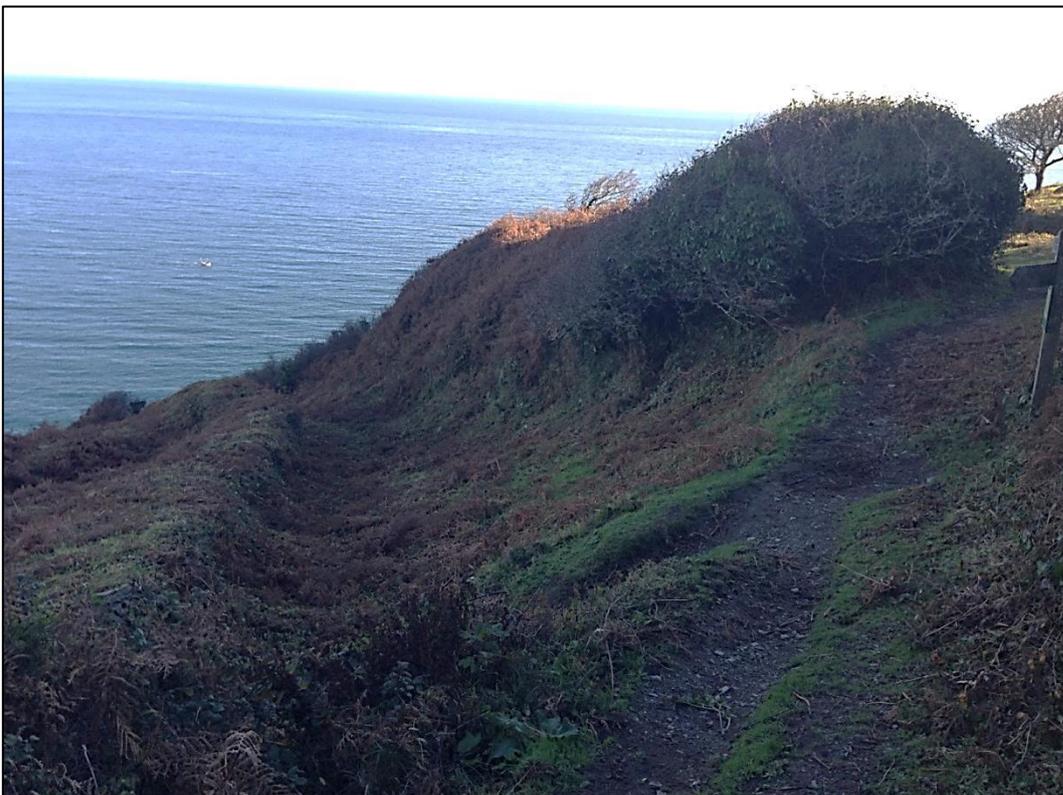
Fig 14 Unknown and undated earthworks on the east side of Dodman Point adjacent to the southern rampart of The Bulwarks, looking south. The coastal path crosses these from north to south

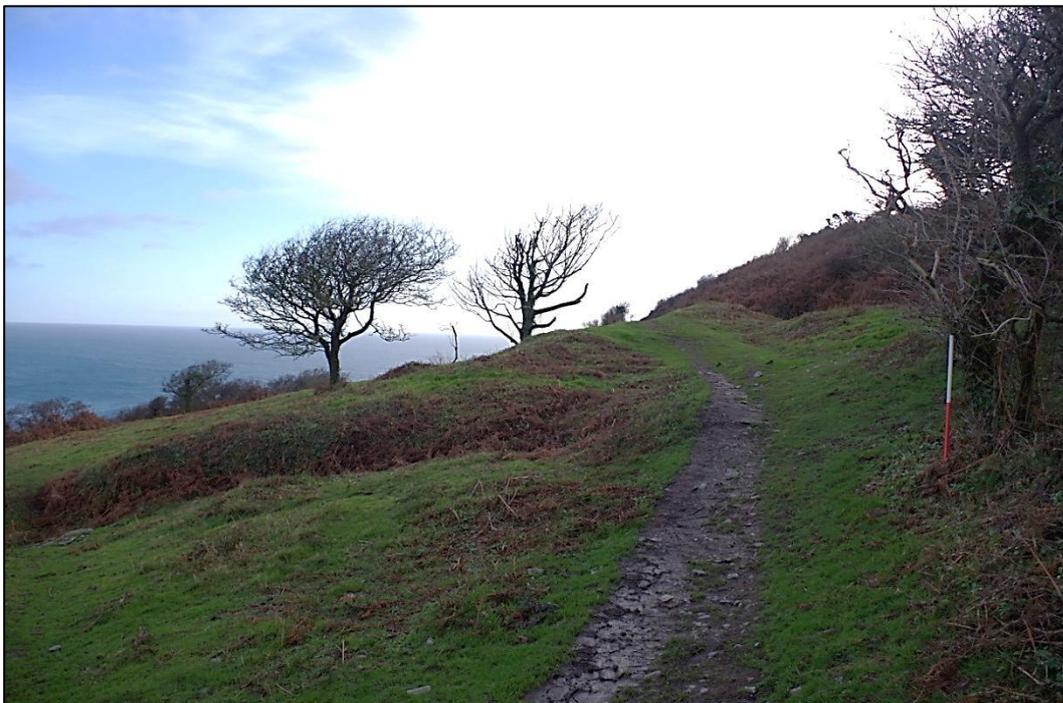
Fig 16 Unknown and undated earthworks on the east side of Dodman Point adjacent to the southern rampart of The Bulwarks, looking south. The coastal path crosses these from north to south

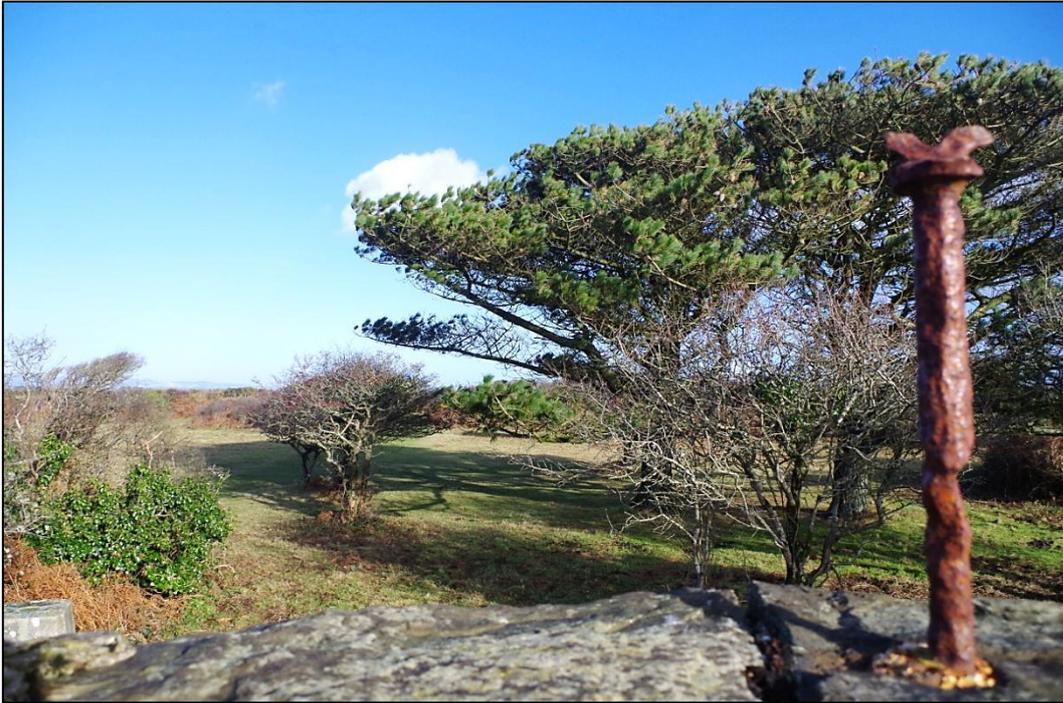
Fig 17 Looking northeast from the lookout platform adjacent to the watch house; cleared glades have been created, retaining some distinctive Monterey pines but the historic sightlines out to other signal stations on nearby coastal points remain obscured

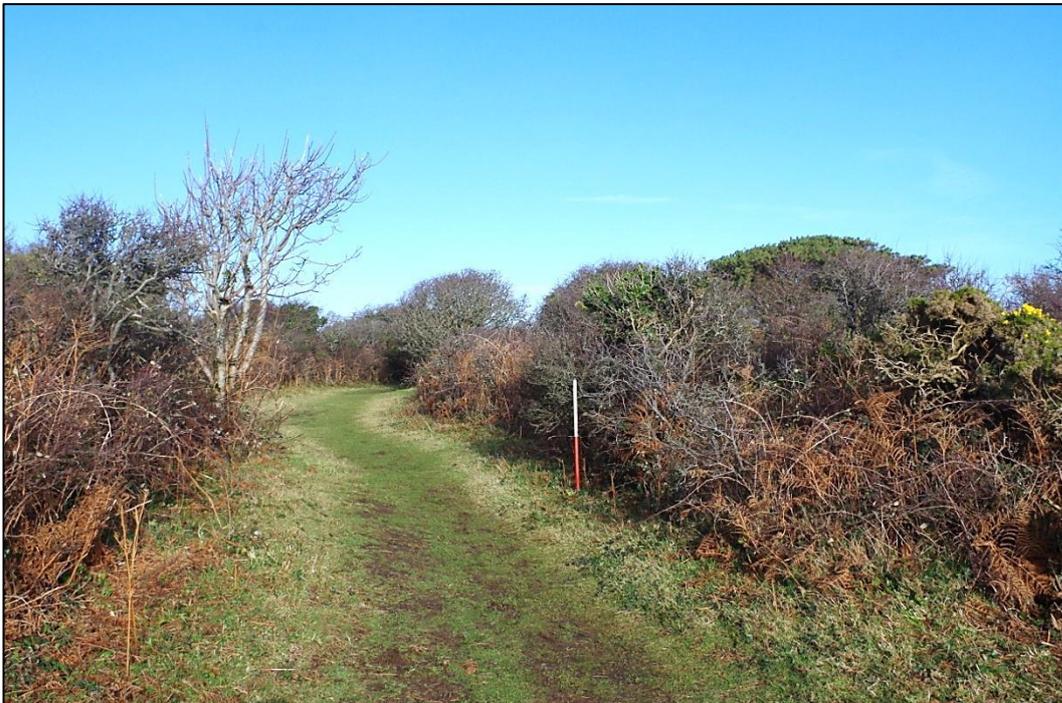
Fig 18 The pathway through the watch house enclosure from the east side of Dodman Point, looking southwest. The watch house enclosure still retains a large percentage of scrub and bracken cover, restricting access and blocking sightlines

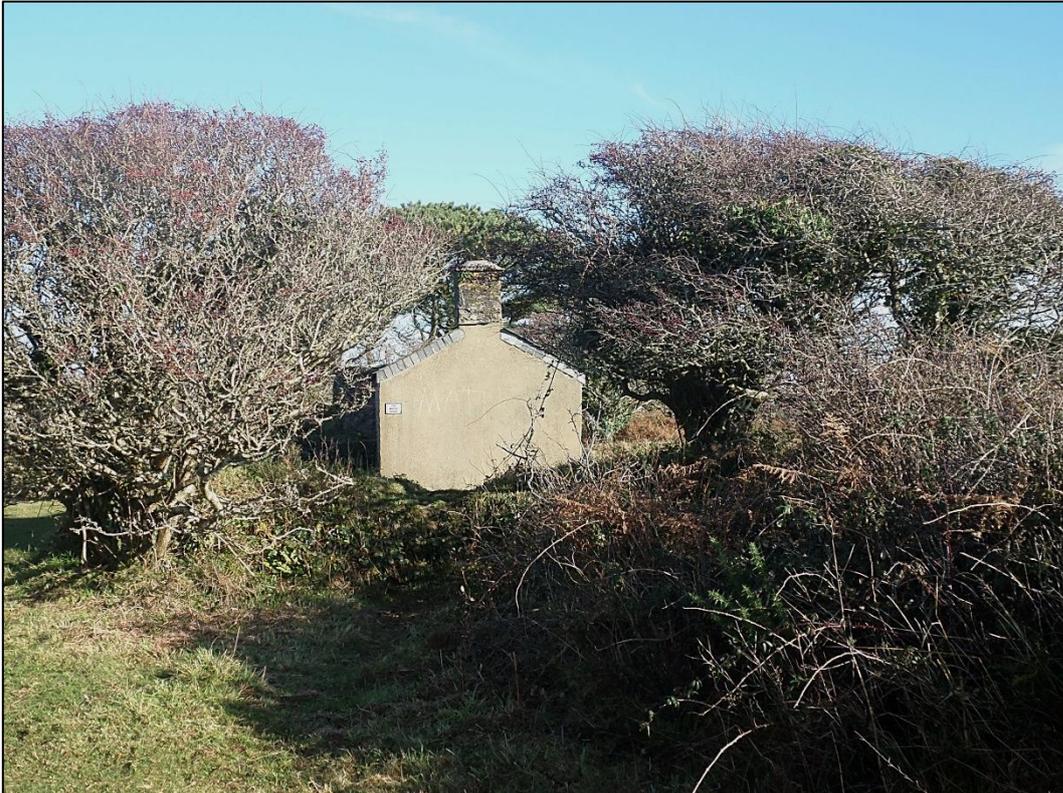
An assessment of the watch house itself (Berry 2014) has highlighted the need for repairs and consolidation to the watch house roof, window and walls (Figs 19 and 20). Climbing ivy is threatening the built fabric of the watch house and adjacent turret and platform and there is visible graffiti on the site, both historic and recent. The watch house grounds are cleared but the boundary walls would benefit from some repair and the gate into the enclosure would benefit from being painted in a more appropriate finish and oiled to make it easier to open; visitors are using other means of entry, causing damage to the external boundary walls. Some of the external ironwork on the site is rusting to the point of failure in places. Signage on the site is minimal and an information board would assist visitors to better understand and appreciate the site and its significance. It is currently understood that an information board has been commissioned by the National Trust through a recent RDPE funded project.

Fig 19 Looking towards the watch house and its small enclosure from the south. Although cleared of some scrub there is still some poor boundary definition and sightlines are obscured by scrub and large trees in places

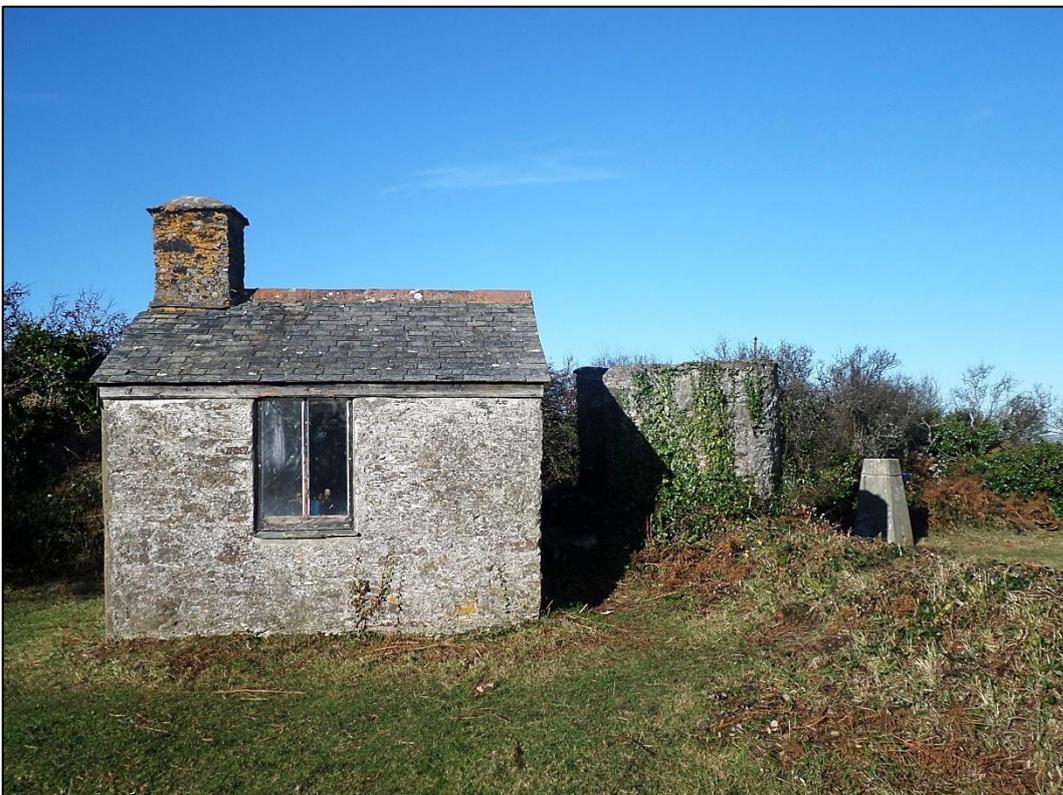
Fig 20 The watch house and lookout platform, looking northwest from inside the enclosure. Climbing ivy threatens the lookout tower and the walls of the watch house and the built structure shows signs of disrepair

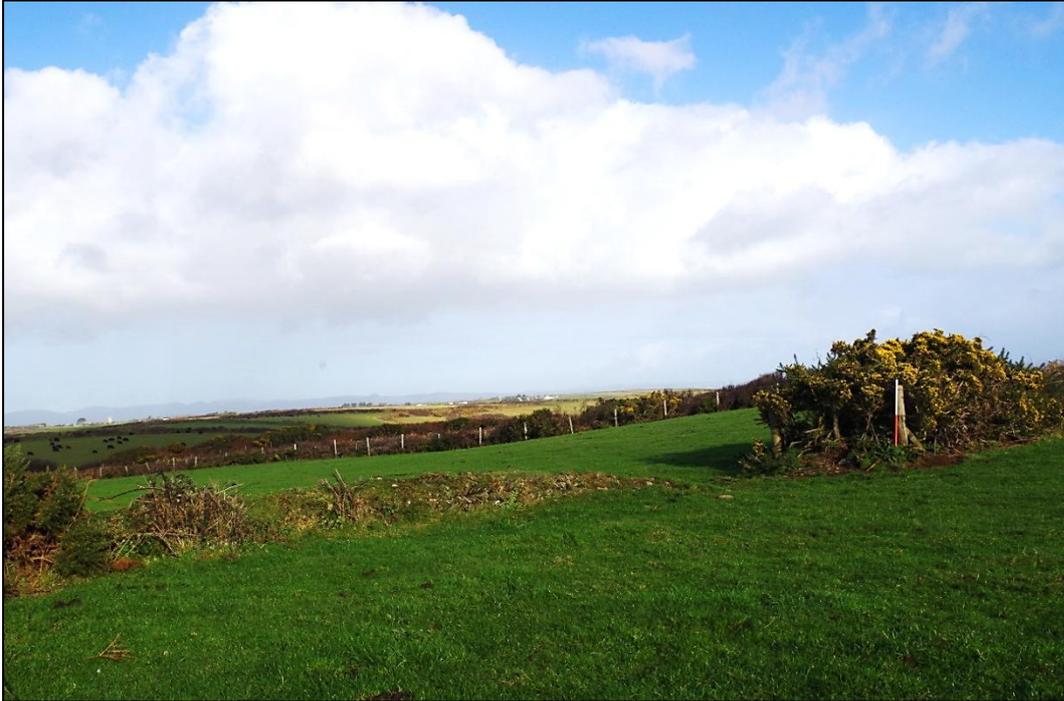
Fig 21 A section of the principal enclosure boundary along the east side of Dodman Point; partly eroded with gorse along the top of the surviving section. Looking northeast towards one of the two known barrows (MCO2549)

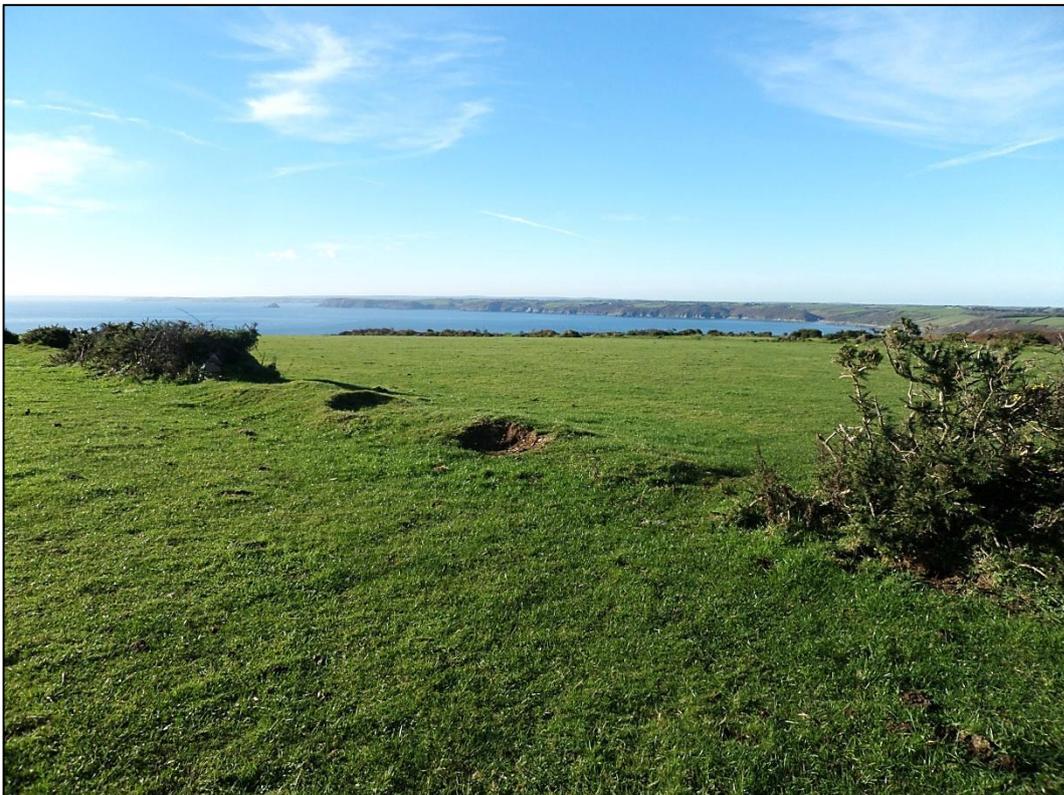
Fig 22 Looking northwest across one of the medieval strip boundaries on Dodman Point, partly eroded and denuded by stock movement and with low gorse along the surviving sections.

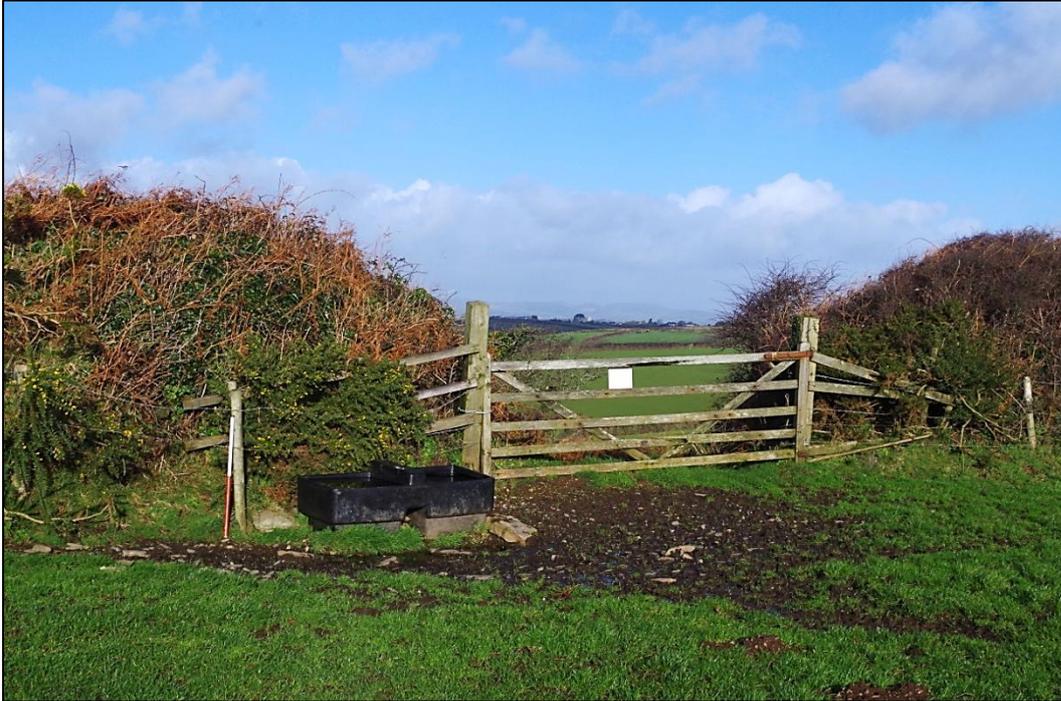
Fig 23 The principal water trough used by stock grazing within the medieval field system on Dodman Point. The ground area around the trough is severely trampled and eroded. Looking north

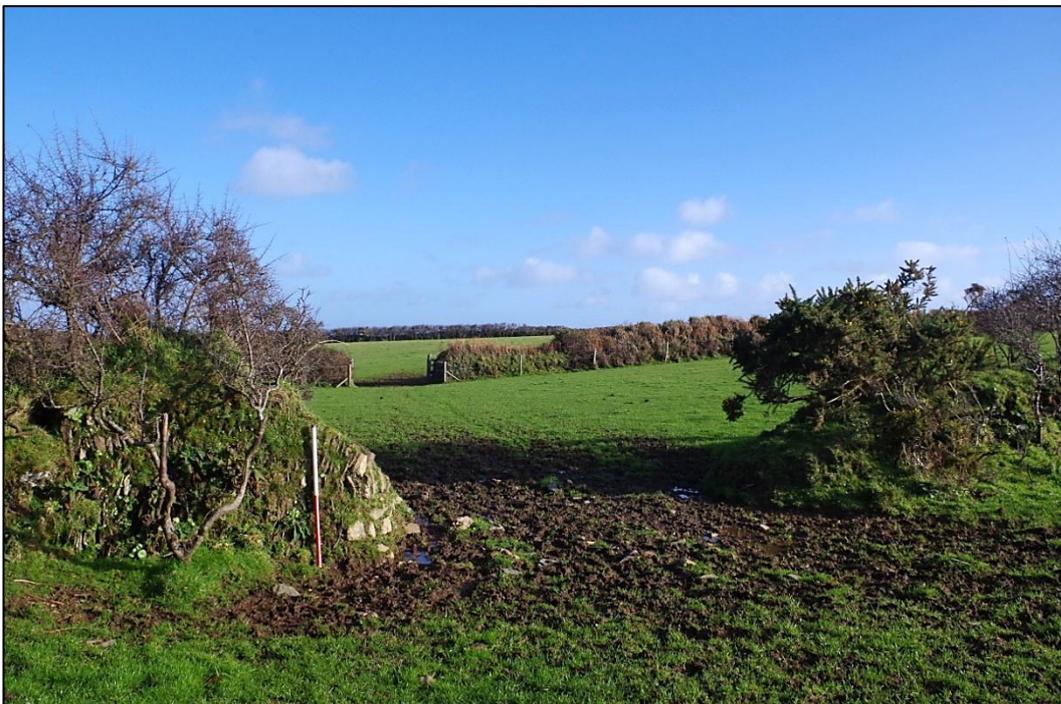
The grazing regime by Dexter cattle has helped maintain the semi-natural grassland on the headland plateau. The principal stock boundaries have been maintained and enclosed with stock proof wire and post fencing. There are some areas of erosion and stock breakthrough, however, and gorse and blackthorn top the boundaries in a number of places (Fig 21). Within the central area the surviving historic boundaries (fossilising former medieval strips) are in poor condition, having been severely denuded and eroded away by stock movement across them (Fig 22). In some places this has reduced the boundaries to ground level. The movement of stock has created established pathways across the field enclosures to access the water troughs by The Bulwarks. One trough is out of commission due to a faulty water pipe whilst the principal trough has an area of significant trample and surface erosion around it (Fig 23). Two open gateways on the eastern side of the fields show significant wear by stock

movement, both the ground surface, which is well trampled, and the edges of the boundary walls, which show some damage from animals pushing past them (Fig 24).

Fig 24 Looking northeast through one of the open gateways within the medieval field system on Dodman Point. The entrance way is severely trampled and the exposed ends of the field boundaries are eroded and topped with gorse and blackthorn

A continued grazing regime is recommended for this area but ideally some of the pressure on stock movement pinch points and areas of erosion should be alleviated where possible. Repair to the principal grazing compartment boundaries and the replacement of fencing in these areas is recommended; this should include the consolidation of the exposed ends of boundaries where open access ways have been created. Repairs to the existing water supply to reinstate the currently redundant water trough and the consolidation of the ground surface around the principal water trough in this area are also recommended. Historic repairs to the boundaries over time have resulted in a variety of buildings methods and materials being used. Where repairs are carried out the philosophy should be to repair breaks and erosion in the style of the adjacent boundary section (or surviving boundary structure if sufficient remains to determine this). Repairs to new and recent breaks coinciding with some areas of sacrifice to permit stock movement might also help by reducing further stock damage.
