Report No: 2015R029

St Agnes mine buildings, Cornwall Archaeological monitoring during repair and consolidation works 2014

Client	National Trust
Report Number	2015R029
Date	August 2015
Status	Final
Report authors	Nigel Thomas (CAU), Adam Sharpe (CAU)
Checked by	Dr Andy Jones
Approved by	Andrew Young

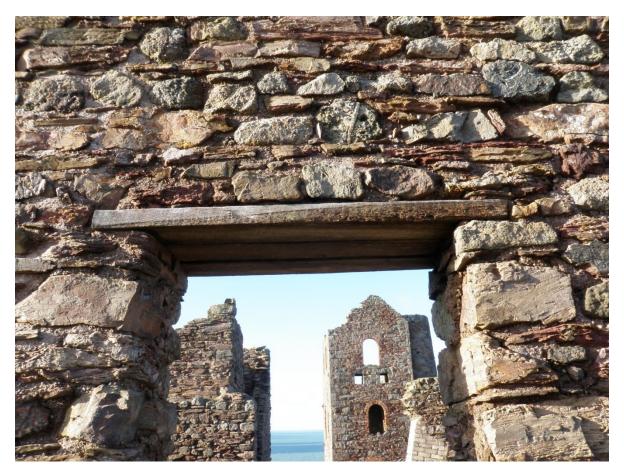
Fig 13. The lintel over the doorway in the eastern elevation of the horizontal whim engine house.

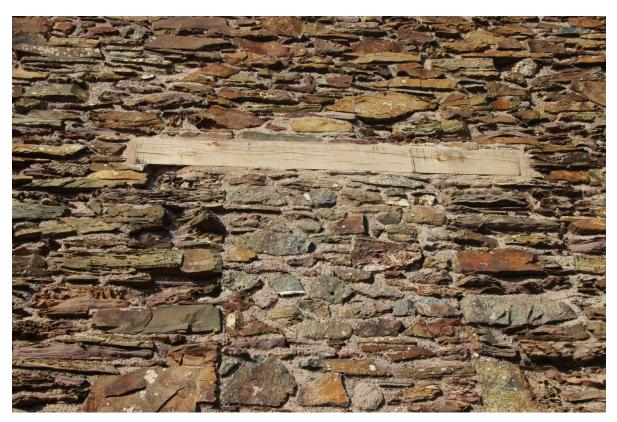
Fig 15. The replacement lintel over the blocked window in the southern elevation of the all-indoor beam whim engine house.

At the higher Wheal Coates site, a proprietary treatment was applied to all incorporated timber exhibiting any woodworm or rot. Within the beam whim engine house, a lintel was replaced over a blocked doorway, as was a substantial supporting timber within a machine pit. In the horizontal whim engine house, minor rebuilds were carried out to a wall end and to an eroded cill and tell-tales were added along a crack to determine whether this feature was moving, whilst within the boiler house new stonework was used to underpin the party wall with the horizontal whim engine house.

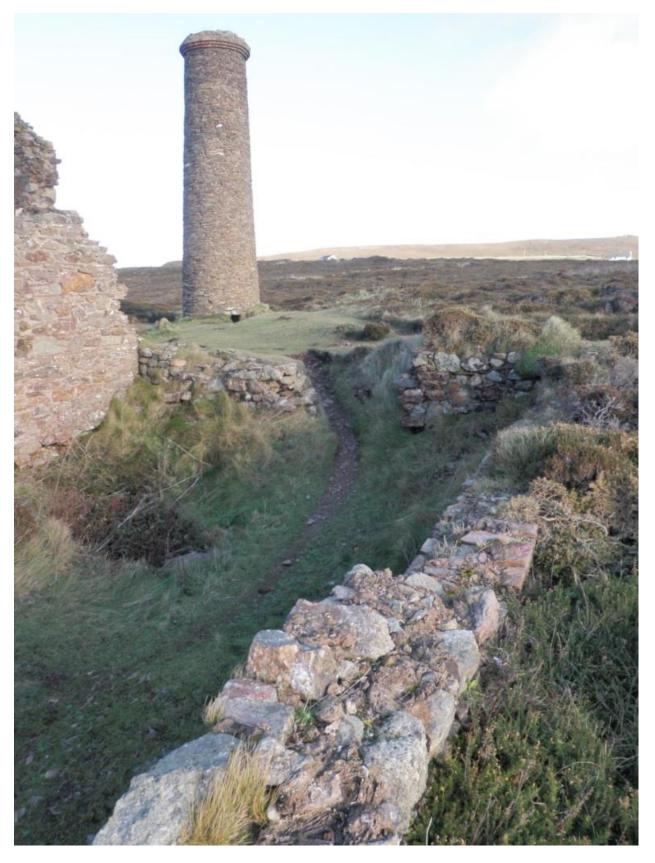
Fig 17. The eastern end of the boiler house associated with the all-indoor beam whim engine house, showing the lost masonry over the flue connection to the chimney and the poor state of the wall heads.

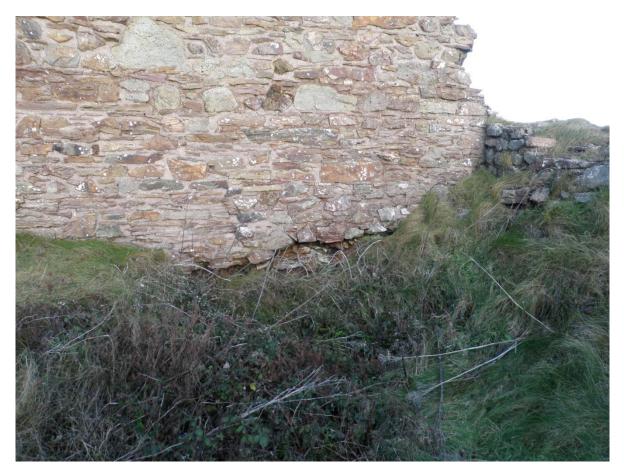
Fig 18. The eastern end of the southern elevation of the horizontal whim engine house, showing stone loss at its base.

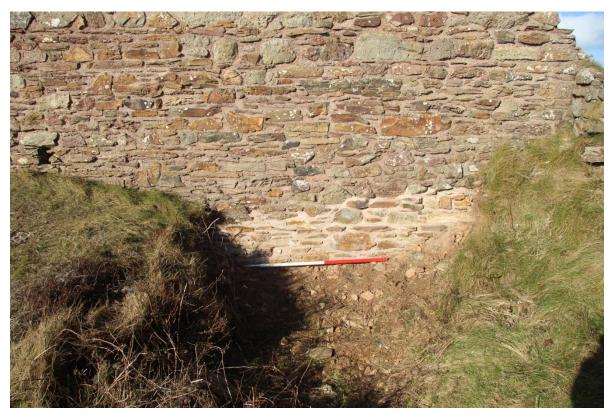
Fig 19. The repairs undertaken to the lower section of the walling of the horizontal whim engine house.

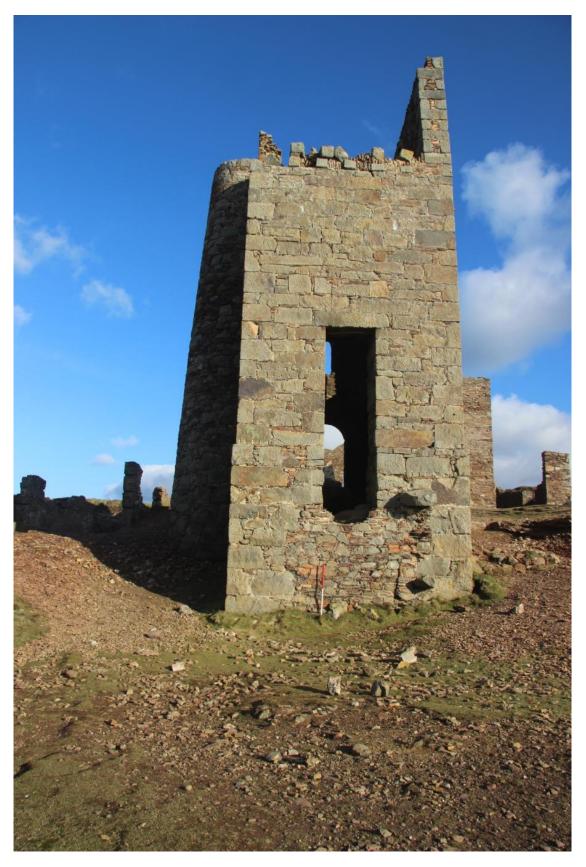
Fig 21. The western elevation of the stamps engine house showing the infill of the scar left when the flywheel loadings were removed and the consolidated collapsed wing way masonry on the head of the bob wall.

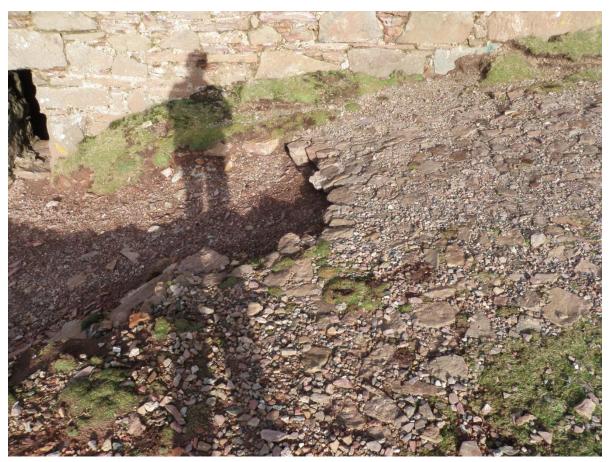
Fig 22. The damaged cobbling at the head of the former tramway from Towanroath Shaft to the whim engine house where it abuts the southern side of the stamps engine house.

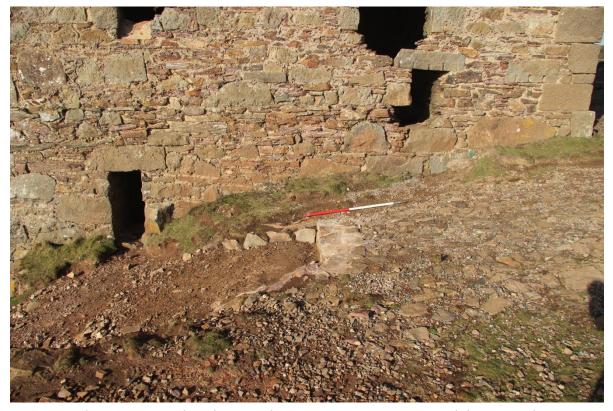
Fig 23. The repairs undertaken to the stamps tramway to stabilise it and prevent further foot erosion.

At the stamps engine house, the cill to the cylinder doorway was rebuilt, and limited underpinning of the cylinder bedstone undertaken. Minor repairs were carried out to a window cill and around the steam pipe opening, whilst the eroded section of the cobbled former stamps tramway was stabilised.

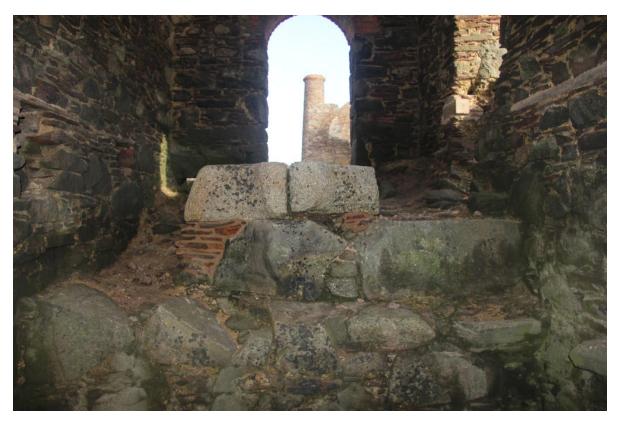
Fig 25. The underpinning masonry inserted beneath the western end of the cylinder bedstones in the stamps engine house.

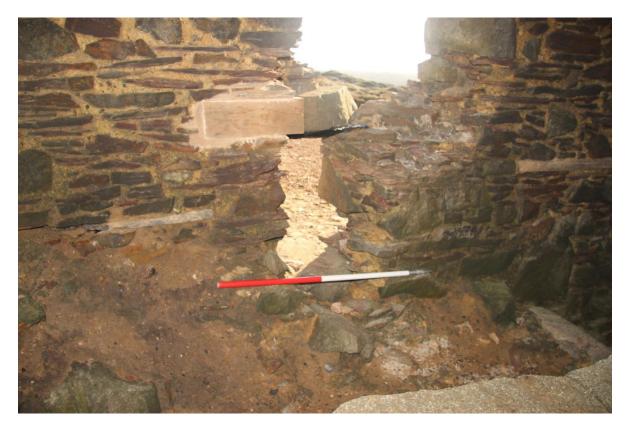
Fig 26. The replacement stub lintel inserted over the ground floor opening in the southern wall of the stamps engine house.

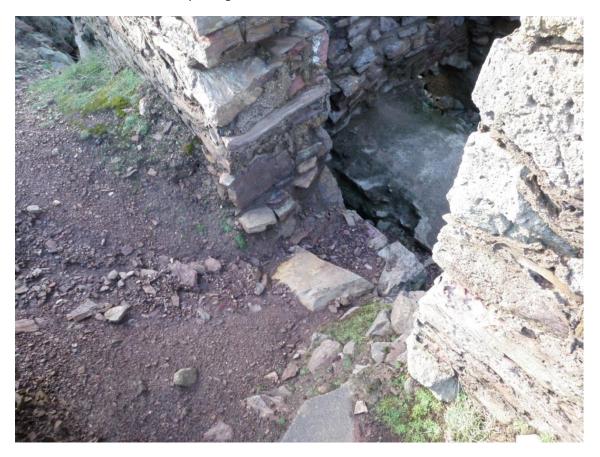
Fig 27. The eroded masonry forming the cill to the doorway in the eastern elevation of the reverberatory calciner.

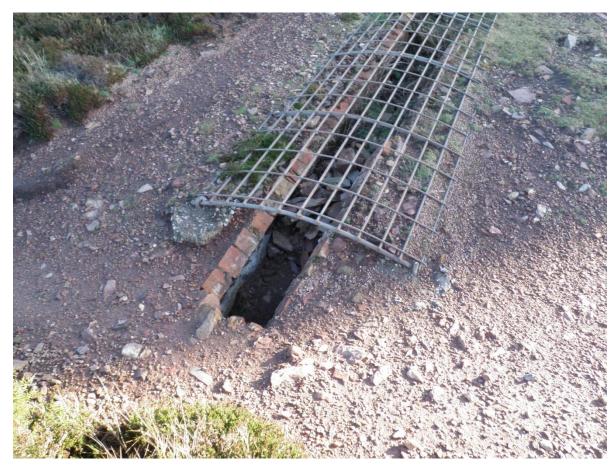
Fig 28. The lost brickwork from the head of the arched calciner flue where it runs just below the ground surface.

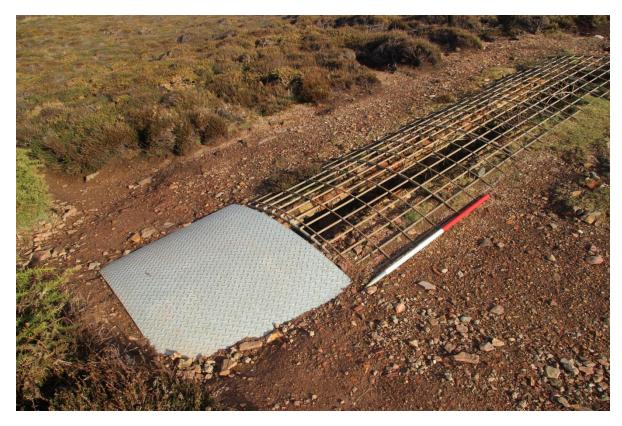
Fig 29. The galvanised steel plate installed over the hole in the calciner flue to prevent further loss of brickwork.

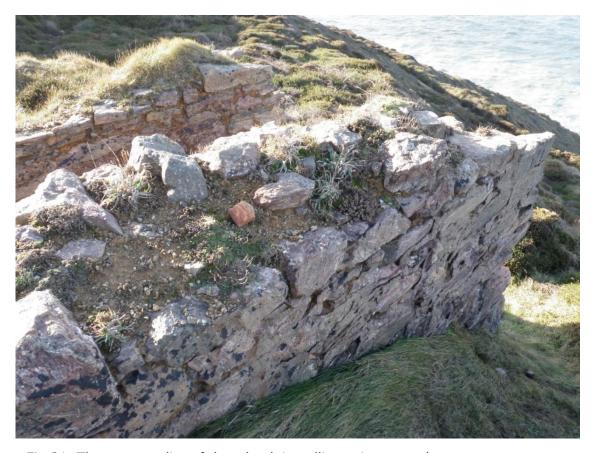
Fig 31. The poor quality of the wheelpit walling prior to works.

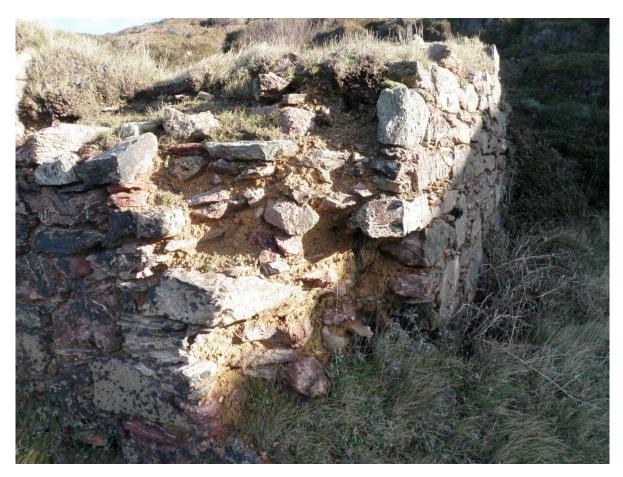
Fig 32. Lost masonry on the south western corner of the stamps gearing platform.

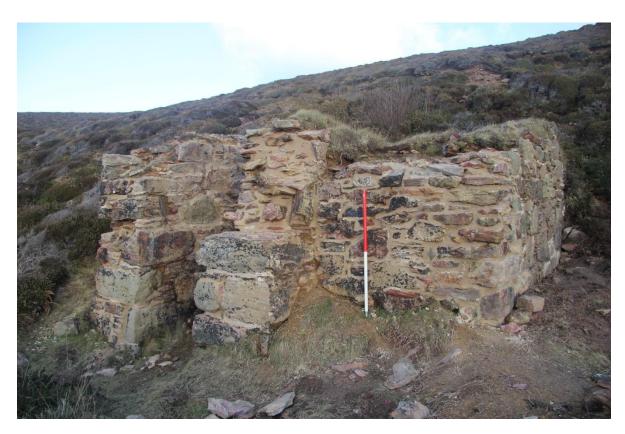
Fig 33. The wheelpit and stamps gear plat following repointing and limited rebuilding.

The tributers' stamps and wheelpit were cleared of scrub vegetation, following which lost masonry was replaced where this was required to confer stability to the remains, and the whole of the structure was repointed.

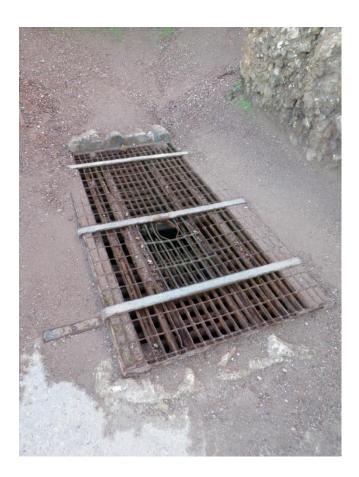
Fig 36. Towanroath Shaft, showing the steel barred grille inserted into the original concrete cap, the Lionweld grille set over it and the steel grille placed over that again. All had been damaged by visitors wishing to drop stones down the shaft.

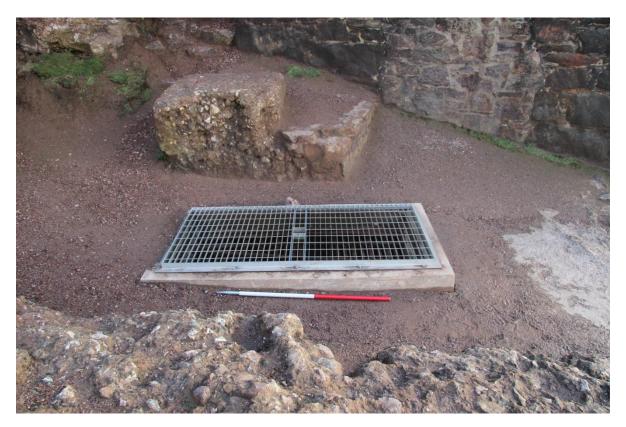
Fig 37. The replacement grille over Towanroath Shaft.

In the lower part of the Wheal Coates site, no works were undertaken to the horizontal engine house, the nearby boiler house and the remains of the dry adjacent to Towanroath Shaft. The shaft grille was replaced and tell-tales were installed on cracks in the pumping engine house walling to monitor potential movement along cracks which had developed in them.

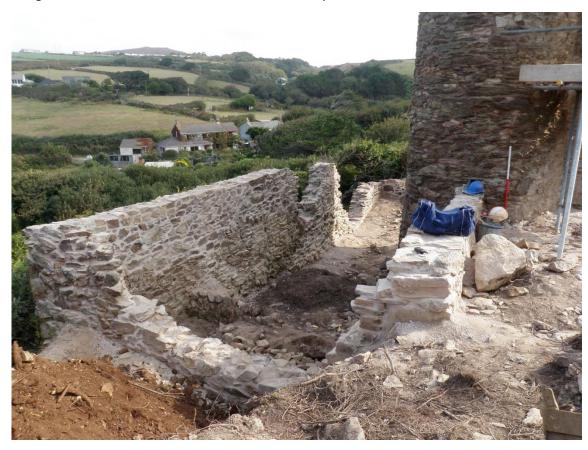
Fig 55. Conservation works in progress within the Charlotte United boiler house, which was fully re-pointed given its condition.
