Tregargus China Stone Mills

St. Stephens, Cornwall

Archaeological recording

Client	Tregargus Valley Trust
Report Number	2015R065
Date	September 2015
Status	Final
Report author	Colin Buck
Checked by	Andy Jones
Approved by	Andrew Young

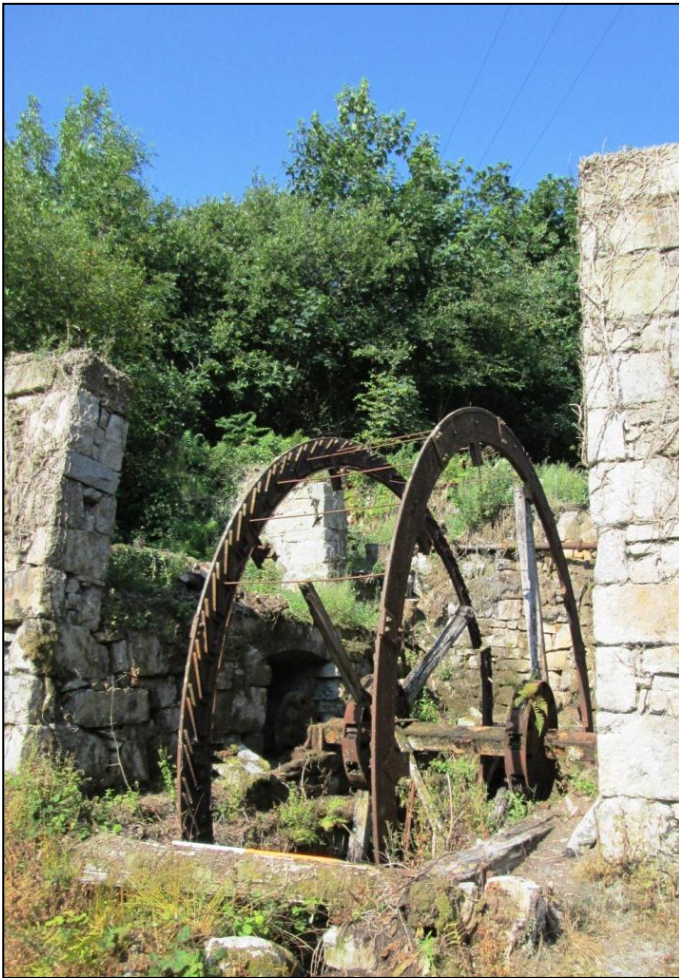
Figure 6 View (from the east) of the Wheal Arthur water wheel before works © CAU, CC 23/7/2014.

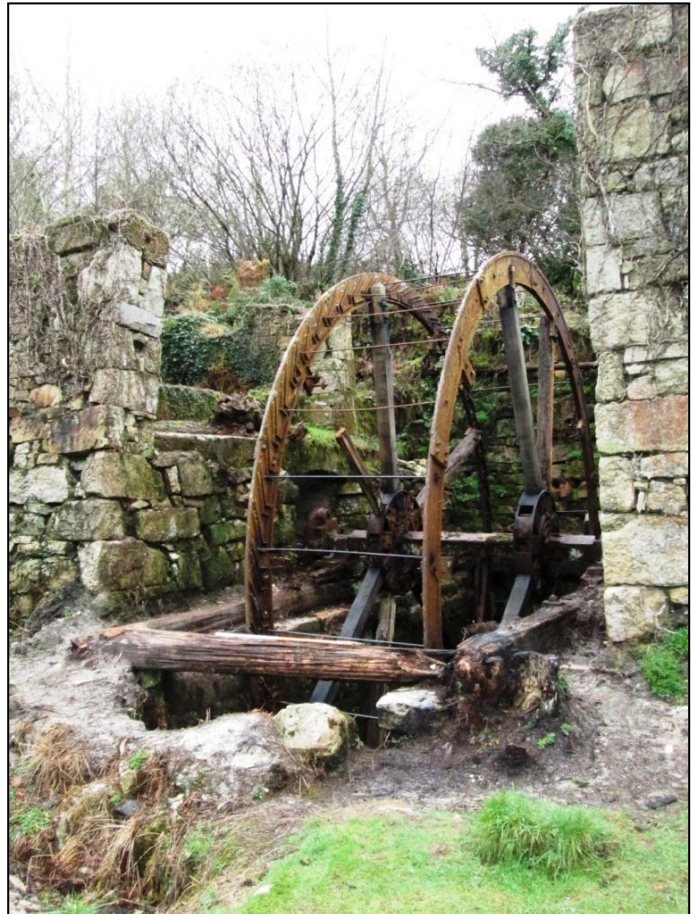
Figure 7 Similar view of the Wheal Arthur water wheel after works © CAU, CC 16/12/2014.

Once the wheel was stabilised in position (albeit with another broken section of rim on the other side set in the pit), the other conservation works proceeded. This included the insertion of three pairs of oak struts to replace rotted equivalents as shown on Figure 5, and in detail on Figure 10. It should be noted that the nuts, bolts and flat washers mirrored the original specification. This now securely connected the wheelpit axle/hub to the outer rims. Ten steel bars were then added by Martin Welsh around the wrought iron rims to support the rims equidistant from each other to further support the wheel *in situ* (see Fig 10). The supporting scaffold was then removed.

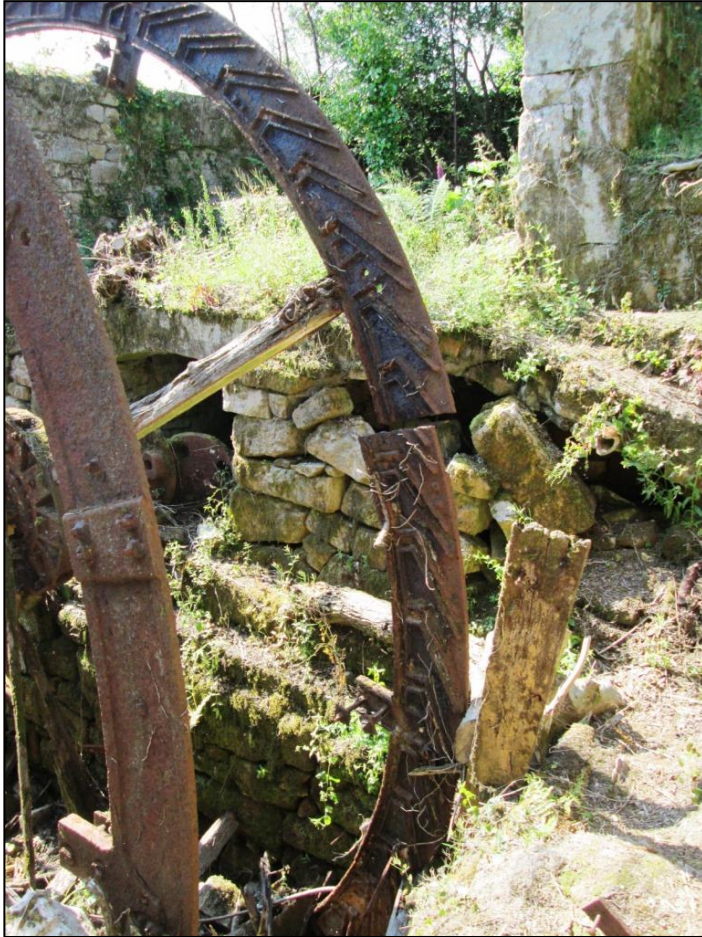
rim was broken away close to the earth/vegetation/fly-tipped infill level in the base of the pit and the other rim broken higher up (see Fig 8). It was also noted at the time that there would also be issues fitting new spokes as the hub spoke holes did not align with those on the shrouds/rims. It appeared the hub/axle would need to be turned slightly to fit the new timber spokes. In addition, it was noted that additional steel bars would need to be made and fitted to the wheel to keep the outer rims equidistant, so keeping the wheel stable.

Figure 8 shows not only the broken state of the wheel rim, but also the condition of the mill building south side wall beyond the wheel pit, and the precarious nature of the foundation support for the adjacent south east wall. A void was found under the wall, of unknown origin and function, whose possible (timber/stone) outer lintel had now gone, had caused the collapse seen in Figure 8. The inner void was infilled with stone and the front face rebuilt as a dry-stone wall (compare Fig 9).

Figure 8 View (from the north) of Wheal Arthur water wheel rim break and south wall collapse before works © CAU, CC 23/7/2014.

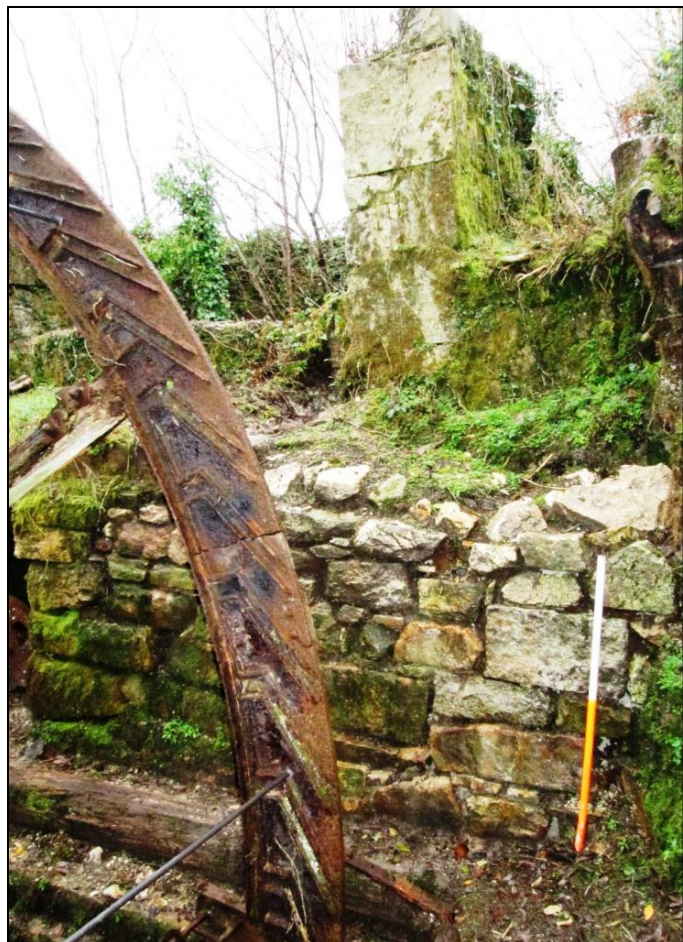
Figure 9 Similar view of the Wheal Arthur water wheel and south wall after repair works © CAU, CC 16/12/2014.

Pdp Green Cons. had prepared the basic site surveys and annotated an approximate works specification (Figs 2 and 3). In early October 2014, Heritage Cornwall stabilised the water wheel with temporary scaffolding to allow sub-contractors (Martin Welsh – metal fabricator), to closely inspect the wheel to make recommendations for its future stabilisation and conservation. Heritage Cornwall cleaned out the wheelpit of its debris and vegetation (compare Figs 6 -before works and 7 - after works). Site meetings were held to discuss the specifications and methodology of carrying out repairs. Following clearance of the wheelpit, and re-positioning/re-centring of the wheel rims using scaffold bars and timber it was decided to attach a plate (Fig 11), to securely hold the two sections of broken rim at the rear of the wheel (compare Figs 8 (before works) and 9 (after works), as unfortunately, the wrought iron could not be welded.

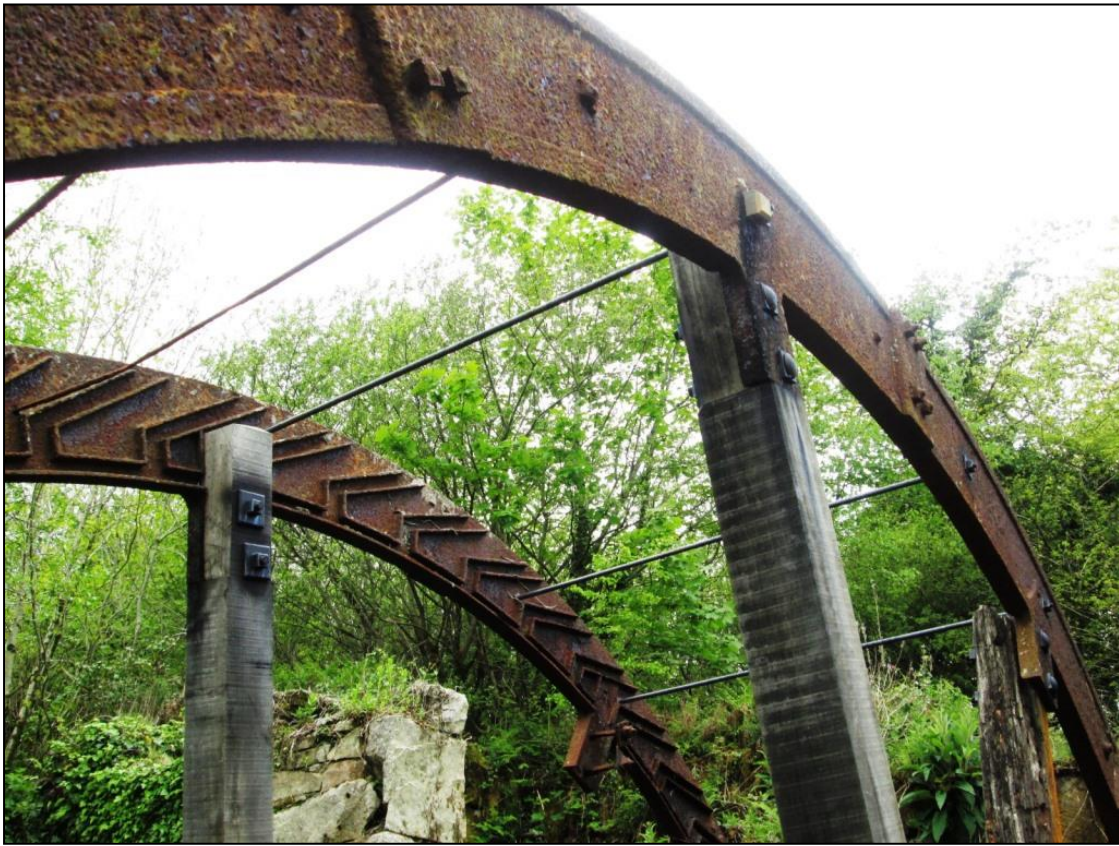
Figure 10 Detail view of the Wheal Arthur water wheel new cross rod steel replacements and new oak timber struts after works © CAU CC 14/5/2015.

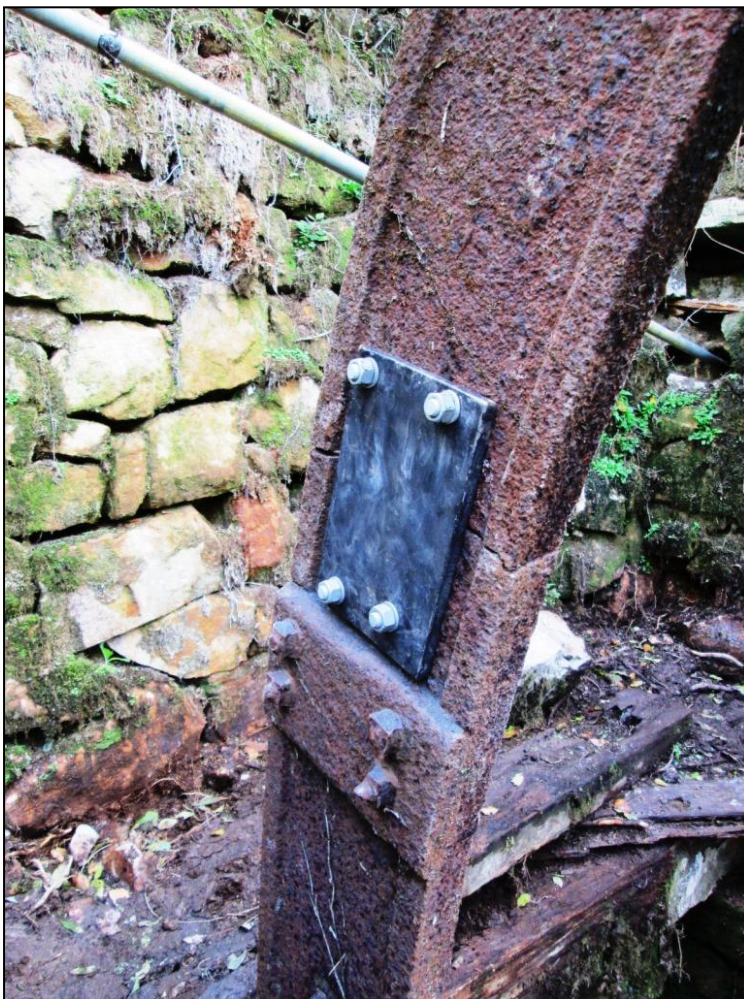
Figure 11 View of the steel clamp plate to repair the water wheel rim © CAU, CC 21/10/2014.

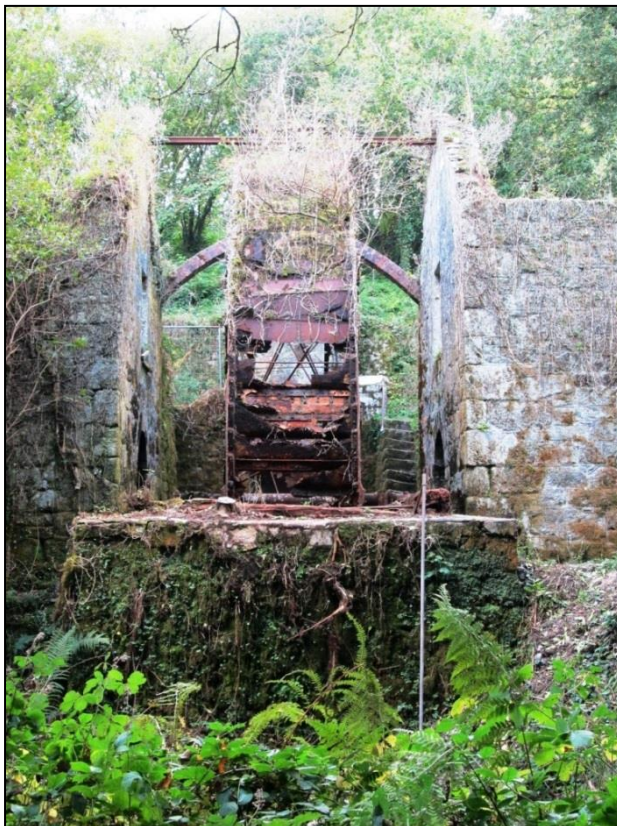
Figure 15 View of the Big Wheel china stone mill 'intact' water wheel from the east after clearance works around the wheelpit © CAU, CC 21/10/2014.

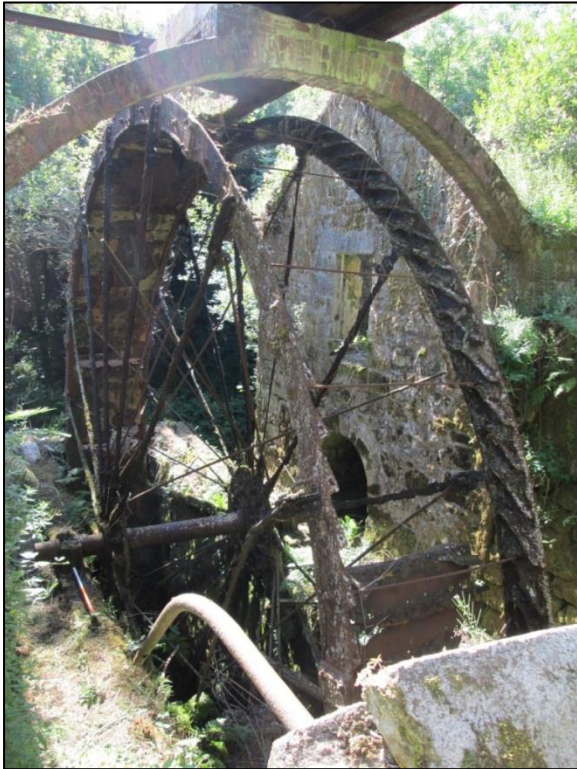
Figure 16 View of the Big Wheel china stone mill 'intact' water wheel from the north west after clearance works © CAU, CC 21/10/2014.

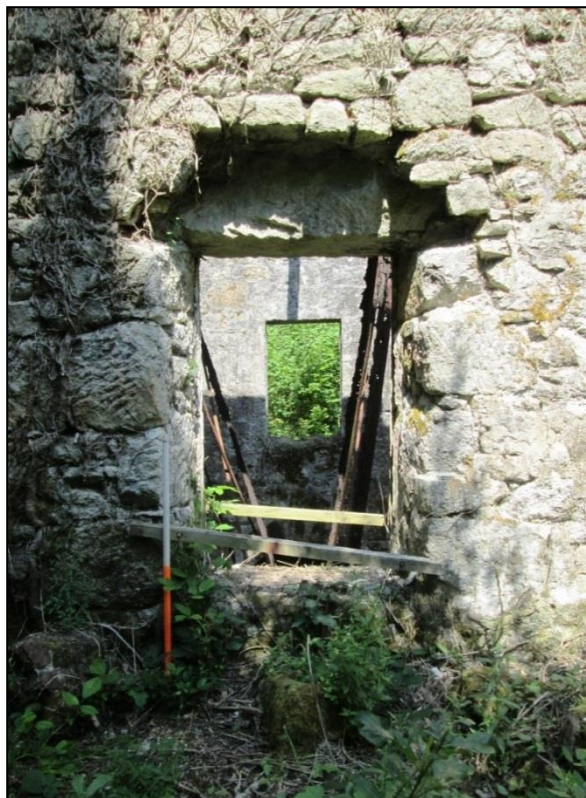
Figure 17 View of the upper northern mill window collapsed lintel before works © CAU, CC 23/7/2014.

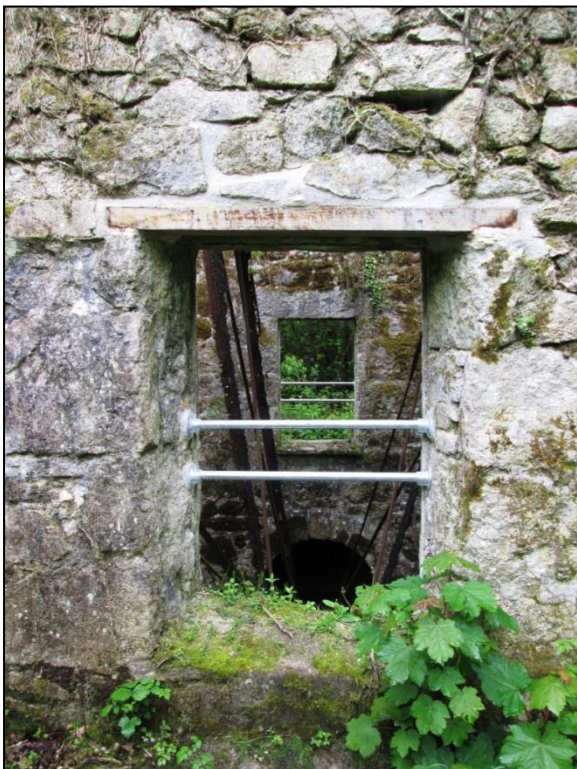
Figure 18 View of the upper southern mill window replaced lintel after works © CAU, CC 14/5/2015.

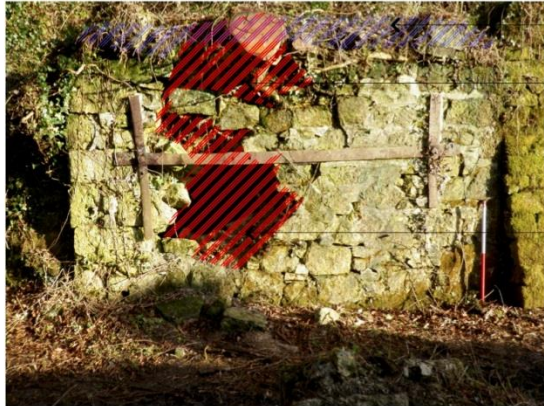
area of collapse to wall, old steel brace remains in-situ, tree growing from wall has been removed but trunk and roots remain
cut away bolts of existing brace to remove from wall, fold back metal work whilst wall rebuilt then re-fix back brace.

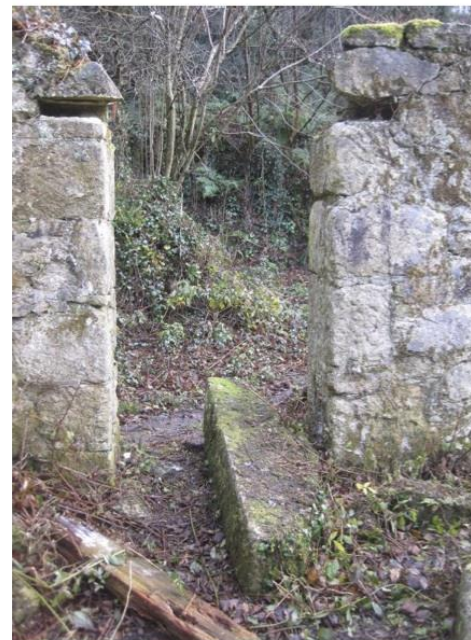
Internal view of opening - note remaining pockets for timber lintel and granite lintel on ground

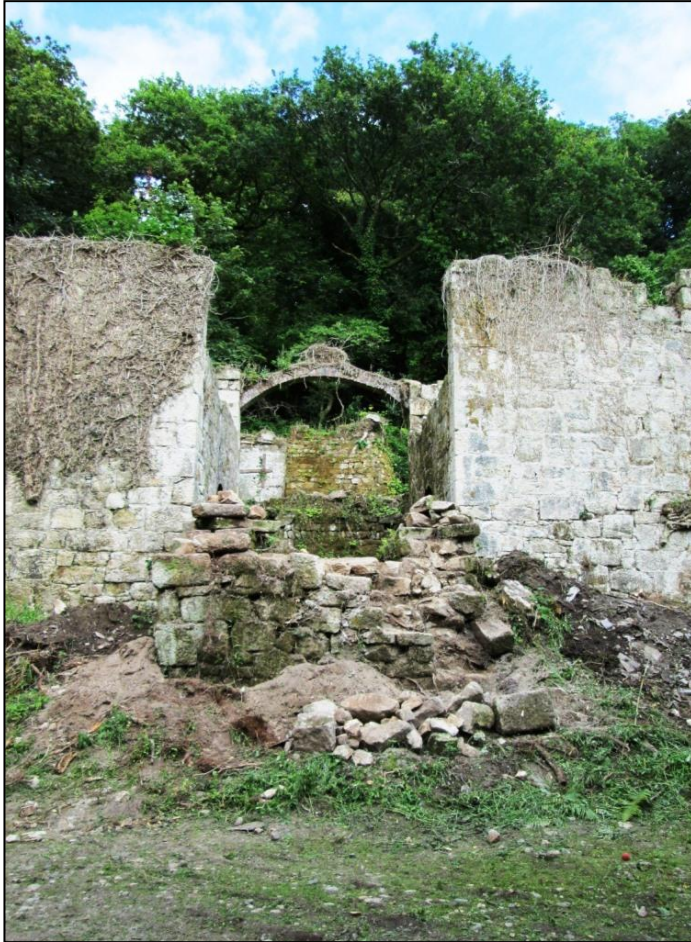
Figure 28 View of the west side of the Trevear wheelpit before works © CAU, CC 15/7/2014.

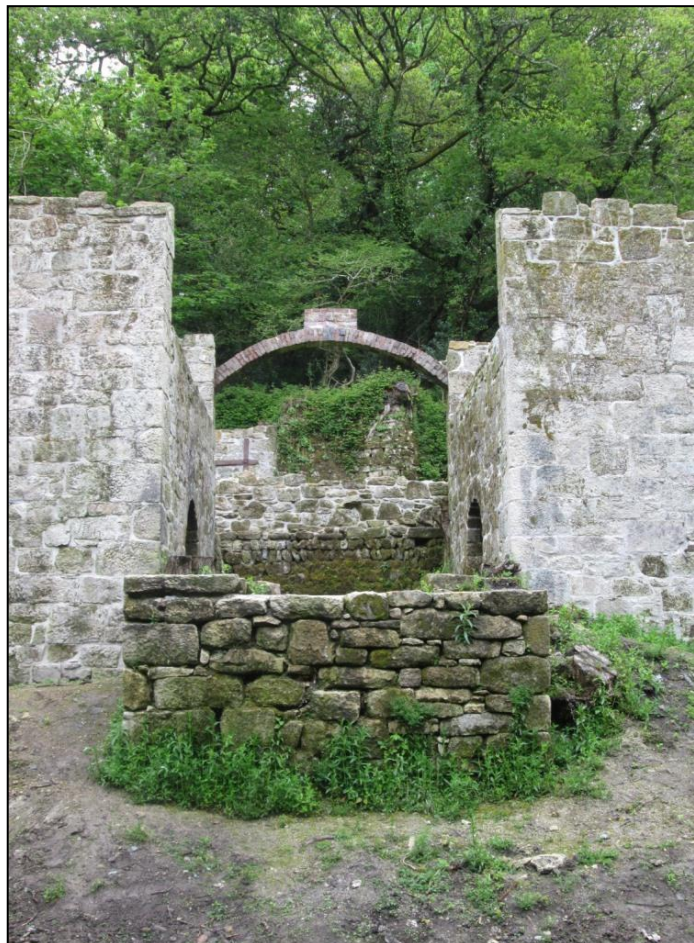
Figure 29 View of the west side of the Trevear wheelpit after works © CAU, CC 14/5/2015.

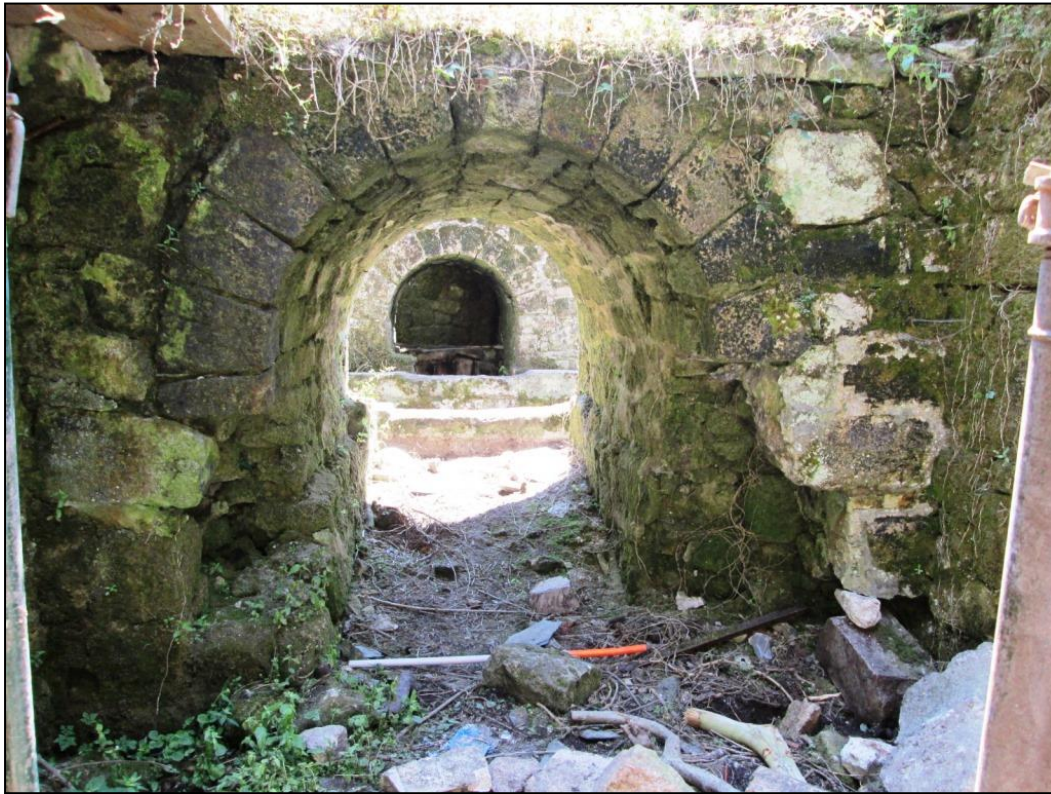
Figure 30 View of the Trevear power arch transmission tunnel before works (looking south) © CAU, CC 23/7/2014.

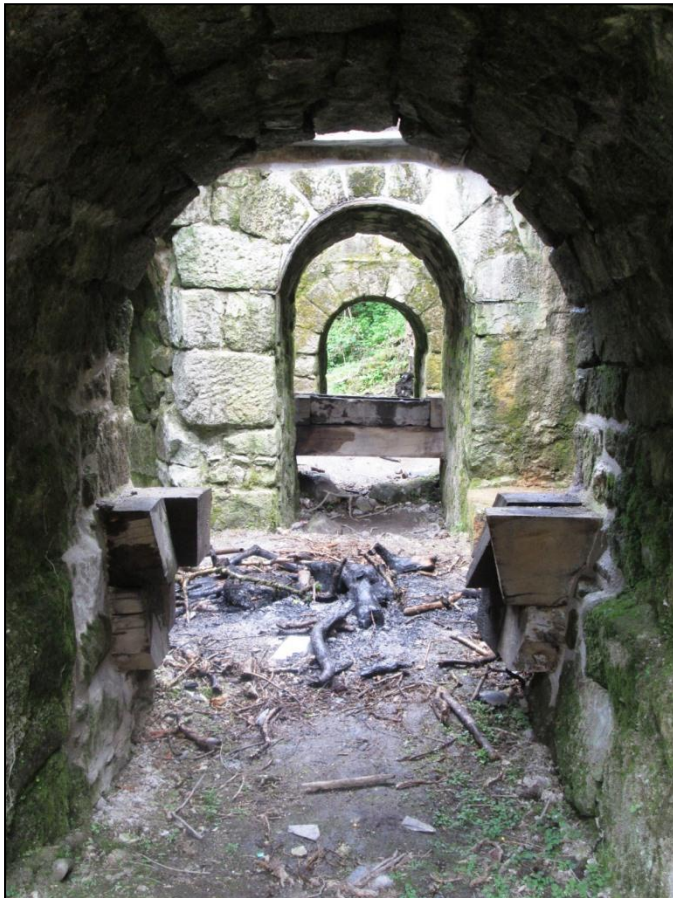
Figure 31 View of the Trevear power arch transmission tunnel after works (looking north) © CAU, CC 14/5/2015.

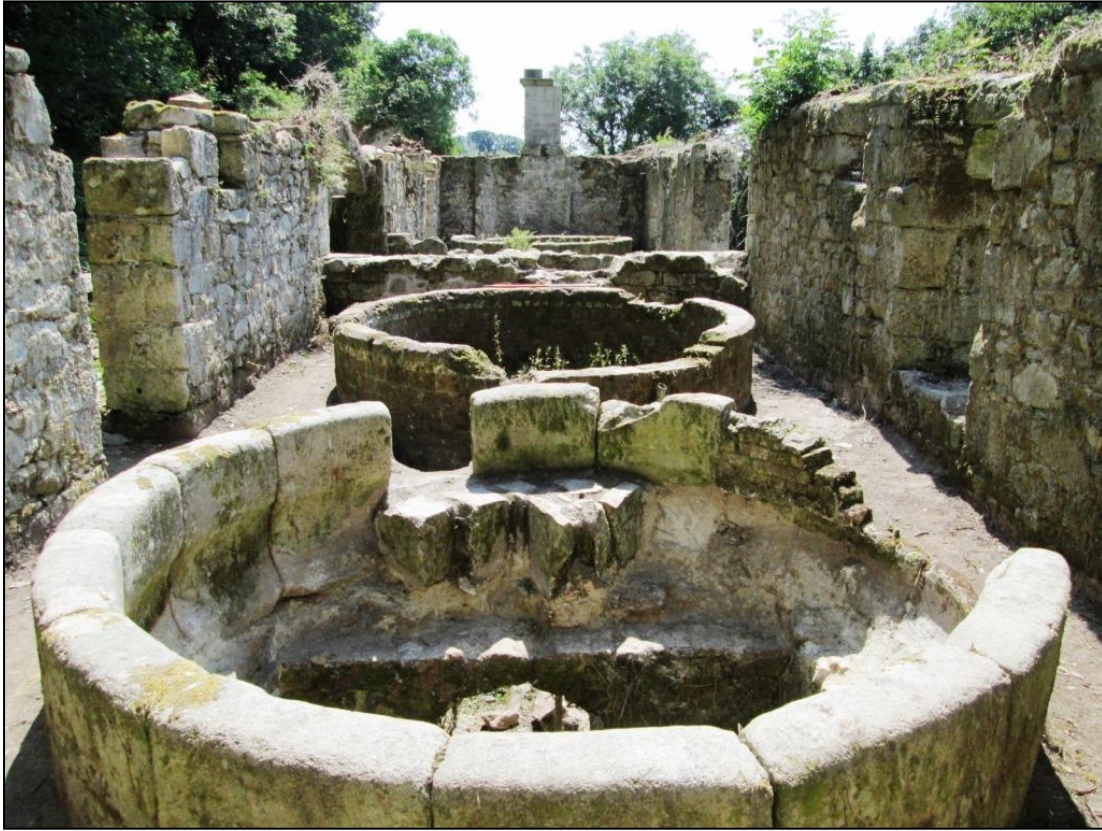
Figure 32 View of the first floor grinding pans and walls before works (looking south)
© CAU, CC 23/7/2014.

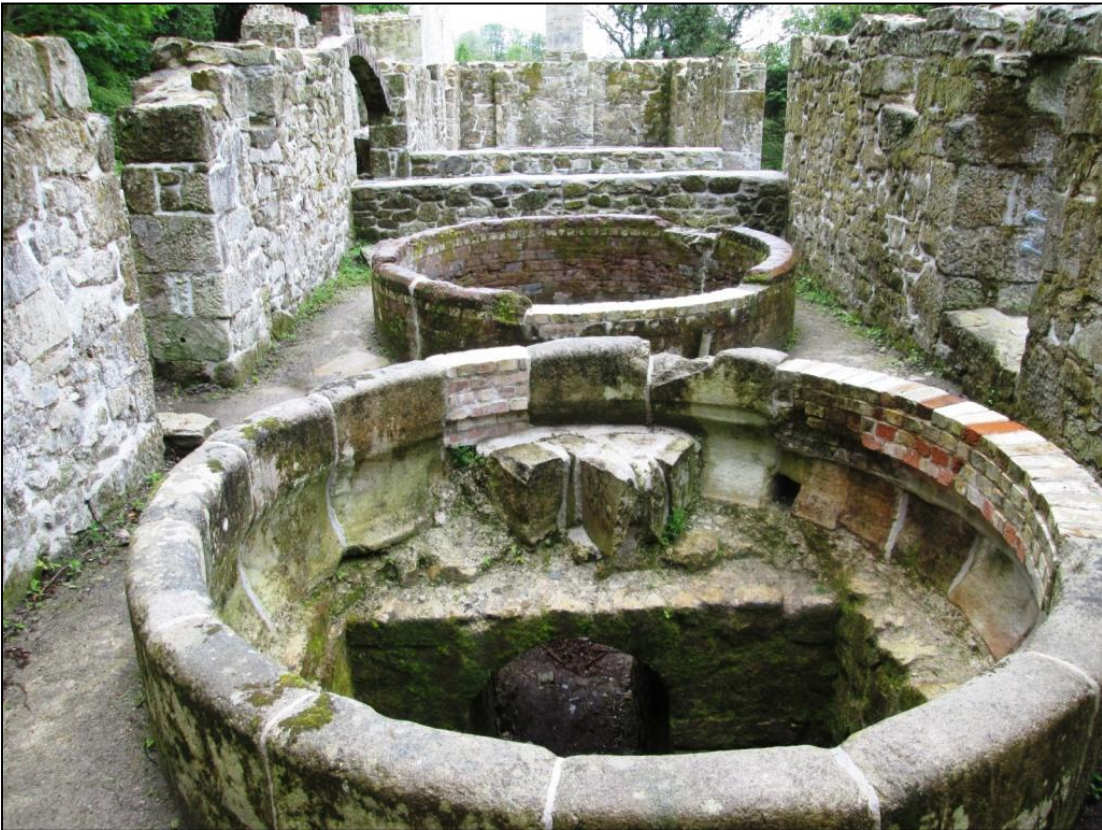
Figure 33 View of the first floor grinding pans and walls after works (looking south)
© CAU, CC 14/5/2015.

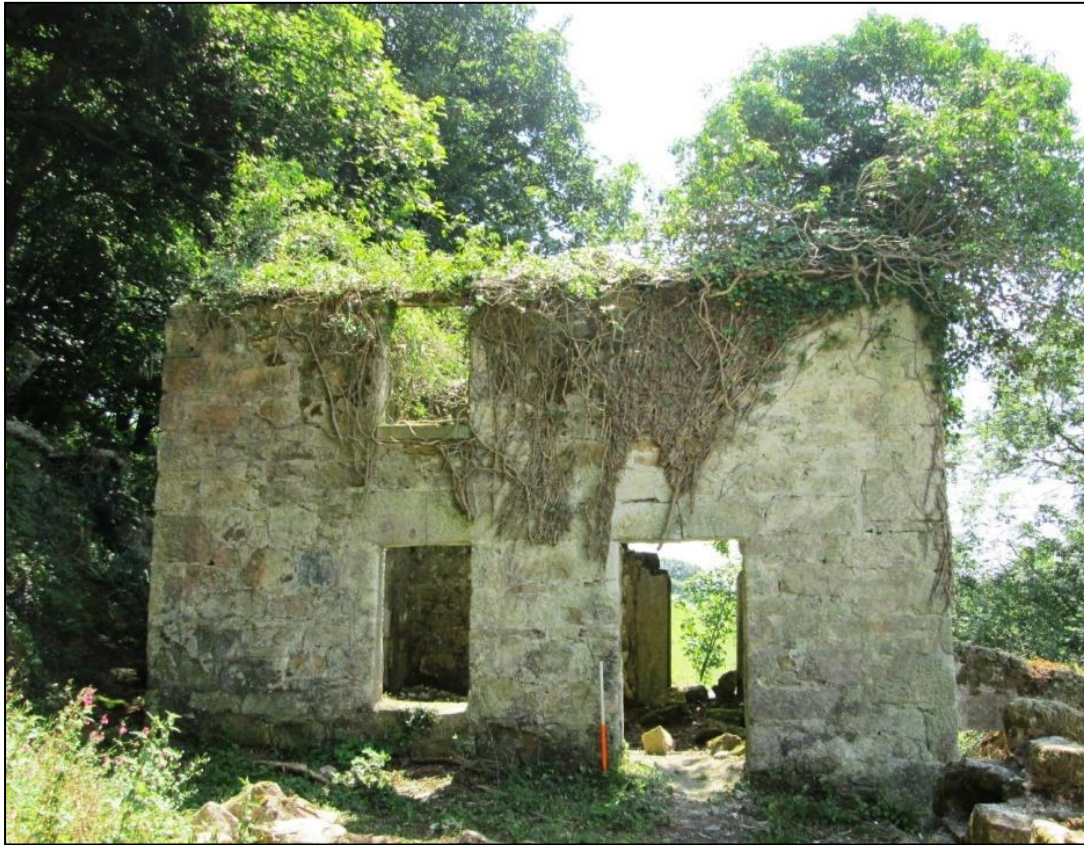
Figure 42 North view of Trevear cottage before works © CAU, CC 23/7/2014.

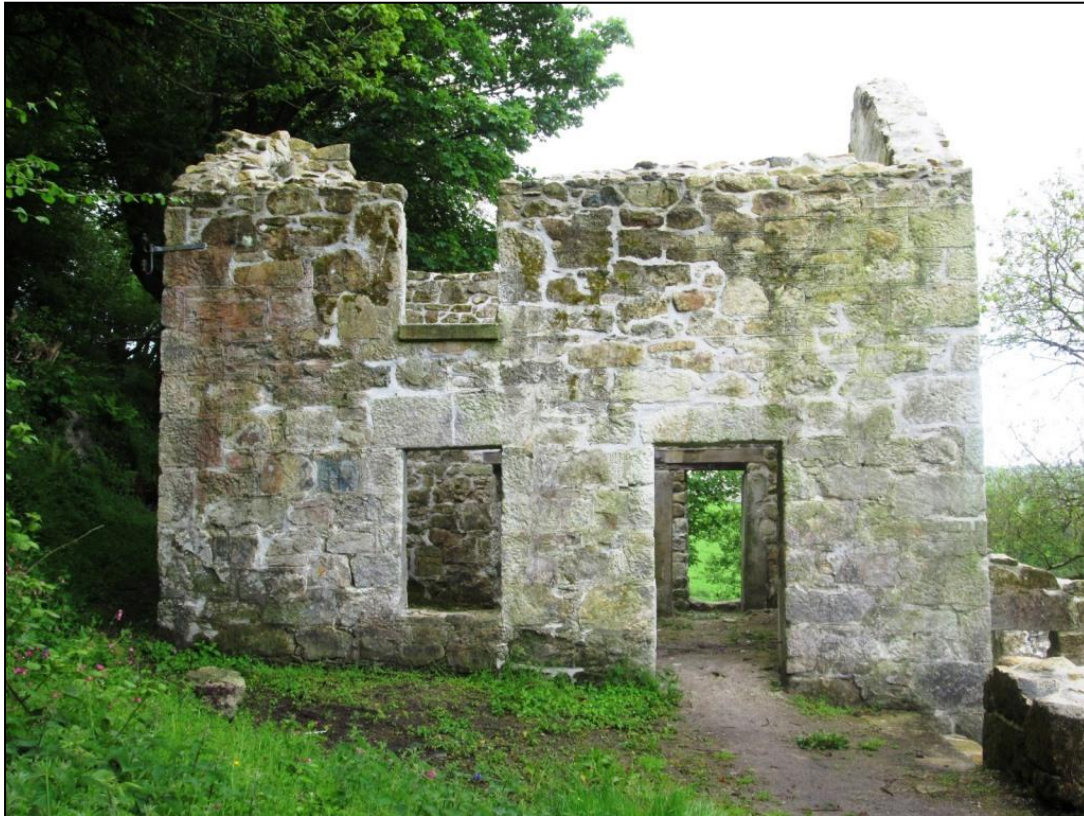
Figure 43 North view of Trevear cottage after works © CAU, CC 14/5/2015.

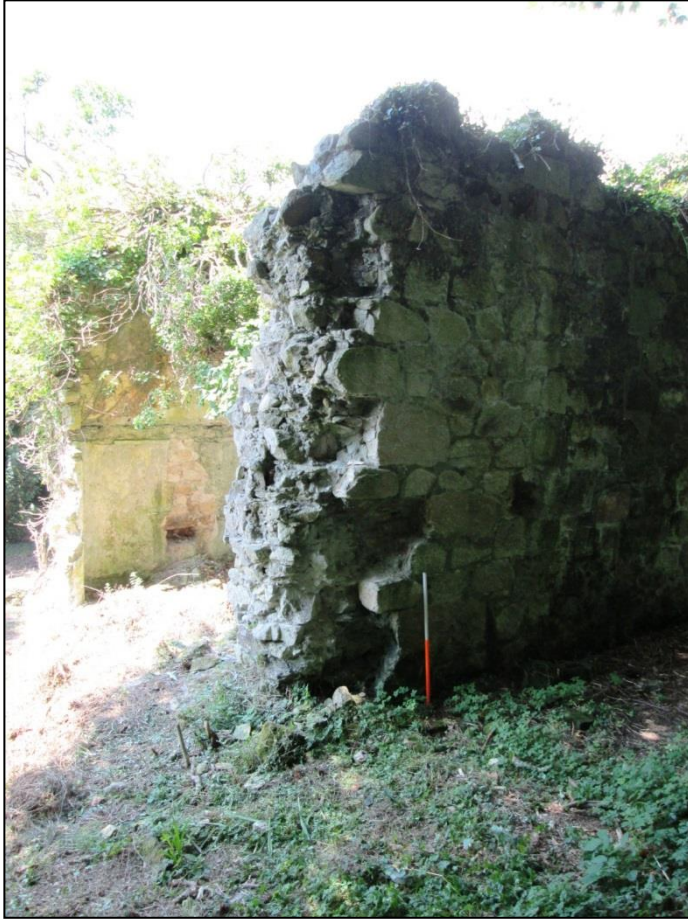
Figure 44 View of Trevear cottage south external elevation (from the south east) before works © CAU, CC 30/7/2014.

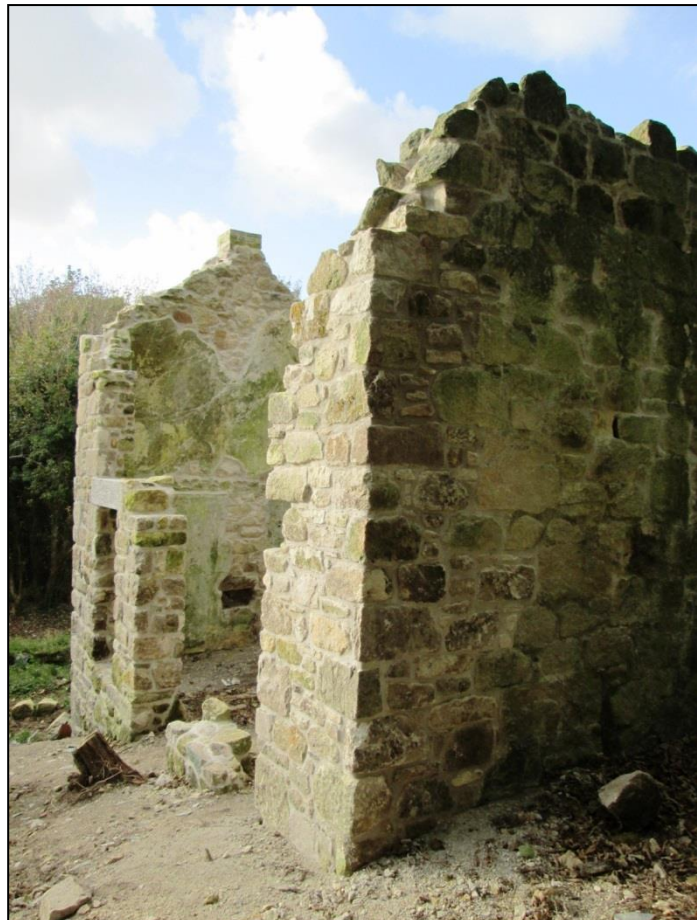
Figure 45 View of Trevear cottage south external elevation after works © CAU, CC 25/11/2014.

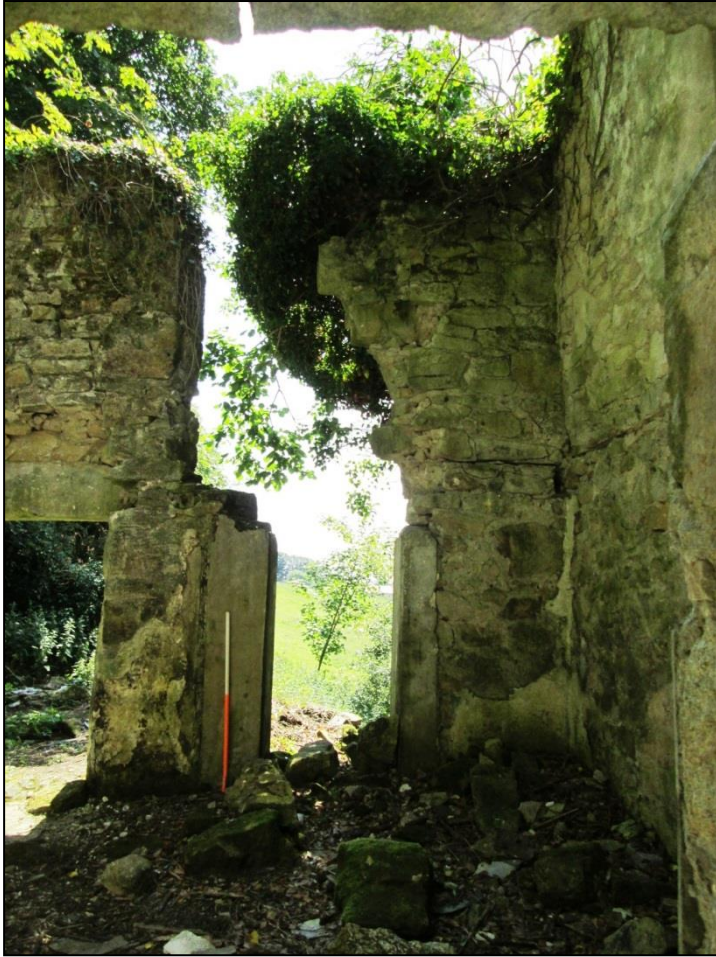
Figure 46 View of Trevear cottage inner south internal elevation (from the north) before works © CAU, CC 30/7/2014.

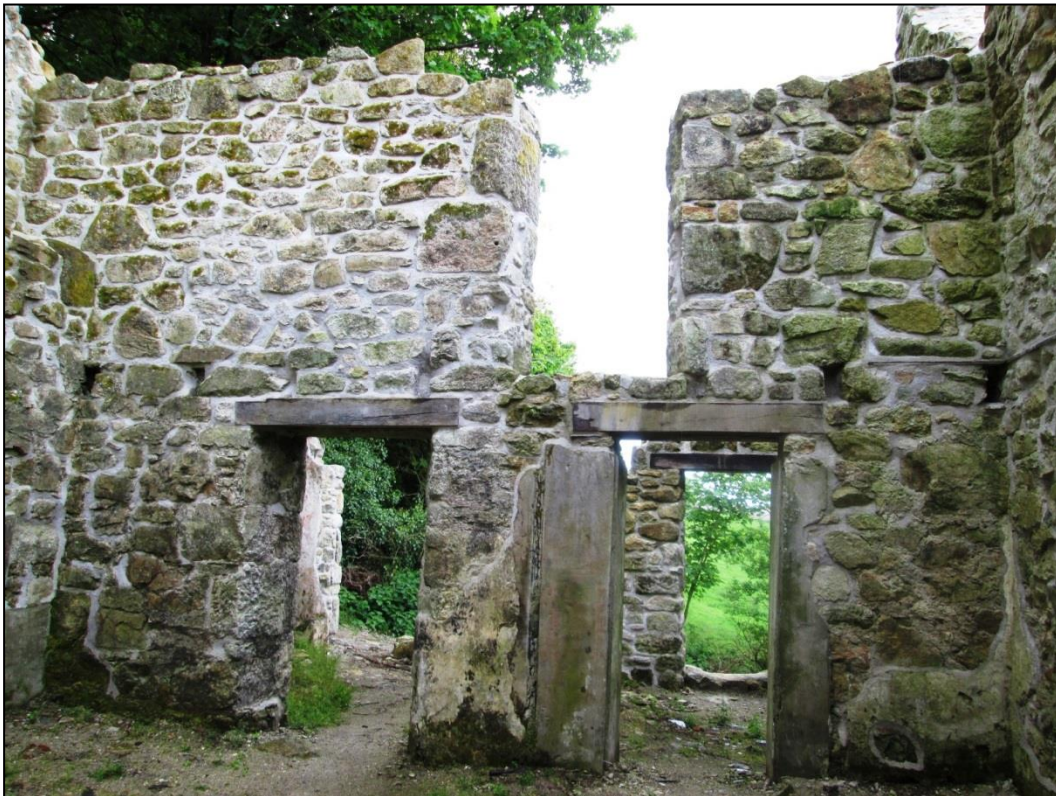
Figure 47 View of Trevear cottage inner south internal elevation (from the north) after works © CAU, CC 15/5/2015.

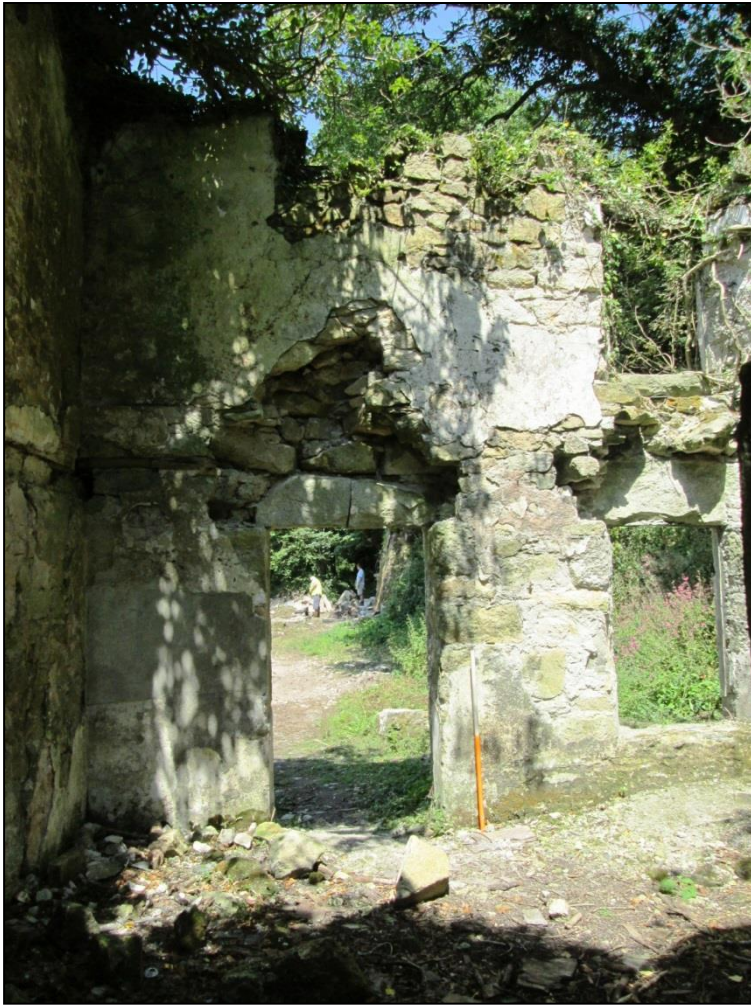
Figure 48 View of Trevear cottage internal north elevation before works © CAU, CC 30/7/2014.

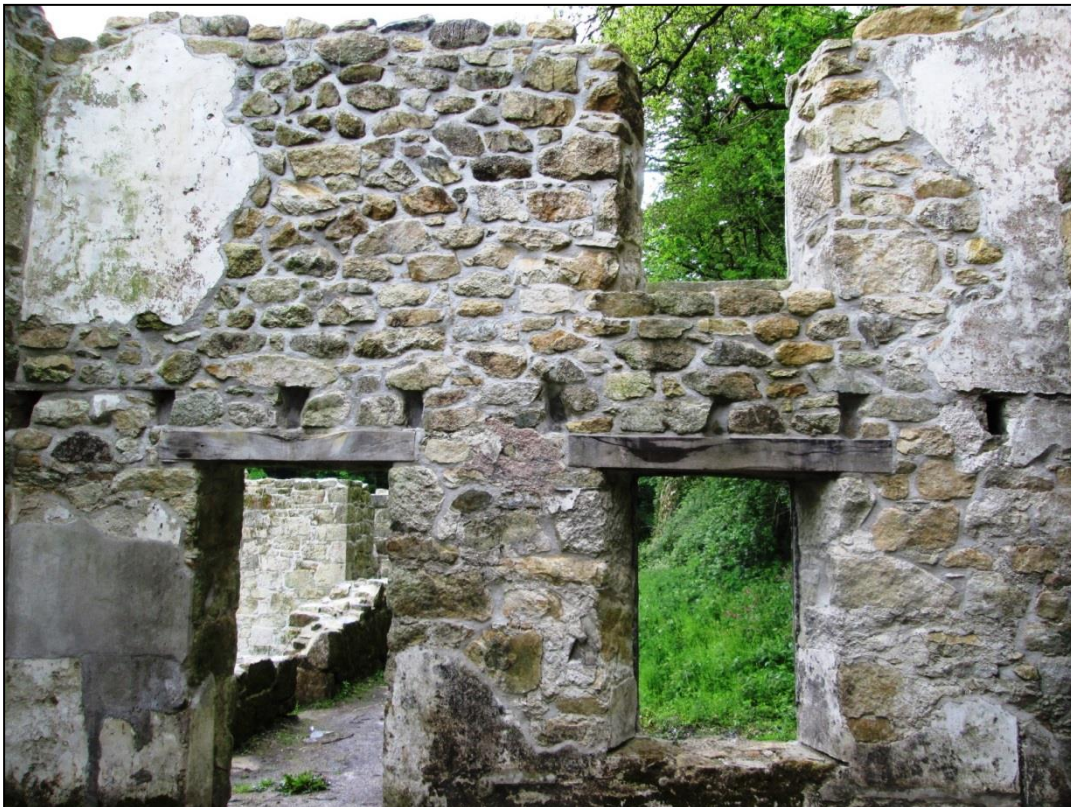
Figure 49 View of Trevear cottage internal north elevation after works © CAU, CC 15/5/2015.
