# **Clapper Bridge, Pillaton, Cornwall Archaeological Recording**

2016R022

Clapper Bridge, Pillaton: Archaeological Recording

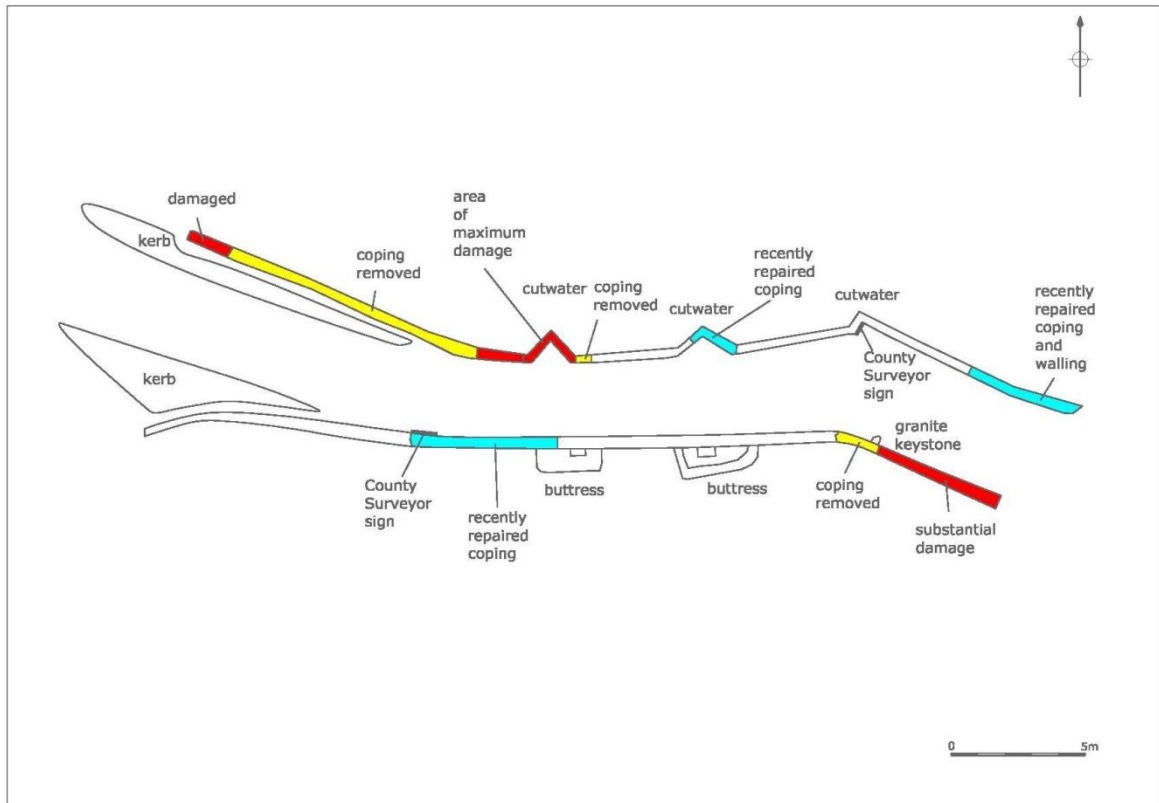
The site was visited in July 2015 during repairs to the bridge occasioned by the damaged to both bridges caused by an HGV on the 6th July. The HGV appeared to have approached the two bridges from the east, scraped through the Clapper Bay Park Bridge resulting in the demolition of the south-eastern pillar, wall, and coping, before becoming wedged in the angle of Clapper Bridge after damaging the walling and coping on both sides at the eastern end of the bridge. An attempt to reverse the HGV then seems to have been made resulting in the westernmost cutwater breaking away from its foundation and pivoting a degree or so to the north. The lorry then seems to have continued on its way westwards, causing more damage to the coping at the western end of the bridge as it did.

Fig 6 Plan of bridge, detailing damage (red-severe, yellow-slight) and repairs (blue).

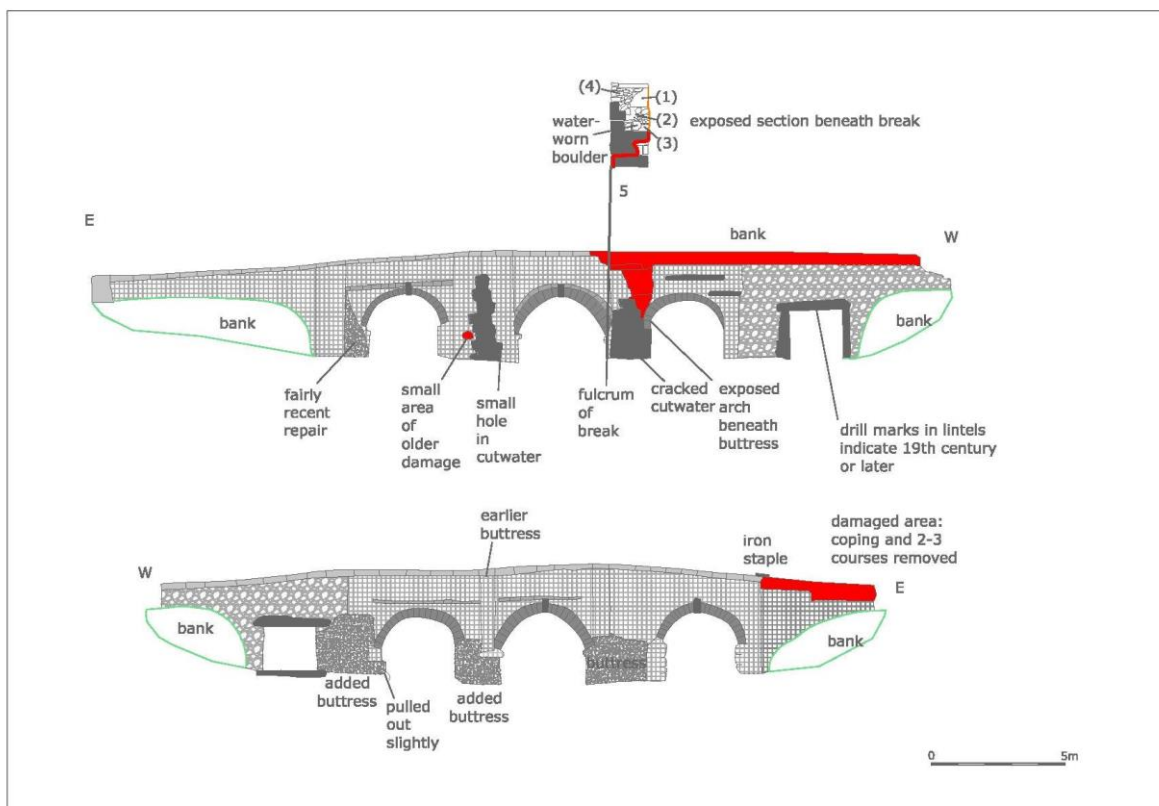
Fig 7 Elevations of bridge, detailing damage (red).

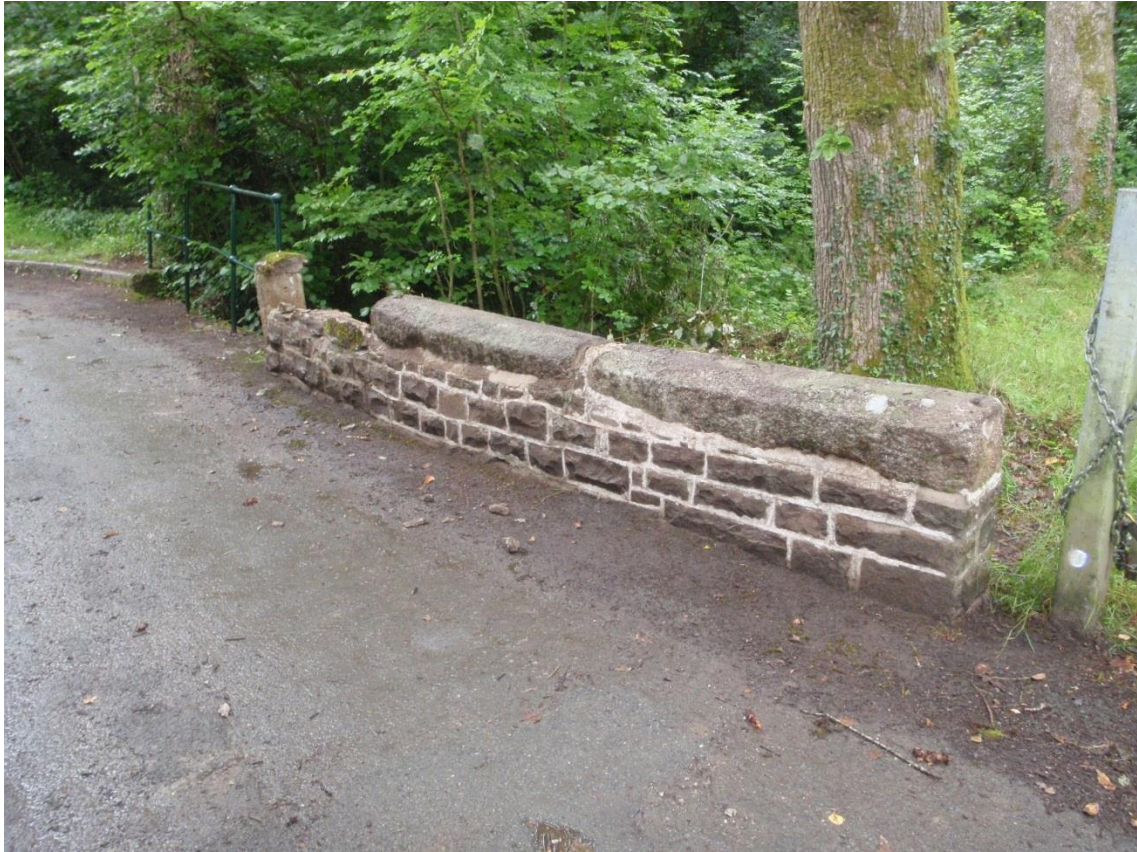
*Fig 8 Damage and recent repairs to the Bay Park Clapper Bridge.*

By the time of the site visit on 20th July much of the walling and coping on the Clapper Bay Park Bridge had been repaired and the engineers were concentrating on the cutwater on Clapper Bridge. The damage necessitated the removal of the stone facing on the south-western face of the cutwater, revealing detail and layers beneath (Table 1; Fig 7). It was apparent that the cutwater, or at least the granite facing stone, was an addition to the bridge and that this addition had occurred relatively recently since cement bonding of the underlying stones of the arch was visible. It is likely that this represents superficial repairs to the underlying structure rather than that the bridge was completely rebuilt at some stage in the 19th century.

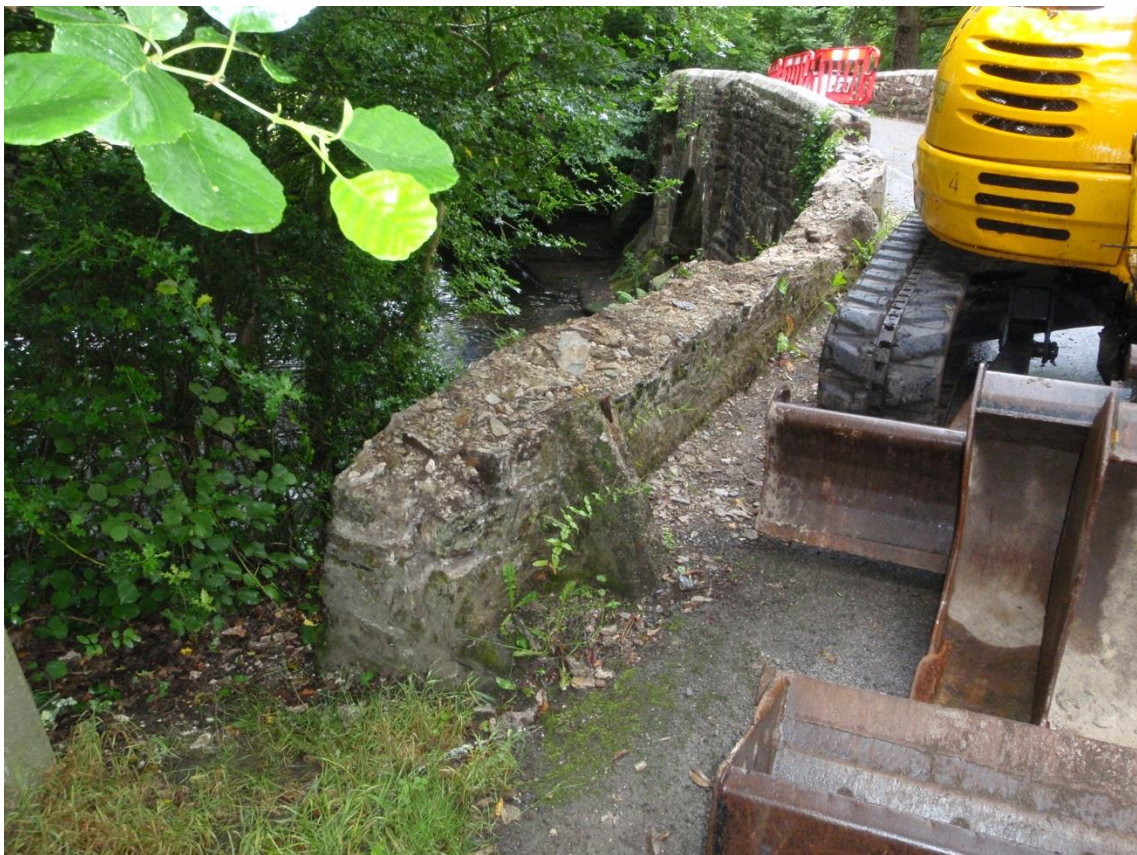
*Fig 9 Damage to the eastern coping, south side of the Clapper Bridge.*

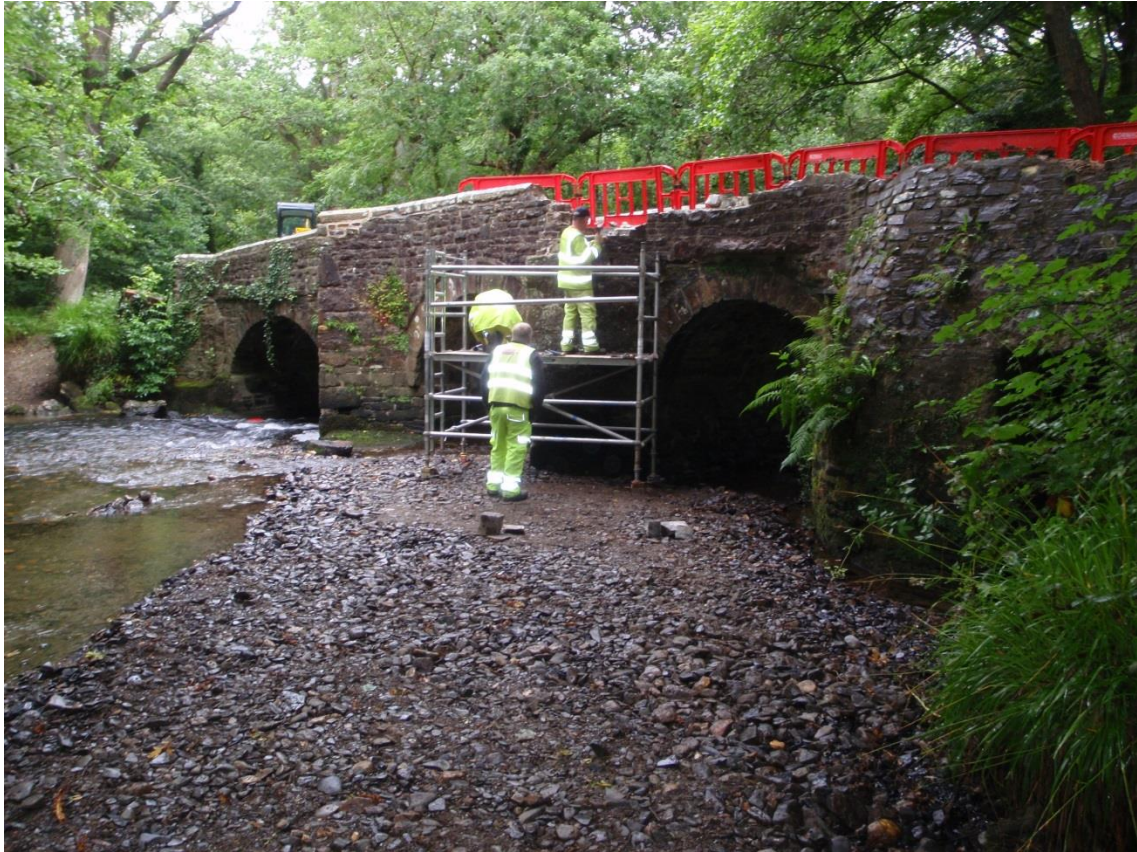
*Fig 10 Damage to the wall and cutwater on the north side of Clapper Bridge.*

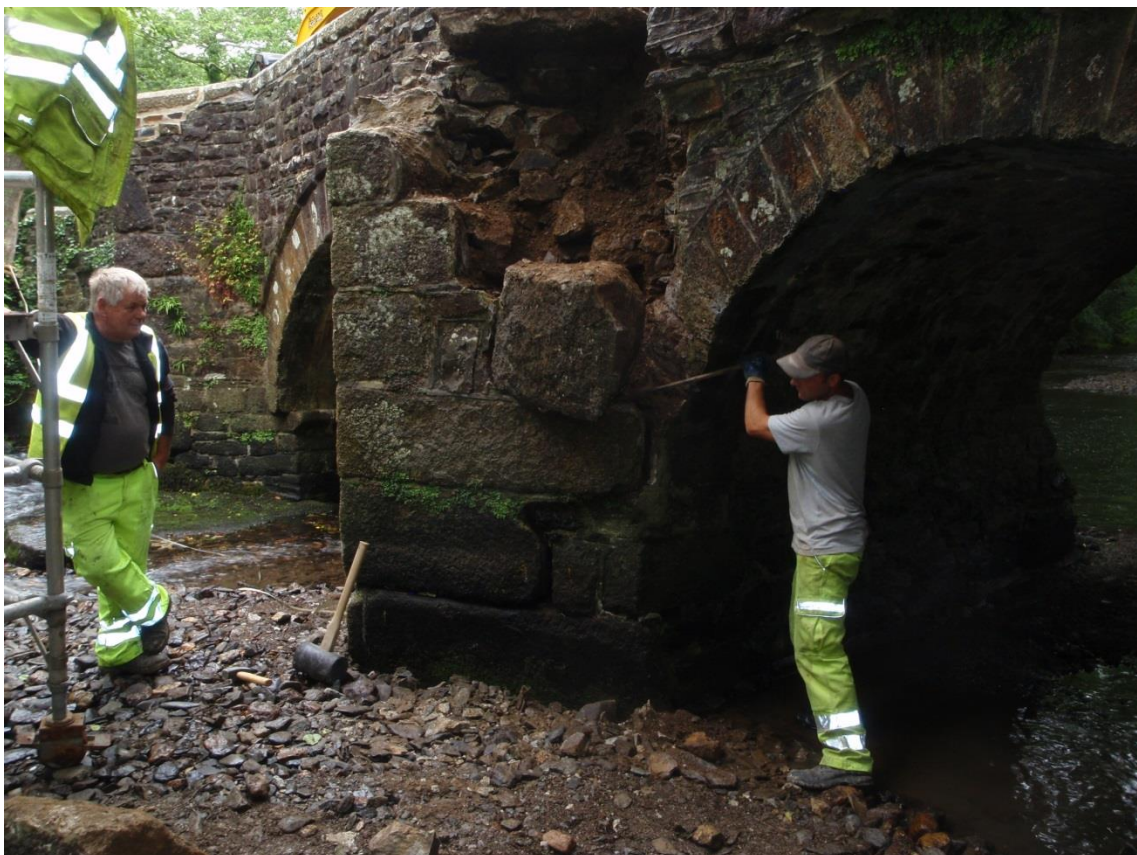
*Fig 11 Removing the damaged section of cutwater.*

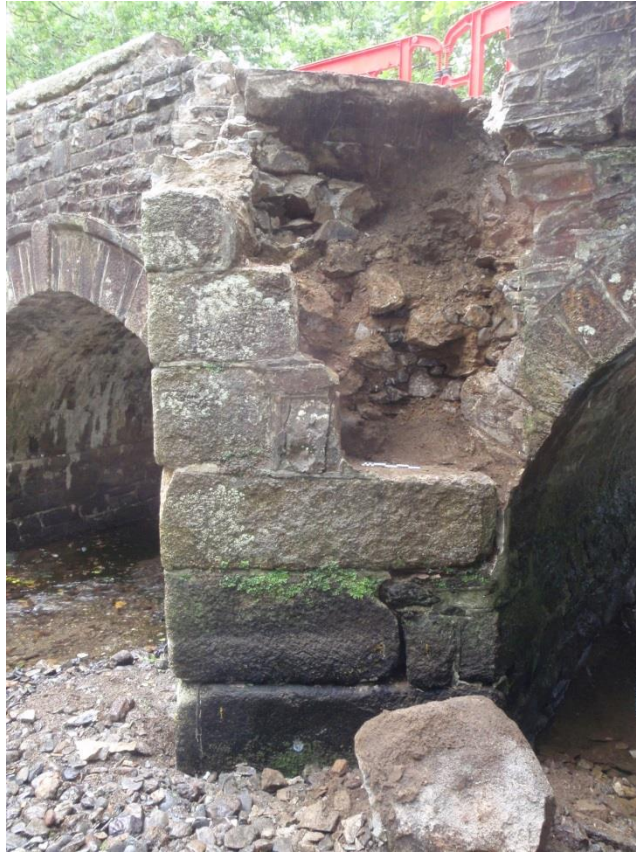
The revealing of cement bonding beneath the dressed granite facing stones of the cutwater shows that the structure underwent fairly extensive repair/rebuilding work in the 19th or 20th century. This work is likely to have been undertaken as part of the remodelling commemorated by the plaque (1889-95). Although the bridge is clearly of earlier origin, evidence suggests that the parapets, the cutwaters and the western span were rebuilt at this time.

*Fig 12 Beneath the damaged cutwater.*
