18 Chapel Street, Penzance, Cornwall
Heritage Assessment

Report No: 2016R039

Heritage Assessment

Client	Cornwall Council
Report Number	2016R039
Date	May 2016
Status	Final
Report author(s)	Jo Sturgess
Checked by	Andy Jones
Approved by	Andrew Young

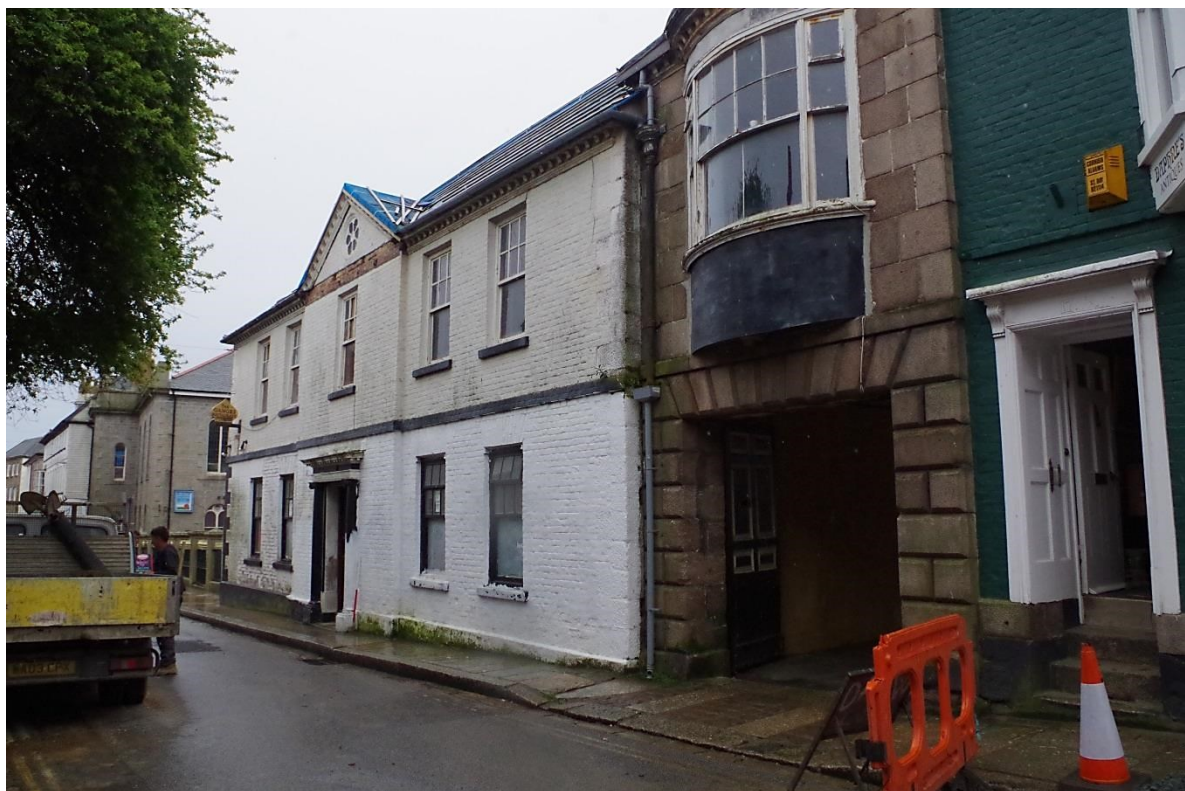
The front (north-east) elevation (Fig 7) is symmetrical and retains its 18th century design, openings and ornament. It has a slightly protruding central section with pediment over containing a decorative, circular window and a front door with decorative columned portico. The symmetrical window openings have flat arches and there is a modillion cornice at the eaves. The windows themselves appear to be 19th or early 20th century replacement sashes with six panes to the top and a single pane to the bottom.

Fig 7 Front (north-east) elevation.

The missing central section of cornice should be replaced to match the original and repairs to the cornice elsewhere should also match the original.

Any repairs to the portico and its decorative mouldings should match the original. If the modern door is replaced, a Georgian style panelled door would be more suitable.

If the sash windows in the main part of the house on this elevation are to be replaced, timber, six-pane, hornless sashes are recommended to top and bottom of each window.

Repairs to the wall above the gateway and oriel window should ensure that original elements are repaired or reinstated.

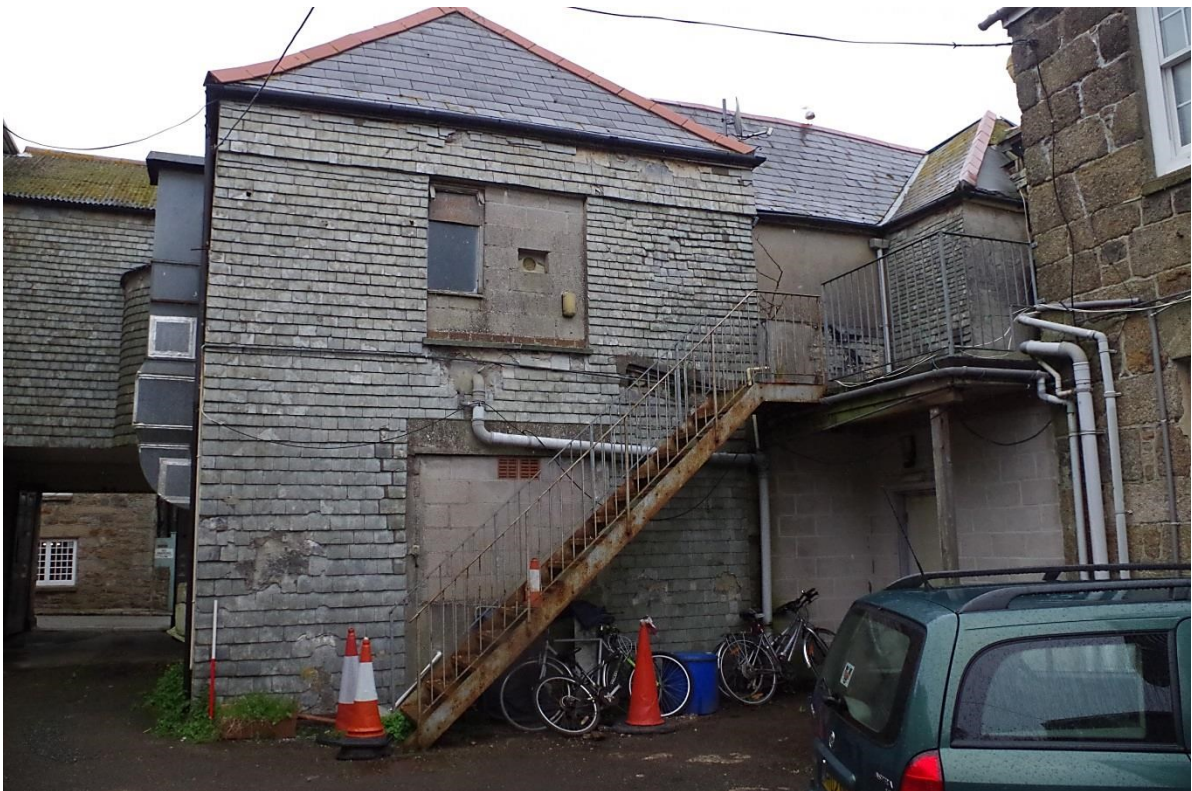
The rear, south-west elevation (Fig 10) is constructed from stone rubble but has later been slate hung and there are modern cement rendered sections where the slate hanging has failed. Much of the south-eastern half of this elevation has been obscured by modern concrete block-built extensions as well as a 19th century slate roofed link corridor leading to the building range in the rear yard. The north-west wing has two wide, blocked window openings, one at ground floor and the other at first floor level. The town plan of c1880 (Fig 5) indicates that the ground floor window was once a bow or bay window. Above the blocked window at first floor level there is slate blocking below the eaves indicating the location of a removed and blocked dormer window which once lit a servants' room in the attic (room 27) (Fig 59).

Fig 10 Rear (south-west) elevation.

If the existing slate hanging is removed from this elevation an archaeological record of the wall face should be made prior to re-slating. It is recommended that blocked original window openings are reinstated with appropriate fenestration where possible. Historic mapping shows that the ground floor window to the north-west originally held a bay window. A 1934 newspaper article describes the now blocked, original, arched staircase window as containing stained glass (The Cornishman 1934).

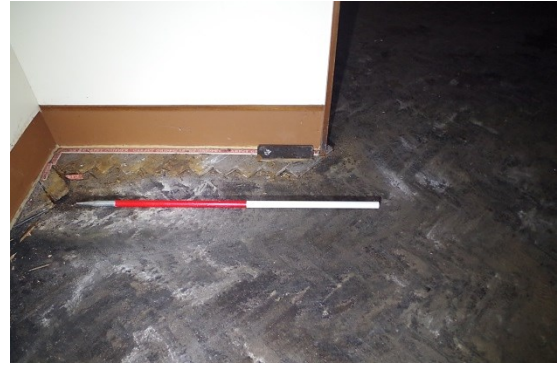
Fig 20 Room 6 removed parquet floor at south end.

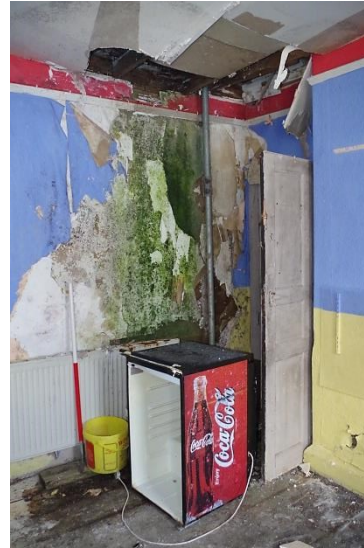
Fig 32 Room 14 water damage in south-west corner.

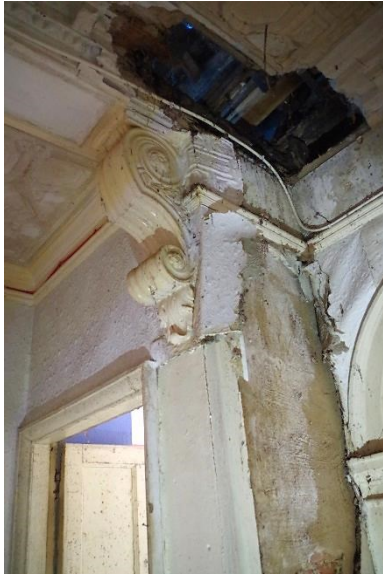
Fig 35 Room 16 detail of 18th century corbel and damaged cornice.

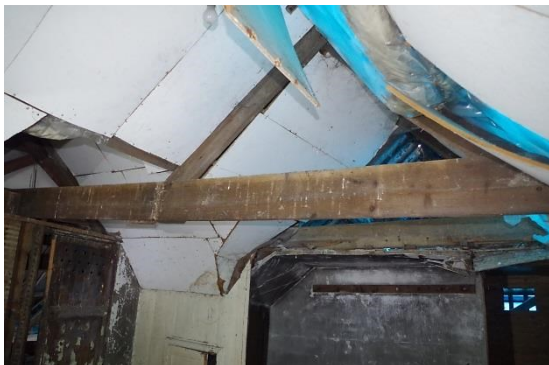
Fig 49 Room 25 sawn off truss looking north-east.

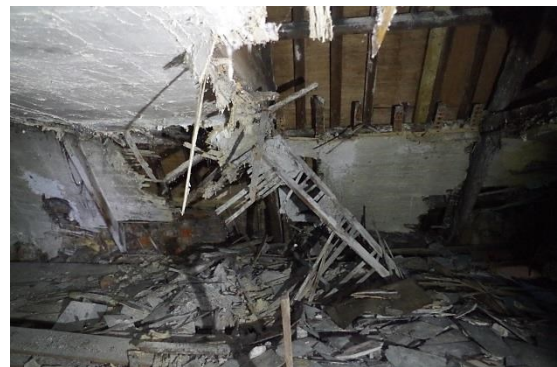
Fig 53 Room 27 collapsed lath and plaster ceiling looking north-west.
