St Buryan Churchyard Cross, Cornwall  
Archaeological recording and watching brief during  
repairs

| <b>Report Number</b> | <b>2016R050</b> |
| <b>Date</b> | <b>August 2016</b> |

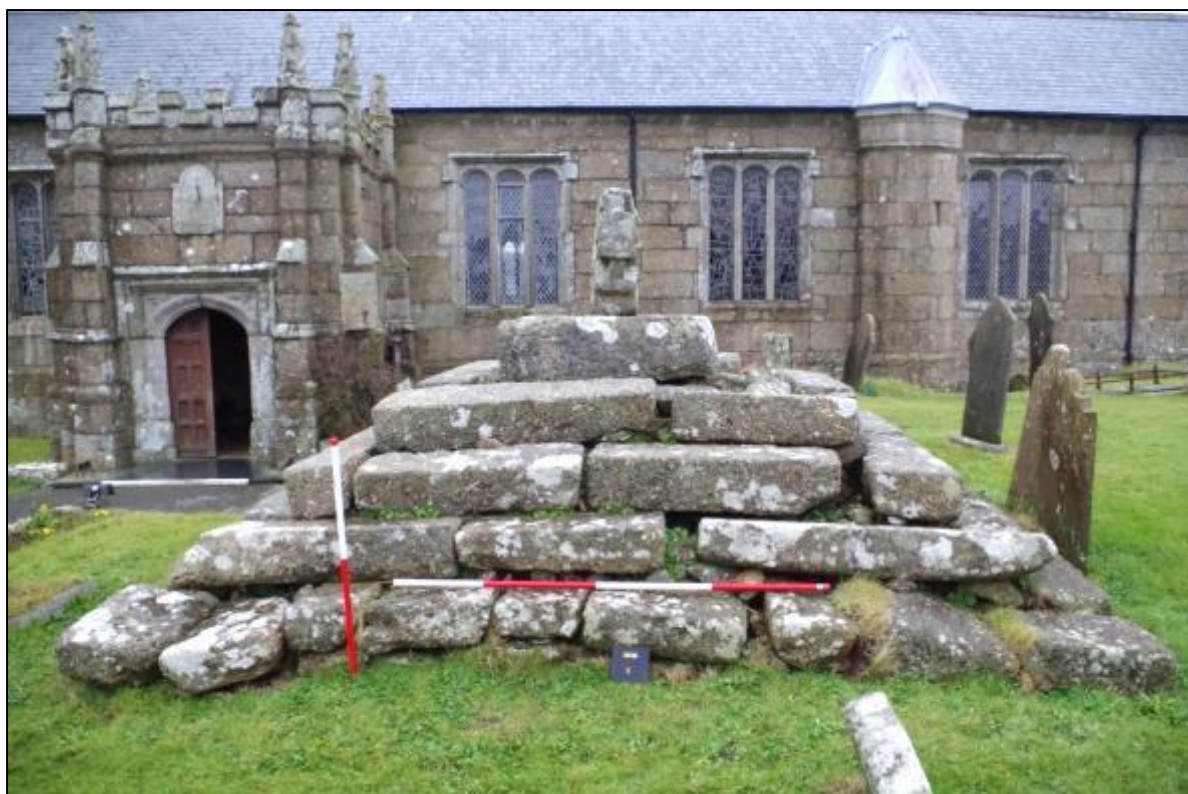
Fig 9 South elevation (JG).

Before the start of this project, the monument was on the Heritage at Risk register. The main area for concern was the stepped pedestal, which is constructed of large blocks of granite trigged with smaller stone. It is assumed that at one time the stepped pedestal would have been neatly levelled and mortared. However, with time, the pedestal had lost all of its mortar and much of the rubble and earth fill had washed out, leaving large gaps between the steps of the pedestal, so that the stones forming the steps were 'loose' and, though large, effectively portable. One was known to have carving on its under surface, and was thought to be part of a re-used medieval grave slab. At the same time, the surrounding ground had settled, causing the steps to slump away from the cross, especially on the east side. As well as threatening the stability of the monument, this situation was a safety issue for the church (see Figs 9 to 16, especially 10, 11 and 12).

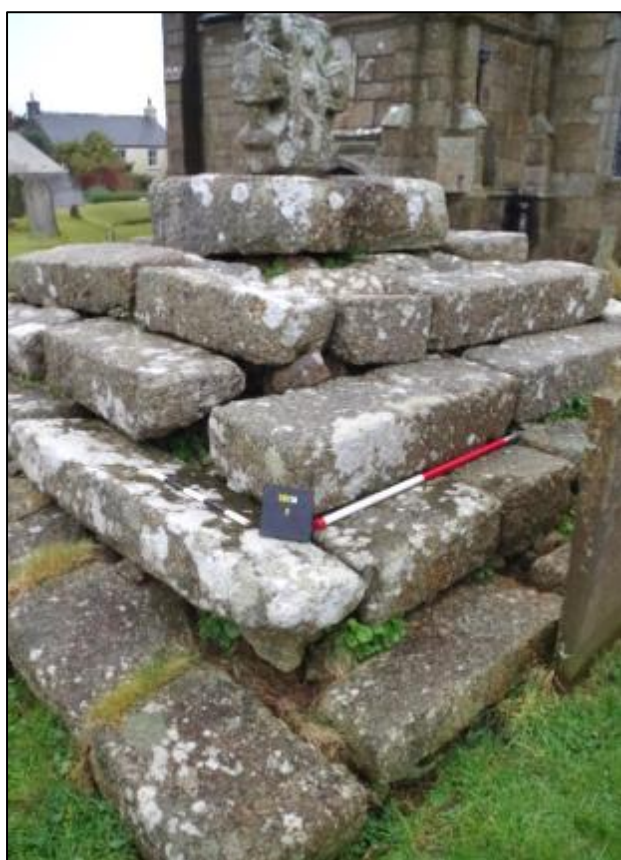
Fig 10 South east corner (JG).

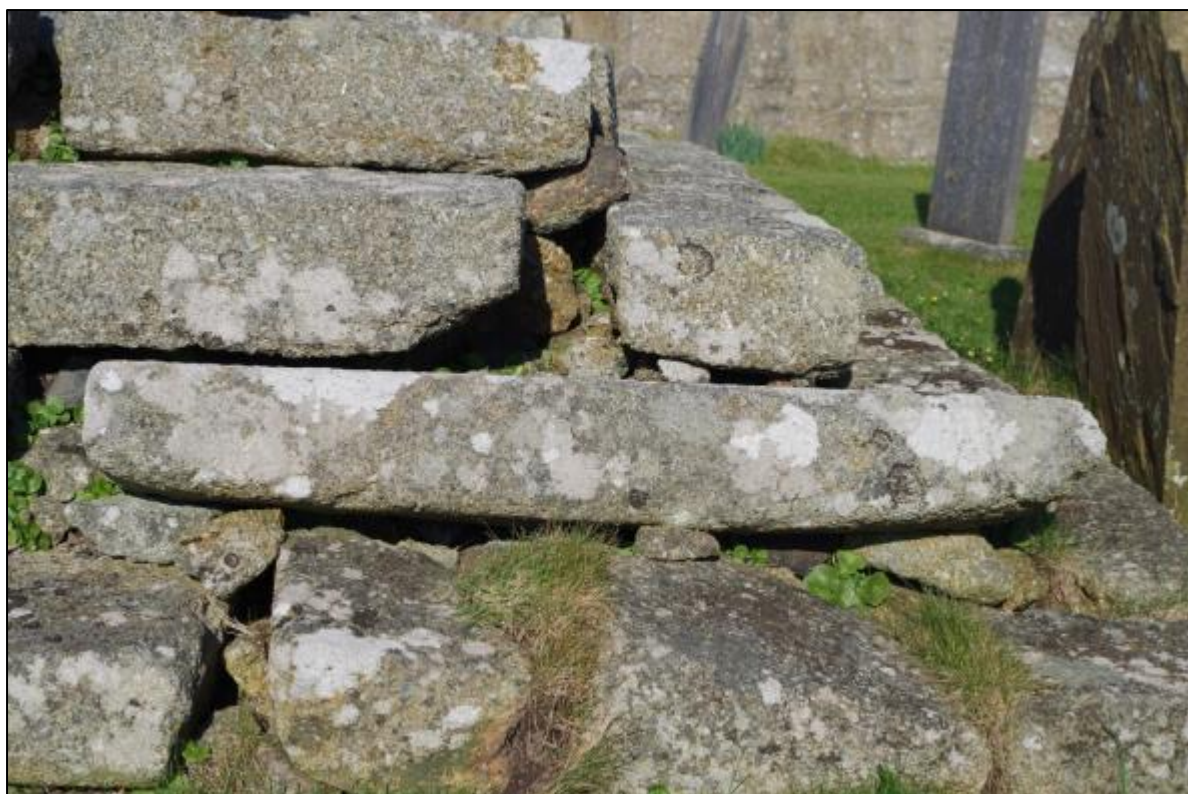
It was clear upon inspection and recording that the monument required urgent attention. Slumping of stonework was particularly prevalent along the eastern side, with both north-east and south-west corners moving outwards, probably as a result of loss of the material used to bed the steps in the nineteenth century. There was also evidence for slumping of the south-west corner, and large voids had opened up between many of the stone blocks, some of which had been filled by smaller stones as part of *ad hoc* repair. The central stone serving as the cross base appeared stable, suggesting that the core of the structure beneath this point – that is, the original pedestal – was sound.

Fig 11 Detail of south east corner showing uneven and collapsing stonework (JG).

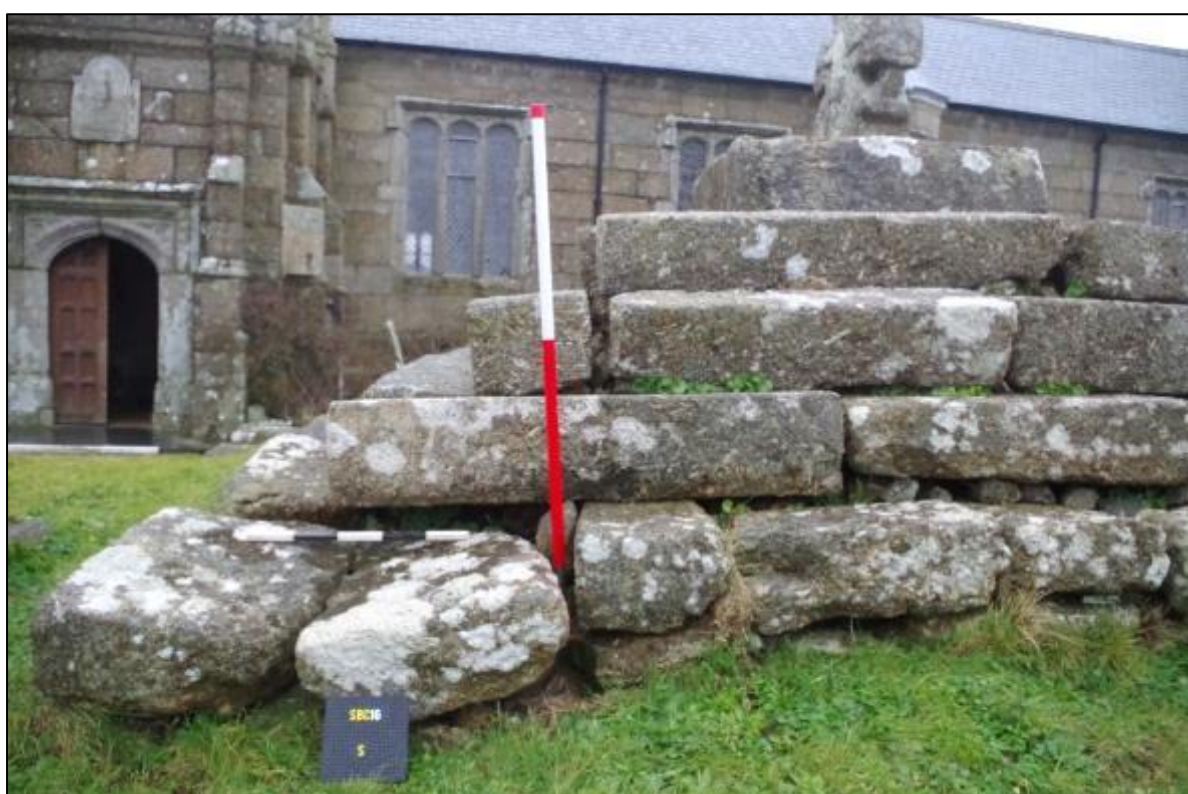
Fig 12 South west corner showing slumping of stonework (JG).

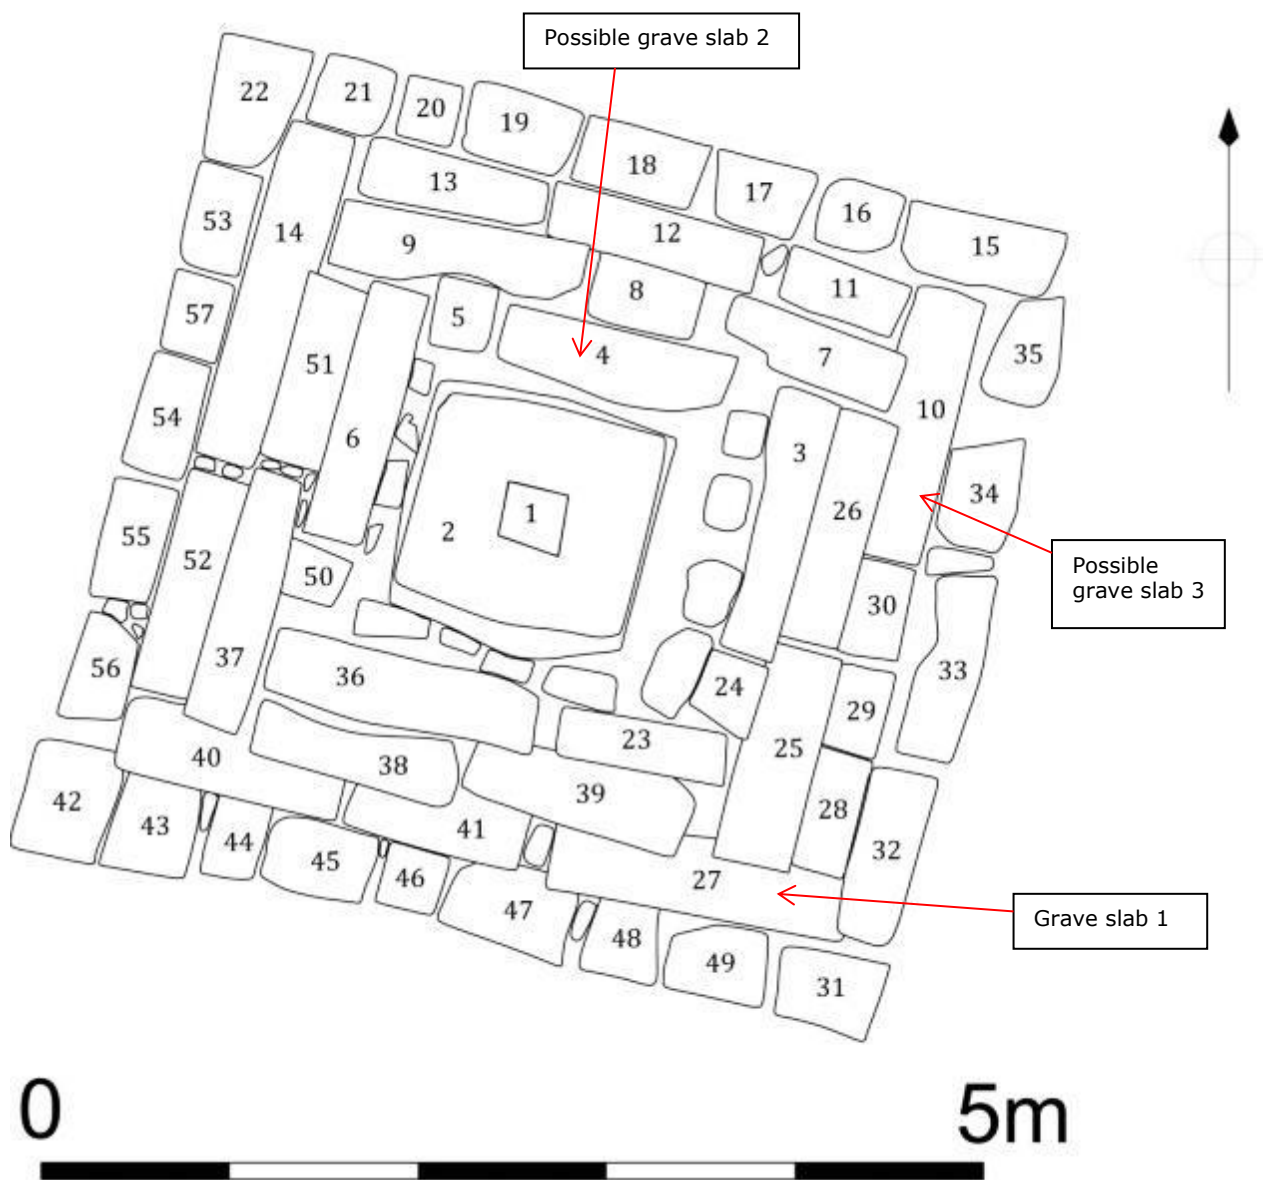
Fig 17 Plan survey of the monument (JG).

A three dimensional survey (using GPS GNSS) including two profiles (north-south and east-west) recorded the condition of the monument prior to consolidation work (Figs 17, 18). This was enhanced by detailed photographic survey (mainly digital but also black and white 35mm 100 ASA film) (Figs 9 - 16) and a historic building record accompanied by sketch plans and profiles (undertaken by Joanna Sturgess). The condition survey helped illustrate the urgent need for conservation work and provided a guide for the building contractor.

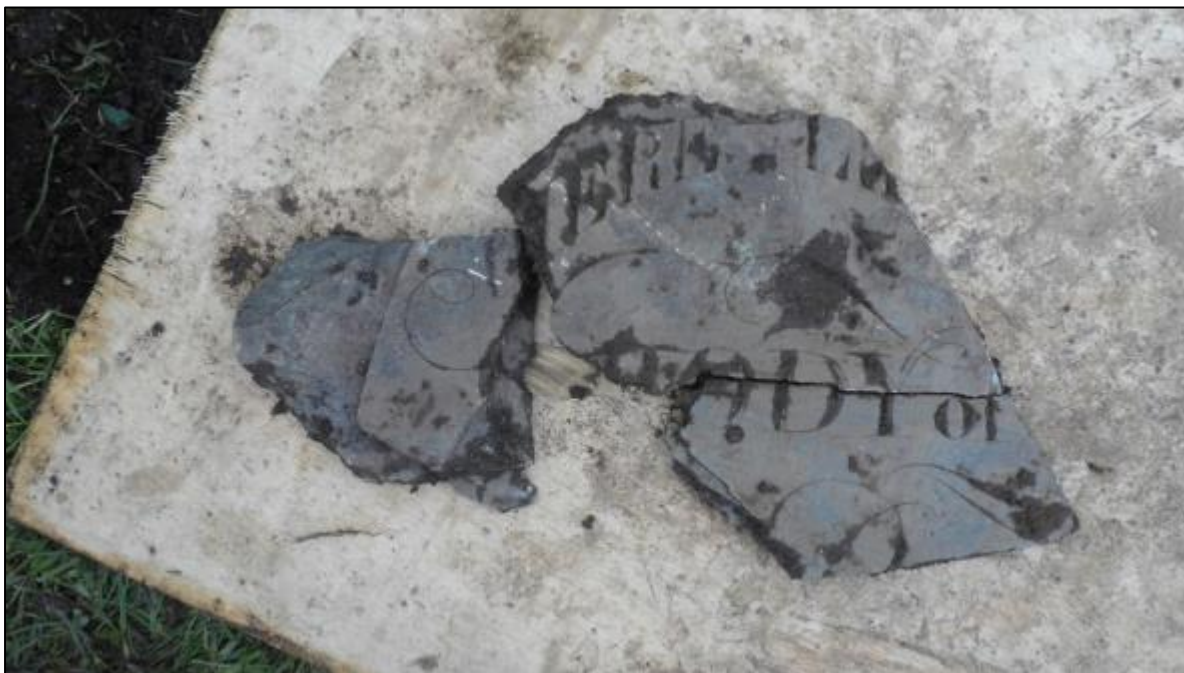
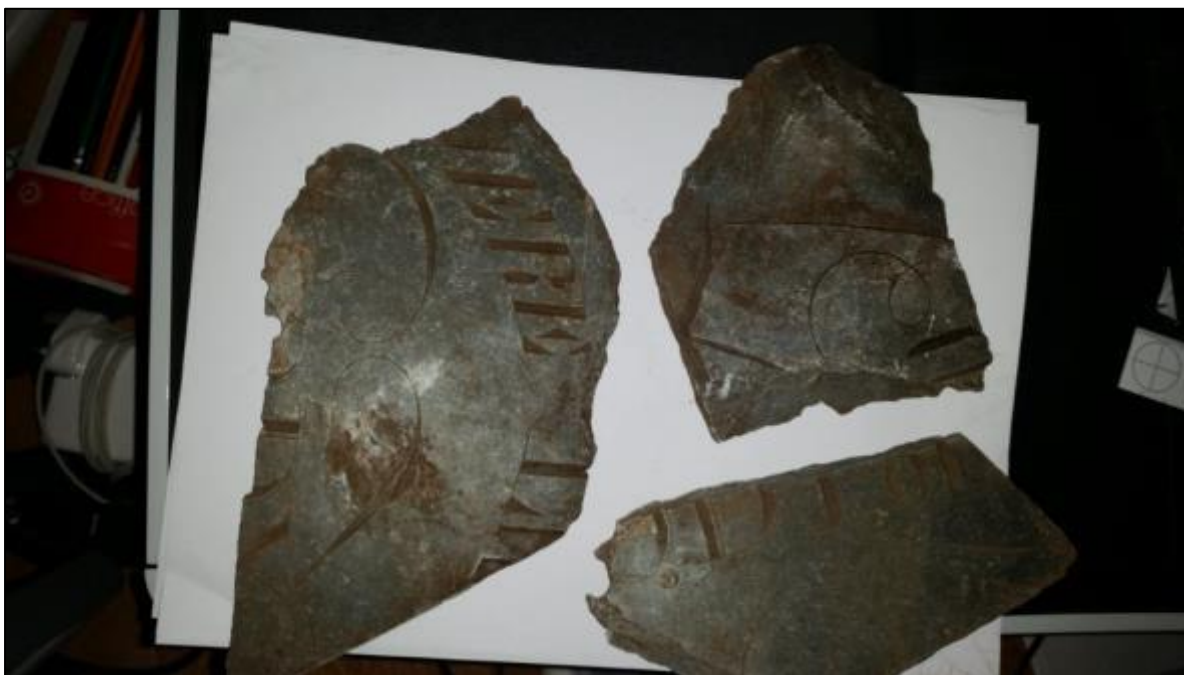
This is confirmed by the fact that when the ground beneath the south east corner of the pedestal was excavated to a depth of over 0.4m to enable a slab to be laid to provide a firm base, some modern pottery fragments and pieces of a nineteenth century slate headstone were found (Figs 21 and 25).

Fig 21 Fragments of headstone found under south-east corner of pedestal (RS).

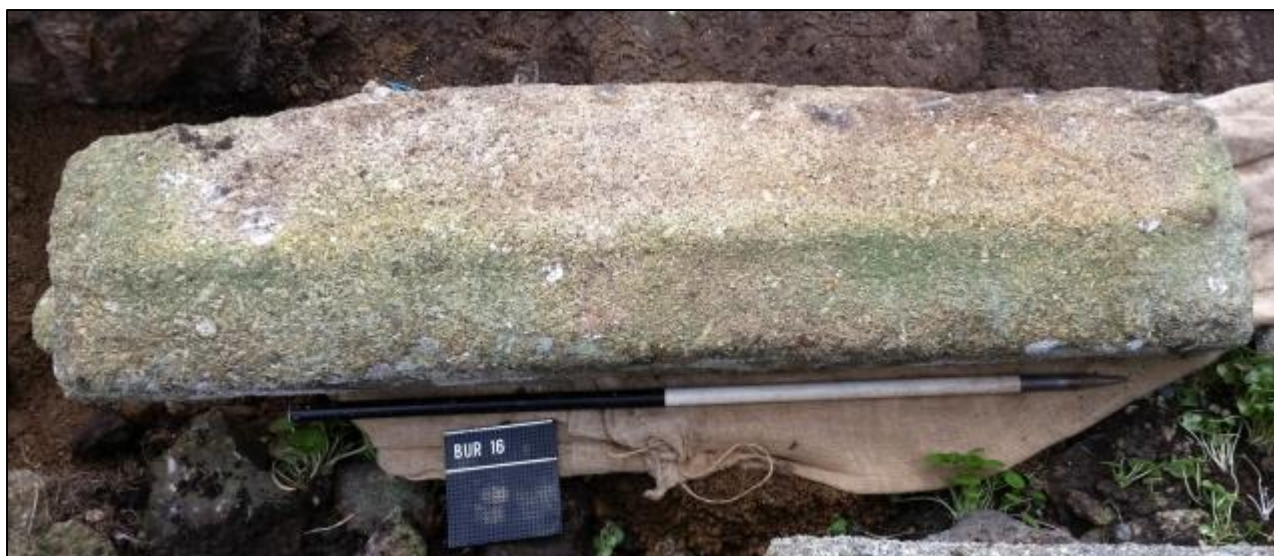
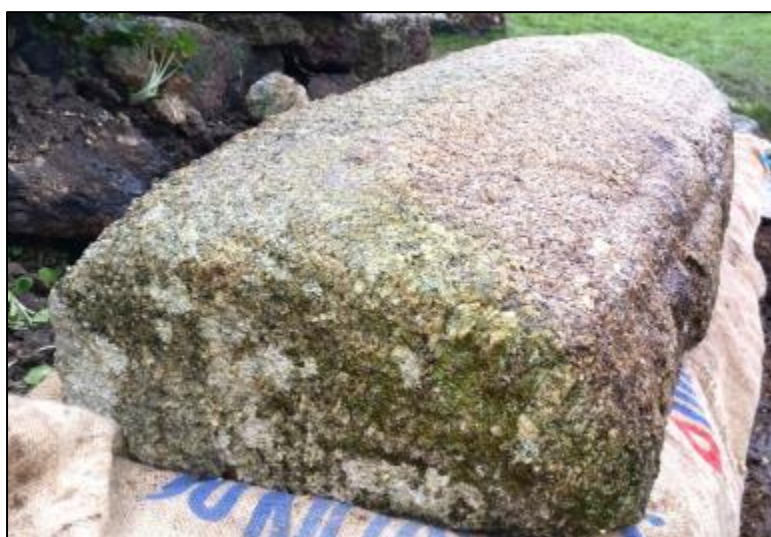
This stone had been re-used as a step within the cross pedestal, inverted, on the south-east side. It was clear even before it was removed that it was likely to be a grave slab since the shape was notable and mouldings on it could be felt on the underside, where the pedestal's fill had washed away. When removed it was found to be a long narrow slab of granite, neatly dressed, with a slightly bowed outline, domed upper surface and flat bottom (which had been used as the surface of the step). It is 1.59m in length, 0.34m – 0.39m wide, and up to 0.24m deep. The stone has a raised ridge running centrally along its axis. On one side only is a roll moulding at the angle; there is no corresponding moulding on the opposite long edge or at either of the narrow ends, because these had been trimmed (presumably to help it fit into the pedestal, or for some other, earlier, re-use).

An initial assumption that the grave slab may be of the eleventh century (see for example: <http://www.cornishman.co.uk/restoration-st-buryan-medieval-cross-uncovers/story-28861525-detail/story.html>) has been confirmed by the recent discovery of a very similar grave slab at Lincoln Castle. This latter, which also has a very similar simple raised ridge, was found *in situ* forming the cover of a stone sarcophagus, which was built into the remains of an Anglo-Saxon church beneath Lincoln Castle; the burial that it contained has been dated to the eleventh century (Hilts 2016, 32).

Fig 22 Grave slab 1 (RS, AGL).

The stone was replaced in its former position, upside down on the south-east corner of the stepped pedestal. See appendix 2, south side, stone 6.

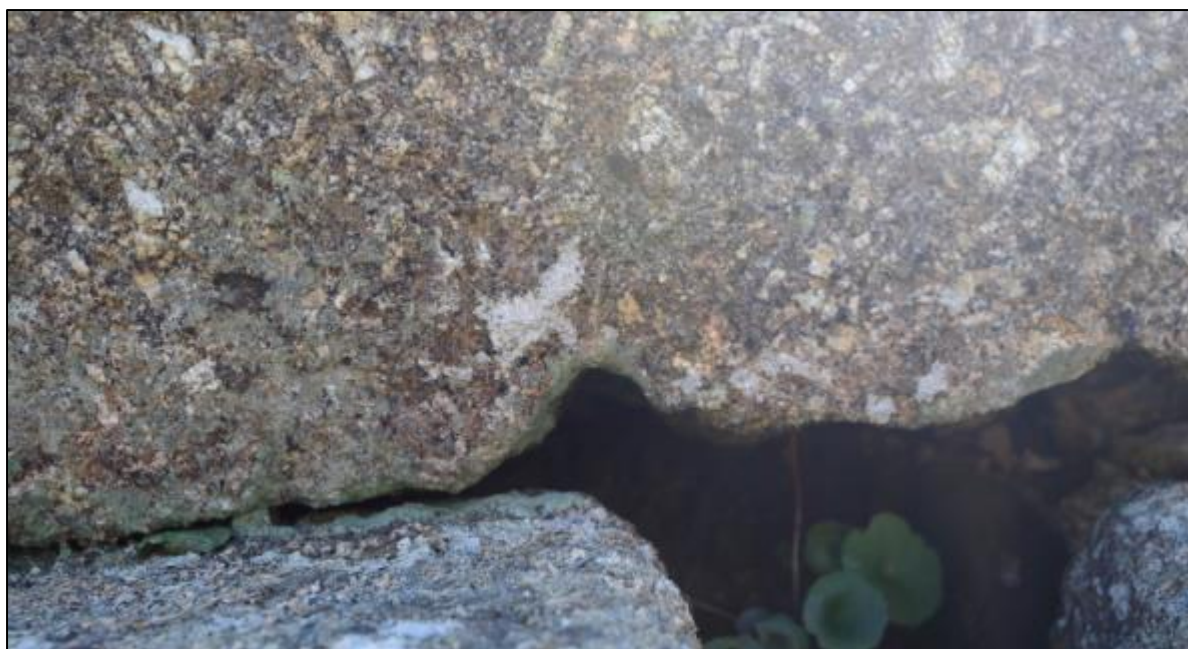
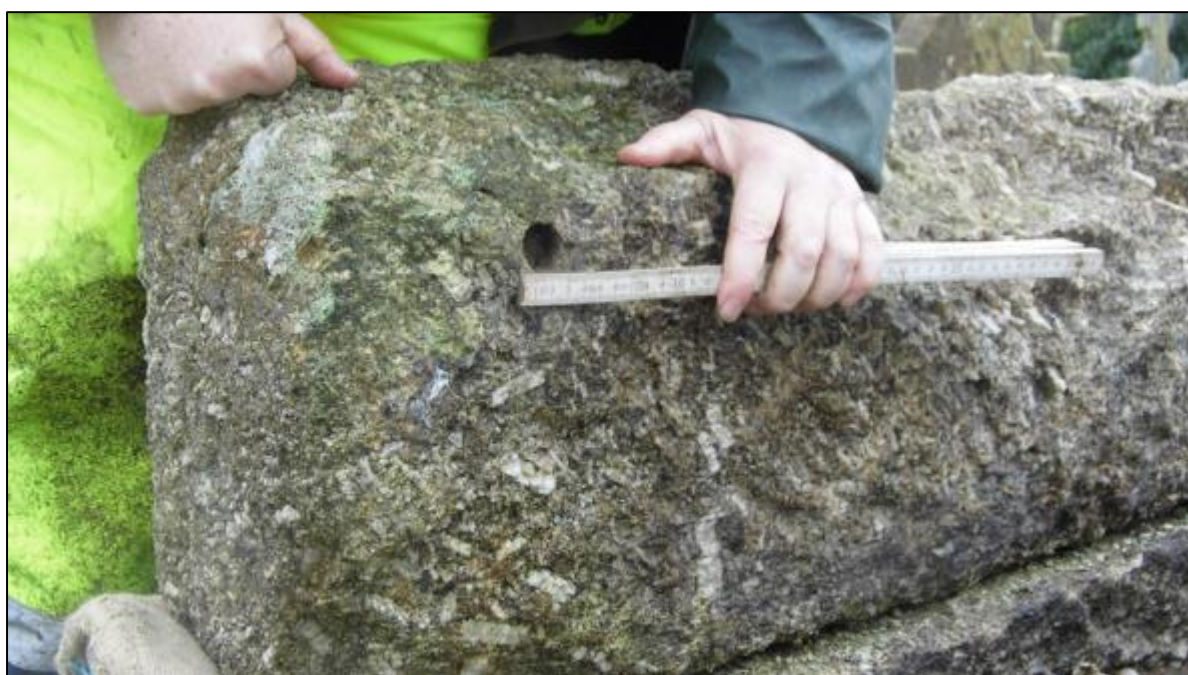
Drill holes present in many of the pedestal's large granite blocks (Fig 26) show that the outer four tiers of the monument were made up of stone quarried in the nineteenth century, suggesting a large-scale rebuild of the monument at around this time. This is supported by the evidence of the nineteenth century illustrations and (with hindsight) by the very conclusive documentary evidence of the churchwardens' accounts (above, section 6). The drill holes were consistent in their diameter of 25mm and varied in depth, but ranging between 0.06 and 0.07m. Similar drill holes can be found in the stone making up the wall approaching the south porch confirming that this work was all of the same period. The stone steps leading to the monument from the north-west are likely to be part of this same build.

*Fig 26 Drill marks (AGL).*

*Above – seen in profile before removal from the plinth and below – one of the drill holes being measured. All the drill holes were approximately 2.5 cm across, and indicative of a nineteenth century date.*

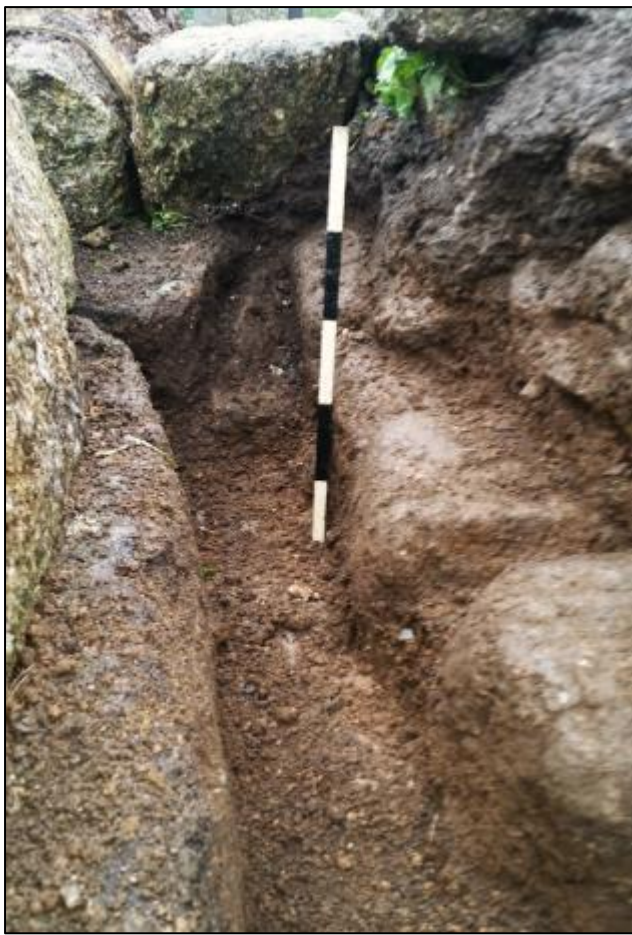
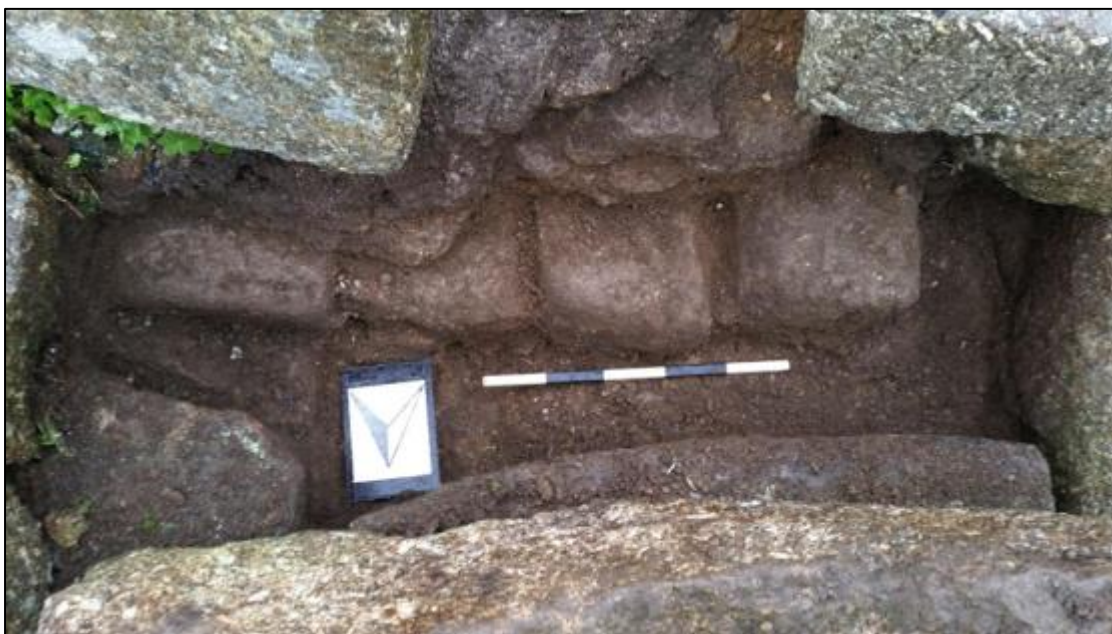
Behind the outer facing was an earlier, possibly original flight of steps which appears to be *in situ*, but in a poor state of repair. This was built of very much smaller stones (Fig 27), without any drill marks evident (although none of these stones were removed). Various spots were probed to determine the foundation of the wall, but these were never confirmed due to the limited excavation. From this it appears very likely that the nineteenth century refurbishment referred to in the churchwardens' accounts, deduced from the illustrations and confirmed by excavation, had involved building a new stone face or shell over and around the entire original stepped base of the cross, the latter forming the foundation for the new work. From the small glimpses allowed by the work methods, it is likely that this original monument survives in its entirety as a core within the nineteenth century steps. This helps to explain the way in which the plinth had deteriorated - slipping away from the core especially on the east side where grave subsidence may have contributed to the effect - while leaving the cross head apparently firmly set at its apex.

*Fig 27 Wall or face of older step hidden within the nineteenth century 'shell', north-west corner (RS).*

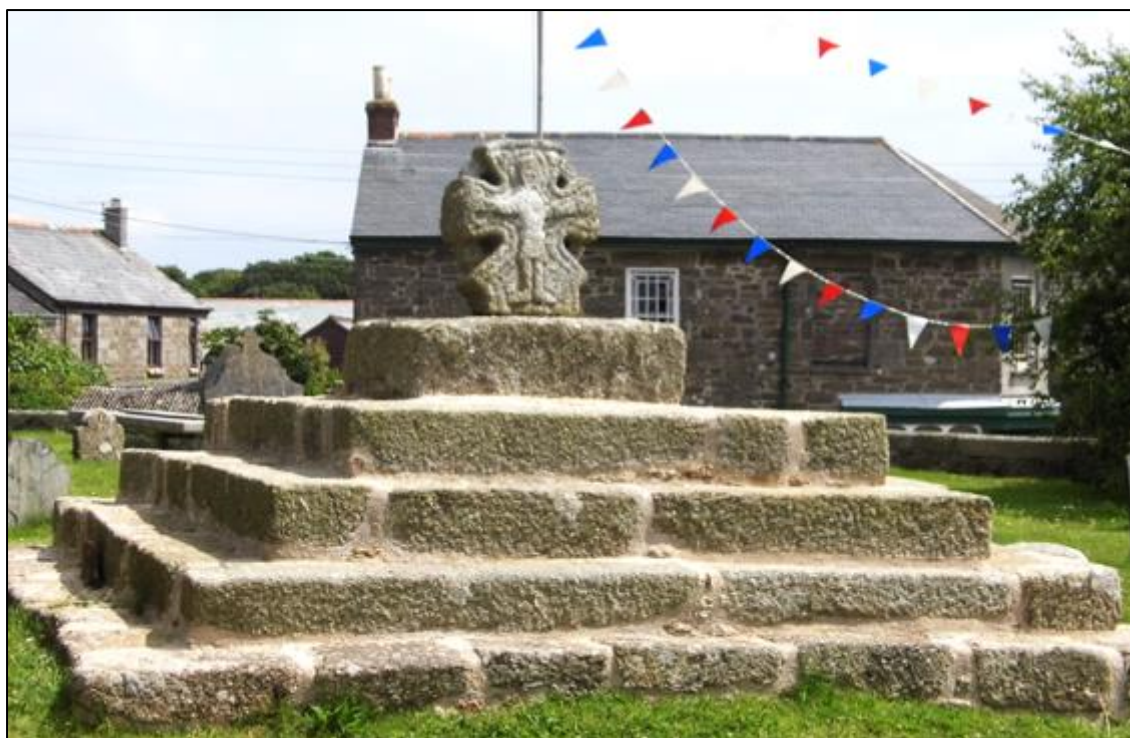
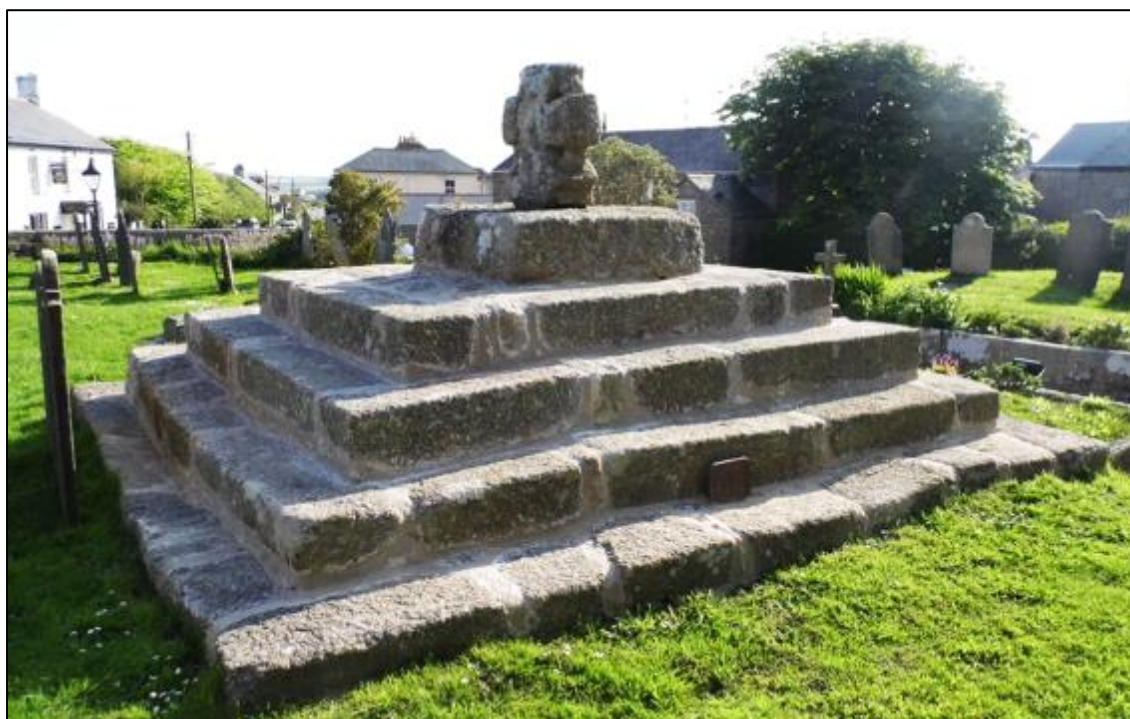
The partial collapse of the outer 'shell' of the monument was due to a rebuild in the nineteenth century that involved insufficiently stable core material and poor bonding (there is no evidence that it was repointed). The presence of two graves close to the eastern side of the monument may have caused some slumping as grave backfill settled. The condition of the monument prior to the nineteenth century rebuild is illustrated by JS Prout's engraving (Fig 6) – clearly it was decided to invest in the structure at this time, creating a larger and more impressive monument. However, the Churchwardens' Accounts show that this was in fact only one part of a massive programme of works in the churchyard at the time: a programme which included the churchyard walls and culminated with the full restoration of the church in the 1870s.

Fig 35 The repaired cross-pedestal: from the west (AGL) and from the north-east (APJ).
