Wheal Drea engine house, St. Just in Penwith, Cornwall  
Archaeological watching brief during structural repairs

Report No: 2016R077

<b>Client</b>	<b>National Trust</b>
<b>Report Number</b>	<b>2016R077</b>
<b>Date</b>	<b>16 December 2016</b>
<b>Status</b>	<b>Final</b>
<b>Report author</b>	<b>Adam Sharpe</b>
<b>Checked by</b>	<b>Dr. Andy Jones</b>
<b>Approved by</b>	<b>Dr. Andy Jones</b>

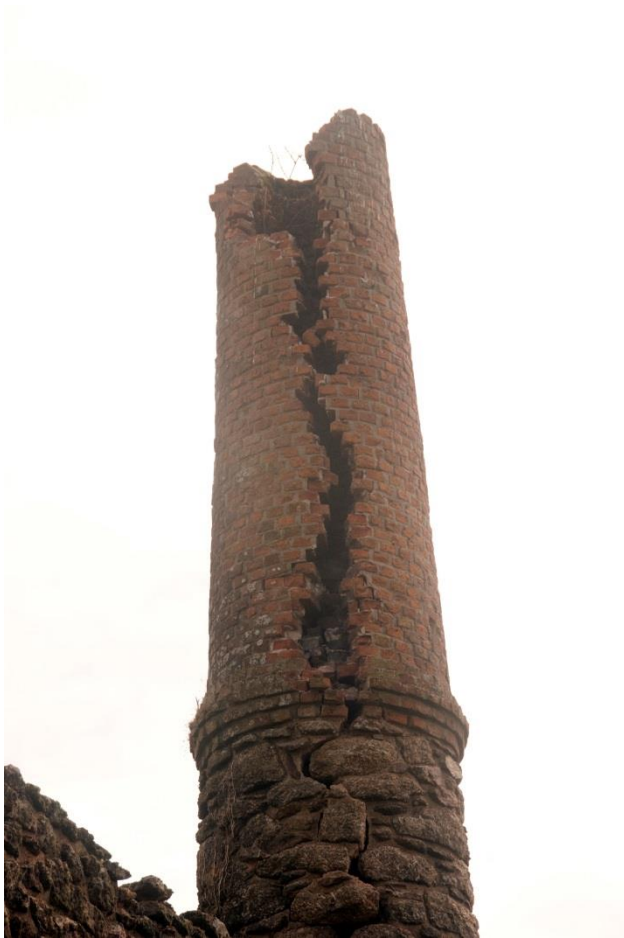
It was clear that the 2014 lightning strike had hit the top of the chimney on its northern side, completely destroying a V-shaped section of brickwork 500mm wide and 500mm deep at the top of the chimney (Fig 3). Fragments of brick littered around the base of the engine house, on the cylinder plat and in the cockpit are assumed to have derived from the damage to this area. The strike had then travelled down the northern side of the brickwork section of the chimney unzipping the brickwork and tearing the chimney open, leaving a gap averaging 250mm wide (Fig 5). The sections of the chimney on either side of the line of the strike had been forced apart, breaking a number of bedding joints down to the base of the five course drip ring. Three full height cracks on the southern side of the chimney showed where the two sections of the chimney had hinged apart, these cracks being significantly wider on the inside of the chimney than on the outer face. The additional thickness of the lowest section of the brickwork had probably given it additional strength, and this had probably prevented the whole of the upper section of the chimney collapsing as a result of the strike. Nevertheless, the brickwork section of the chimney was in a poor state overall. Its eastern half was leaning outwards by several inches at its head, whilst its western half was leaning inwards slightly (Fig 18).

The force of the strike had additionally destroyed all lichen covering on the brickwork and pointing for 250mm on either side of the crack, broken bed and side joint pointing in much of the chimney brickwork and cracked bricks near the strike line on the southern face of the chimney.

*Fig 3. The chimney shortly after the lightning strike.*

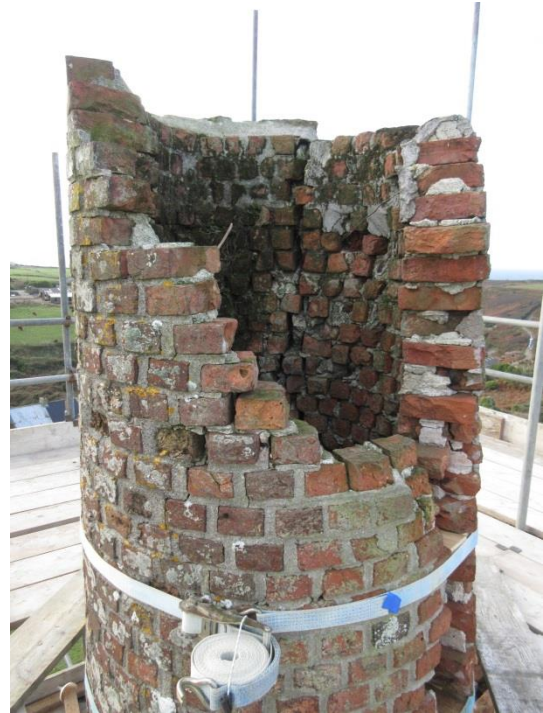
*Fig 4. The top of the chimney, ratchet strapped to secure it at an early stage in the works.*

Given the precarious state of the chimney brickwork, the conservation masons enclosed it with a series of heavy-duty ratchet straps which were progressively tightened until they held the two halves of the chimney together firmly (Fig 4). These were left in place until the bulk of the repair works had been completed. They had the additional effect of drawing the two halves of the chimney together to some degree and assisted considerably in the re-setting of the displaced stonework, whose joints were subsequently deeply packed with lime mortar.

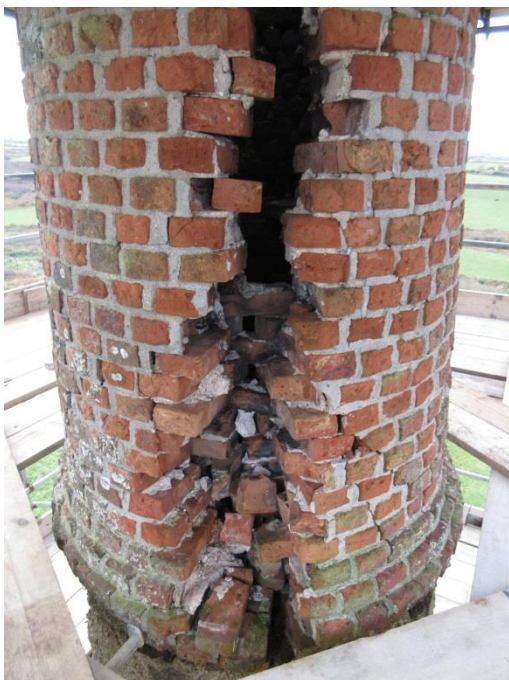
*Fig 5. The unzipped lower section of brickwork and drip ring.*

With the structural stability of the chimney enhanced to some degree by these means, a small number of loose bricks on the edges of the main part of the crack were removed and repairs were undertaken to the drip ring and the lower courses of the chimney to tie these together. Five courses of brick were dismantled at the head of the chimney and the northern crack was infilled with a mixture of original and reclaimed brick, laid in courses to match the original work. Where reclaimed bricks were used these were hand cut to a taper. All repaired sections of the chimney were kept wrapped in a tarpaulin during periods of cold weather and overnight to prevent any danger of frost damage to the mortar as it cured, and to ensure that curing did not take place too quickly owing to wind exposure (Fig 9).

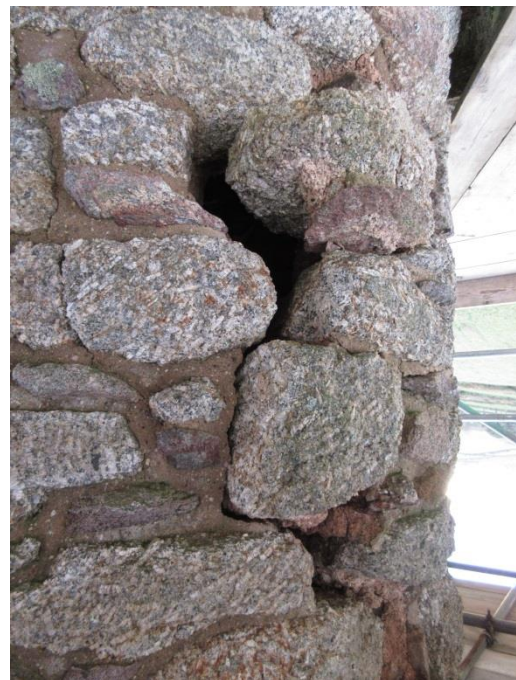
The strike subsequently travelled 1.4m down through the uppermost section of chimney stonework, opening up a full-depth crack and displacing masonry along this line (Fig 6). Below this point, the force of the lightning appears to have dissipated, the strike probably travelling over the surface of the structure – the outer faces of some sections of pointing could be seen to have been blown off as a result.

*Fig 6. The displaced upper section of the stonework below the drip ring.*

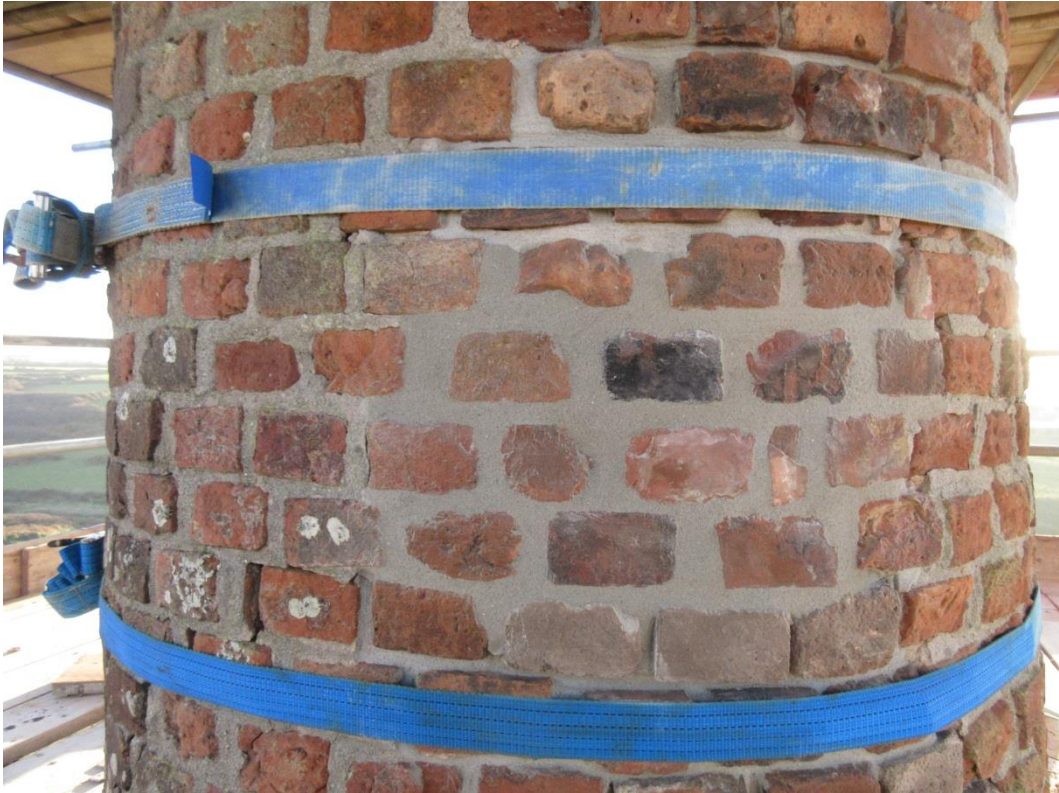
*Fig 7. The sample pointing on the brickwork.*

The use of pointing mixes with suitable textures and colours was a condition of the Listed Building Consent. Two test panels were therefore set up before the repaired sections of the chimney were repointed. On the stonework a 2.5:1 mix of Moor Gate Quarry dark sand and NHL5 hydraulic lime was used (Fig 8). This was tended to produce slightly recessed joints within which the aggregate was visible, though not prominent, and dried to a light buff colour. For the brickwork pointing a 2.5:1 mix of an off-white locally-sourced sand and NHL5 hydraulic lime was used and was again tamped up and allowed to dry (Fig 7). Photographs of the finished test panels were emailed by Mark Gendall of pdp Green Consulting to the Conservation Officer, who approved them by phone.

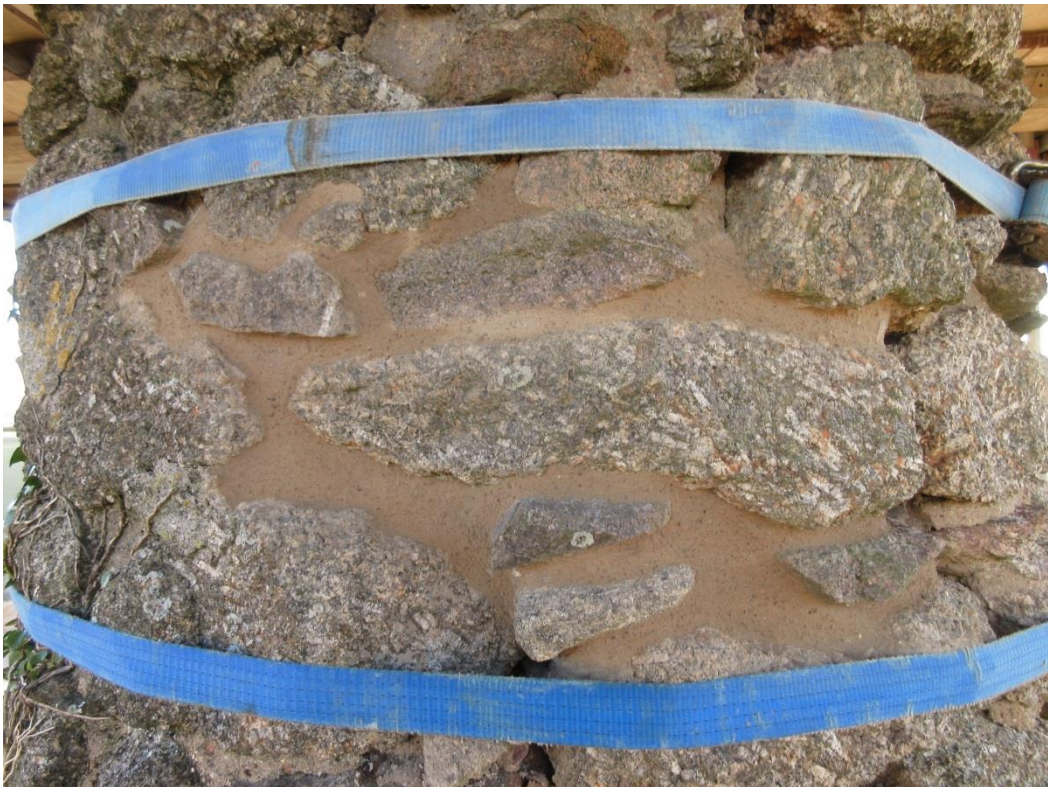
*Fig 8. The sample pointing on the stone section of the chimney.*

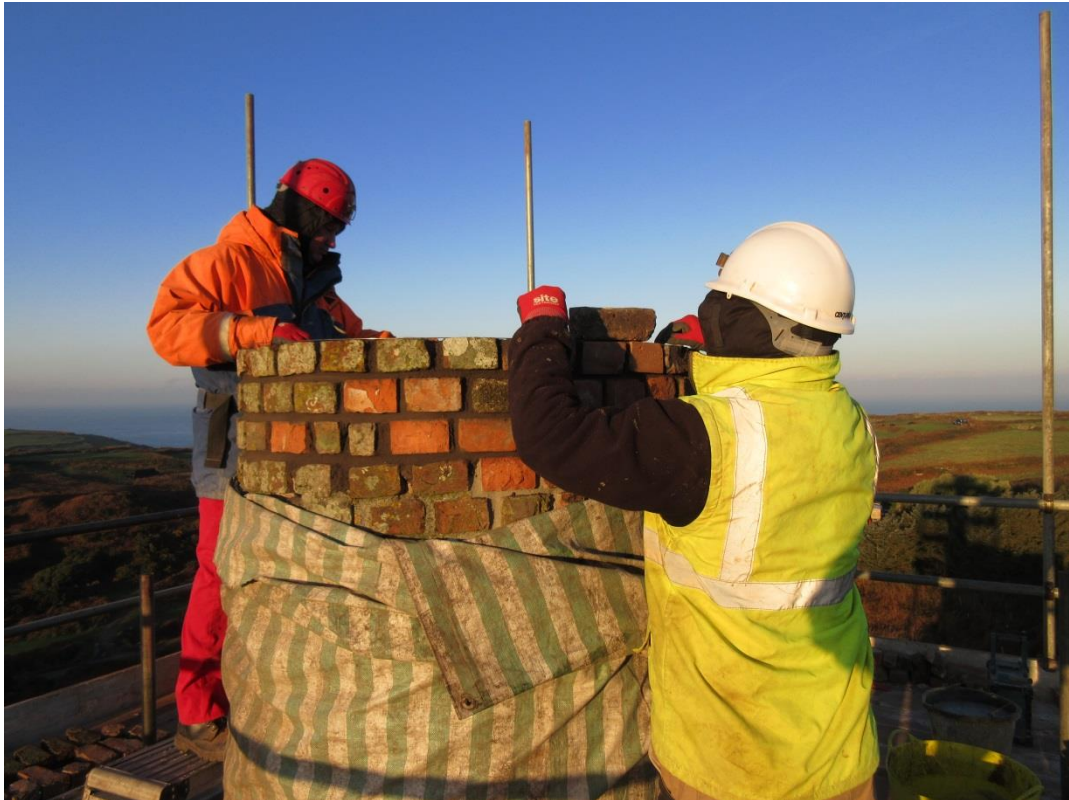
*Fig 9. Rebuilding the chimney brickwork. The tarpaulin was used to protect the mortar from the effects of the winter weather.*

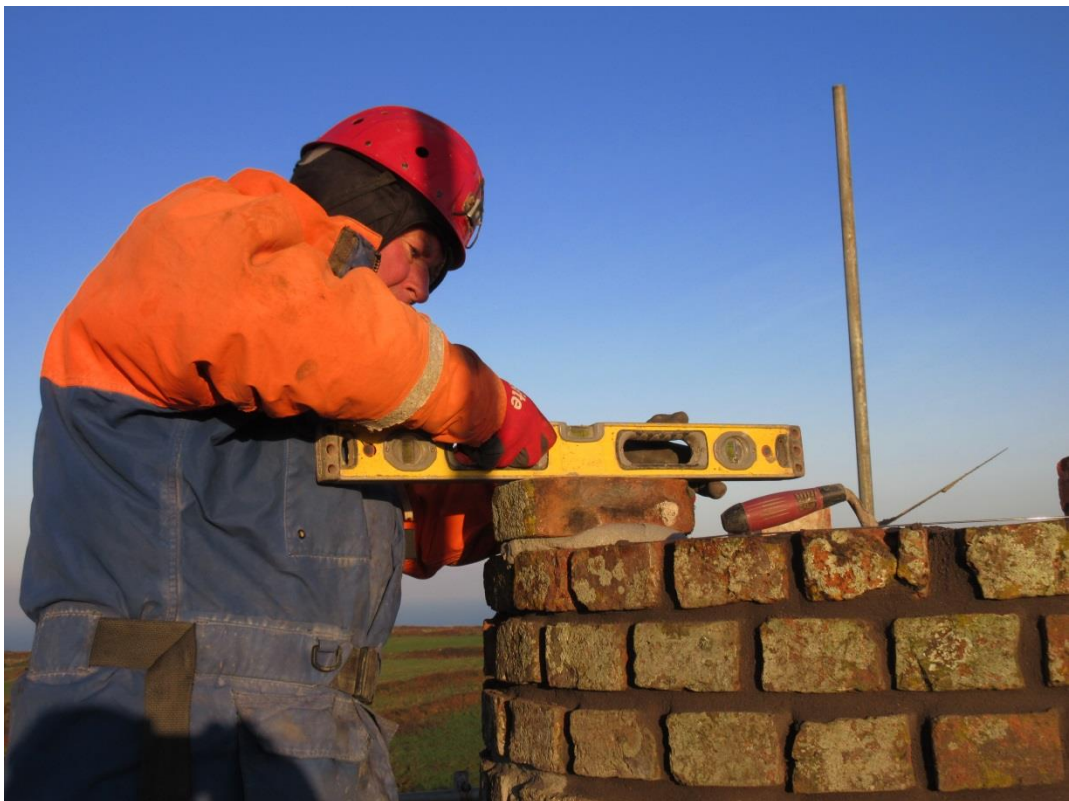
*Fig 10. The original brickwork courses were far from level. Not so their replacements.*

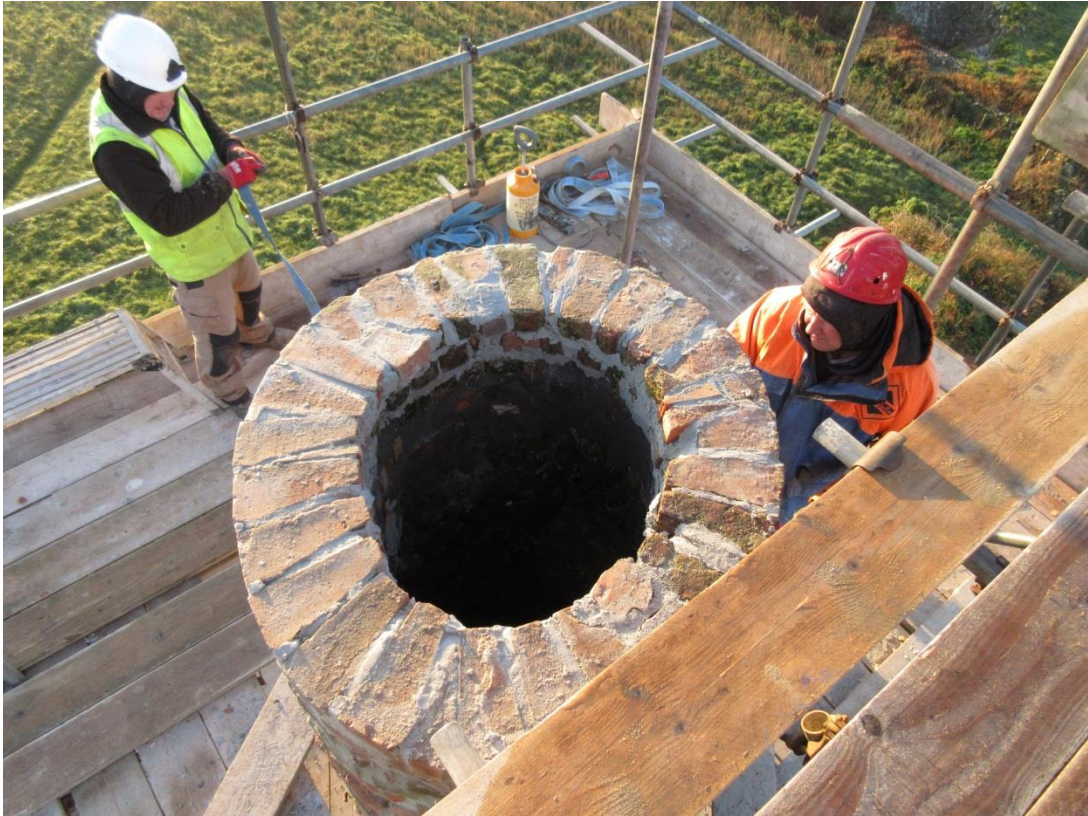
*Fig 11. As can be seen the chimney was far from circular in plan, partly as a result of the lightning damage.*

Once all courses up to the truncated head of the chimney had been repaired, an annular stainless steel reinforcing rod was bedded into the mortar five courses from the intended top of the chimney to provide additional structural strength; a similar annular reinforcing rod was installed two courses above this. The top of the chimney was finished with a complete course of bricks to strengthen this and facilitate the installation of the lightning conductor crown ring. Given the nature of the damage to the chimney brickwork, its final shape (as repaired) was sub-oval, though this is not evident from ground level (Figs 11 and 12). It may well have been the case that this odd shape is also in part the result of differential drying rates in the bedding mortar due to the effects of the prevailing wind when the chimney was originally constructed.

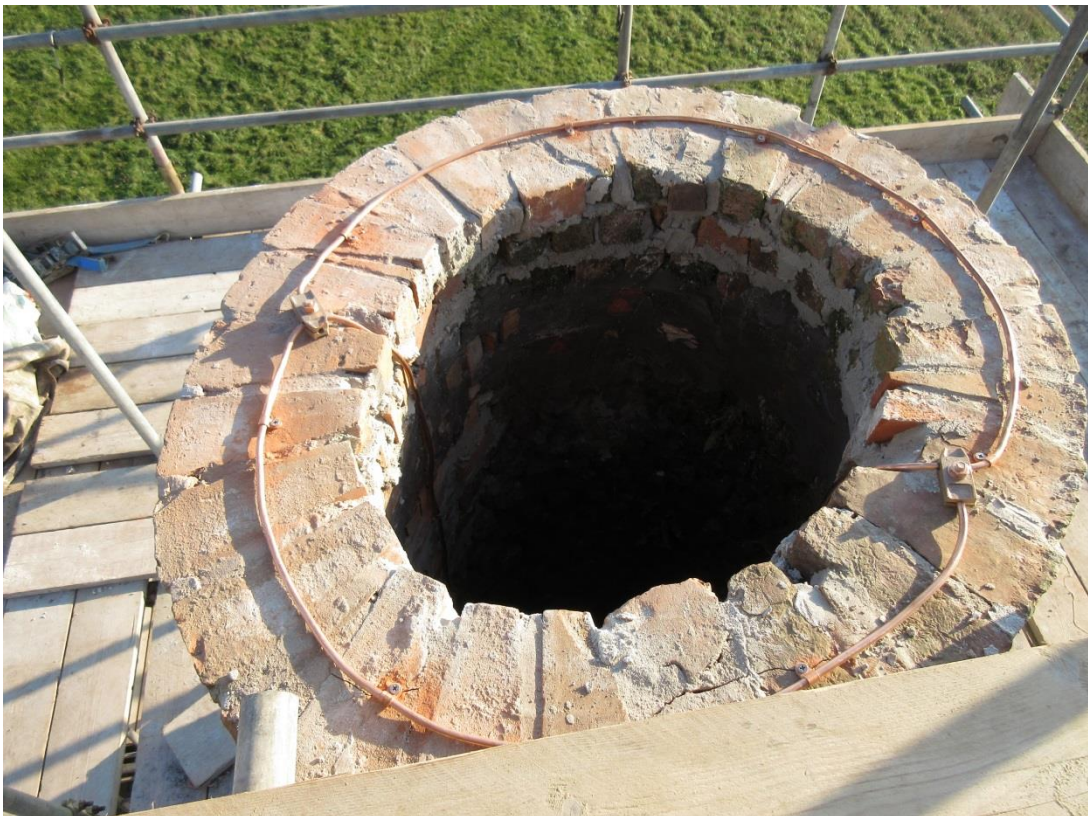
*Fig 12. The lightning protection crown ring and twin down tapes.*

A lightning protection system was installed in the chimney by St. Ives Steeplejacks on 1 December 2016. A copper crown ring was fixed to the upper surface of the chimney brickwork with stainless steel screws (Fig 12); twin down tapes were attached to this and led down the interior of the chimney, being clipped to its inner face at intervals. The masons had cleared out the flue entry at the base of the chimney on its southern side at its base, allowing the earthing tapes to be led out here. On 8 December 2016 John Williams of Pendeen machine excavated a narrow trench from the base of the chimney out into the adjacent field (Fig 20). This was 350mm wide, between 400mm and 600mm deep (down to the surface of the rab) and 10.5m long. At its northern end an original doorway in the flue running round the outside of the boiler house was cleared of rubble to allow the earth tape to be brought out from the flue entry at the base of the chimney. Along the western side of the field John Williams excavated a trench 8m long, 1.2m wide and 1m deep to accommodate the earthing tape and mats (Fig 21). The trench was again excavated down to rab; all of the material above this consisted of clean topsoil with some large stones. The trenches were excavated under archaeological supervision; no artefacts were recovered or structures exposed.

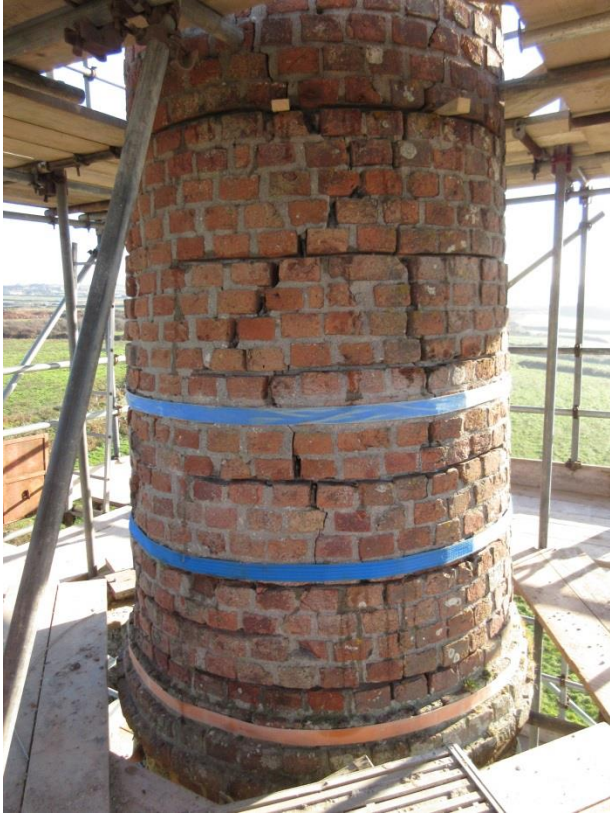
It had initially been proposed to install stainless steel helicoil bedjoint reinforcement into the stonework joints on the southern side of the chimney, but once this area had been rebuilt it was felt that it would be more appropriate to stitch reinforce the three

full height vertical cracks on the southern side of the brickwork section, as daylight could be seen through some of these and they clearly weakened the structure as a whole.

Fig 13. Brick joints cut out across the southern cracks in preparation for the installation of the helicoil bedjoint reinforcement.

Five bed joints at four course spacings were cut out across the three cracks and extending beyond them on both sides for a minimum of 350mm (Fig 13). The helicoil reinforcement was bent to shape and installed using a proprietary grout; small wooden wedges were used to hold the reinforcement in place until the grout had cured (Fig 14). Two additional half-length sections of reinforcement were installed to further tie together lower sections of these cracks. On the northern side of the chimney two other cracks above the drip ring were also tied together using helicoil reinforcement, again set in grout.

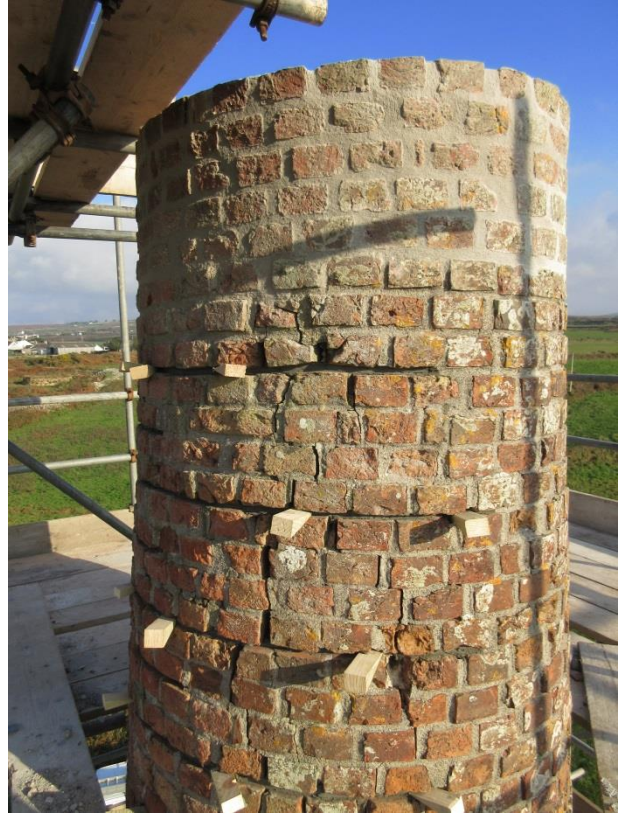
Fig 14. The helicoil reinforcement grouted into place. The wedges held the reinforcing in place until the grout had set.

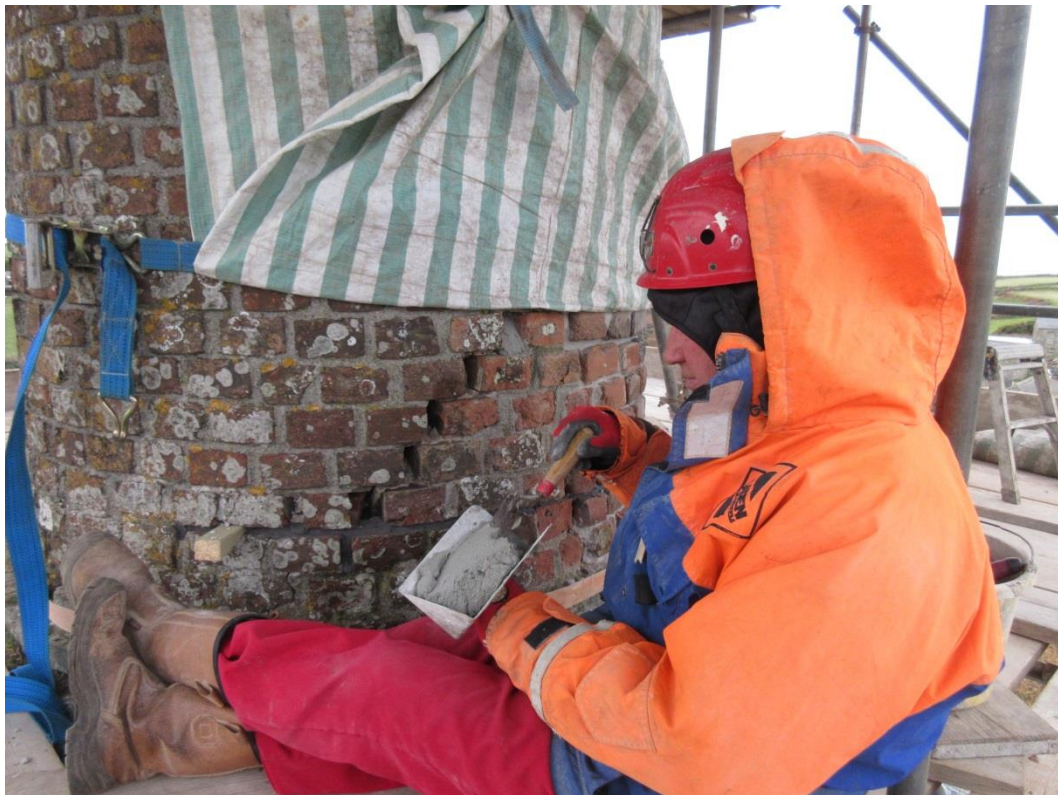
Fig 15. Repointing a stepped crack near the base of the chimney brickwork. The open vertical joints were infilled with brick gallets.

All repaired areas of the brickwork and stonework were repointed. The joints were cleaned out using a leaf blower and wetted up before repointing took place. Once the applied mix had achieved an initial set it was brush tamped to ensure that it adhered to the arrases of the brick and stone and to reveal the aggregate in the surface of the pointing. Where other brick bed and vertical joints had been significantly damaged by the lightning strike these were cut out, filled and repointed. In the case of the wider vertical joints brick slips were used as gallets during the repair works (Fig 15).

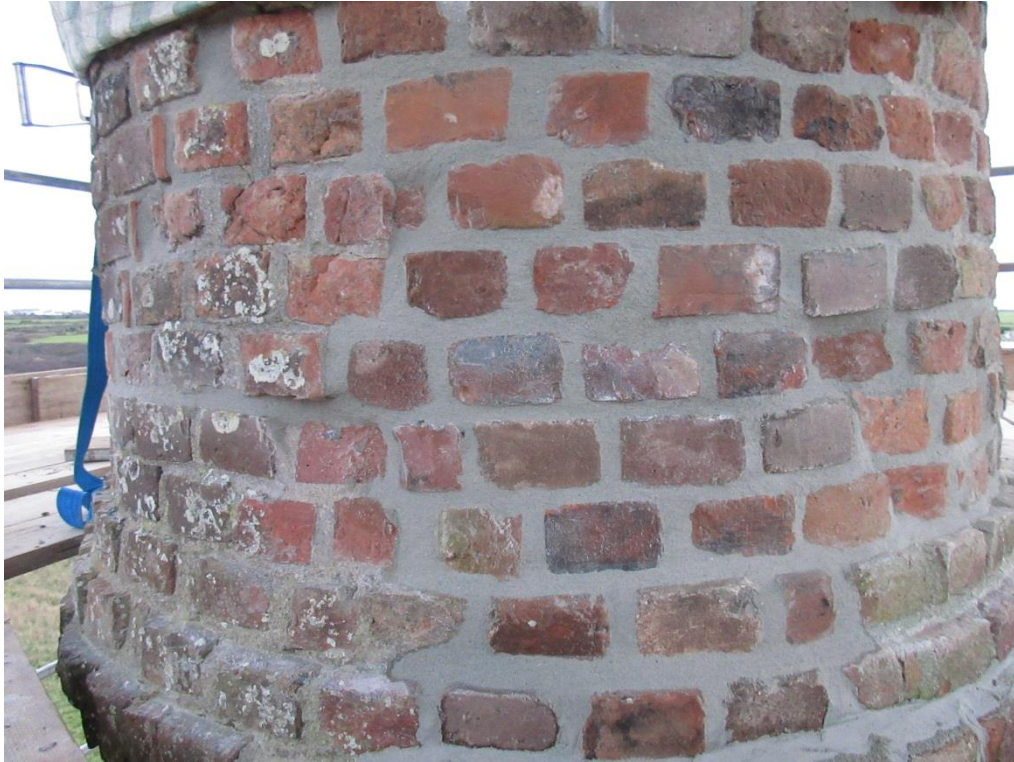
*Fig 16. The lower section of the repaired brickwork at the location of the original major cracks. The mortar had yet to be tamped to bring up its texture.*

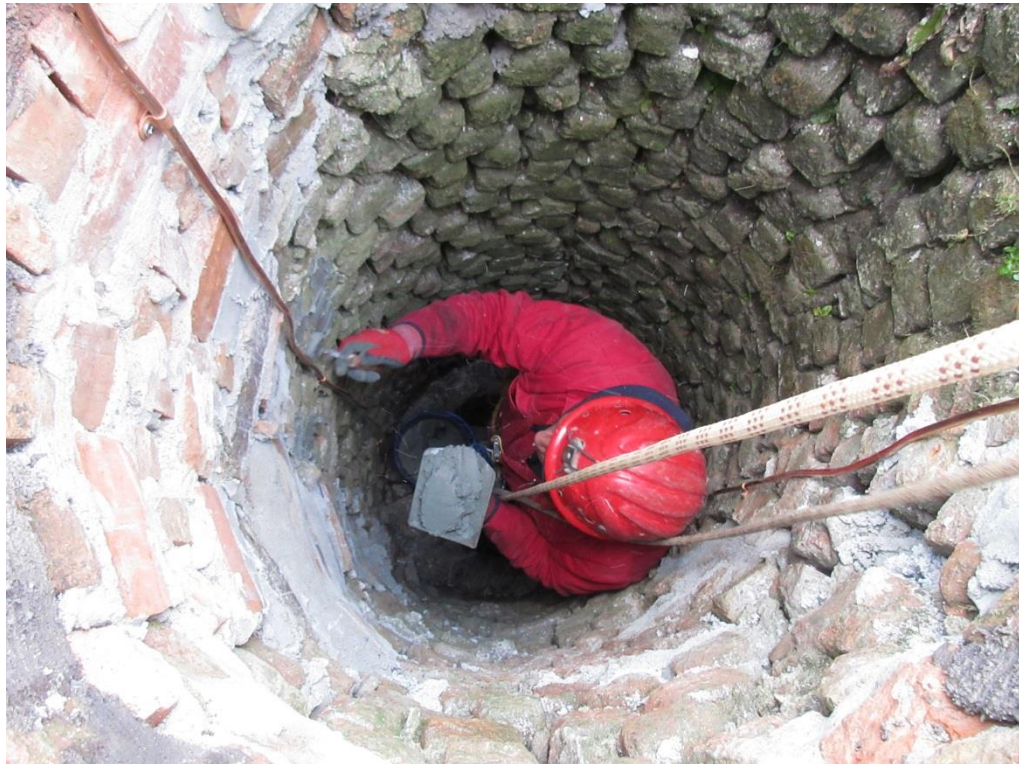
A visual inspection had shown that the brick joints on the interior face of the chimney were, in many cases fairly open, having lost their filling mortar either to weathering or as a result of the lightning strike, particularly on the north side where the two sides of the chimney brickwork had hinged. Working off an abseil rope, wearing a full climbing

*Fig 17. Filling the inner faces of the brickwork joints, which had lost most of their original pointing mortar.*

harness and standing on a scaffold plank cut to size so that it fitted snugly on top of the internal step in the chimney, the conservation mason filled all significant voids in the brick joints back to the inner face of the chimney (Fig 17). This will greatly strengthen the upper section of the chimney in the future.

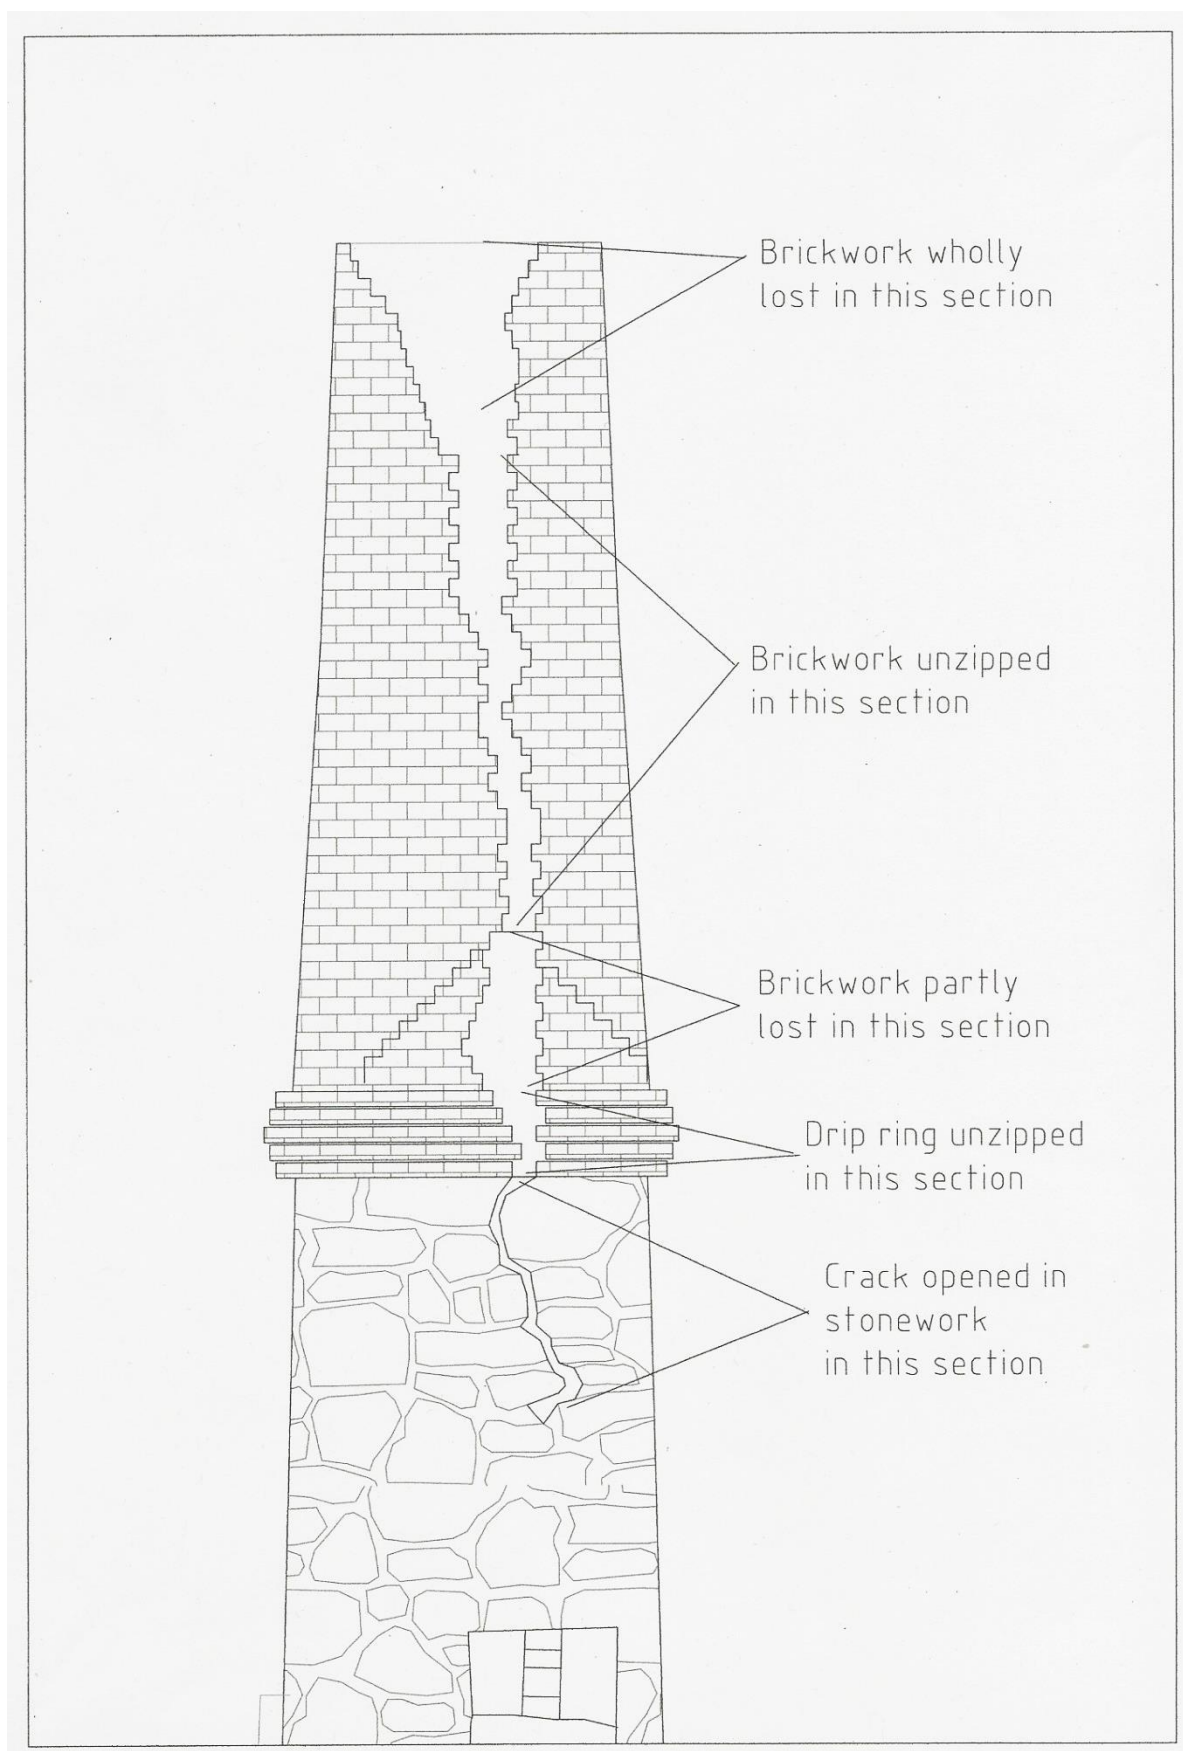
Fig 18. An annotated copy of the pdp Green Consulting drawing of the chimney showing the extent of the damage caused by the lightning strike.

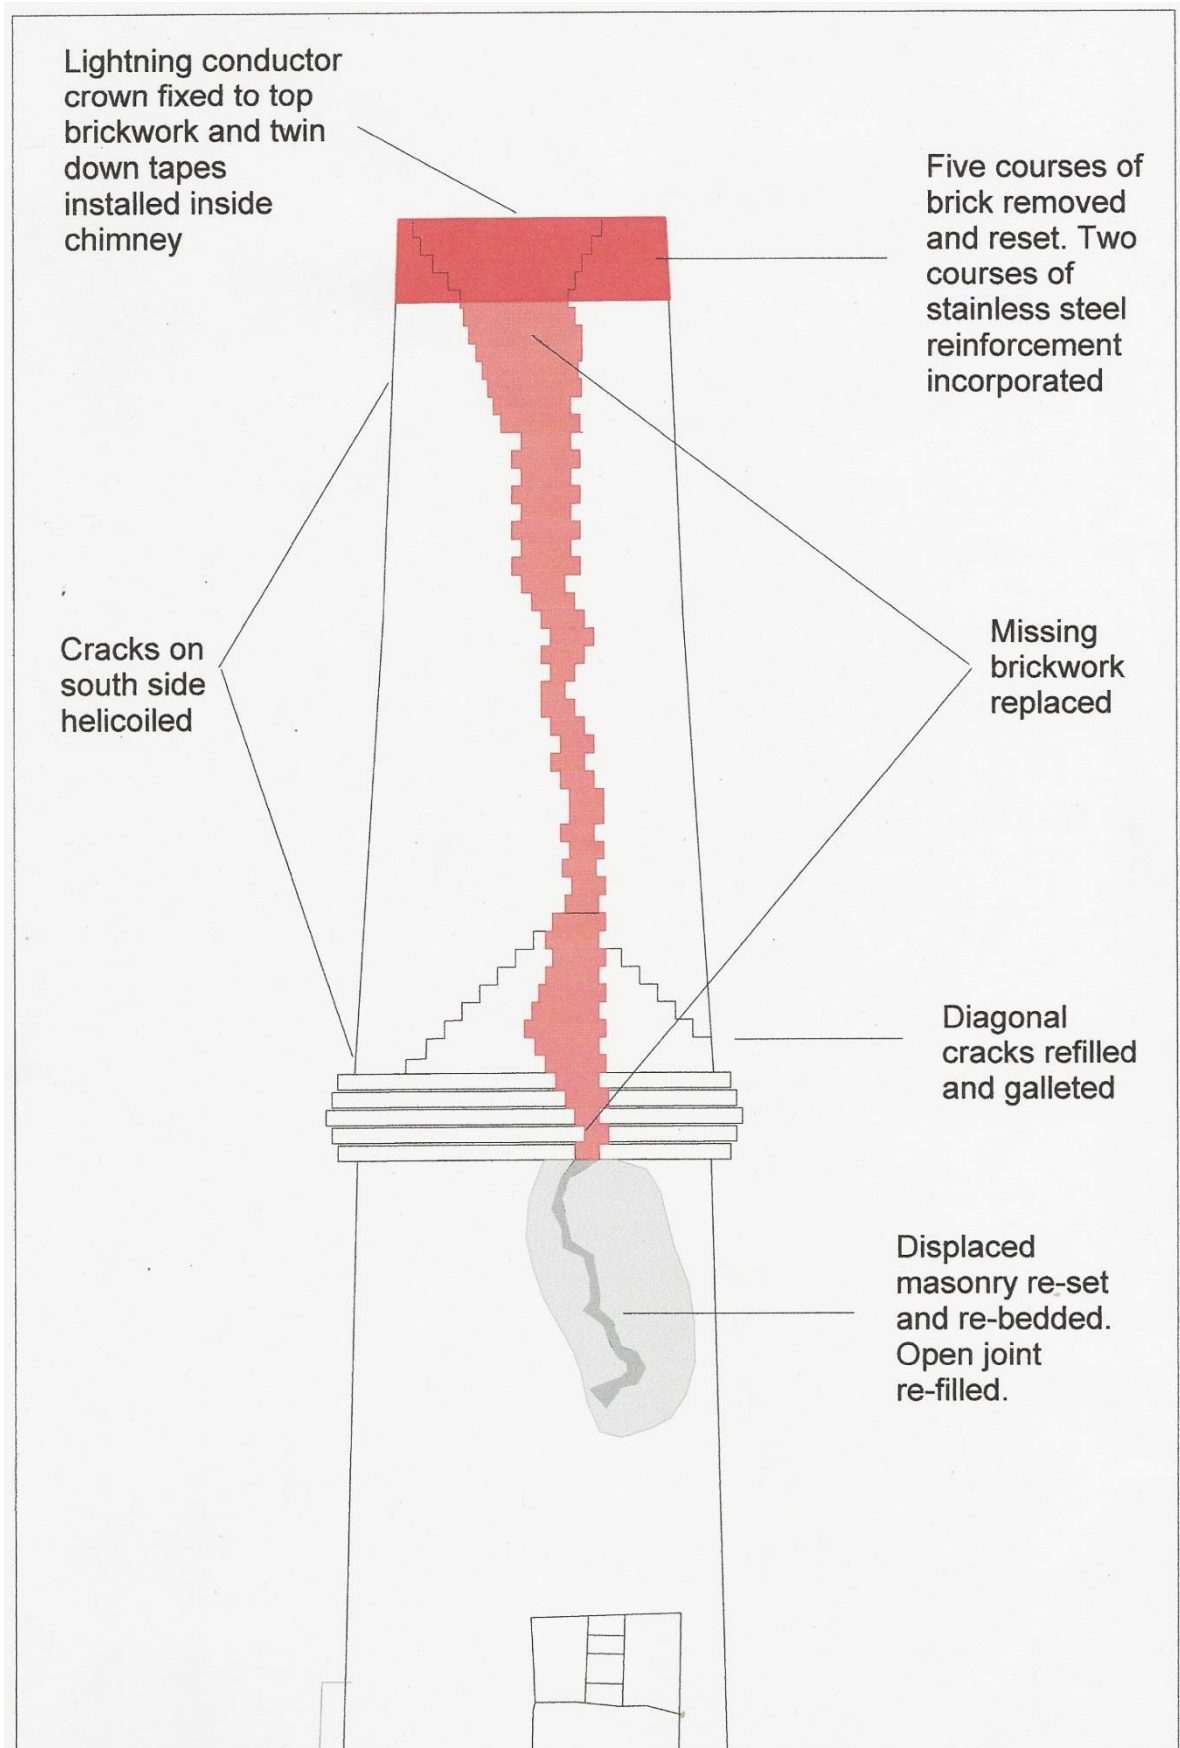
Fig 19. A summary of the repair works undertaken to Wheal Drea engine house chimney in 2016.

It was therefore decided to limit the repairs to the damaged areas of the brickwork and stonework and to keep any dismantling of the chimney to the minimum (Figs 19 and 22).

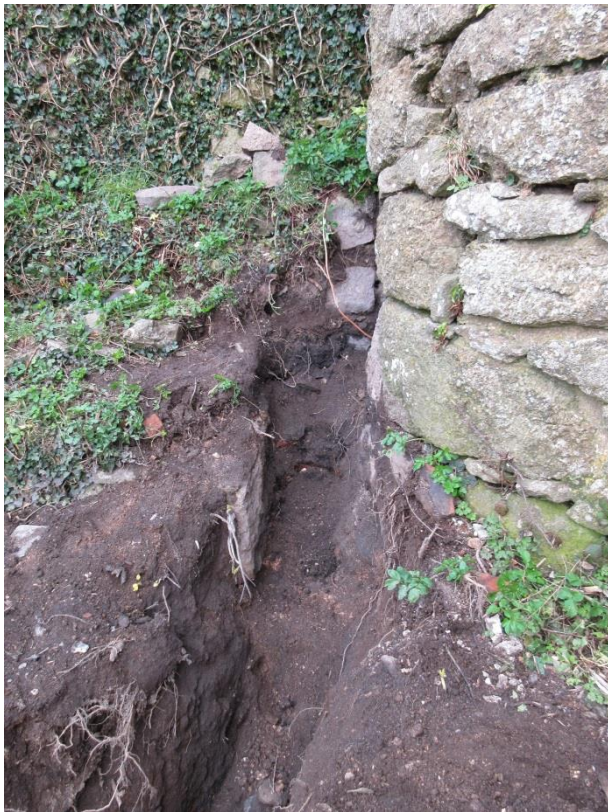
*Fig 20. The trench excavated for the earth protection system showing the doorway into the flue and flue opening in the chimney.*

St. Ives Steeplejacks returned to site on 9 December 2016 to install the remainder of the lightning conductor earthing system, this consisting of four copper earth mats clipped to the tape at one and a half metre intervals (Figs 20, 21 and 23). The trenches were backfilled and consolidated by John Williams on the same day. The following week St. Ives Steeplejacks returned to site to install a resistance test box just outside the flue opening. This was disguised with stones to help to prevent theft of sections of the tape. A recommendation was made by CAU to the National Trust that a galvanised steel grille should be fitted to the flue opening to prevent unauthorised entry to the chimney.

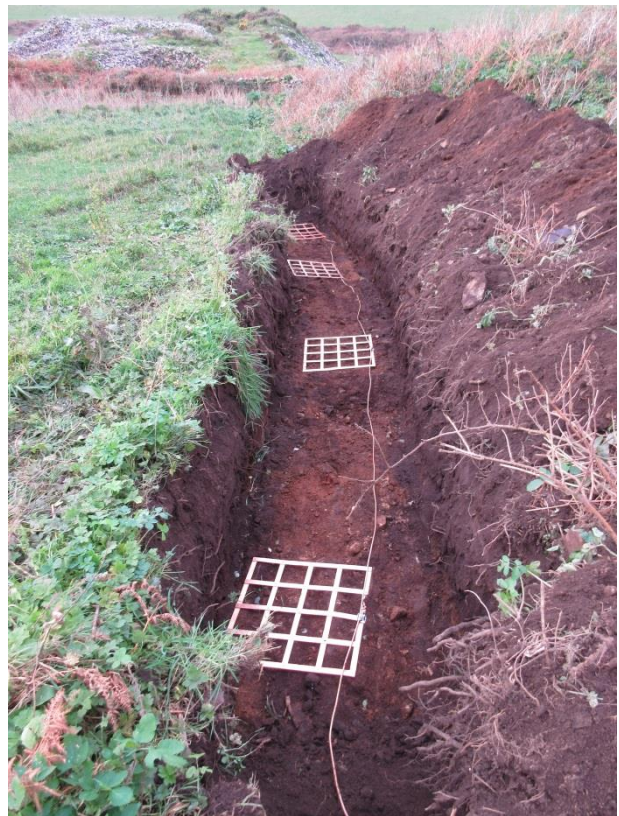
*Fig 21. The earth mats installed in the trench.*

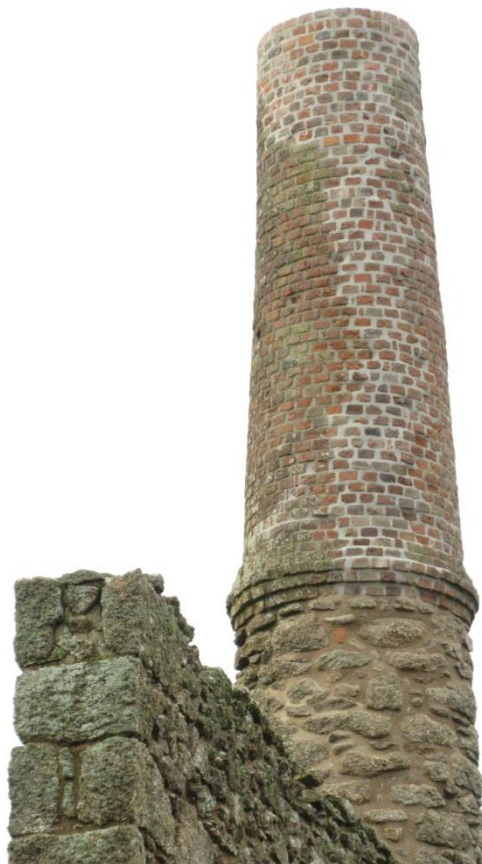
*Fig 22. The repaired chimney viewed from the north.*

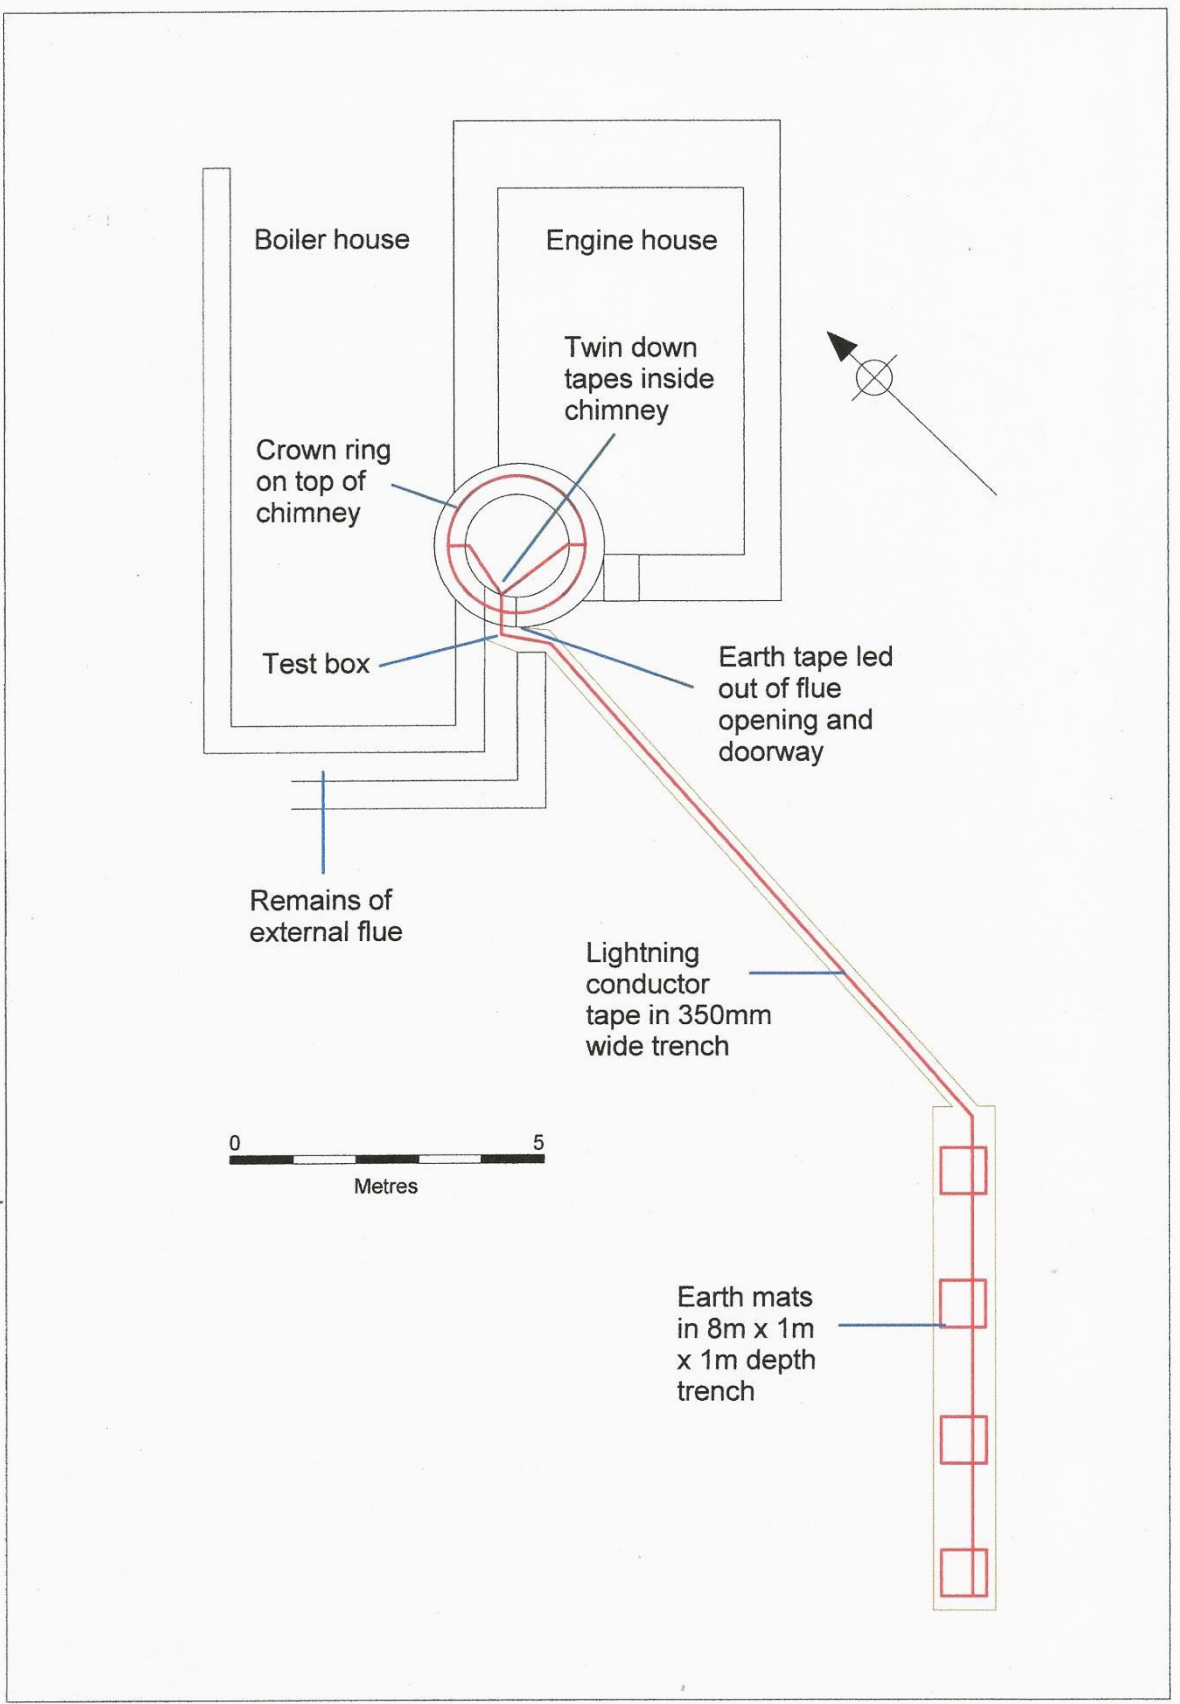
Fig 23. A plan of the earth protection system installed by St. Ives Steeplejacks.
