Helman Tor, Lanlivery, Cornwall,
Archaeological Watching Brief

Report No: 2017R37

Client	Cornwall Wildlife Trust
Report Number	2017R037
Date	June 2017
Status	Final report
Report author(s)	Catherine Parkes BA MCIfA
Checked by	Ann Preston-Jones
Approved by	Andy Jones

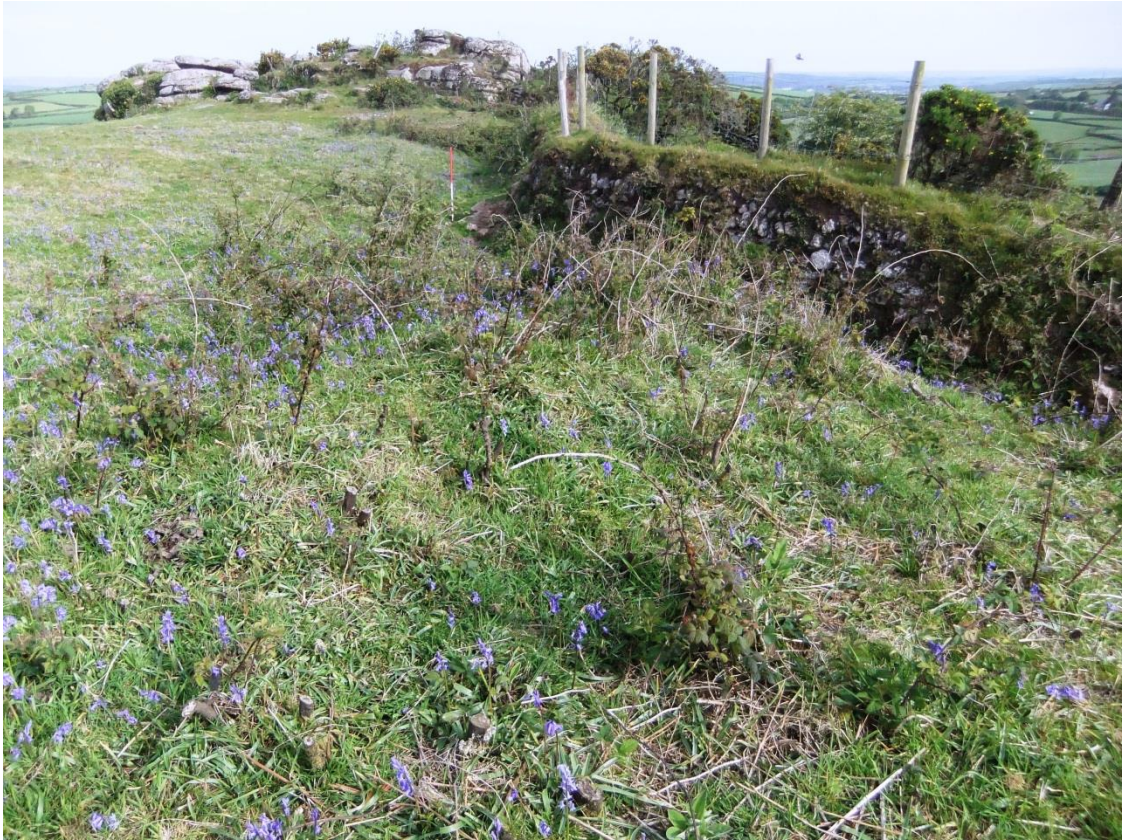
Fig 4 View NNW from Neolithic earthwork north east of summit (foreground) to hedge corner at SX 06183 61714 and tor beyond, taken before groundworks began.

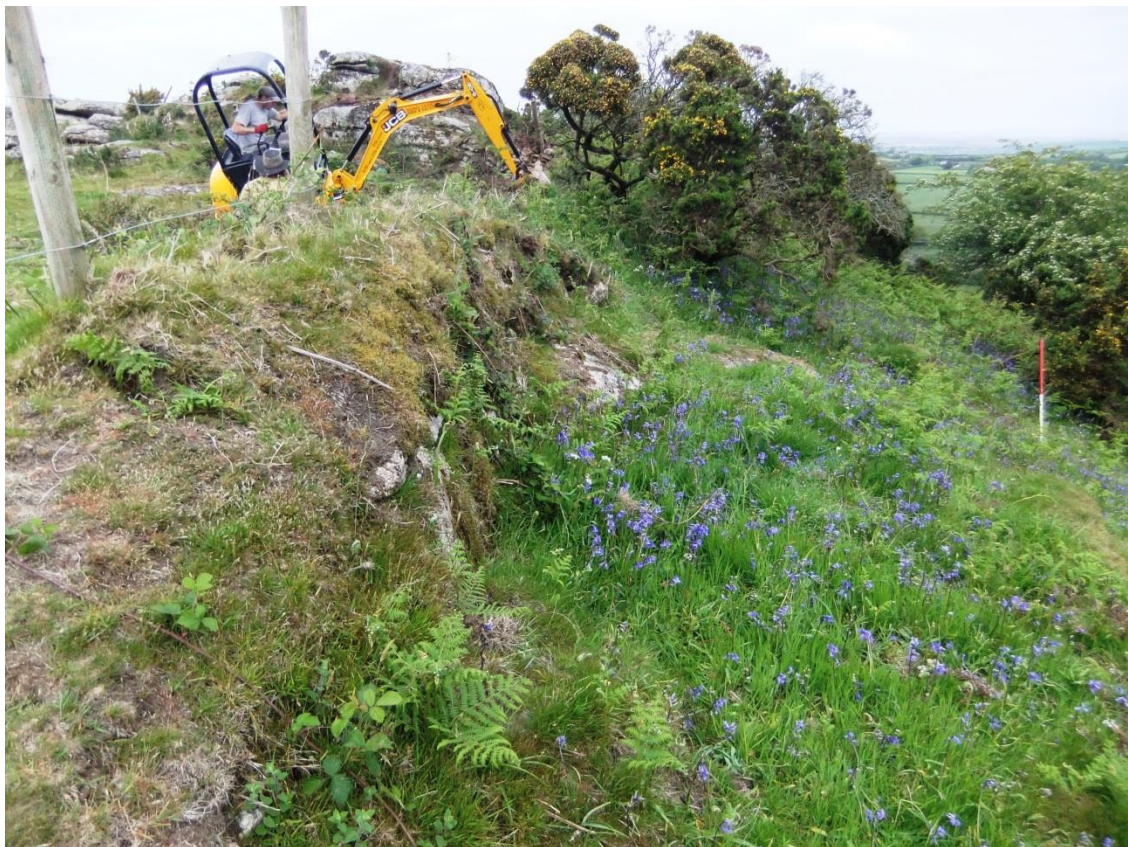
Fig 5 Outer side of hedge on rampart, looking NNW, with 1m scale at rampart base.

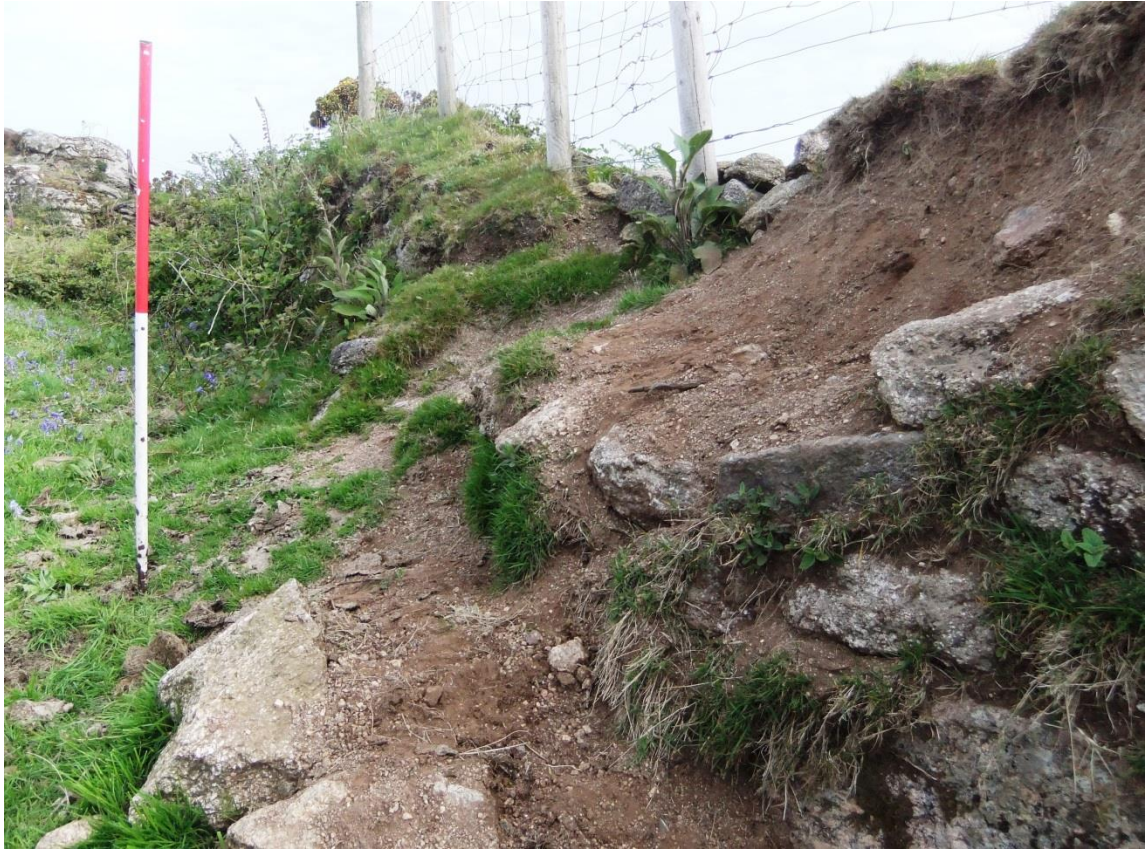
The hedge bank itself is covered in grass, bracken, bluebell and other flora, together with gorse, and blackthorn particularly towards the east. Prior to the repairs, the hedge bank was worn, slumped, or both in many places, most severely at an actively eroding part, some 2m long, just north of the corner where the hedge climbs onto the Neolithic rampart. This most damaged part of the hedge, before repair, is shown in Figures 6 and 7, and recorded in Profile 1 (Figs 28 and 29). It had been trampled by livestock so that it had a low rounded back and a spread of tumbled earth and stone on the uphill, western side; it was topped by a modern fence of round-section posts and meshed and barbed wire, with several loose stones piled on it at the fence line.

Fig 6 Badly worn hedge with tumble spread into hedger's ditch alongside at SX 16183 61714, with 1m scale marking the line of Profile 1, looking NNW along the inner side.

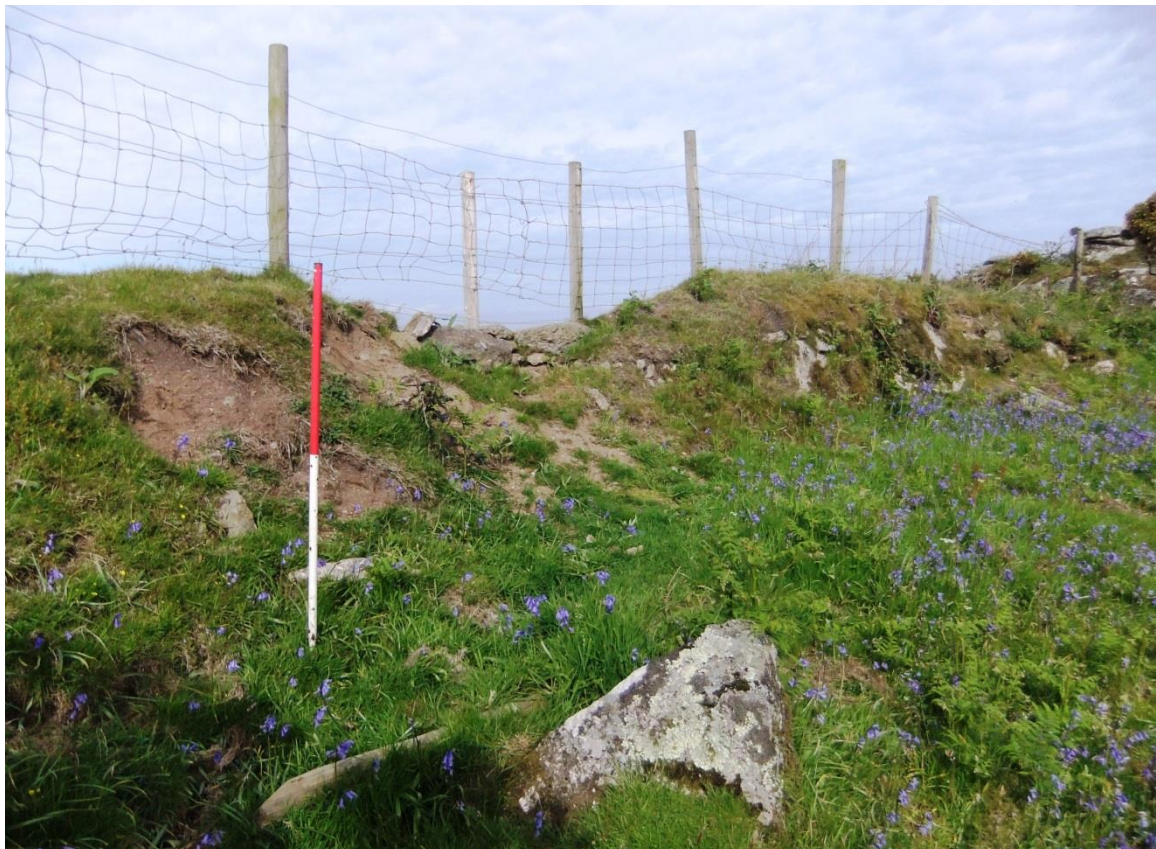
Fig 7 Worn hedge shown in Fig 6, looking NW, from its outer side on the early rampart.

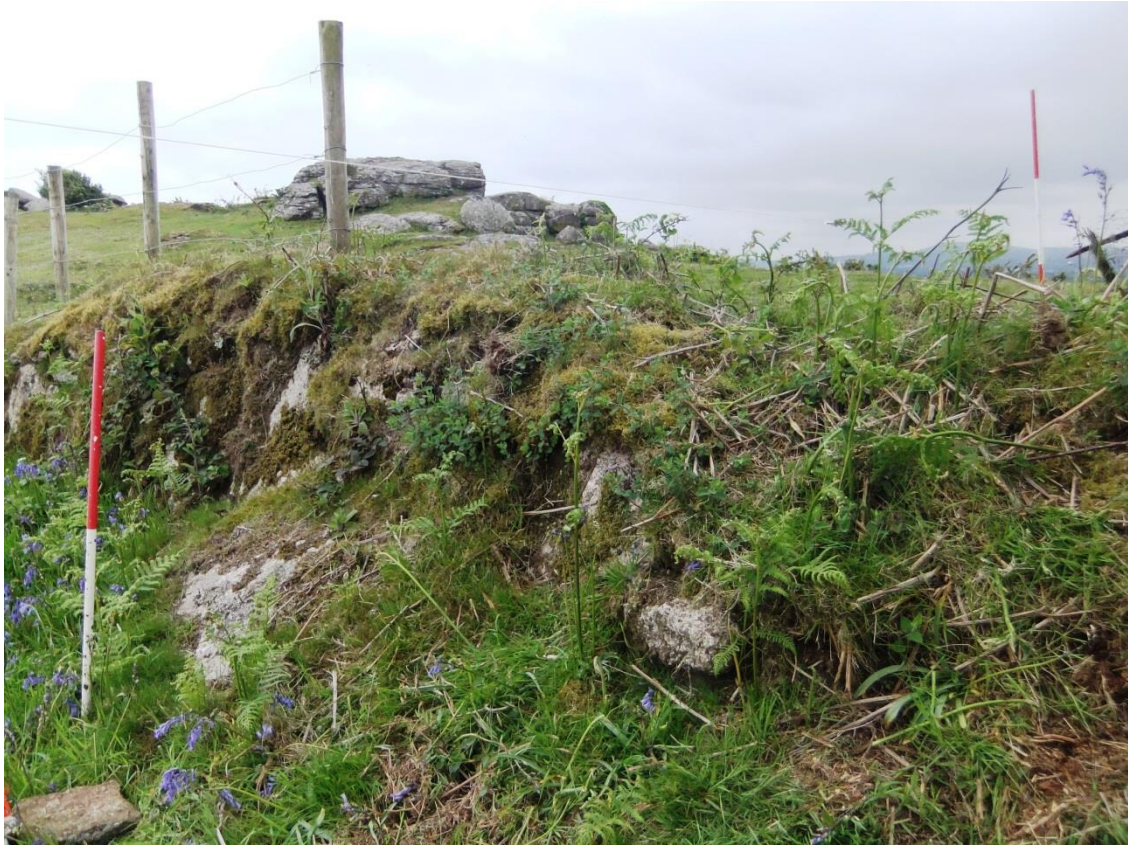
More typical parts of the hedge, less affected by erosion or collapse, show the form recorded in Profile 2 (Figs 8, 28 and 29). The bank generally measures around 1.5m-2m wide and 1m high, spreading to c3m in places, and has steeply battered, stone-revetted sides, and a fairly flat top (cover photo, and Fig 9). Facing stones are all local granite rubble, mostly measuring in the region of 0.1m-0.2m across in the upper part of the hedge, and up to around 0.5m across and less frequently as much as c1m across in the base of the bank. Stones were inspected during the watching brief for stone-splitting marks, whether drill-holes or wedge marks, but none were visible.

Fig 8 Better preserved part of hedge on the rampart at SX 06183 61714, with a boulder in its base as recorded in Profile 2; looking south west to one of the summit tors.

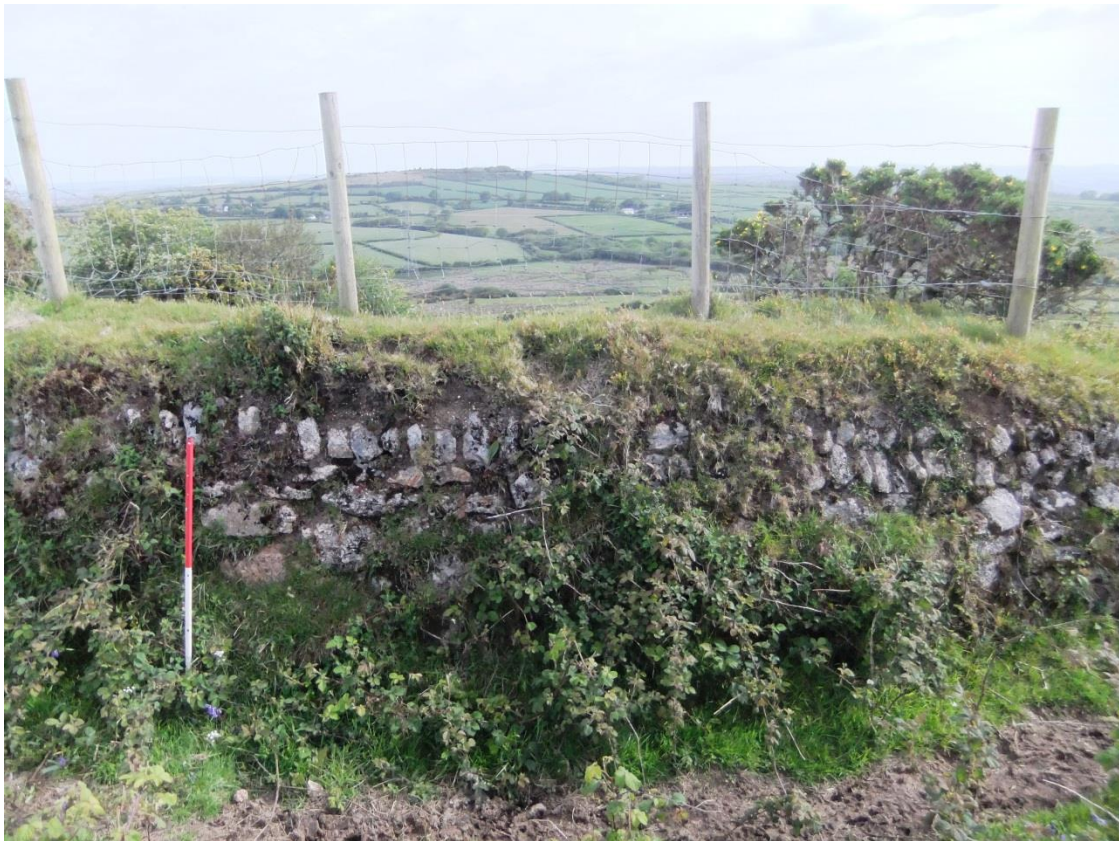
Fig 9 South west side of hedge at the point where it turns and climbs onto the rampart.

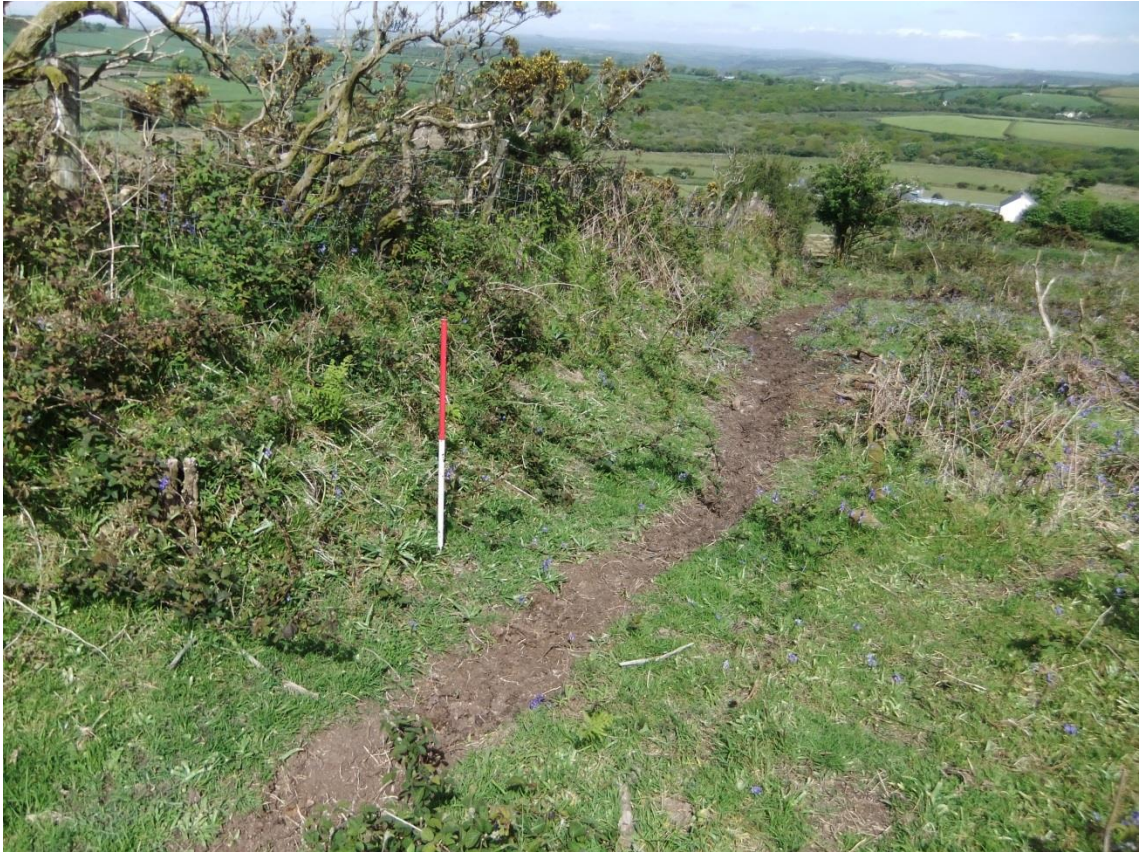
Fig 10 Bank just outside rampart, with sloping sides at least partly lacking facing stone.

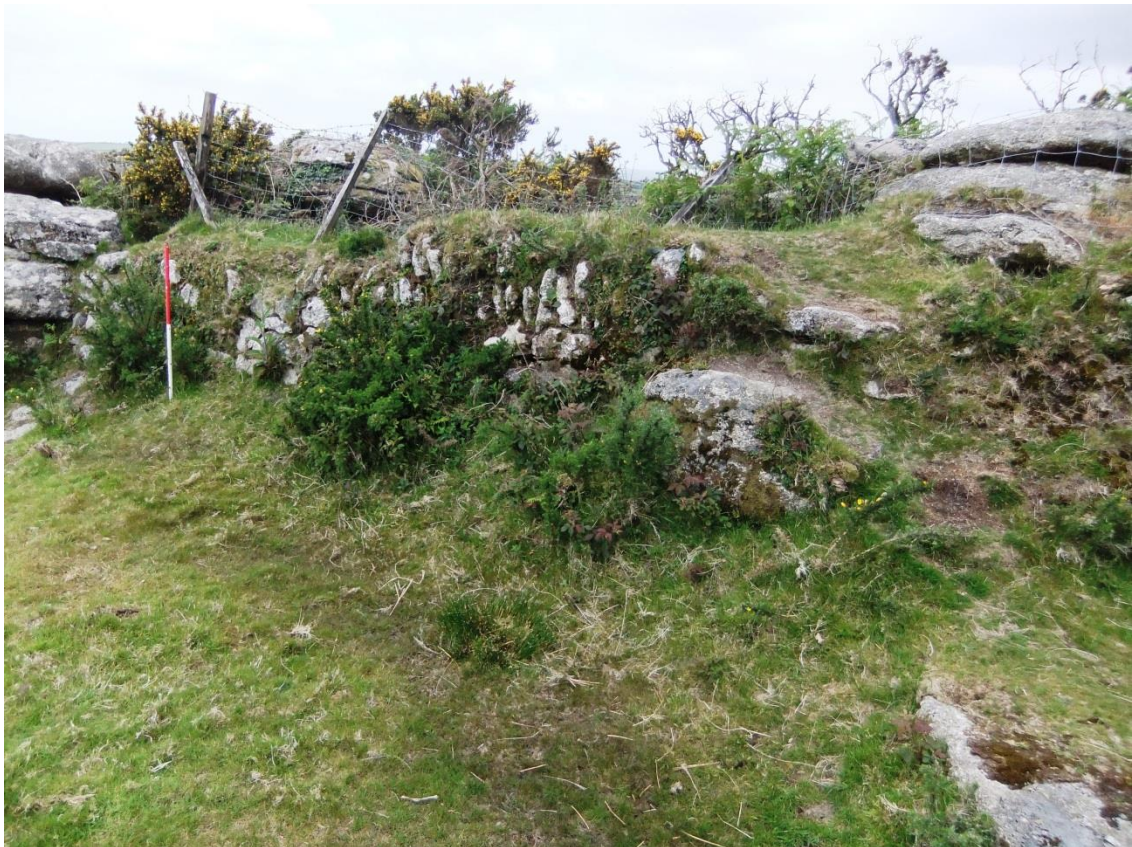
West of the repair work, on the top of the hill, the boundary was made out of the edge of the prominent rock outcrop extending to the north (Fig 11). This was achieved either by building the natural rock ledges up with stone, or simply by incorporating their southern faces where these were sufficiently high. Beside the tall tor at the west end of the boundary, a small recess in the south face of the boundary, c0.45m above the ground, and measuring c0.2m across and 0.1m deep, appeared to have been made as a foothold, allowing one to climb on to the tor with its little 'cheesewrings' of superimposed rocks bearing several eroded basins. Here, against the northern tor, the boundary was made stock-proof using wire on outriders in 2017 (without other repair).

Fig 11 Hedge WNW of the repaired part (mending here involved simply re-fencing), incorporating faces of natural rock at the foot of the northernmost tor on the hilltop.

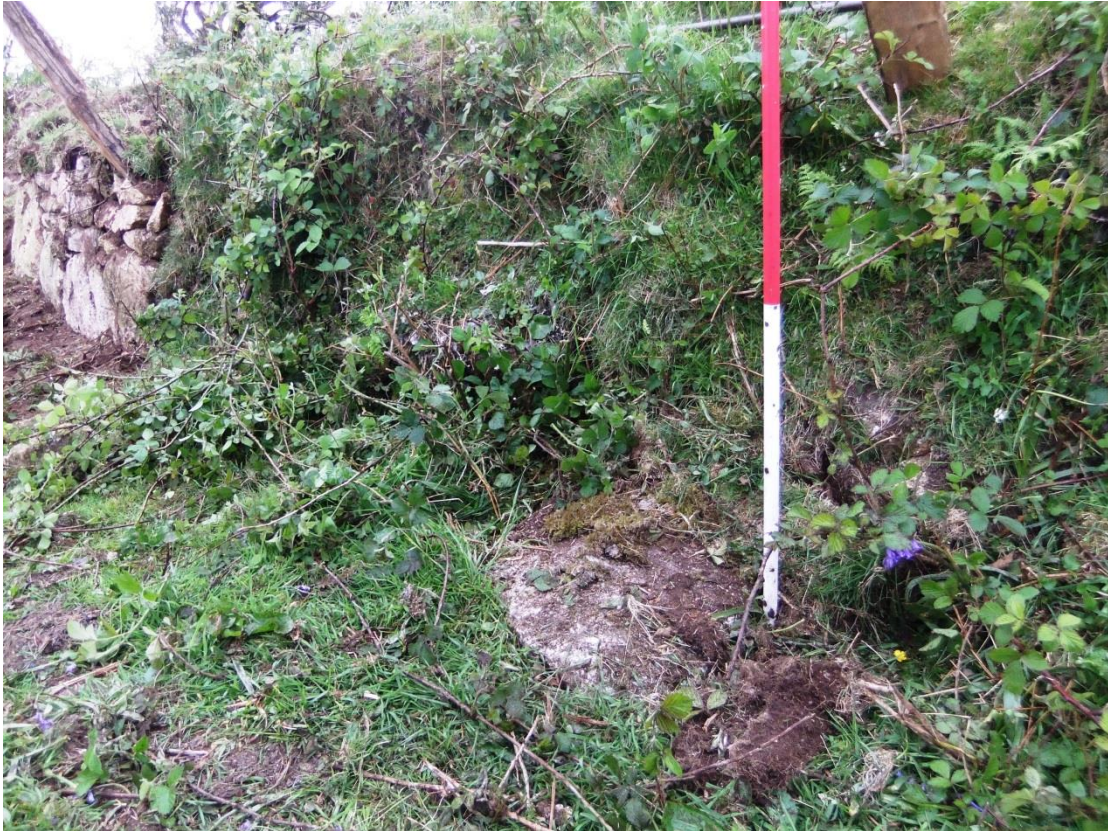
Fig 12 Fallen facing slab (left in place during the works) formerly raised on one long thin side, at SX 06183 61714 beside the hedge on the rampart line, looking NNW.

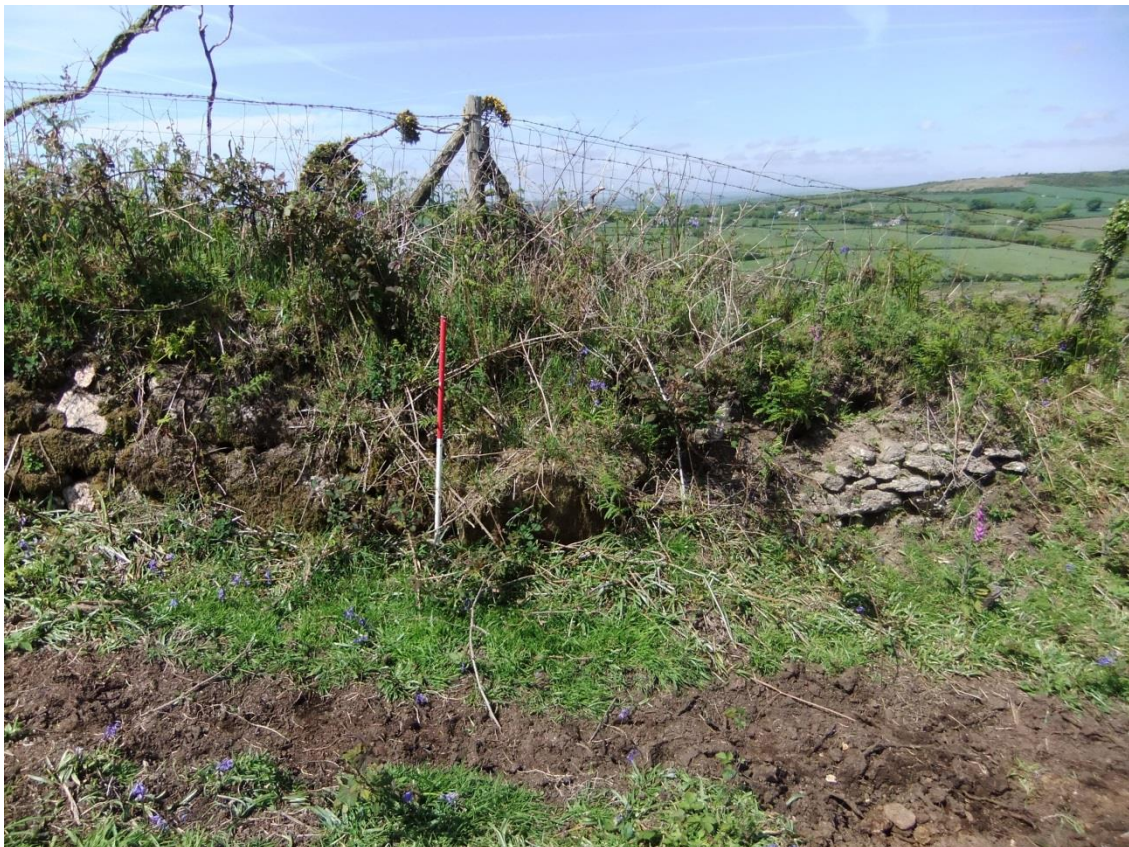
Along the repaired hedge as a whole, the historic hedge-facing style was not clear in many places due to slumping or vegetation growth, but appears mostly to have consisted of using laid slabs and occasional boulders in the lower half of the bank, and roughly coursed pitched (i.e., vertically set) smaller stones above. Many relatively large but thin stones are present, no doubt because of the prevalence of thin slabs among the rocks of the tor from which the hedging stones derive. In places along the hedge, such slabs had been stood up to face the base of the hedge with their longer sides along it, rather than laid – or they had been so, but had slipped or fallen (Fig 12). Like the variations in its form, changes in the style of the facing of the hedge, visible in places, did not appear archaeologically significant. Some evidently represent discrete, previous patching or replacement of failed earlier work (Fig 13).

Fig 13 South face of hedge outside rampart with showing a previous repair (right).

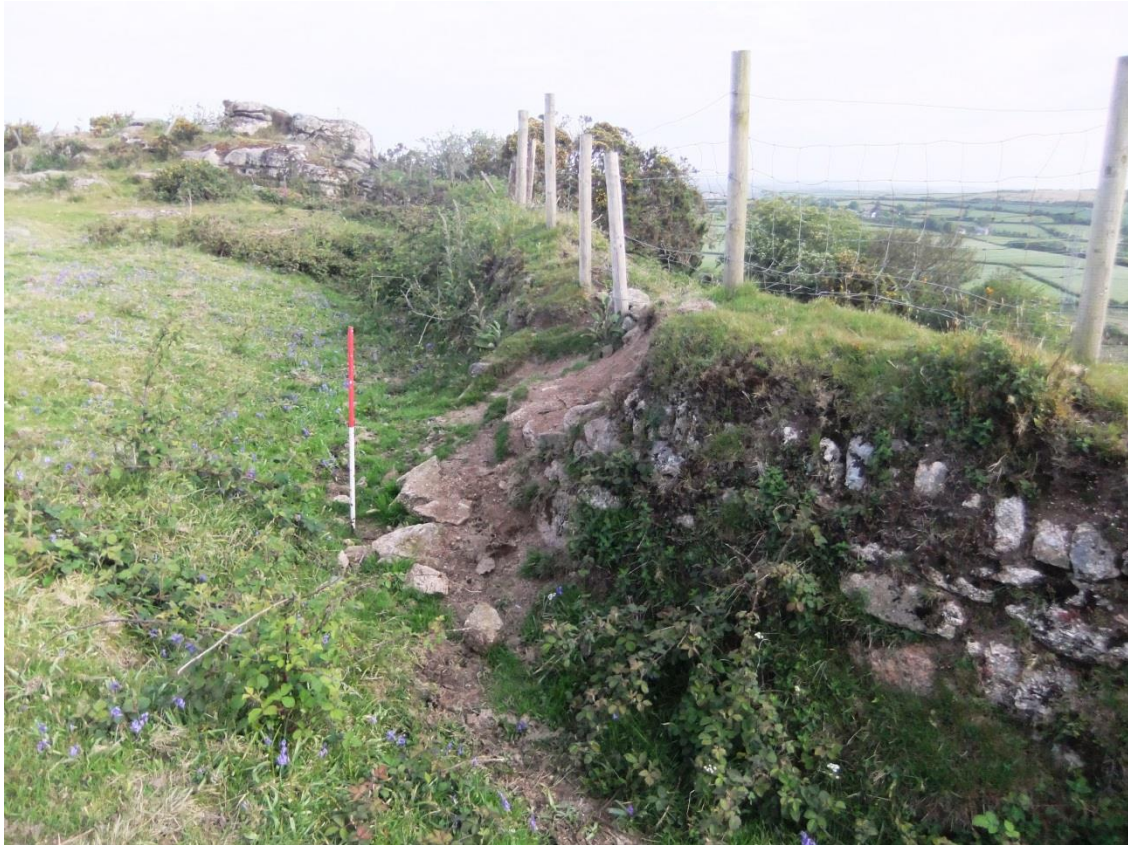
Fig 14 Ditch along the inner side of the hedge on the rampart line, looking NNW.

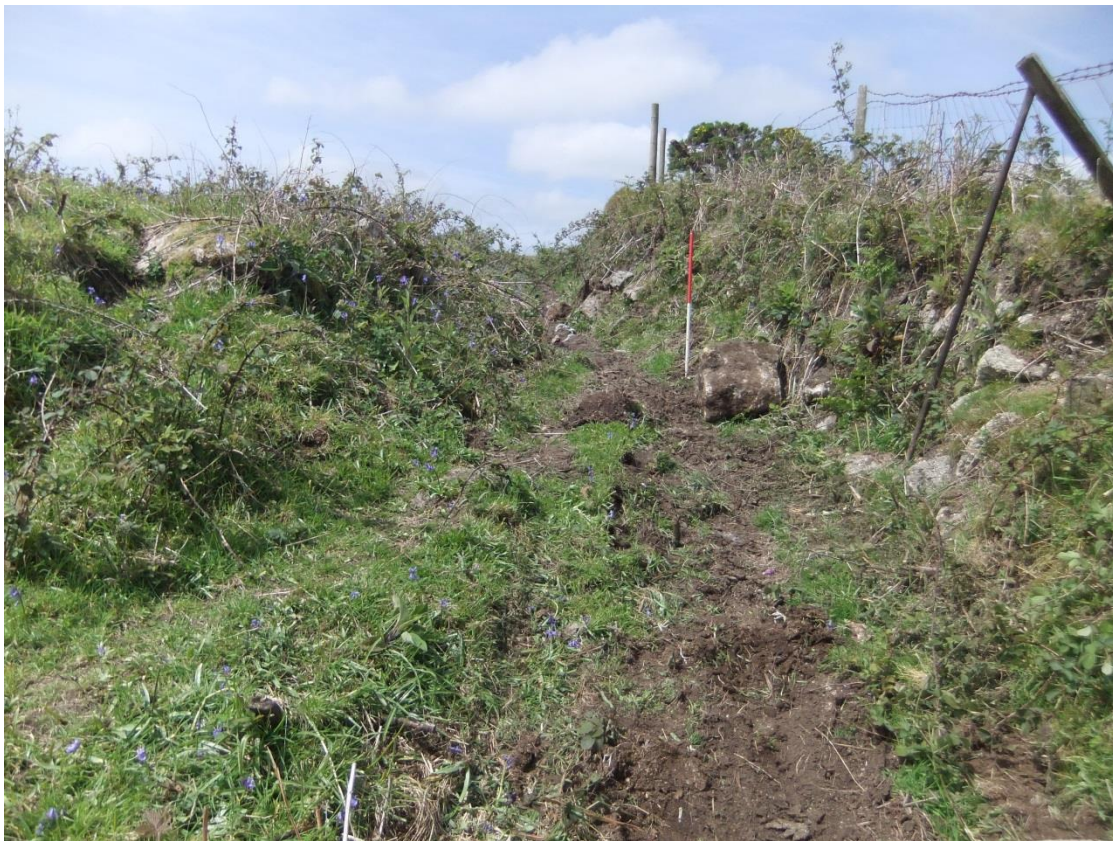
However, some material in the hedge bank may have been sourced from the rampart or from tumble from it. The part on top of the rampart has a slanting earth-fast boulder at its base at the point recorded in Profile 2, possibly incorporated in the rampart (Figs 8 and 29). The visible side of this measures up to c0.9m across. Several of the facing stones in the hedge downslope (east) of the rampart, unusually large compared to the facing as a whole, may well have been shifted from the rampart – perhaps where it was cut through to make the hedger's ditch – for use in making the hedge downslope. A large boulder in the hedge ditch just outside the rampart, which had been displaced from the hedge revetment, was reincorporated in it as part of the repairs (Fig 15).

Fig 15 View from below of the boundary cut through the rampart, with displaced facing boulder (at the 1m scale) probably from the rampart, now re-used in the hedge.

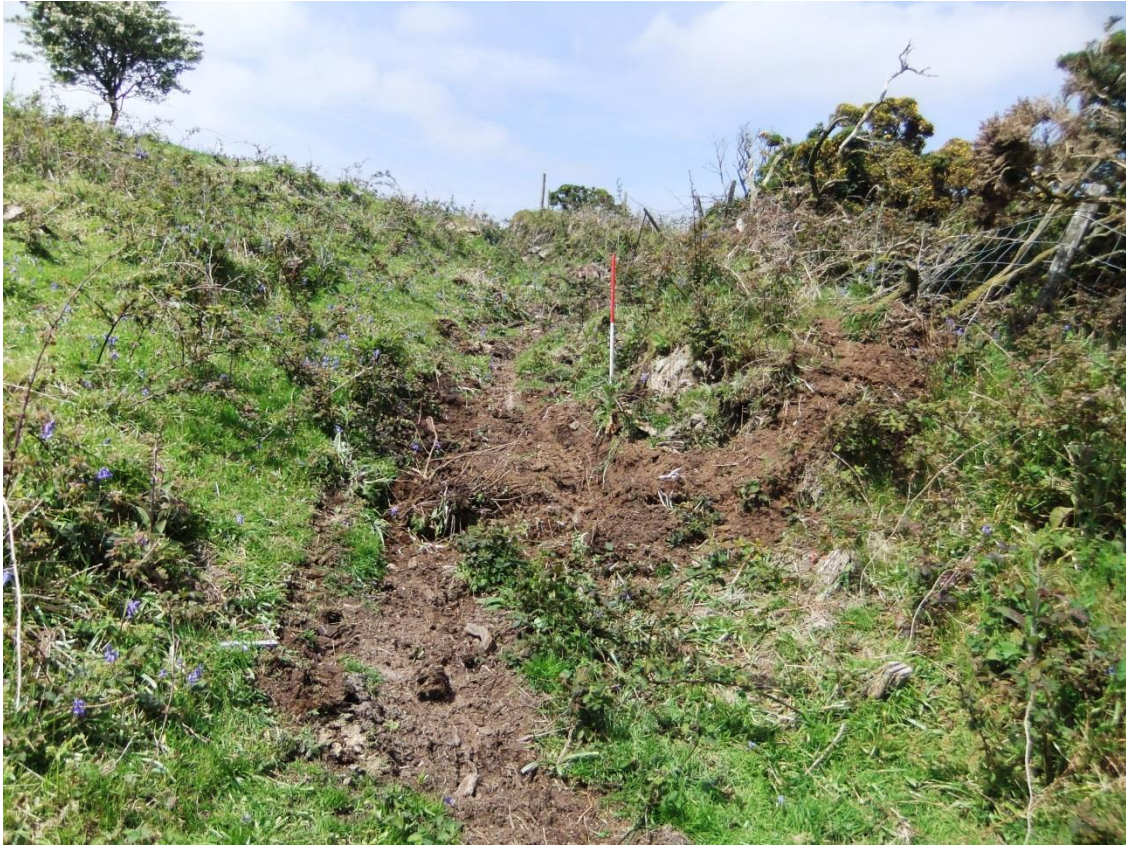
From the evidence of its form and relationships visible on the ground and recorded on the 1984 survey (Fig 28), it appears that this is a hedger's ditch, made to quarry material for the hedge bank alongside while effectively heightening it, of the kind typical of traditional built boundaries in Cornwall. It does not appear to continue east, downslope, beyond the corner in the hedge line at the southernmost point of the repaired length. This is considered to be because the hedge below that southernmost point originated from an earlier, medieval or post-medieval bank (for which the fabric may have been obtained by scraping or ditching on one or both sides which is significantly earlier and no longer evident) while the hedge above the southern corner, where the uphill ditch is clear, was built out from this at a later date, leaving its upper part out of use (Figs 16 and 28, and see map analysis, below).

Fig 16 View towards rampart showing how the hedge kinks away from its former upper part which is visible in the photo as a relict bank running across the foreground.

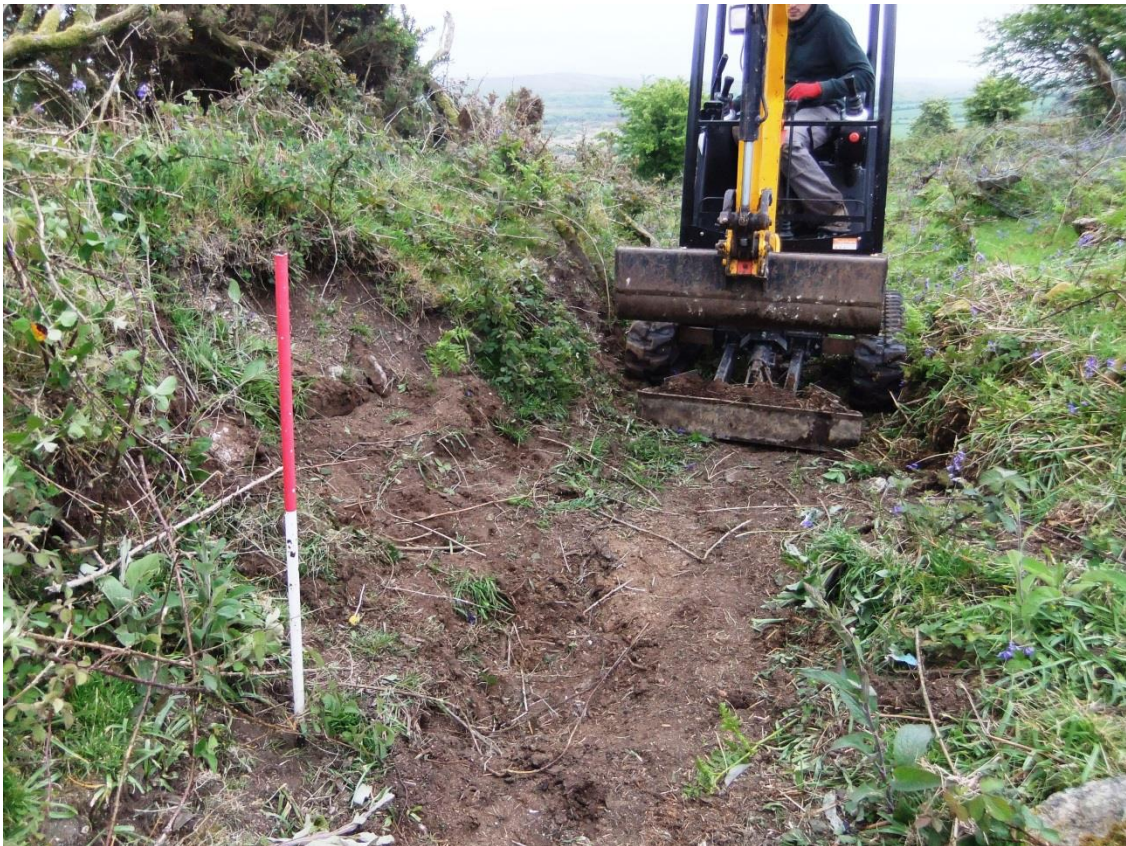
Fig 17 Careful trimming of the hedge to allow re-facing with fallen or similar stone.

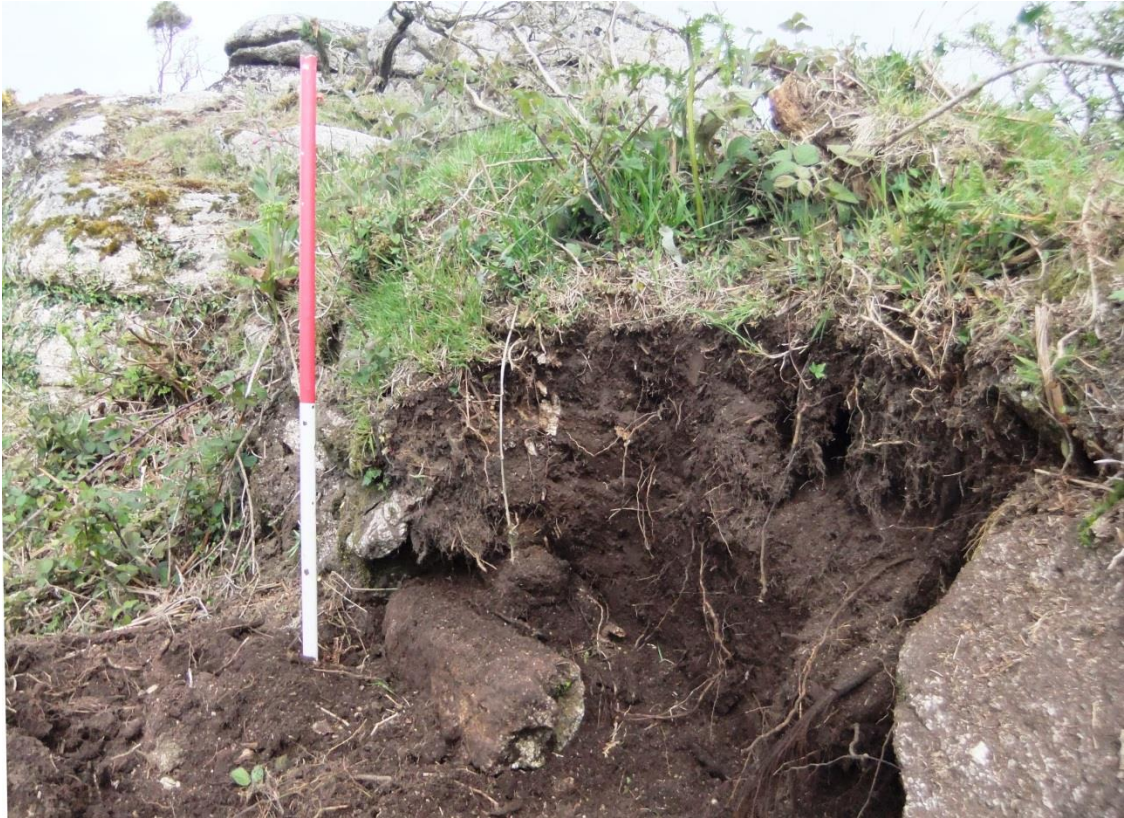
Fig 18 West side of the hedge bank beside the northern tor, revealed by trimming, showing homogenous dark brown loam core and few stones behind the facing slabs.

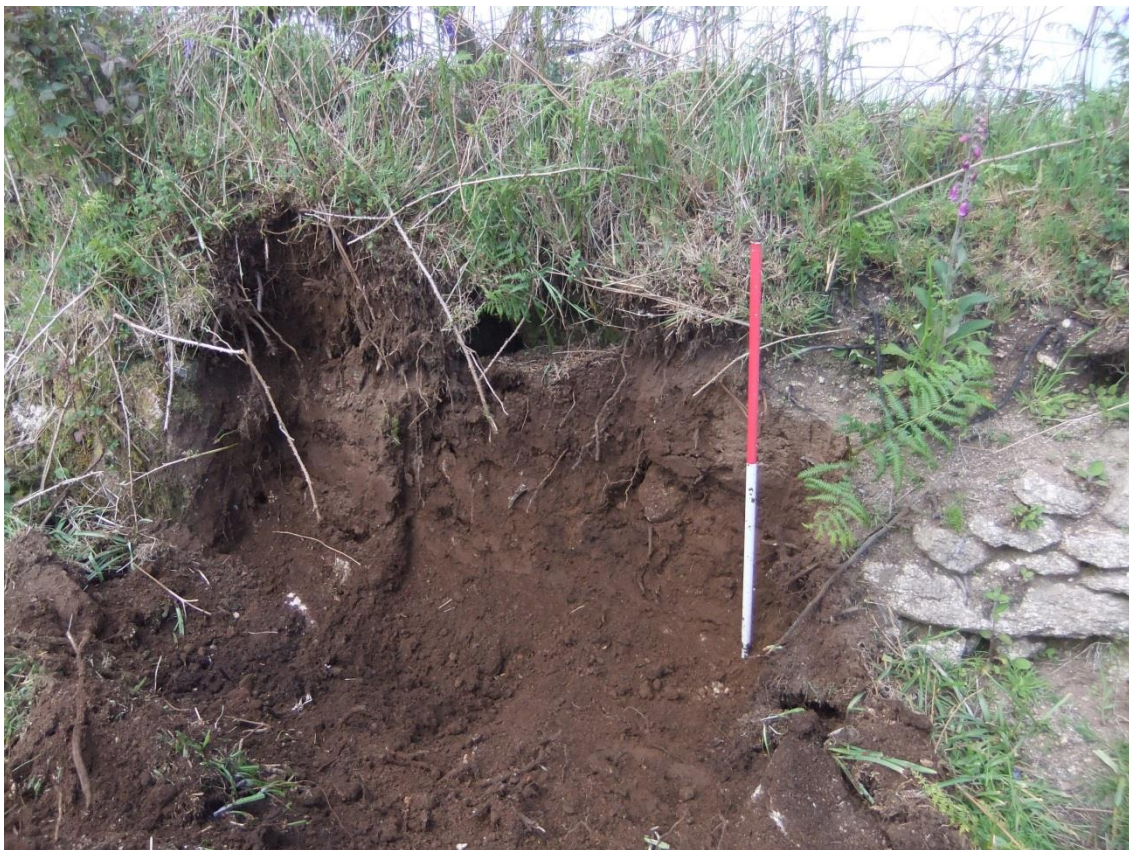
Fig 19 South side of the hedge bank below the tor enclosure, exposed by trimming, with dark brown, slightly orangey loam core and few stones, similar to that in Fig 18.

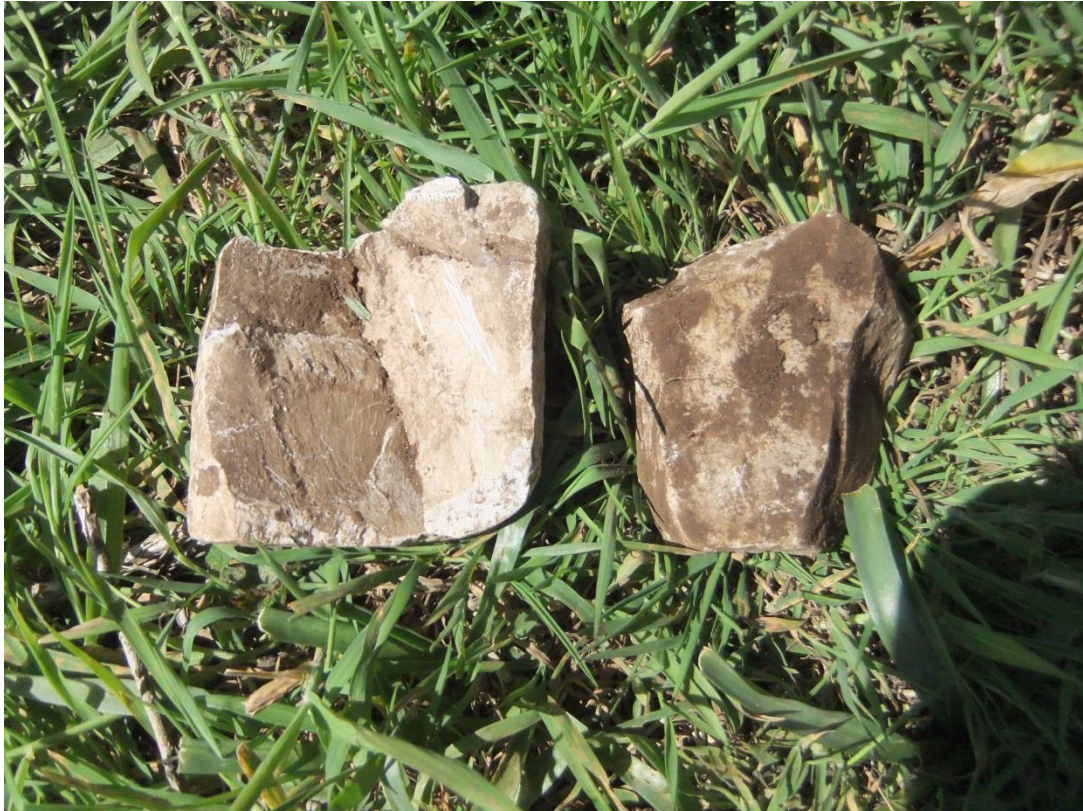
During the works limited datable material was encountered. A piece of white glazed pottery of 19th century type was exposed in turfed-over slumped material outside the facing of the hedge on the south side, downslope from the tor enclosure; this being effectively unstratified contributes nothing meaningful to the dating of the bank. A small piece of limestone rubble c8cm across and c4cm thick from the earthy core material, fractured possibly as a result of heating, was found behind the south face of the hedge further down towards its east end (Fig 20). Historic use of limestone in farmland on the granite areas of Cornwall can be attributed to the improvement of acid soils with burnt lime, a practice recorded as recently adopted and still limited in extent in Cornwall in 1667 (Isham 2000, 6). This find may then indicate that the hedge was built in its present form in or after the later 17th century. The apparent lack of drill-split stones in the fabric of the hedge bank tends to support its being post-medieval, many such stones being visible on the hilltop, some quite close to the hedge.

Fig 20 Small, broken piece of limestone rubble measuring 8cm across, from fabric of hedge 20m from its east end, indicative of rebuilding in the post-medieval period.

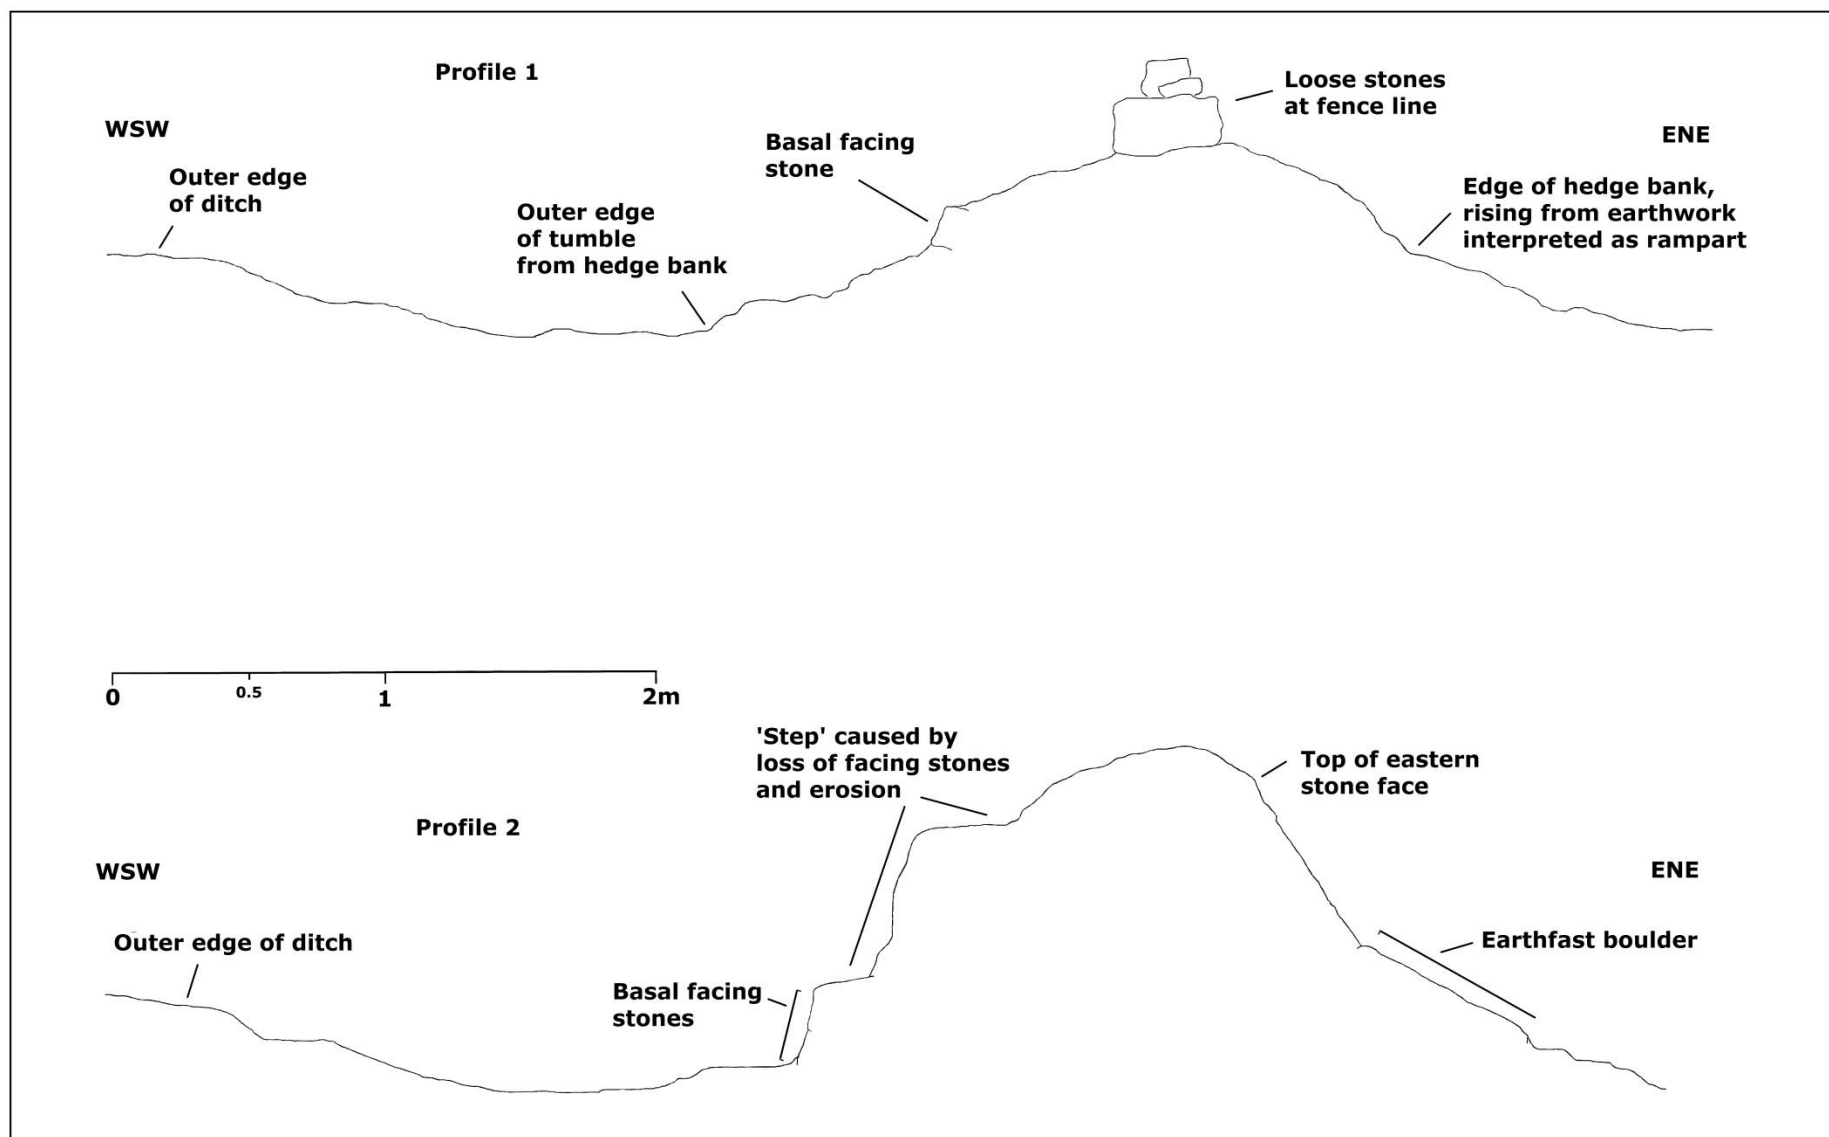
Fig 29 Profiles of the hedge, showing a badly eroded part (Profile 1) and a more typical part (Profile 2), both on the early rampart line.
