Molenick Farmhouse, Tideford, Cornwall
Watching brief and historic building record during renovation works

Report No: 2017R053

Watching brief and historic building record during renovation works

Client	Port Eliot Estate
Report Number	2017R053
Date	September 2017
Status	Final
Report author(s)	Jo Sturgess
Checked by	Andy Jones
Approved by	Andrew Young

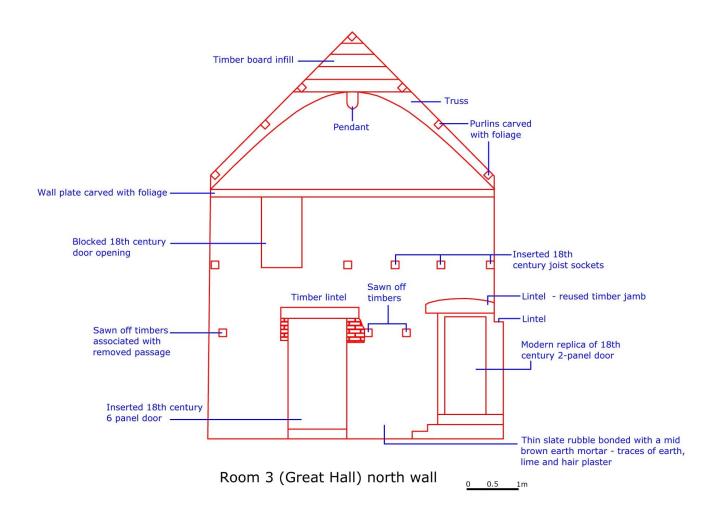
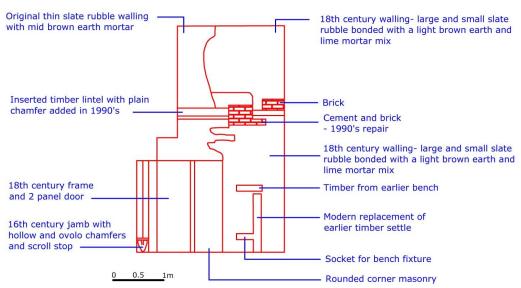
Fig 30 Room 3 elevations.

The north and west walls are part of the original 16th century build. The east wall was almost entirely rebuilt in the 18th century, when a first floor level was inserted in the hall. This new wall was built with a gable and two first floor windows as well as a chimney to serve the first floor. The south wall, an original plank and muntin partition dividing the hall from the screens passage, was destroyed in the 1990s fire and replaced with a concrete blockwork wall.

The hall retains its original roof structure which was extensively repaired after the fire. There are five bays, with a decorative string across the gable ends. It has arched braced trusses, with cambered collars and a carved pendant hanging below each collar. There are two rows of threaded purlins, a wall plate and a ridge purlin. All the members are carved with leaves, wheatears and geometric designs, each one different (listed building description).

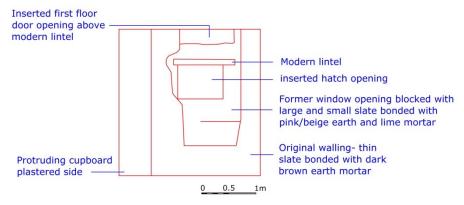
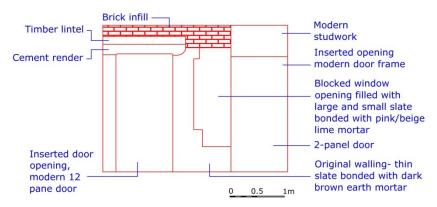
Fig 40 Room 6 elevations.

This wall from ground floor upwards appears to have always been a timber, stud wall dividing the small front wing from the great hall to the east. From the photographs taken after the fire in the 1990s it appears that much of this timber wall was destroyed. However, it is unclear whether it was completely replaced at that time. The existing cupboard to the south of the door was inserted after the 1990s fire.

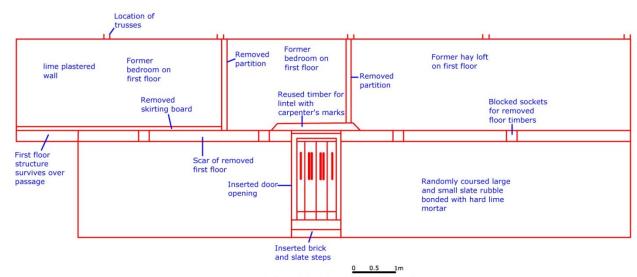
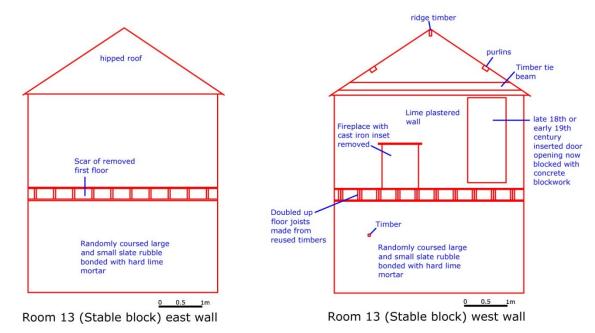
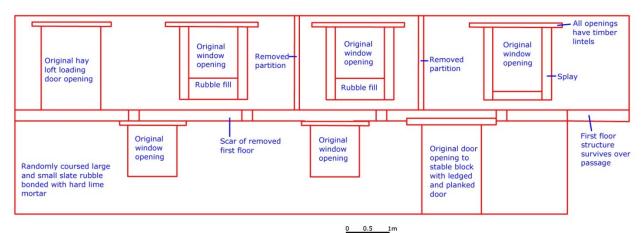
Fig 65 Room 13 elevations

The ground floor surface suggests that there was also a partition wall at ground floor level immediately east of the door opening in the north wall. To the west of this the floor surface comprises what appear to be original slate flagstones (except at the west end where they have been replaced with concrete) and to the east of it the surface comprises original, well laid very small cobbles. Along the north side of the room there are the remains of what appear to have been stall divisions with footings constructed from slate rubble bonded with lime mortar and along the south side of the room there are six brick and lime mortar dwarf walls which appear to be later insertions.

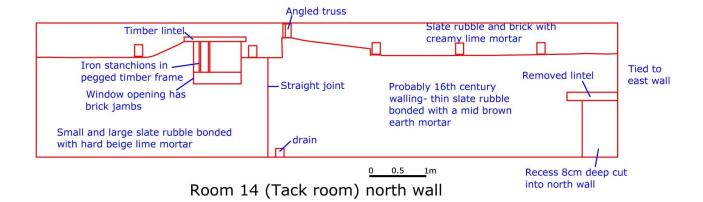
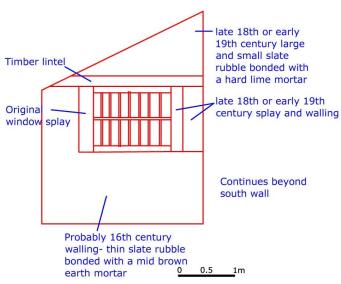
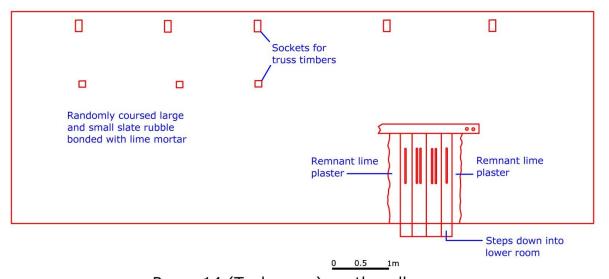
Fig 74 Room 14 elevations

The floor surface shows the two separate phases of the room in its surfaces. To the east of the straight joint in the north wall in the earlier half of the building the floor surface comprises slate flagstones (except at the north-east corner where they have been replaced with very small cobbles) and to the west of the joint the surface comprises well laid very small cobbles.

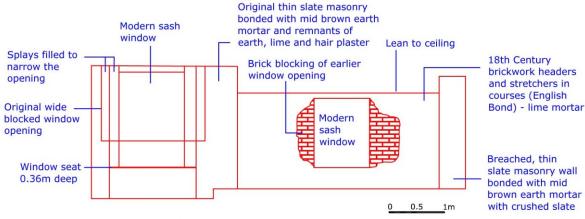
Fig 86 Room 18 elevations.

This wall is part of the original 16^{th} century building constructed from thin slate rubble bonded with a mid brown earth mortar. There is a blocked, square window opening towards the west. The blocking is slate/shillet bonded with lime mortar and the timber lintel has been removed more recently and replaced with cement mortar.
