# Dupath Holy Well, Cornwall

## Archaeological investigation

<b>Client</b>	<b>English Heritage Trust</b>
<b>Report Number</b>	2017R070
<b>Date</b>	<b>January 2018</b>
<b>Status</b>	Final
<b>Report author(s)</b>	<b>Ann Preston-Jones</b>
<b>Checked by</b>	<b>Adam Sharpe</b>
<b>Approved by</b>	<b>Andy Jones</b>

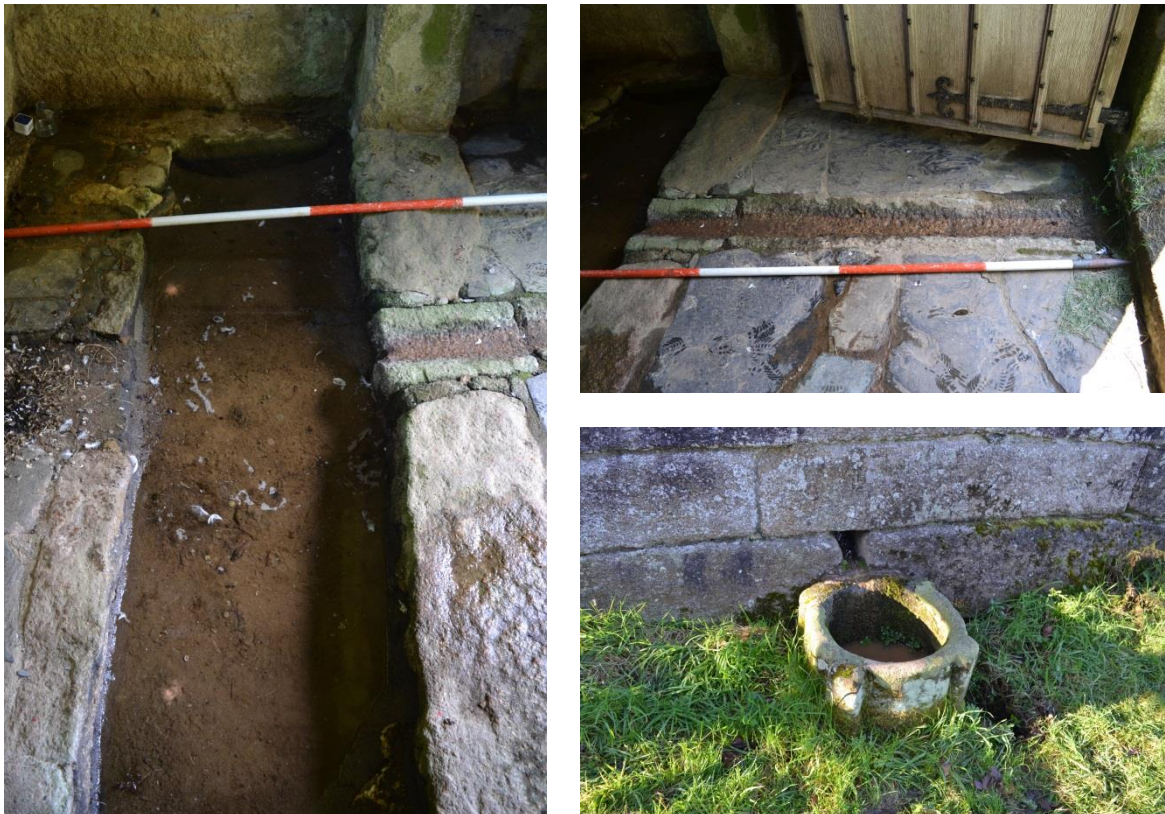
Fig 7. Visible features of the passage of spring water through the well-house. Left, the main trough or pool (before recent repointing). Top right, the granite launder conducting water across the well-house floor to the trough. Below right, the stone basin or mortar into which the water falls after exiting the well-house.

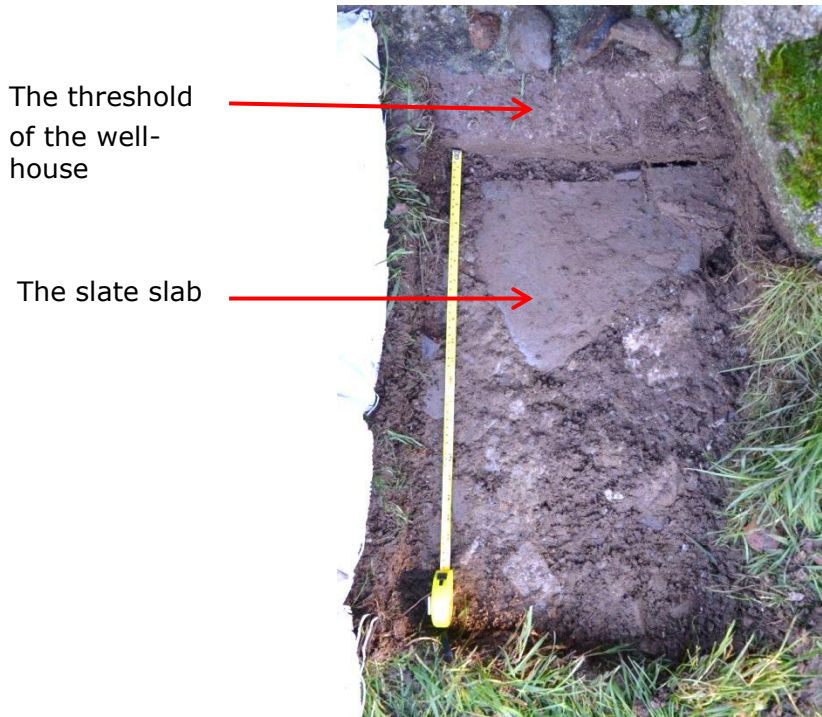
The initial discovery of a slate slab beside the threshold to the well-house (Fig 14) led to the expectation that a neatly-constructed slate culvert would be found, which could be easily traced back to the source of blockage or collapse. This hope proved unfounded, however. Further turf removal only resulted in the discovery of a series of relatively loose rough stones set in yellow-brown clay, adjoining an area to the west of heavily consolidated mid-brown earth and stones, possibly representing a path leading to the entrance (presumably that noted above on page 12). Moving further south, towards a slightly hollowed area suspected as a possible blocked chamber, a large 1.2m long slab of rough granite was identified, and then a series of larger, but randomly-set relatively loose stones in yellow-brown clay with many voids (Fig 15). This was on the site of the slight hollow previously identified by Peter Coombe as the likely site of a collapsed chamber.

Fig 14. The slate slab at the doorway to the well-house: originally (but wrongly) thought to be covering a neat slate-built culvert.

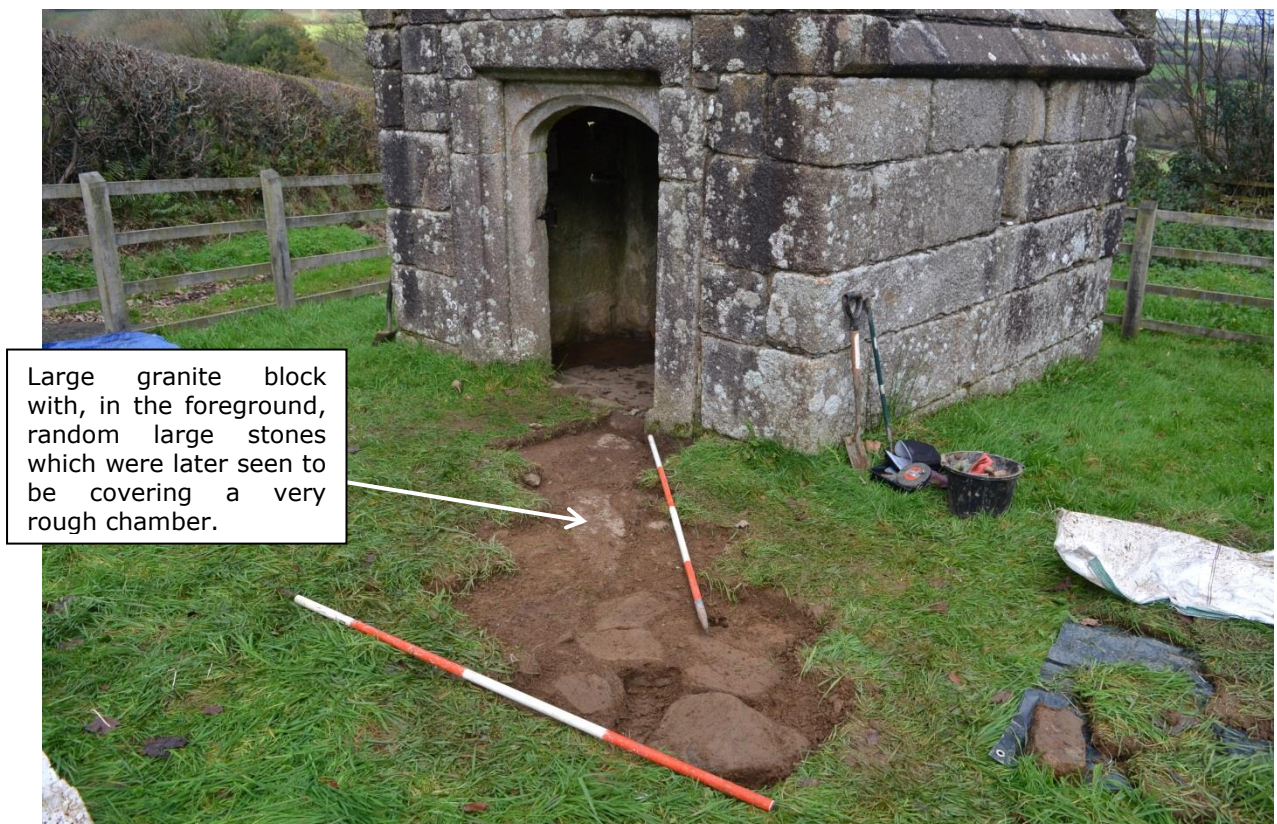
Large granite block with, in the foreground, random large stones which were later seen to be covering a very rough chamber.

Fig 15. Turf removed from the line of the culvert, to reveal a large piece of granite and various slabs of stone. The latter were lifted, to reveal the slate slab seen in Figure 16.

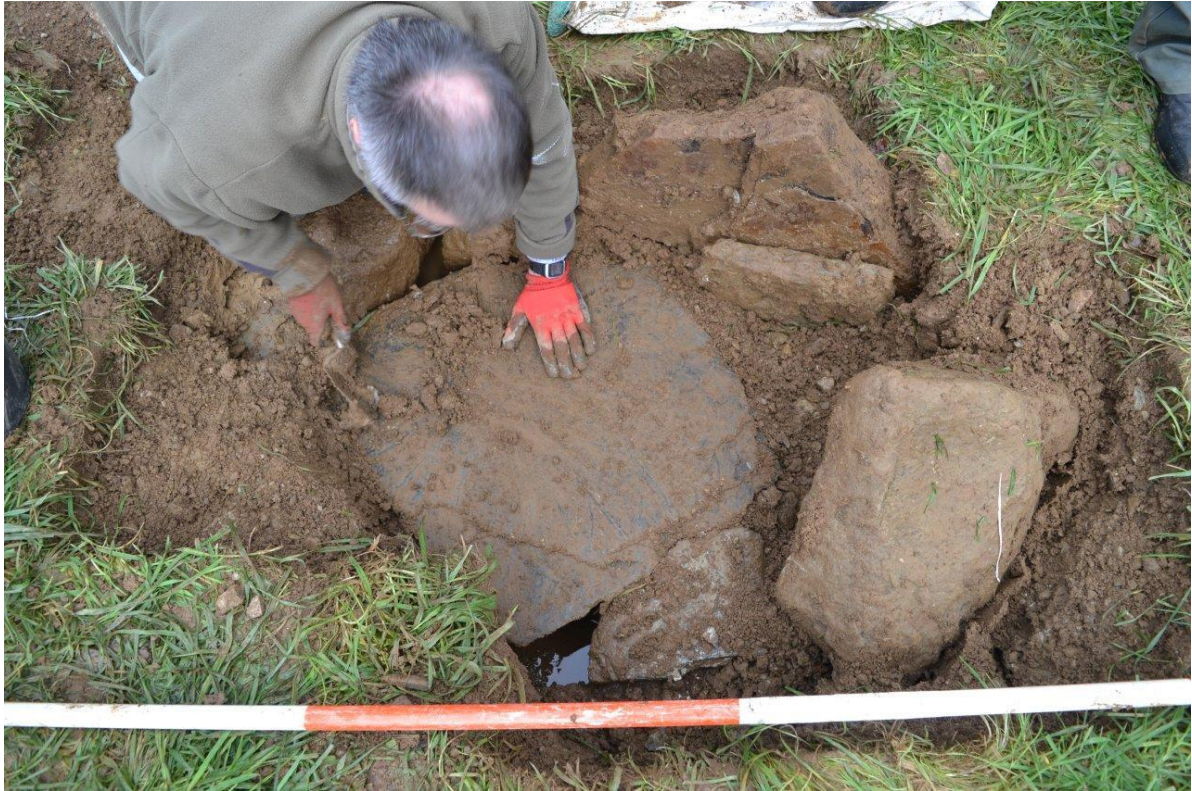
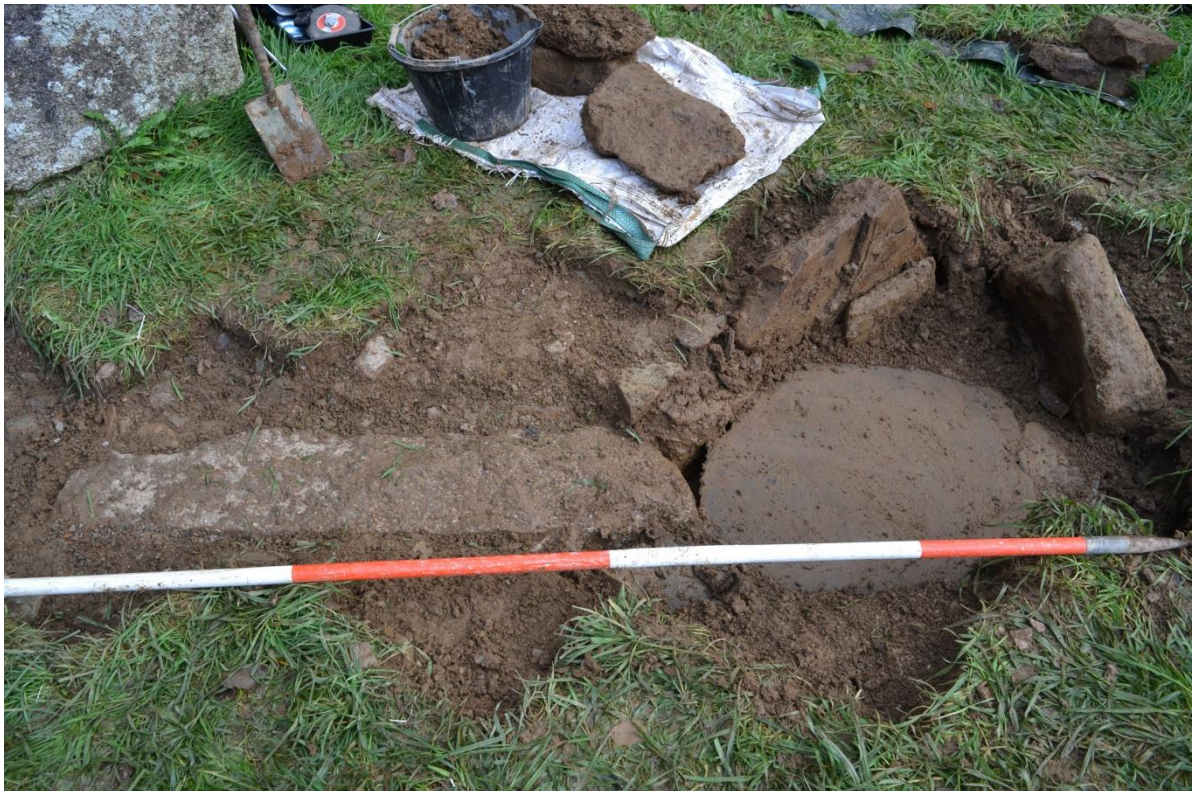
*Fig 16. The first of the slate slabs to be revealed, covering the 'chamber', and its relationship with the inverted granite laundry.*

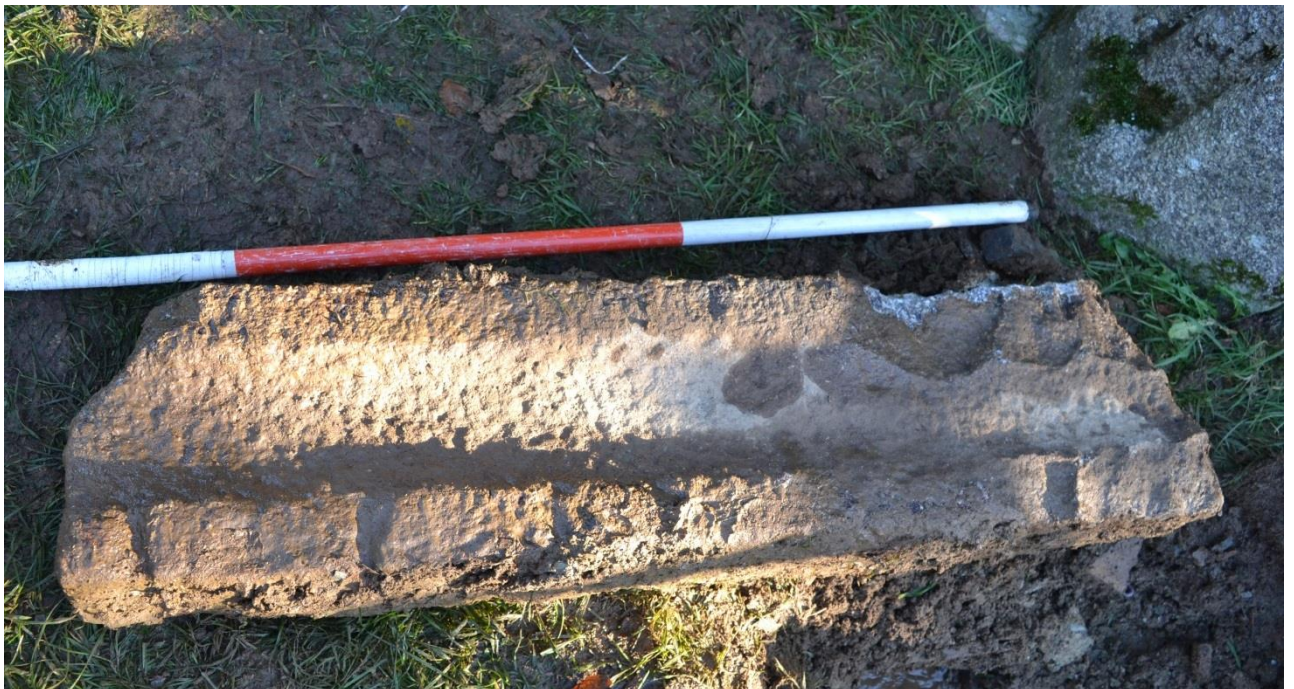
When the granite was lifted, it was found to be a granite launder, similar to those used to conduct water across the floor of the well-house and into the trough or pool. This had been inverted for re-use as a capstone, but as it had been set on only a few small stones, the available channel beneath it was no more than 10cm high. The granite launder measured overall 1.2m long by 15cm deep and 0.15 to 0.25cm wide. Cut into its upper surface (which was facing down when in use) was a curved channel, 12cm wide and approximately 1.5cm deep (Figs 19 and 20). Along one long edge, a series of half-round linear hollows 2cm wide and approximately 17cm apart were noted: the remains of drill marks, indicating that the launder is of 19th century origin. It had been damaged on one side, which may explain why it was re-used in this way.

Fig 20. The granite launder which had been inverted and used to cover the 'culvert'. Note the drill marks along one edge (especially clear on the bottom left of the picture) and the fact that it is slightly damaged (top right on this picture).

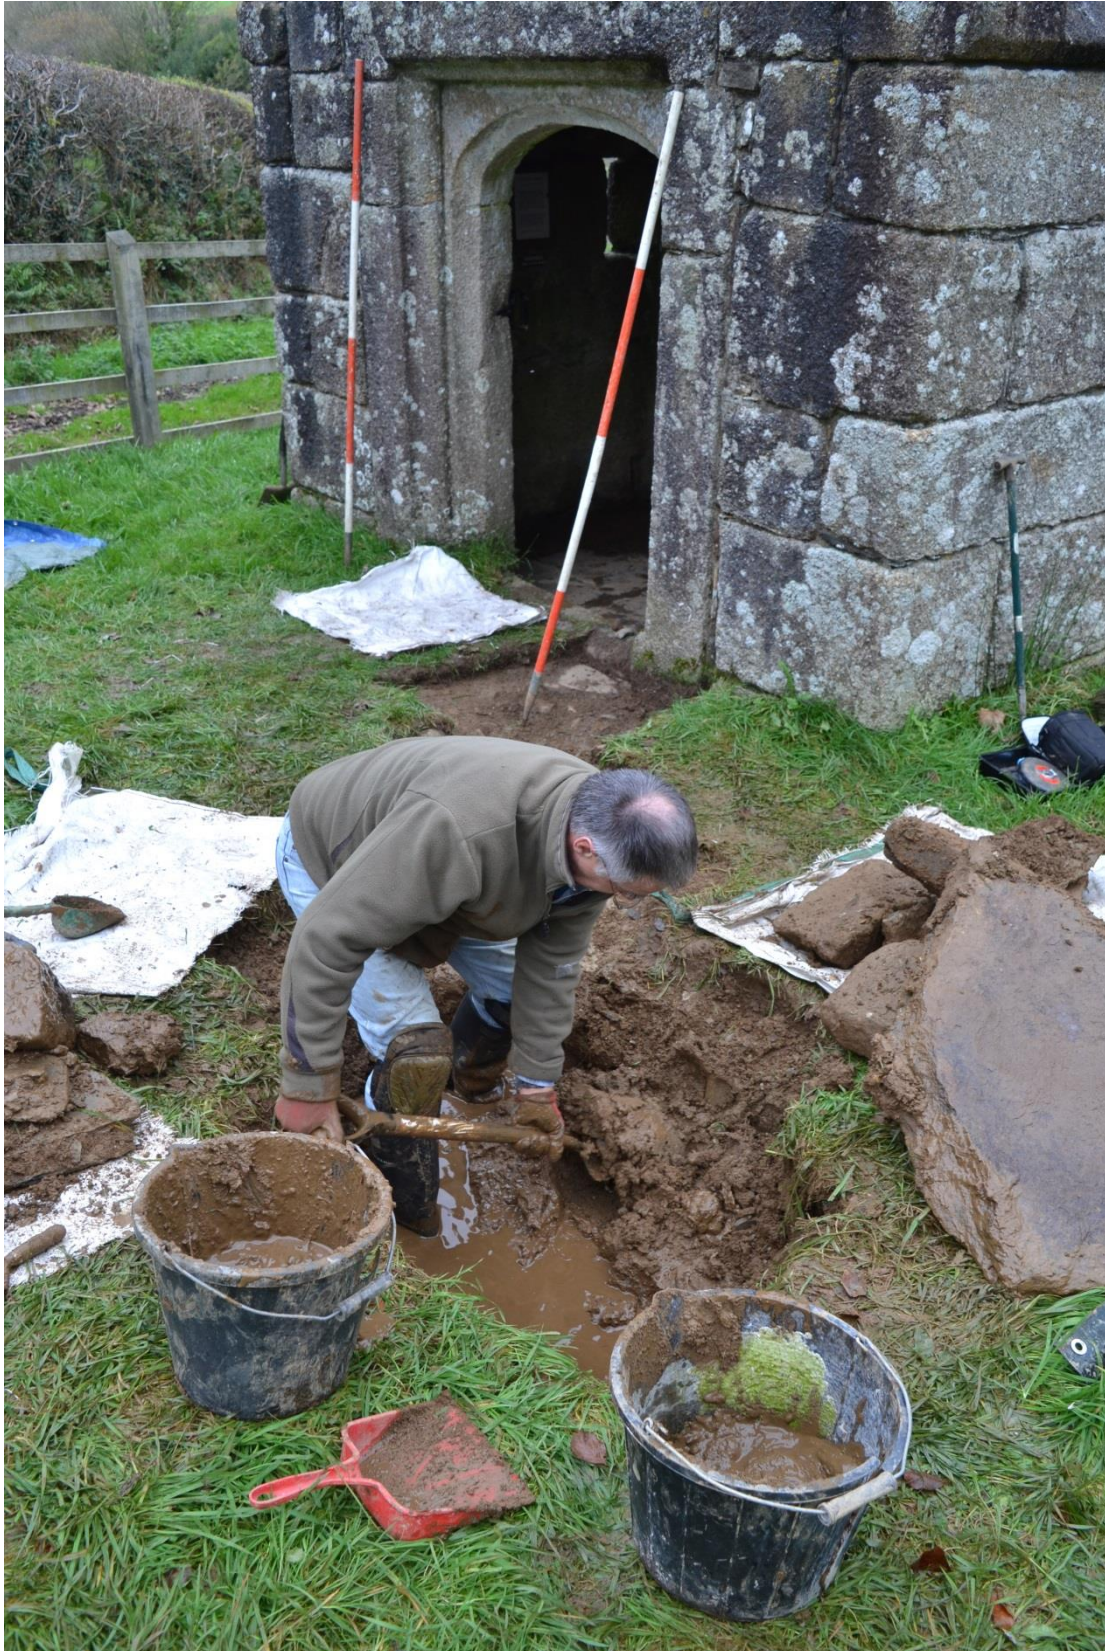
At the base of the chamber was a layer of silt at least 10cm thick. This was dug out to help improve the flow of water (Fig 21). The back of the area revealed by the removal of all these stones was excavated 20-25cm to the south and east. To the south lay a uniform deposit of yellow-brown clay and stones, possibly hitherto undisturbed subsoil while to the east, the subsoil was more disturbed and was cut by a highly decayed iron pipe, approximately 1½ inches in diameter (3.8 cm) (Fig 23). At the base, bedrock - a green-black slaty stone - was encountered and it could be seen that the water was trickling from the junction between the subsoil and the bedrock (Fig 22).

*Fig 21. Andrew Langdon clearing silt from the alleged chamber.*

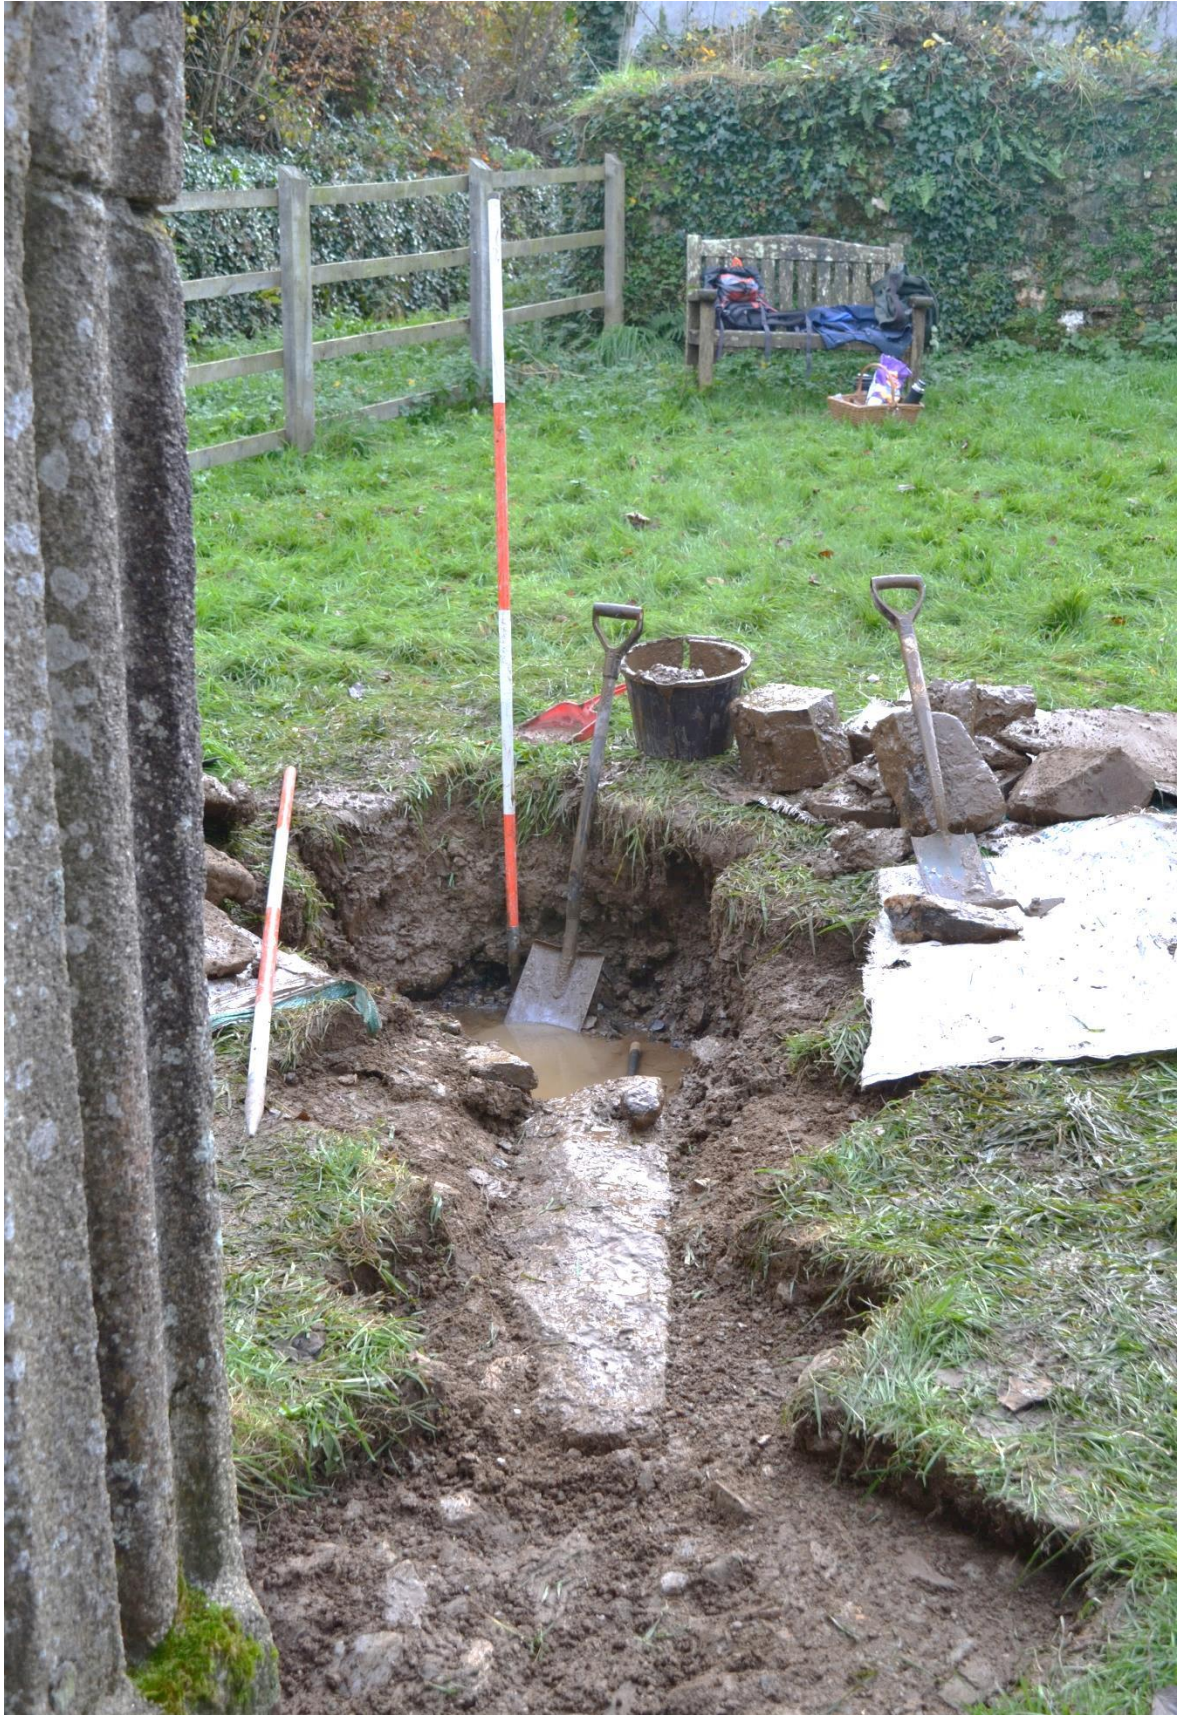
*Fig 22. View southwards, from the doorway of the well-house, showing the full extent of the excavated 'chamber', 0.7m deep. Bedrock can be seen at the back of the excavation, at the bottom, behind the shovel, as well as the unconsolidated clay sides of the hole.*

The repaired chamber is centred at SX 37497 69215, approximately 2m south west of the south corner of the well-house (Figs 22 and 26).

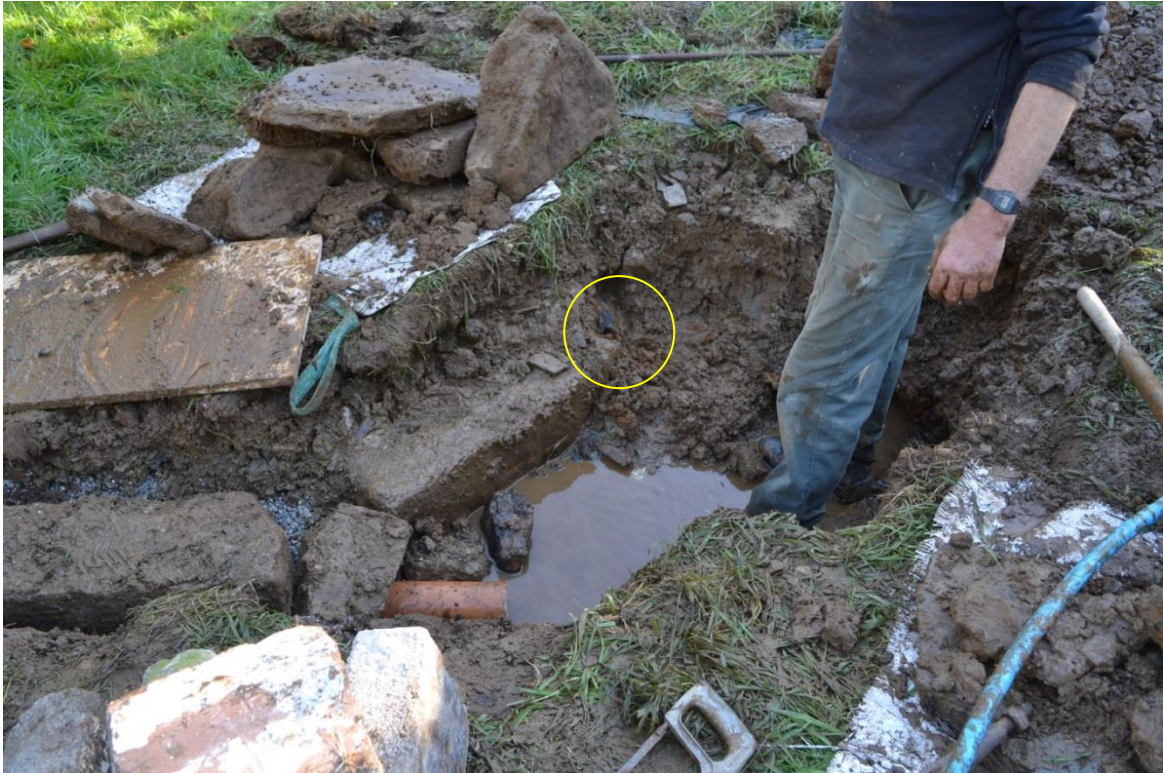
*Fig 23. Iron pipe seen at a late stage, in the excavation on the east side of the 'chamber'. The pipe was black as a result of corrosion which had stained the surrounding ground red. The pipe had been previously cut through, presumably by earlier work on the chamber – it was not damaged during this project. The fall of the pipe (as far as we could ascertain) appeared to be from east to west and its purpose was uncertain.*
